ARCHITECTURAL ANALYSIS | STOOP - NEERLANDIA - PROZEE

TU Delft | RMIT | MSc 3 graduation studio
post-war areas Utrecht, 2011/2012

analyse : architectural & techical
subject : Stoop - Neerlandai - Prozee
area : Utrecht/South/Hoograven

*Verlengde Hooggravenseweg 71
3525 BB Utrecht*

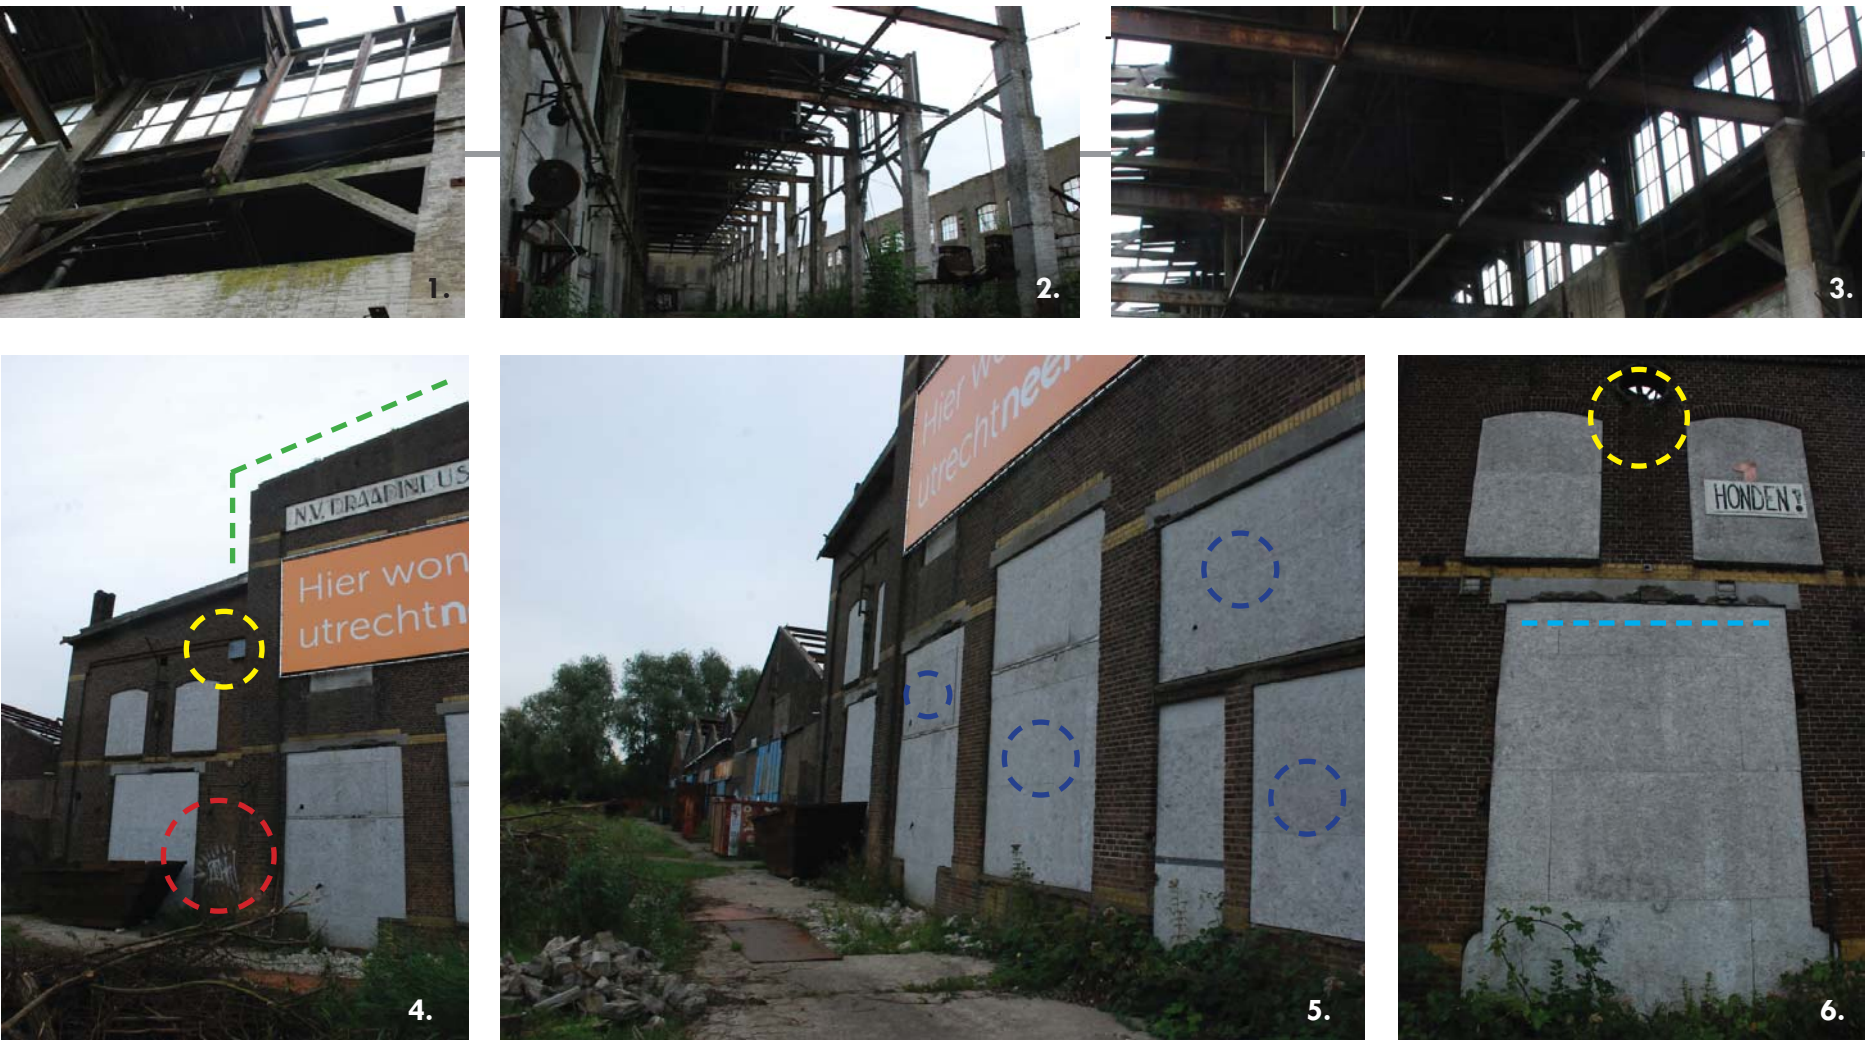
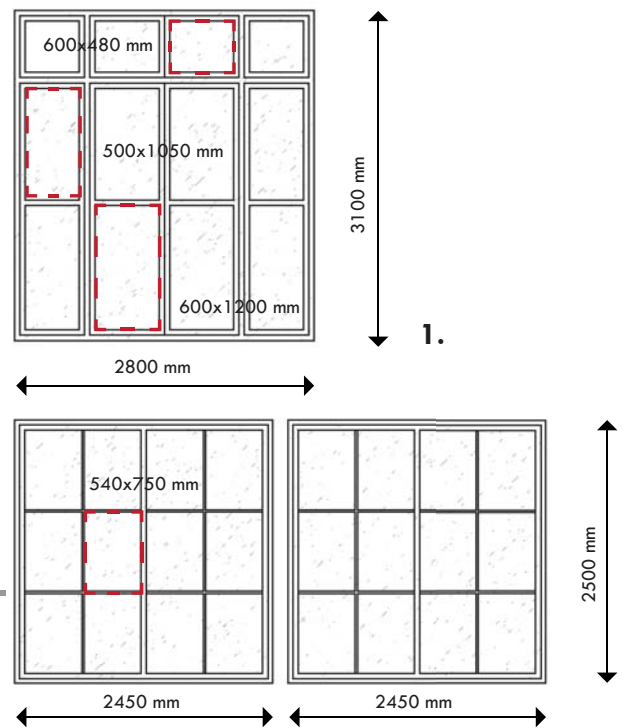
West Facade:

Today, this side is not used for access - the windows and doors had been closed (5) leaving no physical trace of the window design or elements. The lintels are mostly intact (some decay of the plaster and concrete) as well as the decorative yellow brick (6)

The facade doesn't show significant structural damage; however some installations have been placed on it - electrical panels, ventilation fan drilled in the facade (4,6) and there are some accidental plaster marks on it.

Most of the wooden frames on the south side of the building disappeared, except one (2). The wooden window frames on the north facade are still there but in a bad condition; rotten styles, glazing disappeared (3)

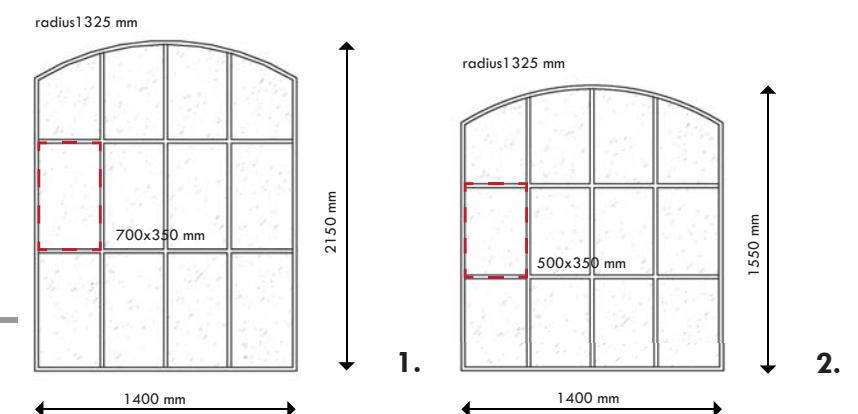
The lower part of the facade had been plastered and shows moisture marks (water infiltration) at the base.

The roofline of the central nave is damaged towards the south side. (5)

the other cast iron frames at the north and south facade are still there but there are strongly corroded. The tipping area of the frame are missing in some parts even as the glass (2).

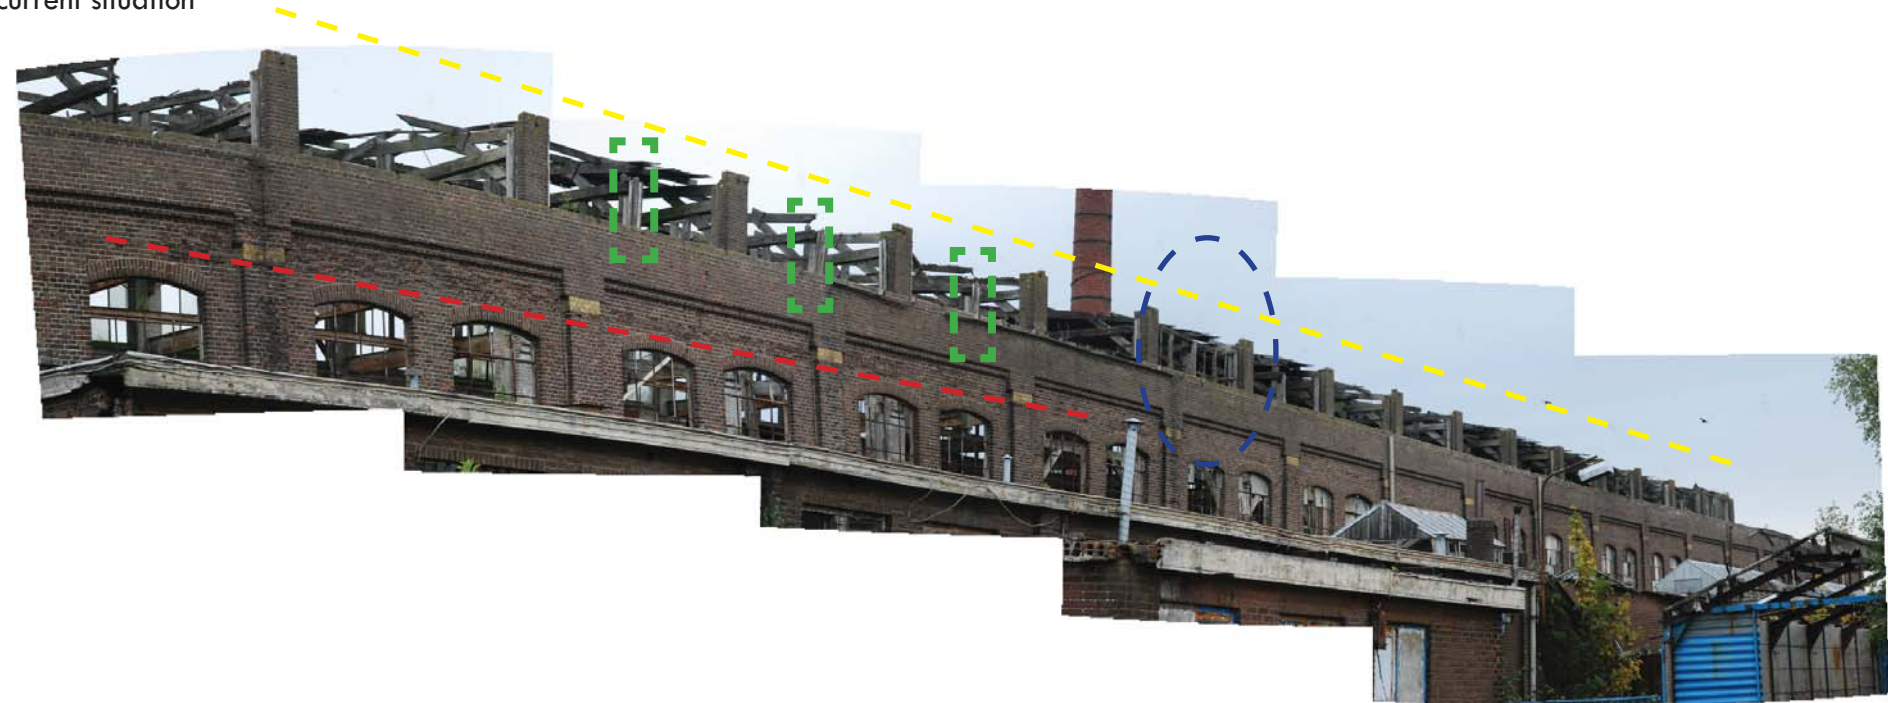
The South facade shows the most structural damage, due to lack of maintenance, which resulted in exposure (to water, wind, change of temperature) and in the end damaged the construction. The upper part of the facade - central nave part - is almost entirely missing; there are almost no windows left, only bricked pillars with fragments of the wood structure from the south apsis.

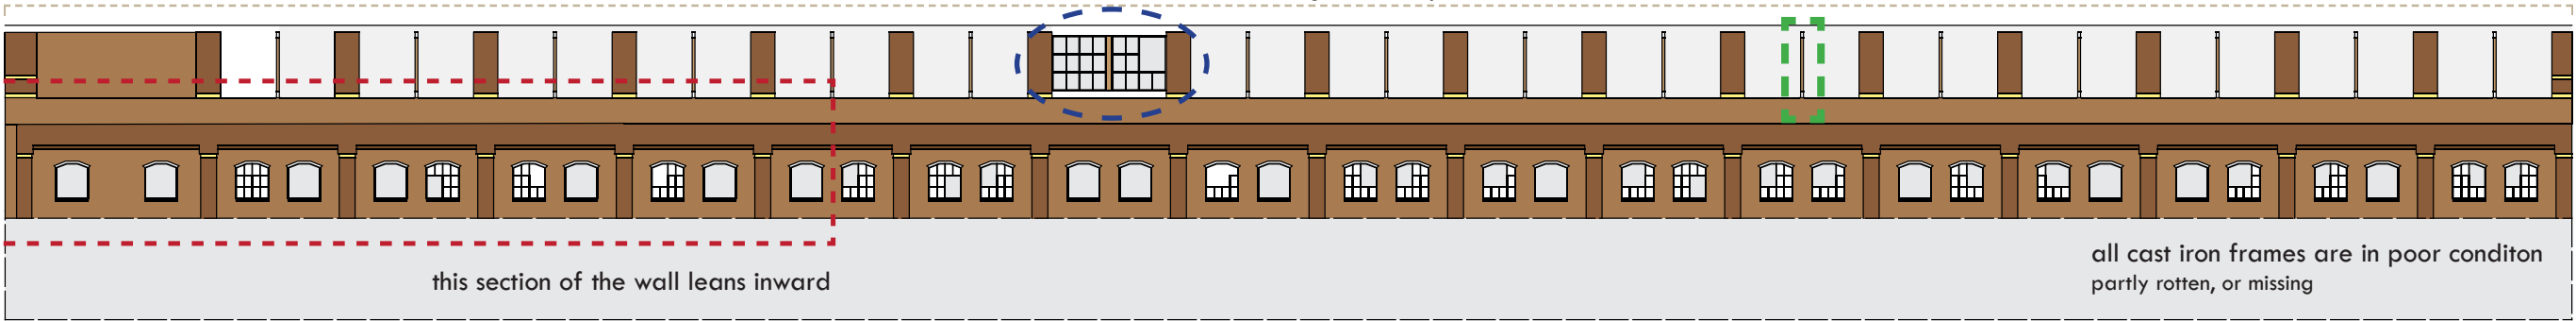
current situation

roof is severely damaged, most part is missing
eaves are almost disappeared

underlying wooden structure is visible by the disappearance of the frames

this section of the wall leans inward

all cast iron frames are in poor condition
partly rotten, or missing

the side wall is along its entire length to a height of 2.5 meters hidden behind an expansion

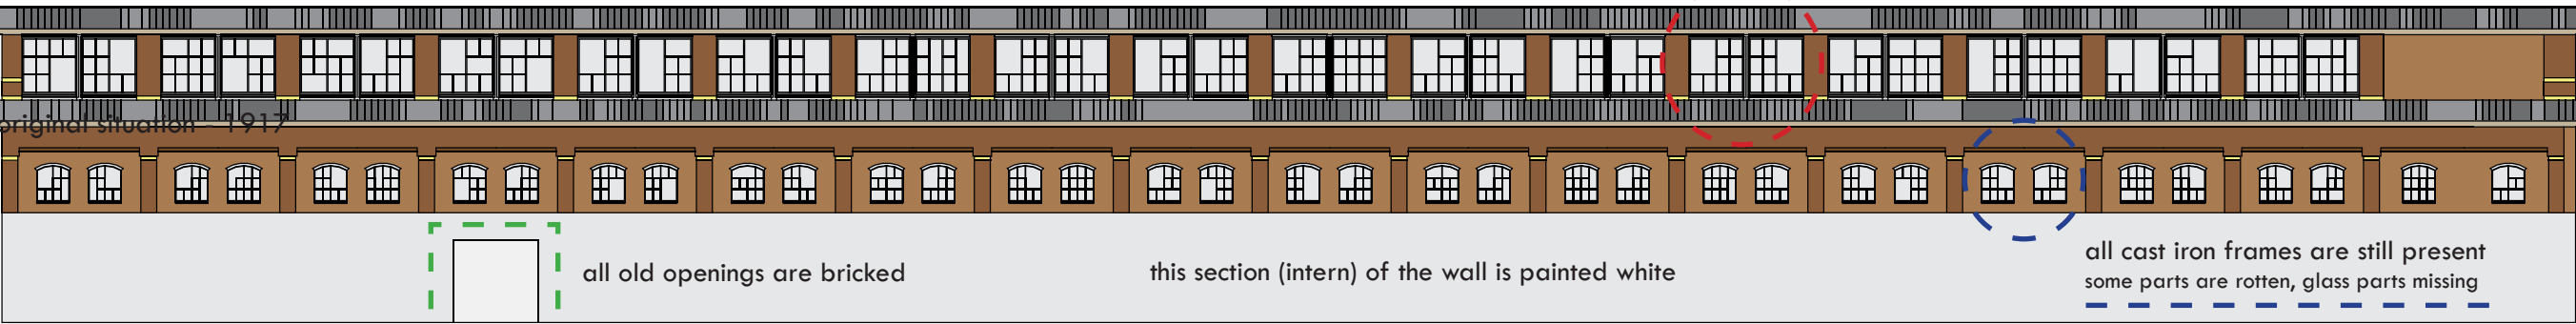
current situation

roof is severely damaged, some parts missing
eaves are almost disappeared

all wooden frames are still there
but in a poor condition, some glass parts missing

the side wall is along its entire length to a height of 2.5 meters hidden behind an expansion

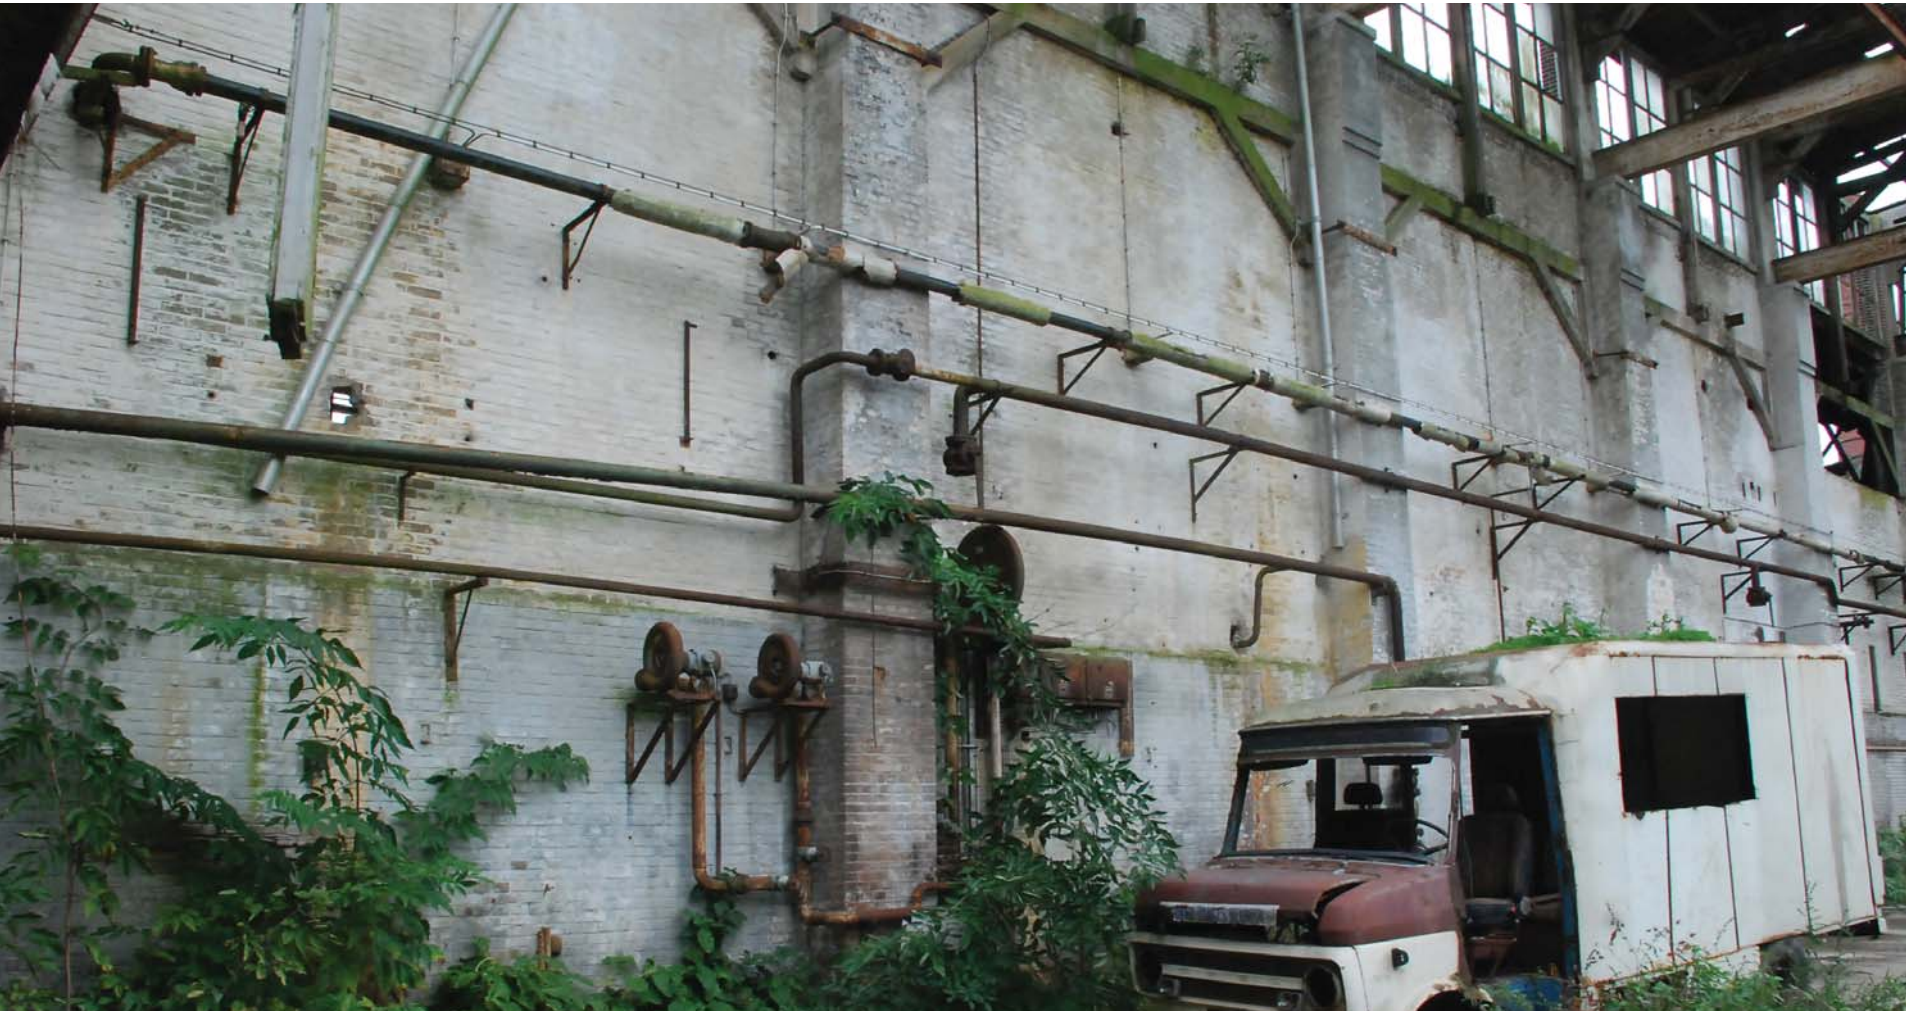
The wall of the central apsis doesn't show major traces of structural damage (1) The few cracks that are visible maybe caused by: instalation weight and un-strengthened openings in the wall (3) Also the mid-floor in the north apsis that is anchored by metal beams to the central apsis wall may be cause of structural failure (3)

Due to water infiltrations or direct exposure to rain biological groth and calcium deposits developed on the wall's surface (1,2,3)

The metal beams from the north apsis and their connection to the walls do not show high structural damage. However, the brick infill of the floor is damaged all along the north apsis wall. (3)

The I profile beams that form the roof structure of the building extension (south) are visible on the south apsis wall and are exposed to external factors, therefore they are rusted. Their exposure also determines a cold bridge in the annex building (4)

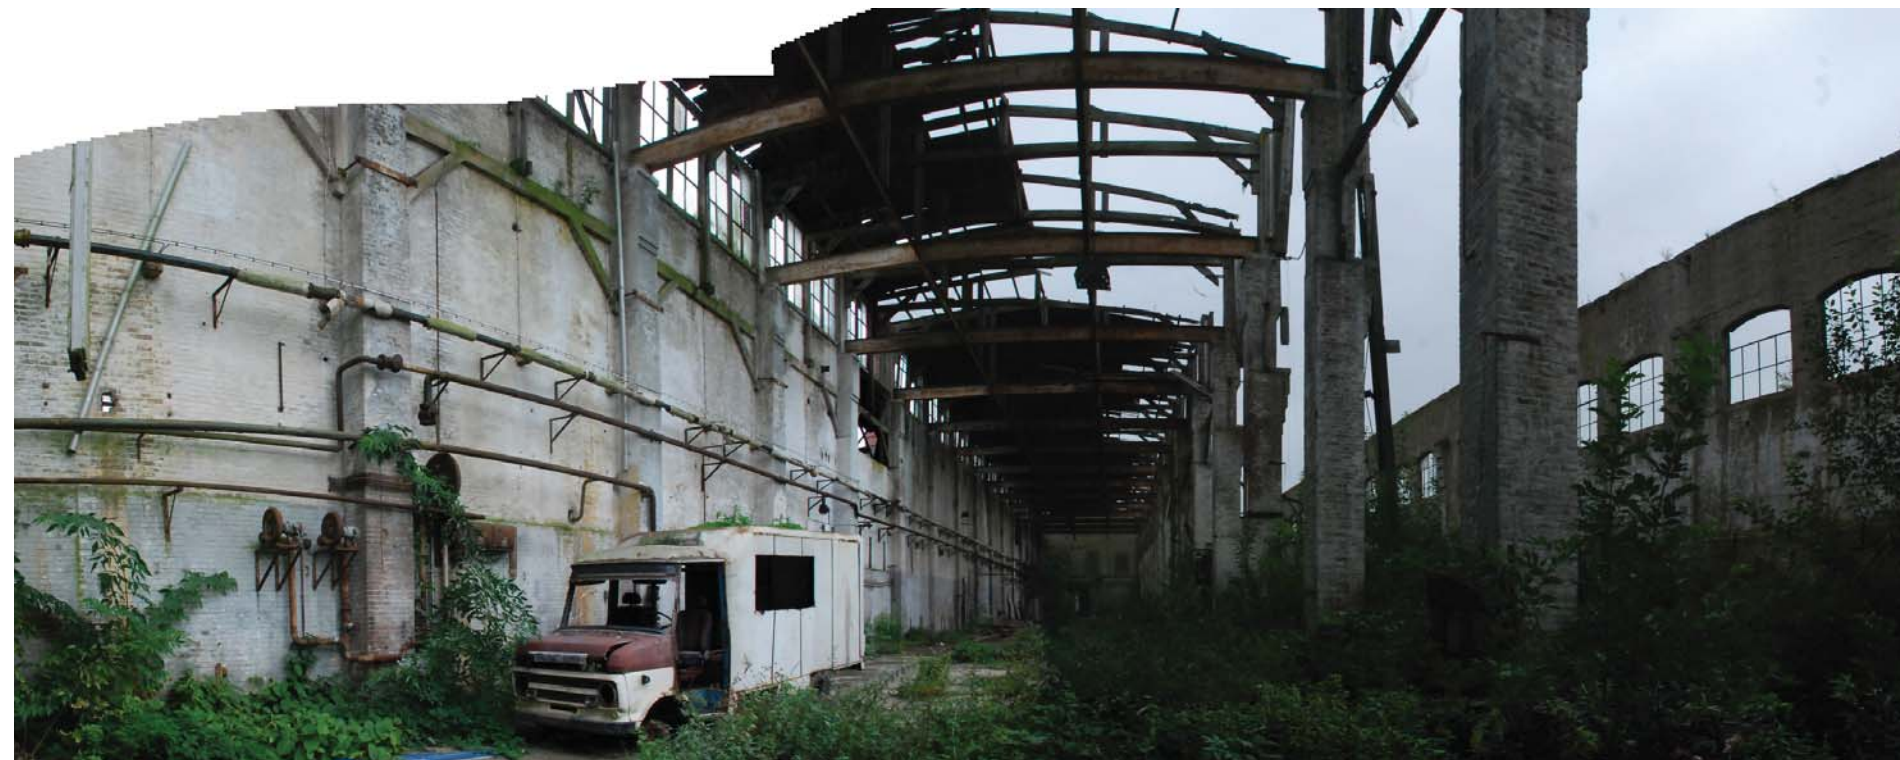
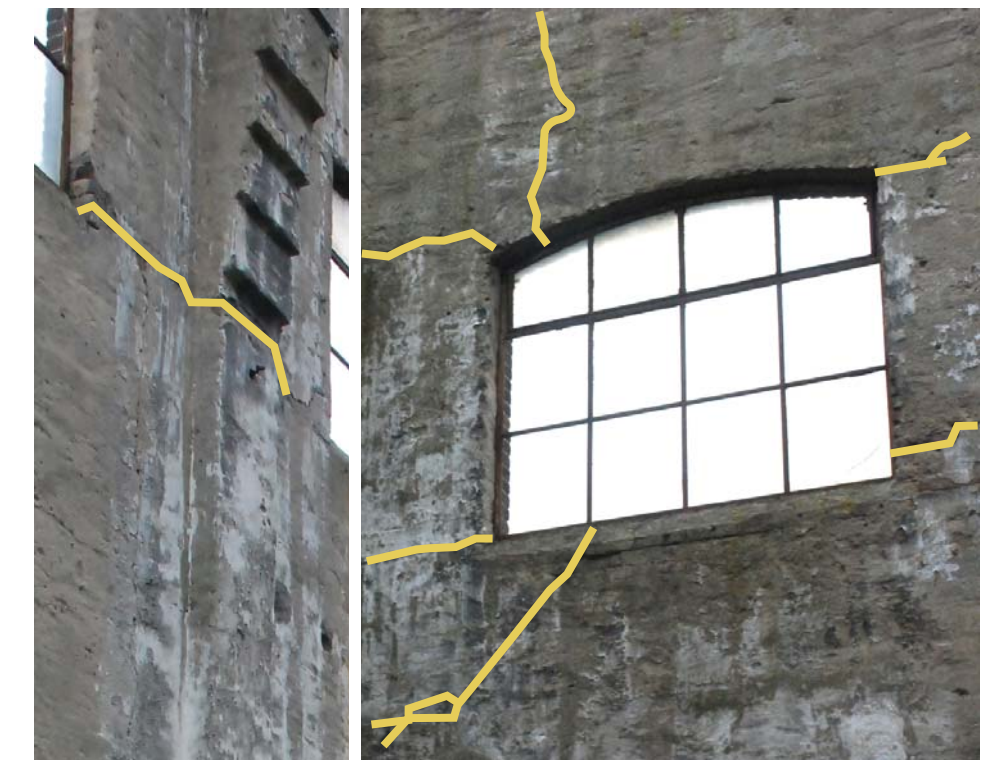
The wooden structure of the central nave suffered high damage due to exposure to external factors and lack of maintenance:

The truss edges are mostly damaged on the south side - due to the earlier destruction of the roof which now is almost completely gone on the south side. The trusses that do not rest on the central pillars are mostly gone, especially in the area where the roof has been completely damaged. The reason is most probably the failure of the whole wooden truss system that connects the central and the lateral trusses.

There are no trusses left on the south apsis; most of the purlins that rested on the central truss have disappeared; the struts between the south row of central pillars are heavily damaged or completely gone.

Structural cracks are visible around most of the windows of the south apsis - the lack of transversal structural connection made the wall of the south facade unstable and naturally cracks occurred around the openings.
