Shearography non-destructive testing of a composite ship hull section subjected to multiple impacts

Proceedings of the 20th European Conference on Composite Materials: Composites Meet Sustainability

An overview of the composite ship hull section is shown in Fig. 1. The dimensions are about 6 meters in height and 2.3 meters in width. The structure is made from FRP laminate skins and foam cores. The composite ship hull section is a RAMSSES demonstrator [11,12] at Damen Shipyards. Before shearography inspection, multiple impact tests (https://vimeo.com/522716506) surpassing helicopter emergency landing loads have been performed on the hull shell and its composite helicopter deck for proving the resilience of composites to harsh marine environments. The impacted area on the hull shell is shown in Fig. 1(c).

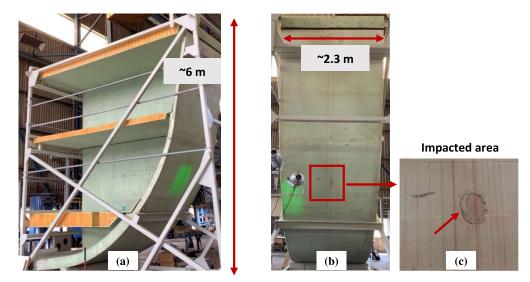
Figure 1 The composite ship hull section at Damen Shipyards: (a) Overall view. (b) Front view. (c) The area with multiple impacts on the hull shell.

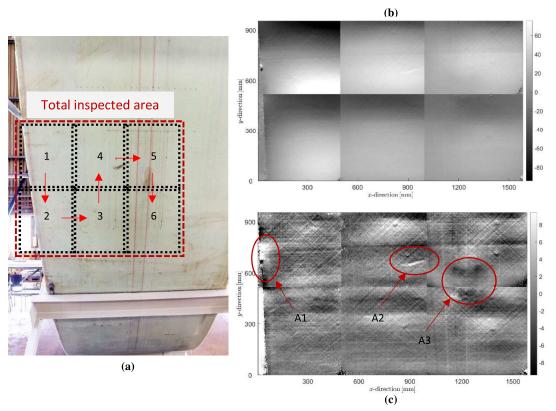
The experimental results with thermal loading are shown in Fig. 3. A total area of about 1500×900 mm² was inspected by stitching six FOVs of 600×600 mm² [Fig. 3(a), 2 in the vertical direction by 3 in the horizontal with about 20% overlap for stitching]. Phase-shifted sets of speckle images were captured continuously during cooling. All sets of the recorded images were analyzed and stitched together to produce built-up phase maps of the whole area [Fig. 3(b)] that represent the evolution of the surface out-of-plane strain during cooling. The resultant phase map was further processed to obtain the compensated phase map [Fig. 3(c)], where the defect-induced deformation was extracted [10]. This compensated phase map reports the presence of damage in the structure. The stitching process can be further improved by considering the shape of the surface, the positions of the camera and the laser [13]. The damage in the impacted region is not obvious, this can be because its position is close to the edge of the FOVs no.5 and no.6, which makes it difficult to extract actual defect deformation.

Figure 3 Stitched inspection results for six FOVs with thermal loading: (a) Total inspected area (FOVs no. 1-6). (b) Origin phase map. (c) Compensated phase map, A1 - skin-to-core debonding, A2 - heat damage, A3 - impact damage of interest. [Unit of phase is radian]
