Case Studies on Failure Investigations in Structural and Geotechnical Engineering

# Balconies in Maastricht

Karel C. Terwel

*This chapter focuses on human and organisational factors that are usually behind the technical cause of failure. This is illustrated by a case of the collapse of five balconies in 2003 in Maastricht (The Netherlands) resulting in two fatalities.*

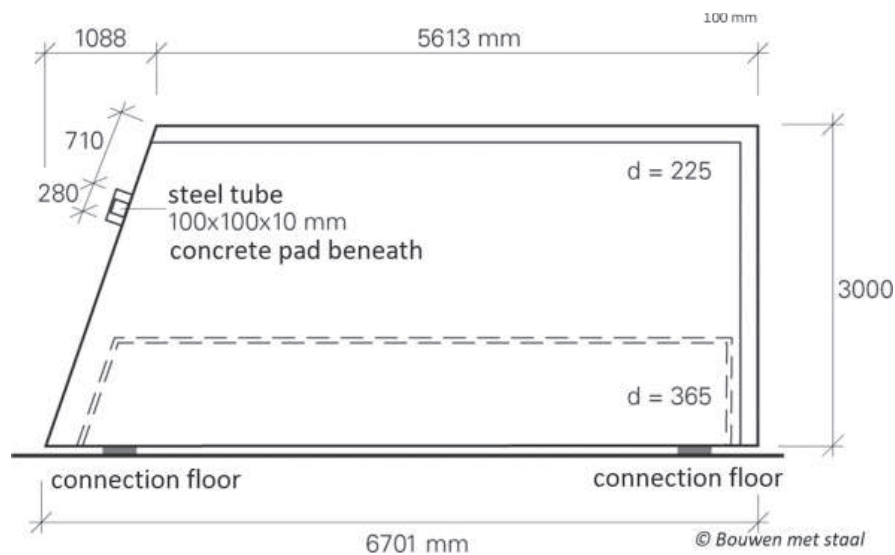
To provide a stable structure a steel column, 100 mm \* 100 mm was added as third support. This column was supported by a foundation wall beneath (see Figure 4.1 for a top view of the standard balconies).

**Figure 4.1** Top view of standard balcony with the position of the steel tube column (adapted from [11, 13] with permission). Mind that balcony slab level 1-5 is thicker than slab on ground level (Figure 4.3).

First, the column was repositioned towards the boundaries of the slab, to be able to integrate the column with the finishing structure (aesthetical reason [11]). Figure 4.1 clarifies the final, changed position of the column. To be able to support the balcony on a pad at the side of the balcony a slab is required (see also figure 4.1). Second, during preliminary design the engineer designed two moment-resisting connections, between the apartment floor and the balcony slab. During the technical design phase, this was changed by a supplier into two hinged connections [6]. These changes resulted in a less robust solution that was more vulnerable to failure.

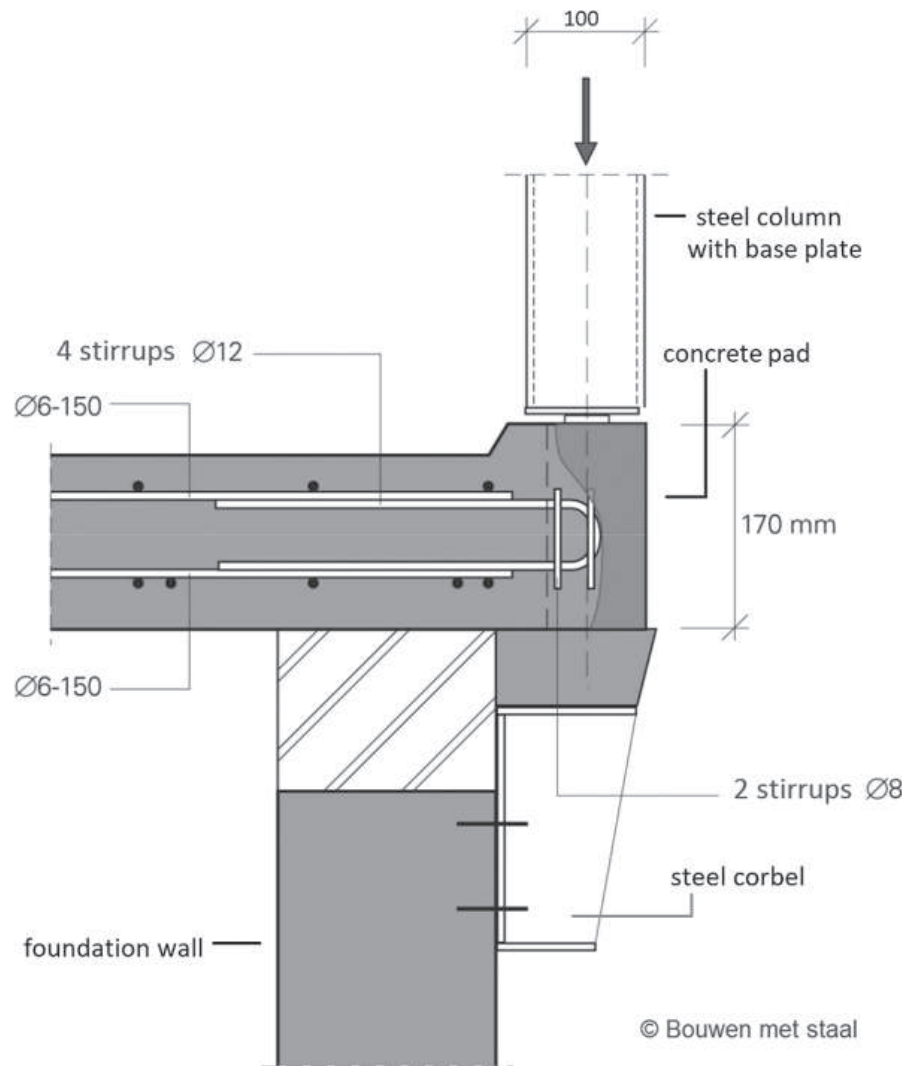
During construction, cracks were observed in the balcony of the ground floor. It appeared that this balcony was reduced in thickness, and that the position of the column was not aligned with the supporting wall, after a change in design. These changes were not incorporated in the design. Therefore, the pad on the ground floor underneath the column was not supported by the foundation wall. This inadequacy was fixed by applying a steel corbel underneath the concrete pad (see figure 4.2). The height difference between the top of the steel corbel and slab was filled with masonry. In this way, it was assumed that the essential column 100\*100 was adequately supported.

Various parts of the structure were subject to the forensic investigations. Experts agreed that detailing of the reinforcement of the pad at ground floor was inadequate and not according to the codes. Furthermore, the bolted connection of the steel corbel on the foundation wall was not properly constructed and the connection between the steel corbel and the concrete pad was suboptimal.

Finally, it was concluded by experts and court that the combination of a bending moment and a concentrated force on the small pad resulted in failure of the pad at ground

**Figure 4.2** Detail of solution with steel corbel ground floor (adapted from [11, 13] with permission).

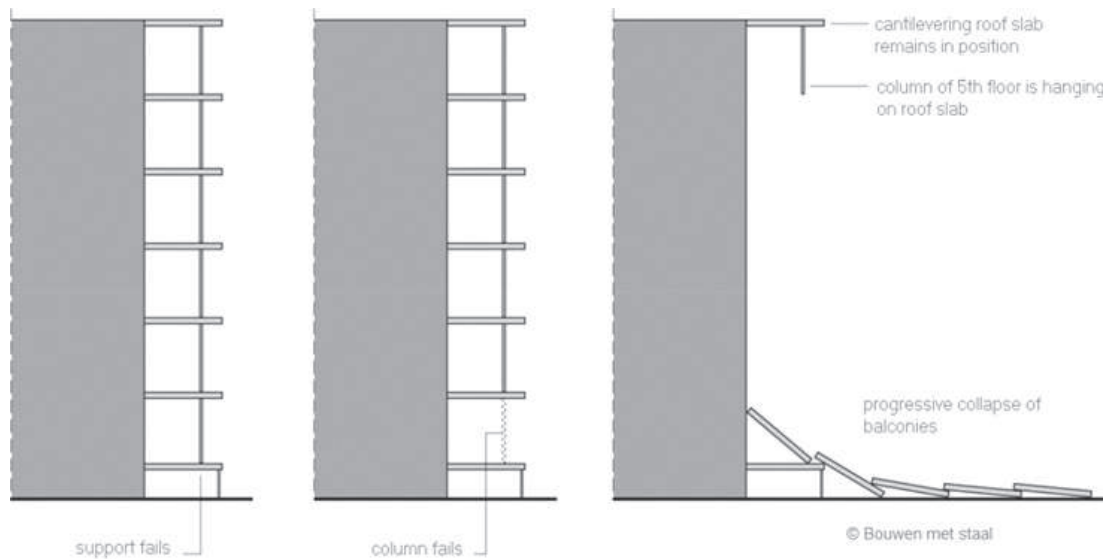
floor level. This resulted in a progressive collapse of the other balconies (see Figure 4.3) as the columns lacked support [3]. The triggering event was not evident; it was suggested that a relatively warm day resulted in lengthening of the steel columns, or that creep effects of the roof slab might have played a role [4].

**Figure 4.3** Side view of building: initial failure leading to progressive collapse (adapted from [11], with permission).
