Corrosion-Fatigue Failure of Gas-Turbine Blades in an Oil and Gas Production Plant

Abstract: This paper investigates the root cause of a failure in gas-turbine blades, made of Nimonic-105 nickel-based superalloy. The failure was reported in two blades in the second stage of a turbine-compressor of a gas turbine in the hot section. Two failed blades were broken from the root and from the airfoil. The failure took place after 20 k h of service exposure in the temperature range 700–850 °C, with the rotating speed being in the range 15,000–16,000 rpm. The microstructures of the failed blades were studied using optical/electron microscopes. Energy dispersive X-ray spectroscopy (EDS) was employed for phase identification. Results showed that failure first initiated from the root. The dominant failure mechanism in the root was concluded to be corrosion-fatigue. The failure scenario was suggested based on the results obtained.

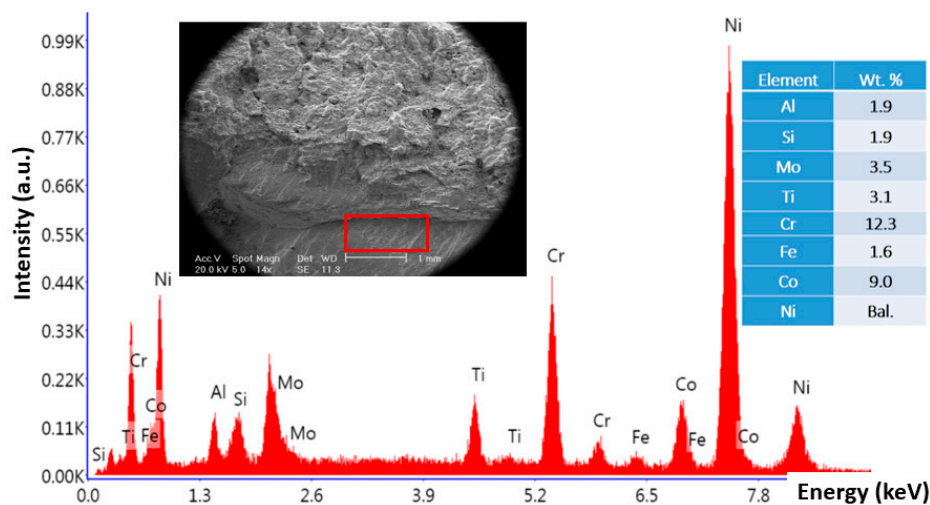
Results of EDS analysis of the microstructure further away from the edge is presented in Figure 5. There is hardly any oxygen, Na, Ca, K, and Cl in the analysis, inferring that the aforementioned corroded area is limited to few hundred micrometers from the edge.

Figure 5. EDS analysis of the area with beach marks in the failed blade, broken from the root.

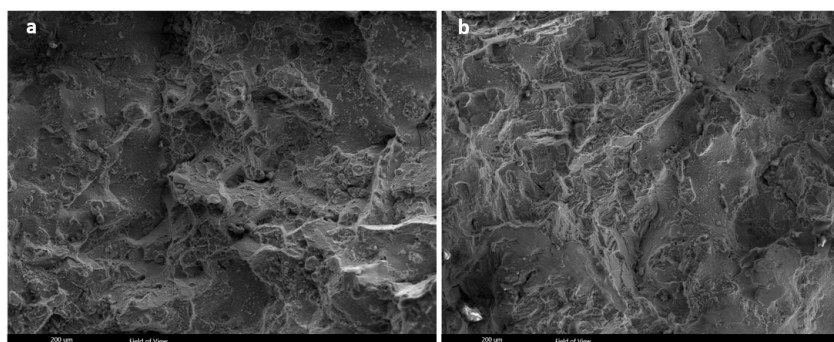
Figure 7. (a,b) SEM micrographs of fracture surface of the blade, broken from the airfoil.

- Fractography of the blade that failed from the airfoil showed that, contrary to the former case, there is hardly any fatigue involved in the failure of this blade.
