Health condition monitoring of insulated joints based on axle box acceleration measurements

Engineering Structures

Health Condition Monitoring of Insulated Joints based on Axle Box Acceleration Measurements

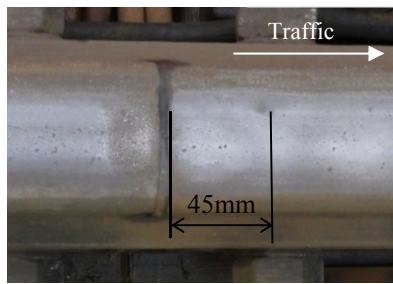
(a) IRJ number 1 with light surface deformation.

In this section, four IRJs from the track Eindhoven – Weert (E-W) were investigated, IRJ number 1 and 2 with light plastic deformation (Figure 5a-b) and the IRJ number 3 and 4 with severe plastic deformation of the rail surface (Figure 5c-d). The plastic deformation is caused by the impact occurring after the gap and has a typical wavelength of about 35-50 mm (Oregui et al, 2015b). Since IRJ number 2 with light surface deformation did not have any other visible damage at the fastener and insulation layer, it will also be used for comparison in the next sections as a reference IRJ in normal condition.

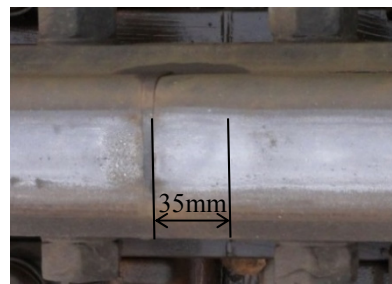
(b) IRJ number 2 with light surface deformation.

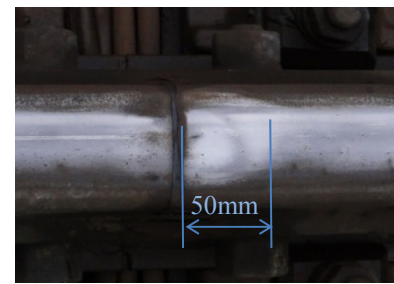
(c) IRJ number 3 with severe plastic deformation.

IRJ number 3 has the longest wavelength of plastic deformation (50 mm) and the highest local maximum ABA compared to the other three IRJs in Figure 6a. However, the PSD at 500-550 Hz for IRJ number 3 was not the highest among these IRJs, because the energy was distributed over a range of frequencies (270 Hz, 730 Hz, 830 Hz, 1150 Hz, see Figure 6b). This can indicate that there is damage in other components of IRJ number 3 besides plastic deformation of the rail surface (sleeper, fastener, etc.) Thus, there is no direct correlation between degree of plastic deformation of the rail surface and PSD at 500-550 Hz. However, the combination of high ABA magnitudes and high values of PSD at 500-550 Hz can

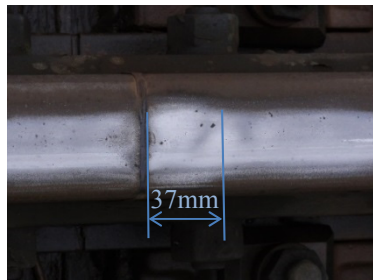
(d) IRJ number 4 with severe plastic deformation.

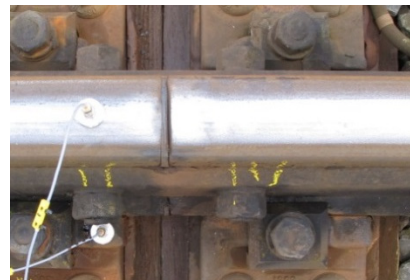
(e) IRJ number 7 with rusty fastening.

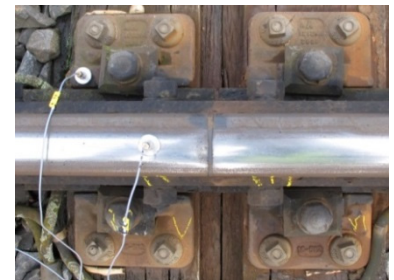
(f) IRJ number 8 with rusty fastening.

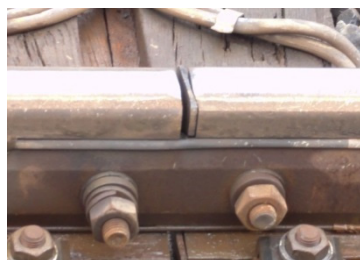
(j) IRJ number 16 with damaged insulation layer and a crack in the fastener.

In this section, an IRJ number 16 with two types of damage was investigated: with damaged insulation layer (Figure 5j) and the crack in the fastener (Figure 5k). The damage of the fastener for this IRJ was similar to the one of IRJ number 9 in Figure 5h.

The ABA at this IRJ is shown in Figure 7a with a solid line. The ABA magnitude at this IRJ is comparable to the reference IRJ ($a_{D_3}^{max}=86 \text{ m/s}^2$), but the wavelength is shorter than that of the reference signal. The PSD at the IRJ with the damaged insulation layer is shown in Figure 7b. The major two frequencies for this IRJ are 100 Hz and 645 Hz.

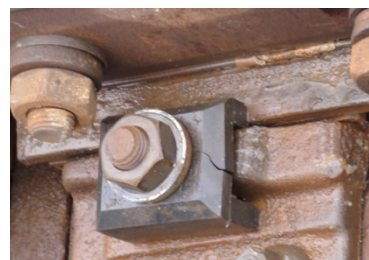
(k) IRJ number 16 with damaged insulation layer and a crack in the fastener.

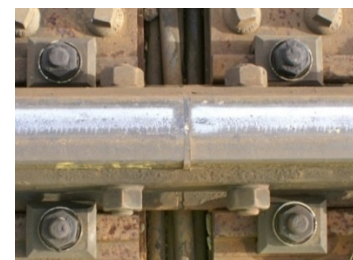
(l) IRJ number 3 on the track Groningen – Assen.

In Figure 4b the ABA on the track Groningen – Assen has less variation in values, than on the track Eindhoven – Weert, with the average local maxima ranging between 50 to 100 m/s². The IRJ with the highest ABA value is number 3, which has moderate degradation of the rail surface D_I (Figure 5l).

Figure 6c presents the ABA measured at IRJs 3 from the track Groningen – Assen (G-A), see photo in Figure 5l. The ABA signal at this IRJs had a wavelength of about 50 mm. The local maximum ABA was $a_{D1}^{max} = 100 \text{ m/s}^2$, which is quite close to the normal condition ($a_N^{max} = 91 \text{ m/s}^2$). The PSD at these IRJs is shown in Figure 6d. There major peaks for this IRJ are 90 Hz, 350 Hz and 570 Hz, which is consistent with the frequencies in Figure 6b.
