Surface characterization and microstructural evolution of railway rails in a medium-wide curve after preventive grinding

B. Schotsman ^{a,b}, M.J. Santofimia ^a, R.H. Petrov ^{a,c}, J. Sietsma ^a

Rail grinding
Preventive maintenance
Premium rail steel
Track test
Crack initiation

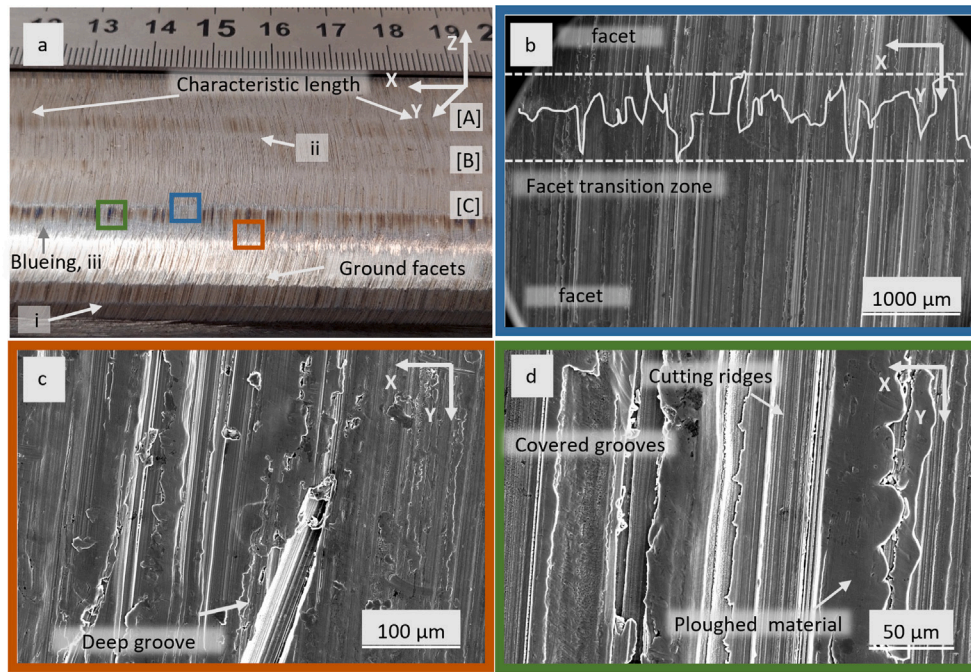
Fig. 3d presents the surface in the green-framed area of Fig. 3a and it encloses facet 7. Four characteristic features of the grinding grooves on facet 7 are:

- Cutting ridges are present at the bottom of the groove. In machining operations these ridges are associated with tool wear [16] and in grinding with the shape of the cutting face of the abrasive particles.
- Parallel grinding grooves, which display a mutual distance of $\sim 80 \mu$ m caused by abrasive particles that simultaneously treated the surface.

Fig. 3. Representative micrographs of the ground rail surface of sample RS0. (a) Optical micrograph of the ground surface. The measurement positions A–C, the characteristic length of the grinding process, and the various degrees of blueing, see *i-iii*, are indicated. (b) Facet transition zone. The extremities of the grinding grooves that define the transition zone are highlighted. (c) A grinding groove crossing the facet transition. (d) The characteristic grinding groove. Cutting ridges are present in the grinding grooves. At both sides of the groove ploughed material is observed.

- Plowing, which is characteristic for grinding [16] and causes material pile-ups or plowed ridges. At the $-X$ -side, the material is plowed directly adjacent to the groove, whereas on the opposite side, several smaller frayed layers are present covering adjacent grinding grooves. The smooth surface texture of the plowed material is caused by the rubbing of the abrasive particle on the surface.

Fig. 3a presents the freshly ground rail surface and Fig. 3b shows that the facets are connected by transition zones. During grinding with vertical-axis grinding systems, facets are formed on the rail surface that together approximate the contour of the rail head. The angle between the facets depends on the position on the head of the rail and is sharper at small radius sections and more obtuse at the top of the rail. This geometric deviation from the continuous rail contour causes contact stress concentrations at the transition zones which is, in the literature, indicated as a cause of damage initiation [13,15].

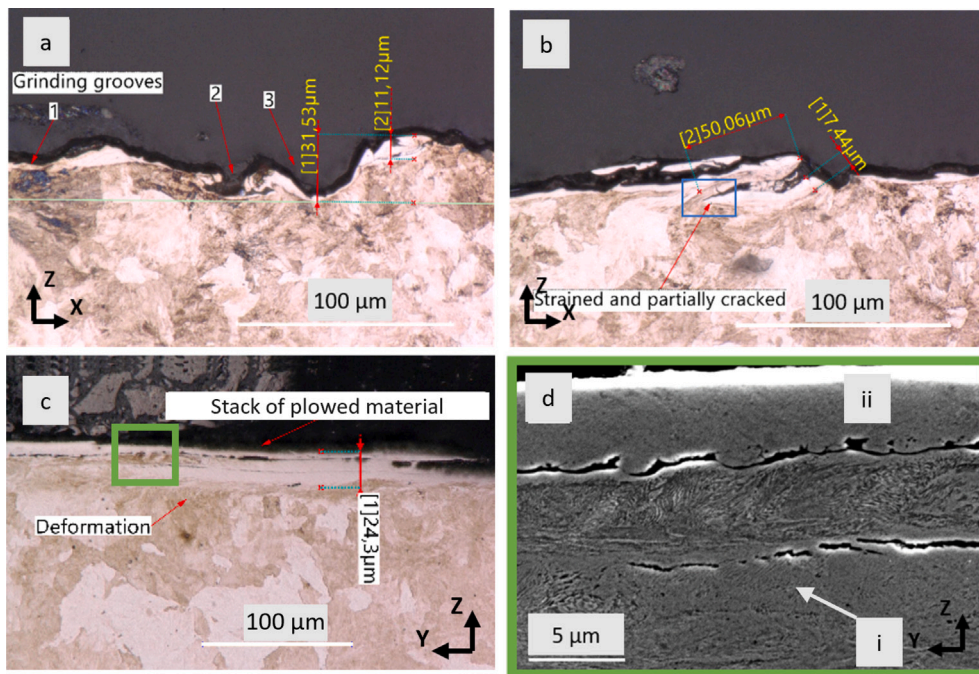
Fig. 4. The freshly ground rail surface observed in cross-section on metallographic specimens from rail sample RS0. (a) Grinding grooves with various widths and depths. Grinding groove 1 is shallow, grinding groove 2 is deeper and covered with extruded material, groove 3 is narrow and the distance to the ridge at the side is $R_t \sim 31 \mu\text{m}$. (b) Strained and partially cracked material that was not removed and covers the WEL-coated surface. (c) A stack of plowed material. The layers have a total thickness of $\sim 24 \mu\text{m}$. Below the layers, the deformation orientation is in the $-Y$ -direction. (d) The SEM micrograph shows the green framed area in Fig. 4c in detail. The top layer is phase transformed, see *ii*. At the bottom, see *i*, a $\sim 2 \mu\text{m}$ WEL is observed while the middle layer consists of strained pearlite with a small WEL at both sides.

Fig. 4 shows representative micrographs of RS0 to study the freshly ground surface. The micrograph in Fig. 4a is observed transverse to the running direction. It displays the variety of grinding groove profiles resulting from the abrasive particle size variation. The presence and orientation of extruded material in the parallel grinding grooves show

The same figure shows a detached WEL at the top of the ridges, possibly caused by frictional heat generated in the friction zone of the abrasive particle. Thin WEL is present at the bottom of the groove, resulting from frictional heating in the cutting zone. Fig. 4b shows another consequence of the cutting depth variation between abrasive particles. Material is strained instead of cut and removed, and is covering the freshly ground surface.

Fig. 4d presents a detailed SEM image taken within the green framed area of Fig. 4c. The strained pearlite of the middle layer has a $\sim 1 \mu\text{m}$ thick WEL on both sides which is also present at the interface, see *i*. The surface layer, see *ii*, consists of WEL and the interface between the top layer and the pearlite middle layer is frayed. The protrusions seem to have deformed the pearlite microstructure.

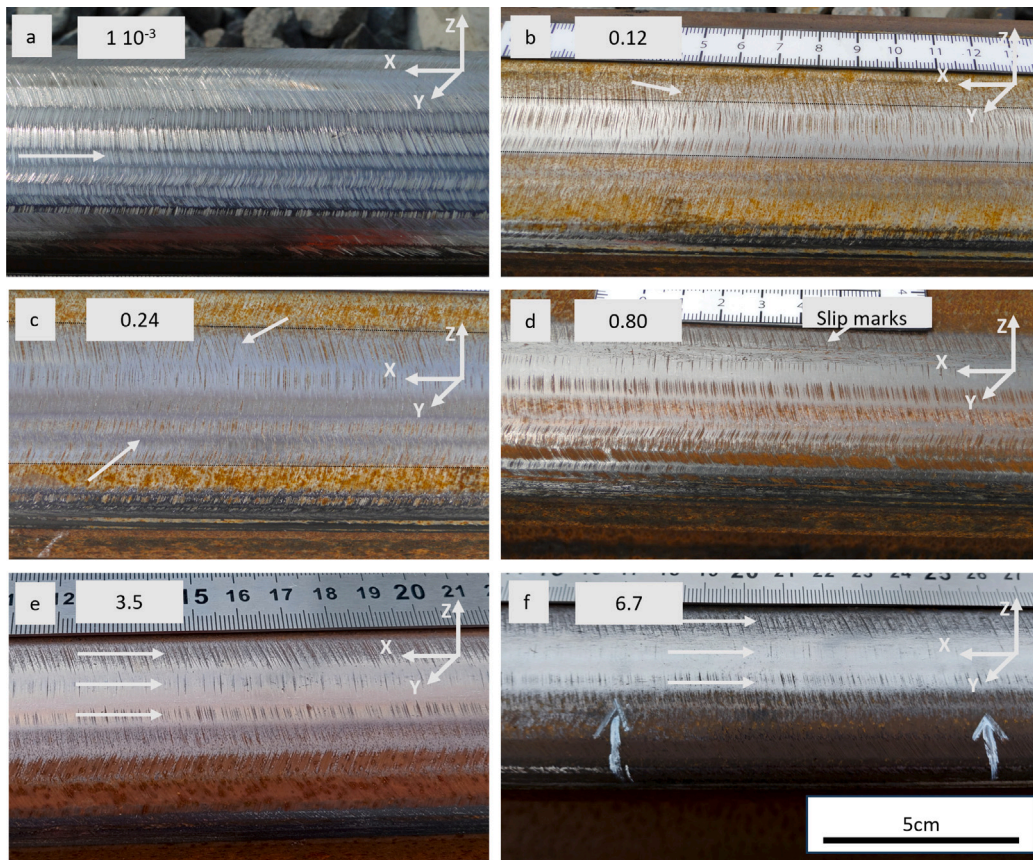
Fig. 5. The contact-surface formation as a function of the cumulative load, based on rail surface inspections in daylight. The cumulative load in Mt is presented in each micrograph. (a) 1×10^{-3} Mt. Contact-surface formation takes place at the facet transitions of facet 8, indicated by the arrow. Blueing from grinding is still present. (b) 0.12 Mt. Surface corrosion has taken place. The contact surface widens and load-carrying surfaces start to develop between the grinding grooves at the face surface. Grinding grooves with diverging orientations appear. (c) 0.24 Mt. The surface of the facet transitions is smooth on the gauge side of the contact zone. Surface corrosion is locally present at the facet surfaces and the grinding grooves with diverging orientation are still present. (d) 0.80 Mt. The contact surface width is reached and the corrosion layer has thickened. The length of grinding grooves shortens, but deeper grooves remain. Slip marks at the surface are caused by track maintenance and are not investigated. (e) 3.5 Mt. Three arrows are placed to observe the grinding groove lengths and the densities. (f) 6.7 Mt. The surface condition just before the field test is completed.

In Fig. 5b the contact surface after 0.12 Mt is presented. The contact has widened and includes facet 9, which can be determined well by the surface corrosion that was worn away. In addition to the contact surfaces on the facet transitions, load-carrying surfaces develop on the facet surface, as evidenced by the surface widening between the brownish grinding grooves.

Fig. 5c shows that the contact width after 0.24 Mt of train load is wider than after 0.12 Mt. At the gauge side of the contact surface the wheel contact is concentrated at the facet transition zones, resulting in smooth and light gray surfaces.

The inspection results in Figs. 5d–f cover a longer period of time because the development of the contact surface, after the initial stage, occurs more gradually. The figures present the rail surface at 0.80 Mt, 3.5 Mt, and 6.7 Mt of train load, respectively. The contact surface width in Fig. 5d and in Fig. 5c is the same, from which it is deduced that the contact surface widening that took place during the initial stage of

the contact-surface formation stopped. The number of grinding grooves on the center of the contact surface decreases and the length shortens. Deep grooves are still present.

In order to compare the length and density of the remaining grinding grooves in Figs. 5e and 5f three arrows are placed at the same longitudinal and transverse positions relative to the characteristic grinding length and the facets. The comparison between both surface conditions shows for the middle arrow that the length and density of the remaining grinding grooves decrease and that some deeper grinding grooves remain. At the positions of both outer arrows, the length of the grinding grooves becomes only slightly shorter and the density remains almost the same.

In this study it is observed that a contact surface is formed on the facet transition zones as soon as wheel–rail contact takes place, see Fig. 5a. As the contact surface widens and extends over multiple facets, the contact surface forms first at the transition zones of the facets added to the contact, see Fig. 5c. This contact surface-formation is faster at the transition zone compared to the facet itself because of the presence of locally high contact stresses and the local surface characteristics. These surface characteristics are determined by the grinding pattern whereby less material is removed in the transition zones than on the facet. Two aspects of rail grinding will be discussed briefly.

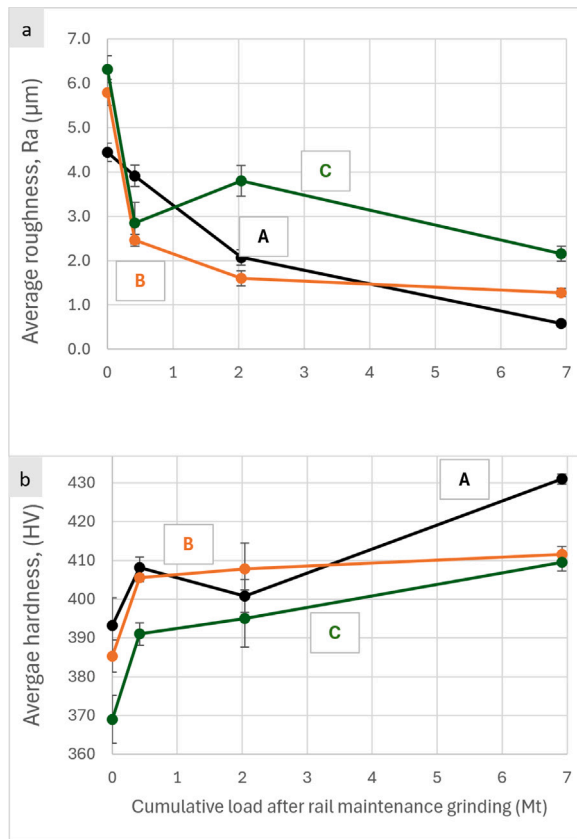
Fig. 6. The evolution of surface roughness (a) and hardness (b) in positions A, B and C, during the field test. The measurements were made on the surfaces of the extracted rail samples. See Fig. 2 for reference on the measurement positions.

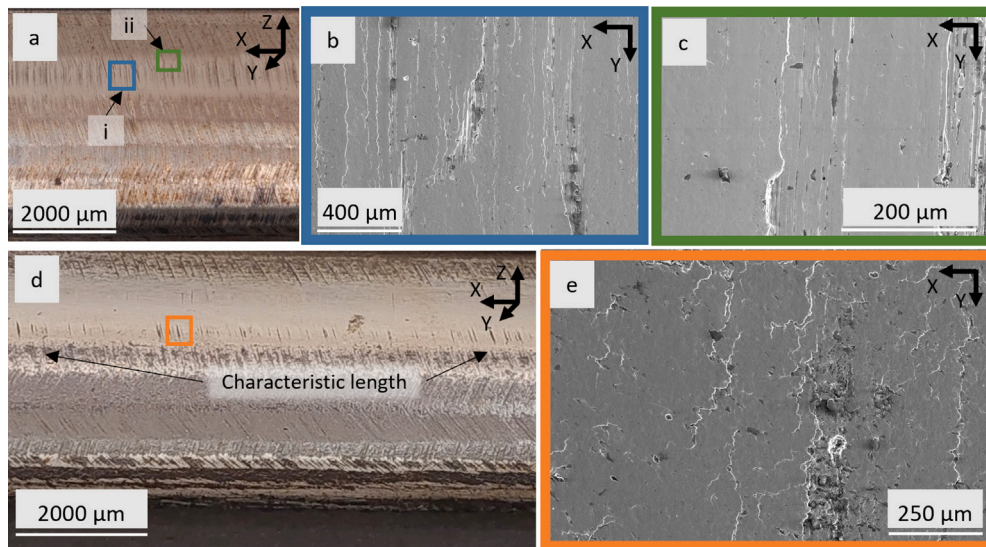
Fig. 7d shows the rail surface of RS6.9, after completion of the field test. A different form of wear has taken place at the surface in the orange-framed area. Wear slivers show serrated edges and have various orientations and lengths in Fig. 7e. These characteristics are associated with rolling contact fatigue damage initiation [1] rather than with wear tongue formation [35] or ratchetting-based wear [20].

Fig. 7. The contact surface at rail sample RS0.4, a–c, and rail sample RS6.9, d–e. (a) Micrograph of the rail surface. Load-carrying surfaces develop between grinding grooves, see *i*, and the facet-transition zones are smooth, see *ii*. (b) On the facet surface in the blue frame, vertical lines and partly covered grinding grooves are present. Both are the result of extrusion of roughness asperities. (c) Extrusion lines on the surface in the facet-transition zone of the green-framed area. The parallel lines exhibit a lower density. (d) Micrograph of the rail surface. The middle of the contact surface is smooth but on both sides the deeper grooves remain. (e) The contact surface in the orange-framed area. The serrated edges of the lines on the surface exhibit various orientations and length. These are associated with rolling contact fatigue damage initiation.

Figs. 7b and c present the surface of RS0.4 evidencing the ratchetting-based wear. The parallel extruded slivers exhibit small mutual distances corresponding with the distances of the grinding grooves shown in Fig. 3d. Fig. 8c shows a micrograph of a facet transition of RS0.4. The slivers that are formed by extrusion cover and fill valleys in the ground surface, accelerating the reduction of the roughness. The direction of extrusion is determined by the tractive shear stresses that point in the $-X$ -direction.

Fig. 7e shows the surface condition of RS6.9. The parallel slivers at the surface that were visible in RS0.4 are replaced by serrated lines and rolling contact fatigue (RCF) damage initiation has taken place.

The expected wheel slip ratio at the railway steel in the test section is applied at the bottom of the slip range by Wang [1]. The surface condition as presented in Fig. 7e shows the best fit with the 1% slip ratio of the eutectoid rail steel surface.

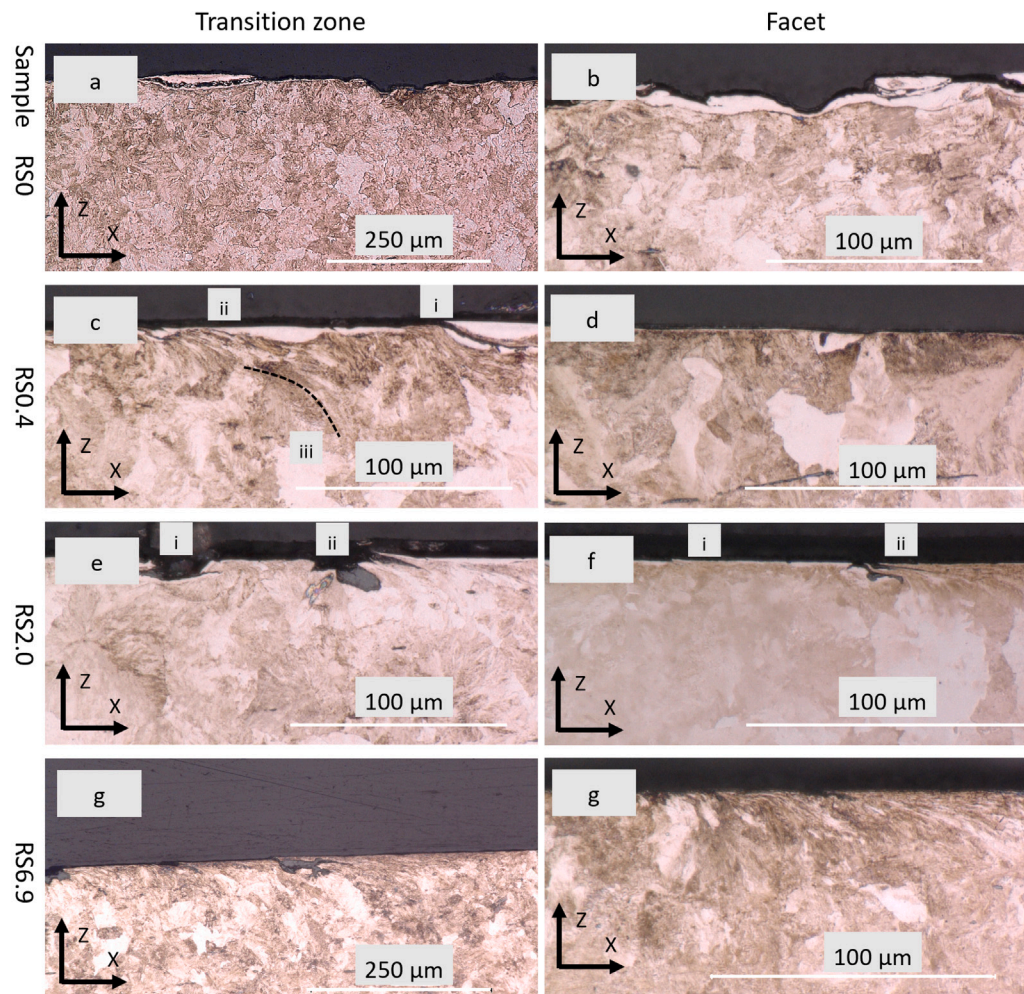
Figs. 8c and 8d present the rail surfaces at RS0.4. In the transition zone, the mechanisms that contribute to the rapid formation of the contact surface are explained by three characteristic features. First, material extruded from the asperities covers grinding grooves, see *i*. Second, WEL formation takes place. The deformation and sharp transition between WEL and the pearlitic microstructure evidence the high temperatures that are reached during extrusion of asperities [36,37]. WEL is formed on both the extruded slivers and on adjacent areas, see *ii*. Third, subsurface deformation aligns with the direction of the traction, as highlighted by the dotted line. The deformation reaches a depth of $\sim 60 \mu\text{m}$ and is only locally present, see *iii*. The facet surface is smooth and slightly wavy. At the facet no deformation or fresh WEL, associated with wheel load and slip, are observed.

Figs. 8e and 8f present the surfaces at sample RS2.0. At the facet-transition zone, the WEL thickness is smaller than that of RS0.4. The residual grinding groove in Fig. 8e, indicated with *i*, is partly covered with material from both sides. The second grinding groove, see *ii*, is filled with corroded material and damage initiates at the positive *X*-side. On the surface, next to the damage initiation, a fresh WEL has formed. The facet surface in Fig. 8f shows damage initiation at the extreme of the WEL, indicated with *i*, but the feature of interest is the large damage, see *ii*. A crack starts at the grinding groove bottom, bending downwards, and a parallel crack has initiated. Deformation, both at the surface and also below the surface, is concentrated at the positive *X*-side of the grinding groove.

Figs. 8g and 8h show the surface and deformation of rail sample RS6.9. The surface conditions at the facet and the transition zone are comparable and only the larger depth of deformation in the transition zone indicates a still slightly higher load.

Fig. 8. The contact surface formation as observed on longitudinal sections. The rows of the array present the micrographs of sections from rail samples RS0 to RS6.9. The columns present the micrographs of sections from the transition zone position on the left and from the middle of the facet on the right. The microstructure details are described in the main text.

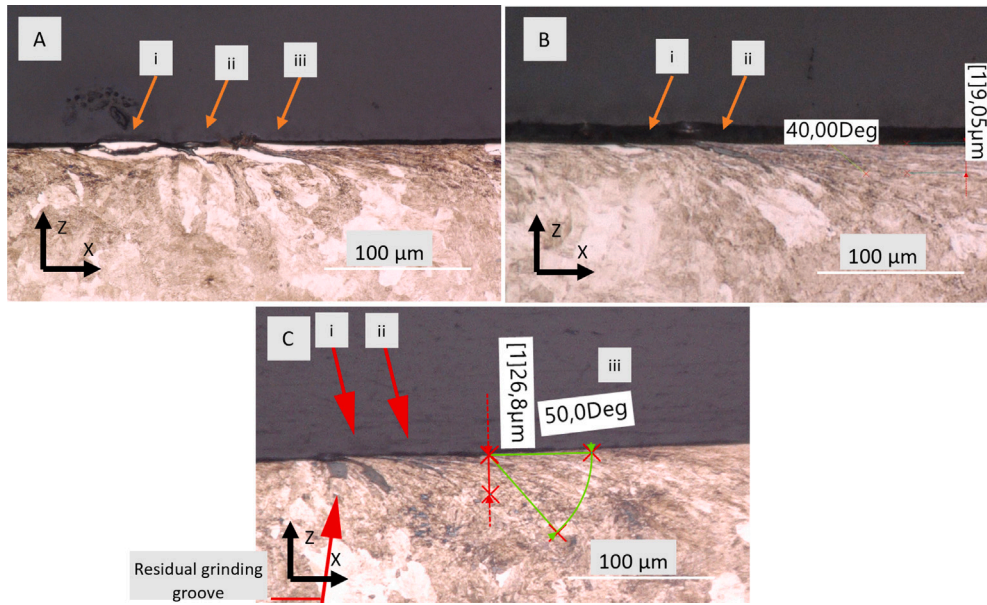
Fig. 9. Evolution of damage in the facet-transition zone of the rail surface. (a) RS0.4; the WEL in the grinding groove acts as a boundary for deformation and is submerged. The figure shows a detached WEL caused by grinding, see *i*. The freshly formed surface is partly embedded by material that has been extruded, see *ii*. A second extrusion is present which also traps the WEL at the surface. Here the deformation is more evident and a slip-related WEL has formed at the surface, see *iii*. (b) RS2.0; damage initiates at the surface. The WEL patch is pressed and embedded into the surface, see *i*. The crack that forms next to it reached a crack depth of 19 μm and the propagation orientation is 40° with respect to the surface, see *ii*. (c) RS6.9; at the surface two cracks are observed. One crack is present next to the residual grinding groove and is filled with corrosion products, see *i*. The second crack is closed and has a slightly shallower propagation orientation, see *ii*. The crack depth is ~27 μm and the propagation orientation is 50° with respect to the surface, see *iii*.

Previous sections showed that during contact-surface formation the presence of grinding grooves contributes to inhomogeneous deformation, extrusion of material and damage initiation. Fig. 9 highlights the evolution of the facet-transition zone surface under increasing cumulative load, evidencing damage initiation. Details of the microstructure, WEL and damage are described in the caption.

Fig. 9b presents the surface of RS2.0 to demonstrate the next stage of damage initiation. The surface crack, indicated with *ii*, is filled with corroded material and the crack faces are open. The crack propagates along the local deformation orientation and shows characteristics of both rolling contact fatigue and wear tongue formation.

Fig. 9c shows the surface of RS6.9 with two cracks, indicated with *i* and *ii*. Crack *i* is open and filled with corrosion products, which suggests that it initiated at a grinding groove. These grinding grooves form an obstacle for deformation, resulting in a locally deformed area. Crack *ii*, as a result, initiates in the zone of accumulated deformation.

- The study shows that deep grinding grooves introduce the risk of damage initiation from the ground surface. Deep grinding grooves are associated with high grinding depth, deformation, and burn. Depth variation in the grinding grooves is an inevitable characteristic of rail grinding. Despite the characteristic variations, deep grinding grooves should be avoided or fully removed by finishing passes. An acceptable depth seems to be defined by the material removal by wear during the formation of the contact surface.
