A case study of apparently spontaneous fracture

Abstract Spontaneous failures in thermally toughened glass are frequently reported, although the actual percentage is quite small, suppliers in the Netherlands reporting one or two cases a year while thousands of tempered panels are supplied. These cases are rarely investigated in the Netherlands because the broken thermally toughened glass is usually not in one piece and can thus not be sent for analysis. In 2015 several sliding thermally toughened glass single curved vehicle roof windows failed within several months. A butterfly pattern was seen and NiS failure was suspected by the window manufacturer. As a coloured adhesive foil had been applied during manufacturing the glass shards were kept together. The broken glass was shipped back to the supplier and was together with several non-broken roof windows sent to Delft University of Technology for analysis. The compressive surface pre-stress in the intact roof panels was measured with a SCALP 5 device. It was found that the compressive surface pre-stress varied, as bands of low compressive surface pre-stress alternating with bands of high compressive surface pre-stress appeared in

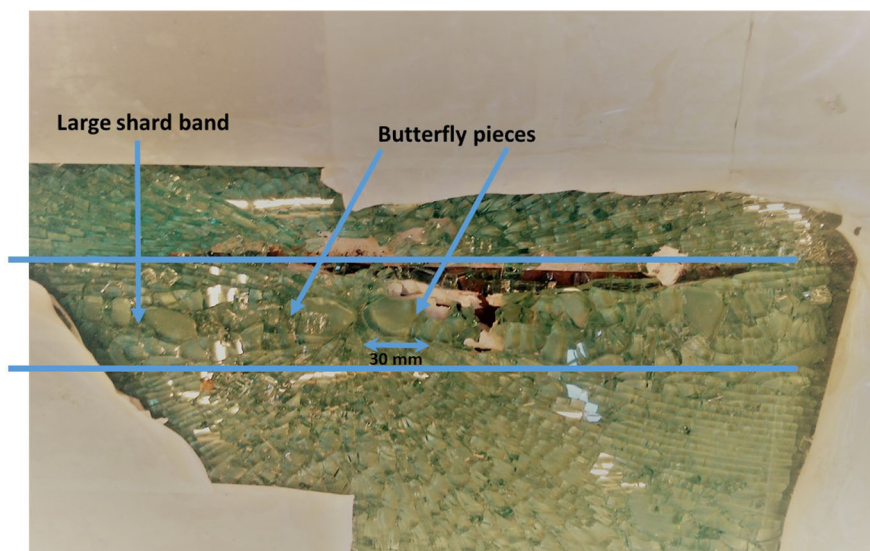
Fig. 1 Band of large shards and butterfly in spontaneously failed vehicle roof window supplied to authors after in service failure. Length of butterfly fragment around 30 mm, width of small shards about 4 mm

The spontaneously broken windows showed two clear characteristic features. Firstly, there were alternating bands of large and small shards, illustrated in Fig. 1, indicating uneven tempering. Secondly there were pairs of shards that looked like a butterfly pattern at what looked like the initial point of failure from the radiating fragmentation pattern centred on the butterfly, as is shown in Fig. 2. It should be noted that as the glass was monolithic and only held together by the foil, the butterfly shards were slightly displaced, showing a gap between them. The butterfly shards were carefully removed and fractographically examined.

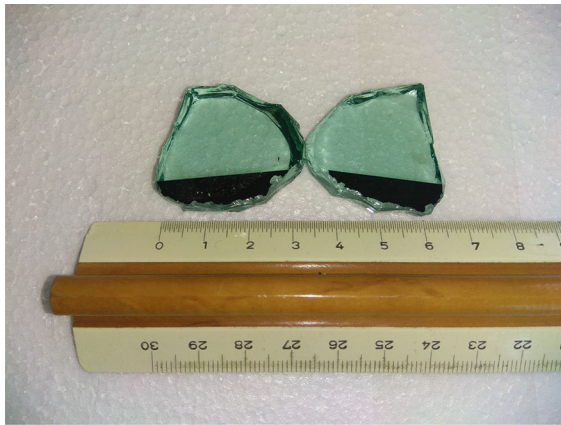
Fig. 2 Butterfly fragments removed from “spontaneously” failed window

The butterfly specimens of the two available spontaneously failed windows were carefully removed.

On one set no clear fractographic information was visible with a microscope. However, if the two pieces were put together it was clear that a small piece was missing. Presumably the piece of glass where the fracture originated was separated from the butterfly pieces and not recovered.

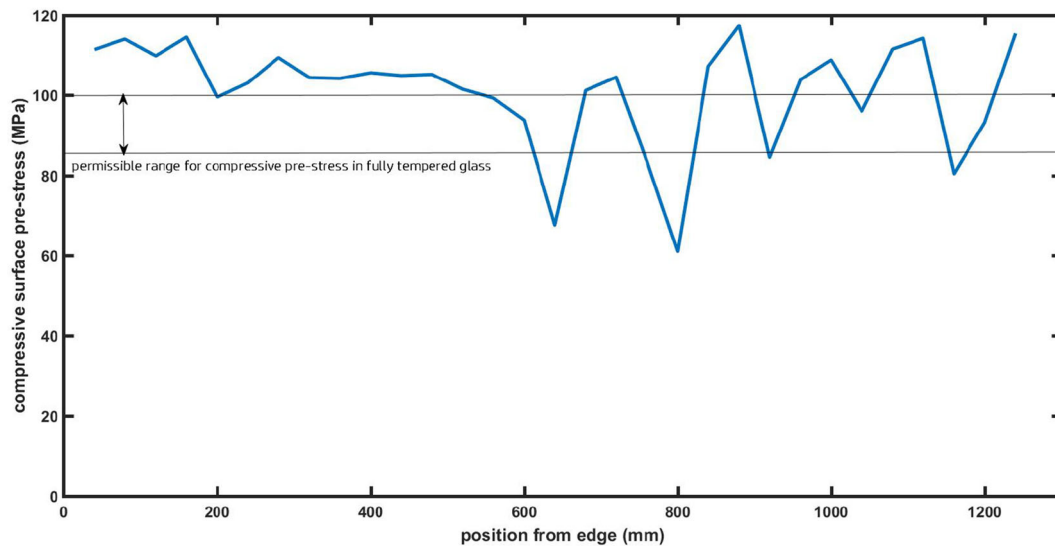
Fig. 3 Measured compressive surface pre-stress at the centre of the length of the window, measured across the width of the window from left edge to right edge for specimen 1

The compressive surface pre-stress was found to vary considerably across the width of the window forming bands similar to the bands of shards visible in the spontaneously failed specimens. As the variation is far greater than the 5% measuring error, the differences must be assumed to represent physical differences in the compressive surface pre-stress.

Figure 3 shows a typical variation in compressive pre-stress as measured with the SCALP 5 device. It should be noted that at the centre of the specimen, where the highest bending stresses occur, the compressive surface pre-stress is significantly lower. Depending

on the specimen, local values for the compressive surface pre-stress as low as 20 MPa were measured. This is in sharp contrast with the values of 100 MPa measured in the properly thermally toughened zones.

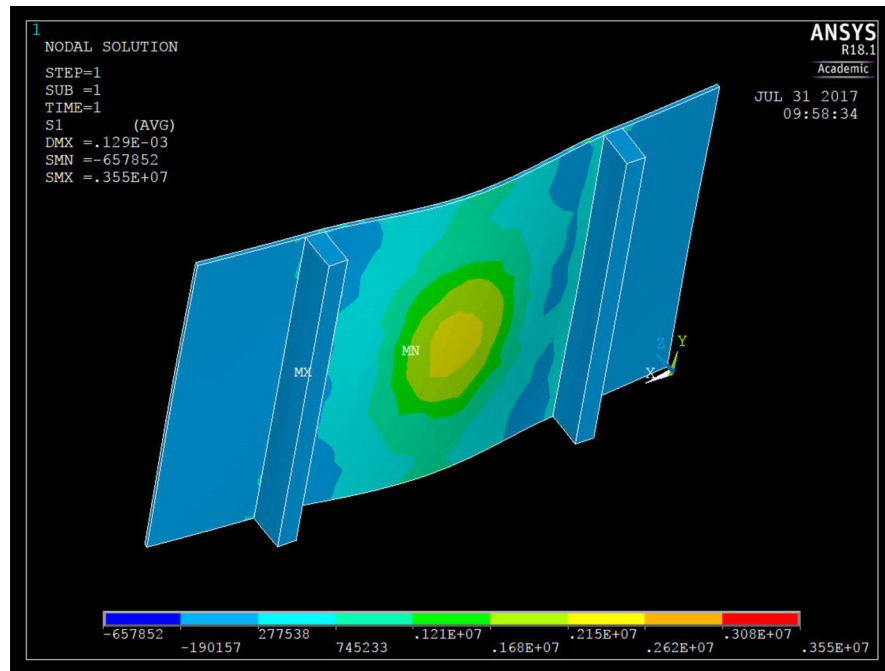
Fig. 6 Stress distribution according to ANSYS model

and illustrated in Fig. 7. All failures originated in the area with the highest applied stress shown in Fig. 6. The bands of large and small shards visible in Fig. 7 corresponded to the bands of lower and higher compressive surface pre-stress measured with the SCALP 5 device.
