Contributing human and organizational factors for the failure of balconies in Maastricht

Karel C. Terwel

Delft University of Technology / IMd
Consulting Engineers

In 2003 five balconies of an apartment building in Maastricht, the Netherlands, collapsed, resulting in two fatalities. The building was just completed.

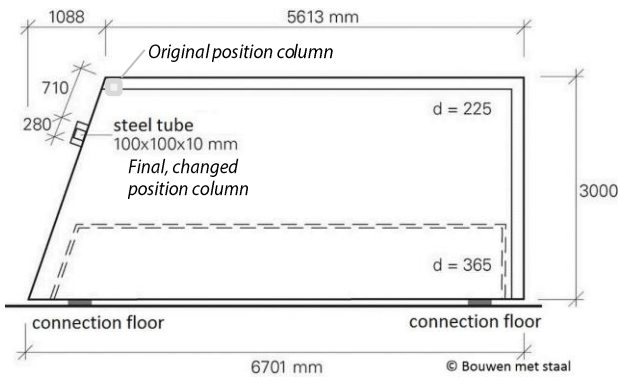
Figure 1: Top view of standard balcony with original and final position of column (adapted from [11,12] with permission). Mind that balcony slab level 1-5 is thicker than slab on ground level (figure 2).

First, the column was repositioned towards the boundaries of the slab, to be able to integrate the column with the finishing structure (aesthetical reason [11]). Figure 1 clarifies the original position and the final, changed position of the column. To be able to support the balcony a ridge on the side of the balcony slab is required (see also figure 1). Second, during preliminary design the engineer designed two moment resisting connections, between floor of apartment and balcony. During technical design phase, this was changed by a supplier into two hinged connections [6].

These changes resulted in a solution with less robustness, that was more vulnerable to failure.

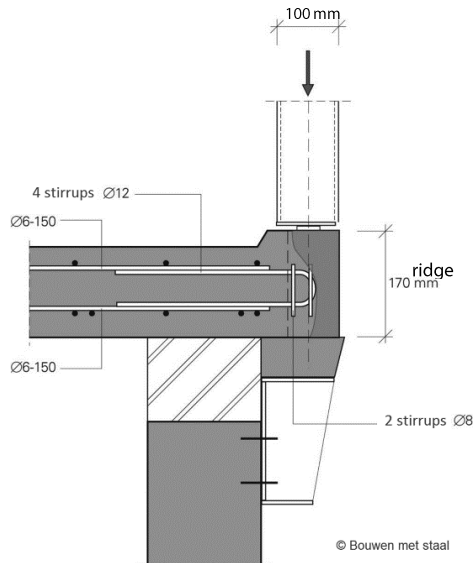
During construction cracks were observed in the balcony of the ground floor. It appeared that this balcony was reduced in thickness, and that the position of the column was not aligned with the supporting wall, after a change in design. These

changes were not incorporated in the design. Therefore, the ridge on the ground floor underneath the column was not supported by the foundation wall. This inadequacy was fixed by applying a steel support underneath the concrete ridge (see figure 2). The height difference between the top of the steel support and slab was filled with masonry. In this way, it was assumed that the essential column 100*100 was adequately supported.

Figure 2: Detail of solution with steel support ground floor (adapted from [11,12] with permission)

Various parts of the structure were subject to the forensic investigations. Experts agreed that detailing of the reinforcement of the ridge at ground floor was inadequate and not according to the codes. Furthermore, the bolted connection of the steel support on the foundation wall was not properly constructed and the connection between the steel support and the concrete ridge was suboptimal.

Finally, it was concluded by experts and court that that the combination of a bending moment and a concentrated force on the small ridge resulted in failure of the ridge on ground floor level. This resulted in a progressive collapse of the other balconies as the columns lacked support [3].

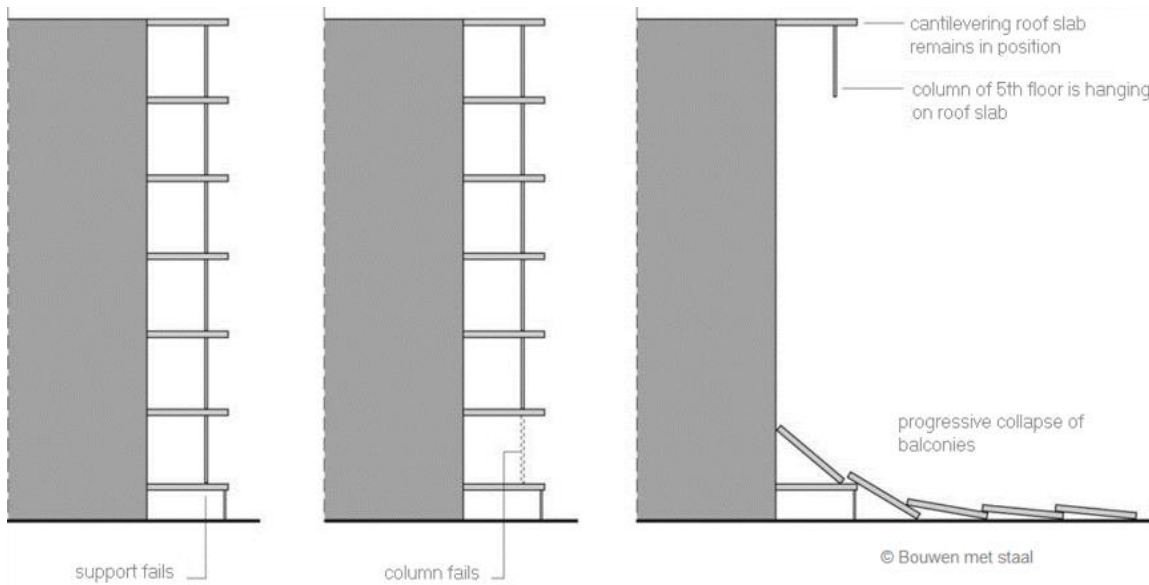
Figure 3: Side view of building: initial failure leading to progressive collapse (adapted from [11], with permission)
