# Demonstration of the Structural Resiliency of Damaged Sentryglas Laminated Heat Strengthened Glass Fins in Full Scale Testing

**Abstract:** A unique structural design was made for the glass façade of the Co-Creation Center building in Delft. The roof is completely carried by the glass fins. The fins are laterally stabilized by being included in the triple glazed façade. To certify the safety of the design full scale tests on the fins were done at Delft University of Technology. Due to a transportation accident the fins were damaged at one end. This allowed an additional study into the effect of this pre-test damage on the residual compressive stresses induced by the tempering. It was found that the residual stresses were not significantly affected by the damage. During the compression tests no cracks developed at the damaged ends. A load of 200 kN, more than double the maximum design load did not produce failure in the prototypes. After intentionally seriously damaging all plies of the fins, the fins could still carry the 200 kN load for 30 min without buckling or other failures being noted. Measurement of the residual stress in the outer plies of the fins after damage showed th

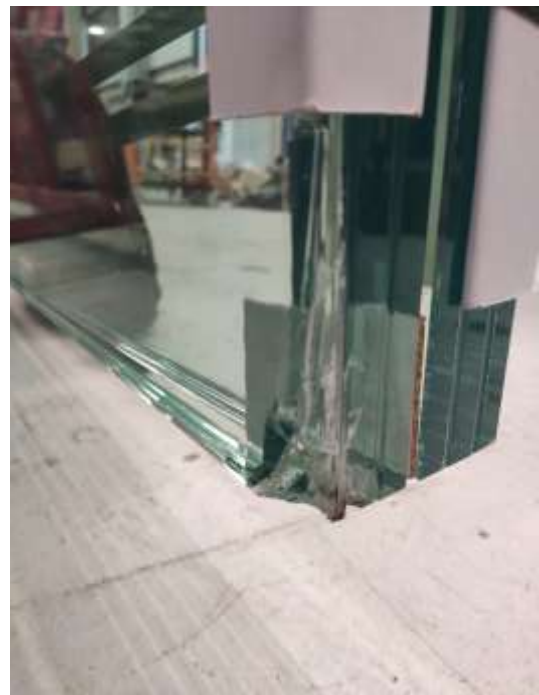
Unfortunately the glass fins were damaged at one end when they were moved into the laboratory by staff not specifically trained to handle glass. The damage is shown in Fig. 4. The damage was measured using a contour gauge as shown in Fig. 5 to determine the depth of the damage. Essentially at the bottom corners of the specimens a triangular bite was taken out of the outer ply over a length of some 24 mm as shown in Fig. 5. This

damage was about half of this some 40 mm up, over a 12 mm length the missing glass tapered from 12 to 6 mm. Above 100 mm from the lower longitudinal edge there was no visible damage. As getting new specimens would take two months and the damaged specimens were assumed to give a conservative test result the damaged specimens were used for testing.

**Fig. 4:** Transport damage to corner of fin before testing

Scalp measurements of the compressive surface pre-stress at the edge of the damage showed values of  $-60 \pm 15$  MPa. This is comparable to the values on the undamaged center line of the specimens. This indicates that the damage should have little effect on the glass strength in this case.

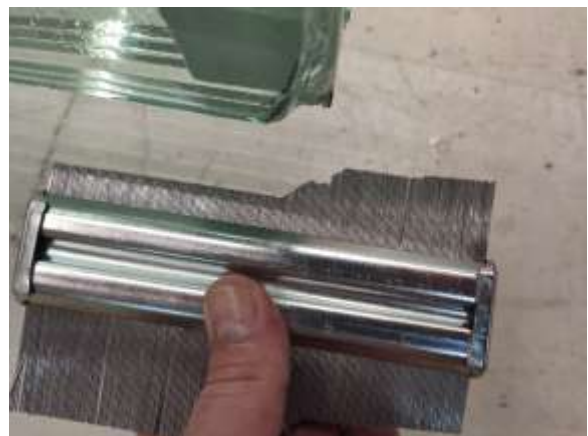
**Fig. 5:** Measurement of damage using a contour gauge

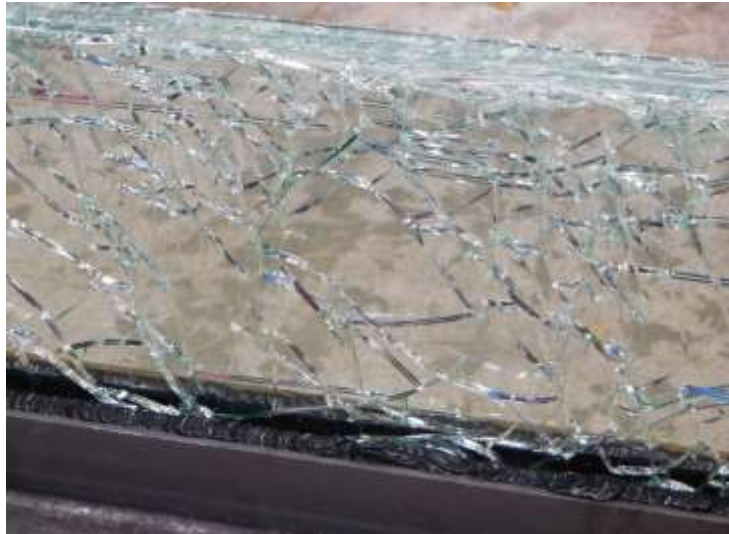
Specimen 2 was loaded to 200 kN, the maximum the hinged connection at the top could sustain safely. After observing there was no damage after 30 min the specimen was unloaded slowly and all 3 plies were damaged in a similar way as was done to specimen 1.

The damage did not result in short term creep, as is shown in Fig. 12, as holding the load constant did not result in additional displacement. Considering the significant levels of damage inflicted on the specimens, as shown in Fig. 13, this result is significant as the interlayer plays a significant role in transmitting forces in damaged specimen.

**Fig. 13:** Part of specimen 2 after having 3 plies damaged. Note the overlapping cracks in successive plies

- The use of heat strengthened glass which breaks into large fragments. These large fragments still maintain a level of compressive surface pre-stress after cracking of the glass and form an overlapping pattern allowing for stress transfer. In essence the cracking of the heat strengthened monolithic fin, turns it into a segmented spliced overlapping fin. As shown by (Trösch, 2015), this can be almost as efficient structurally as monolithic elements with proper lamination
- The use of Sentryglass foil as the laminating agent. The stiffer and stronger Sentryglass foil keeps the glass fragments together very well and the higher stiffness helps prevent buckling
