# Root Cause Analysis of Surface Cracks in Heavy Steel Plates during the Hot Rolling Process

**Abstract:** This paper investigates the root cause of the formation of surface cracks on hot-rolled C–Mn constructional steel heavy plates. Cracks are rather evenly distributed over the surface in the form of colonies of cracks. Samples were cut from the heavy plate. The microstructure of samples in the as-cast and hot-rolled states were studied using optical and electron microscopes as well as energy dispersive X-ray spectroscopy (EDS). Results show that cracks are heavily oxidized. De-carburized areas are also seen alongside cracks. The crack tip is in the form of a deer-horn, indicating that crack branching has taken place during deformation. The crack initiation sites are V-shaped grooves on the surface of as-cast slabs. Correlations between microstructures, processing parameters, and crack formation are discussed.

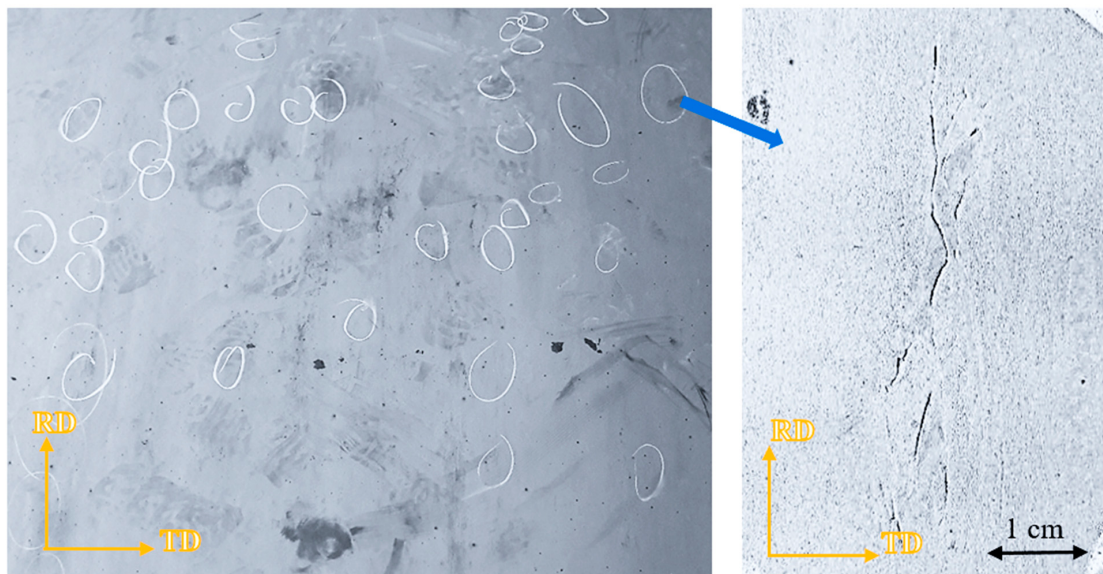
Surface cracks in this case are related to heavy plates of 30 cm thickness with average chemical composition 0.16 C–1.20 Mn–0.022 P–0.02 S–0.257 Si–0.045 Al–Fe (Bal.) (wt. %). Original slabs were made by continuous casting. Slabs were pre-heated at approximately 1250 °C up to 4 h, and were hot rolled to the final thickness of the heavy plate (30 cm) after approximately 16 passes in a reverse mill. Figure 2 shows the visual appearance of surface cracks on the heavy plate. Cracks are scattered all over the surface. There is no indication that cracks are more frequent at the side or the centre of plates. Spots, shown in Figure 2, are colonies of accumulated smaller cracks. The size of these crack colonies range from 5 to 30 cm. Cracks are all oriented along rolling direction. The depth of observed surface flaws in some cases are so high that plates are inevitably returned to the casting unit. In some cases, surface cracks can be eliminated by surface grinding. This causes major trouble in the rolling company, in the sense that these cracks need to be removed by grinding of the surface, which necessitates spending a lot of time as well as performing double inspection (one before grinding and the other one after grinding). This work aims at investigating the root cause of the problem.

**Figure 2.** Visual appearance of surface cracks on the surface of heavy plates.

To solve this problem, one needs to minimize the formation of surface V-grooves, given that these surface irregularities are spots, where cracks can nucleate. Presence of the oxide phase inside the crack is possibly to do with an improper pre-heating atmosphere. In case the oxygen/gas ratio in the pre-heating stage is not optimized, free excess oxygen can enter into surface notches and this results in the formation of an iron oxide phase inside cracks. The oxide phase is in nature a brittle phase which cannot accommodate plastic deformation. Besides, oxidization inside cracks is associated with de-carburization of the alloy in the vicinity of the cracks. In the worst case condition, this will result in a fully ferritic microstructure adjacent to the crack. This means that the area close to the crack is comparatively softer and undergoes a higher degree of deformation, which in turn has

implications for crack propagation. One way to tackle this problem is therefore trying to minimize oxidation during reheating. During reheating of the slab before rolling, oxygen present in the reheating furnace diffuses through the crack opening and reacts with the carbon of the steel, resulting in partial decarburization around the crack. Decreasing the oxygen/gas ratio in reheating furnaces could have a key positive impact.

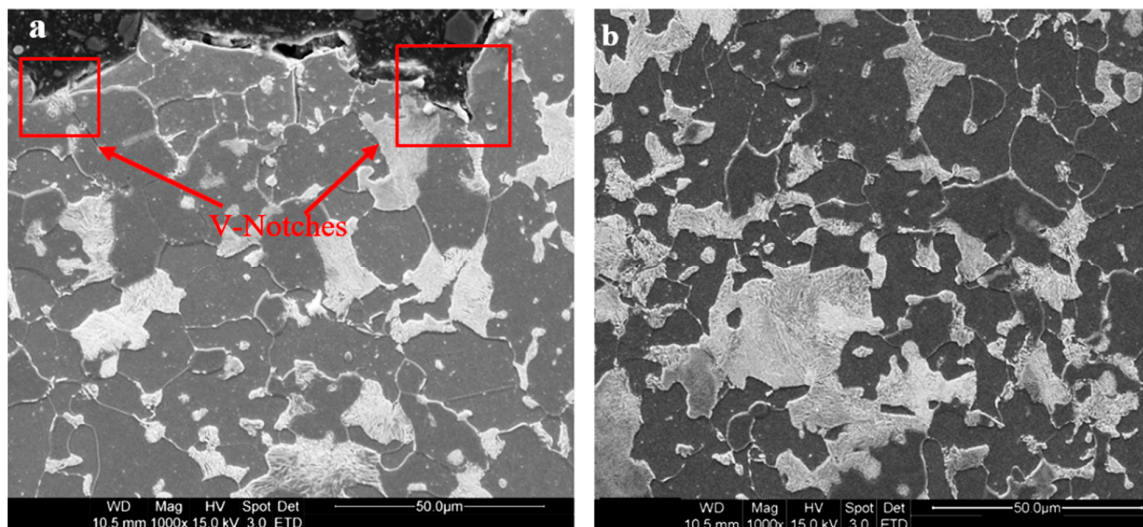
Figure 3 shows a SEM image of the typical ferritic–pearlitic microstructure of heavy plates in the bulk and surface of slabs (before hot rolling). There were not many inclusions found in the microstructure, inferring that the quality of the alloy in terms of secondary oxide/sulphide particles was overall very good. Typical features at the surface of the slab were surface V-notches, as marked in Figure 3a. These V-notches have depth in the order of a few tens of micro meters and are filled with surface oxide scales/phases. V-shaped grooves are possibly formed because of oscillation during the casting stage. Oscillation marks are a normal surface feature in continuously cast slabs. They periodically form at the meniscus because of mold oscillation. Yet, in case of improper control, the depth of these oscillation marks can increase to levels that they act as crack initiation sites [17,18].

**Figure 3.** Typical ferritic–pearlitic microstructure from (a) the surface and (b) the bulk of slabs.

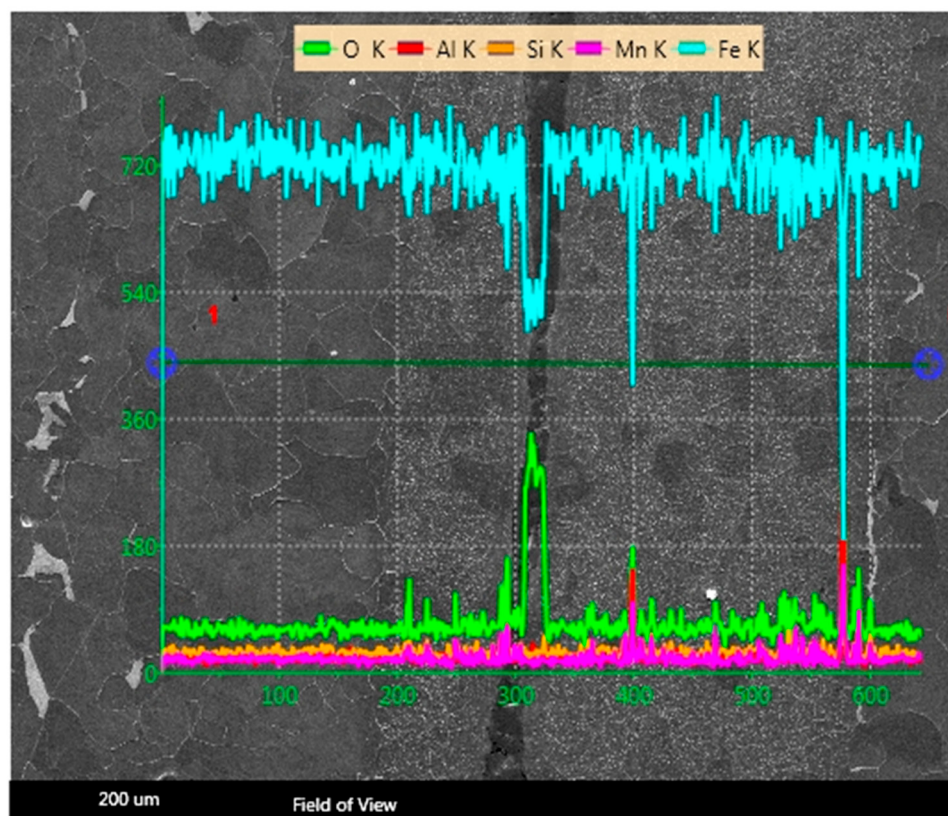
Figure 4 represents an elemental line scan on top of a crack. As can be seen in this figure, the concentration of oxygen at the crack is significantly higher than that in the vicinity of cracks, inferring that the crack is filled with an iron oxide phase.

**Figure 4.** Elemental line scan on top of a crack at the surface of the heavy plate.

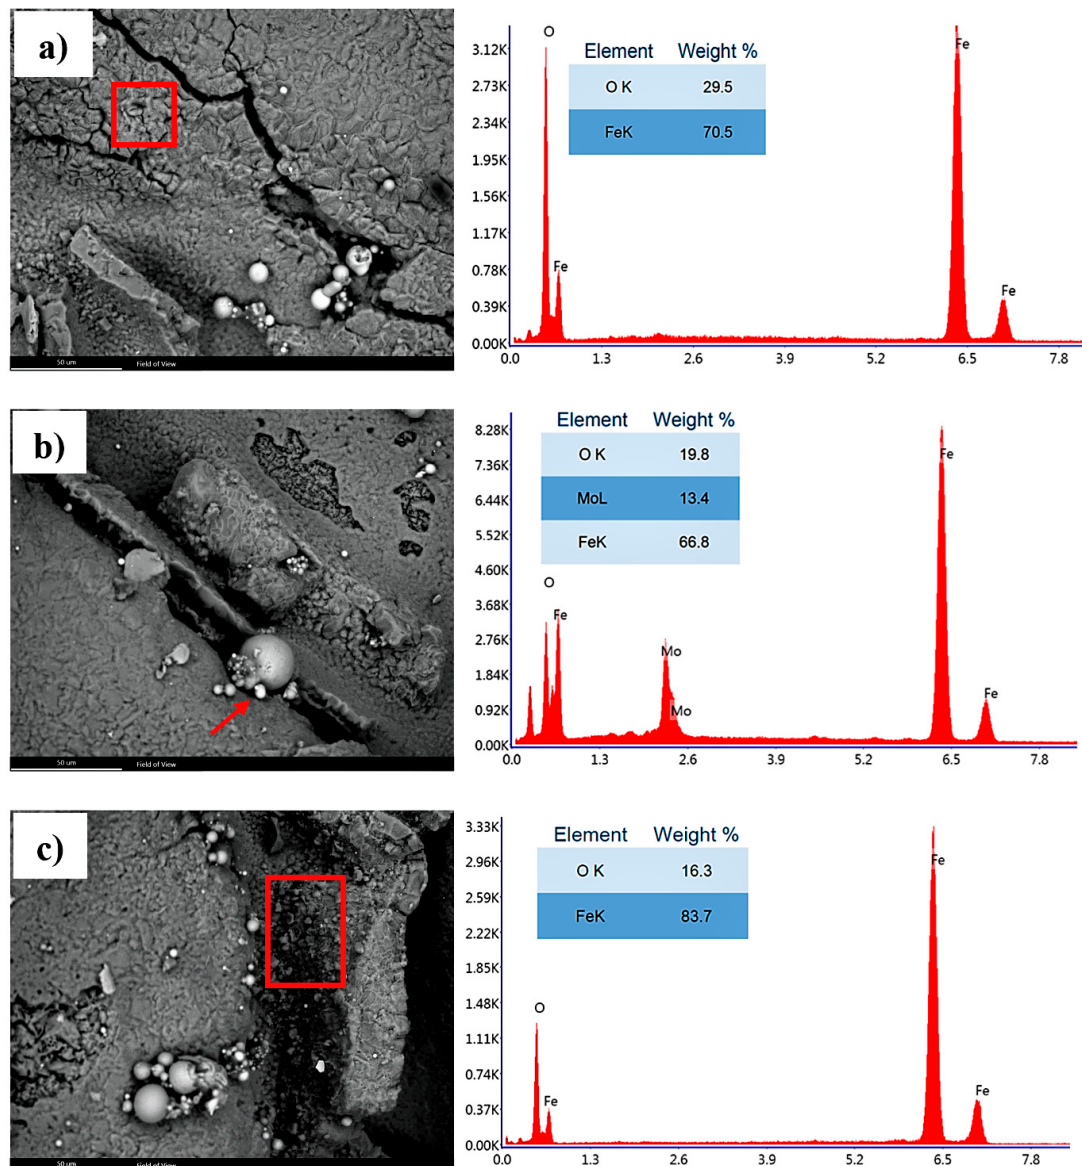
Figure 5 shows SEM images of a crack at the surface. It appears that the crack is formed due to the breakage of the oxide layer on the surface. Some rounded particles are also observed inside cracks and in areas in the vicinity of the cracks with their sizes ranging from a few microns up to 30 microns. Three different features were analyzed using EDS, i.e., the surface, as shown in Figure 5a, rounded

white particles, as shown in Figure 5b, and small particles inside cracks, as shown in Figure 5c. Results of EDS analyses indicate that rounded particles are either iron oxide particles or molybdenum-rich particles. Small molybdenum-rich particles are only in small percentages of rounded particles inside cracks. Most particles inside cracks are iron oxide particles. Given that the starting material is not expected to contain any molybdenum, and as molybdenum is not added to the melt, the only option left for the origin of these molybdenum-rich particles must be residues from the processing.

**Figure 5.** SEM images and energy dispersive X-ray spectroscopy (EDS) analysis of cracks on the surface of a hot-rolled heavy plate. The highlighted spot is analyzed by EDS. (a) Surface area surrounding crack, (b) rounded white particles, and (c) small particles inside cracks.

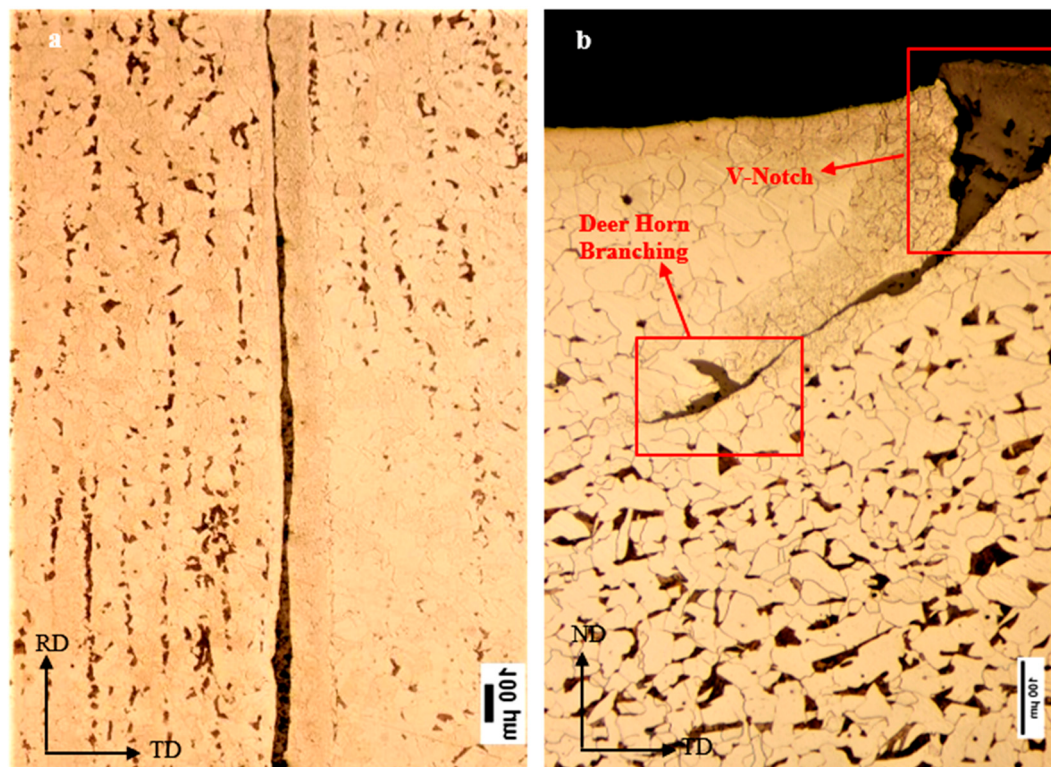
Figure 6 reveals optical microscope images of the microstructure around the crack. There are several features worth mentioning. First of all, the crack is completely filled with an iron oxide phase. The presence of this oxidizing environment inside the crack results in de-carburization in the vicinity of cracks, in such a way that there is a band of fully de-carburized ferritic microstructure alongside the crack. The microstructure of the steel away from the crack is ferritic–pearlitic as commonly observed in plain carbon steel plates. Other than this de-carburized layer, there is no other

microstructural abnormality, like excessive grain coarsening or deformed/elongated grains in either side of the surface crack.

**Figure 6.** Optical microscope images of cracks (a) from the top and (b) perpendicular to the crack.

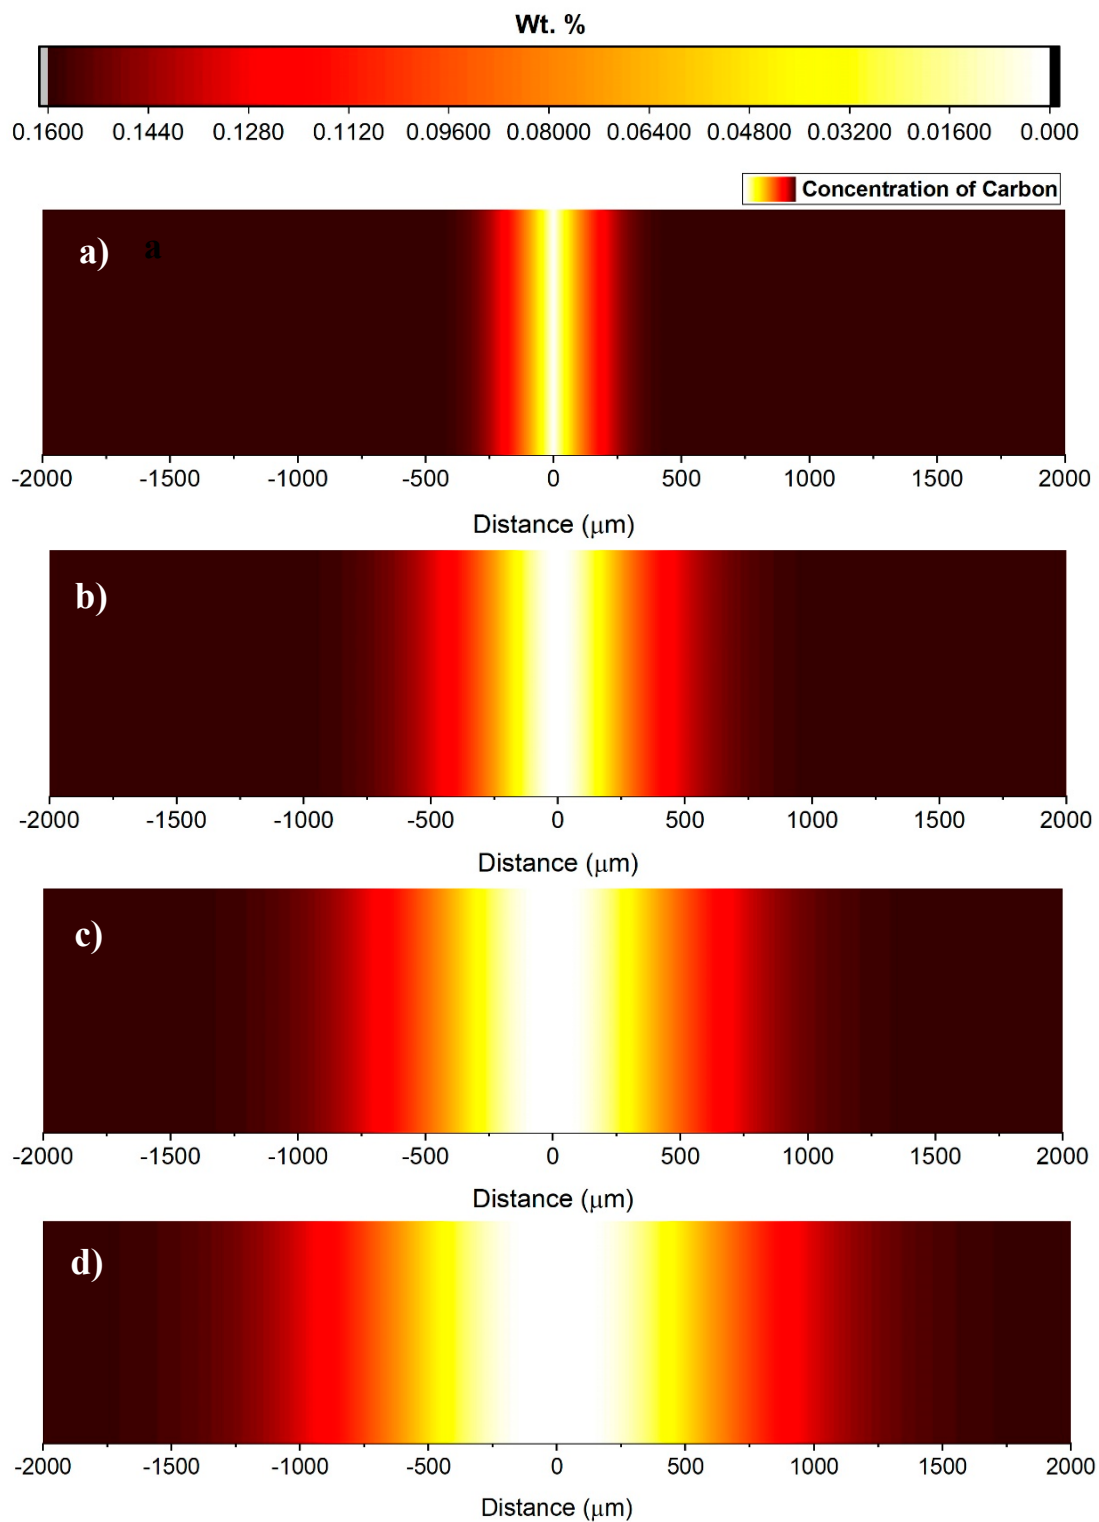
where  $D_0 = 2.3 \times 10^{-5} \text{ m}^2/\text{s}$ ,  $Q = 148 \text{ kJ/mol}$ , and  $R = 8.314 \text{ J/mol}\cdot\text{K}$  [20]. An average value of  $1100^\circ\text{C}$  was assumed for the rolling temperature. Figure 7 shows the contour of carbon diffusion across the crack. Results show that after 16 passes carbon is heavily depleted in approximately  $300\text{--}400 \text{ }\mu\text{m}$  distance from the crack. It is also seen that with increasing pass numbers, the depletion layer gets wider. According to Fe-C diagram, pearlite is not expected to form in carbon content less than  $0.008 \text{ wt. \%}$ . Results of this calculation is very well in accordance with the experimental results.

**Figure 7.** Contour of carbon diffusion in and around areas of a crack (a) after 1 pass of hot rolling, (b) after 5 passes, (c) after 10 passes, and (d) after 16 passes.

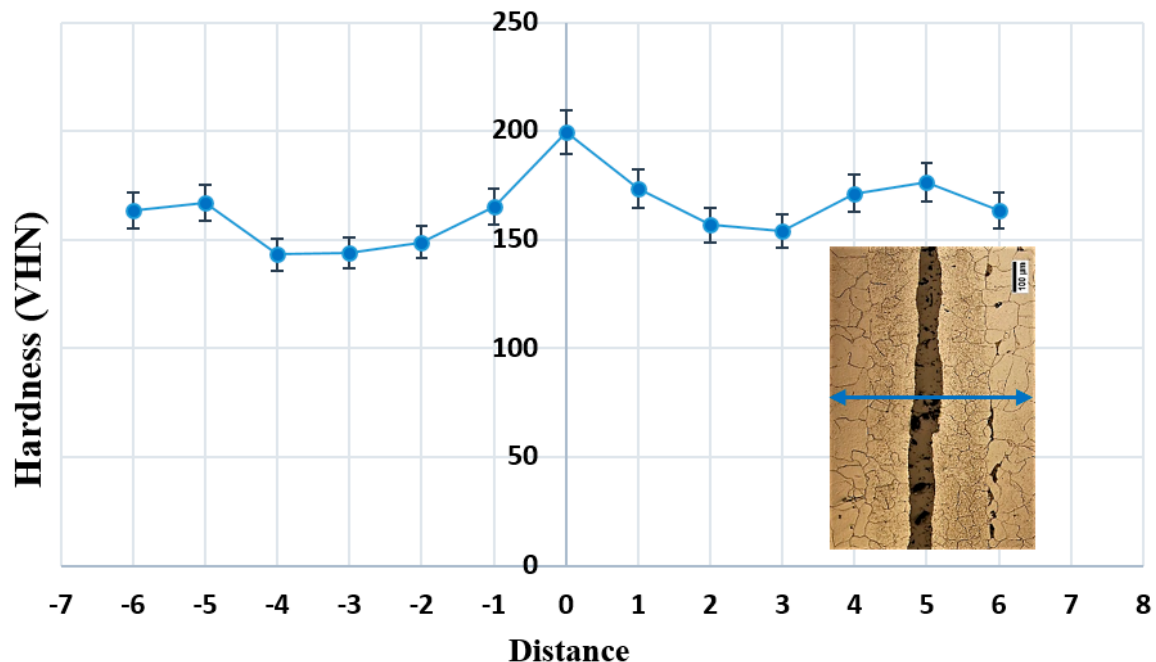
Figure 10 shows a typical hardness profilometry across the crack. As can be seen in this figure, the hardness at the center of the crack, where the oxide layer is present, has significantly increased. This is not surprising, since the layer inside the crack is heavily oxidized. Areas in close proximity to the oxide layer are clearly the weakest spots, which obviously has to do with the fact that the microstructure at the vicinity of the cracks is ferritic.

**Figure 10.** Hardness profilometry across the crack (distance between spots is 100 microns) (VHN: Vickers Hardness Number).
