Preliminary Report on
**THE GREAT
HANSHIN
EARTHQUAKE**

January 17, 1995

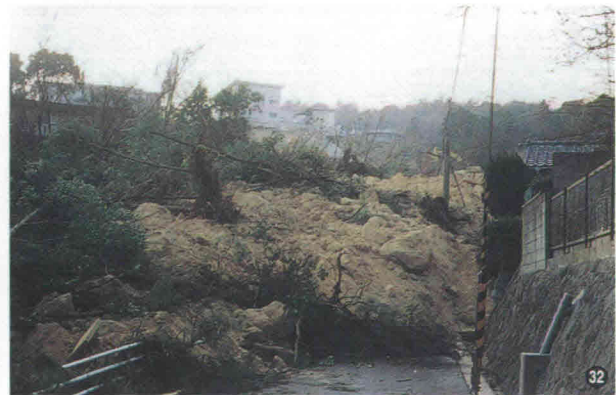
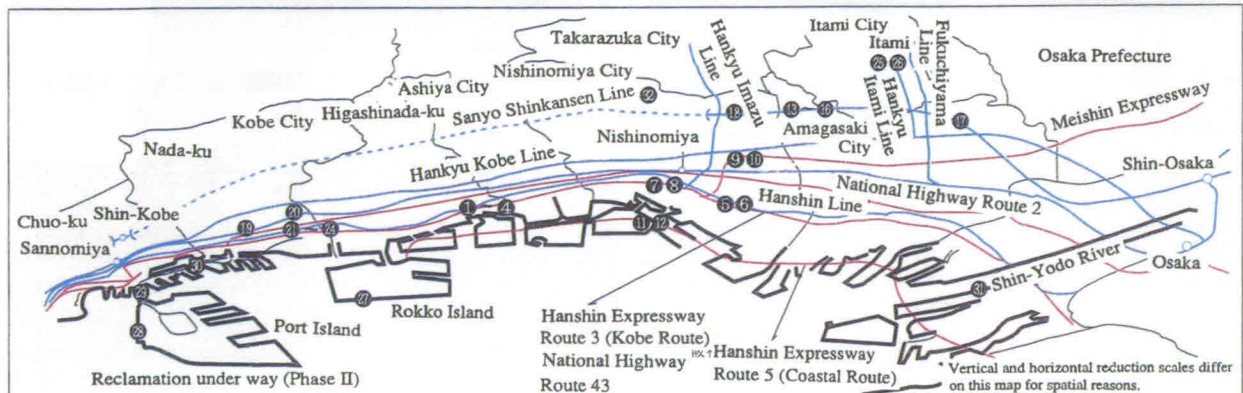
Photographs by courtesy of Asia Air Survey Co. (No. 1, 13, 25), Ministry of Transport and Hanshin Electric Railway Co. (No. 21, 22, 23, 24), Ministry of Transport and West Japan Railway Co. (No. 17, 18, 19, 20), Ministry of Transport (No. 28), National Land Agency (No. 29)

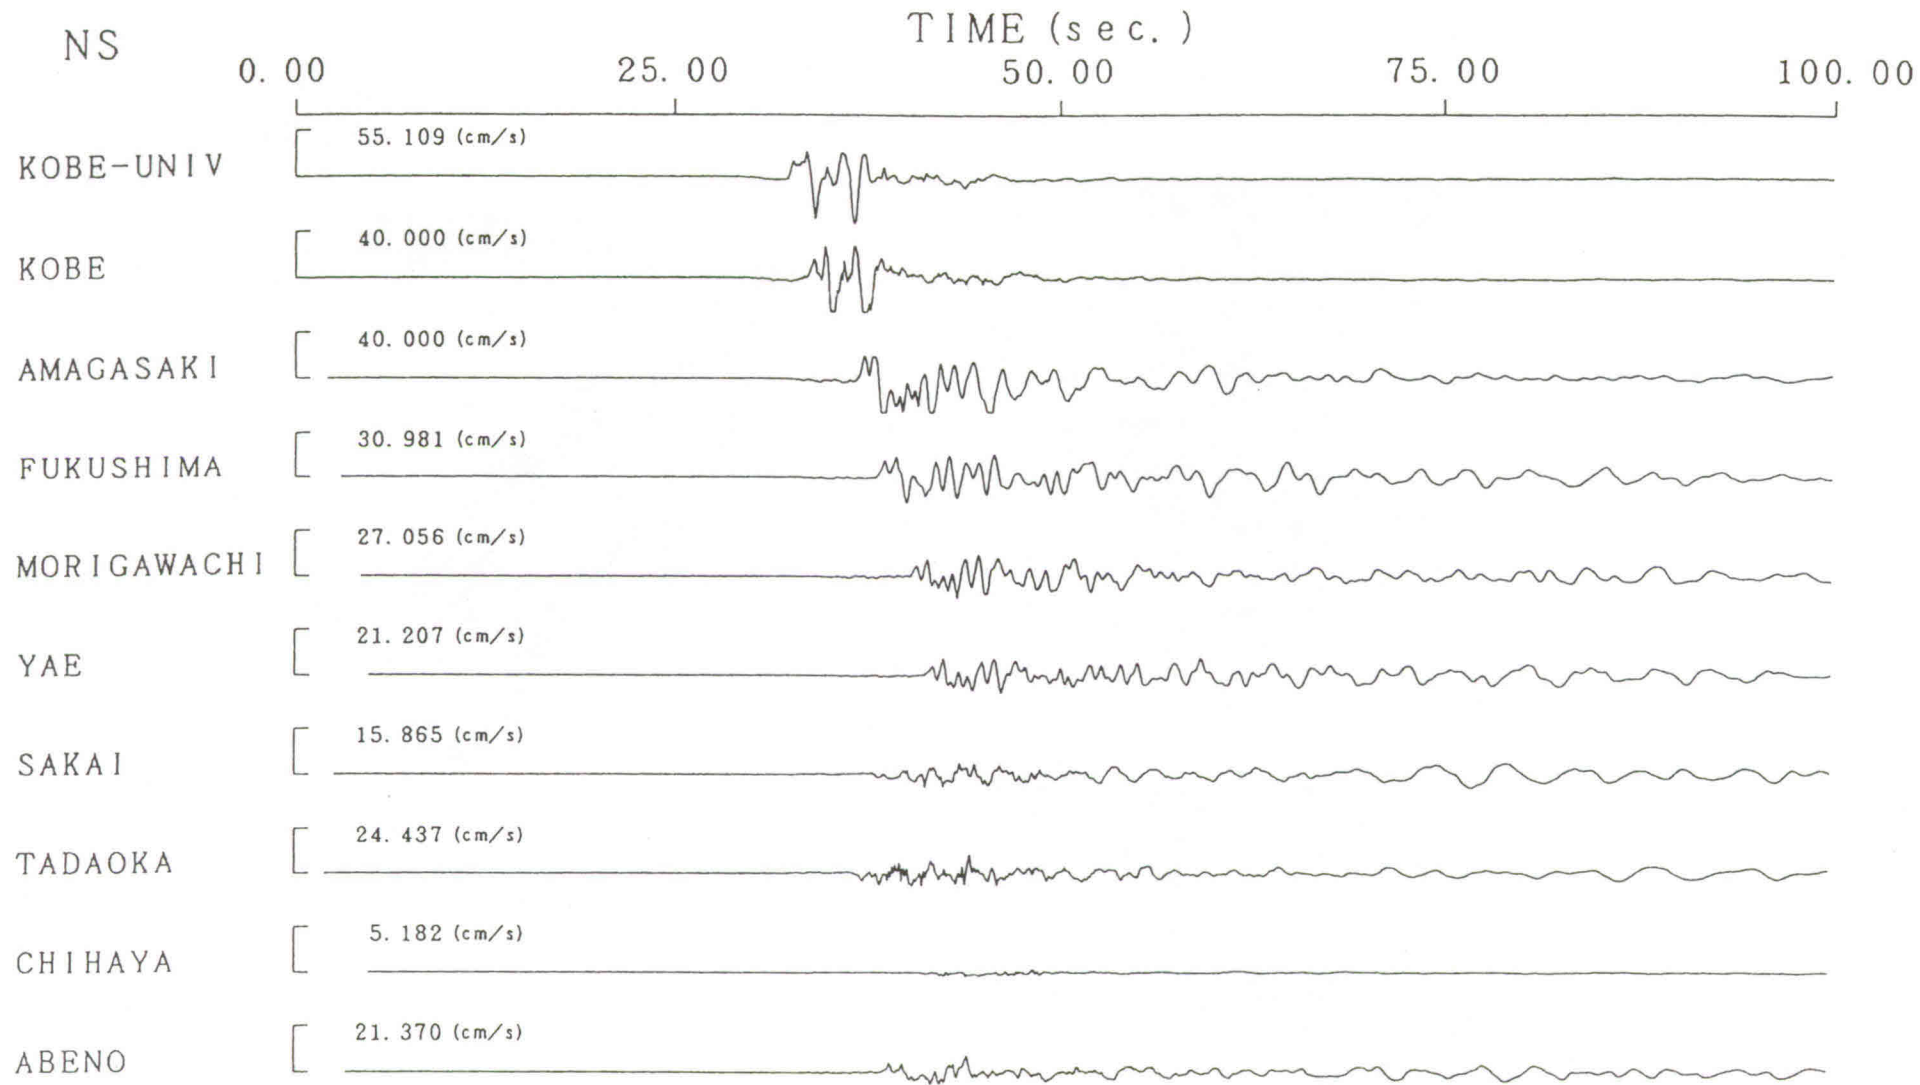
ORIGIN TIME 1995-01-17 05:46:27.78 DT=0.010 (s)

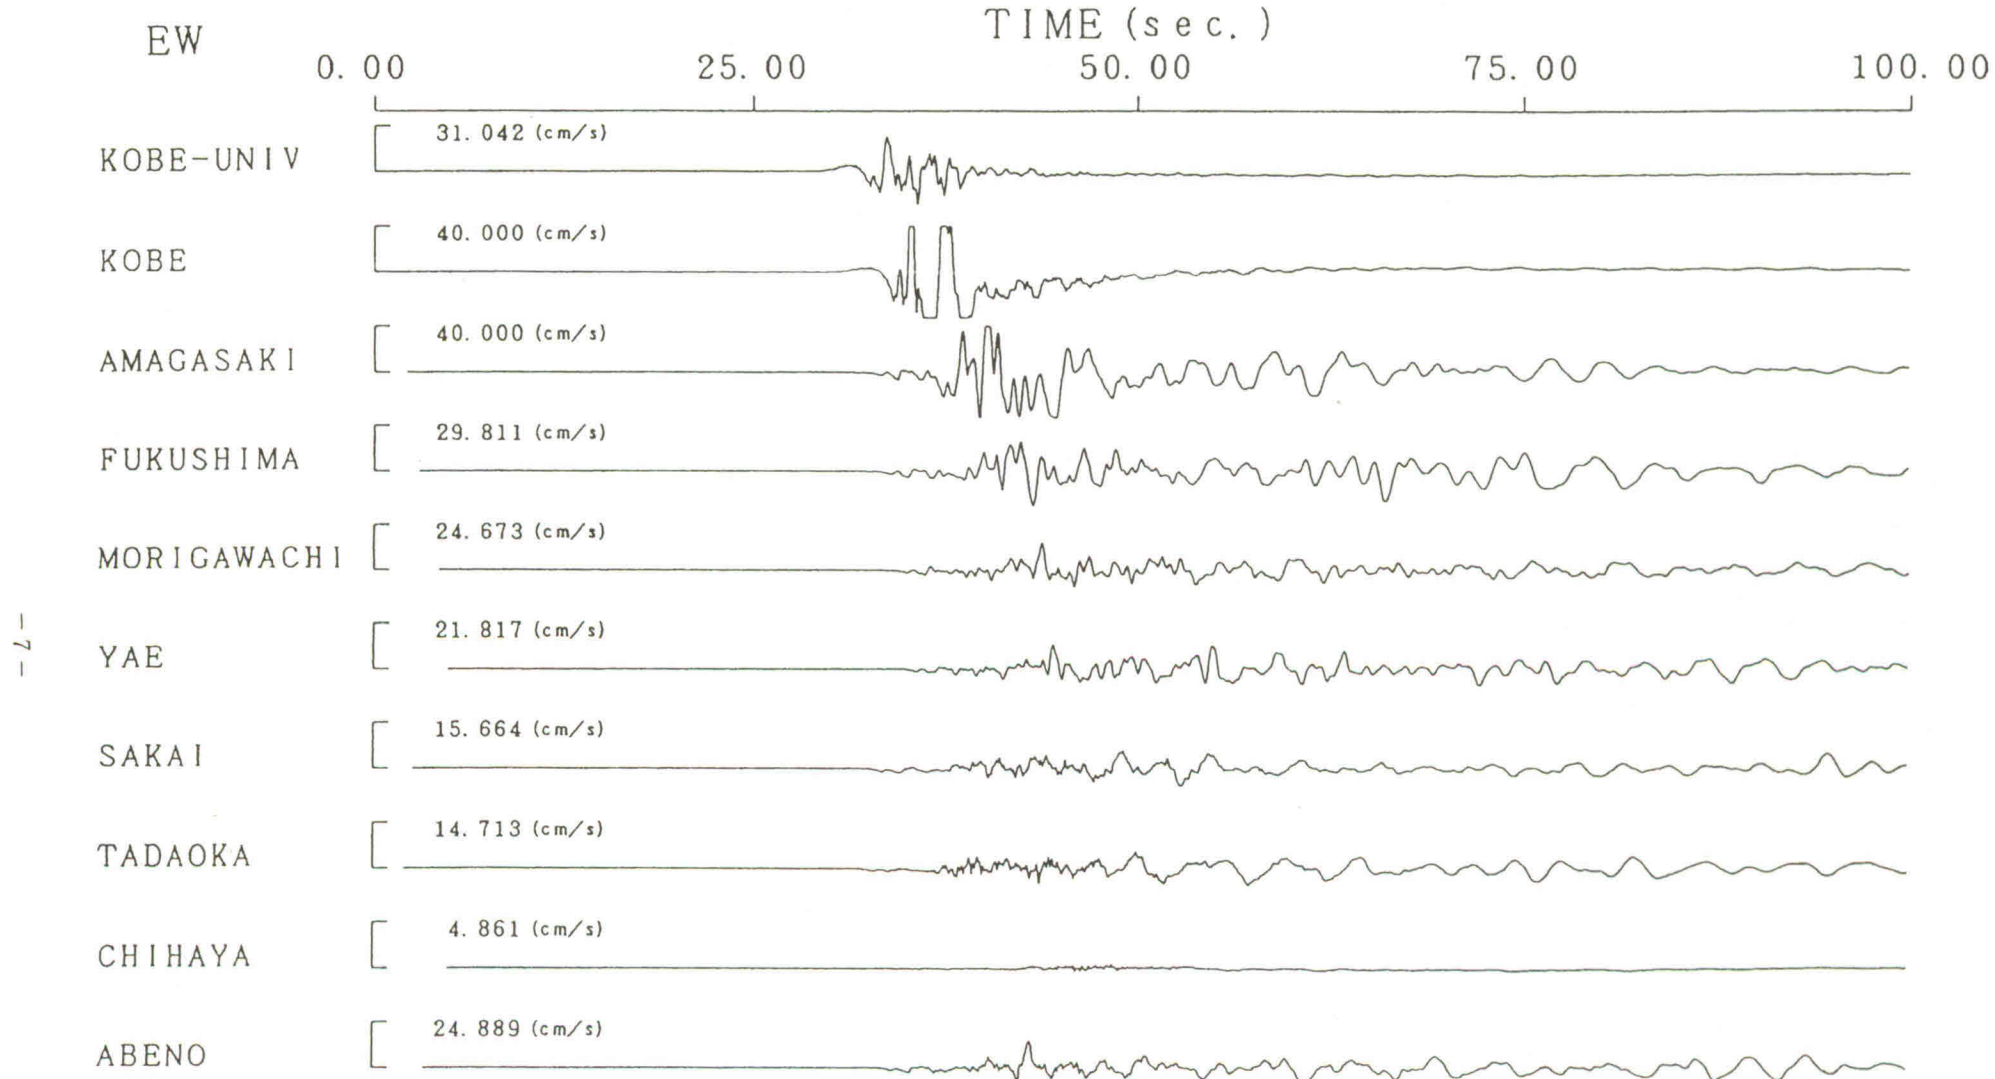
ORIGIN TIME 1995-01-17 05:46:27.78 DT=0.010 (s)

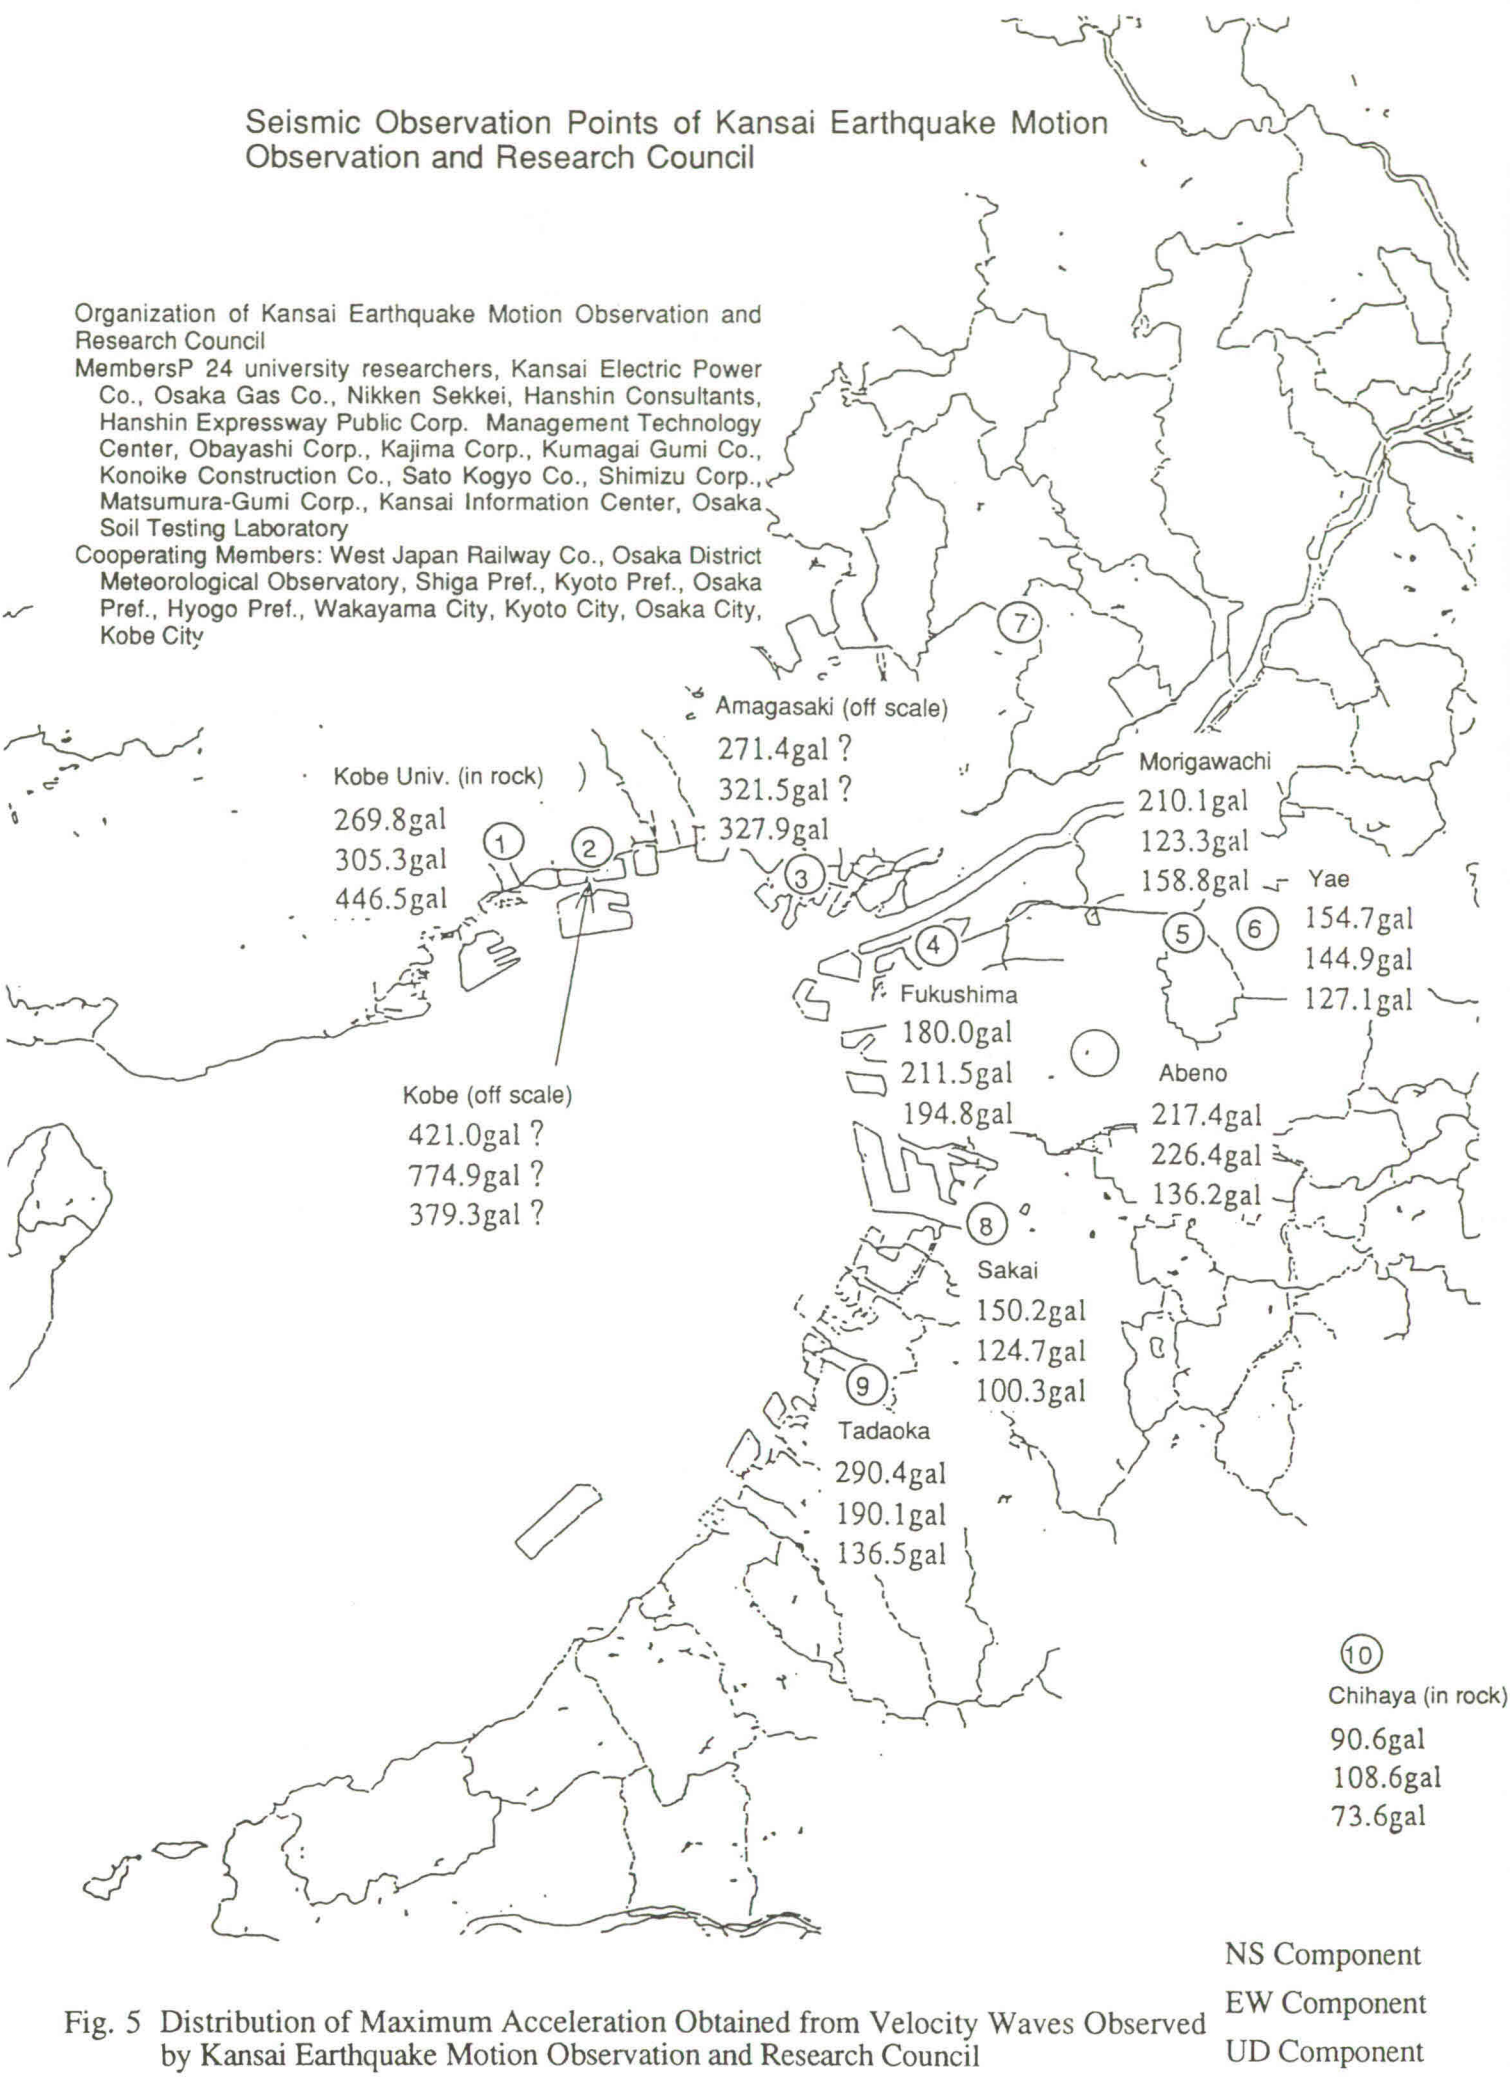
Fig. 5 Distribution of Maximum Acceleration Obtained from Velocity Waves Observed by Kansai Earthquake Motion Observation and Research Council

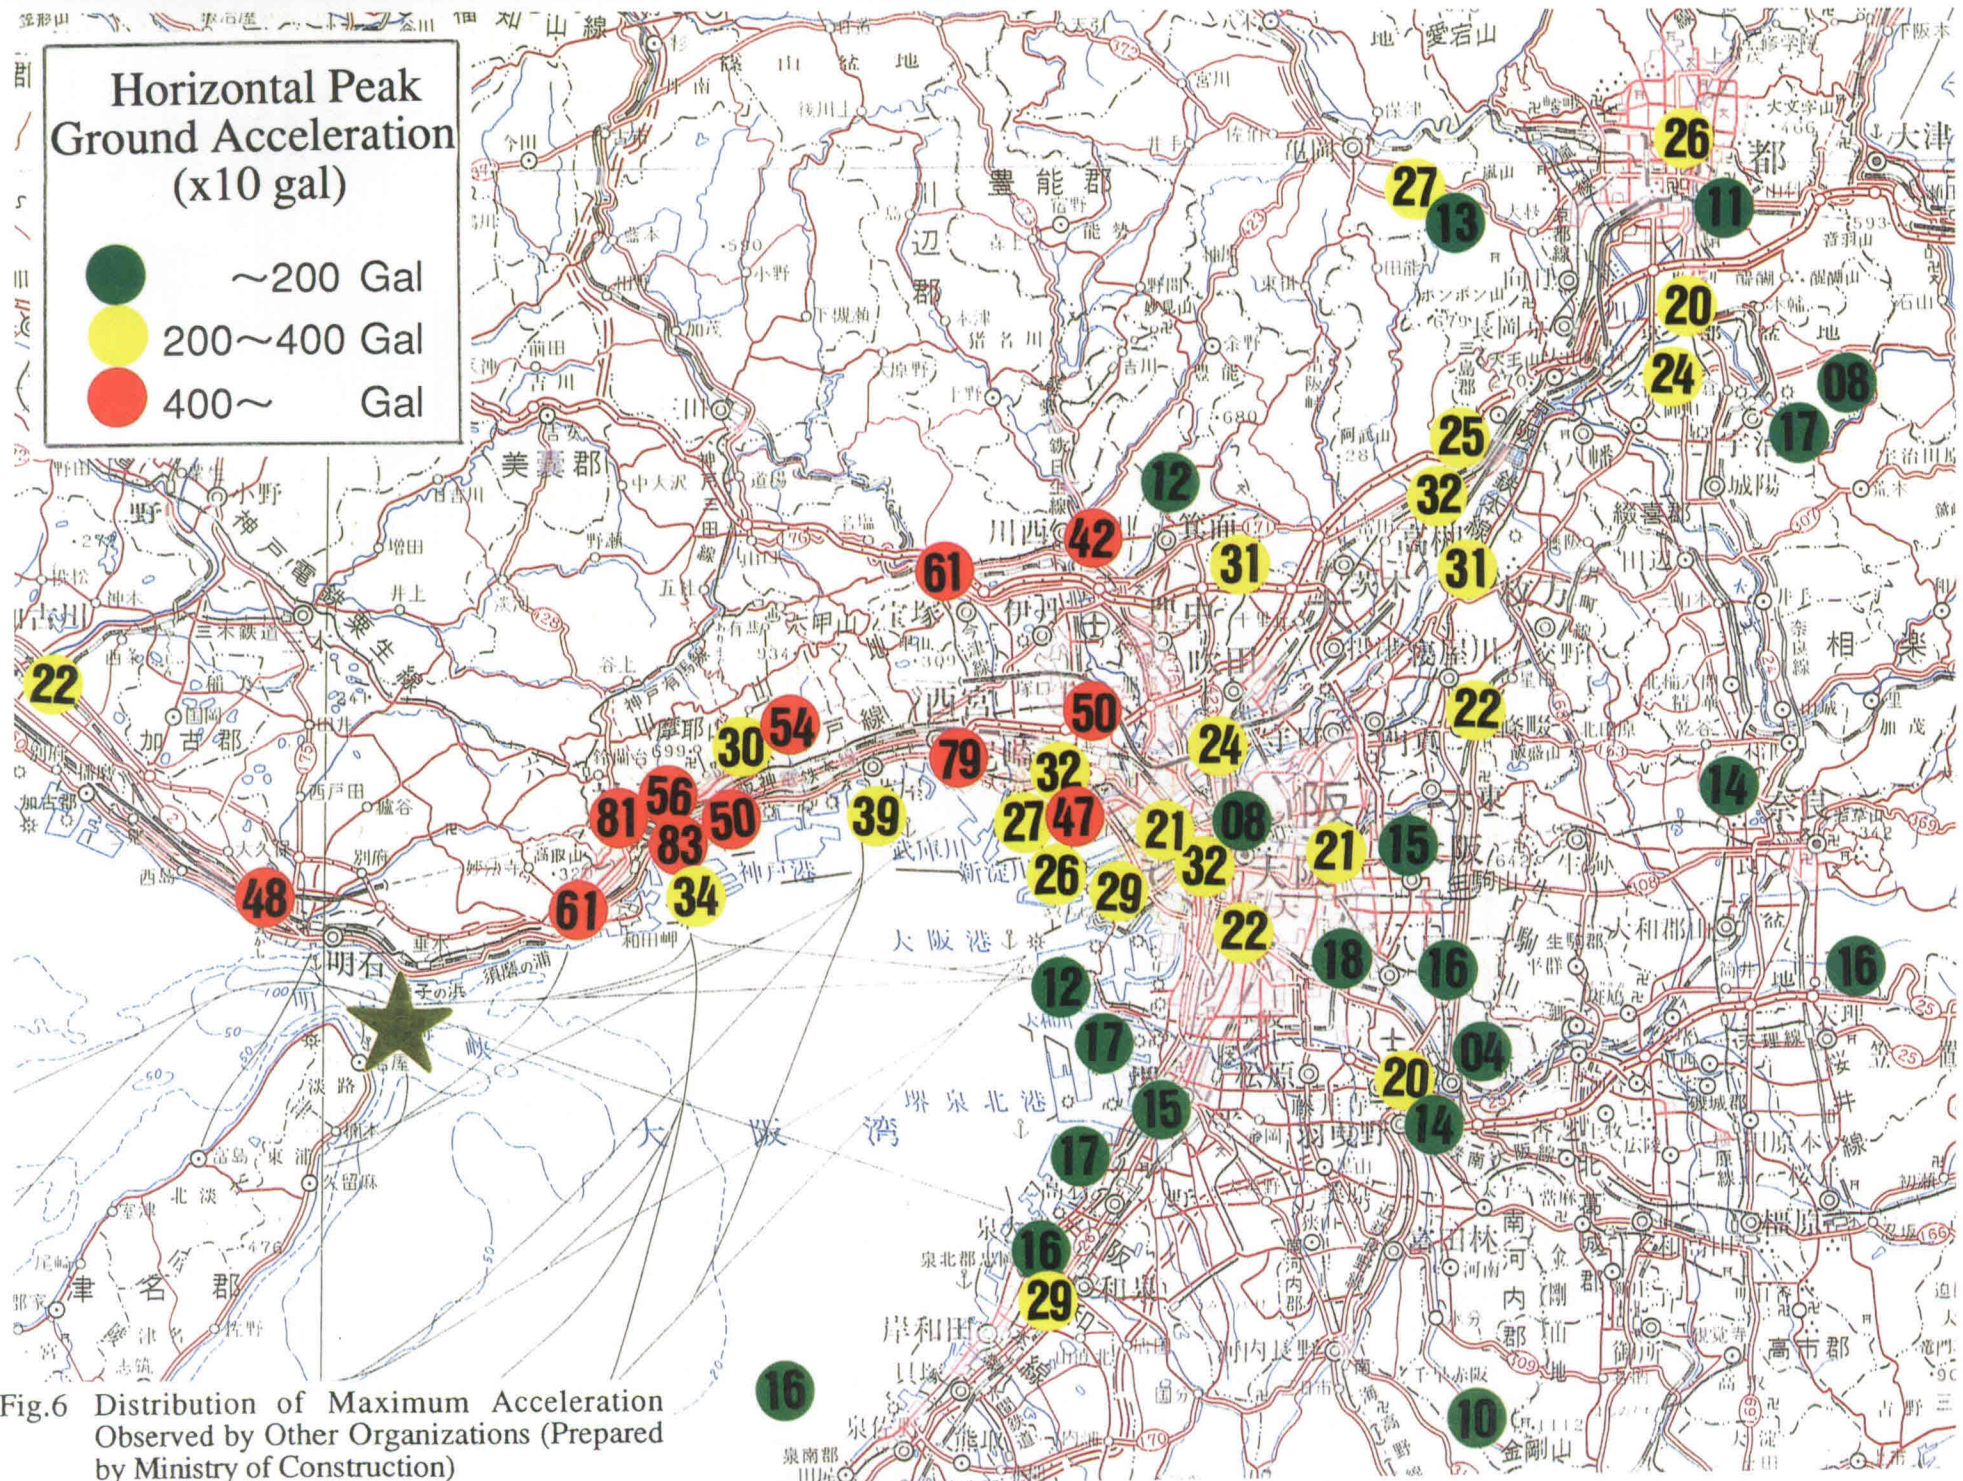
Fig.6 Distribution of Maximum Acceleration Observed by Other Organizations (Prepared by Ministry of Construction)

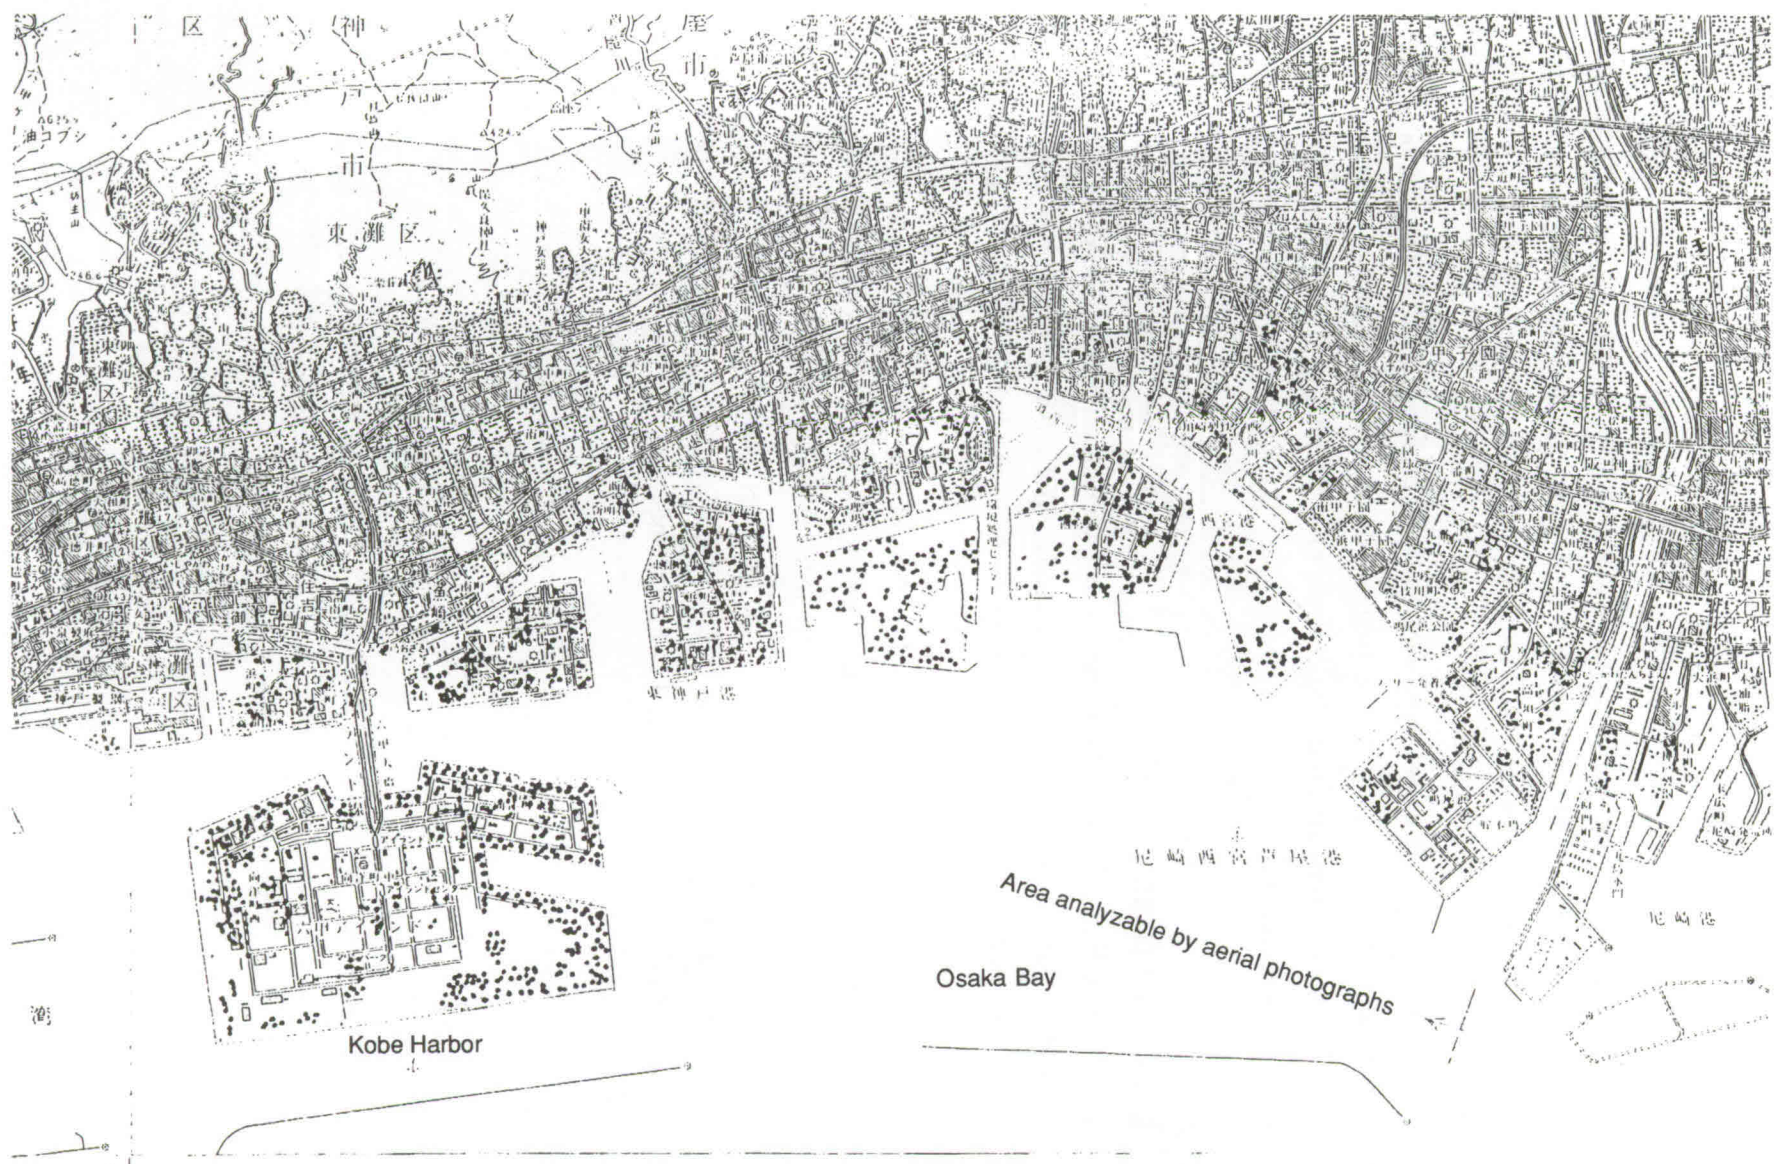
Figure 1 Liquefaction distribution map based on aerial photographs

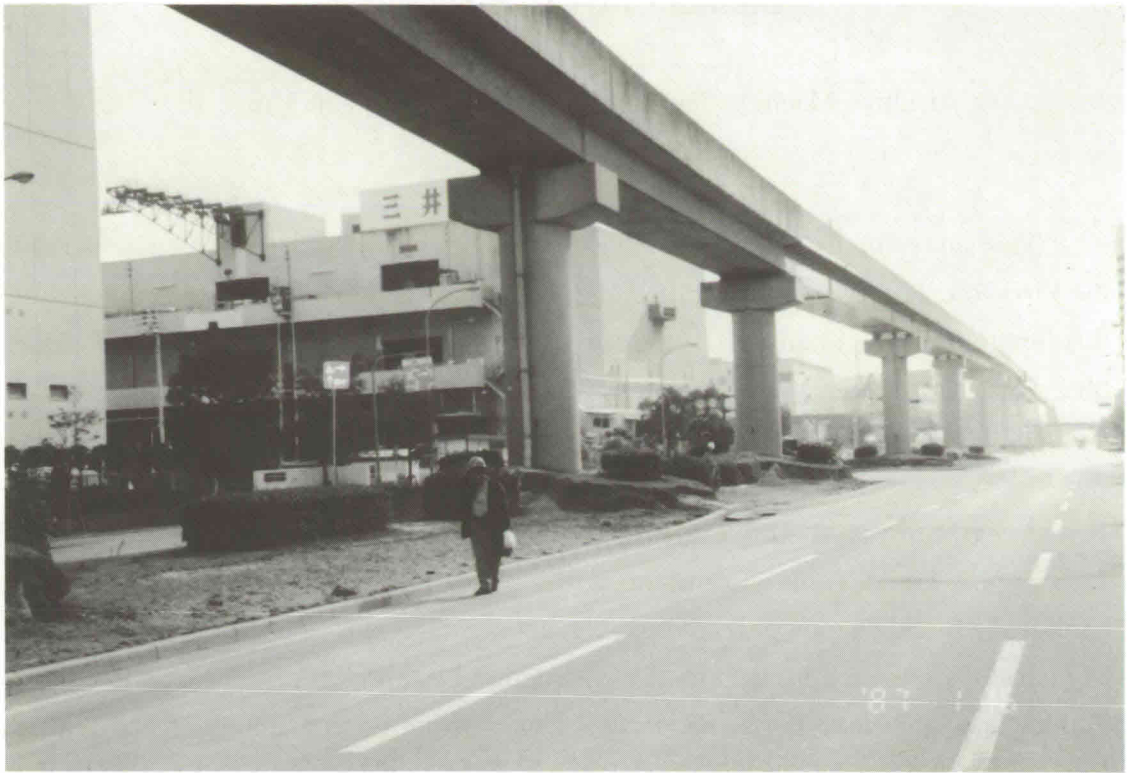
Photo 2 Ground settlement around Shinkansen monorail support column foundations

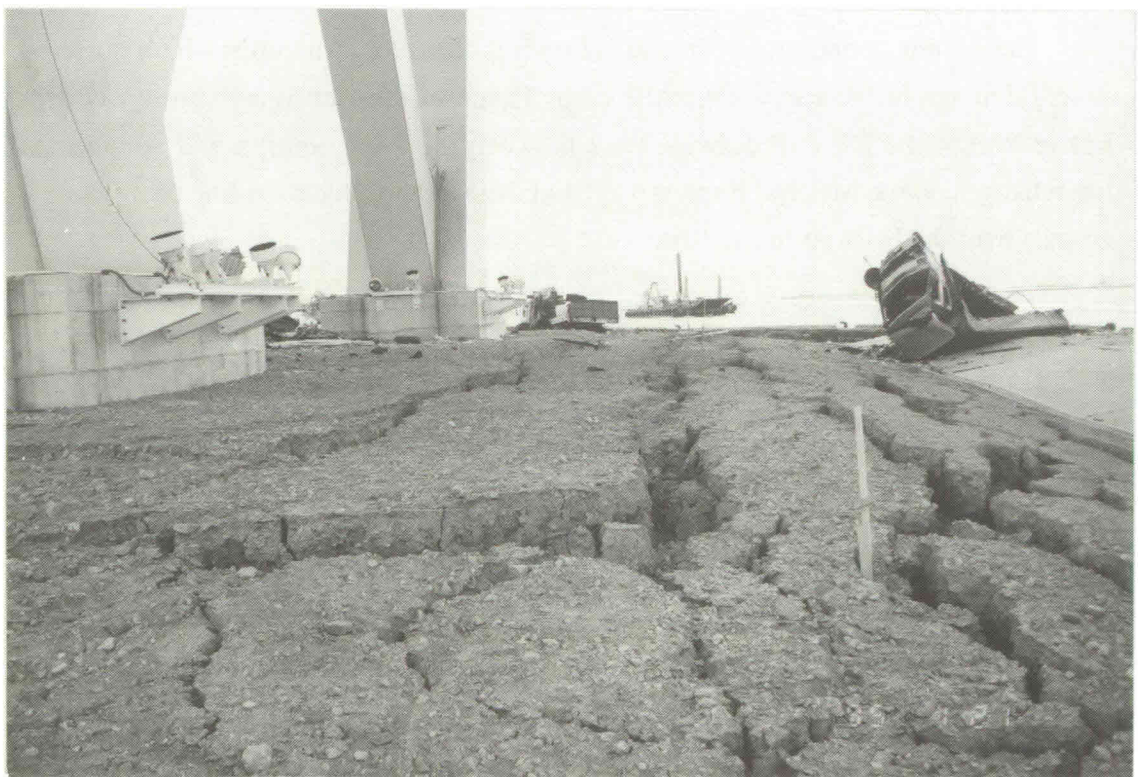
Photo 3 Cracks on the ground around the Nishinomiya Bridge abutment

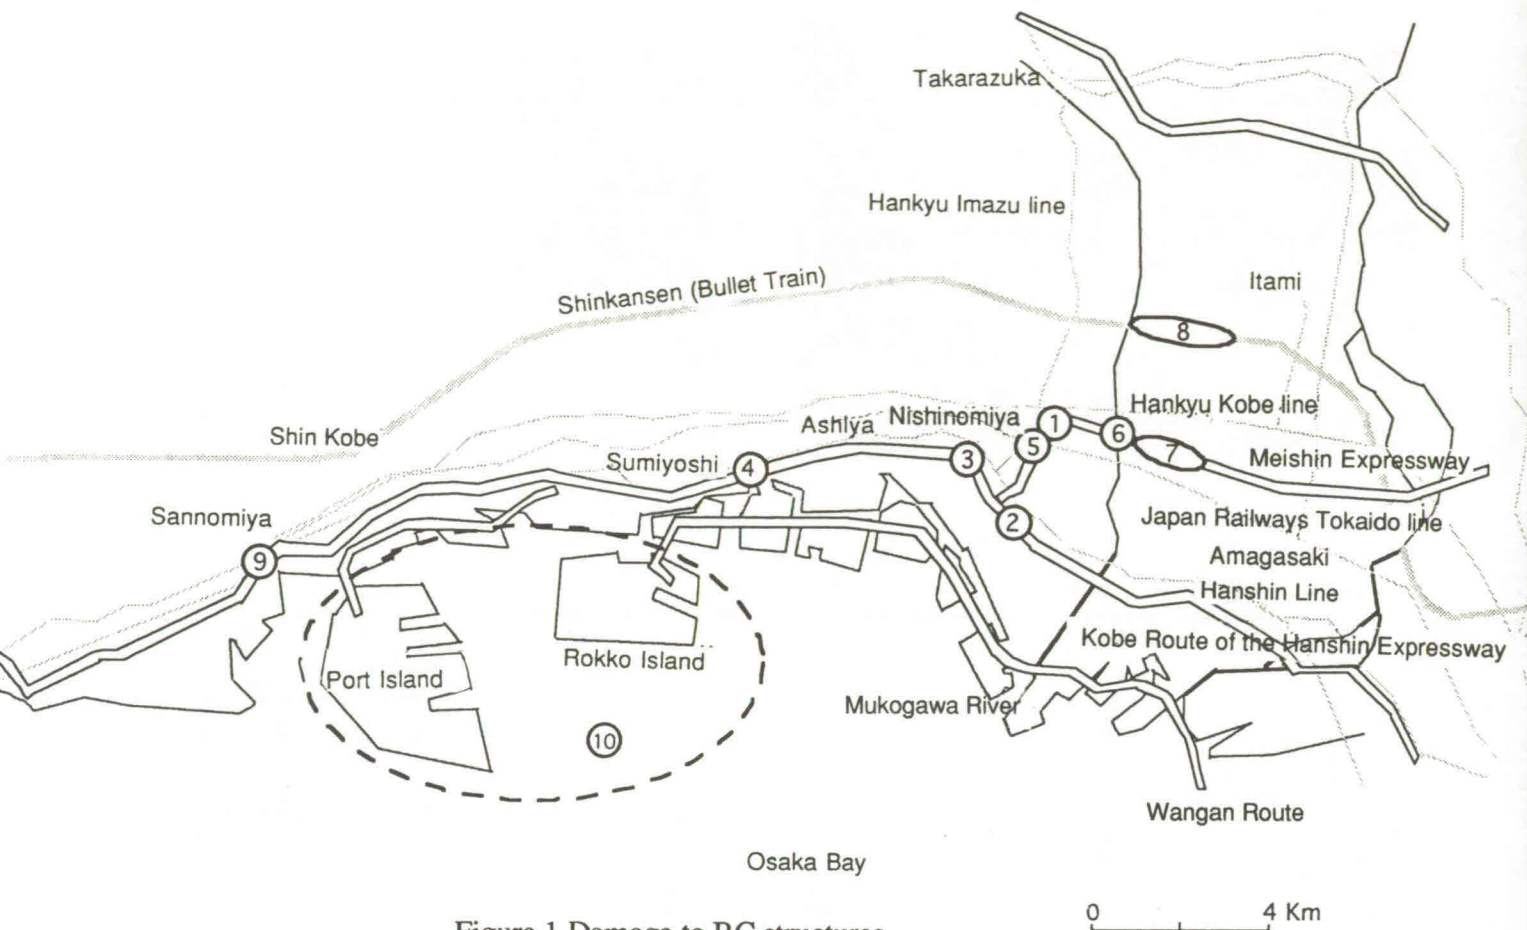
Figure 1 Damage to RC structures

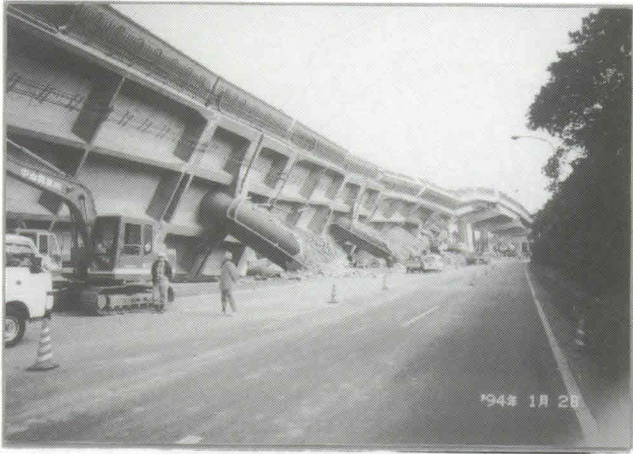
10	Kobe Harbor	Kobe	Rokko Island & Port Island	Large displacement and deformation

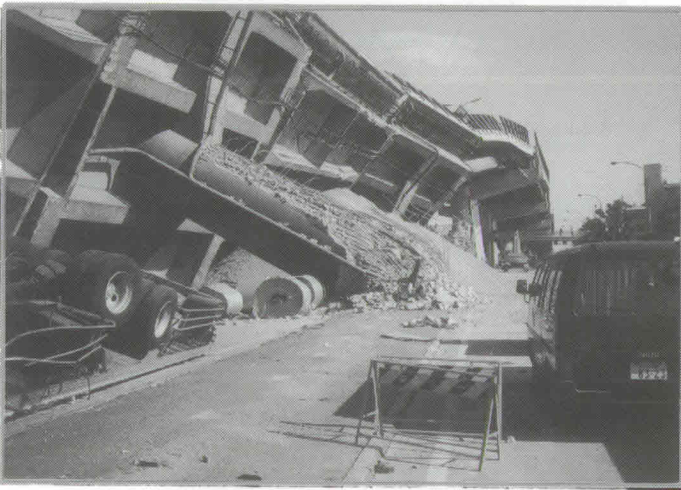
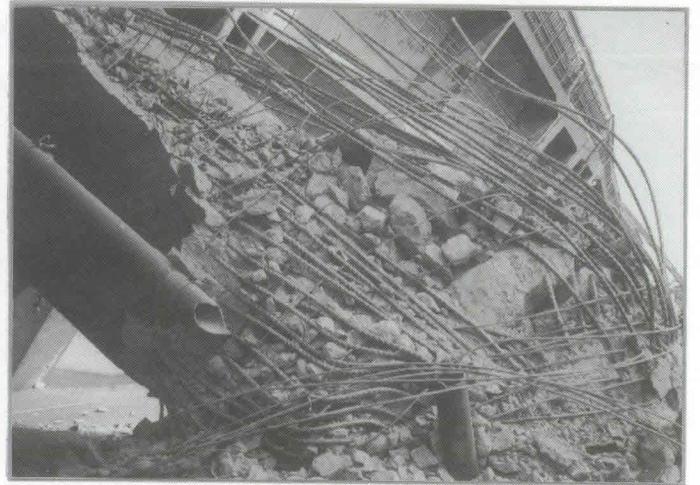
Fractured column, probably as a result of shearing where the quantity of steel reinforcement changed

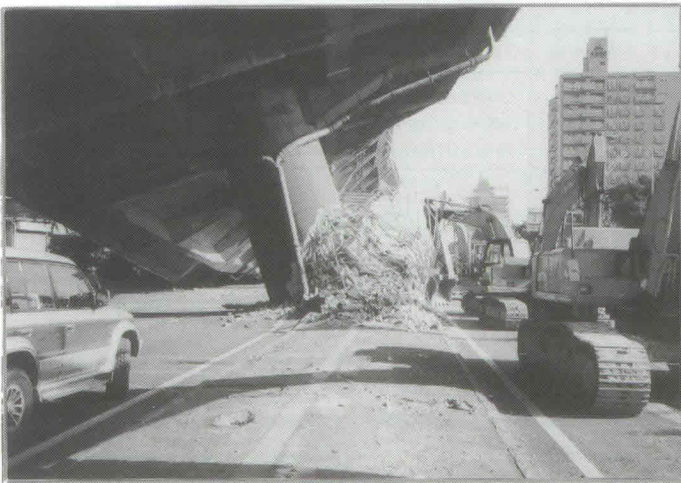
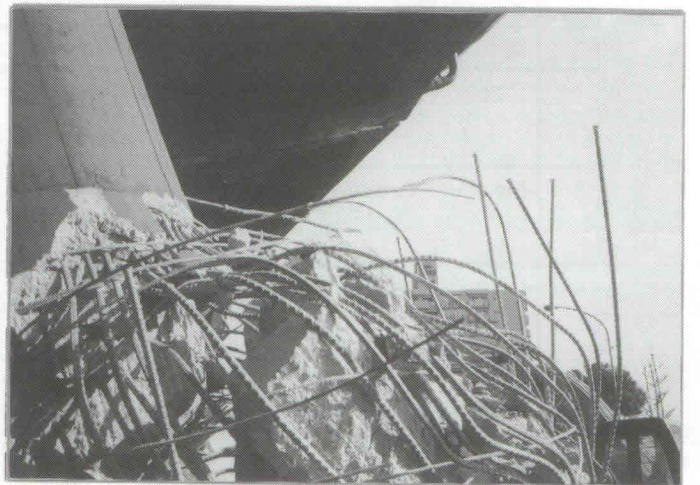
Shear-fractured column, probably as a result of shearing at stud joints

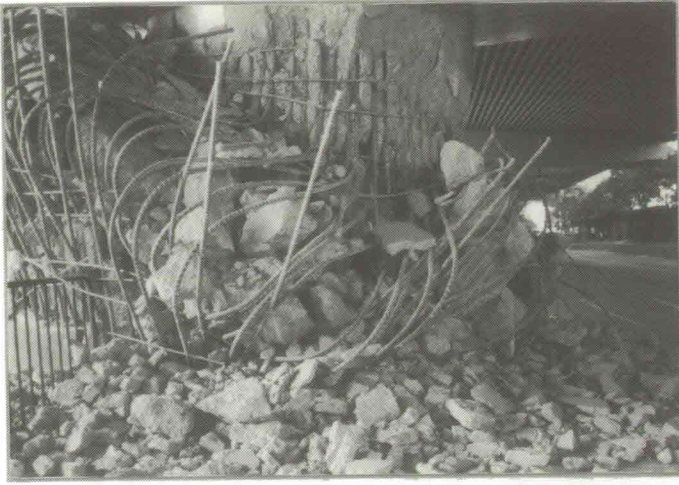
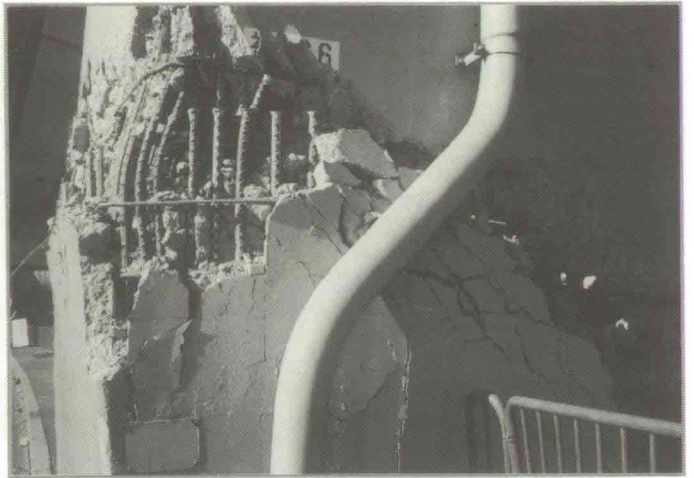
Fractured column at stud joints

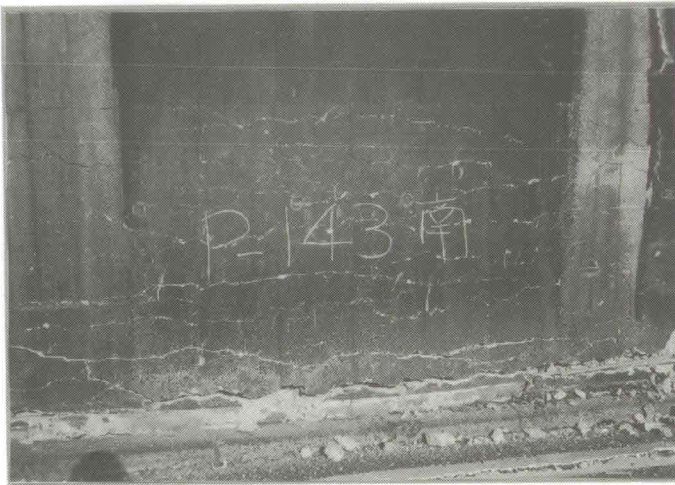
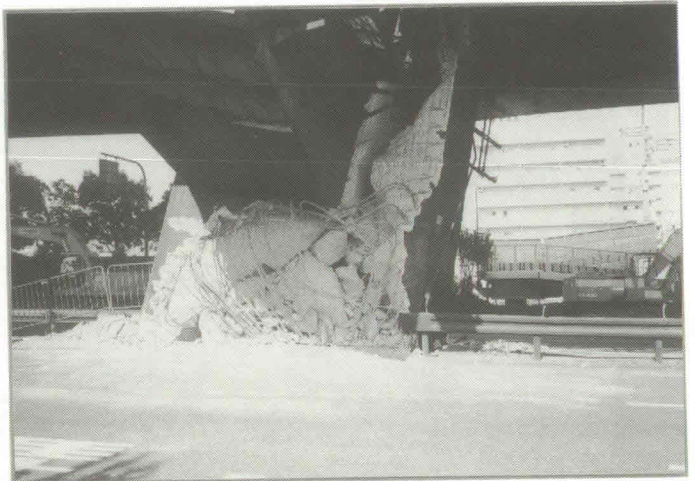
Fractured short column, probably due to shearing

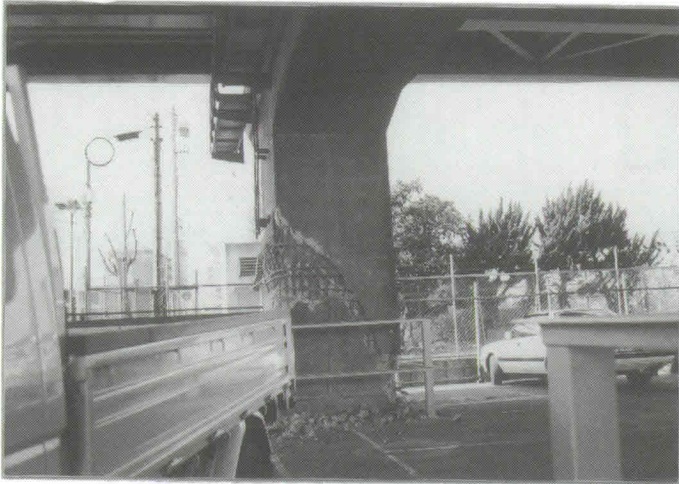
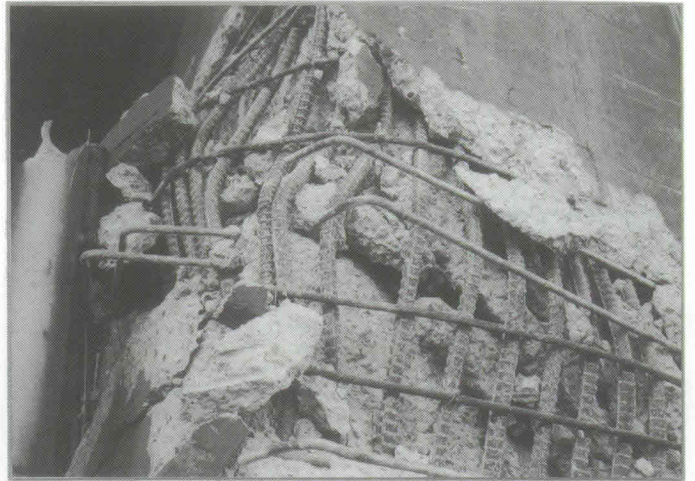
Shear-fractured expressway bridge column of rigid frame construction

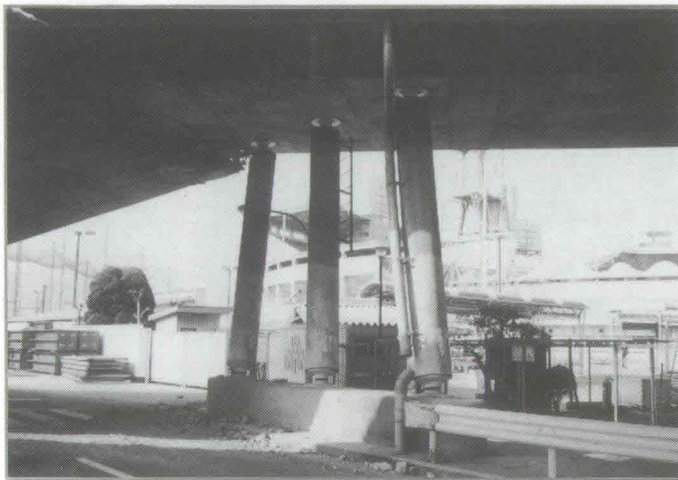
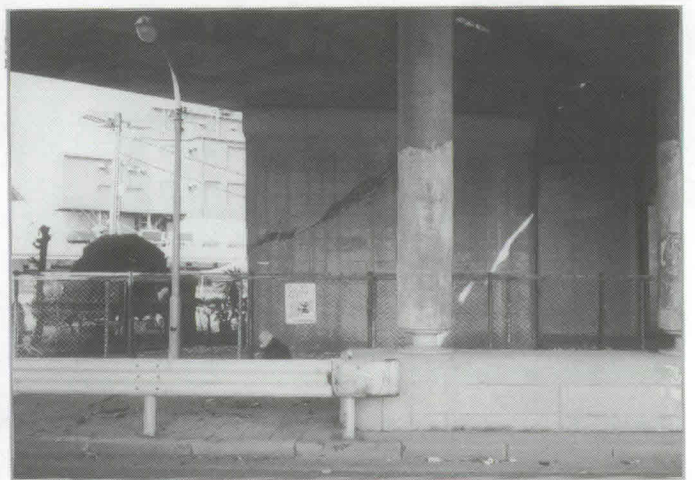
Tilted **rocker** column

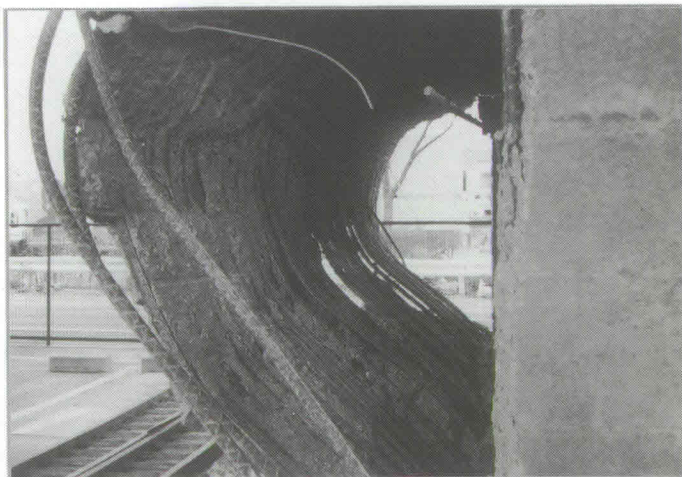
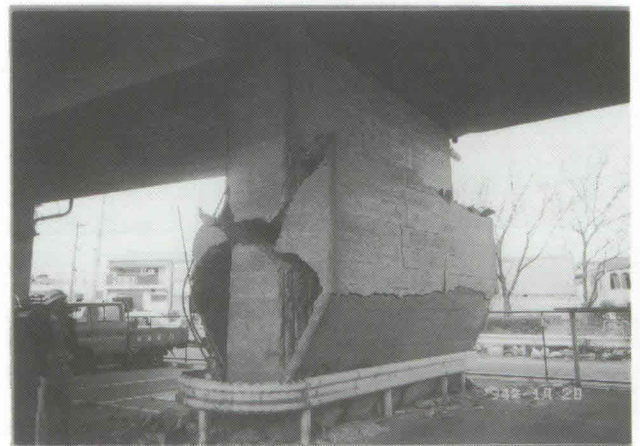
Shear-fractured column of wall type

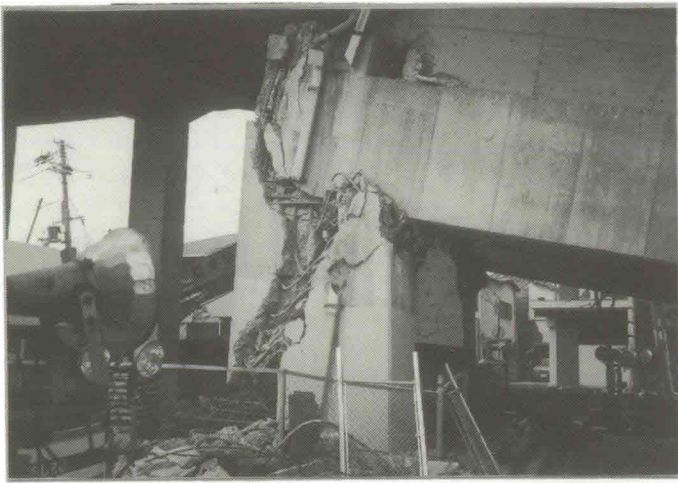
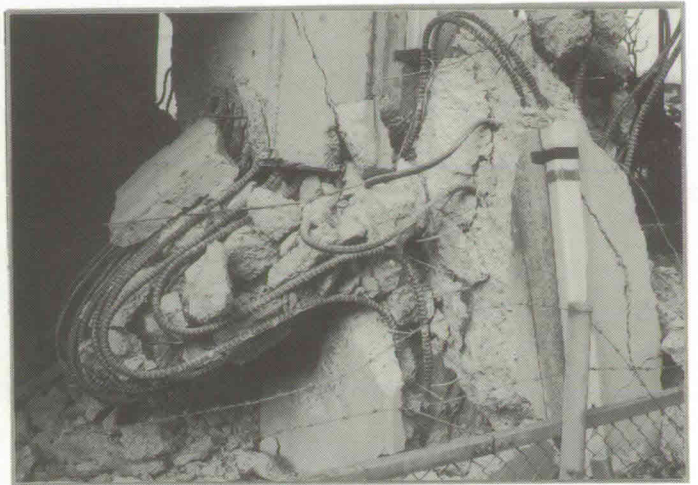
Shear-fractured abutment of rigid frame construction

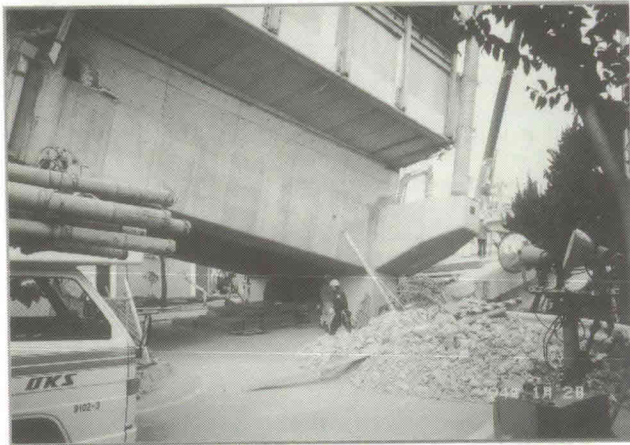
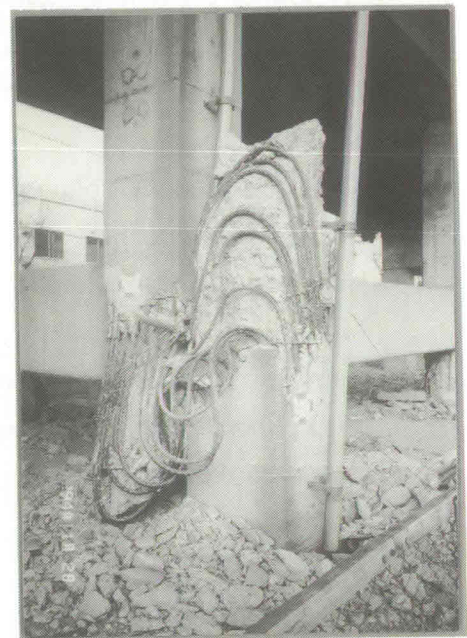
Shear fractured column of rigid frame construction
