Preliminary Report on
**THE GREAT
HANSHIN
EARTHQUAKE**

January 17, 1995

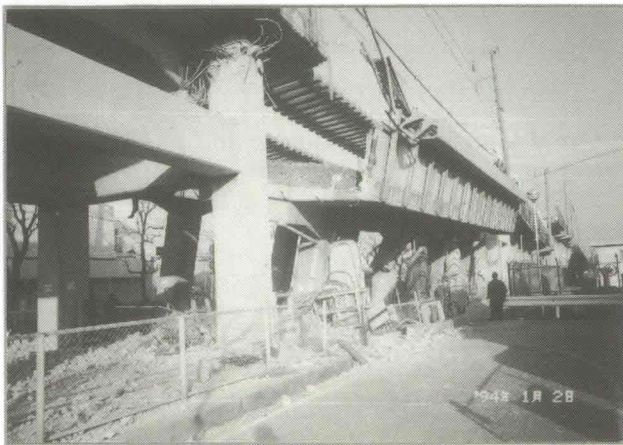
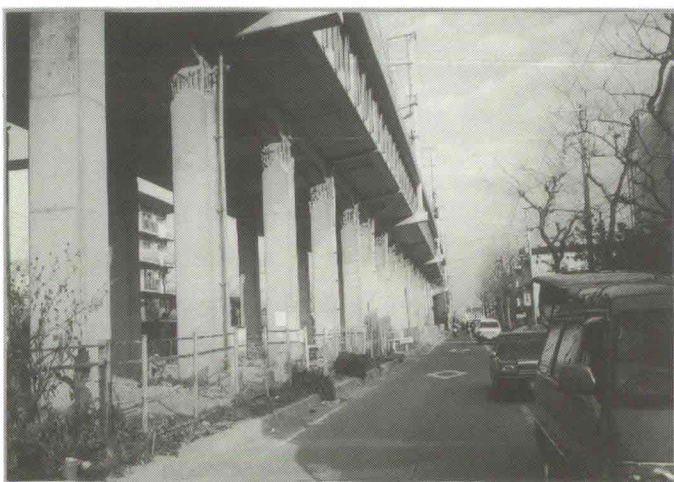
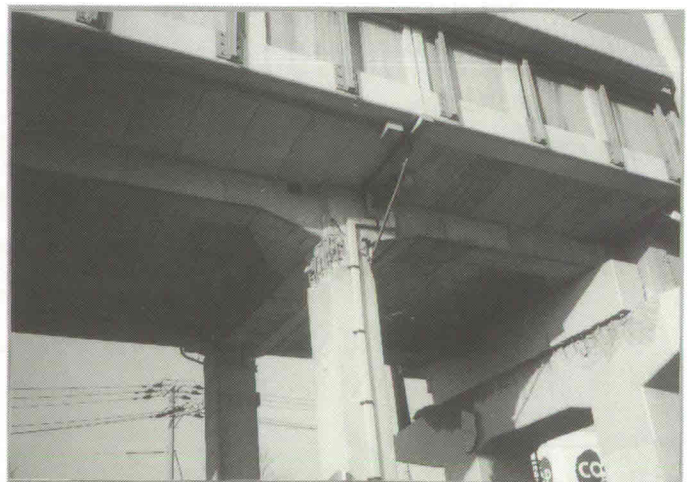
Photo 4 Damage to the Sanyo Shinkansen

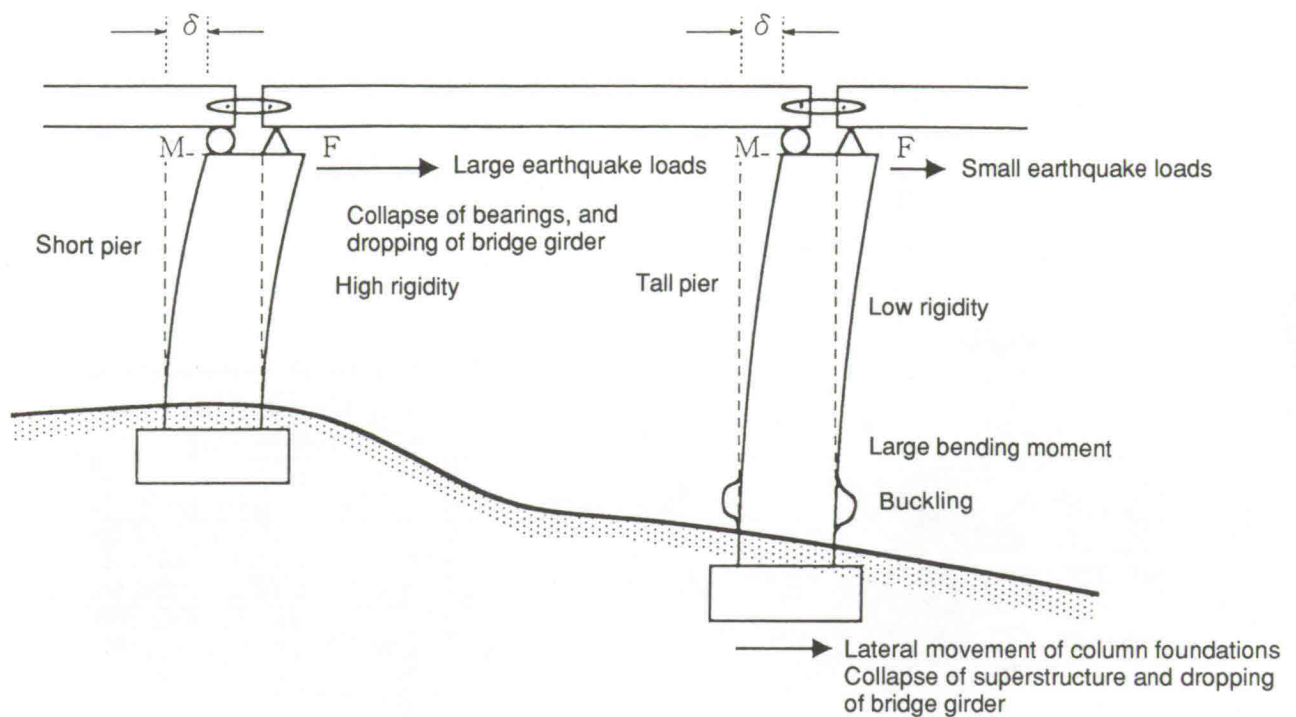
- The bridge girder undergoes large relative displacement due to earthquake loading. The girder follows almost the same horizontal displacement through the action of connecting members.

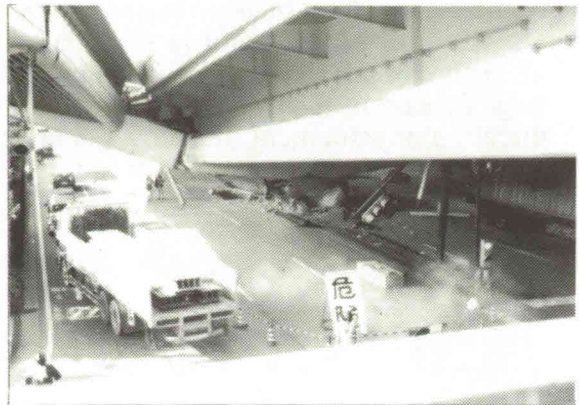
Wangan Route of the Hanshin Expressway

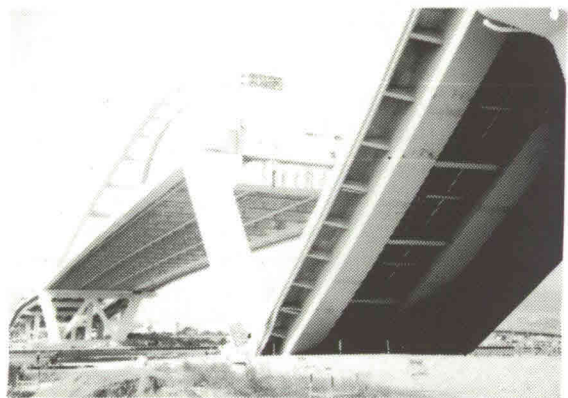
Harbor Highway at Maya Pier

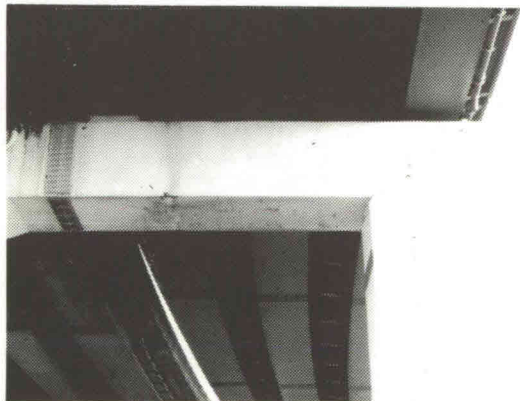
Wangan Route of the Hanshin Expressway

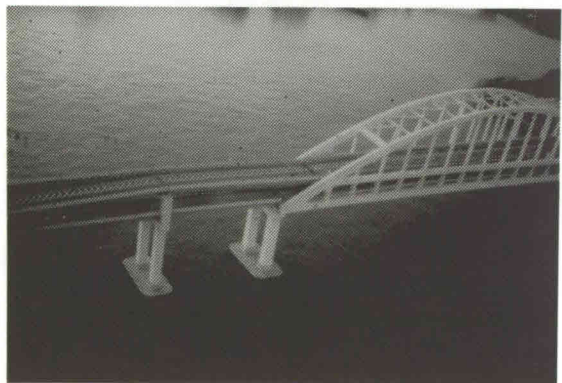
Side bearings of this double-deck Lohse bridge were damaged at the Rokko Island end, causing a great discontinuity in level between the bridge girder and the side span. The cause of this damage appears to have been extraordinary earthquake loading on the bearings.

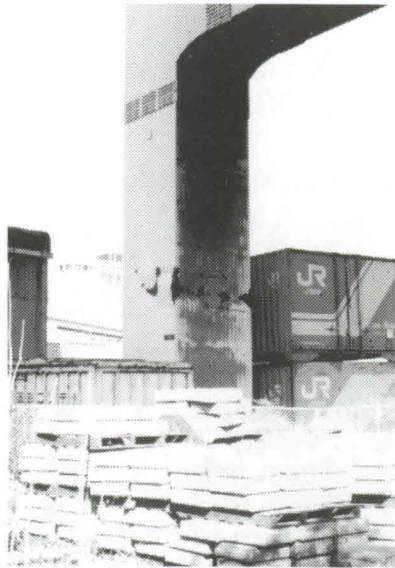
A double-deck highway column of rigid frame construction buckled toward the north at two thirds of its height in the first layer. The cause of this damage seems to have been large motion in the transverse (north-south) direction or settlement of bridge columns at the south end (toward the sea).

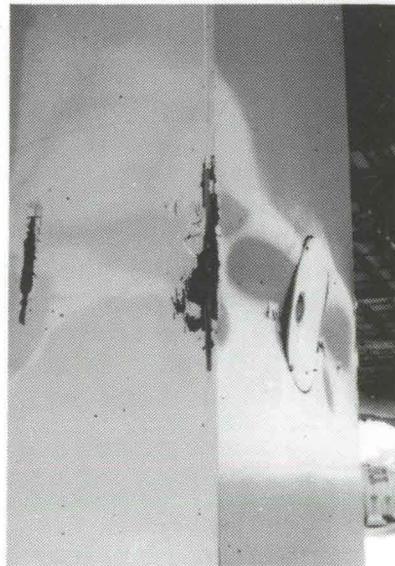
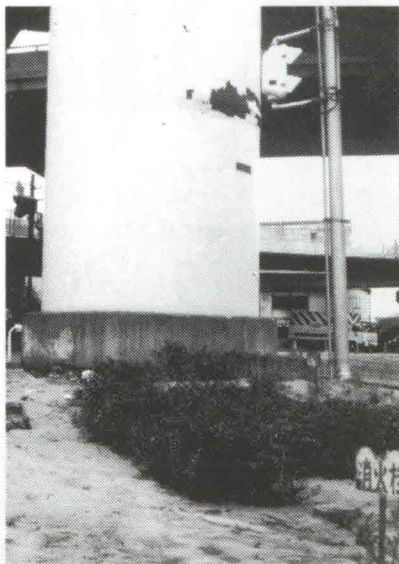
Harbor Highway at Junction with Kobe Route of the Hanshin Expressway

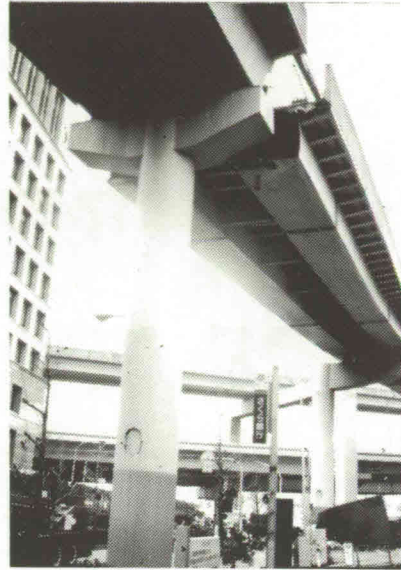
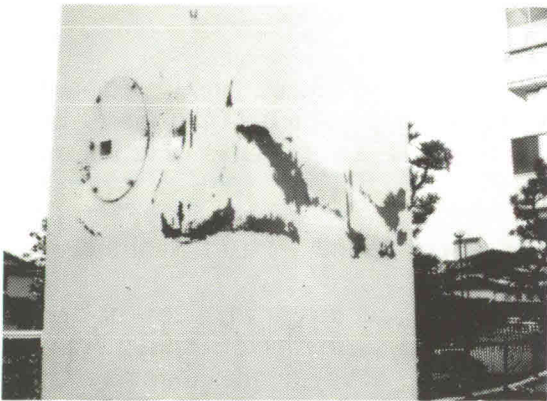
Shinkotsu Port Liner to the north of Uozaki Station

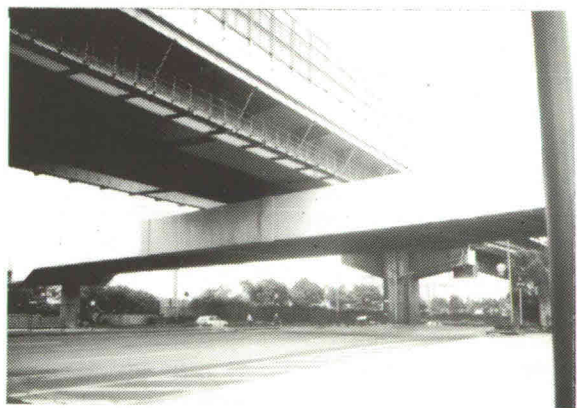
A three-span continuous-girder highway bridge of the Hanshin Expressway was damaged at its support bearings. As a result, the girder dropped by about 70 to 80 cm, forcing closure of the Rokko Liner immediately below the expressway because adequate clearance could not be secured.

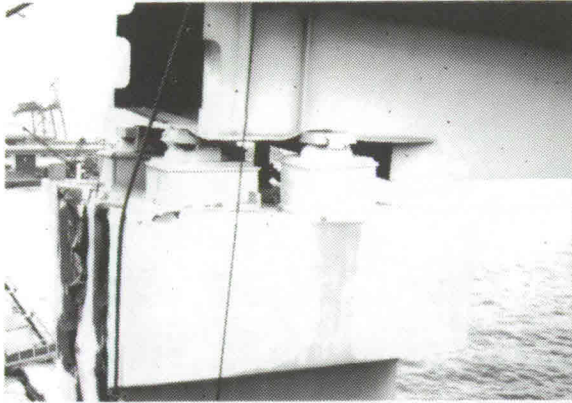
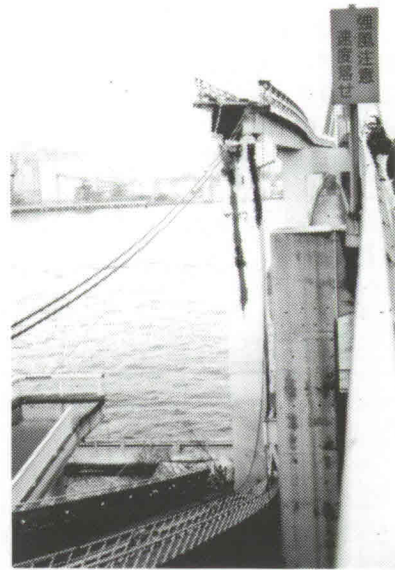
Shinkotsu Rokko Liner to the south of Rokko Bridge

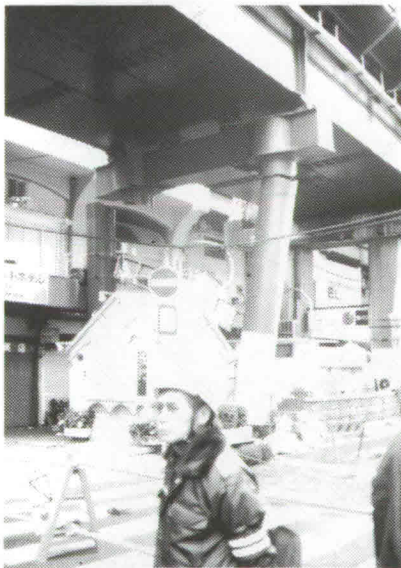
Kobe Kosoku Railway to the west of Sannomiya Station

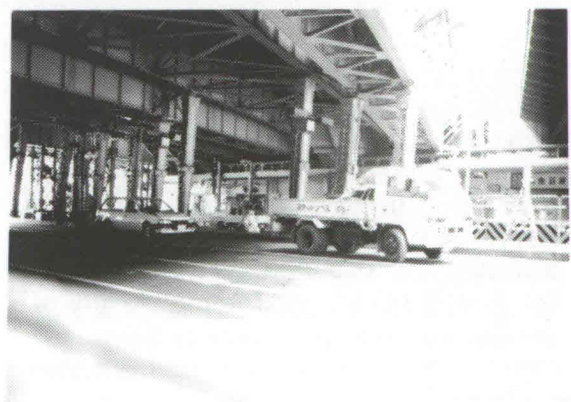
Japan Railways and Hankyu Lines at Sannomiya Station

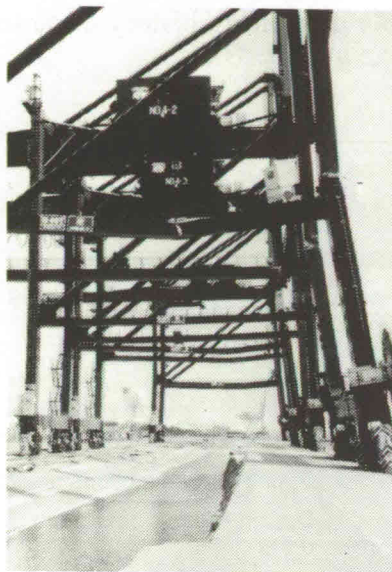
5. LOADING TESTS ON A STEEL BRIDGE COLUMN MODEL

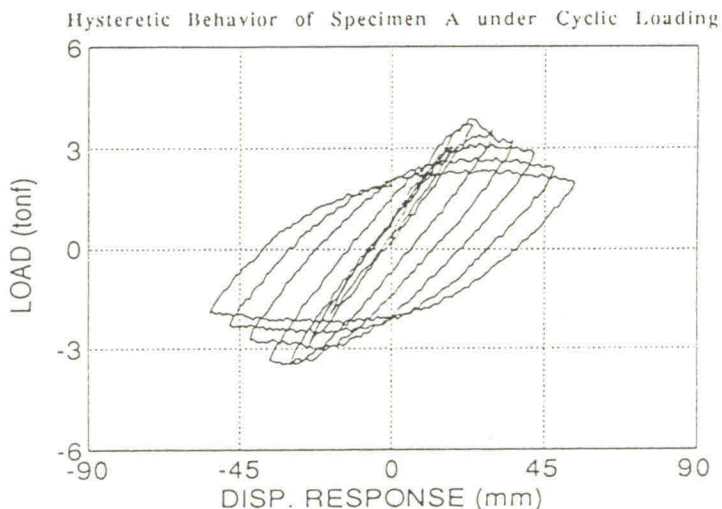
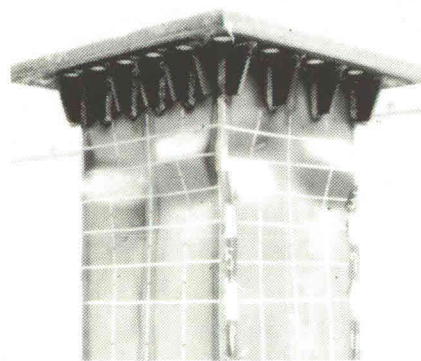
Table comparing history of earthquake damage and seismic design codes for bridges in Japan and the U.S.

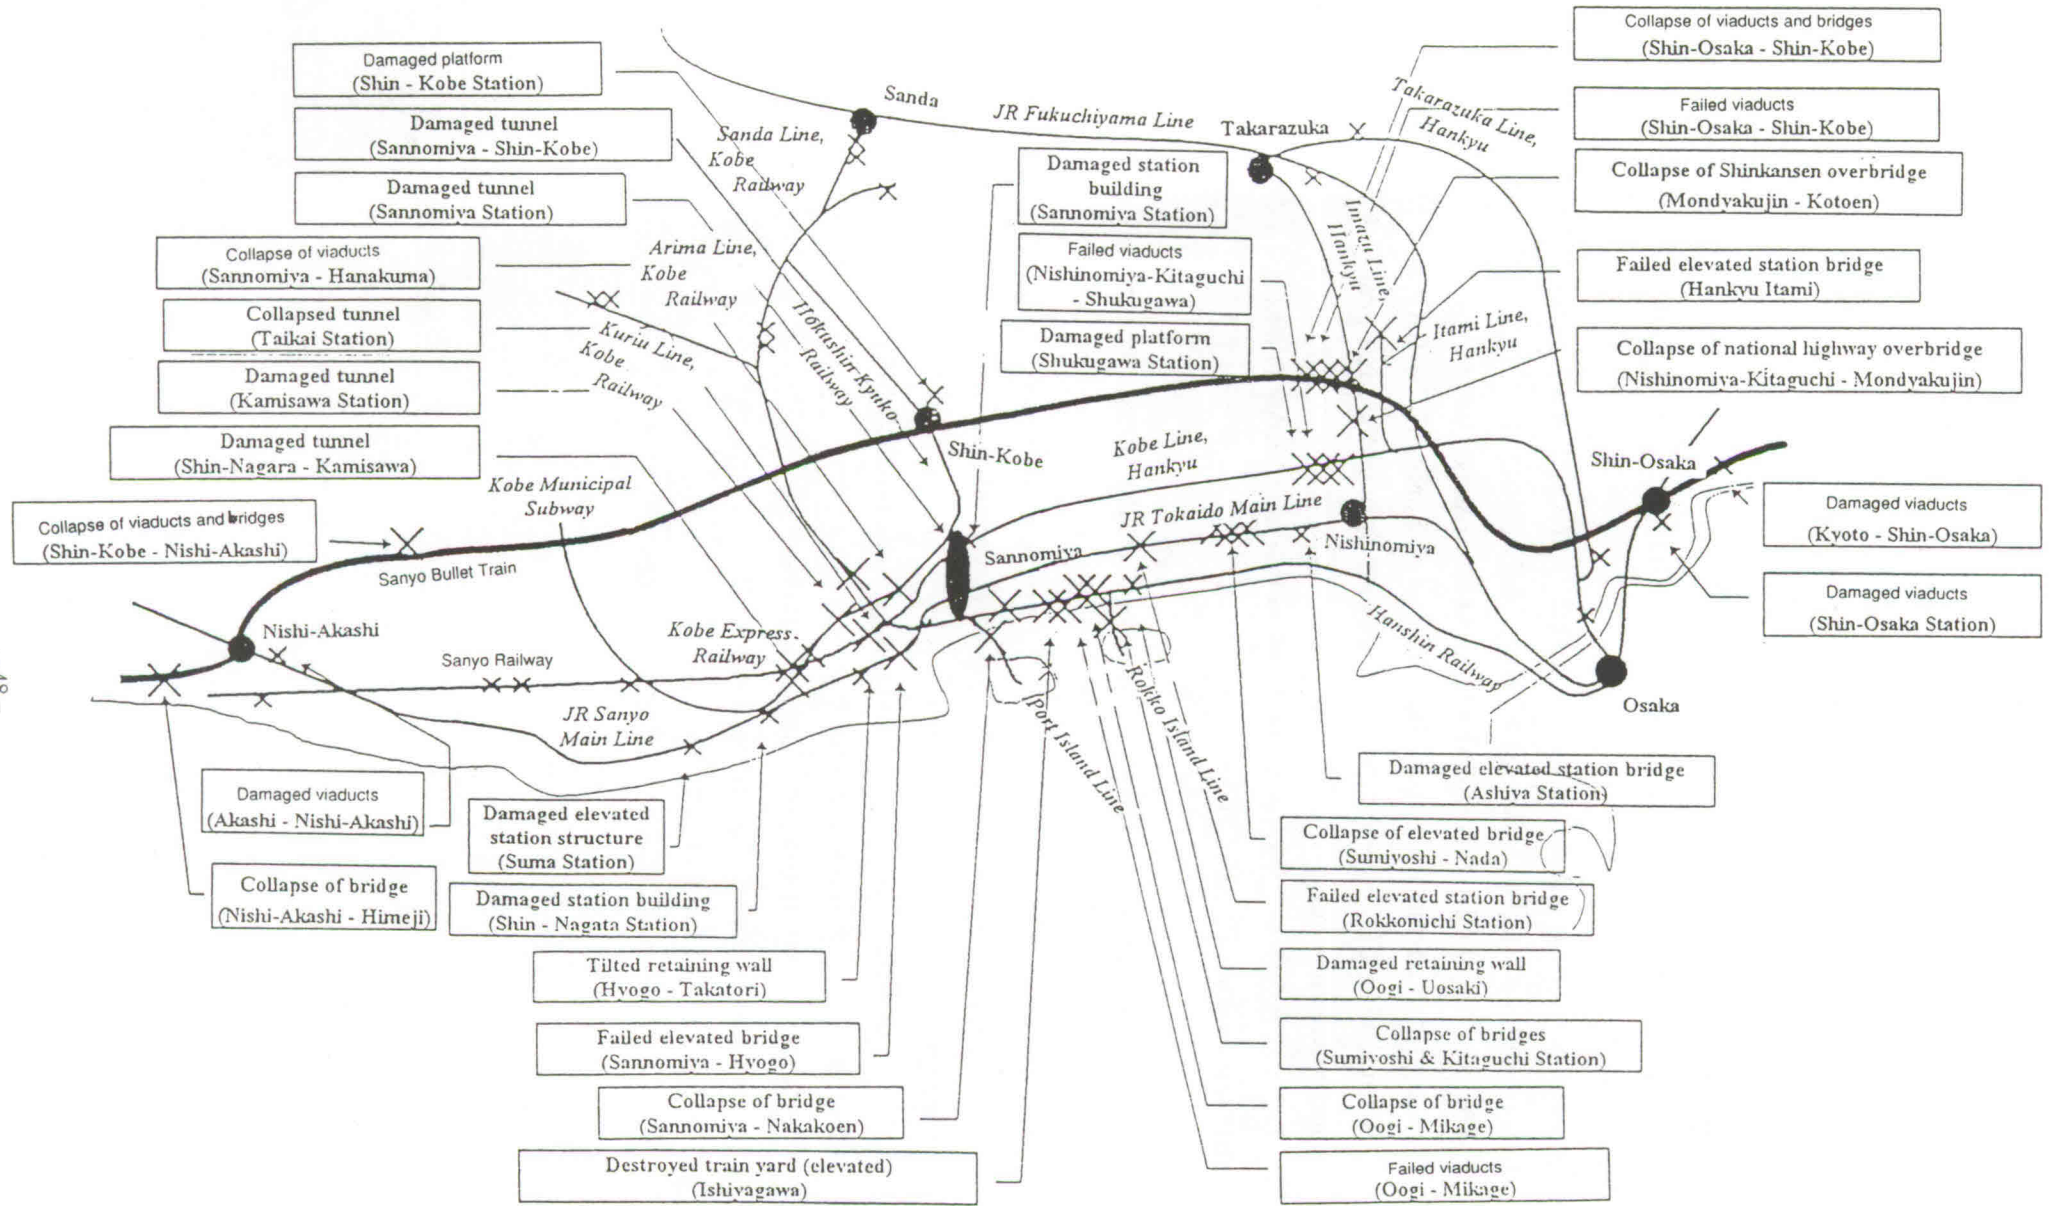
Fig. 1 Damage to Railway Structures

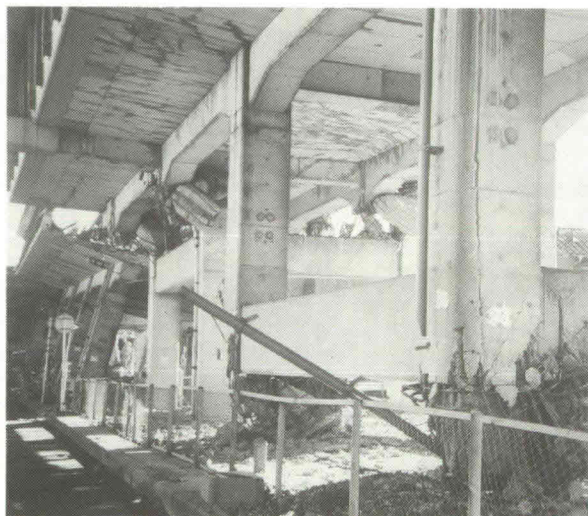
Photo 1 Collapse of double-deck rigid-frame viaduct (Hansui Viaduct, Sanyo Bullet Train in Nishinomiya City)

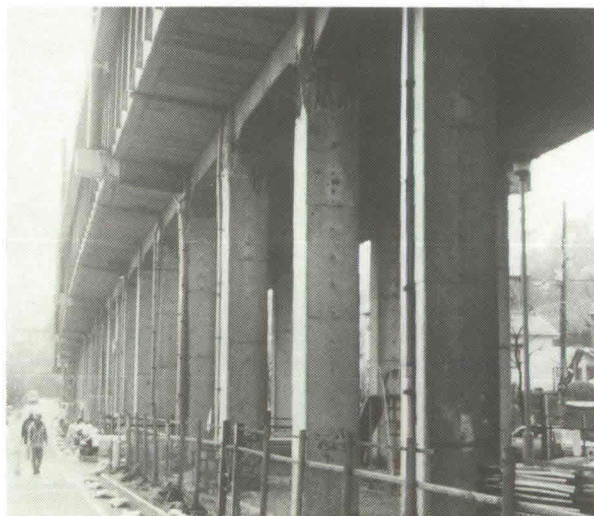
Photo 2 Damage to tops of columns of rigid-frame viaduct, just below haunch

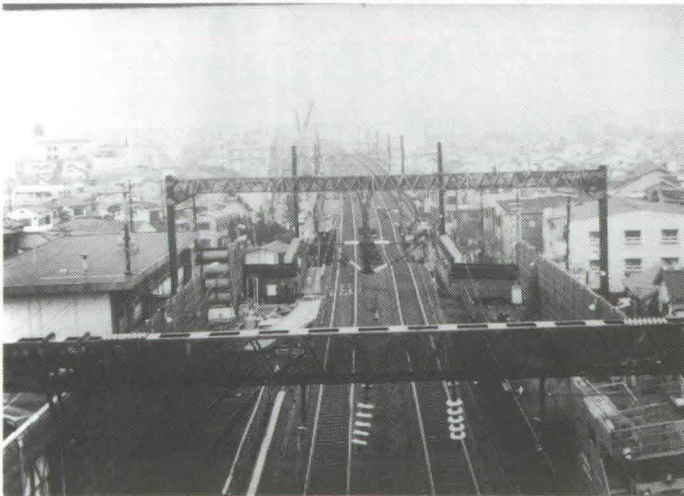
Photo 3 Track of Sanyo Bullet Train Line as seen from the eastern entrance to the Rokko Tunnel; damage to the ballast and rails is slight despite failure of the viaduct

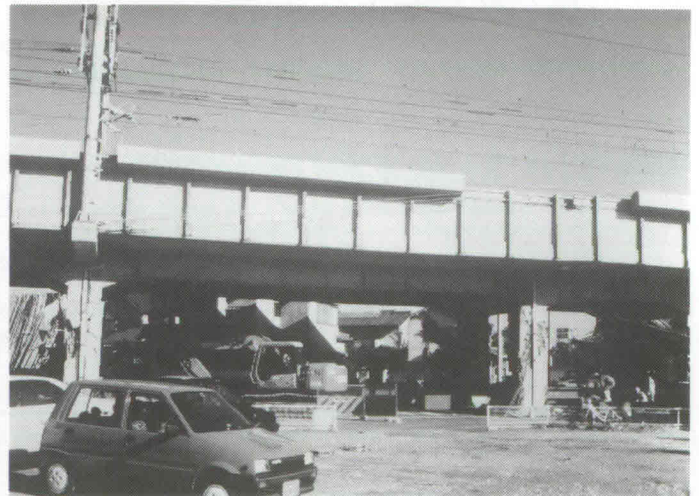
Photo 4 Damage to rigid-frame viaduct with three unequal spans (near Nishi-Akashi Station, Sanyo Bullet Train Line)

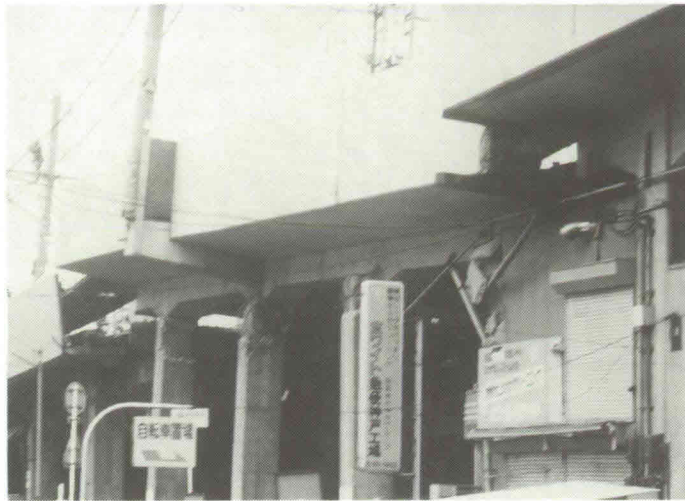
Photo 5 Failure of rigid-frame viaduct and twisted rails (near Rokkomichi Station, Tokaido Main Line)

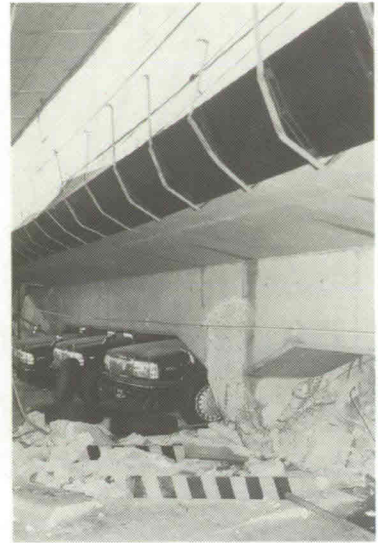
Photo 6 Failure of columns of rigid-frame viaduct

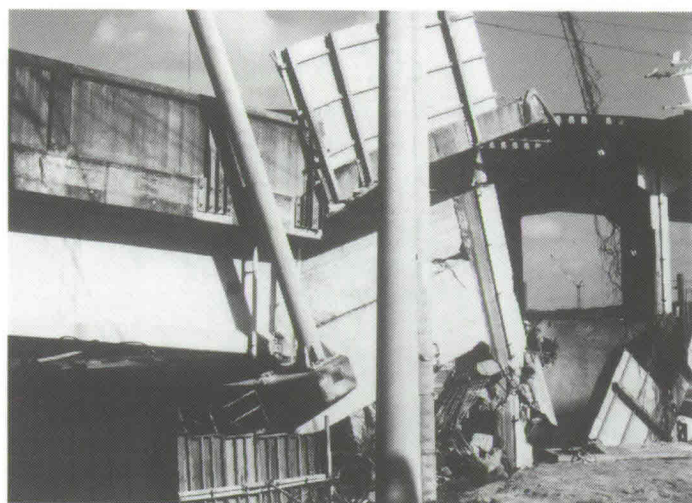
Photo 7 Failure of rigid-frame abutments (Ikawa River Bridge, Sanyo Bullet Train Line); upper and middle girders in contact after destruction of the upper-deck side columns

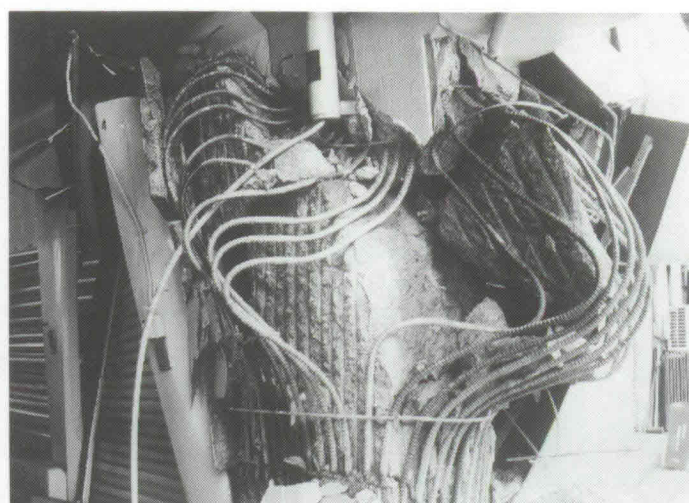
Photo 8 Failure of reinforced concrete piers of an overbridge (near Rokkomichi Station, Tokaido Main Line)

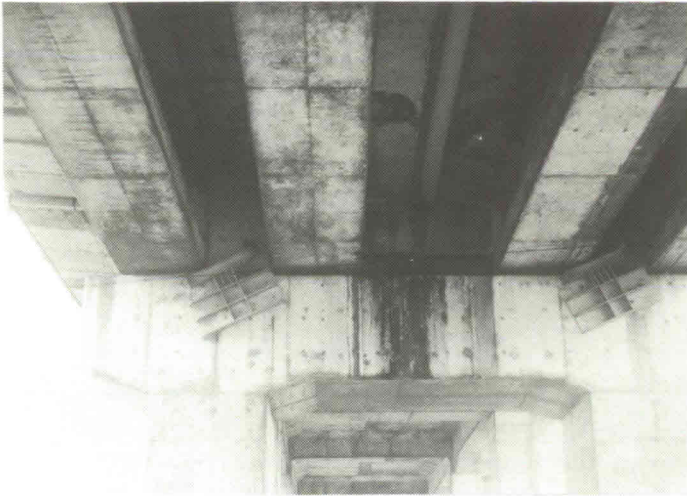
Photo 9 Failure of devices to check the lateral movement of girders (Kaminoro Overbridge, Sanyo Bullet Train Line in Nishinomiya City); failed bolts

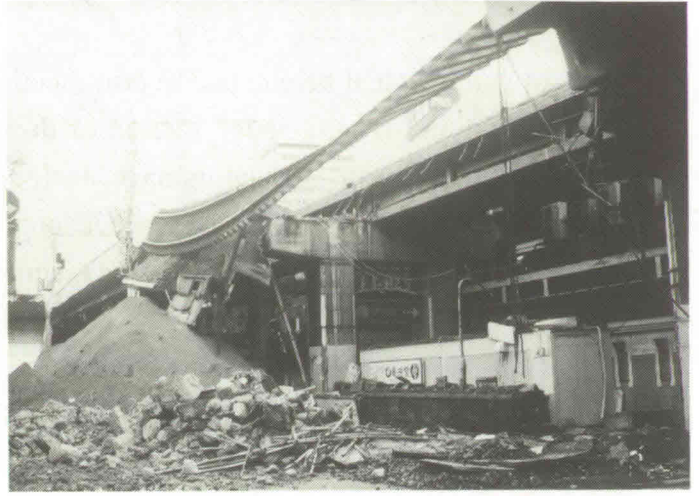
Photo 10 Girders moved laterally and collapsed (near Sannomiya Station, Kobe Express Railway)

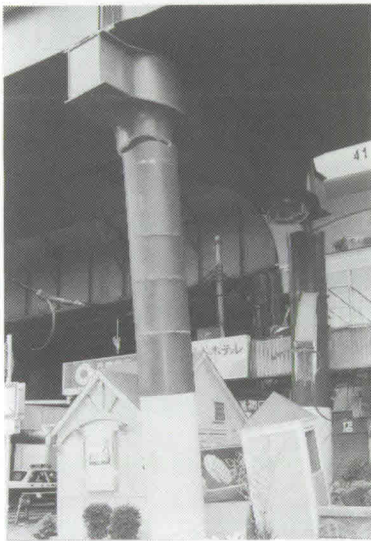
Photo 11 Brittle failure of steel piers (near Sannomiya Station, Kobe Express Railway)

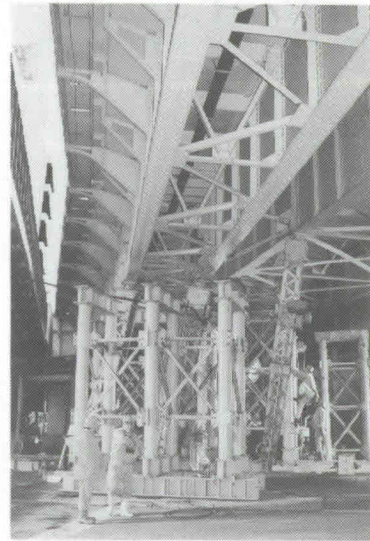
Photo 12 Tilting rocker piers (near Sannomiya Station, Tokaido Main Line)

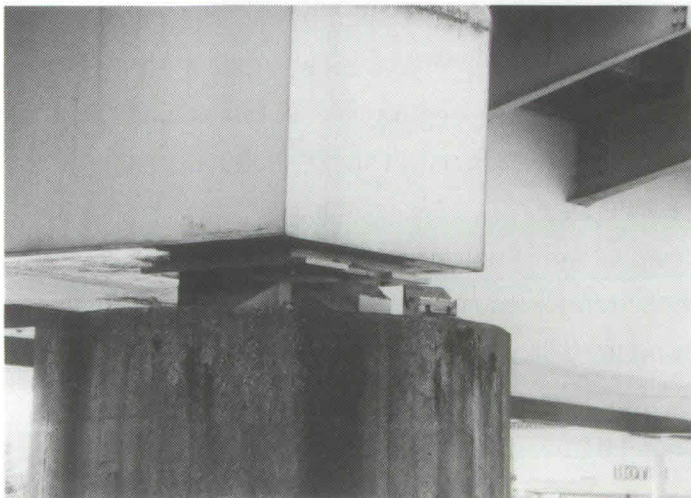
Photo 13 Failure of lower shoes on transverse box girders on a steel girder bridge (Ikawa River Bridge, Sanyo Bullet Train Line)

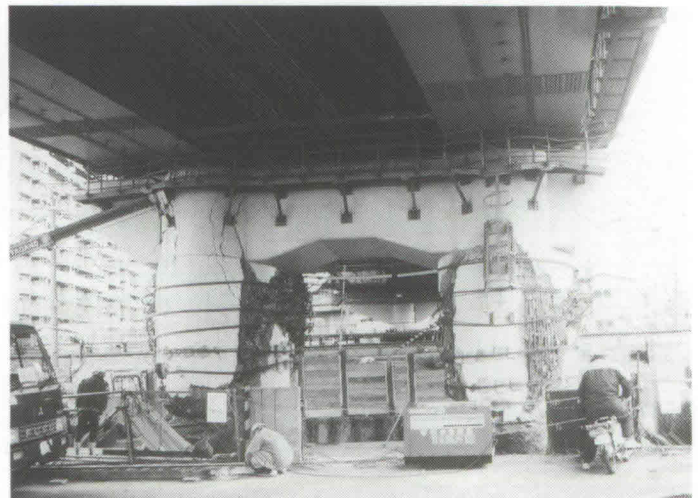
Photo 14 Failure of piers of the Second Shinmei Overbridge, with continuous steel box-girder superstructure

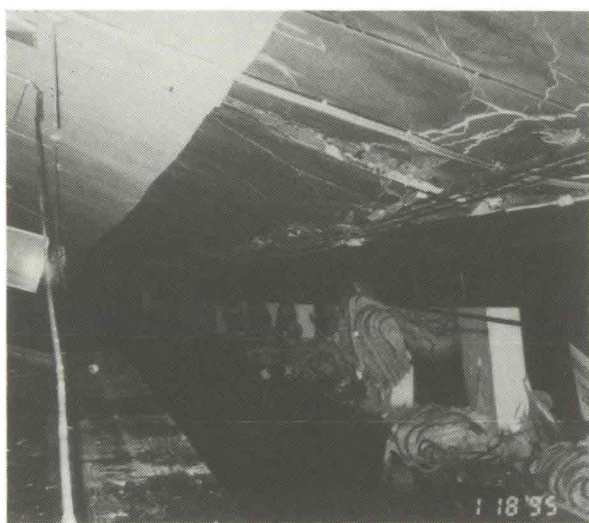
Photo 15 Failure of central subway columns holding up slab of rigid-frame box structure (Taikai Station, Kobe Express Railway)

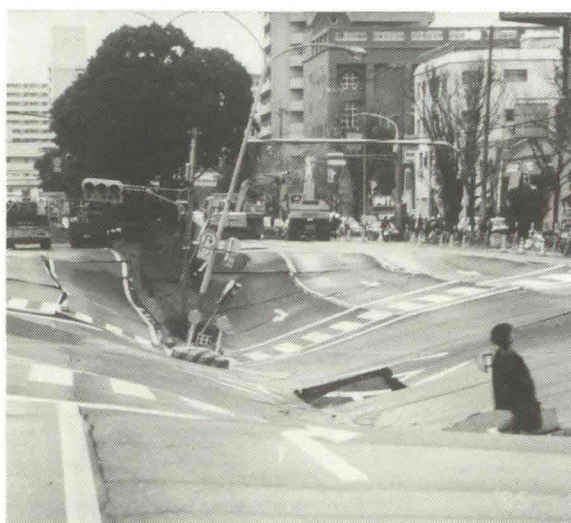
Photo 16 Subsided road surface directly above Taikai Station

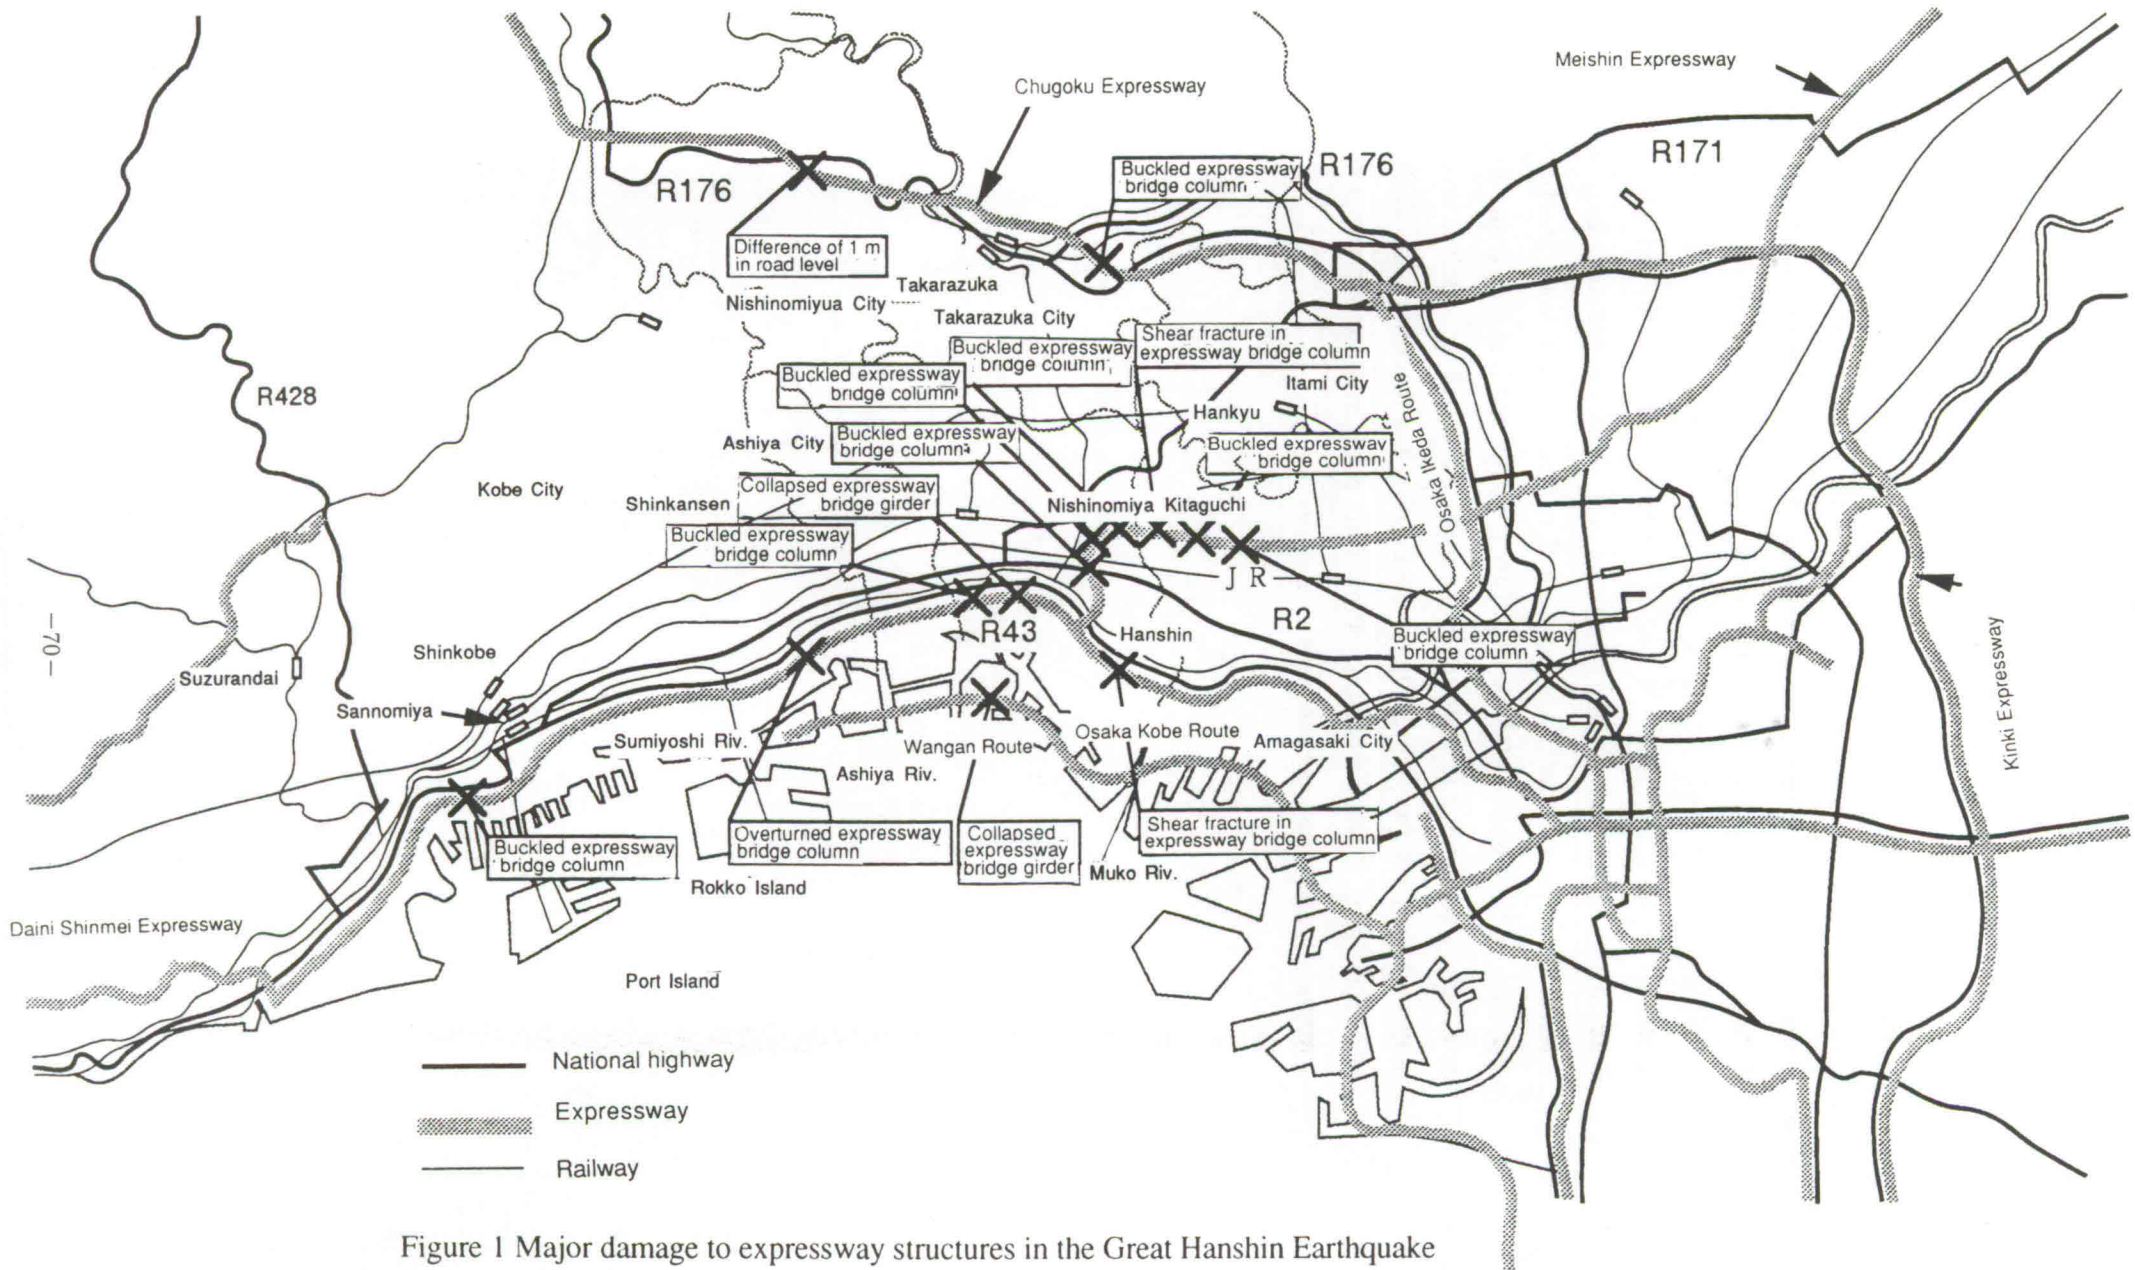
Figure 1 Major damage to expressway structures in the Great Hanshin Earthquake

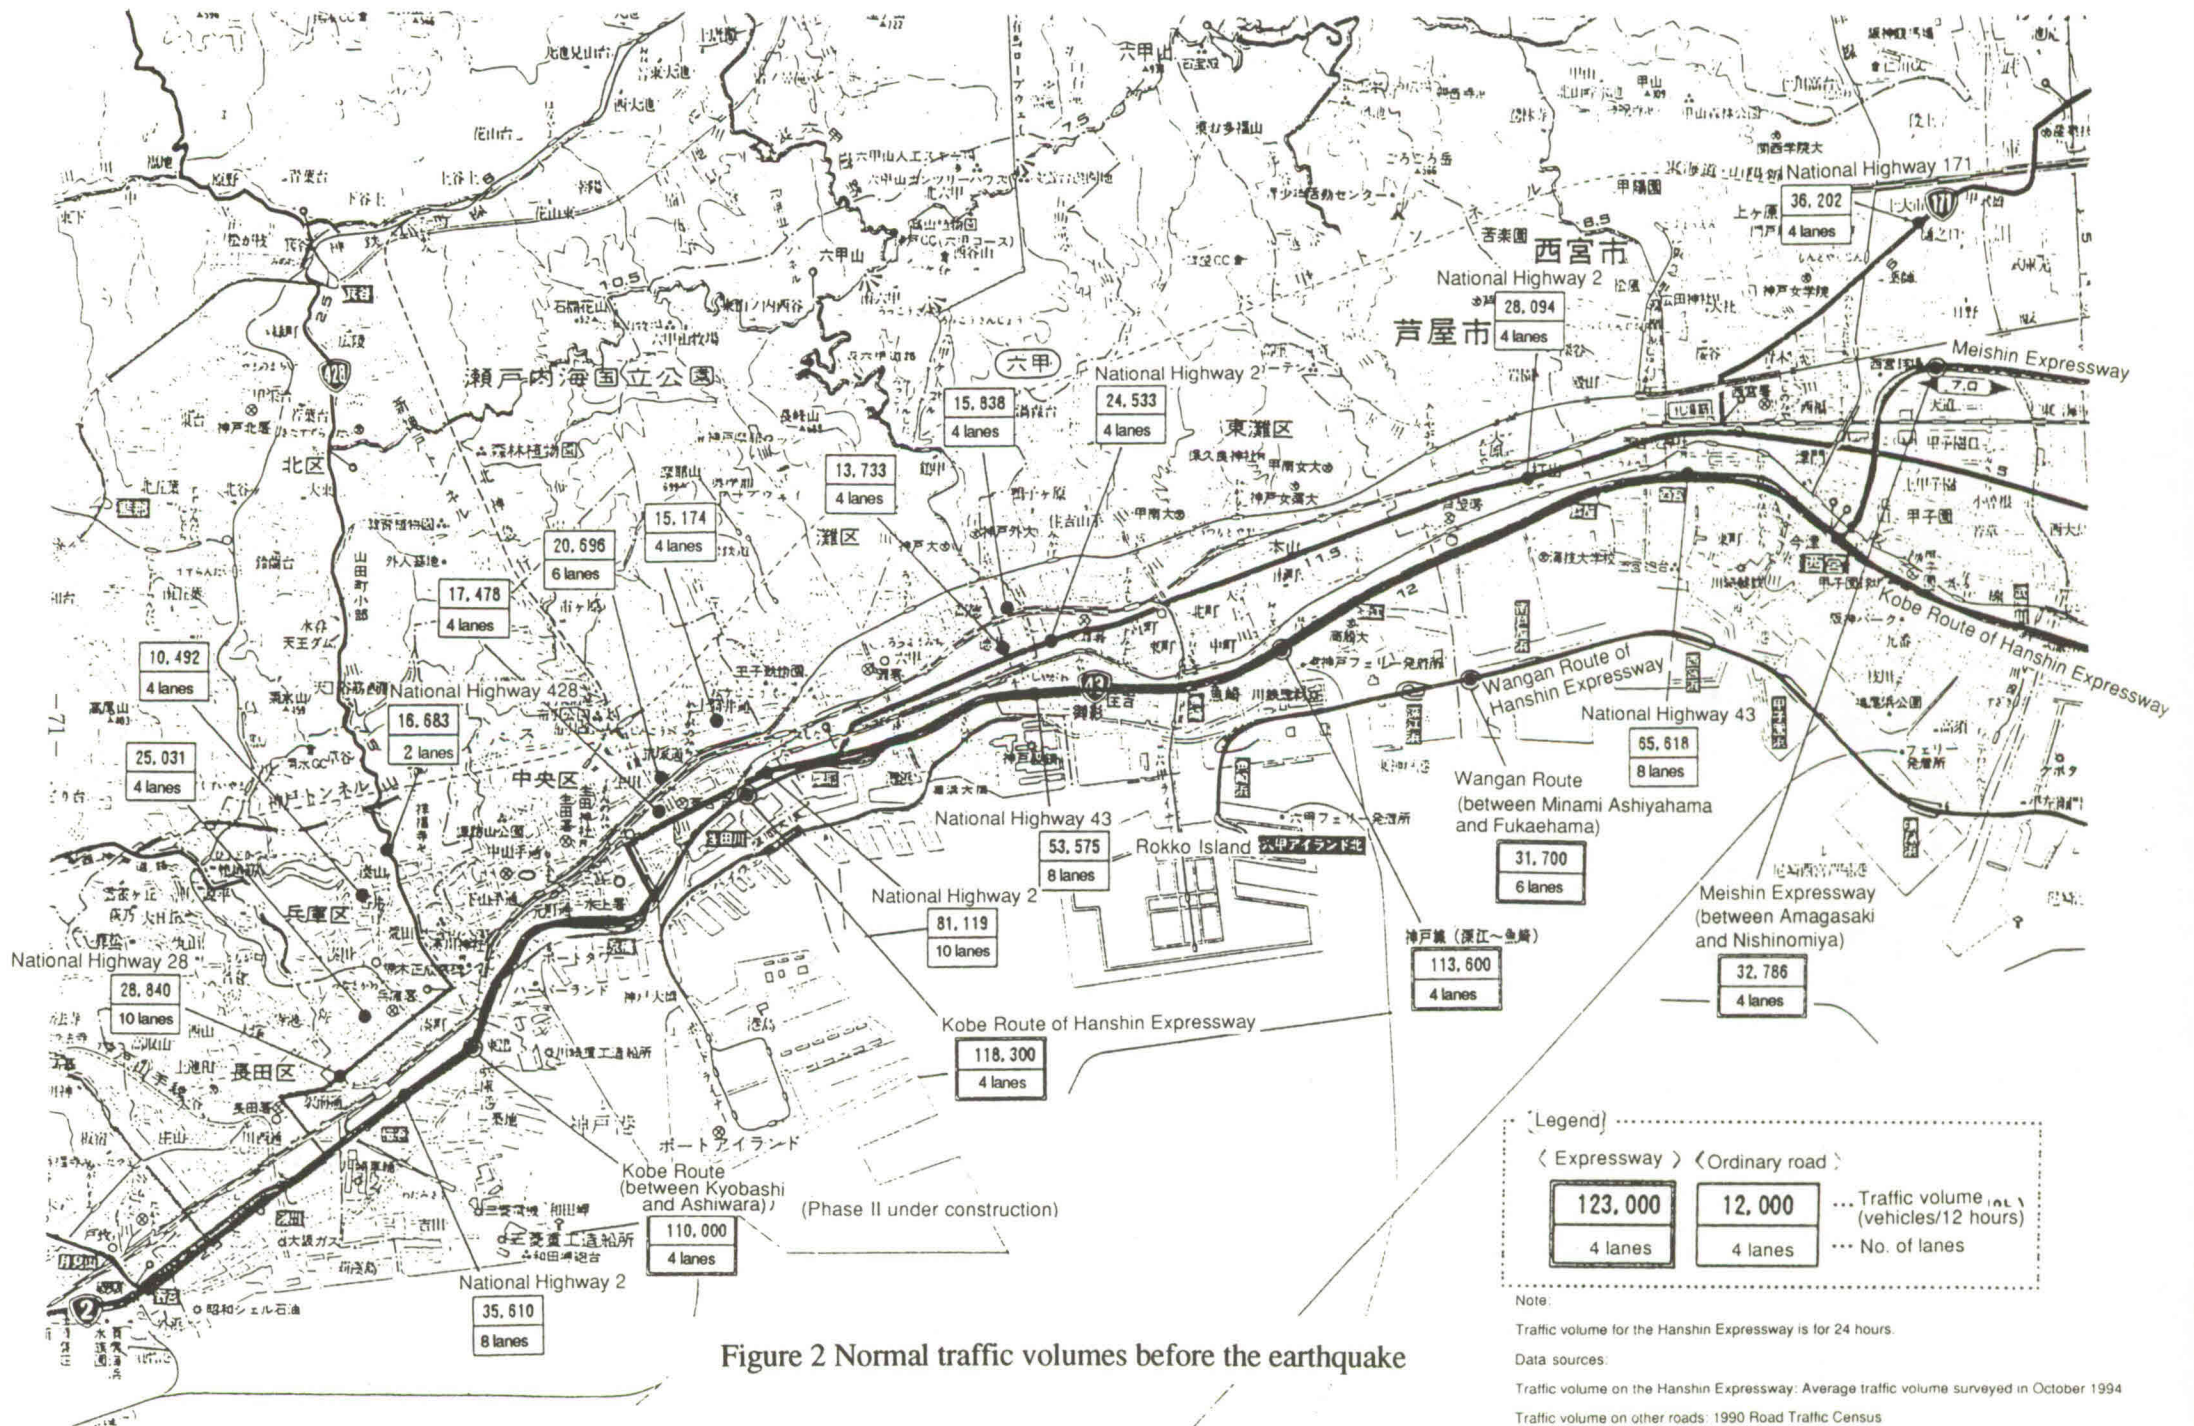
Figure 2 Normal traffic volumes before the earthquake

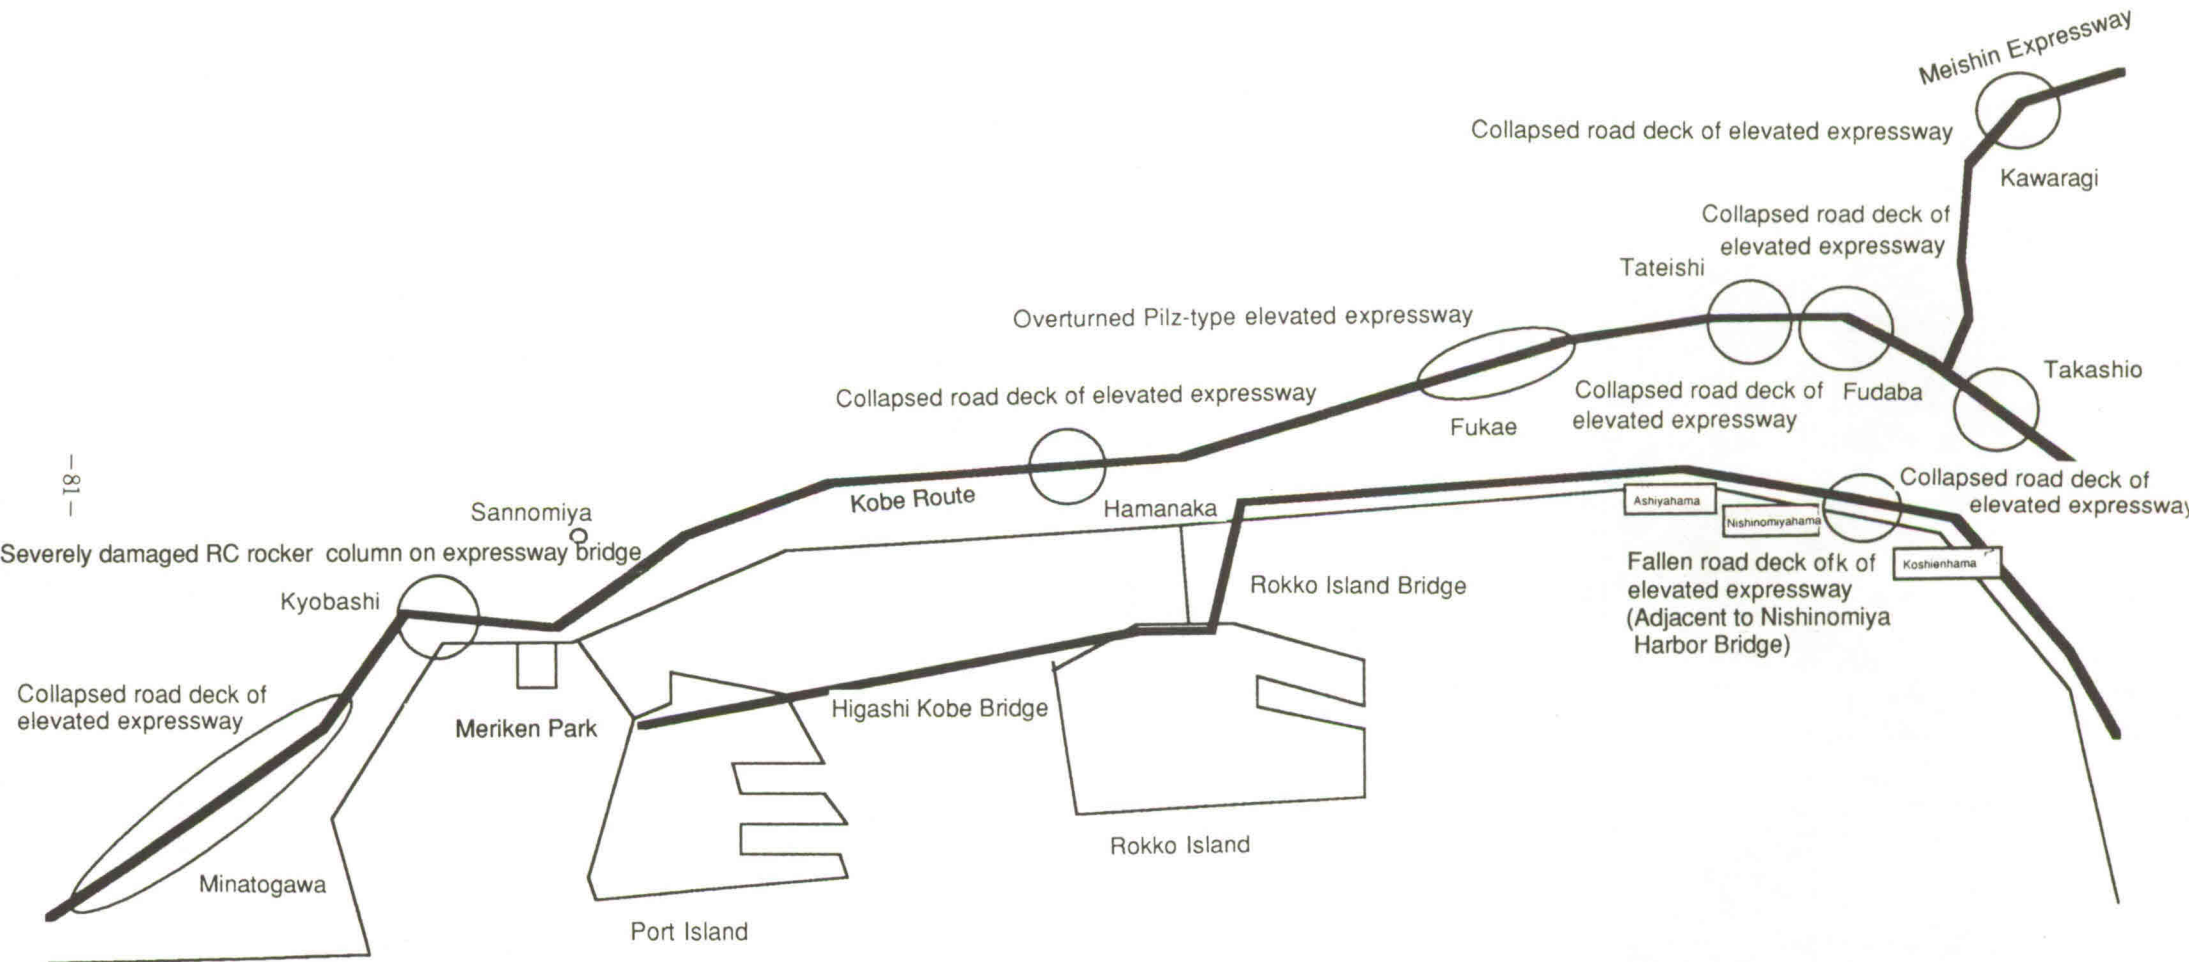
Major damage to road structures

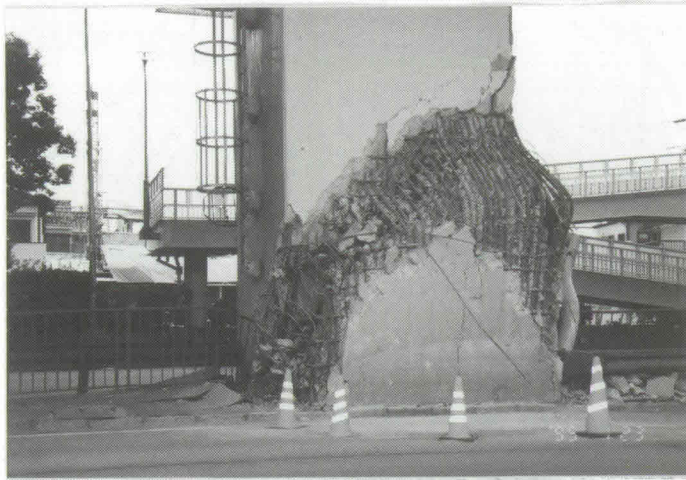
Photo 1 Shear-fractured RC pier on elevated expressway (Kobe Route)

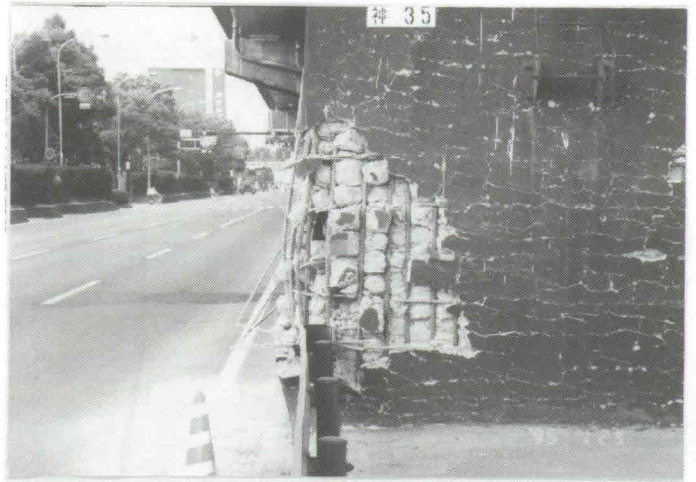
Photo 2 Base fracture in RC pier of elevated expressway (Kobe Route, near Koshien)

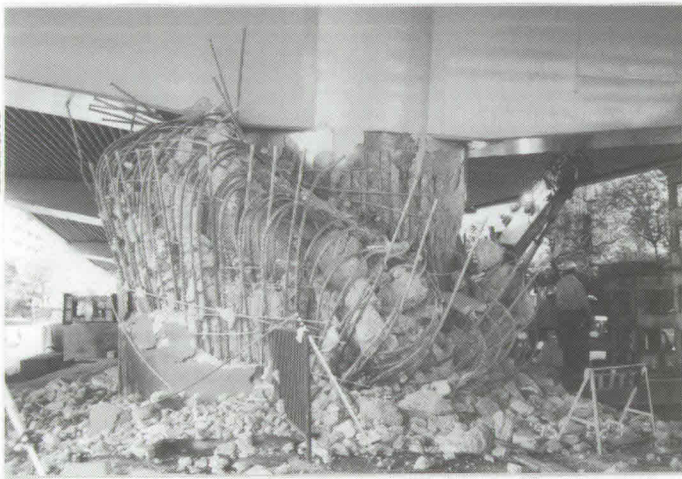
Photo 3 Collapsed RC pier of elevated expressway (Kobe Route, near Tateishi intersection in Nishinomiya)
