Preliminary Report on
**THE GREAT
HANSHIN
EARTHQUAKE**

January 17, 1995

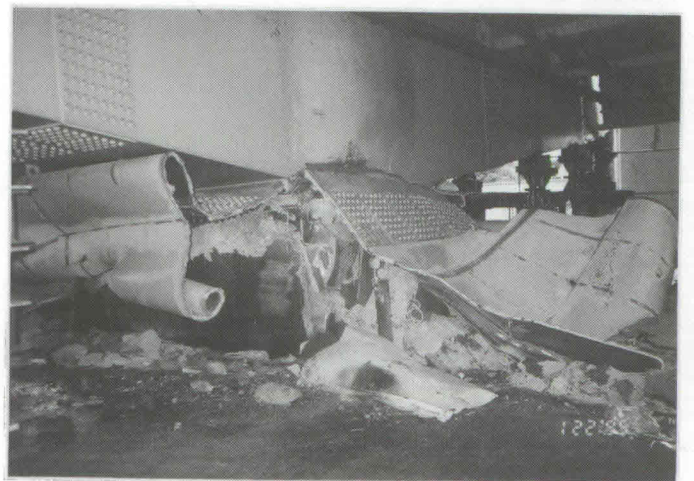
Photo 6 Collapsed T-shaped steel pier supported on two RC piers; transverse girders failed at center (Kobe Route, near Tateishi intersection in Nishinomiya)

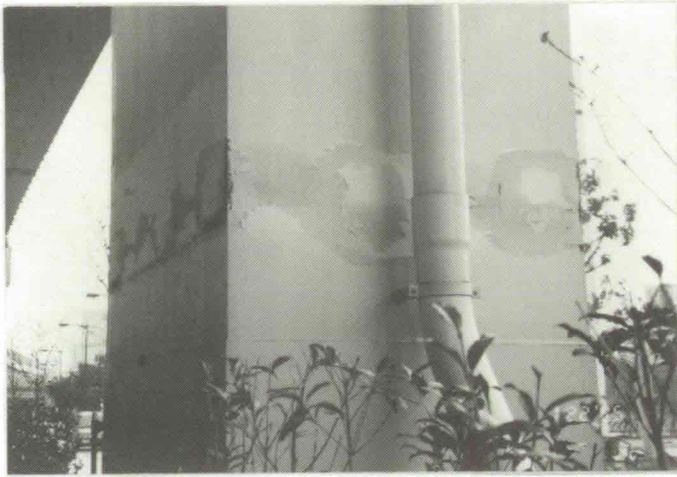
Photo 7 Locally buckled steel pier of rigid-frame elevated expressway (Kobe Route, near Koshien)

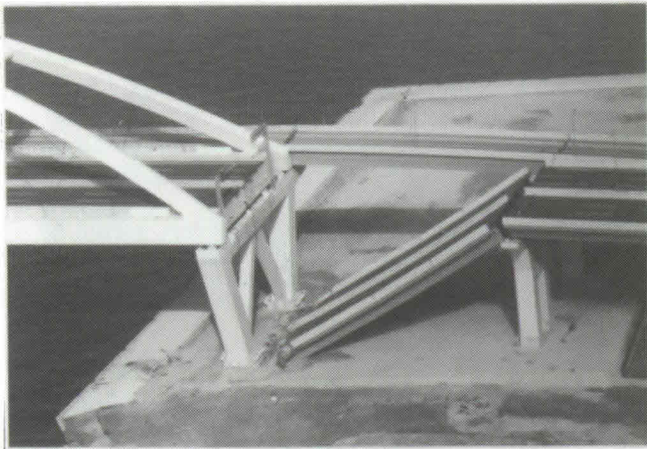
Photo 12 Collapsed approach road girder due to the seaward movement of Nishinomiya Harbor Bridge foundations (Bayshore Route)

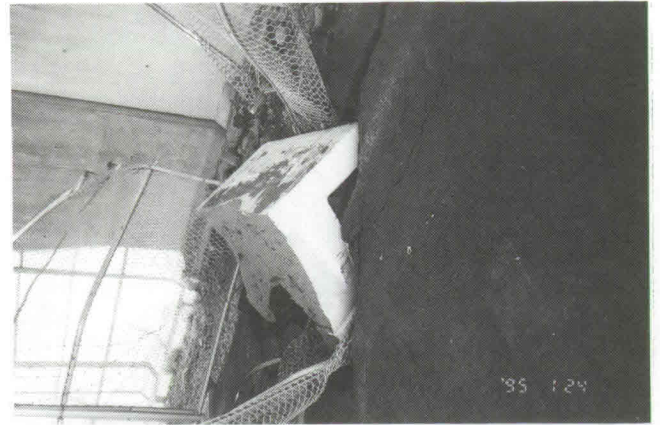
Photo 13 Broken section of upper shoe fallen from fixed bearing to the ground

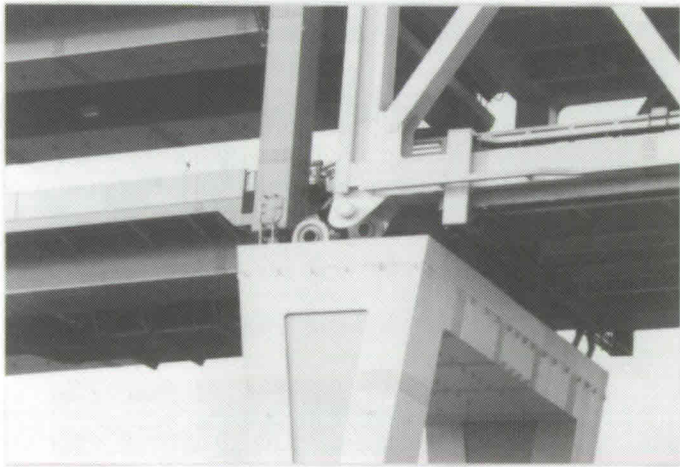
Photo 14 Fractured Pendel bearing support (web) on the Higashi Kobe Bridge (at the Kobe end)

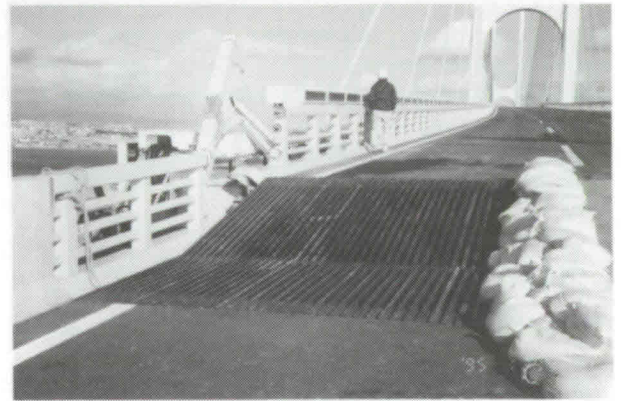
Photo 15 Lifted side span and fractured expansion joints due to broken Pendel shoes (Bayshore Route, Higashi Kobe Bridge)

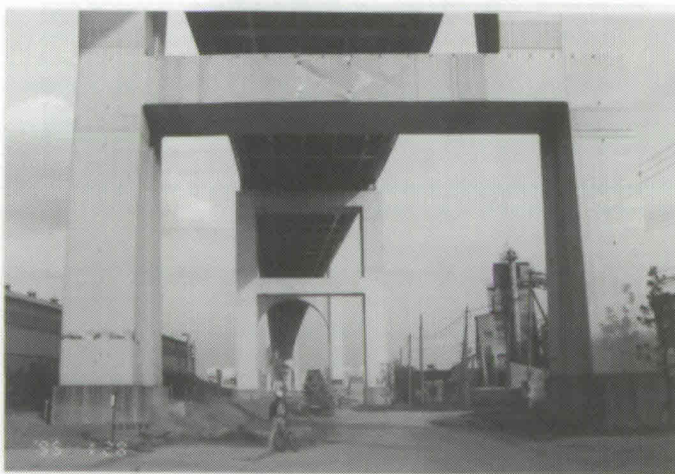
Photo 16 Buckled transverse girder at mid and end piers below fractured Pendel bearing (Bayshore Route, Higashi Kobe Bridge)

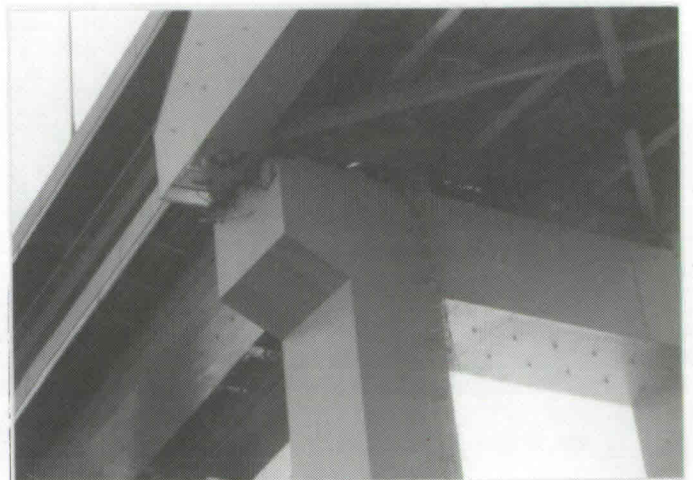
Photo 17 Bridge girder near collapse (Bayshore Route, Rokko Island Bridge)

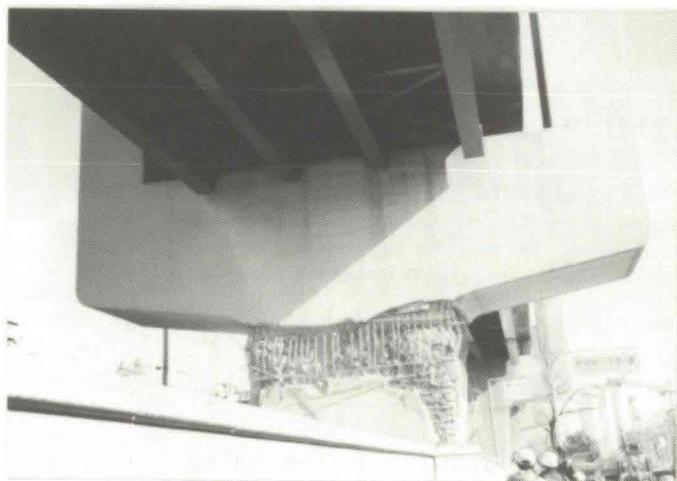
Photo 20 Bending fracture of racket-type double-deck rigid-frame RC bridge (Harbor Highway, Komachihama in Kobe)

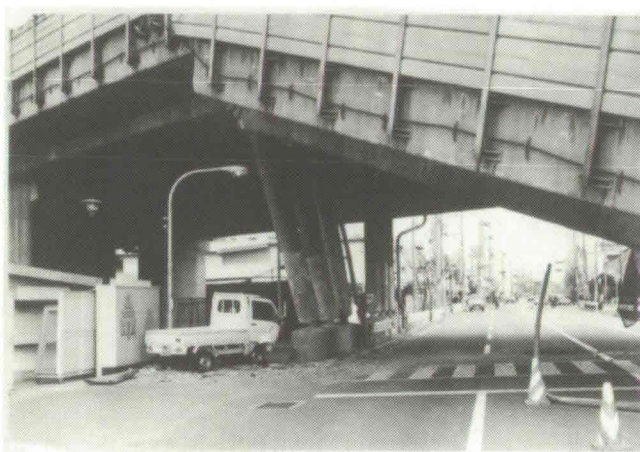
Photo 21 Overturned rocking column and collapsed RC hollow-slab girder (Meishin Expressway of Japan Highway Public Corp., at Kawaragi Nishi)

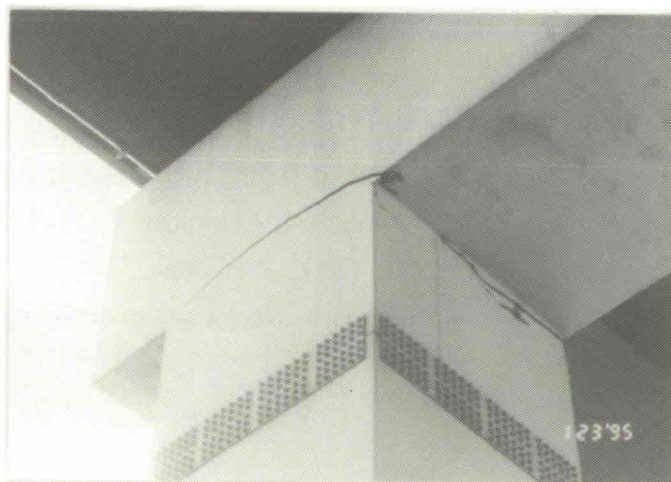
Photo 23 Cracking at the corner between pier and girder on steel rigid-frame bent supporting road bridge: extending nearly 360° (Harbor Highway in Kobe, near No. 1 Jetty at Suma in Nada Ward)

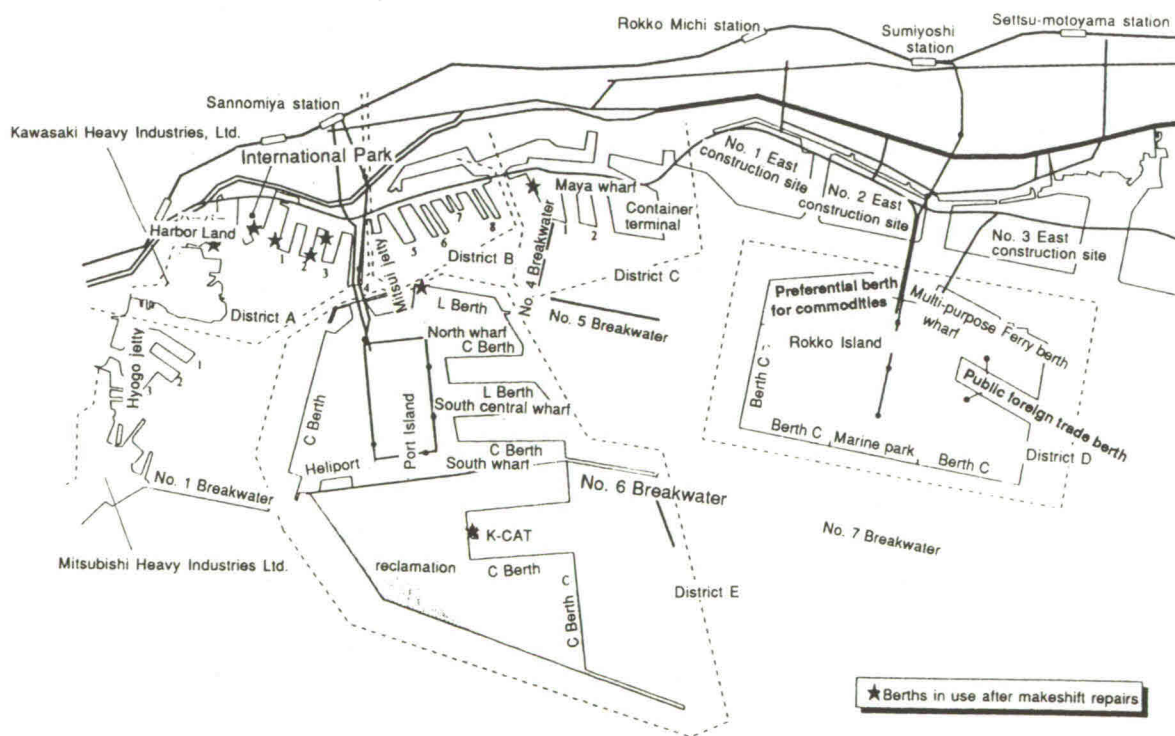
Figure 1 Areas surveyed (on January 22 through 24, 1995)

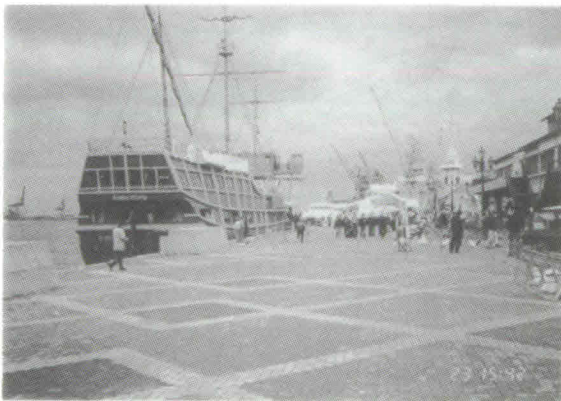
Photo 1 The Santa Maria, a pleasure boat in service as an emergency transport ship

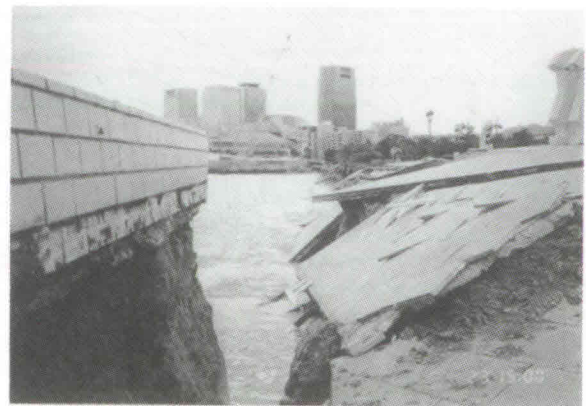
Photo 2 Destroyed south revetment of International Waterfront Park

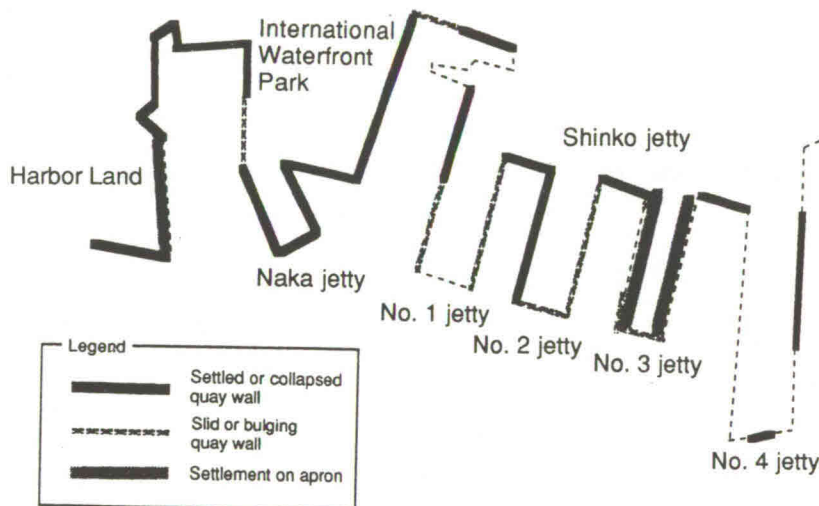
Figure 2 Damage to quays in District A

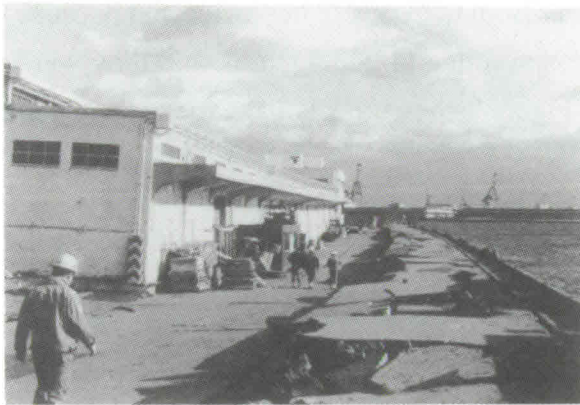
Photo 3 Damaged west quay of No. 6 Shinko jetty

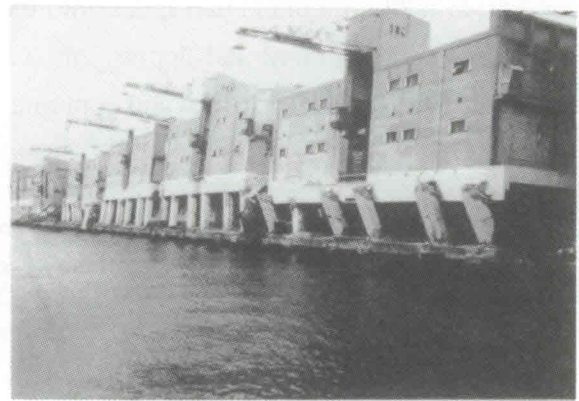
Photo 4 Damaged sheds on No. 8 Shinko jetty

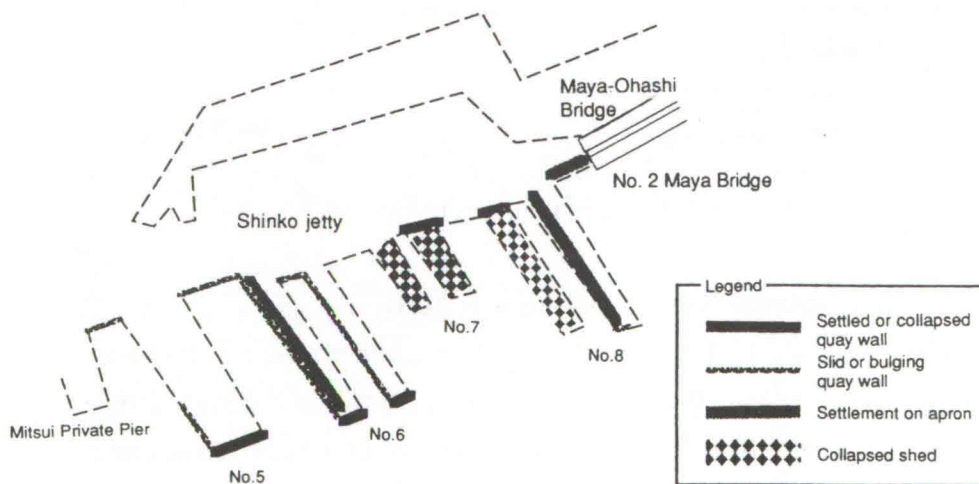
Figure 3 Damage to quays walls in District B

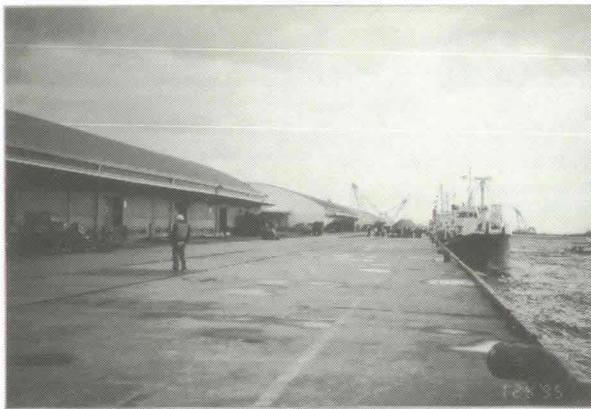
Photo 5 Surviving earthquake-resistant berth (west quay wall of No. 1 jetty)

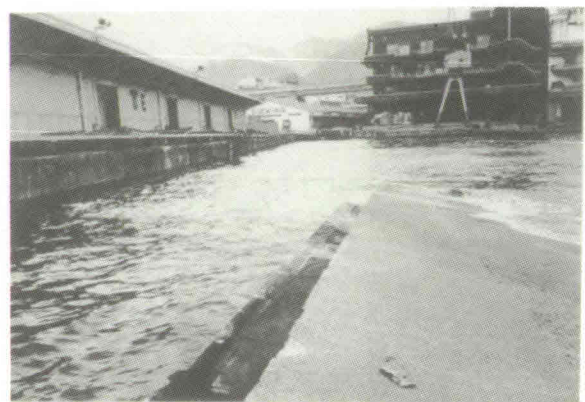
Photo 6 Damaged east quay wall of No. 1 jetty

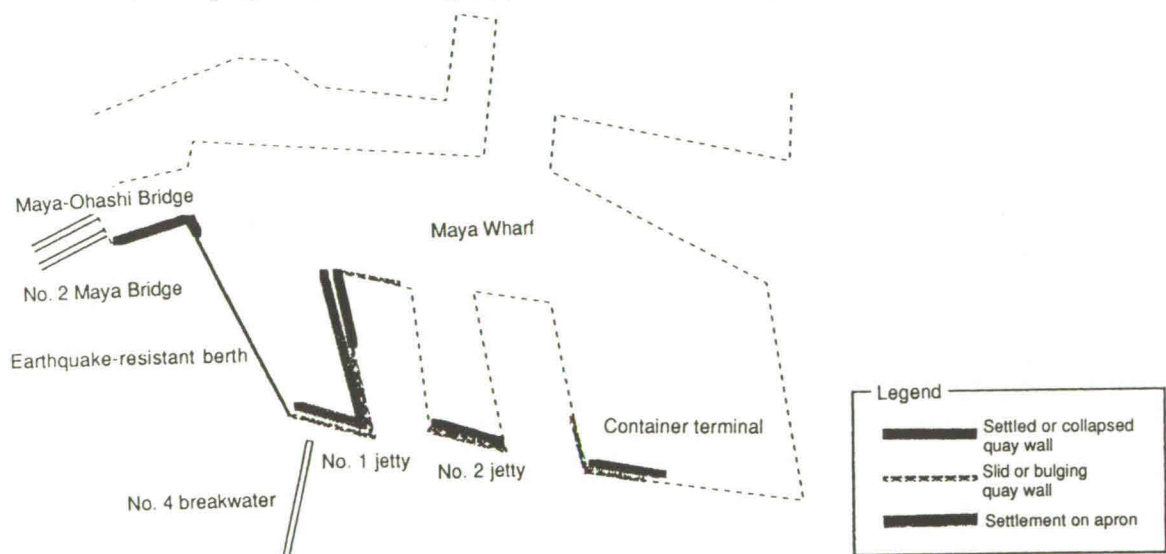
Figure 4 Damage to quay walls in District C

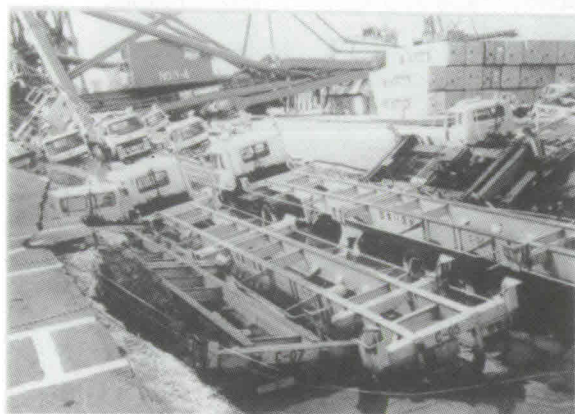
Photo 7 Crane overturned as a result of settlement

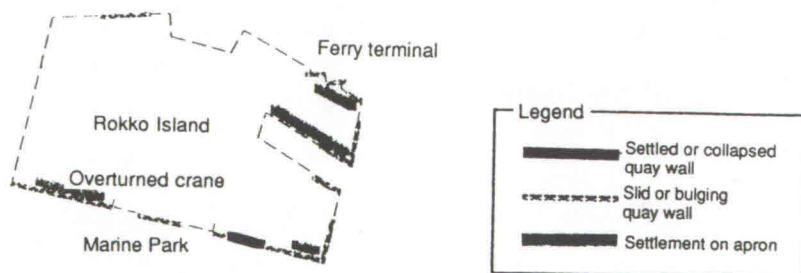
Figure 5 Damage to quay walls District D (Rokko Island)

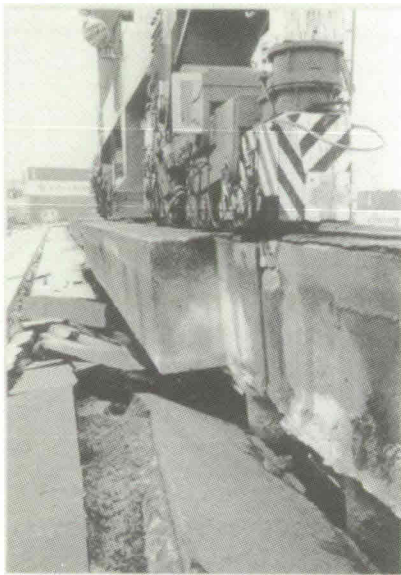
Photo 9 Settled North Wharf

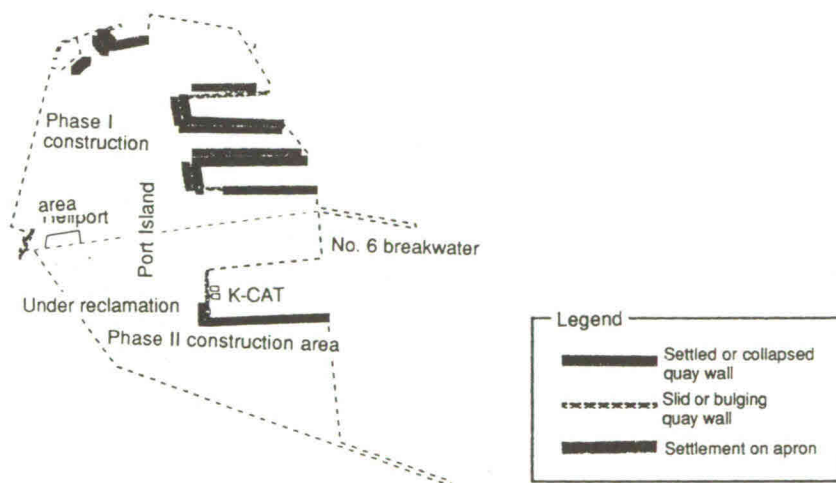
Figure 6 Damage to quay walls in District E (Port Island)

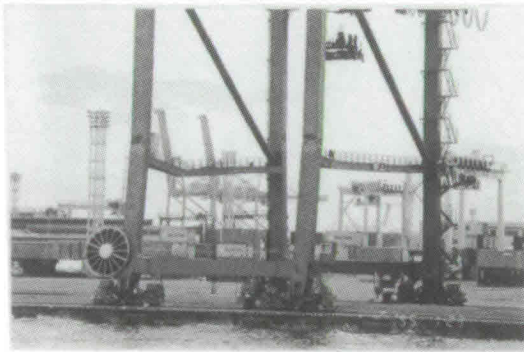
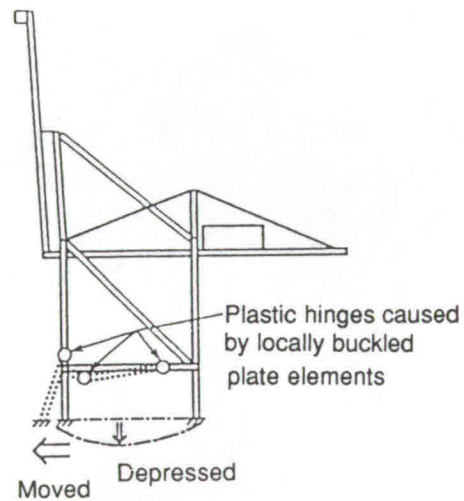
Photo 11 Collapsed column and girder plate elements and plastic hinges

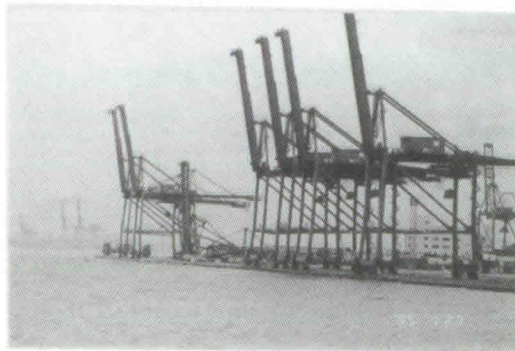
Photo 12 Collapsed container cranes

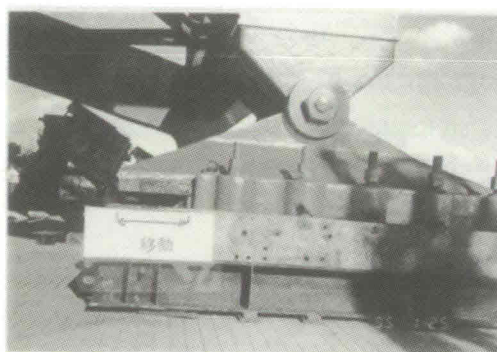
Photo 13 Displaced bearing on the Kobe-Ohashi Bridge

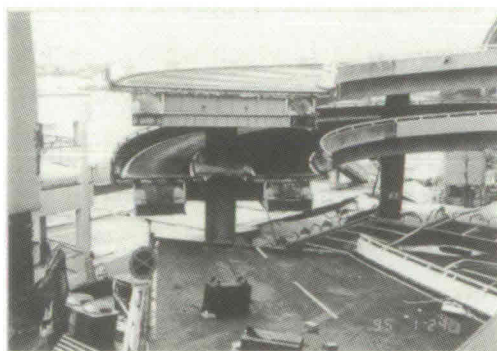
Photo 14 Fallen loop bridge on the approach to the Kobe-Ohashi Bridge

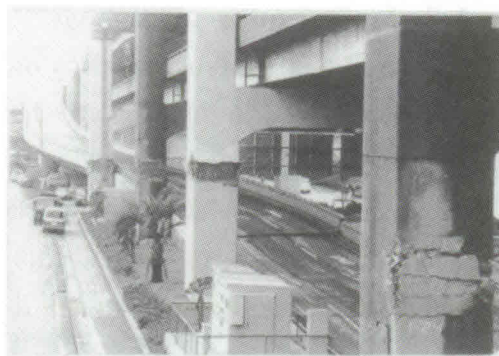
Photo 15 Collapsed RC bridge columns of moment frame structure at an approach to the Kobe-Hashi Bridge

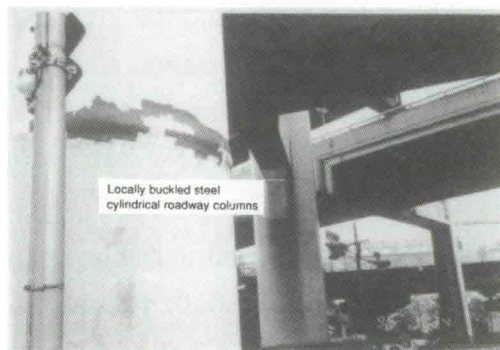
Photo 16 Locally buckled hollow cylindrical roadway columns at a junction

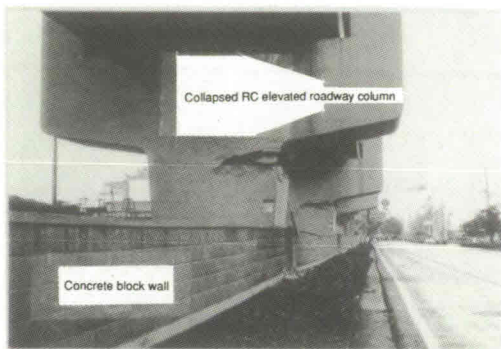
Photo 17 Fractured RC bridge pier of harbor by-pass

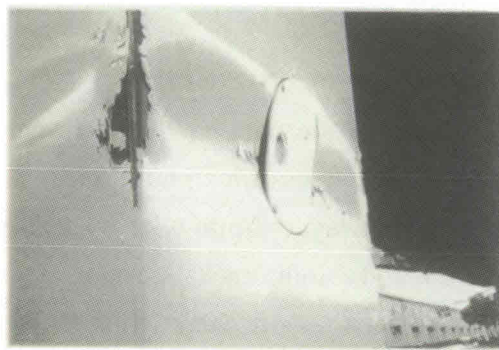
Photo 18 Steel pier buckled locally at a manhole flange of the harbor by-pass

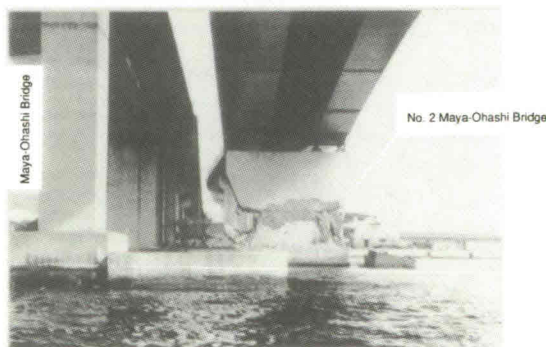
Photo 19 Fractured RC piers of No. 2 Maya-Ohashi Bridge

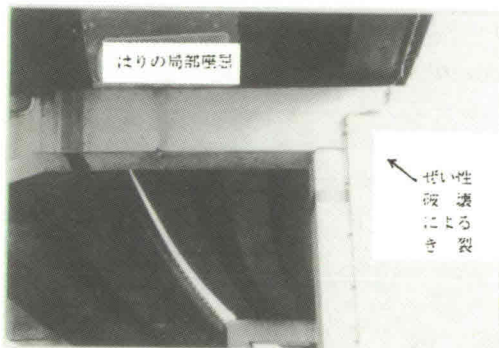
Photo 20 Brittle fracture at a joint between the girder and column on a steel moment frame pier of an elevated road bridge

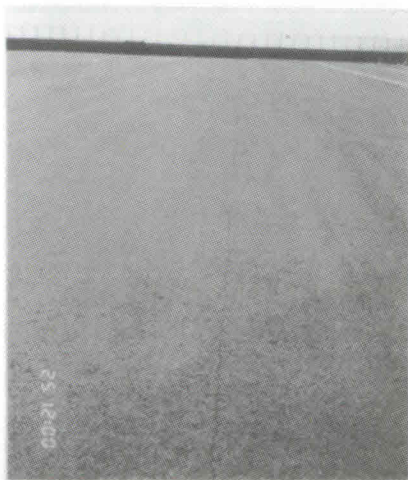
Photo 21 Hairline cracks in apron

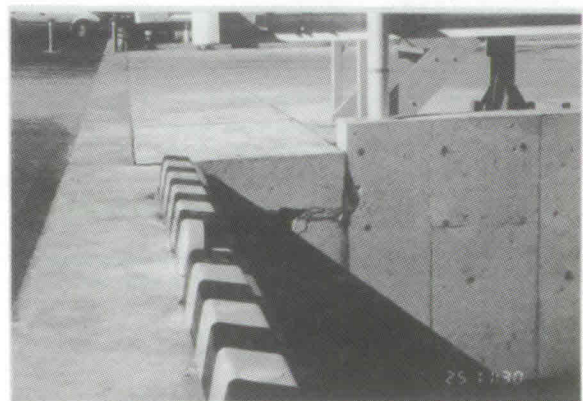
Photo 22 Slightly damaged quay walls

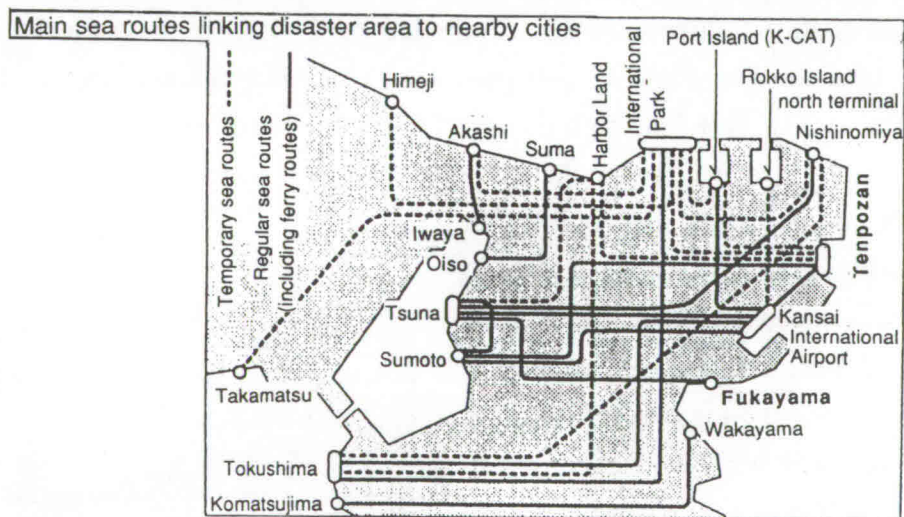
Figure 7 Regular and temporary sea routes (source: *Asahi Newspaper*)

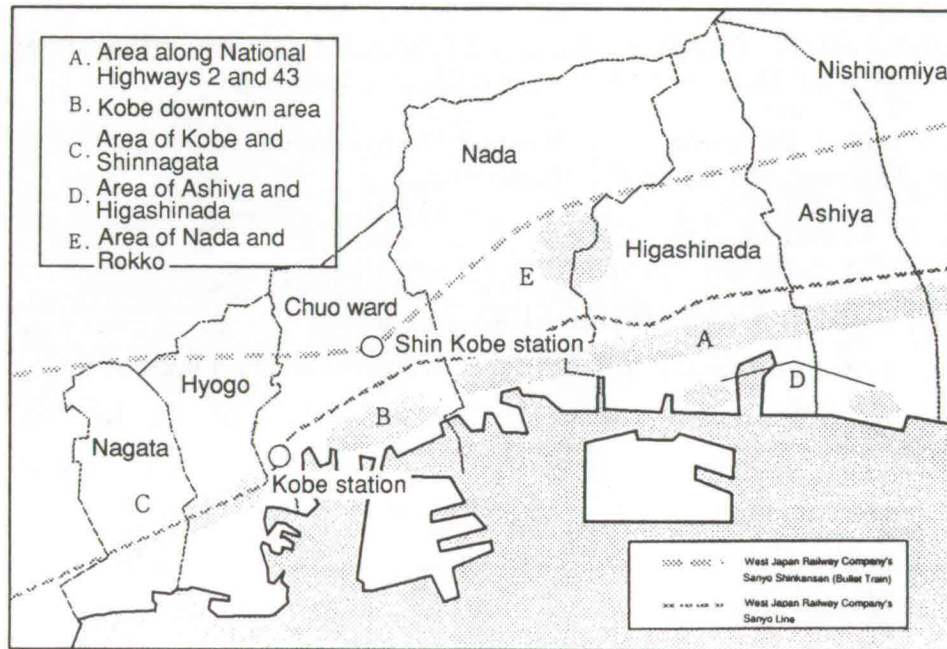
2. OVERVIEW OF DAMAGE

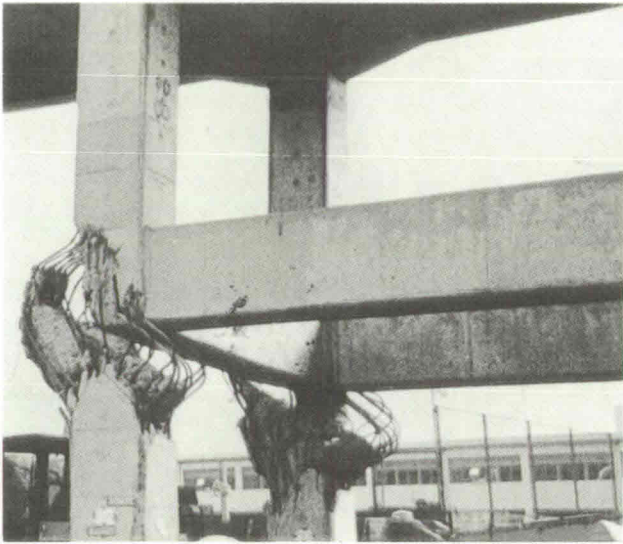
S2: Shear cracking below intermediate beam

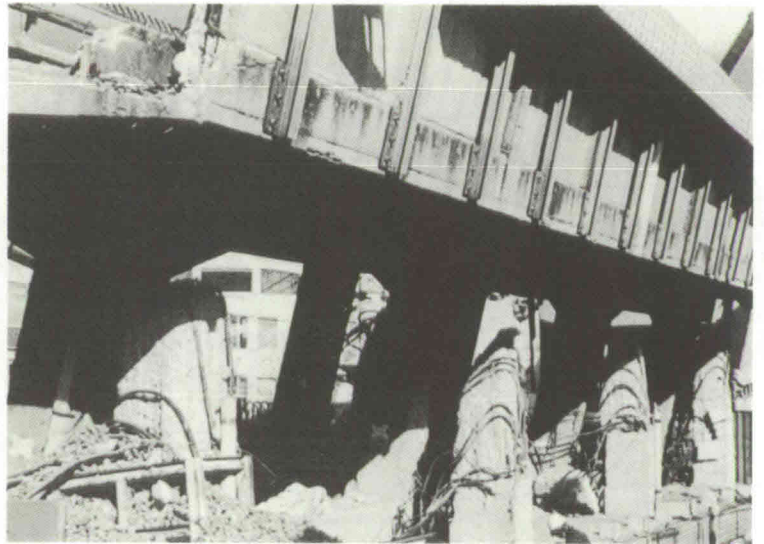
S3: Upper section collapsed to the north in the direction normal to the bridge axis

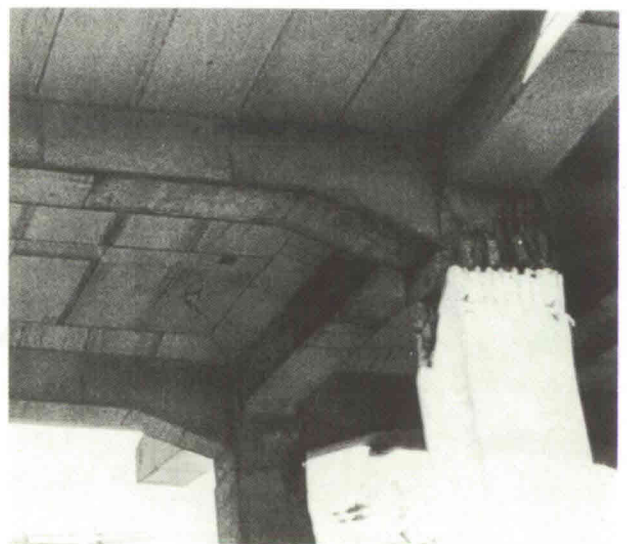
S5: Shear cracking just after flexural yielding

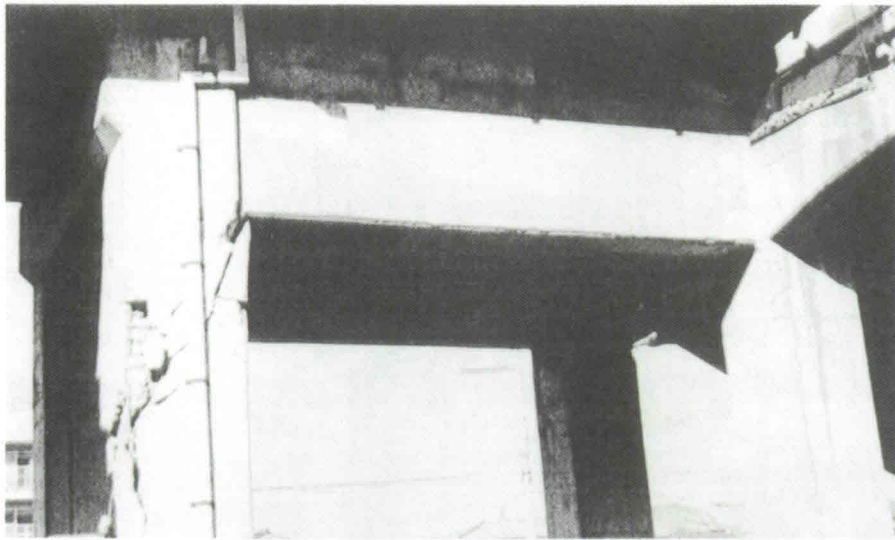
S6: Tall beams used in a rigid-frame abutment

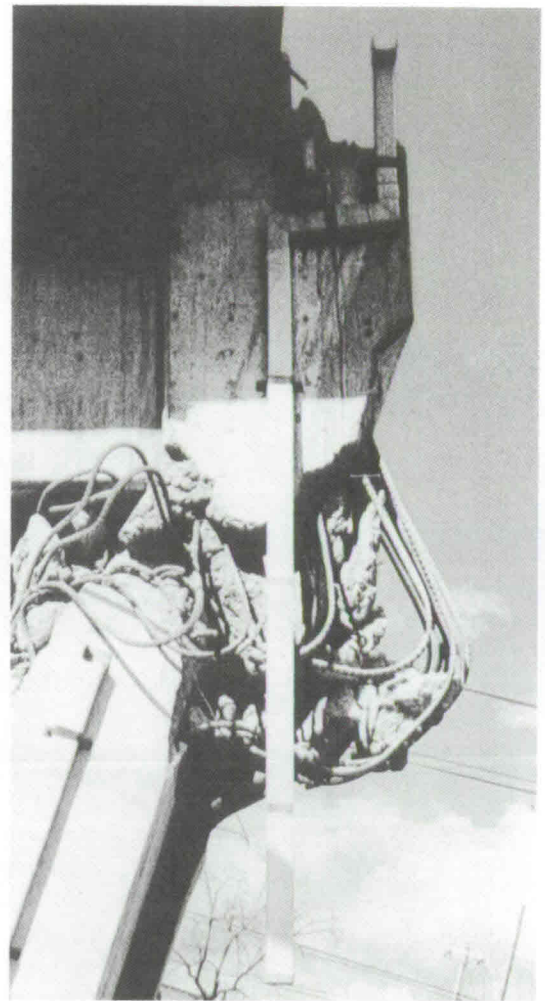
S7: Shear failure just below the rigid-frame abutment support. Collapse of PC beam bridge

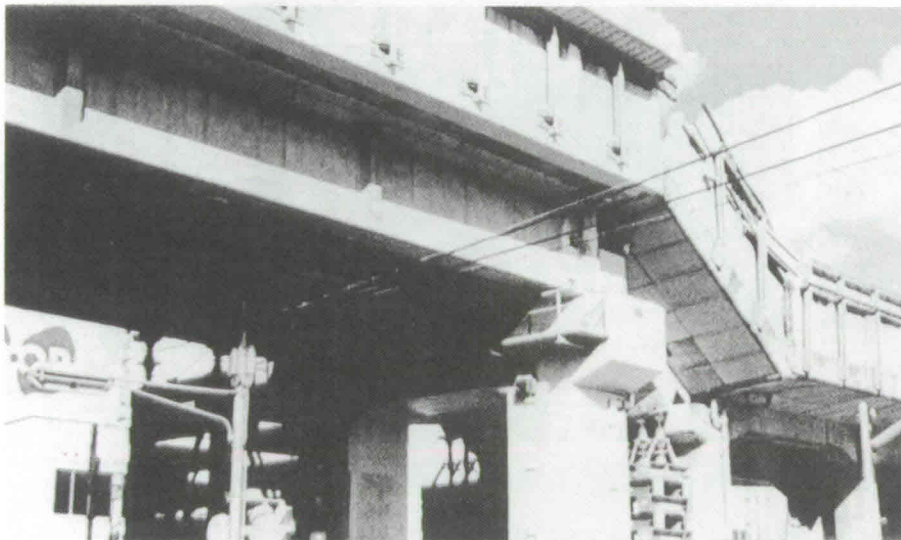
S8: Sound rigid-frame bridge pier supporting PC beam

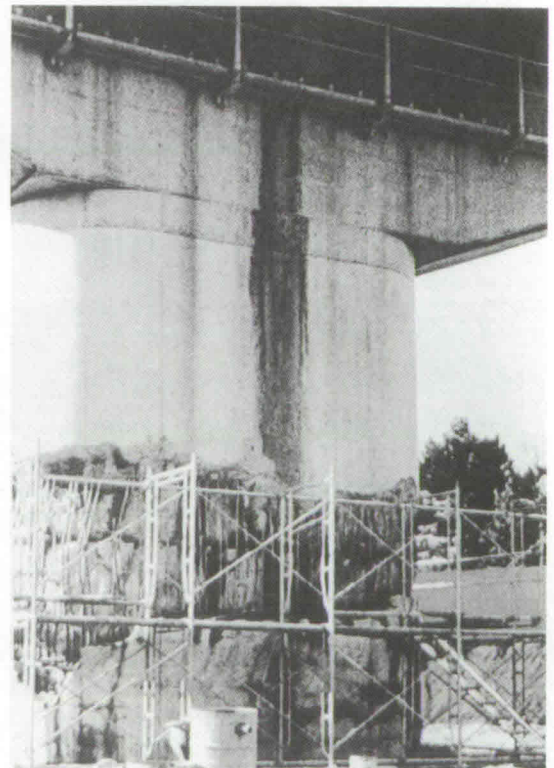
S10: Local buckling of rebar where amount of reinforcement reduces where rebar has yielded in bending. Concrete cover spalled off. Ruptured hoops. Horizontal construction joints seen at pier mid-height

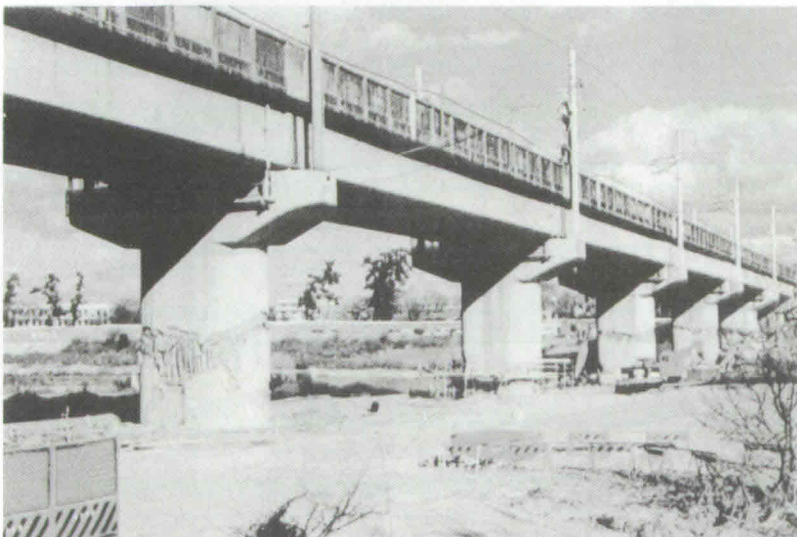
S9: Mukogawa Bridge with oval-shaped piers

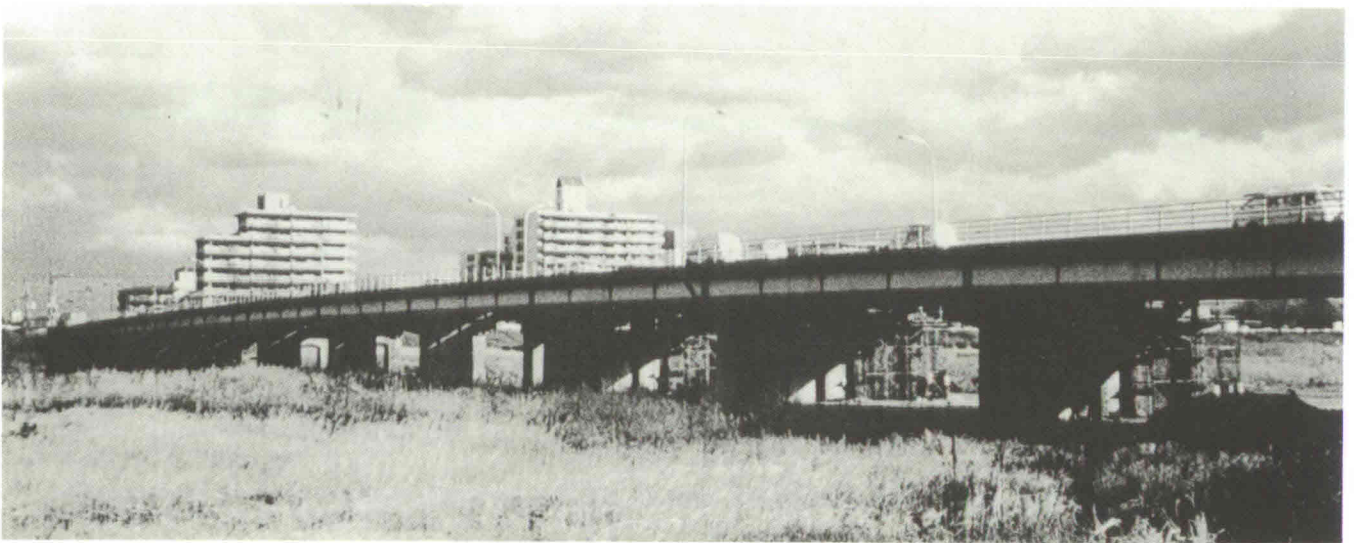
S12: Bridge piers supporting National Highway 171 with minor damage

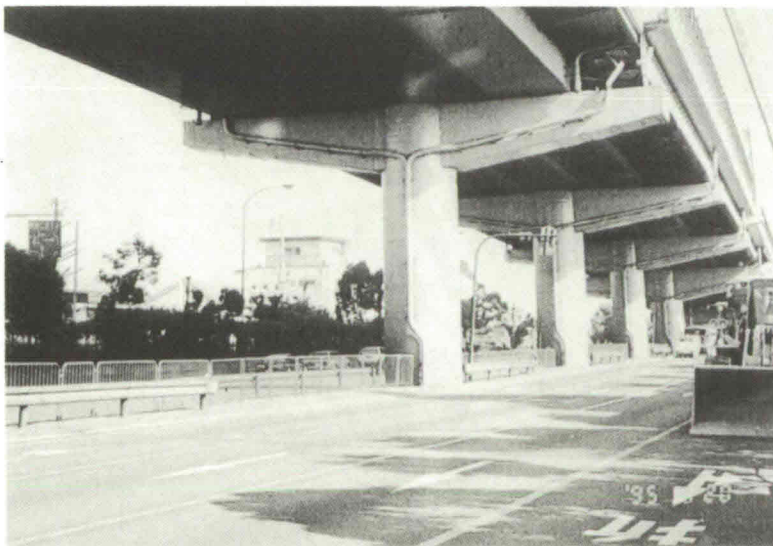
K1: Single-column circular bridge pier supporting the Hanshin Expressway

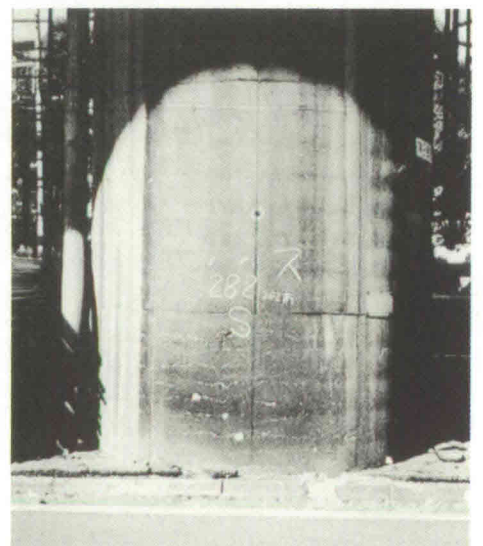
K2: Flexural cracking

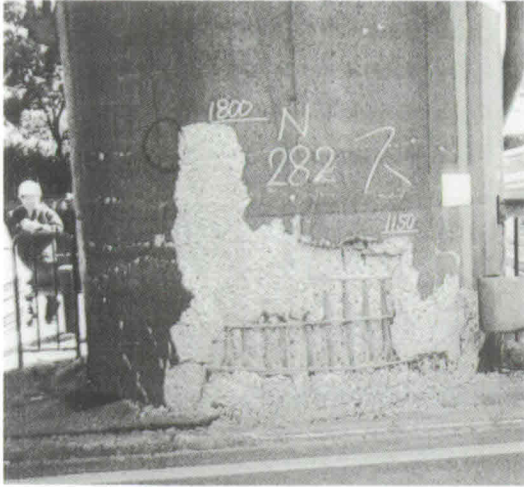
K3: Yielding of reinforcement

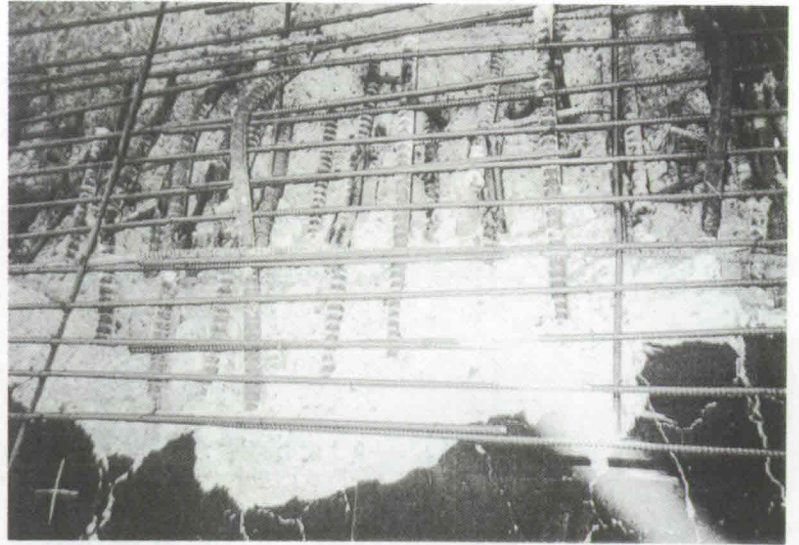
K4: Failure of welded joints
Joints which did not fail suffered local buckling

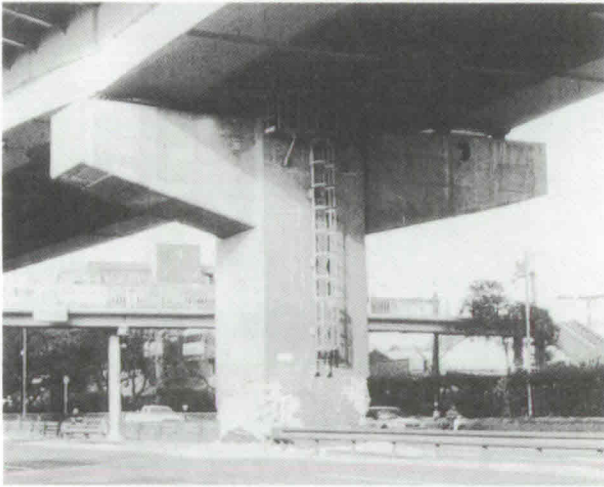
K5: Bridge pier with rectangular section.
Flexural yielding.

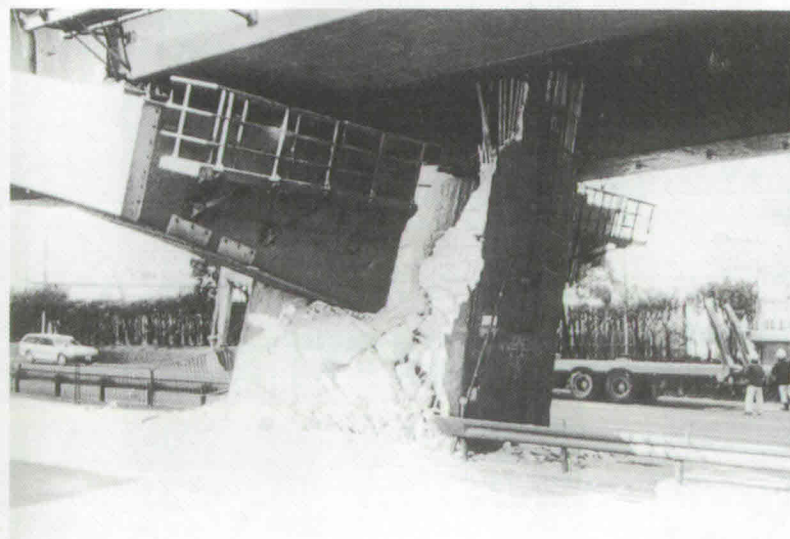
K7: Collapse of single-column rectangular bridge pier

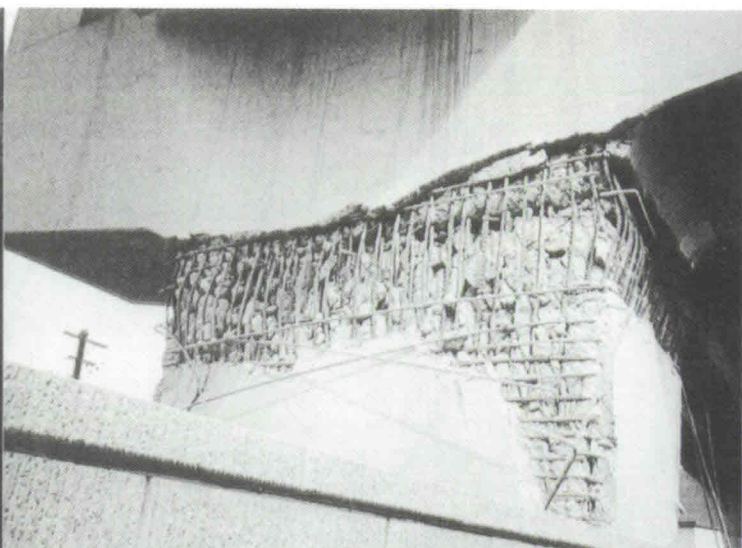
H4: Horizontal construction joints. Rebar reduced in quantity. Failure at welded joints. Improper anchorage of hoops.

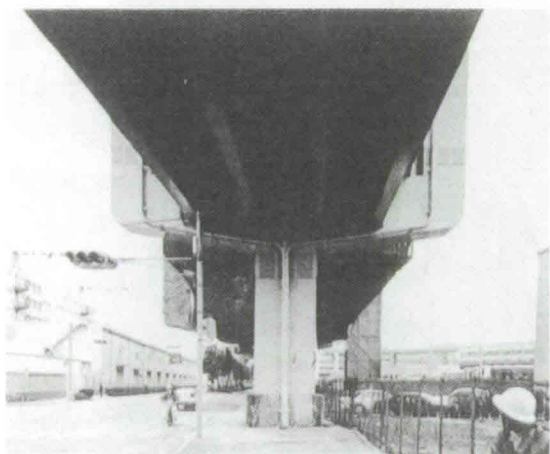
H5: Locally buckled steel bridge piers

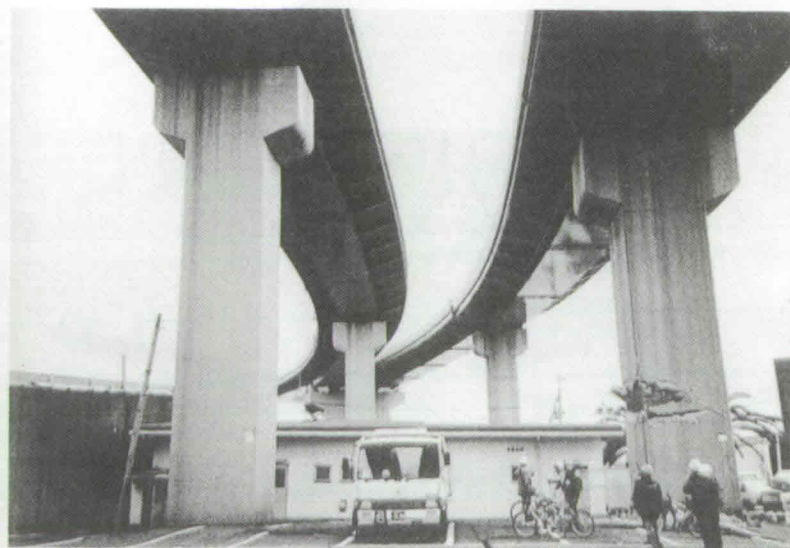
H7: Damage to tall single-column bridge piers. Rebar yielded at point of reinforcement reduction

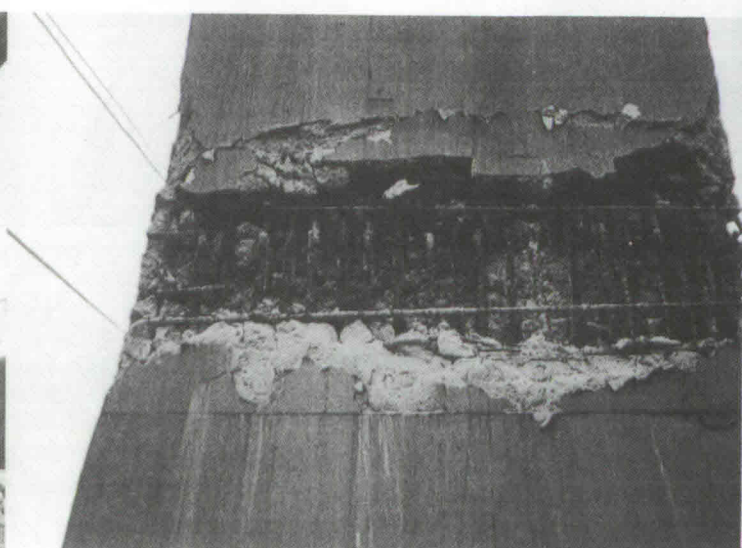
H8: Failure at welded joints. Hoops improperly anchored

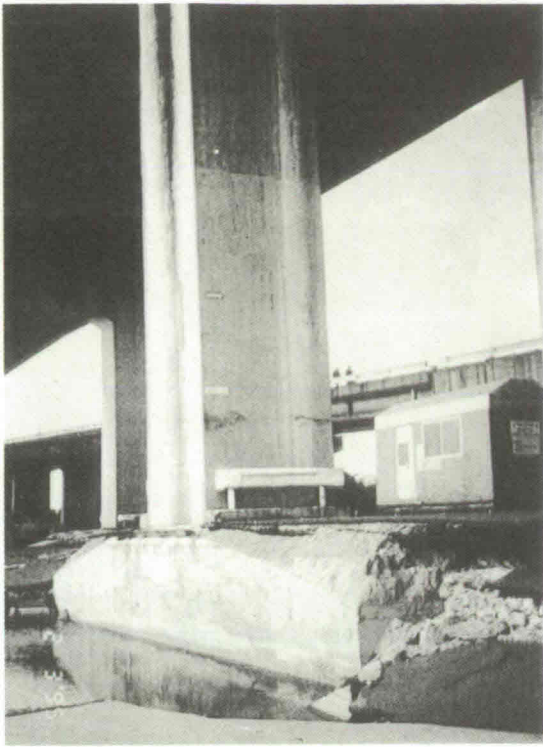
H9: Sound footing. Some settlement of nearby land in evidence.

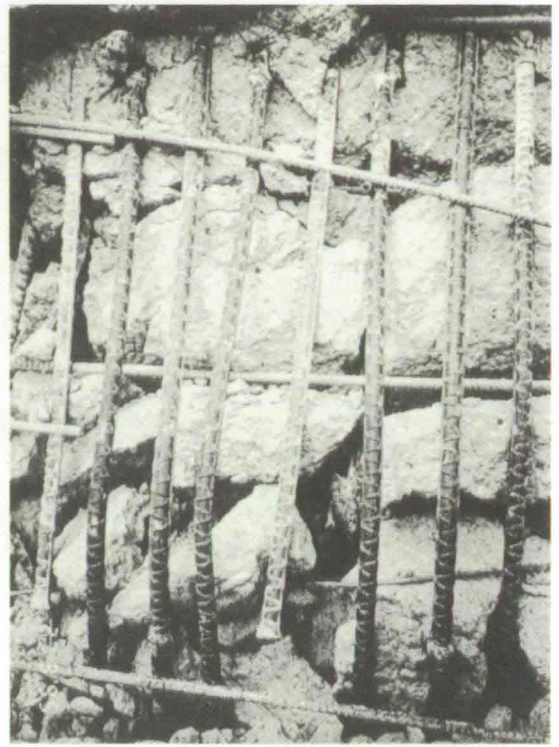
H10: Failure of welded joint

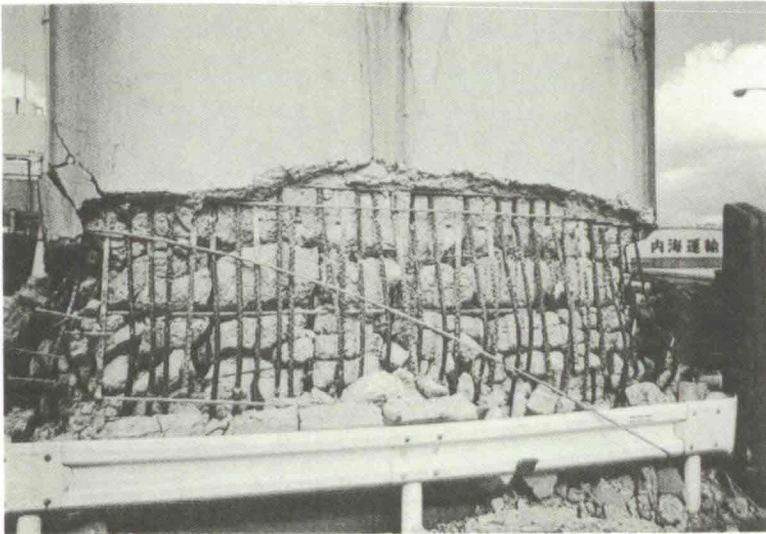
H11: Relationship between welded joints at two positions and cross section of bridge pier

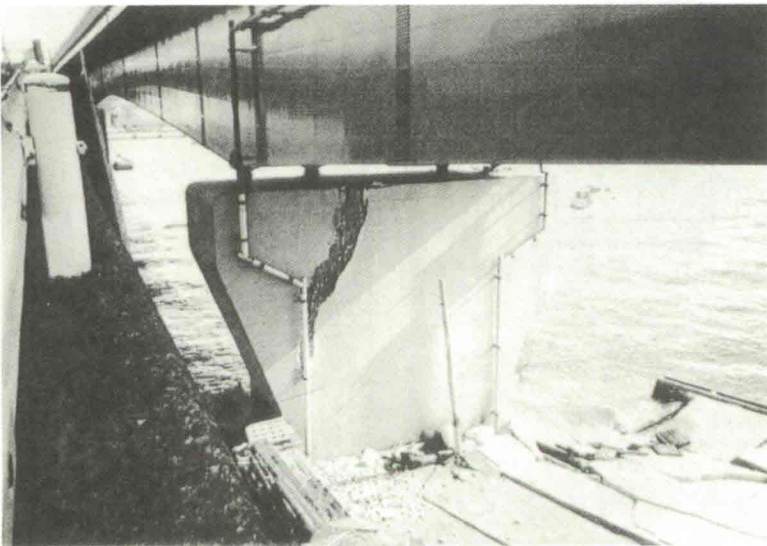
H12: Unusual cracking on a pier of the Second Maya Bridge

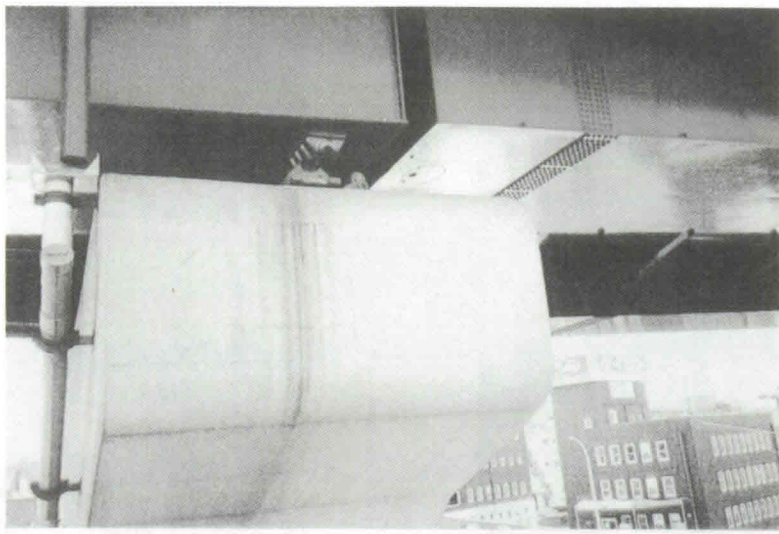
H13: Steel beam slid off bearing

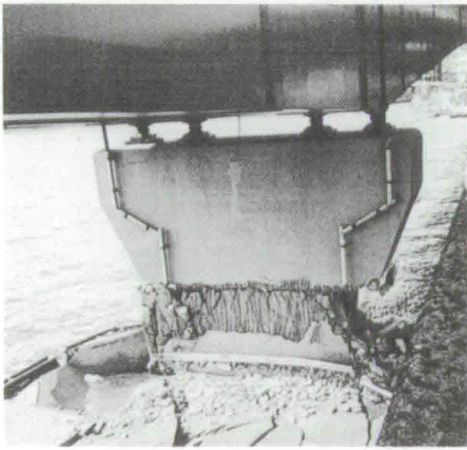
H14: Horizontal construction joint and failure of rebar
