Preliminary Report on
**THE GREAT
HANSHIN
EARTHQUAKE**

January 17, 1995

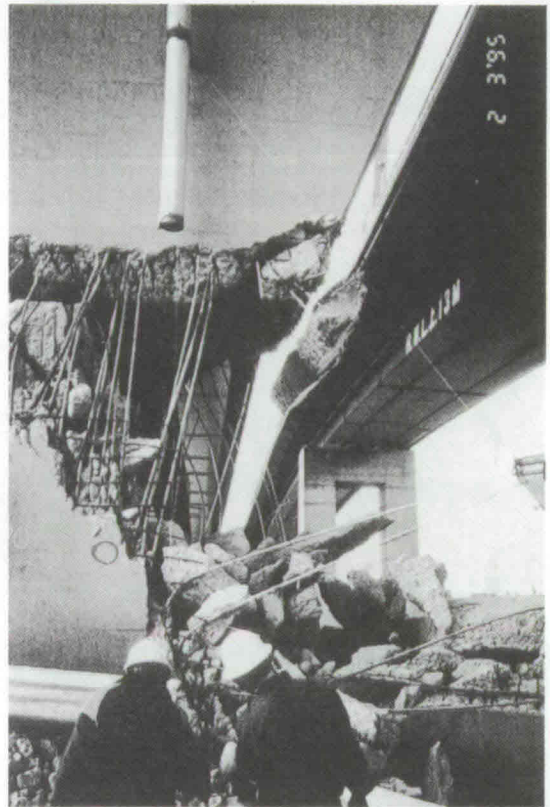
H15: Failure of rebar and collapse of concrete

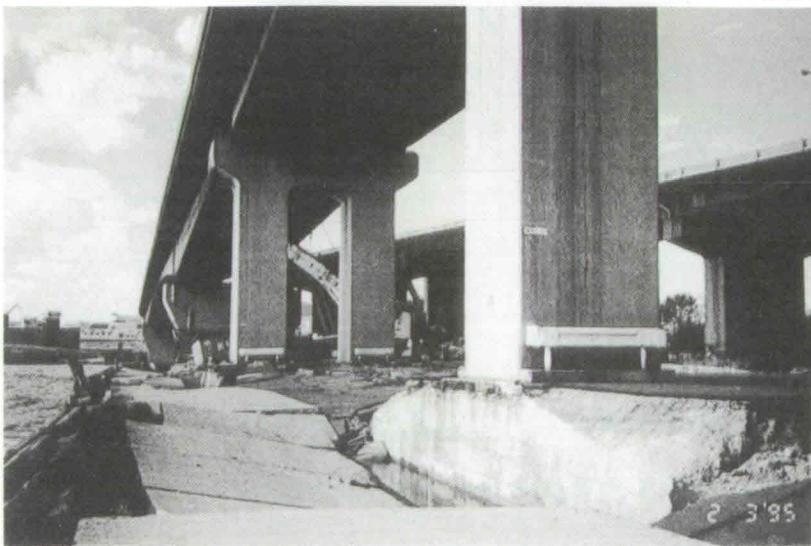
H16: Sound rigid-frame bridge piers

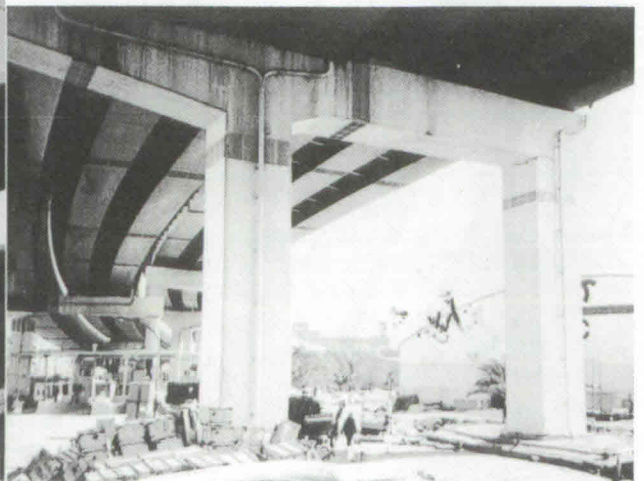
H17: Cracking of steel bridge piers

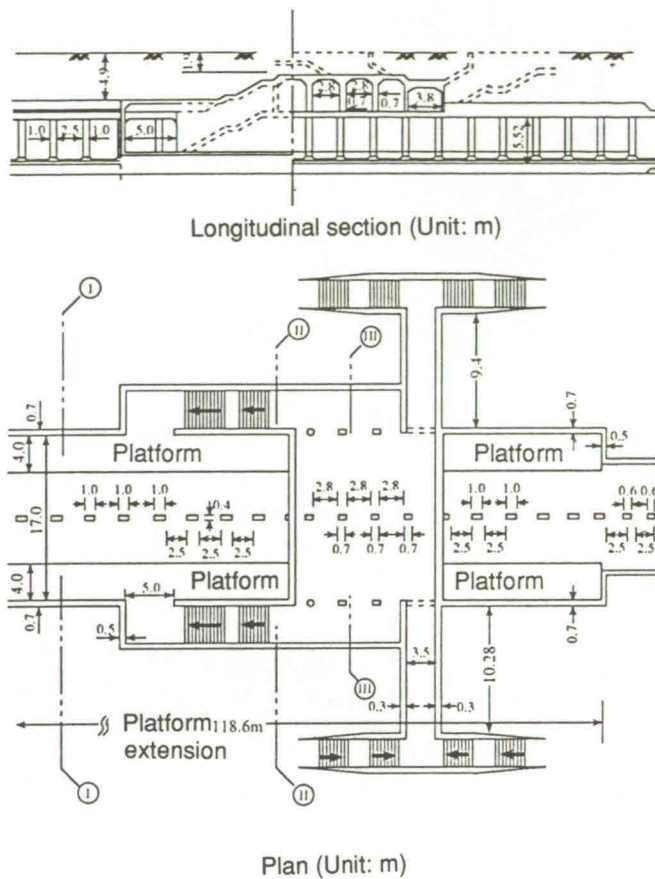
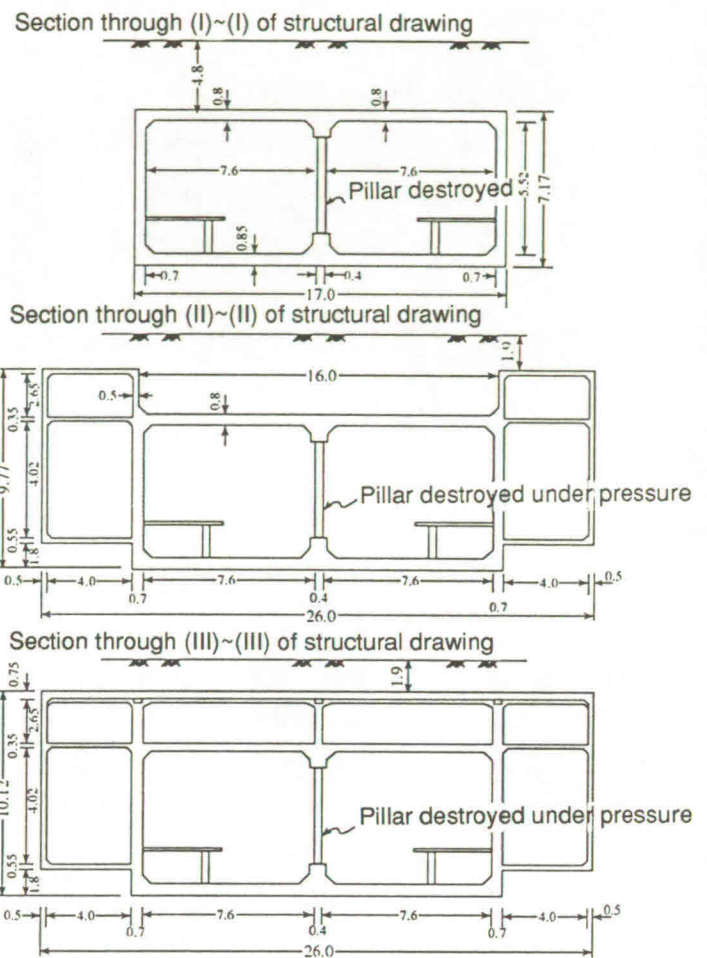
Fig. 1 Structural outline of Daikai Station (Subway Portion) of the Kobe Express Railway Co., Ltd.

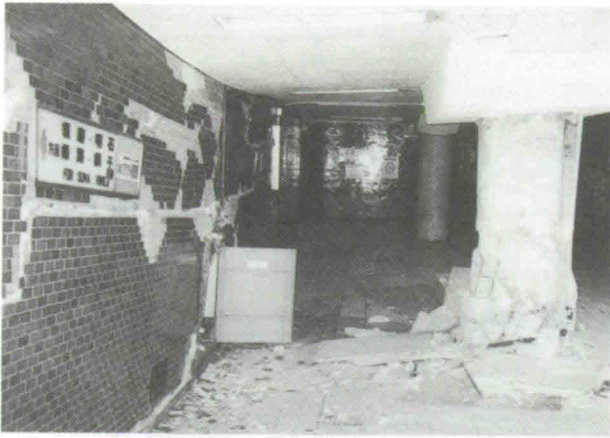
Photo 1 Damage to B1 floor of Daikai station

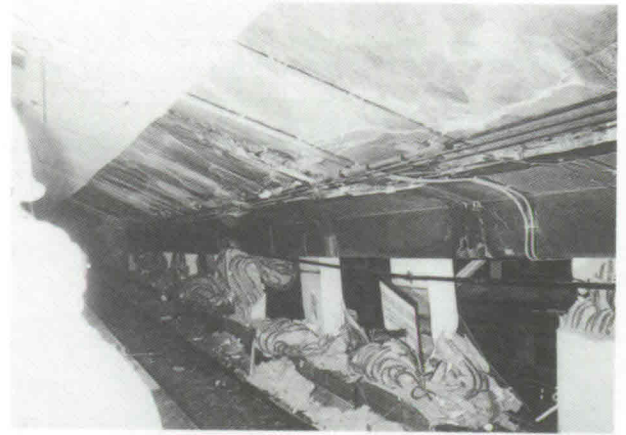
Photo 2 Damage to B2 floor of Daikai station (Nagata-cho side)

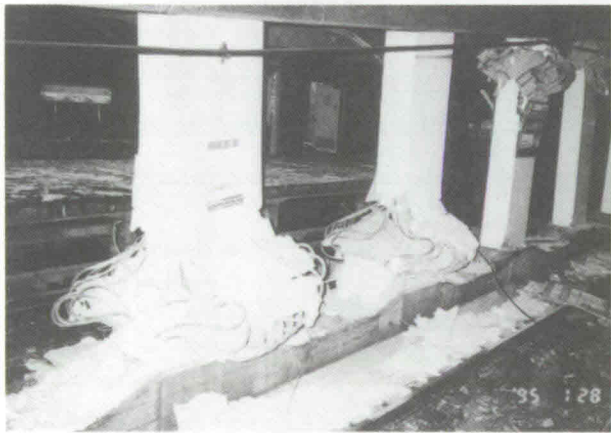
Photo 3 Damage to B2 floor of Daikai station (Sannomiya side)

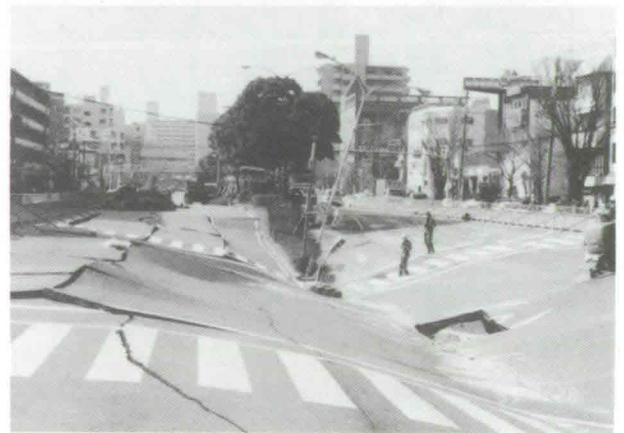
Photo 4 Road subsidence on surface above Daikai station

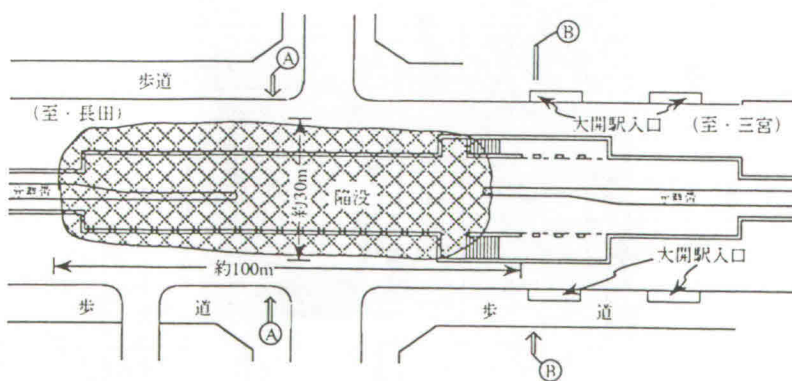
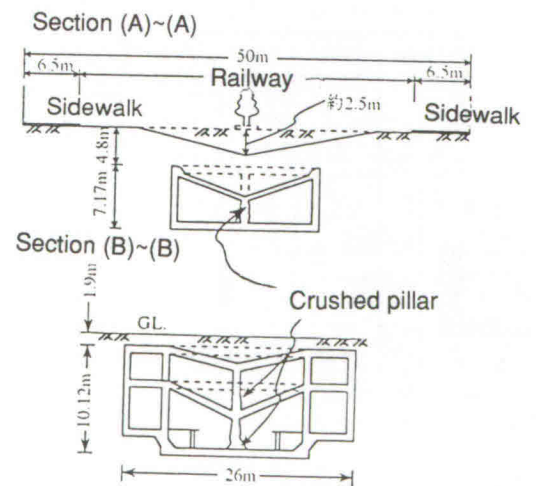
Fig. 4 Road subsidence on surface above Daikai station

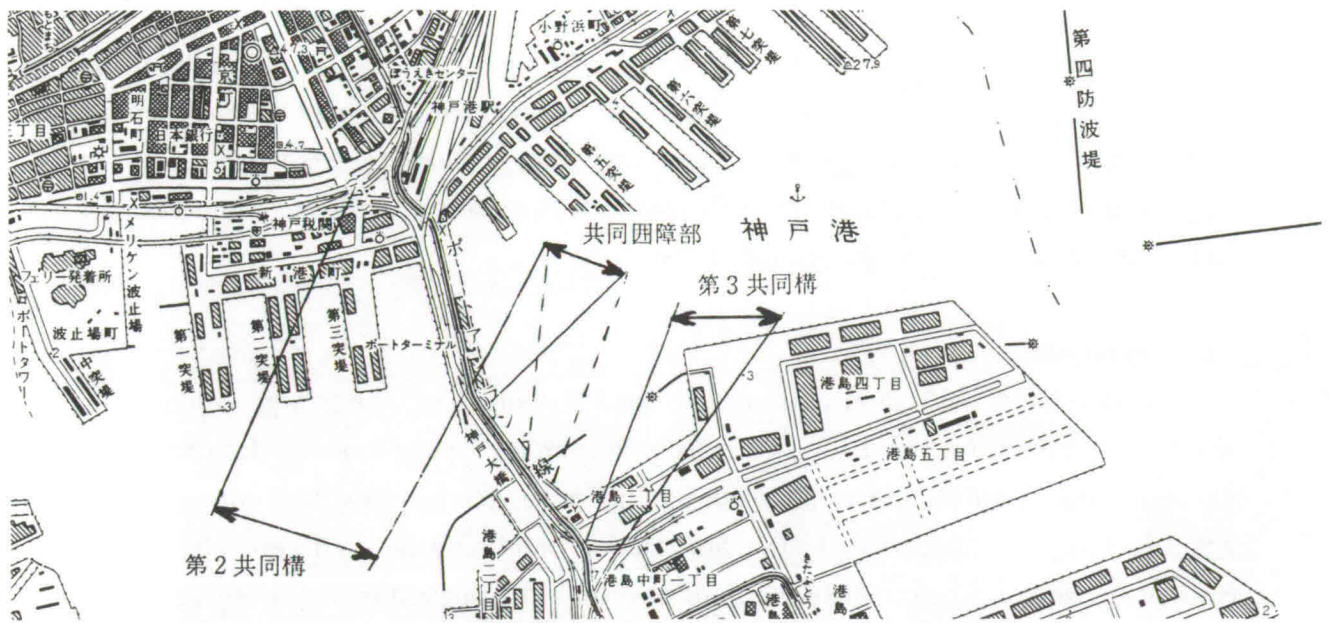
Fig. 5 Route of duct placed between New Port No. 4 Pier Terminal and Port Island

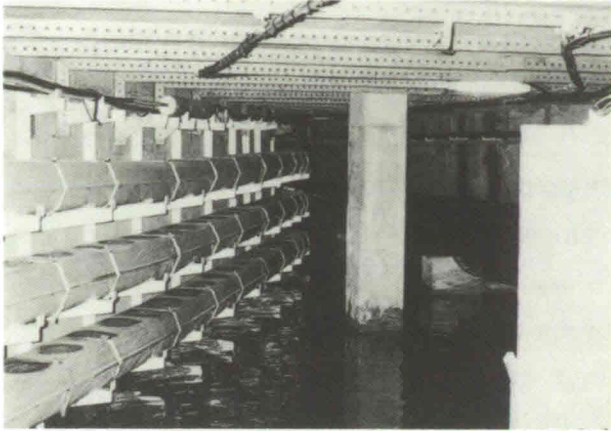
Photo 5 Flooding in duct due to water in-flow

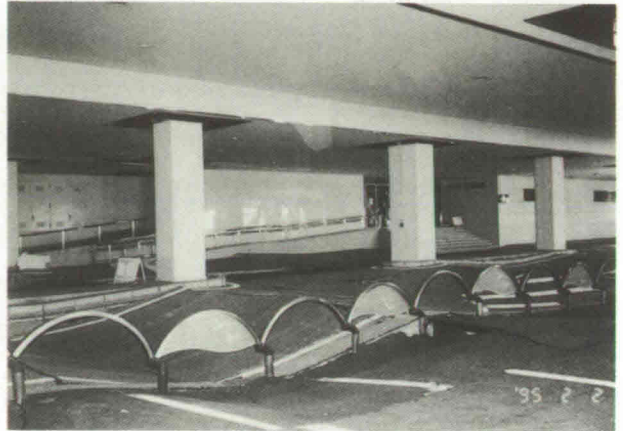
Photo 6 Damage to parking lot above duct route

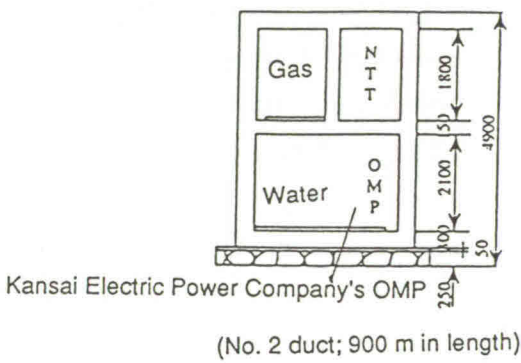
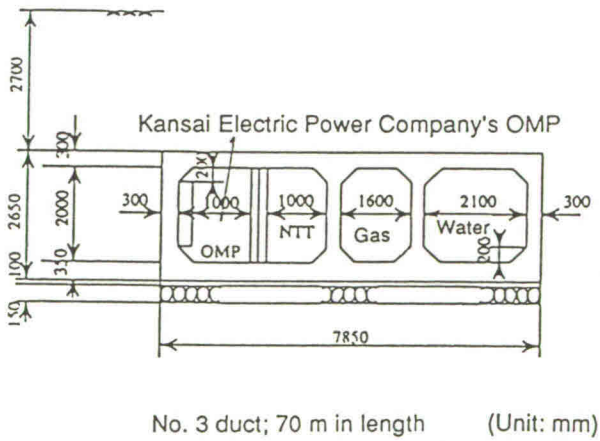
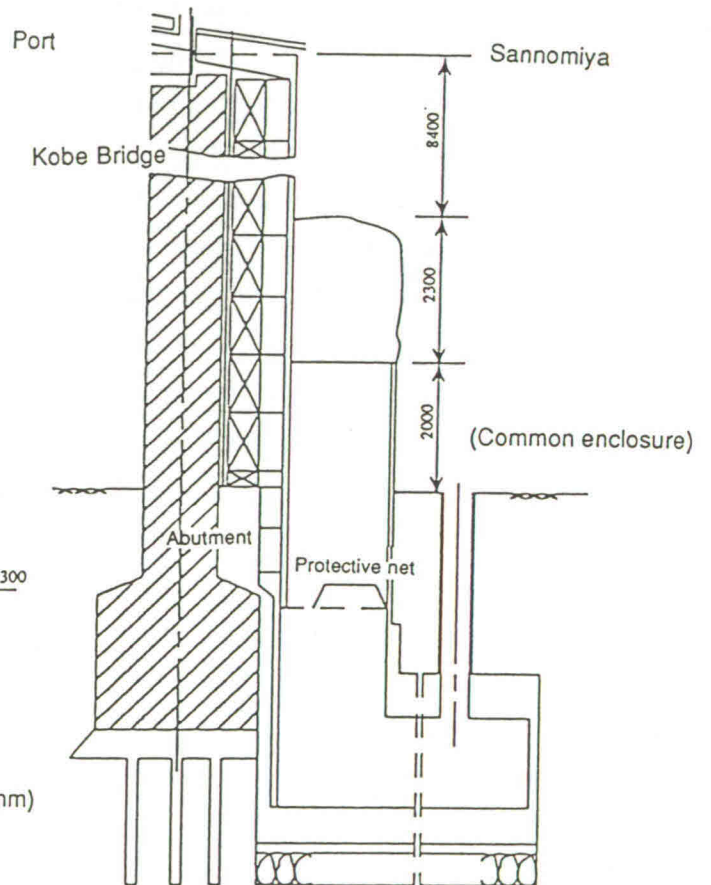
Fig. 6 General structural drawing of underground multi-purpose duct

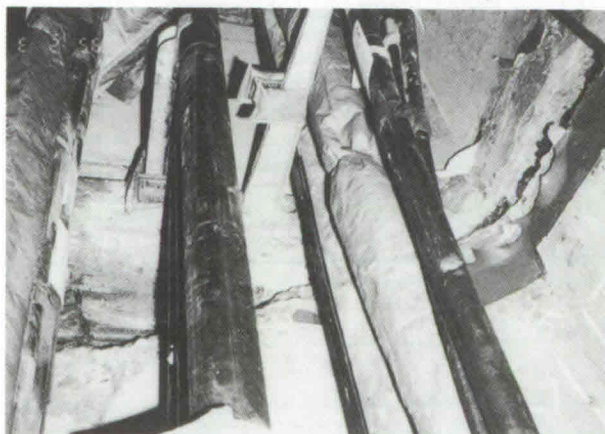
Photo-7 Opening resulting from damage to expansion joint

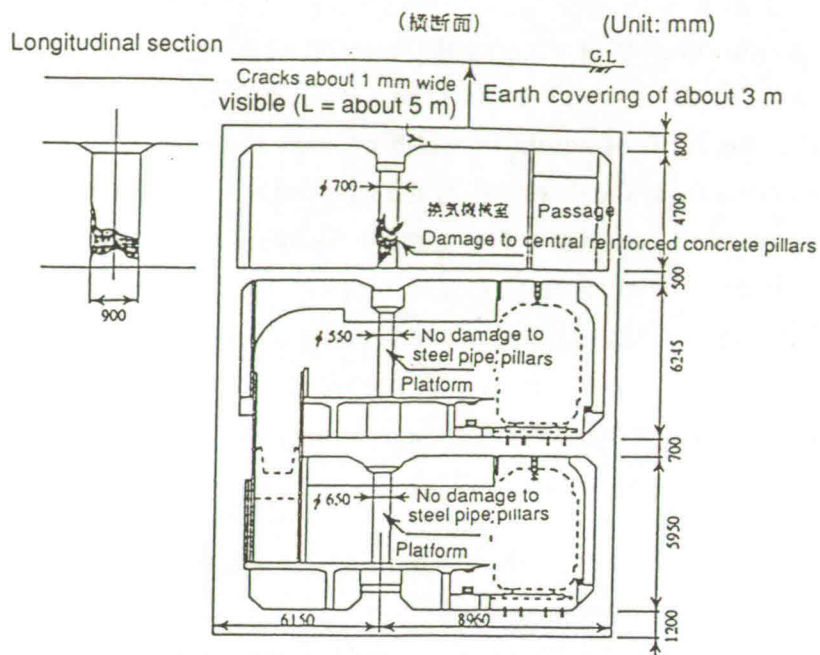
Fig. 7 Example of damage to Sannomiya station of the Kobe Municipal Subway

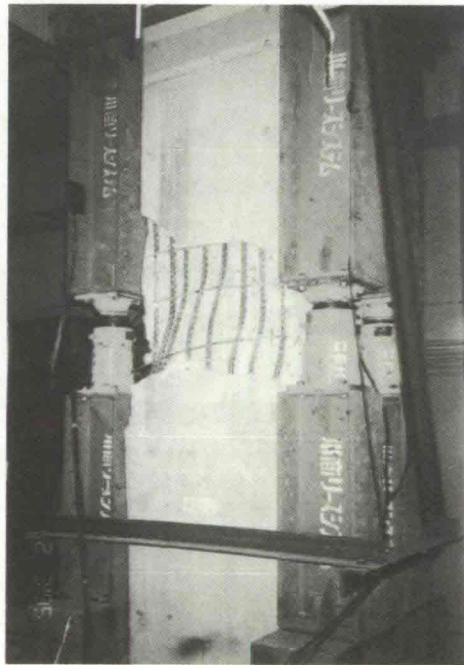
Photo 8 Temporary reinforcement to central pillars at Sannomiya station of the Kobe Municipal Subway

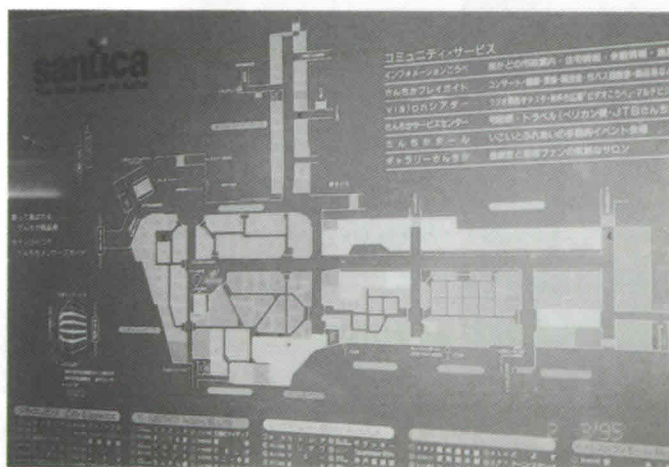
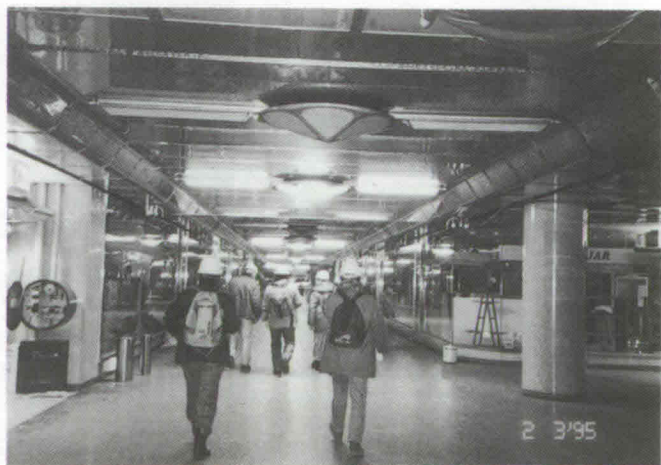
Photo 9 View of Sanchika Shopping Mall Photo 10 View of Sanchika Shopping Mall

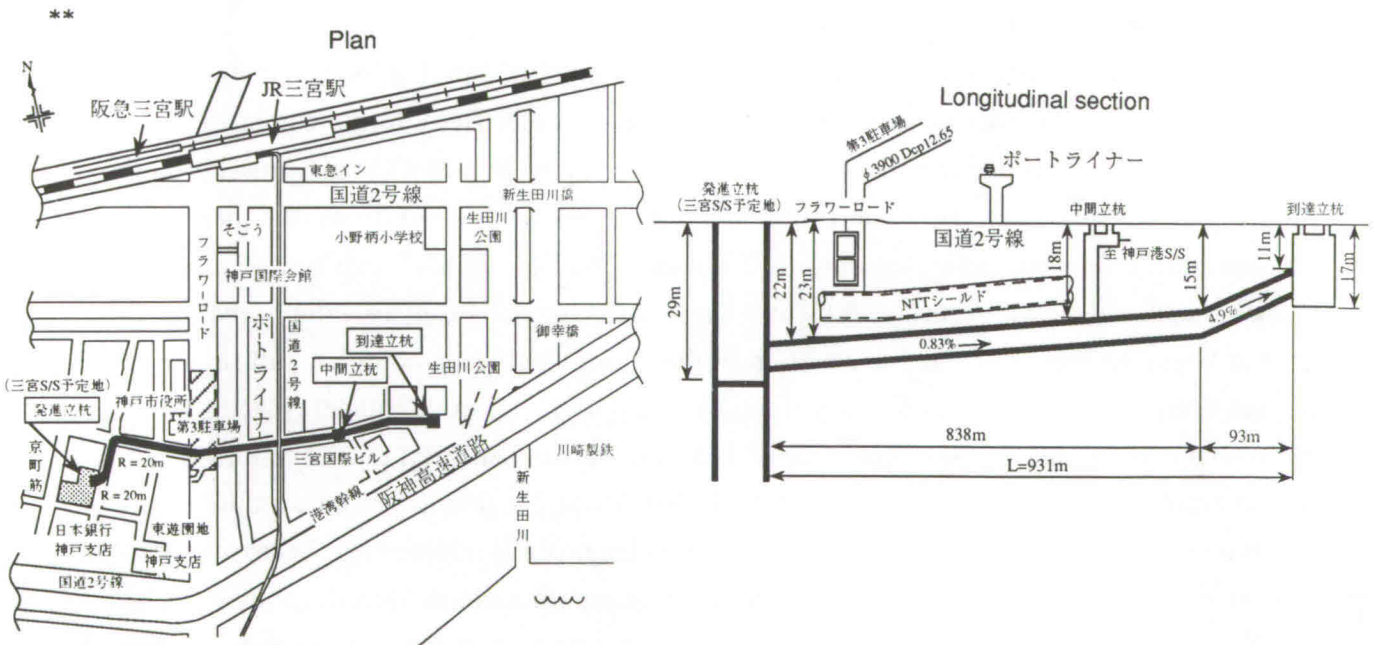
Fig. 8 Kansai Electric Power Company's Isobe Dori Shield Tunnel

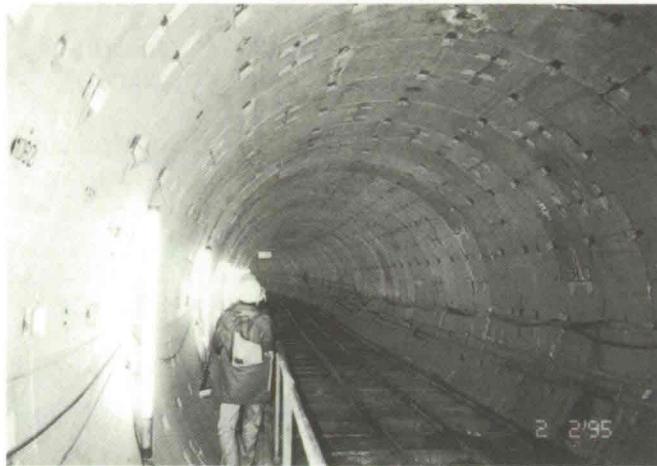
Photo 11 View of Kansai Electric Power Company's Isobe Dori Shield Tunnel

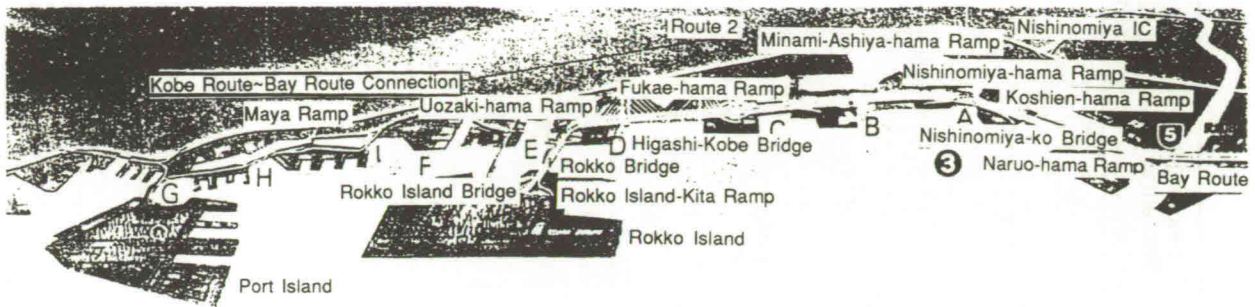
Fig. 1 Map of bridges covered by the investigation

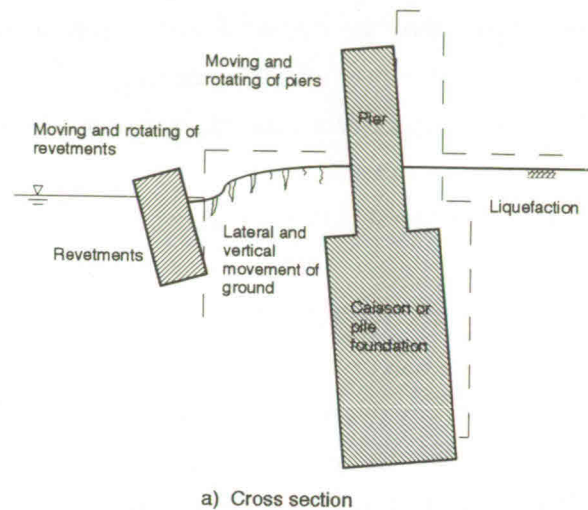
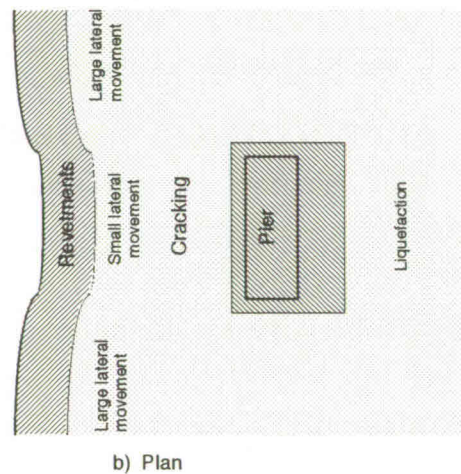
Fig. 2 Schematic drawings of typical damage to waterfront structure foundations

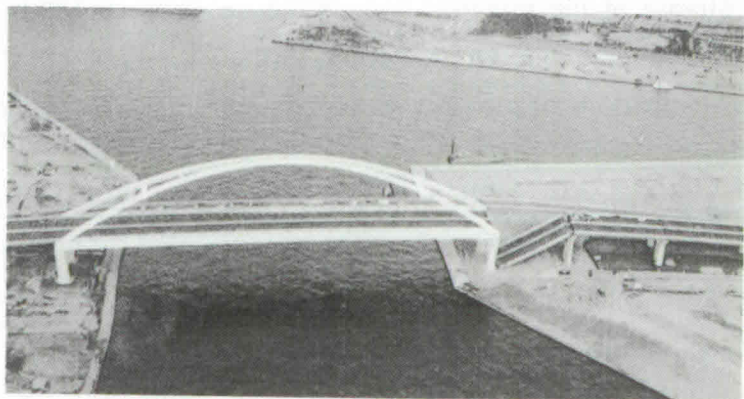
Photo 1 Collapse of girder of Nishinomiya-ko Bridge at the Koshien-hama

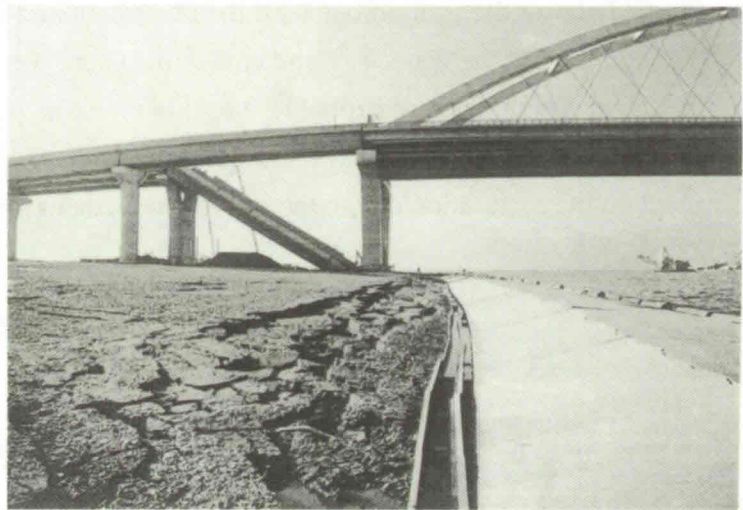
Photo 2 Revetment in front of bridge pier and nearby conditions

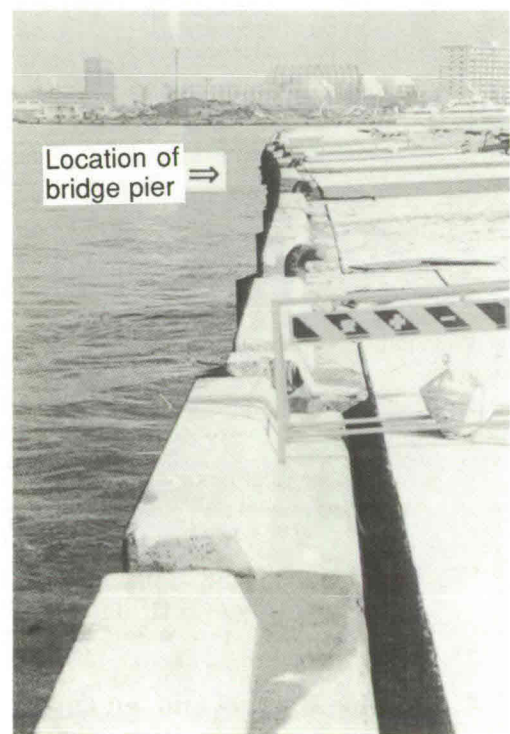
Photo 3 Damage to revetment

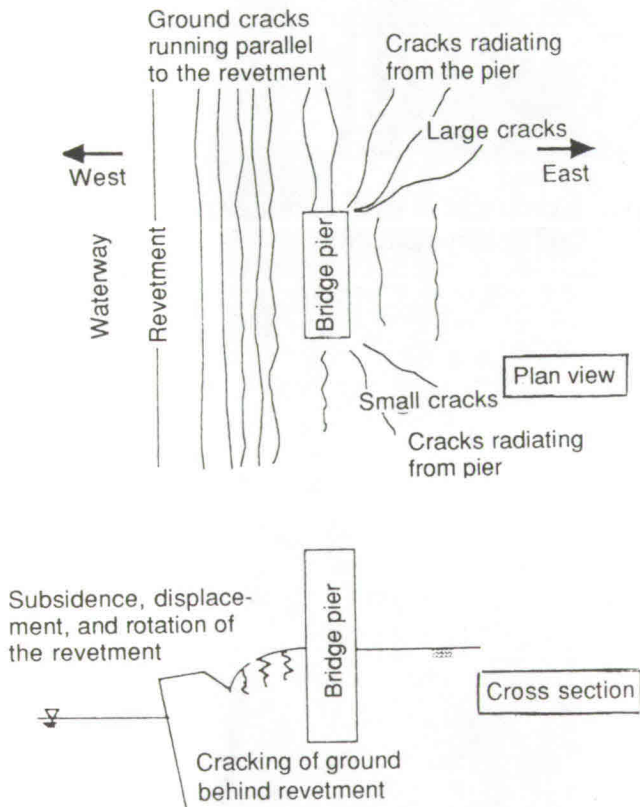
Fig. 3 Ground around a pier of the Nishinomiya-ko Bridge

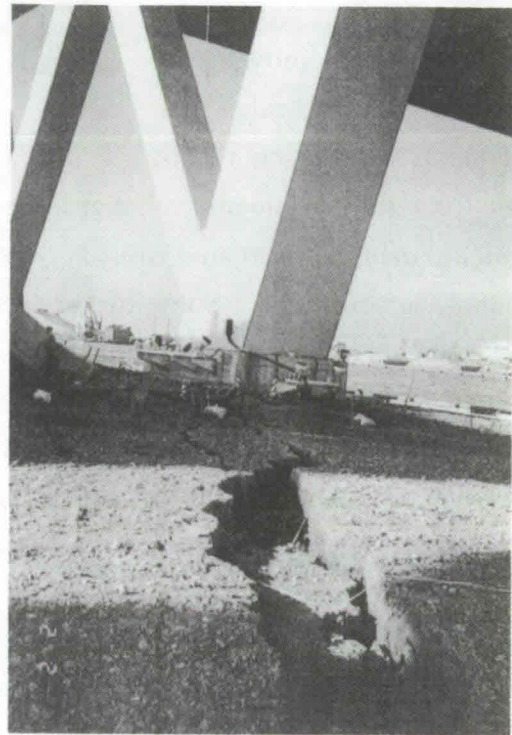
Photo 4 Cracks radiating from bridge pier

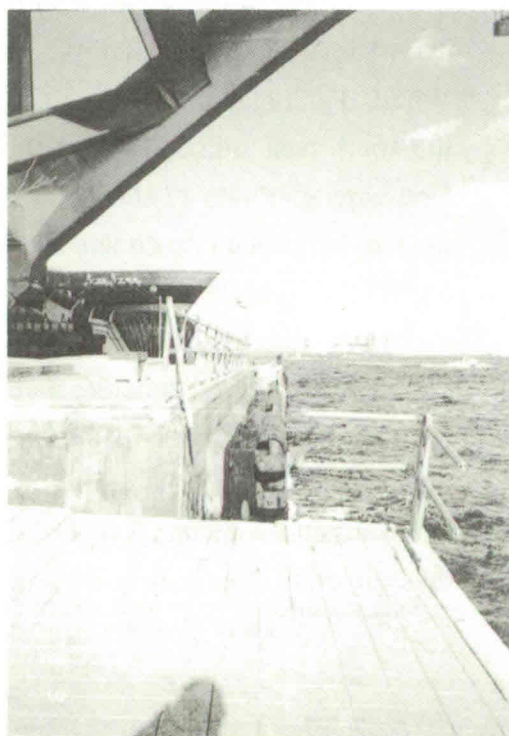
Photo 9 Damage to revetment at foot of the jetty

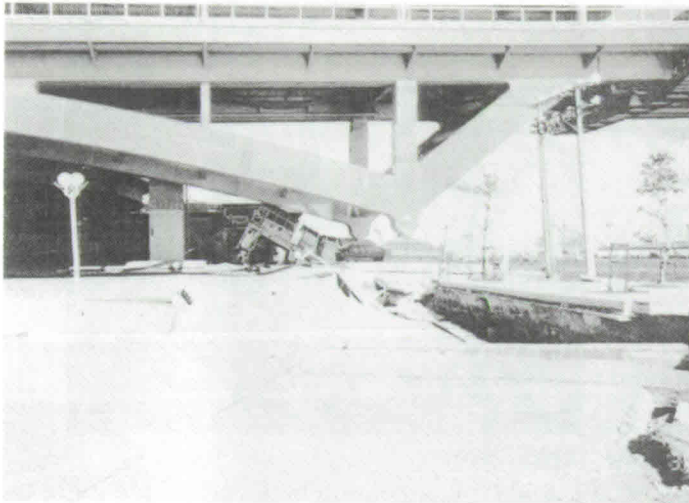
Photo 10 Damage to ground behind the abutment of the Kobe Bridge (Kobe side)

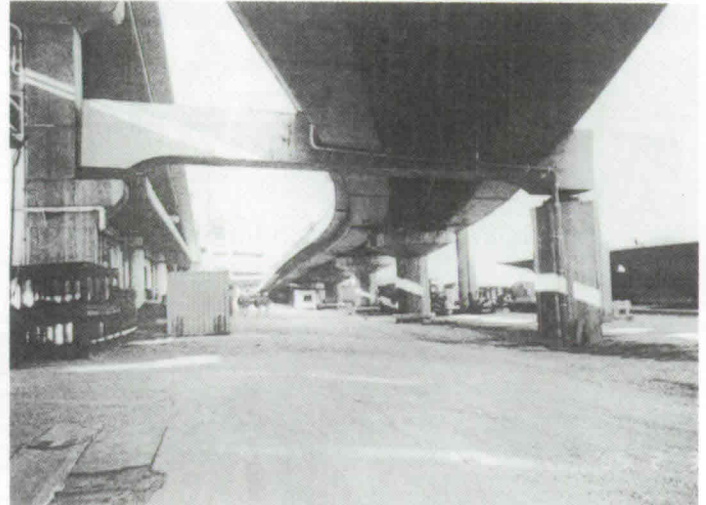
Photo 11 Piers of the elevated approach span connecting to the Kobe Bridge

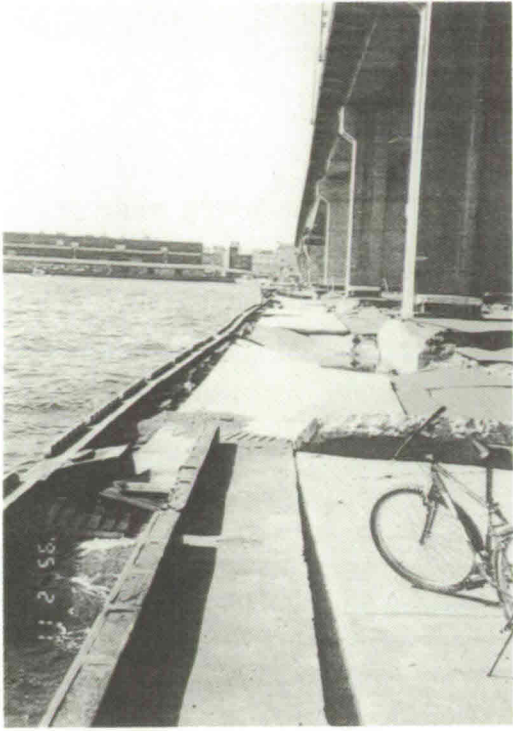
Photo 12 Collapse of southern revetment of the jetty

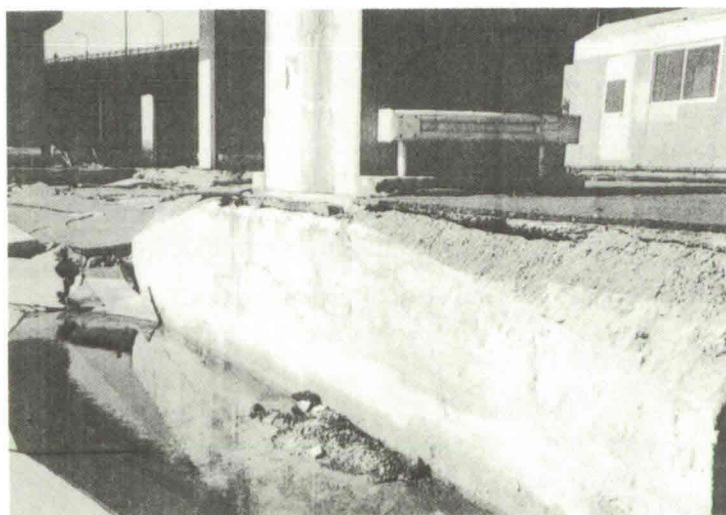
Photo 14 Foundation of elevated approach span connecting to the Second Maya Bridge

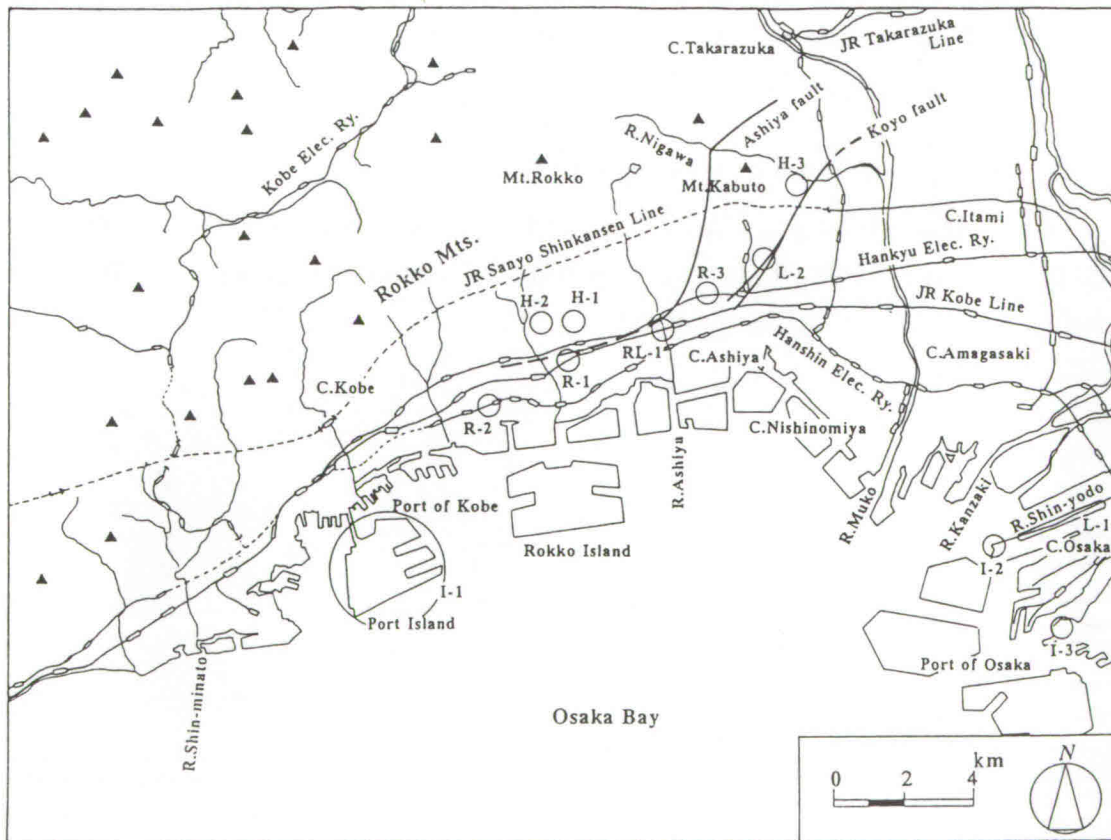
Fig. 1 Map of investigated locations

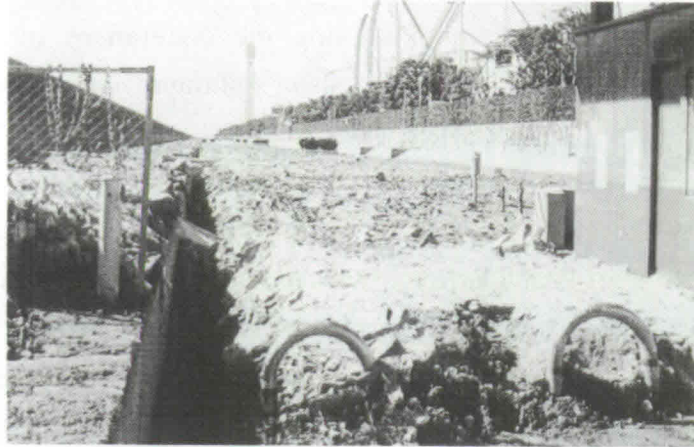
Photo 1 Traces of sand boiling on Port Island

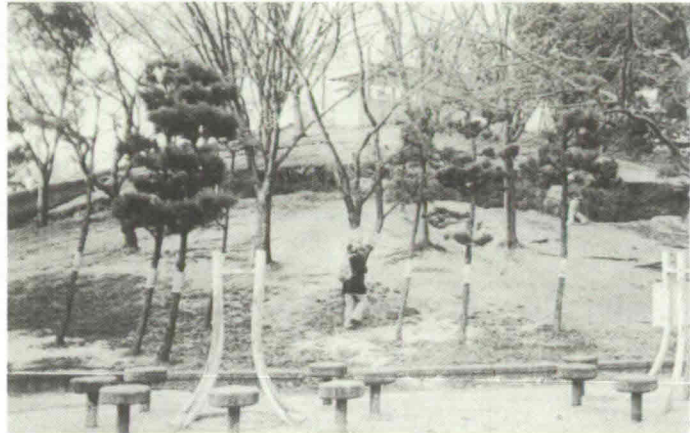
Photo 3 Landslide at Tenpozan mound

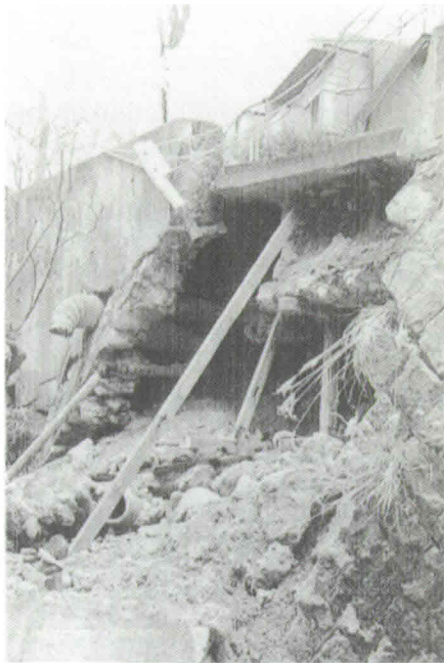
Photo 4 Collapsed fill at Okamoto 6-chome

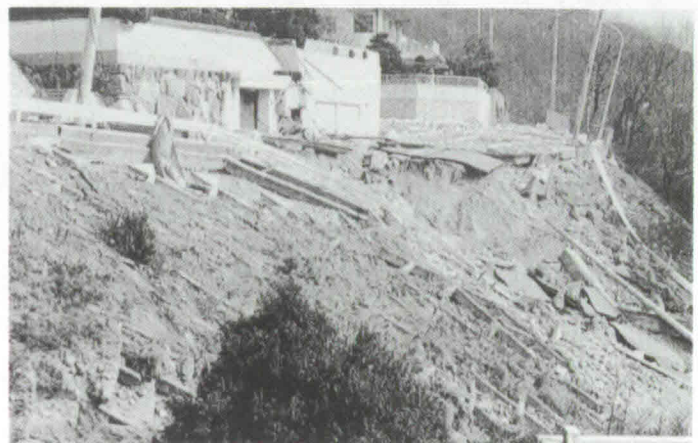
Photo 6 Collapsed embankment at Nishi-okamoto 7-chome

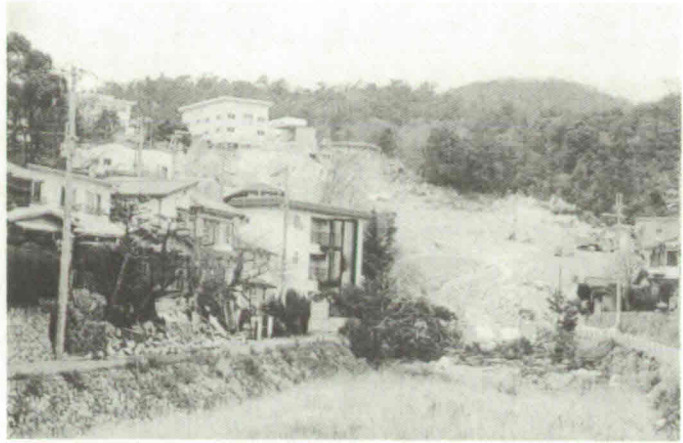
Photo 7 Overall view of slope failure at Nikawa

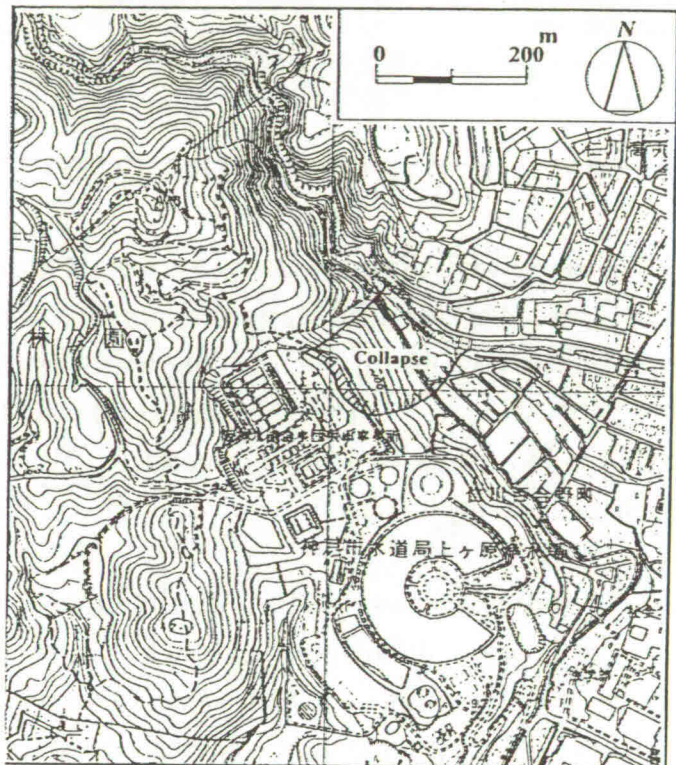
Fig. 3 Topography in neighborhood of slide location at Nikawa [taken from topographical map (1/10,000 scale) by the National Geographic Agency]

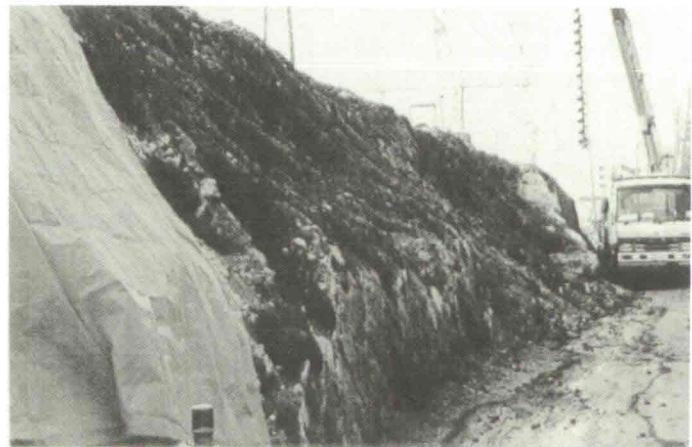
Photo 8 Collapse of fill near Setsumotoyama station

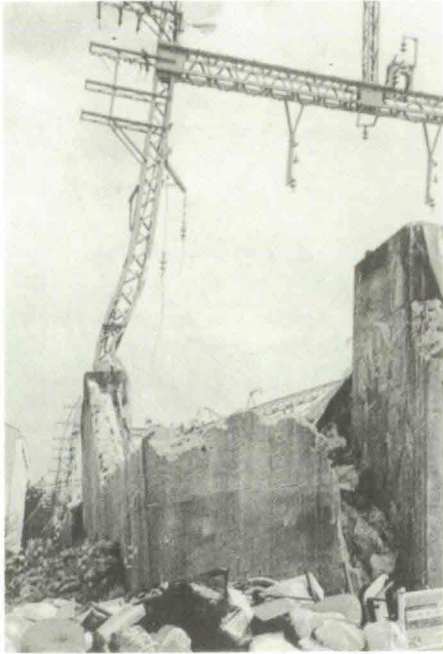
Photo 9 Collapse of fill at Ishiyagawa station

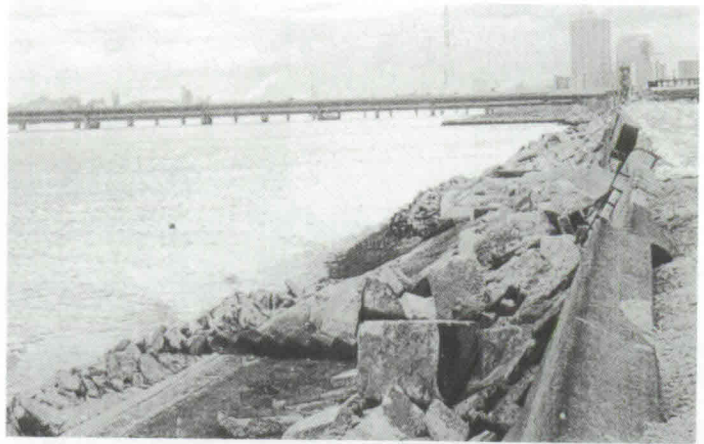
Photo 11 Shinyodogawa river embankment damage

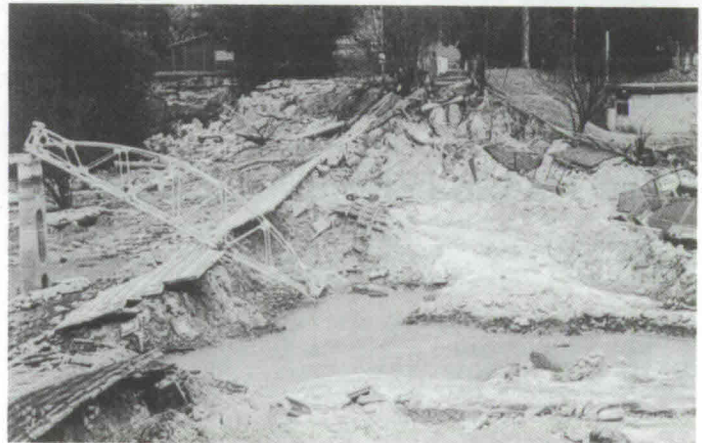
Photo 12 Damage to the Niteko pond embankment

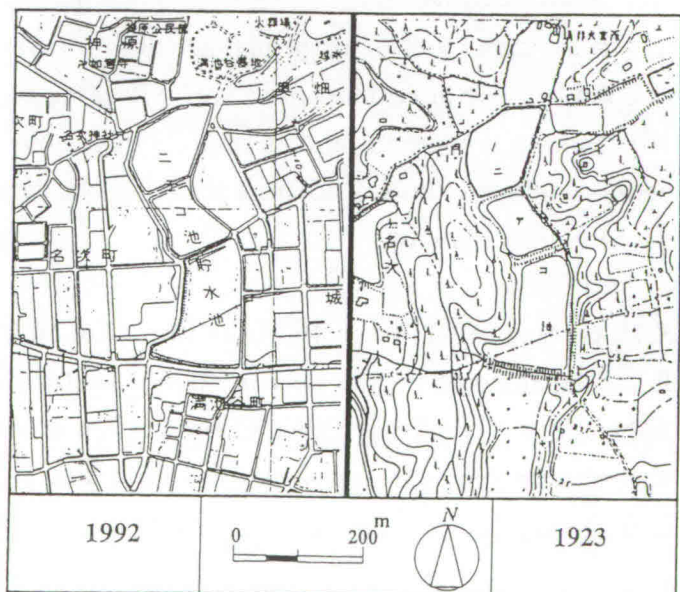
Fig. 5 Former topography near the Niteko pond [taken from topographic map (1/10,000 scale) of the National Geographic Agency]

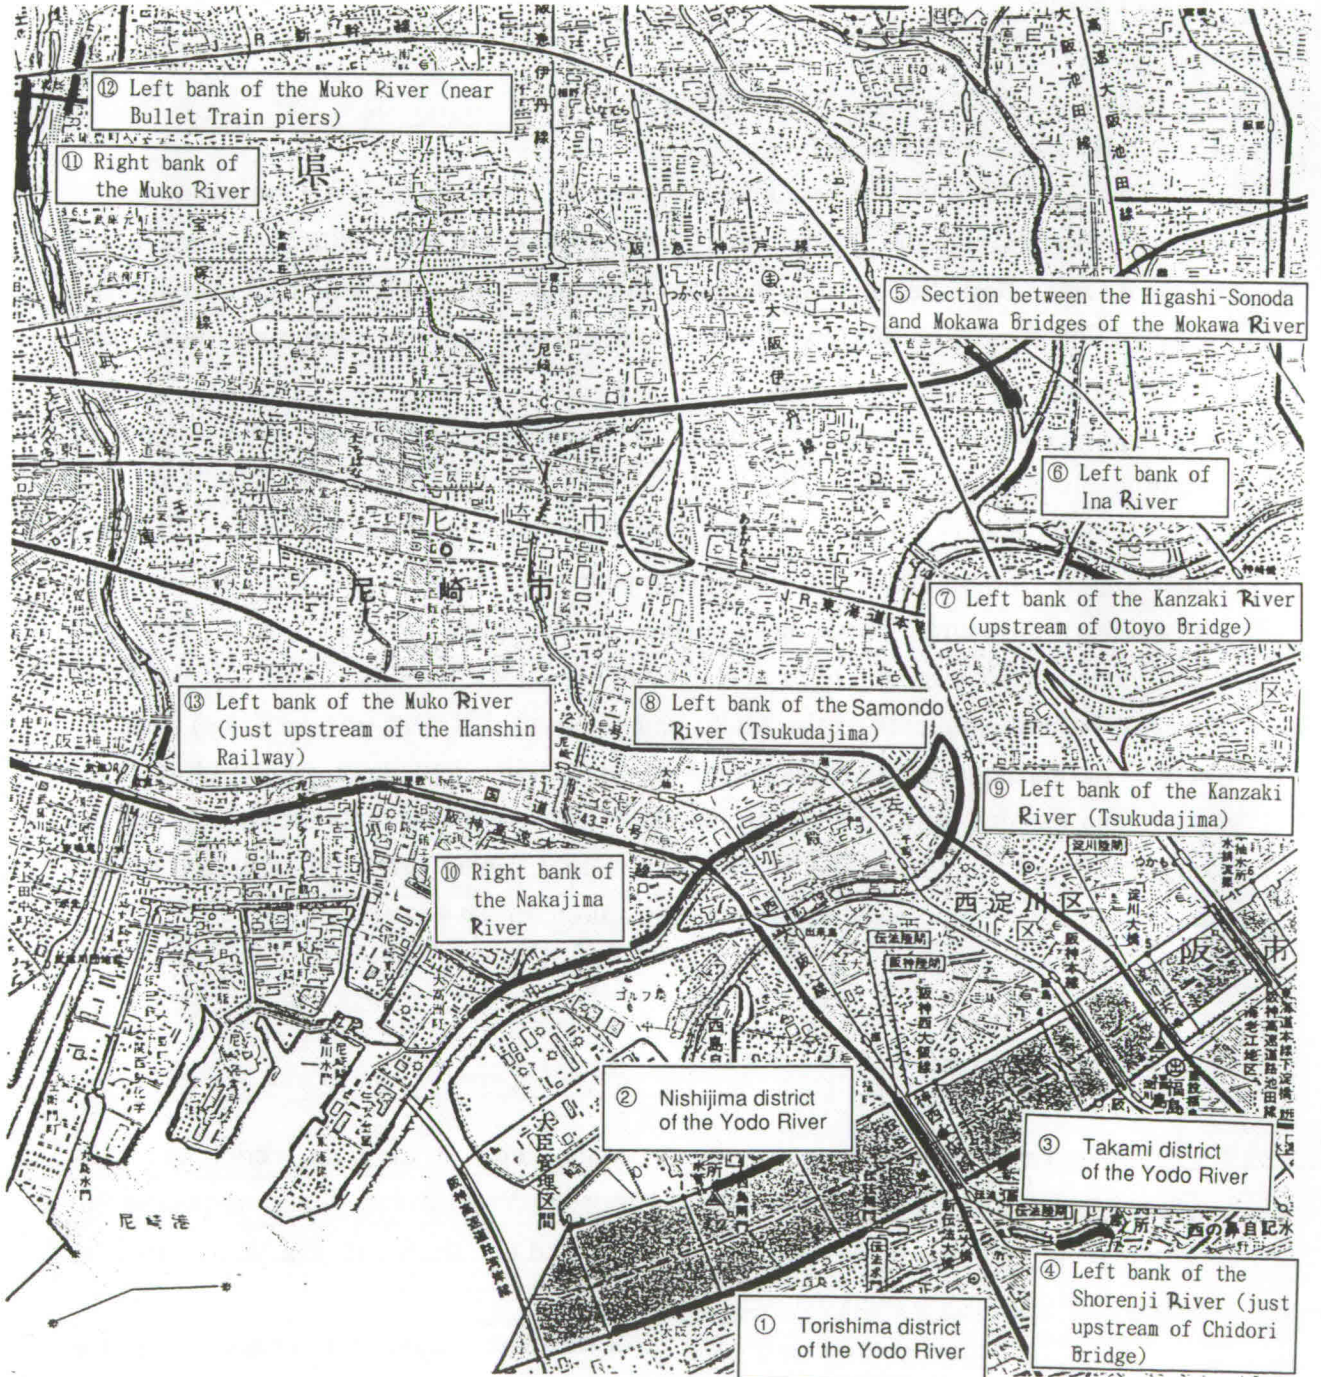
Fig. 1 Embankment sections suffering major damage in the earthquake (damaged sections indicated by thick lines)

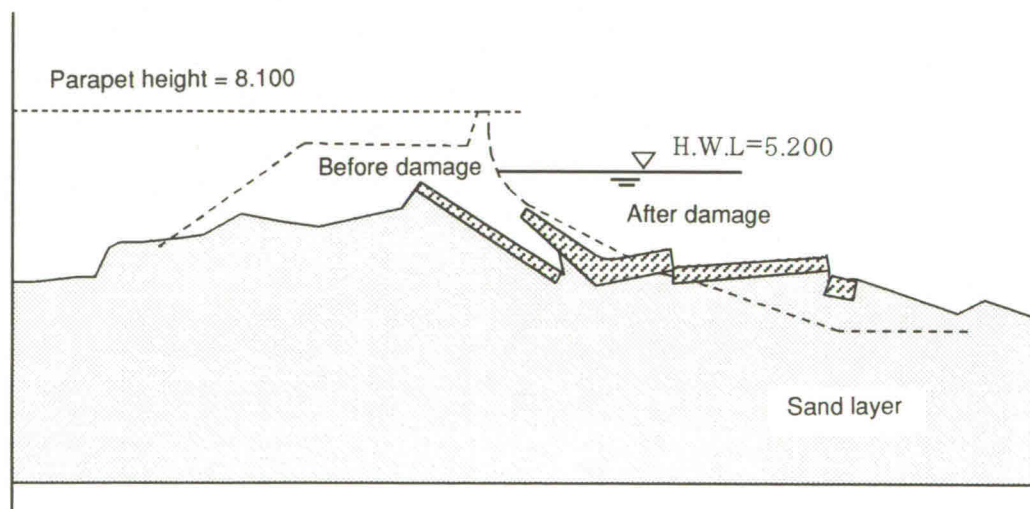
Fig. 2 Destruction of embankments in the Torishima district of the Yodo River (according to data from the Yodo River Work Office of the Ministry of Construction)

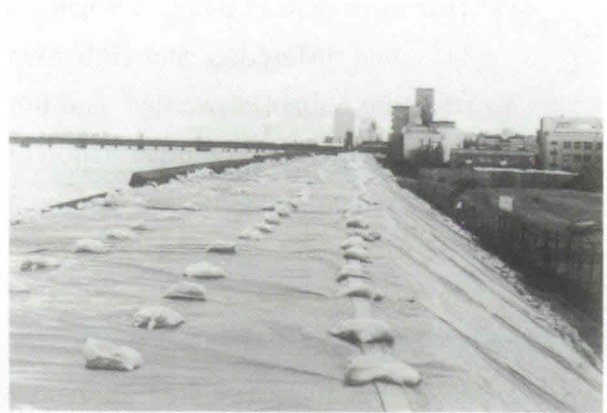
(b) Emergency repair work

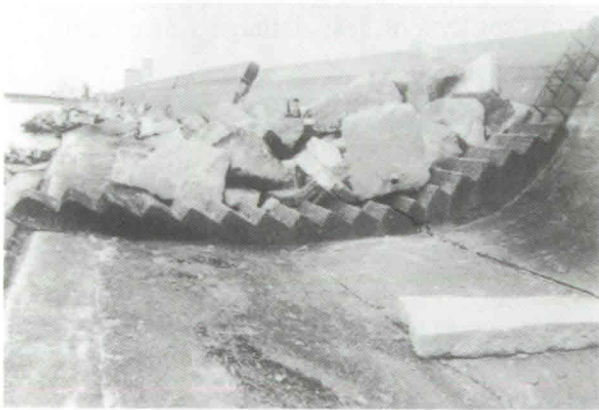
(c) Collapse of dike

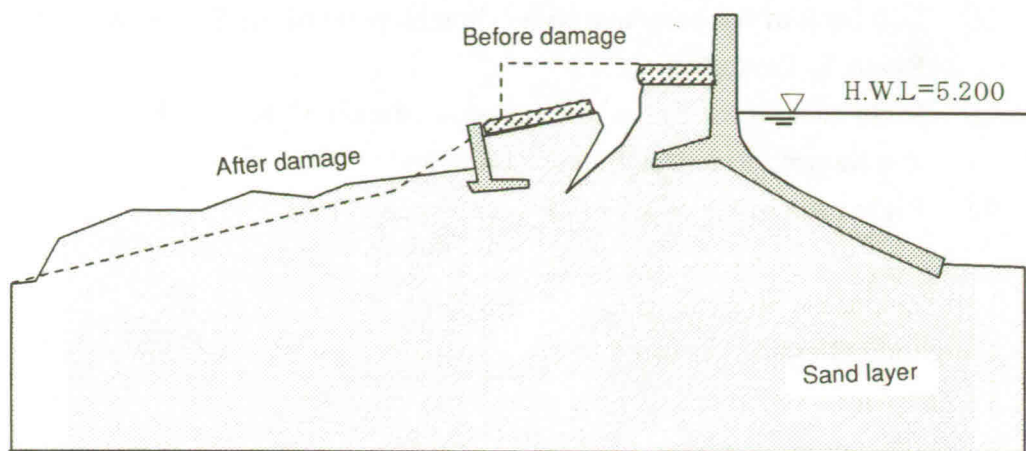
Fig. 3 Destruction of embankment in the Nishijima district of the Yodo River (according to data from the Yodo River Work Office of the Ministry of Construction)
