Preliminary Report on
**THE GREAT
HANSHIN
EARTHQUAKE**

January 17, 1995

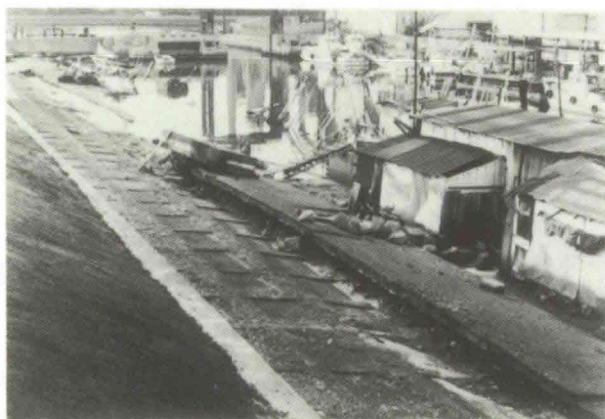
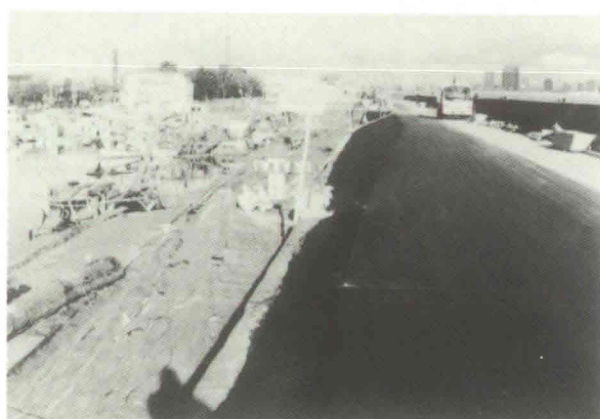
(a) Collapse (sliding) of rear slope (b) Levee crown after emergency repair

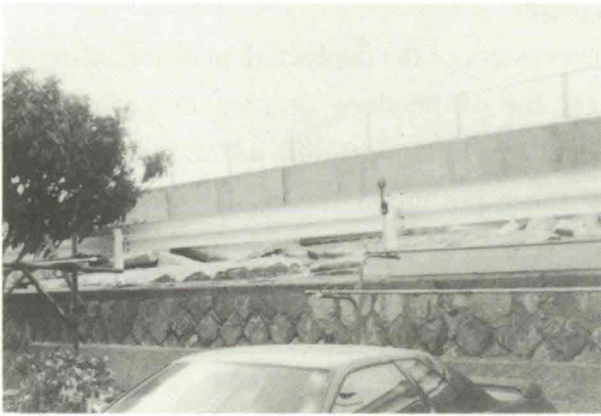
Photo 3 Shorenji River
(damage to levee crown)

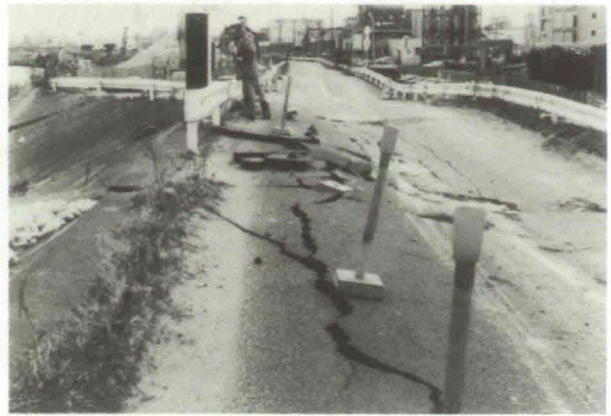
Photo 4 Kanzaki River
(cracking and settlement of levee crown)

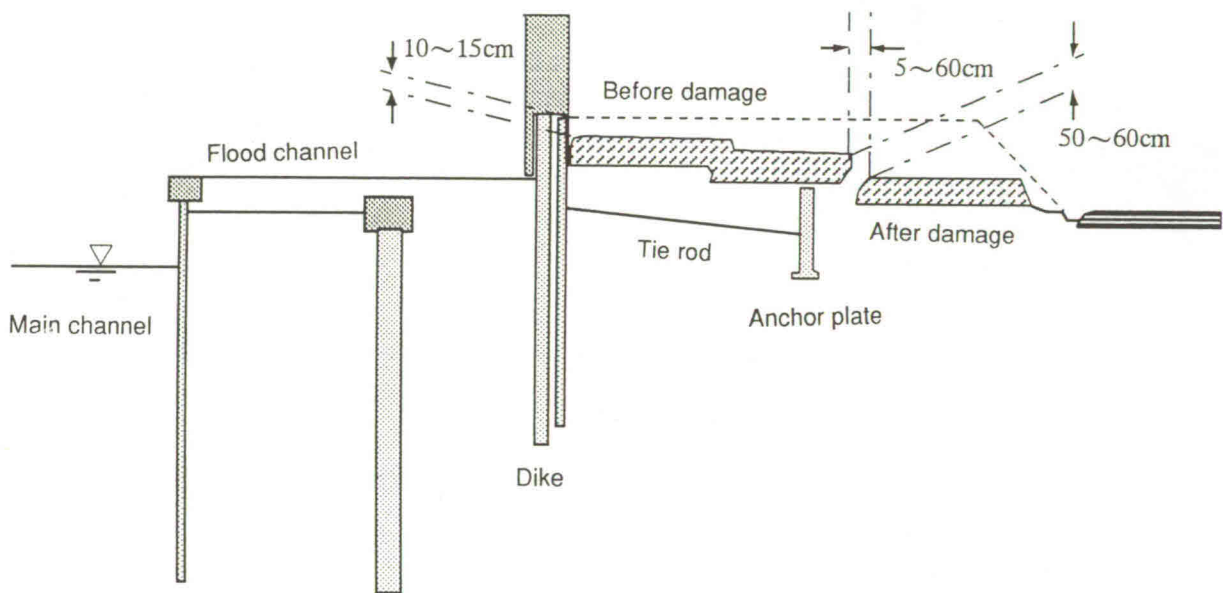
Fig. 4 Destruction of embankment along the Kanzaki River
(Tsukudajima) (according to data provided by Osaka prefecture)

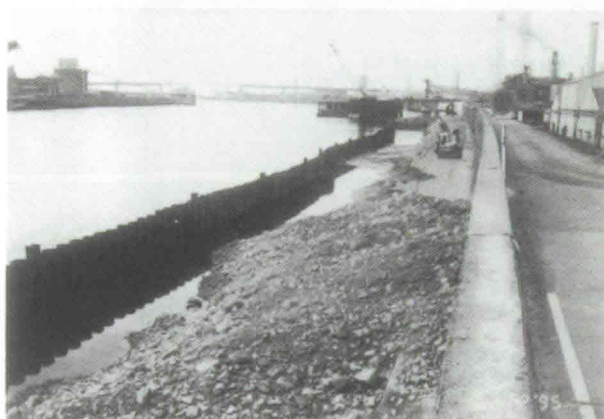
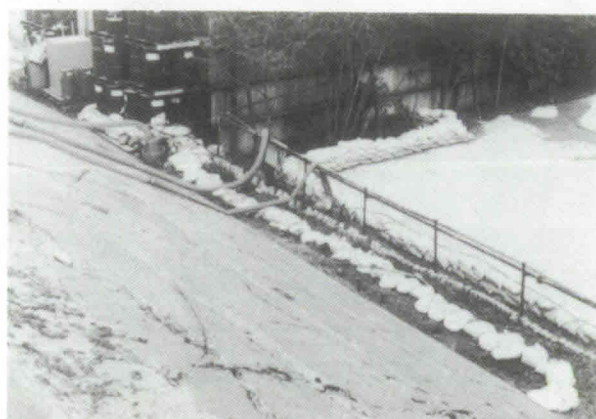
(a) Sheet piling as the preventive measure of water leakage

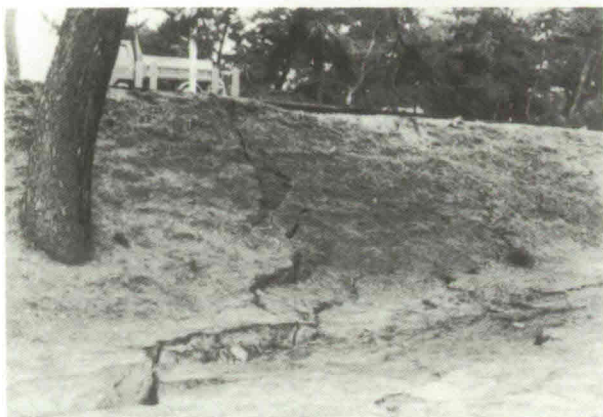
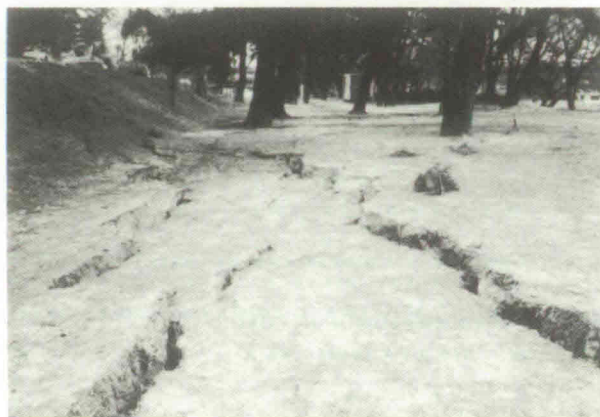
(a) Cracked embankment slope on river side

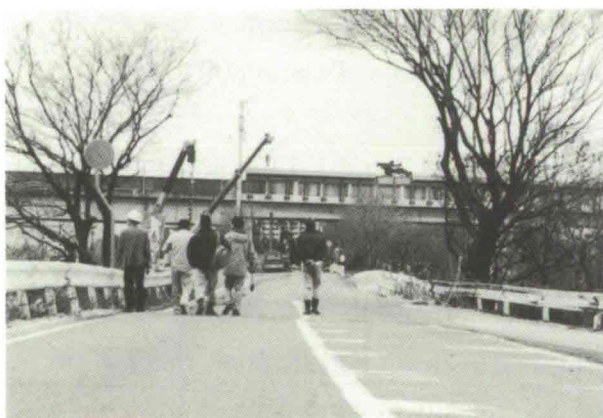
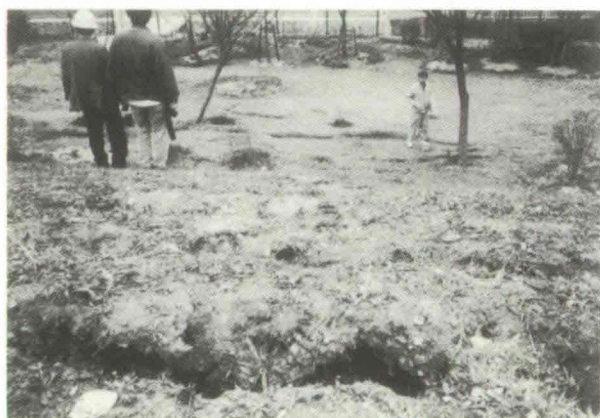
(a) Wavy levee crown

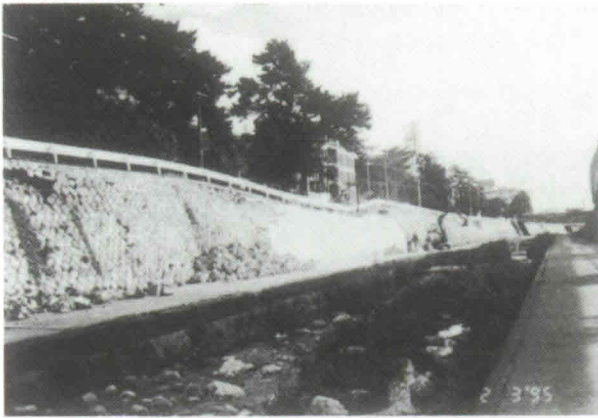
(a) Collapsed stone-masonry revetment

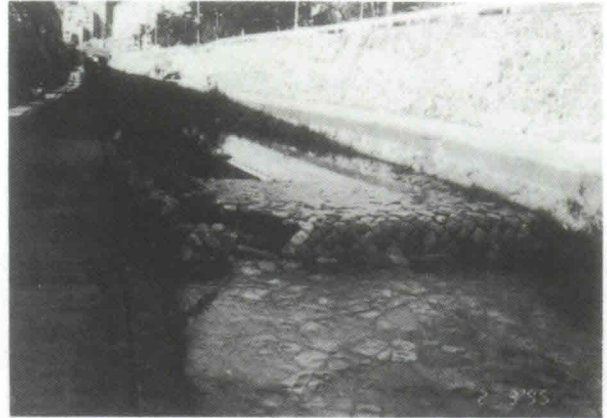
(b) Damaged main channel revetment and consolidation work

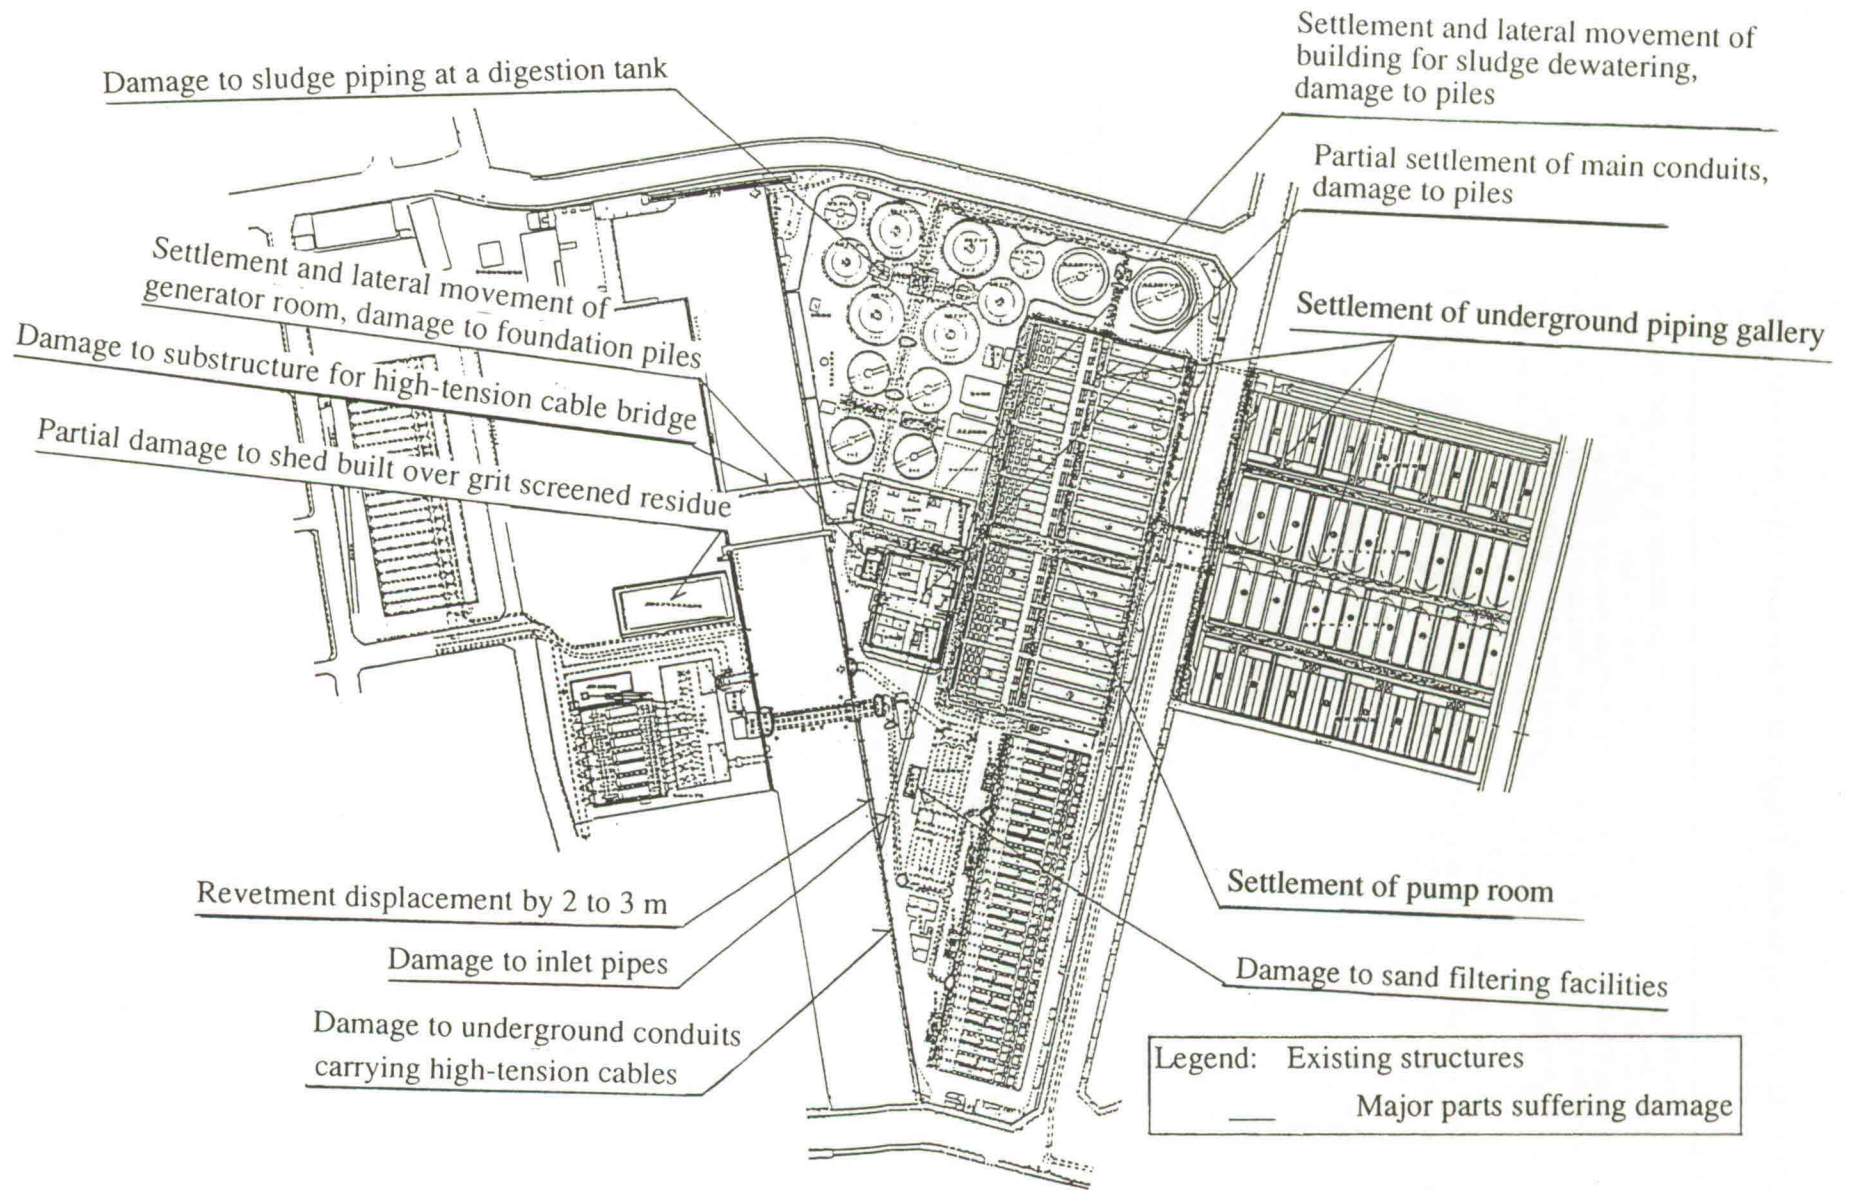
Figure 1 Plan view of Higashi-Nada Sewage Treatment Plant

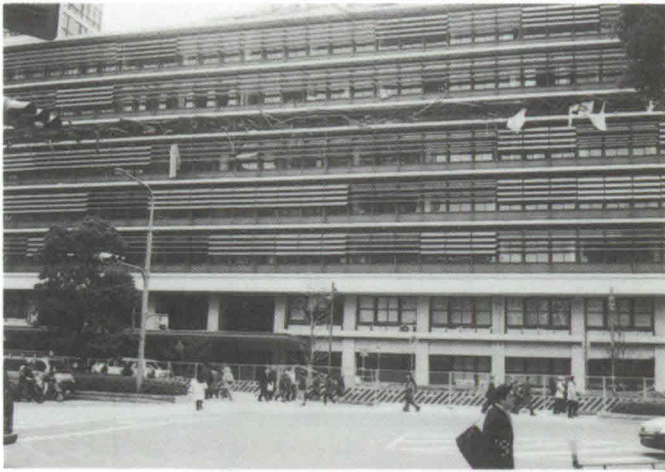
Photo 1 Damaged No.2 Building of Kobe City Office

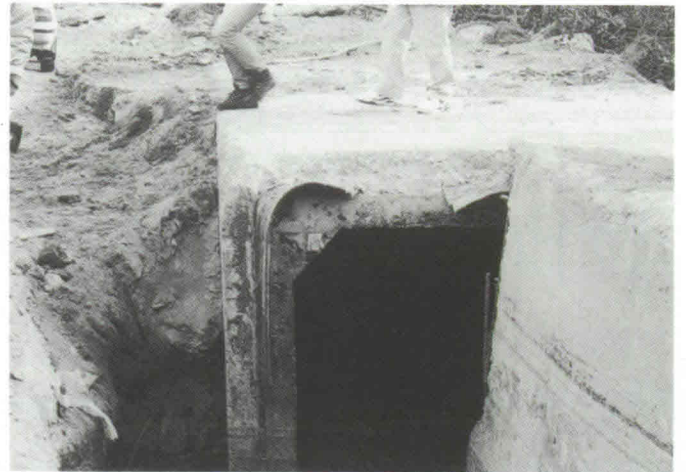
Photo 2 Damaged Higashi-Nada Sewage Treatment Plant

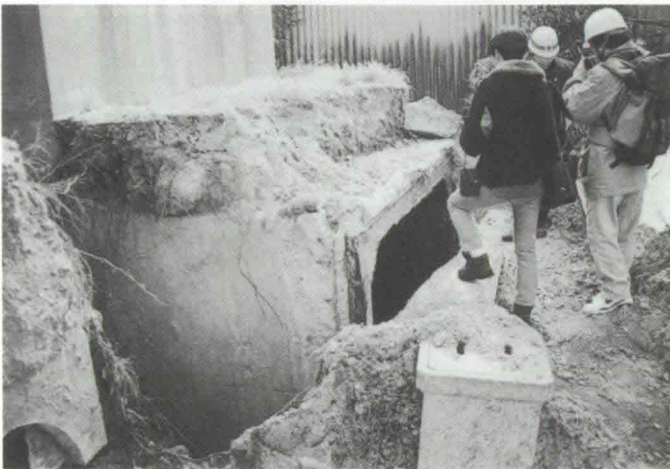
Photo 3 Damaged Higashi-Nada Sewage Treatment Plant

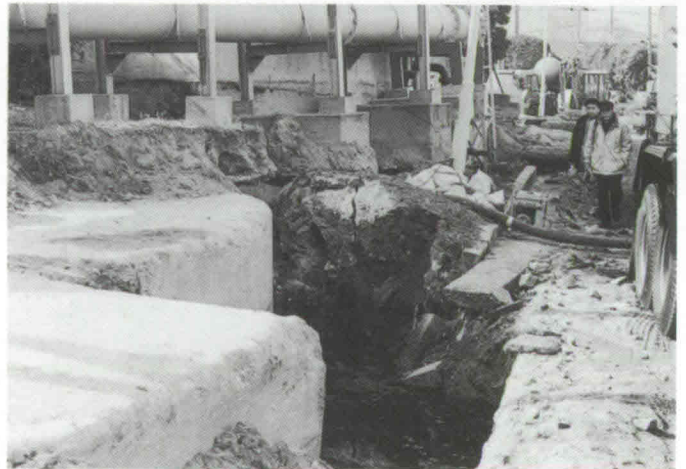
Photo 4 Damaged Higashi-Nada Sewage Treatment Plant

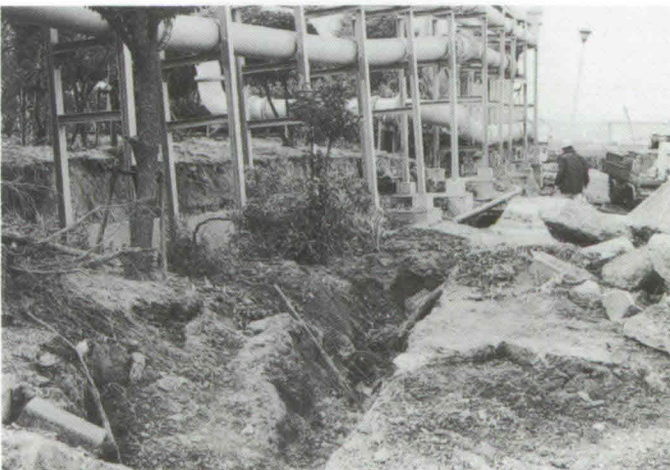
Photo 5 Damaged Higashi-Nada Sewage Treatment Plant

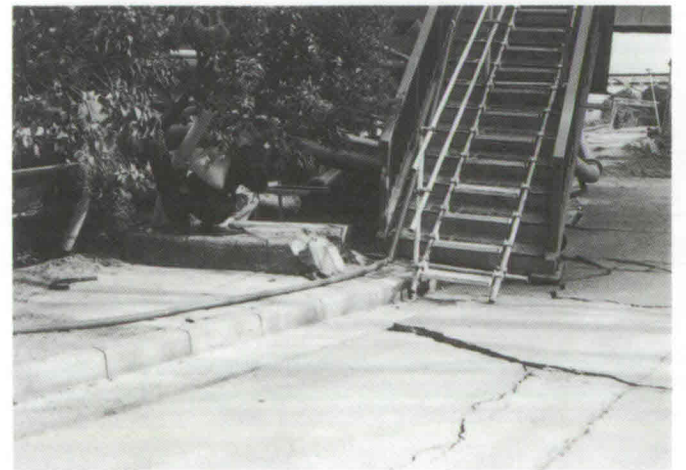
Photo 6 Damaged Higashi-Nada Sewage Treatment Plant

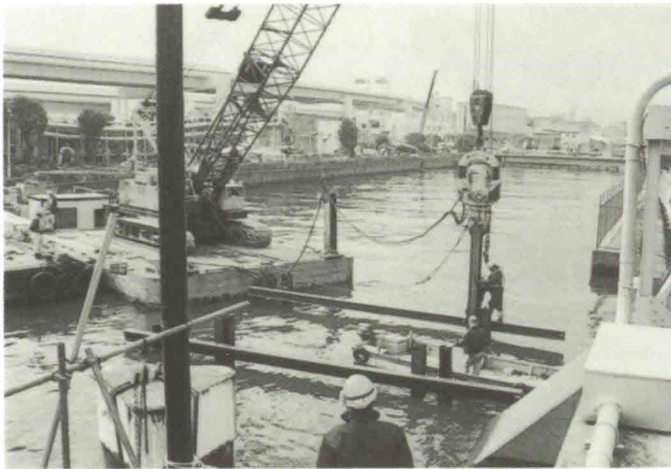
Photo 7 Closed off canal

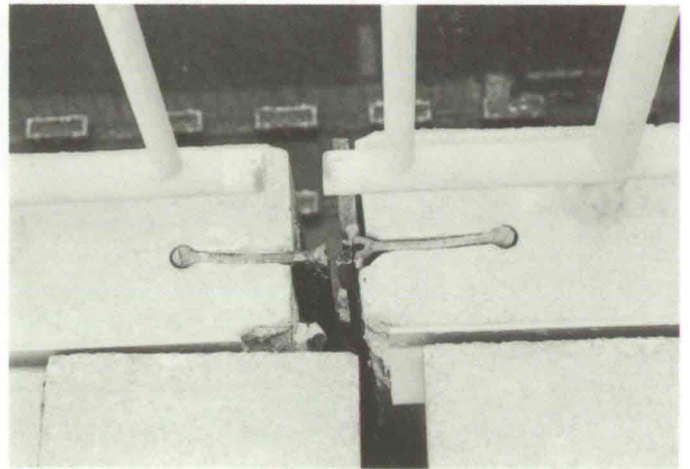
Photo 8 Damage to joints on water tank walls

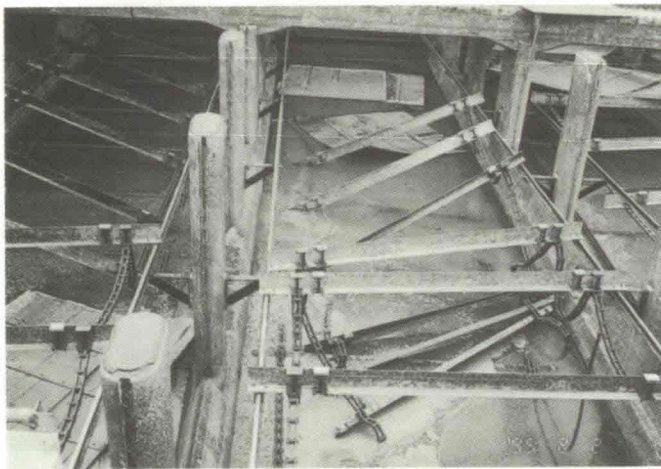
Photo 9 Sludge scraper of primary sedimentation basin

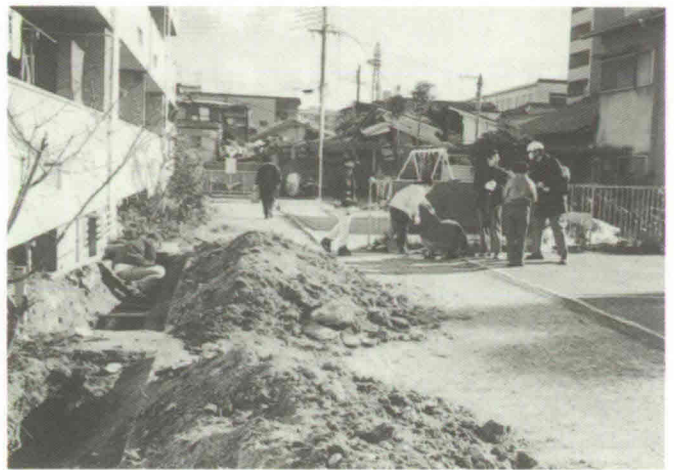
Photo 20 Apartment building sewer being repaired

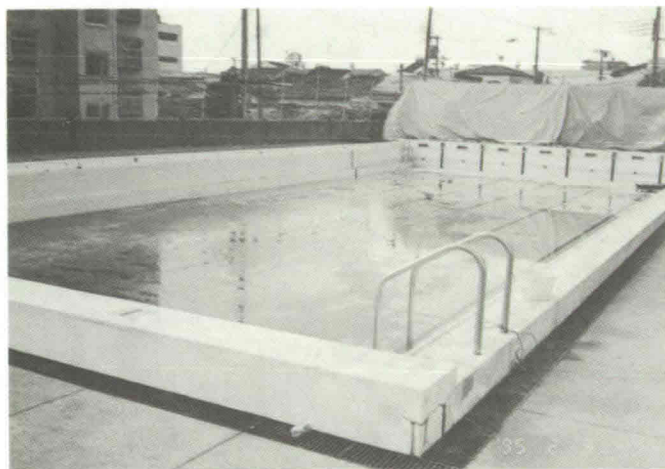
Photo 21 Elementary school swimming pool

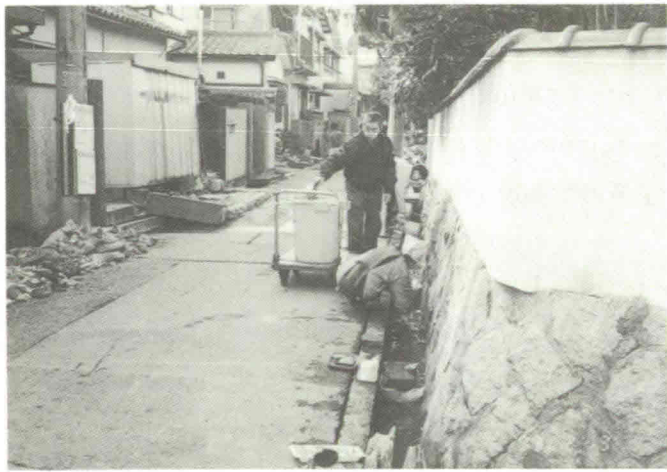
Photo 33 Citizens ladling leaking water from supply pipe

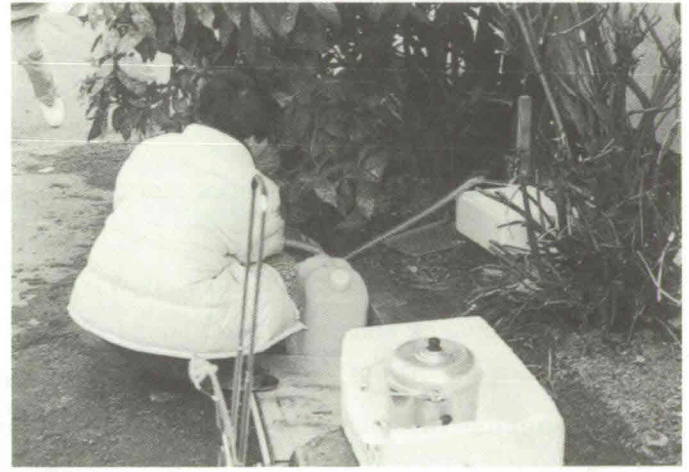
Photo 34 Citizens ladling leaking water from supply pipe

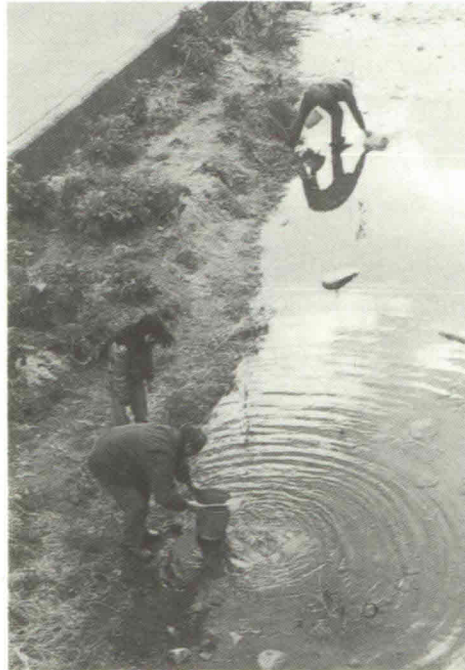
Photo 35 View of Sumiyoshi River

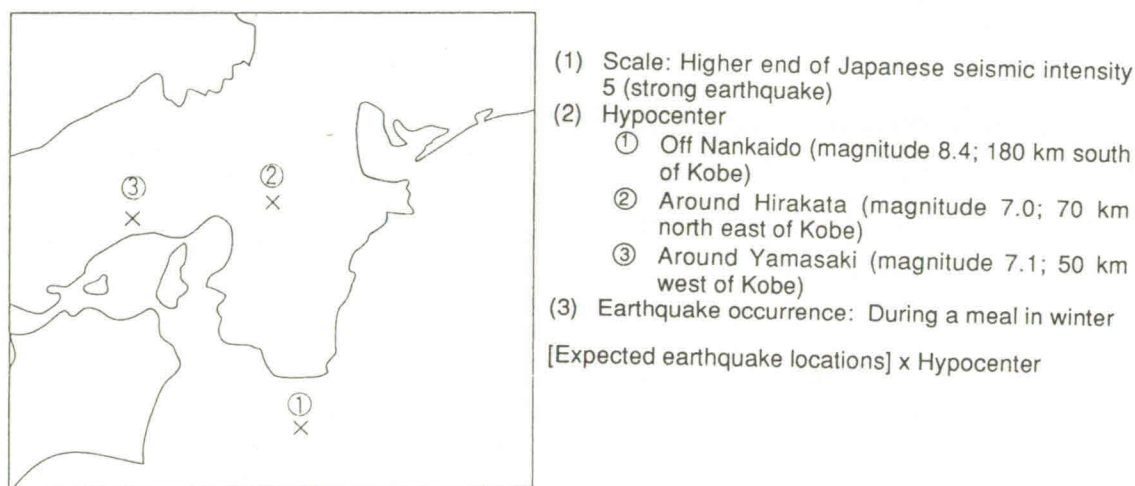
Fig. 1 Anticipated Earthquakes in Kobe

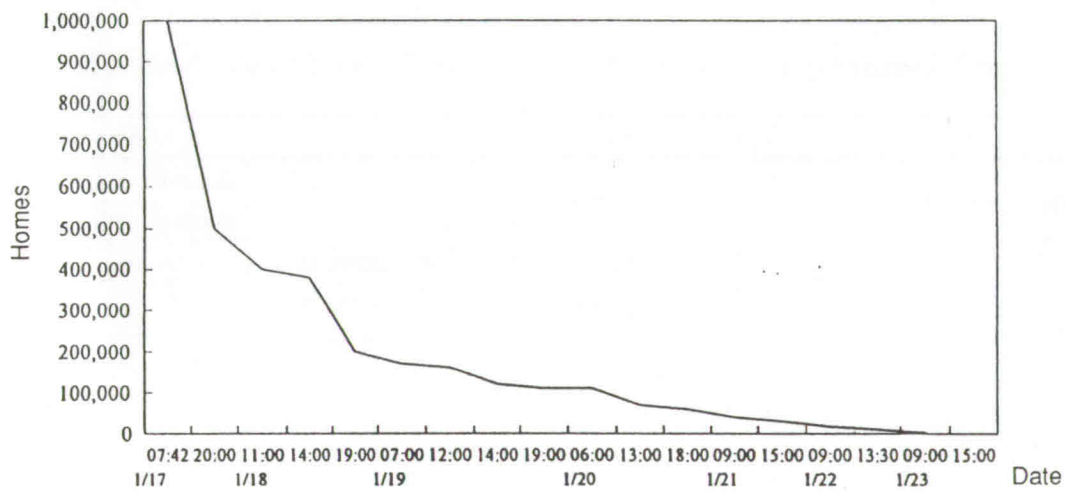
* Excluding some 20,000 facilities and houses without power supply

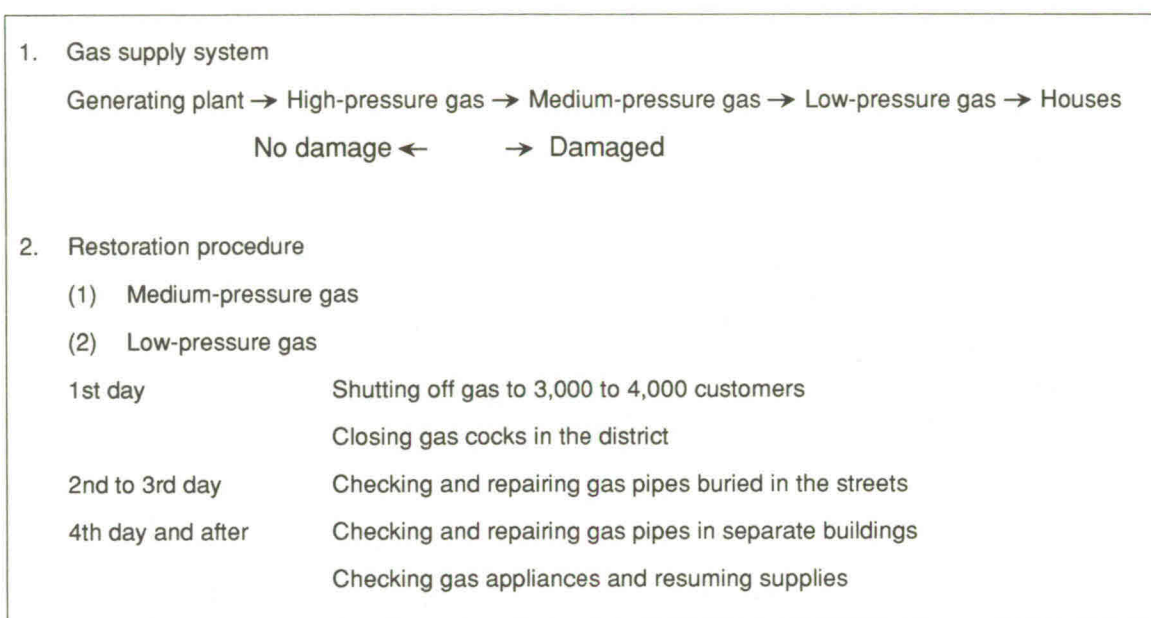
Fig. 3 Damage to City Gas Facilities and Restoration Procedure

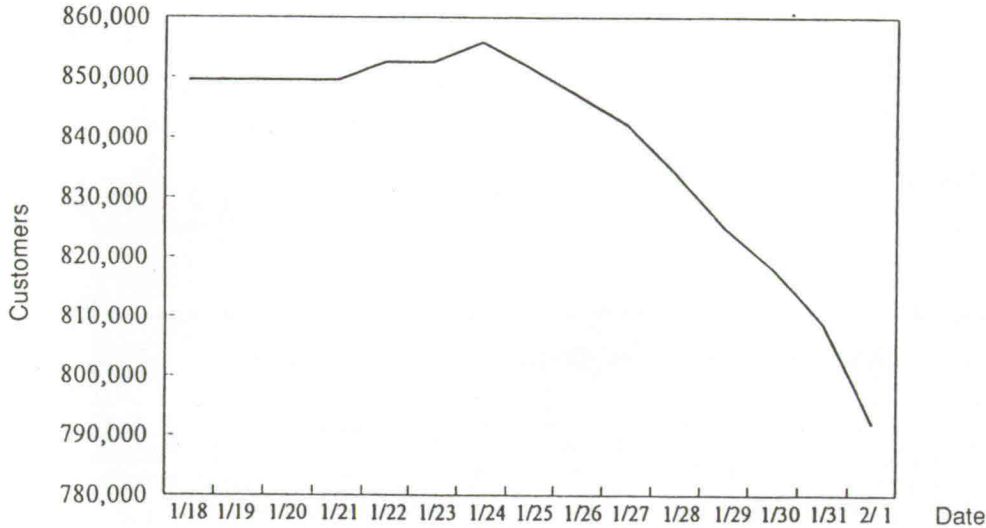
Fig. 4 Restoration of City Gas Supplies (data provided by Osaka Gas Co.)

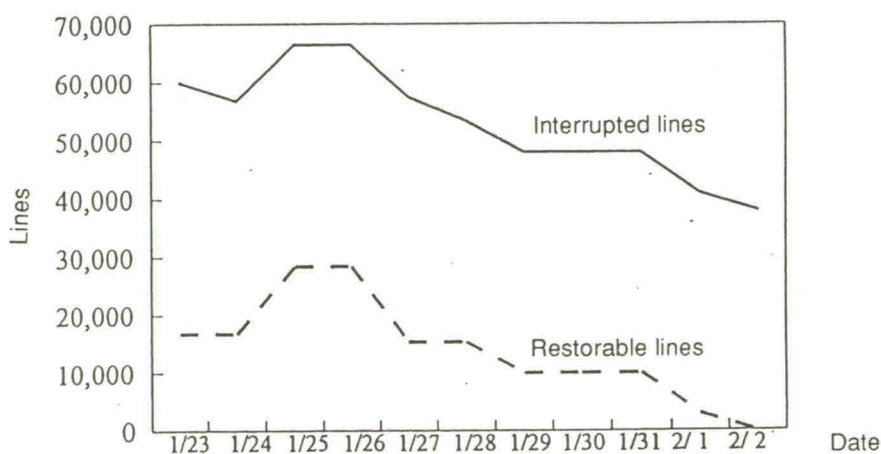
* 38,000: Cannot be quickly restored.

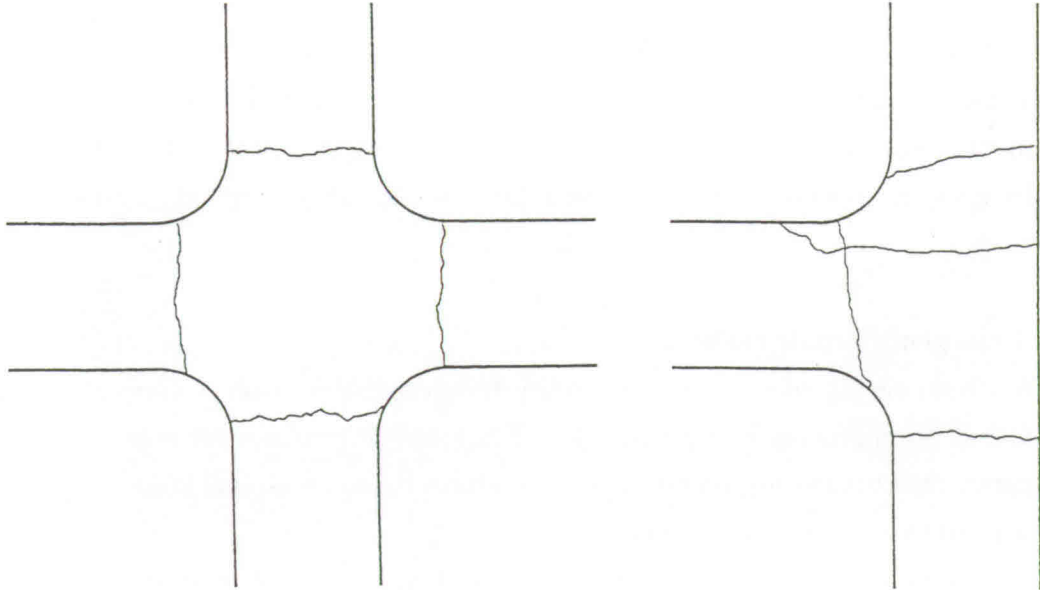
Fig. 1 Typical cracks near intersections

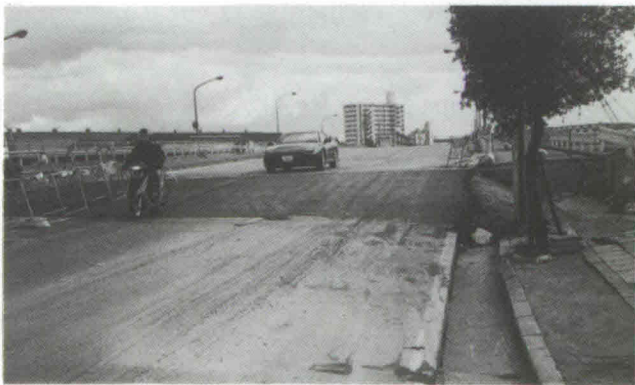
Photo 1 Laying asphalt mixture on road surface behind abutments

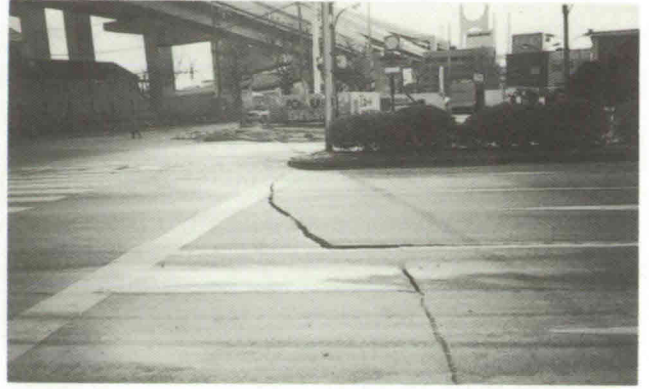
Photo 4 Cracks near intersection (No. 1)

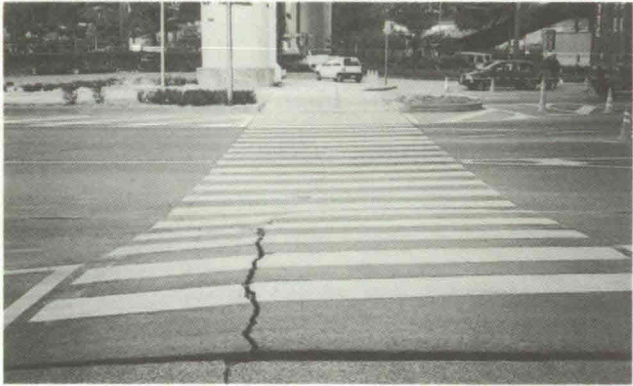
Photo 5 Cracks near intersection (No. 2)

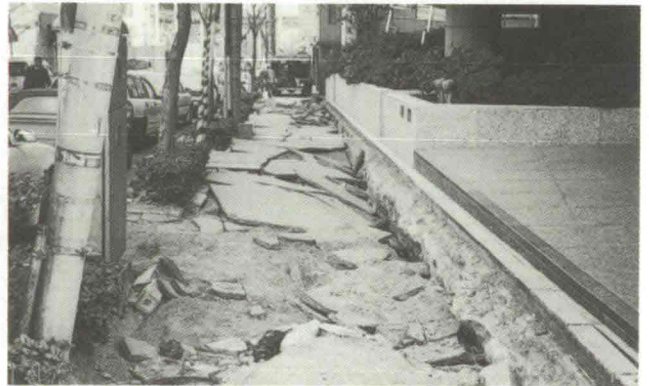
Photo 6 Damage to sidewalk (No. 1)

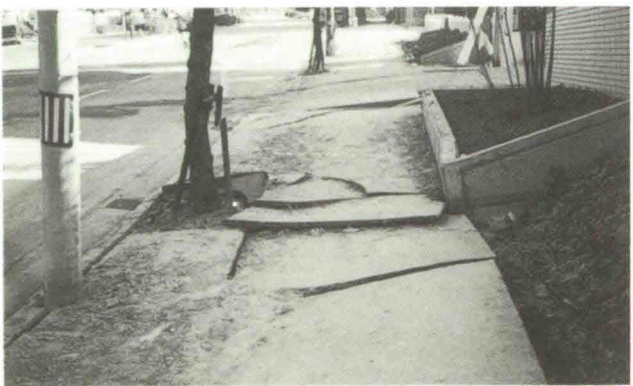
Photo 7 Damage to sidewalk (No. 2)

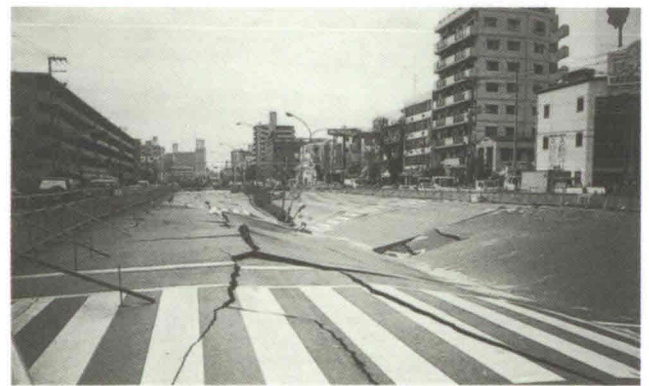
Photo 8 Collapse due to subsidence

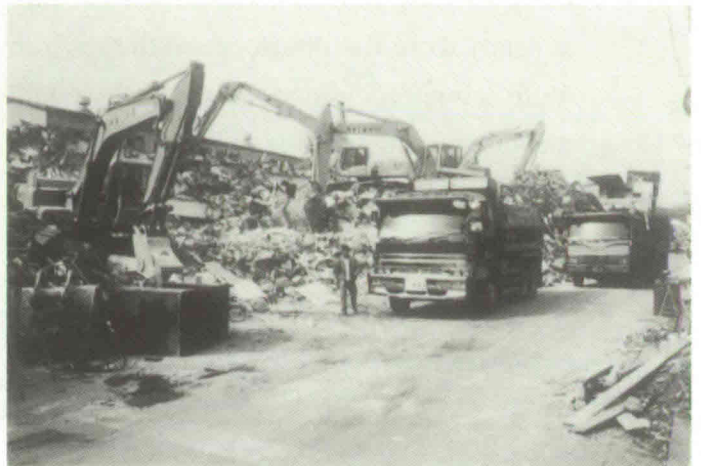
Photo 2 Disaster waste from collapsed buildings (in Nagata Ward, inadequately classified and sprayed with water)

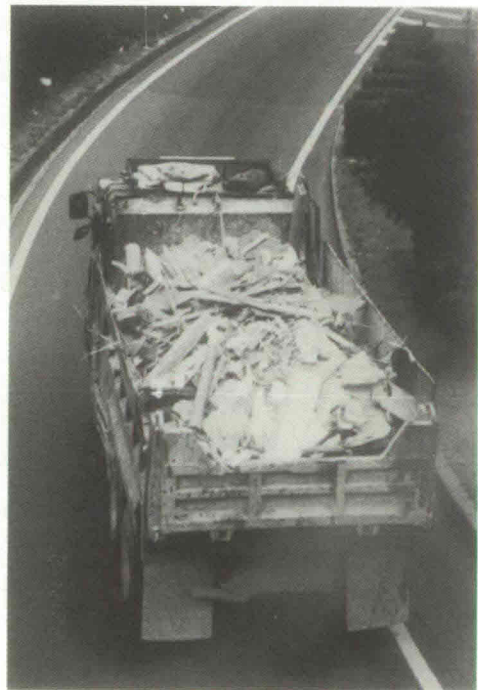
Photo 3 Disaster waste being transported by truck (on Nishi Kobe Toll Road to Fusehata temporary disaster waste disposal site)

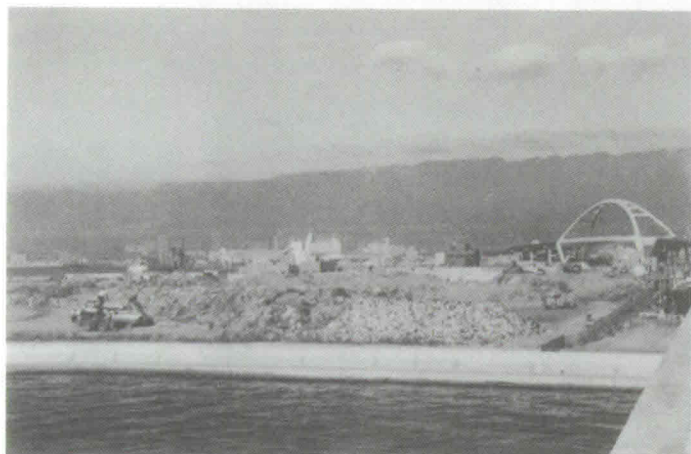
Photo 4 Temporary disaster waste site
(at Koshienhama in Nishinomiya)

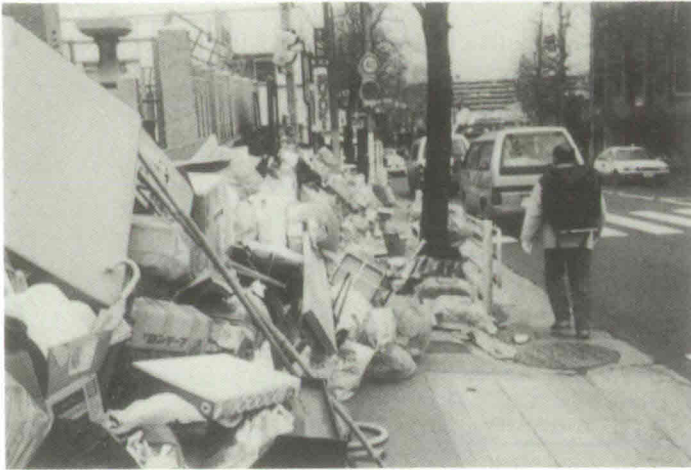
Photo 7 Domestic refuse blocking a sidewalk

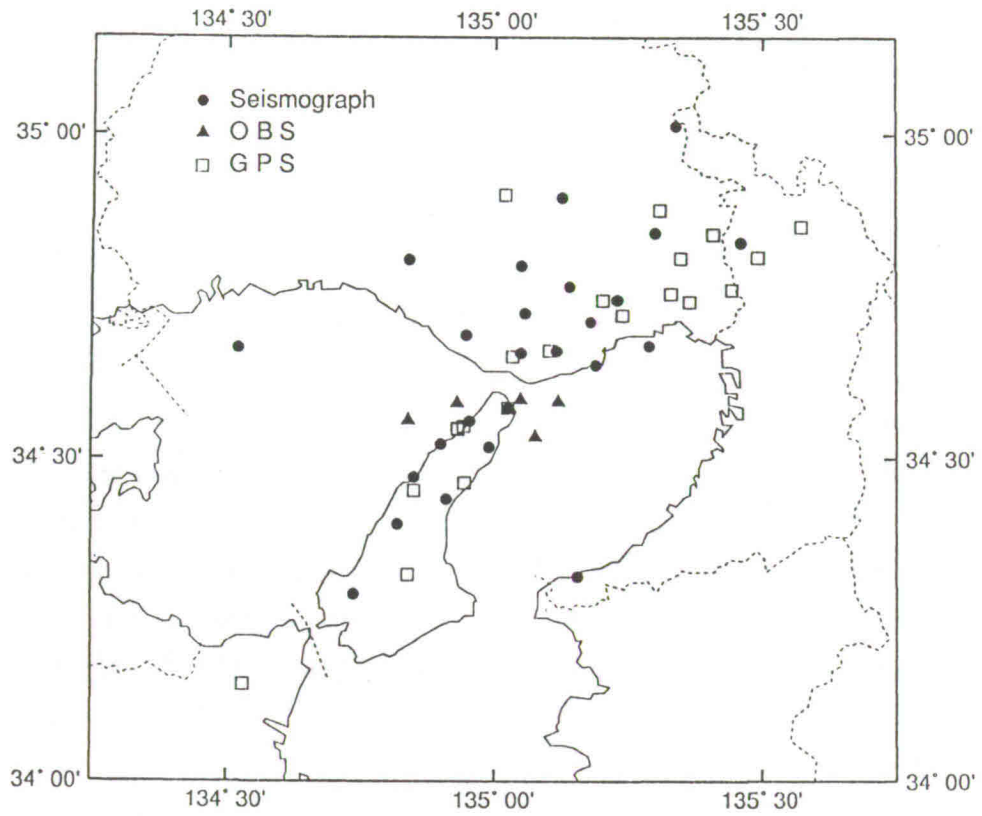
Figure 1 Large-area observation networks after the earthquake
(Maps edited by Prof. Yoshii of the Earthquake Research Institute)

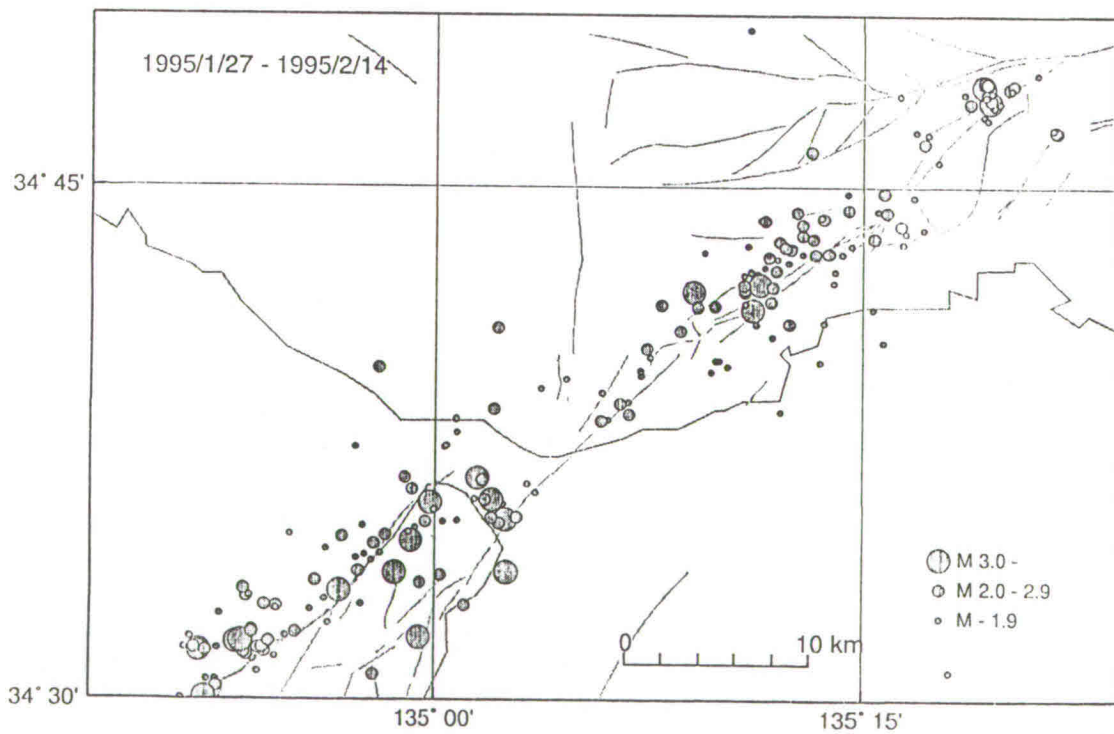
Figure 2 Distribution of aftershocks

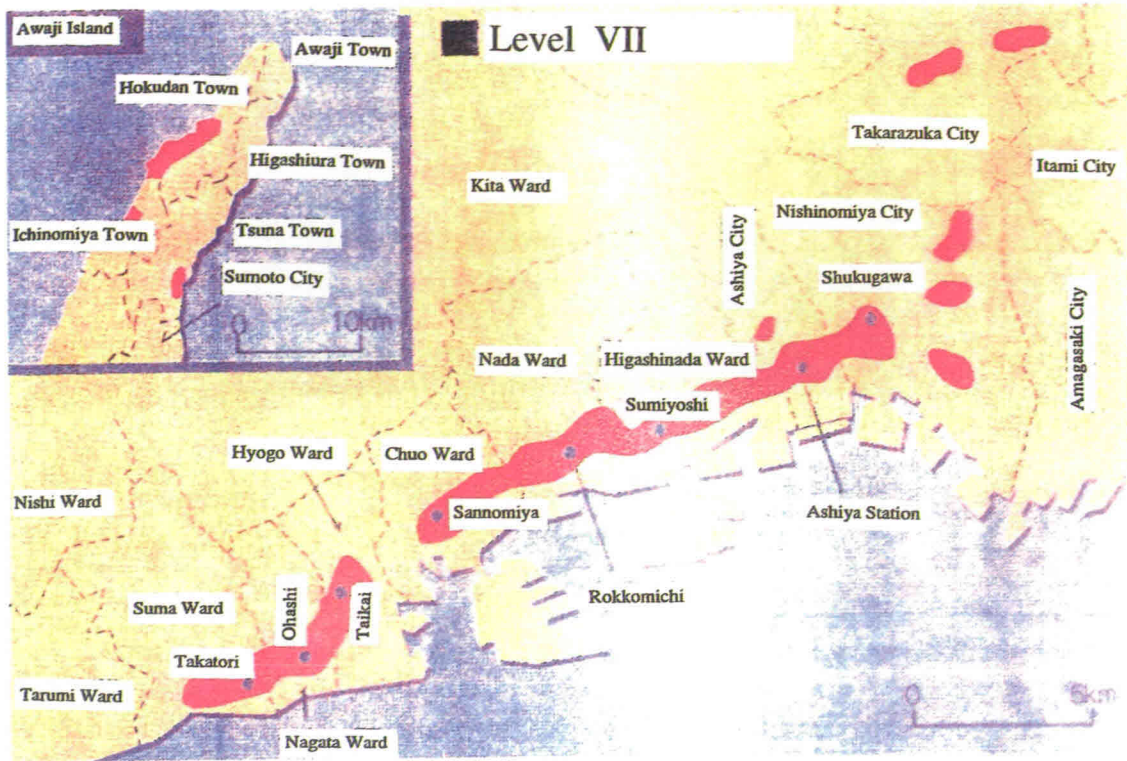
Figure 1.1 Distribution of Areas Subjected to Intensity Level VII

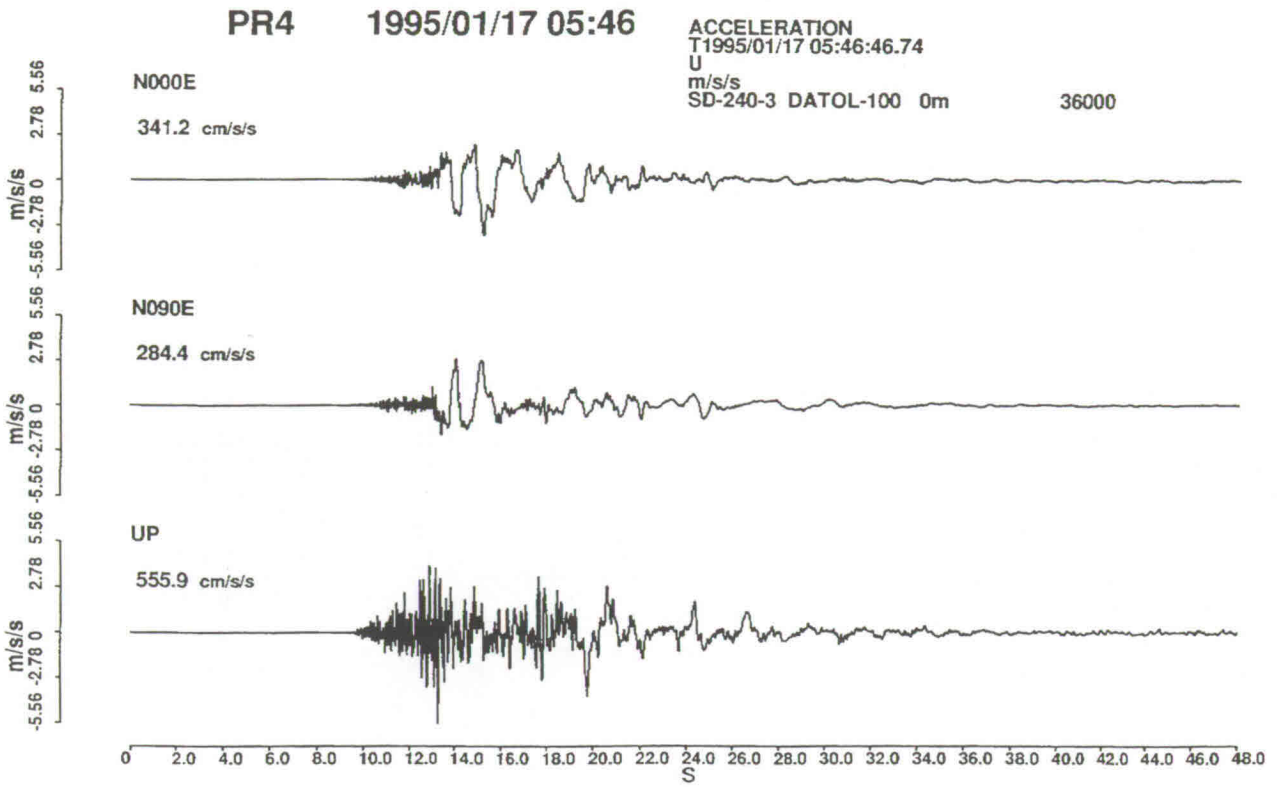
Figure 2.6(a) Wave Forms Observed on Port Island

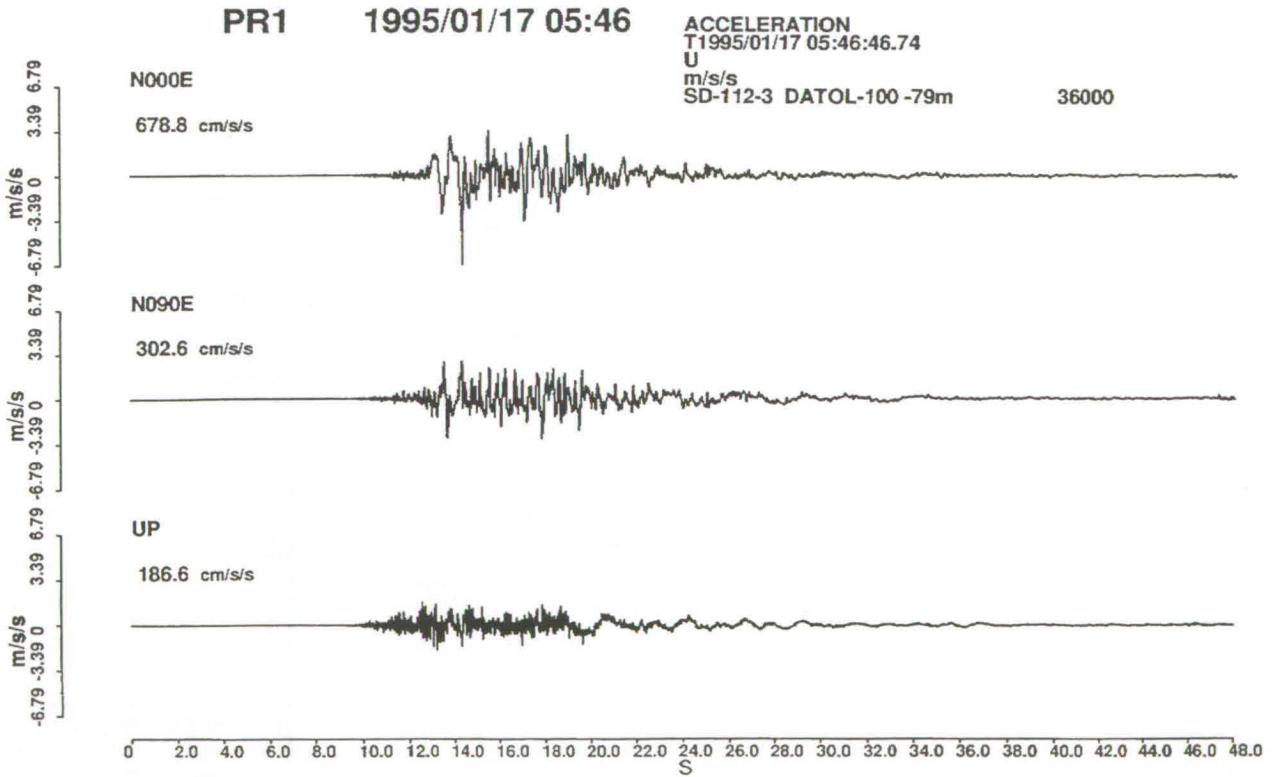
Figure 2.6(b) Wave Forms Observed on Port Island

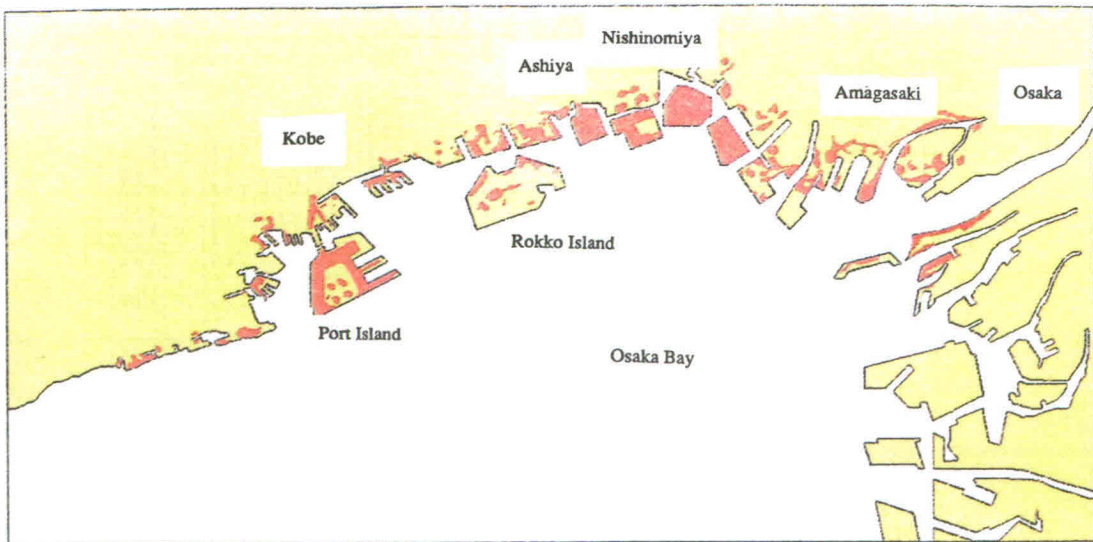
Figure 3.6 Distribution of Liquefaction (Hyogo Prefecture only)
