Preliminary Report on
**THE GREAT
HANSHIN
EARTHQUAKE**

January 17, 1995

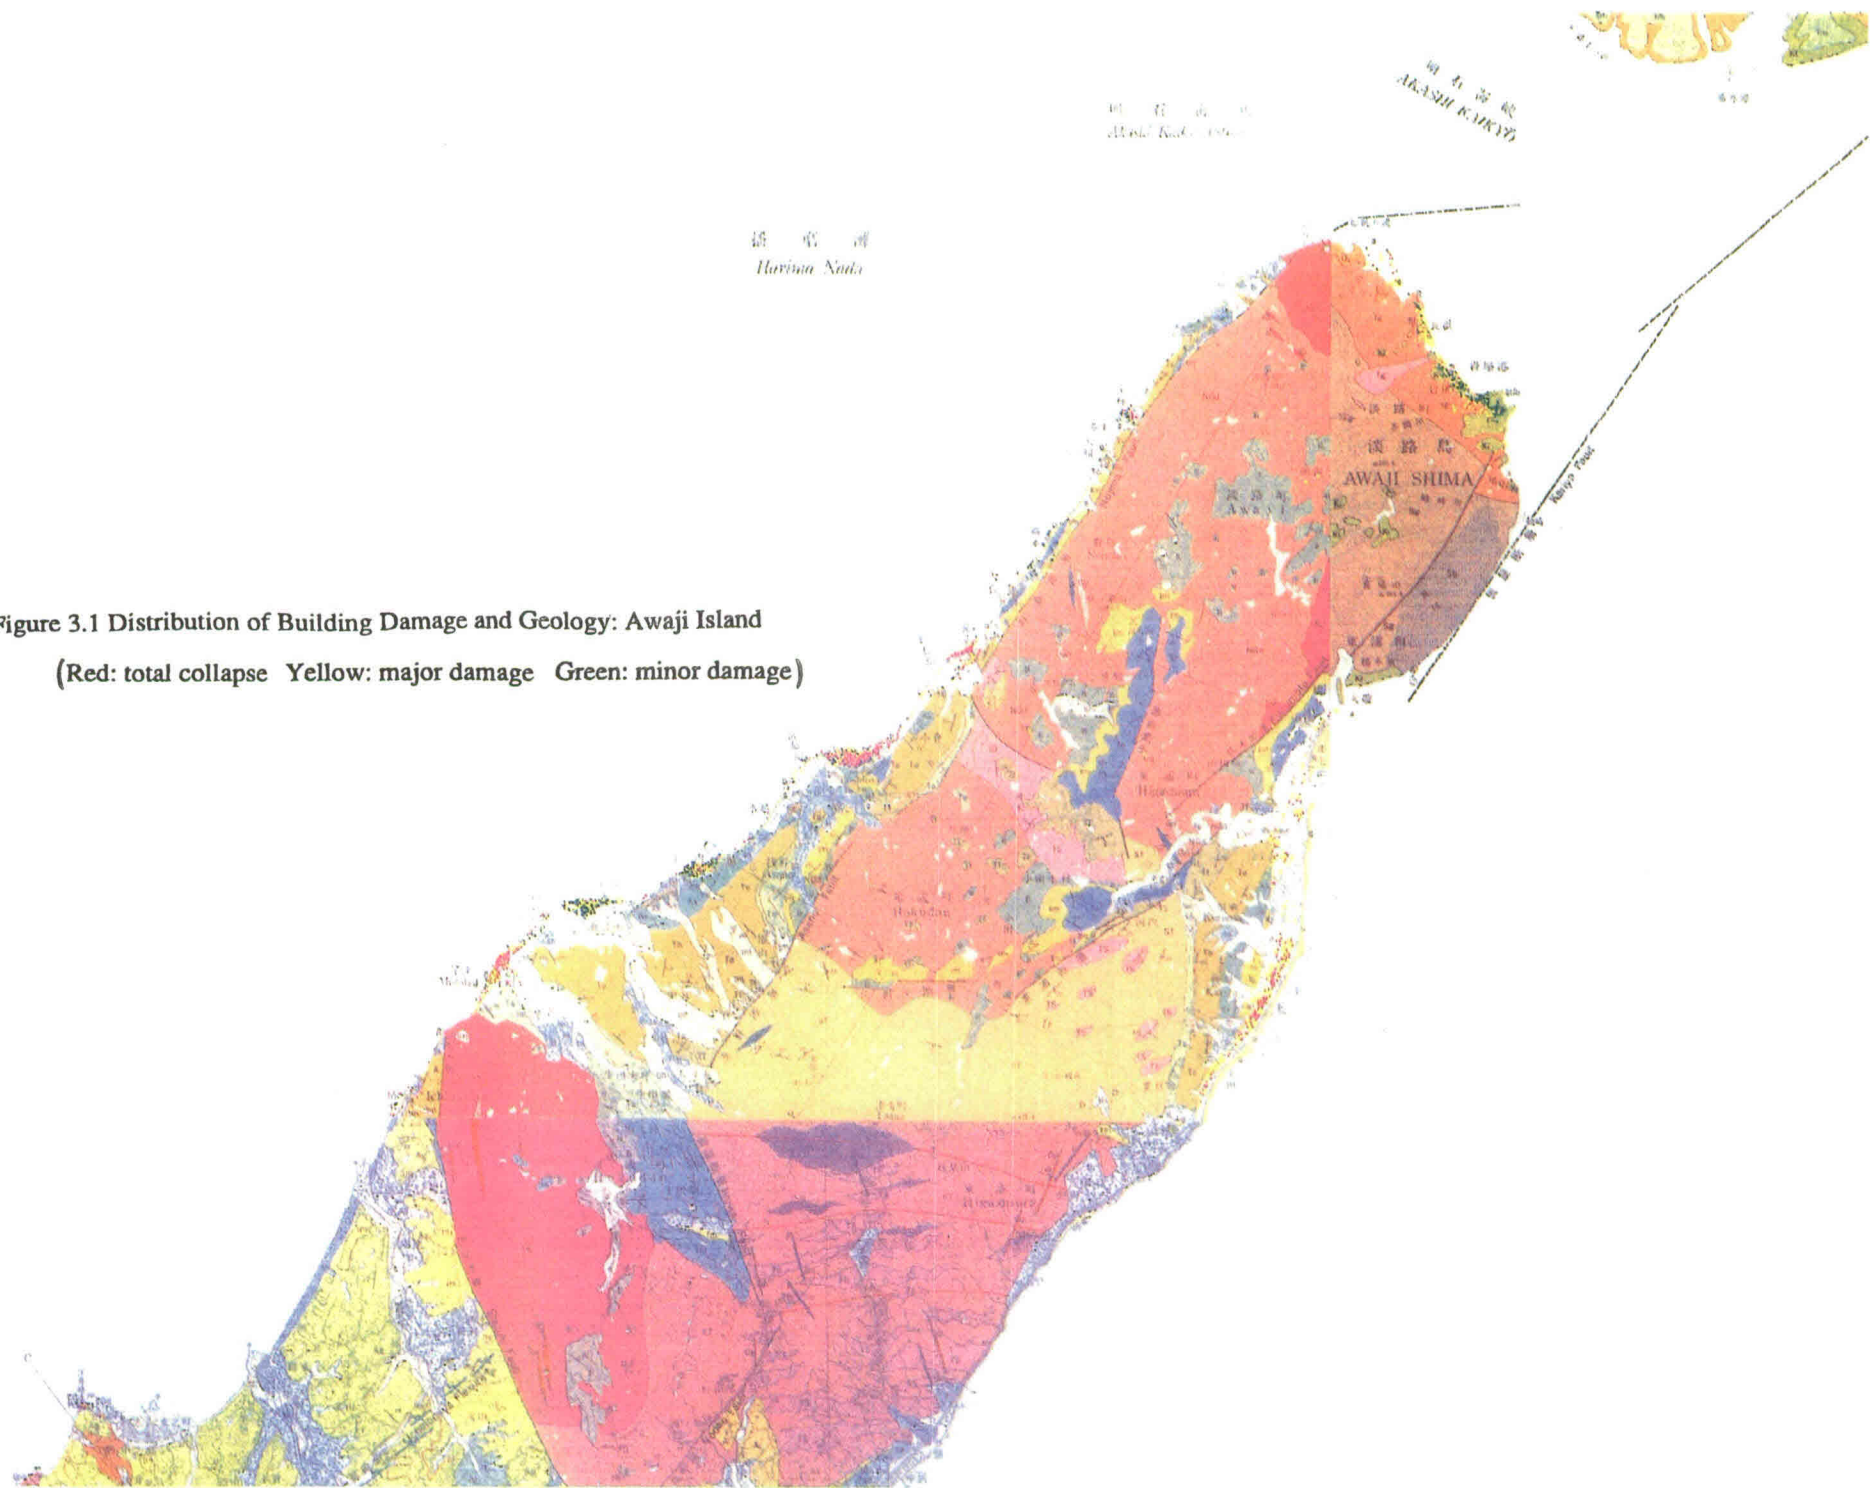
Figure 3.1 Distribution of Building Damage and Geology: Awaji Island
(Red: total collapse Yellow: major damage Green: minor damage)

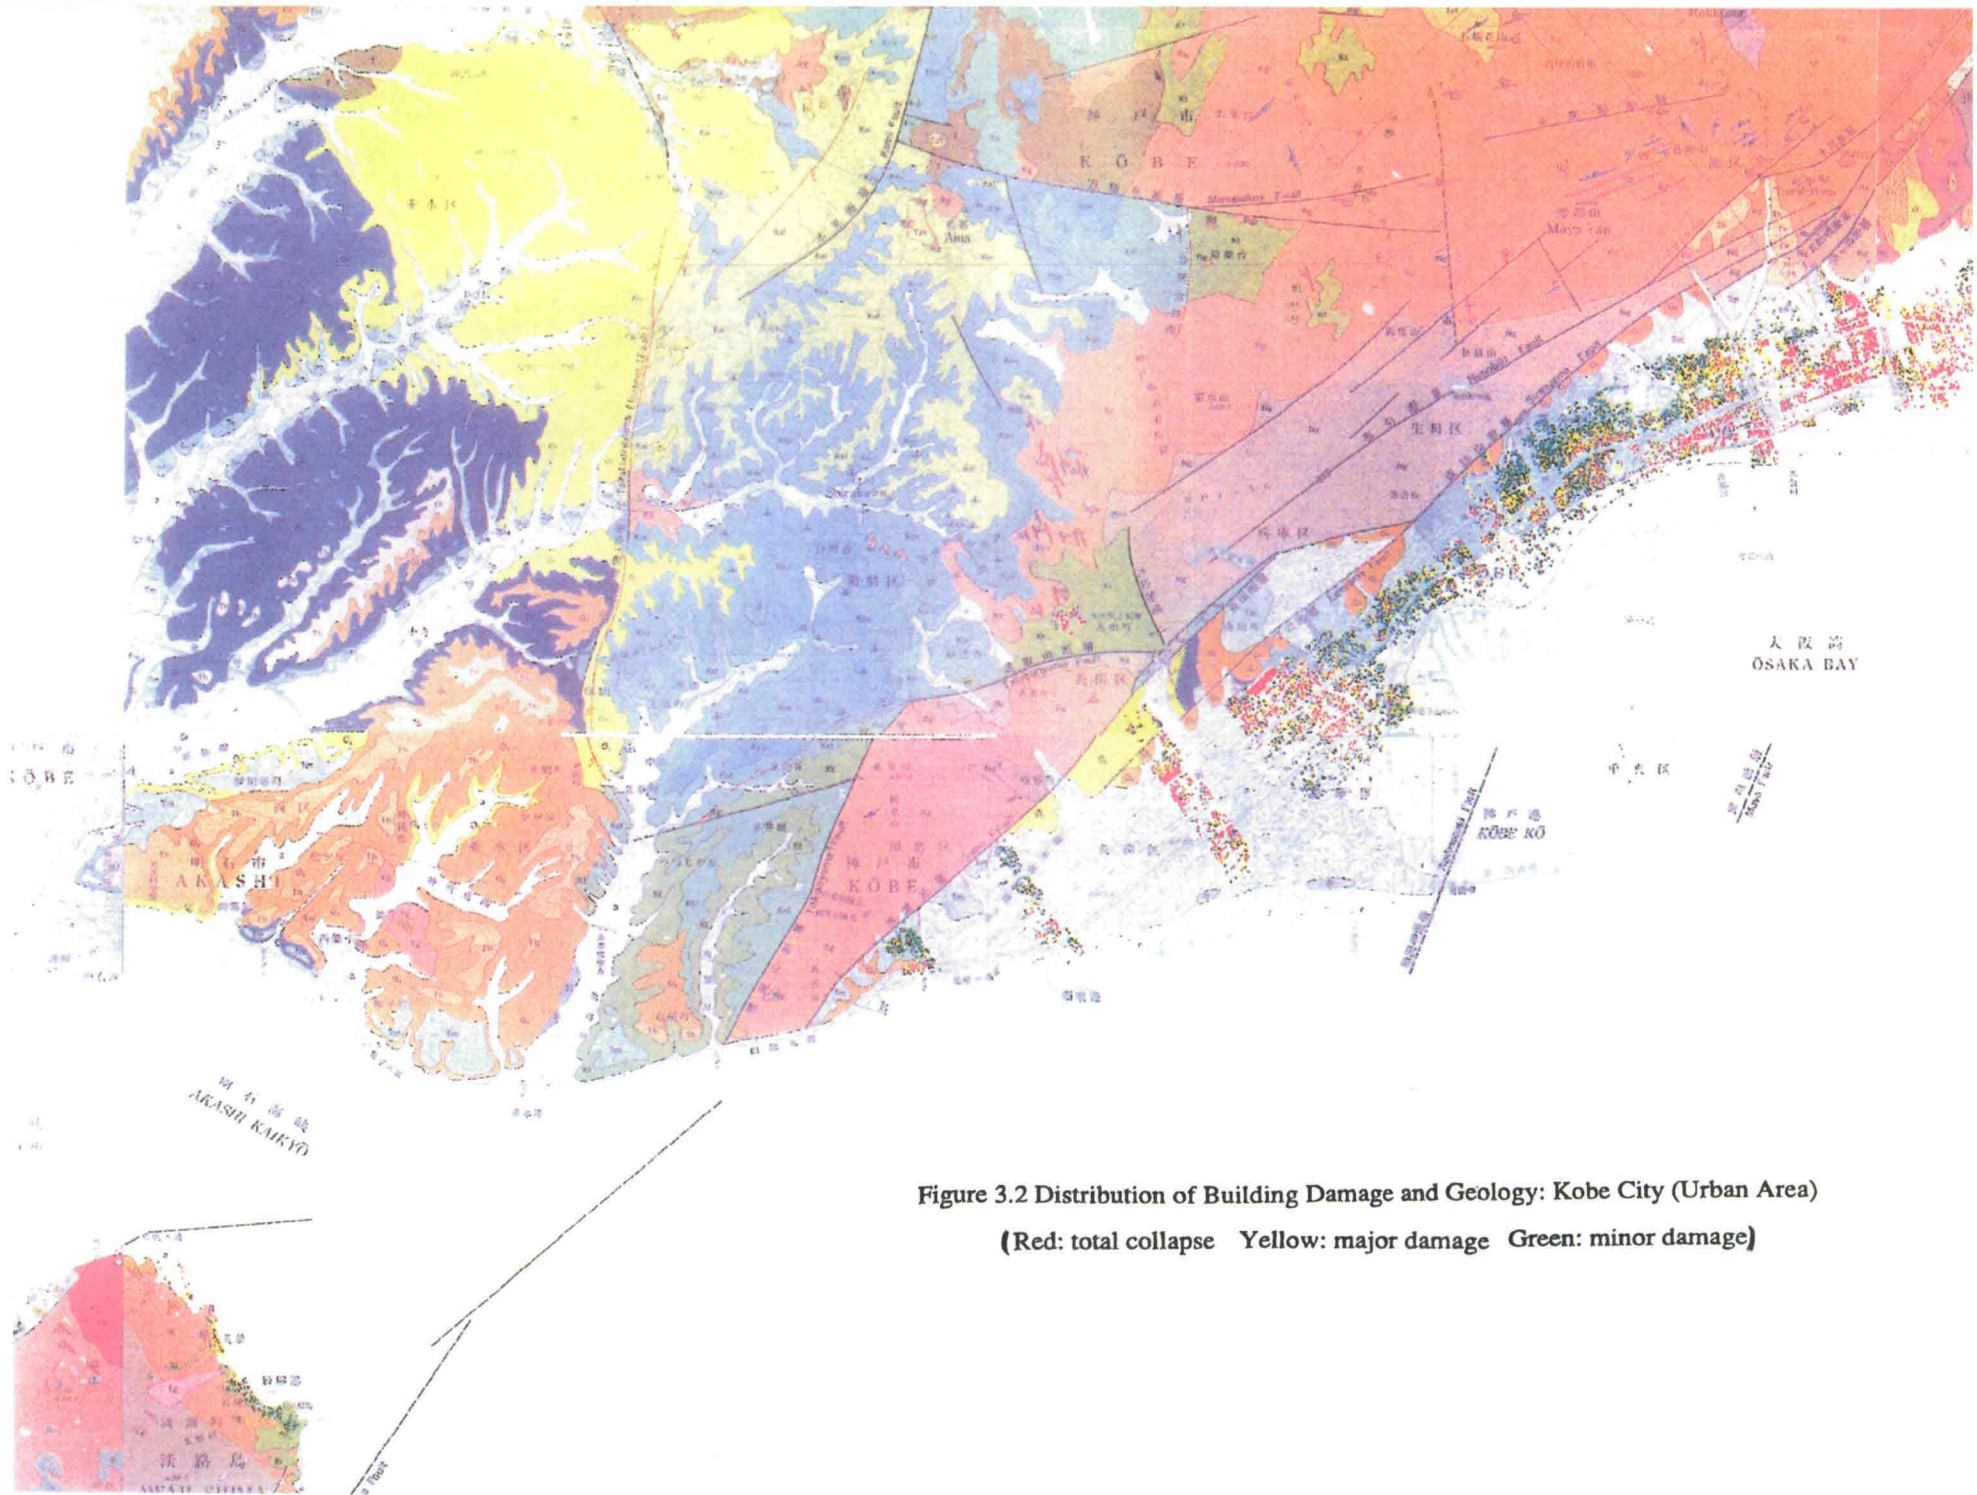
Figure 3.2 Distribution of Building Damage and Geology: Kobe City (Urban Area)
(Red: total collapse Yellow: major damage Green: minor damage)

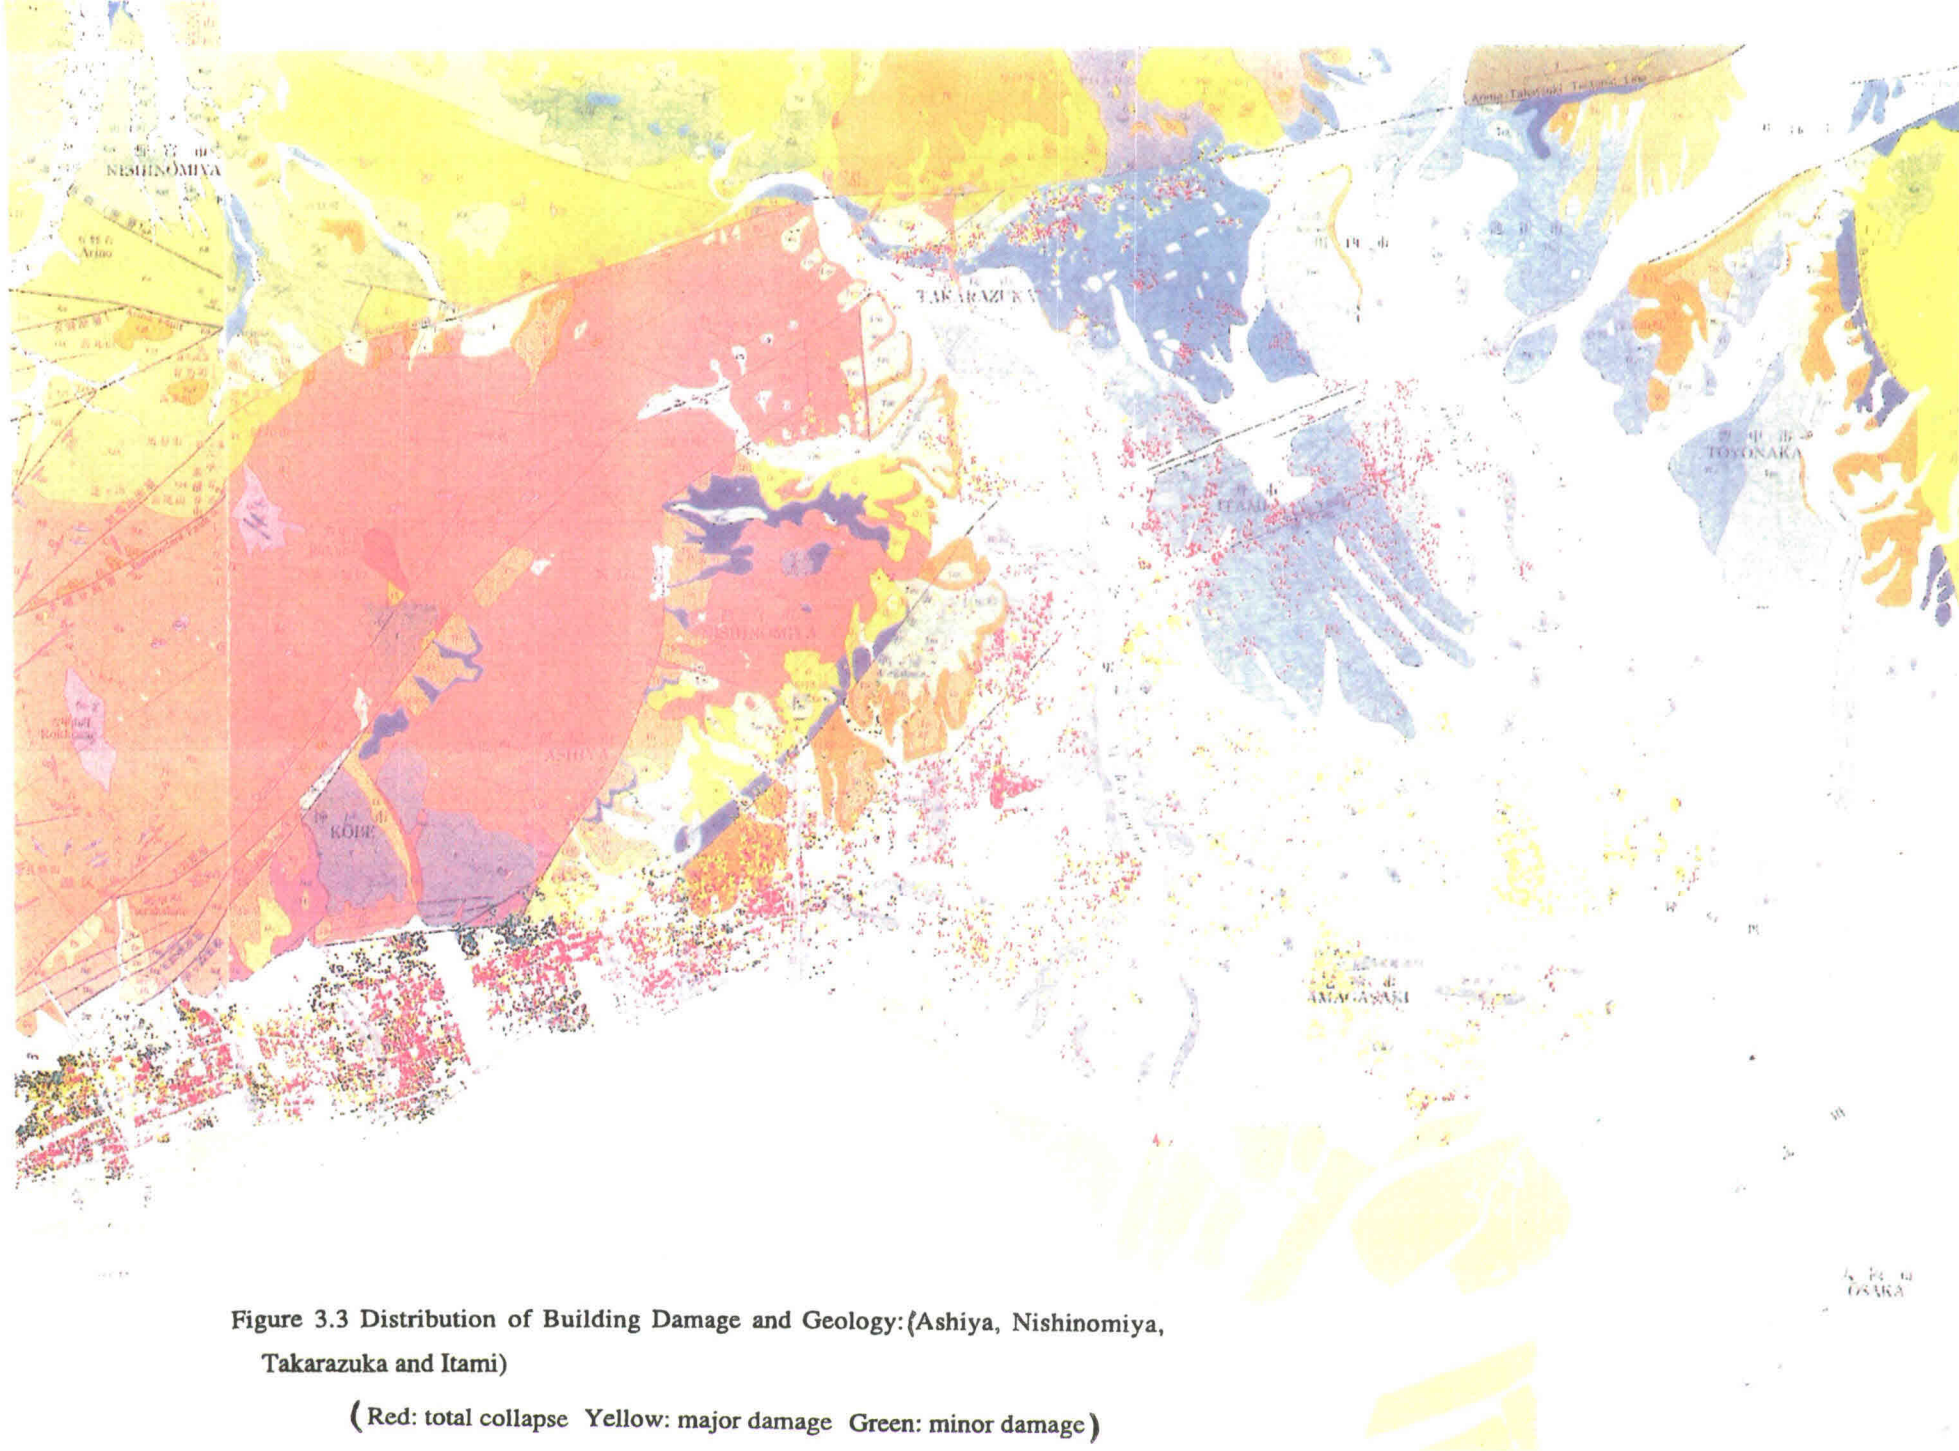
Figure 3.3 Distribution of Building Damage and Geology:(Ashiya, Nishinomiya, Takarazuka and Itami)

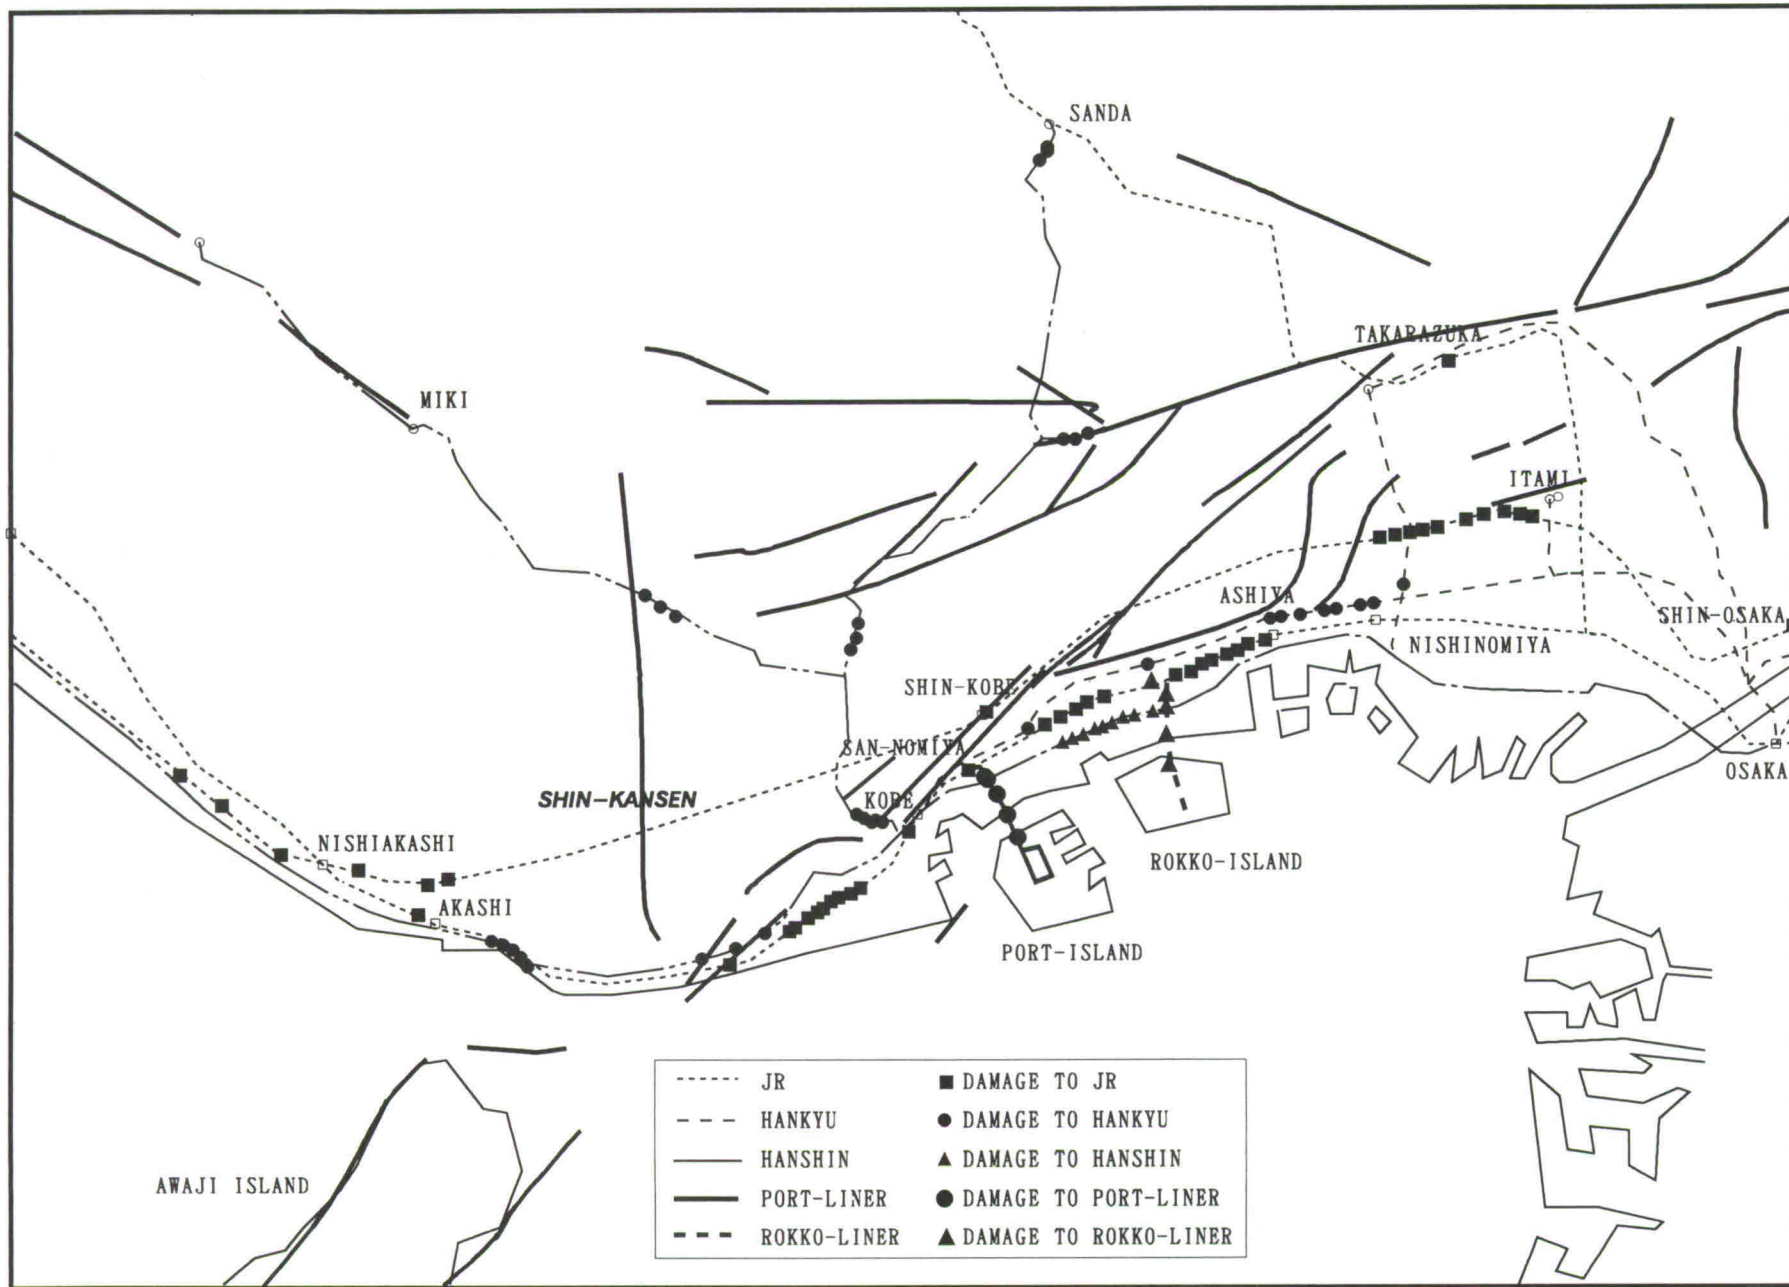
Figure 3.4 Damage to Railway Facilities and Fault Locations

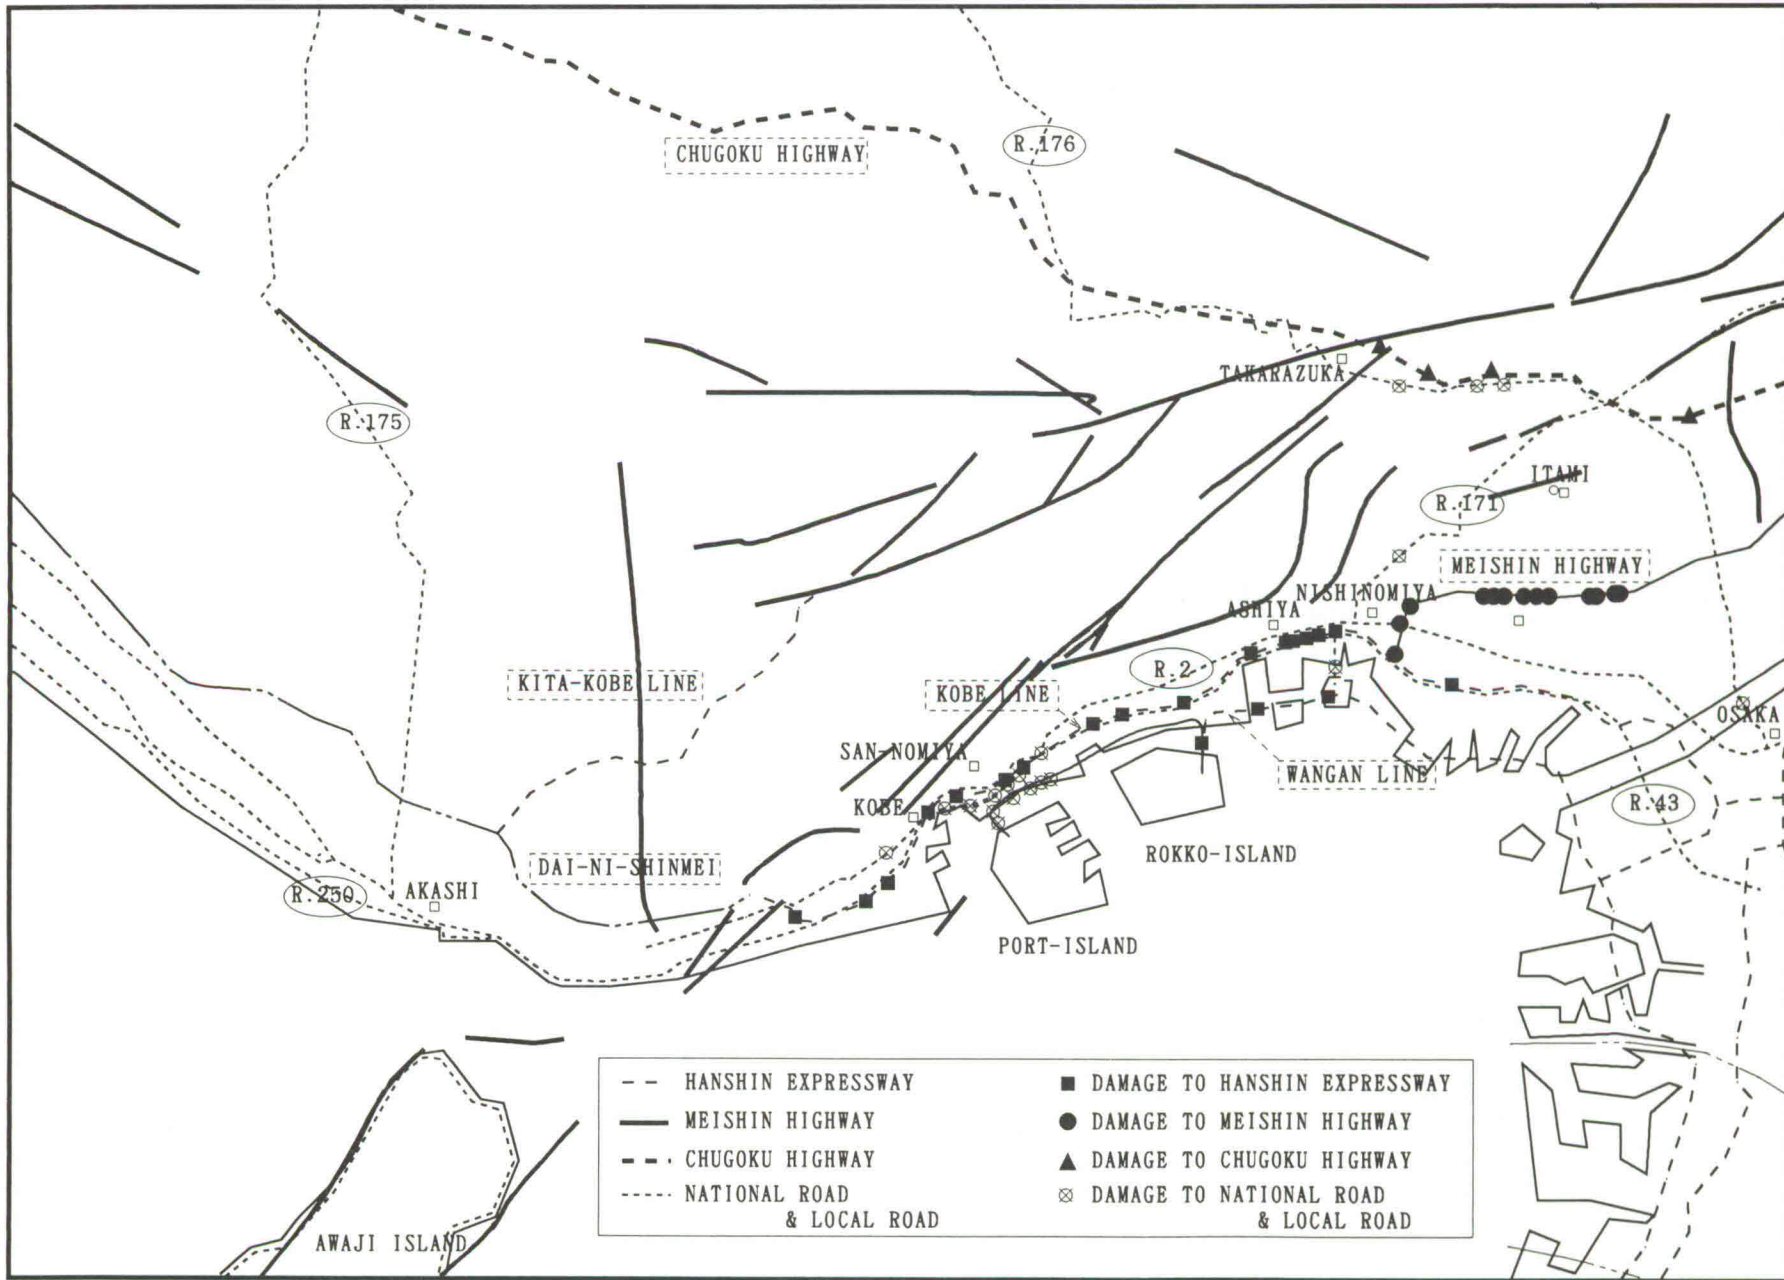
Figure 3.5 Damage to Roads and Bridges and Fault Locations

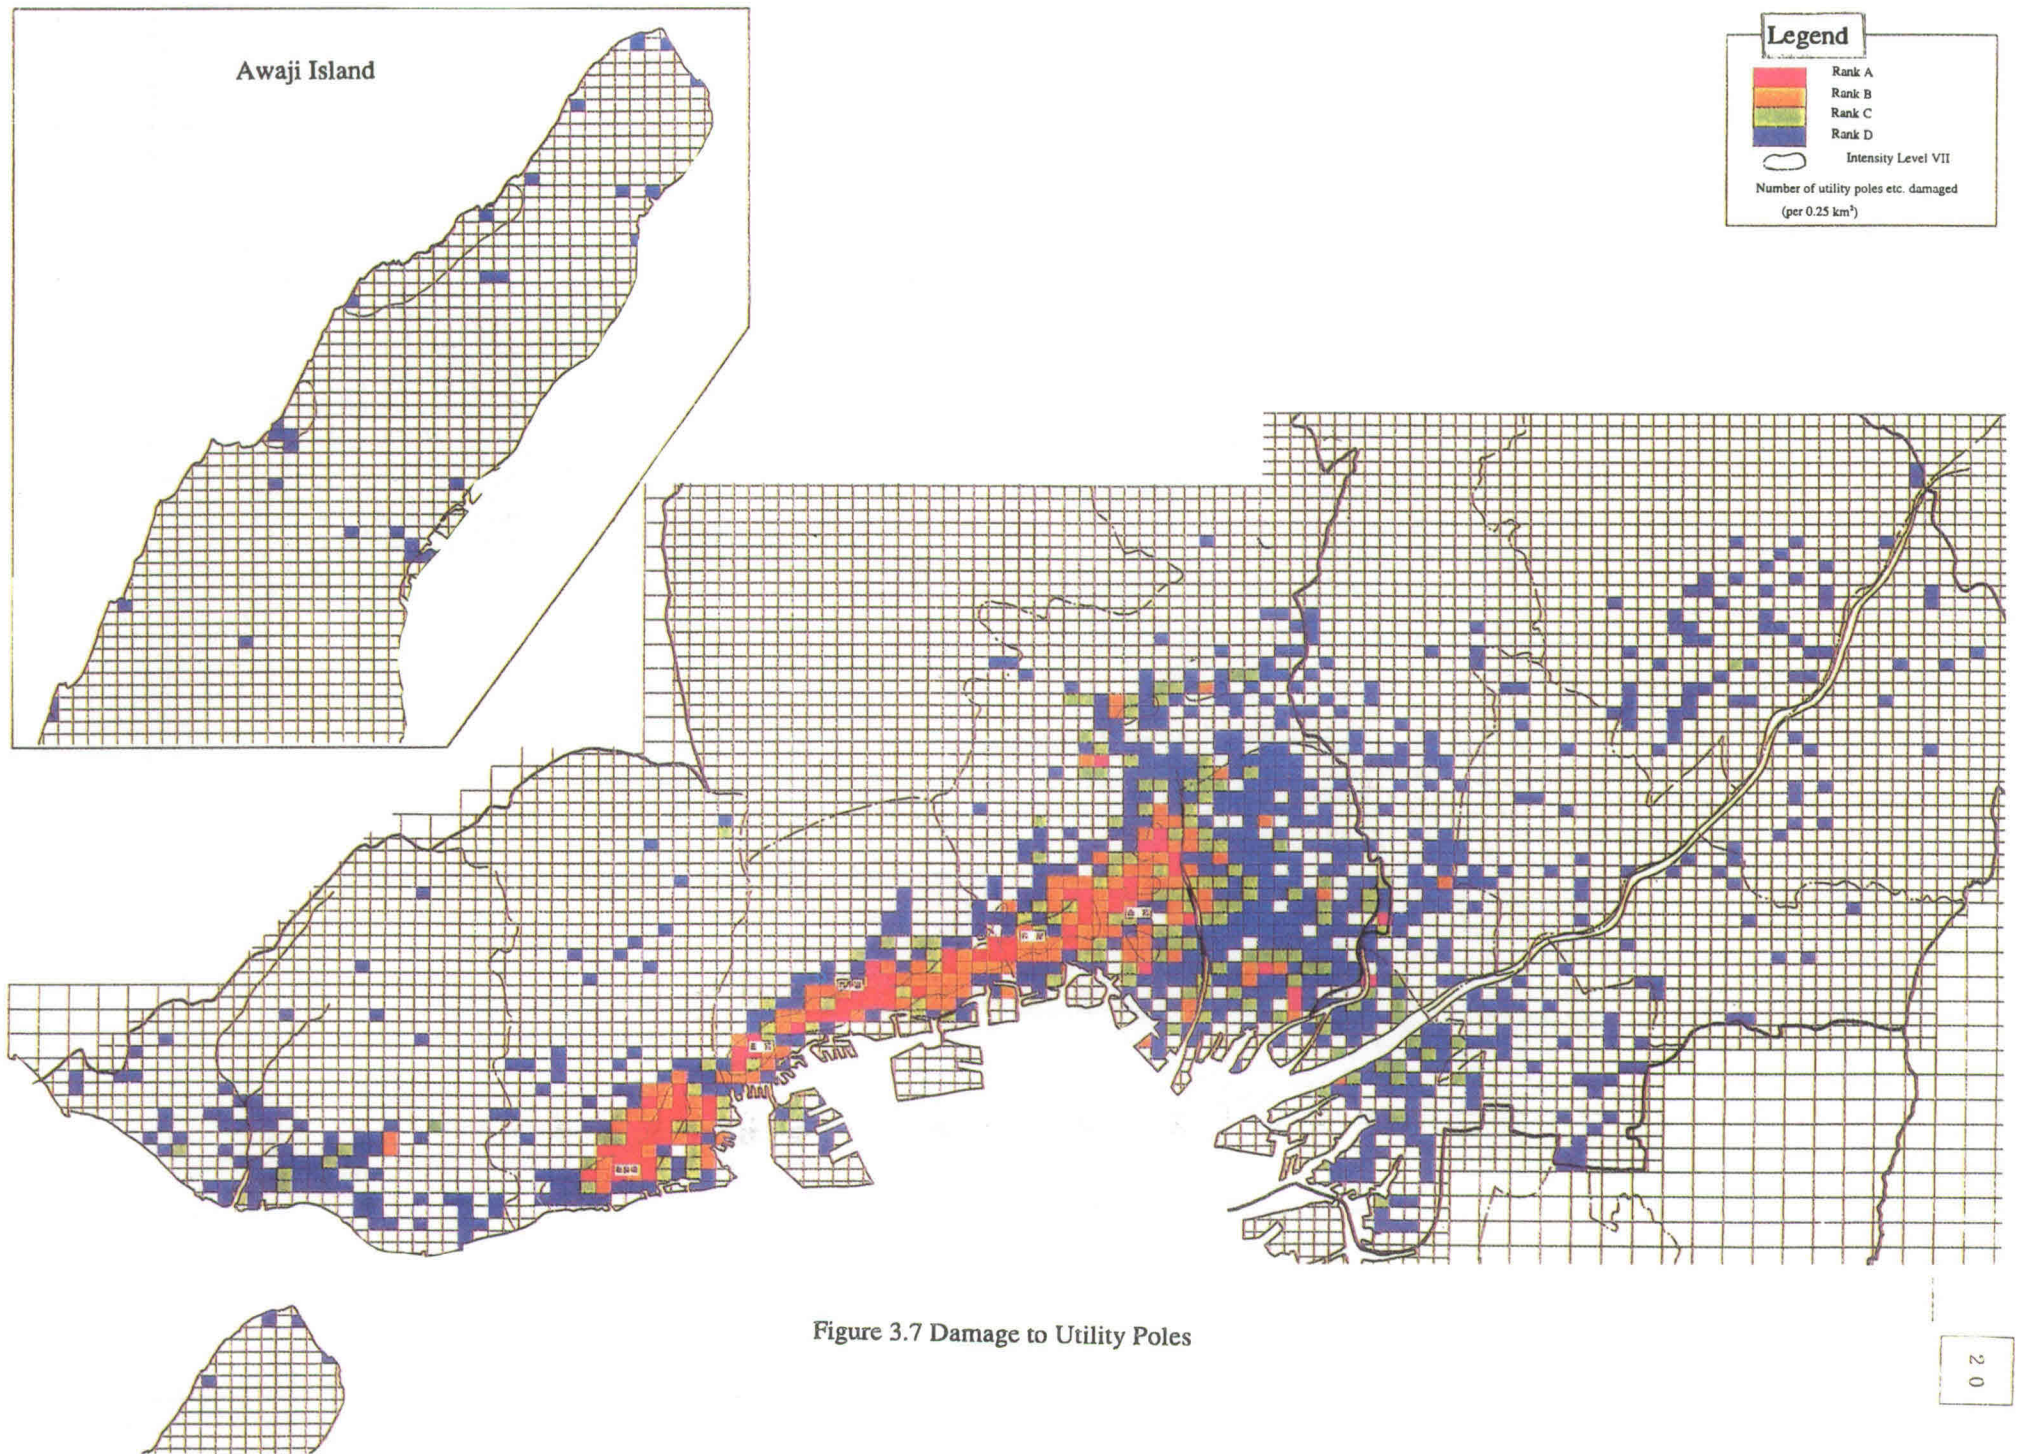
Group Report: Roads and Railways I

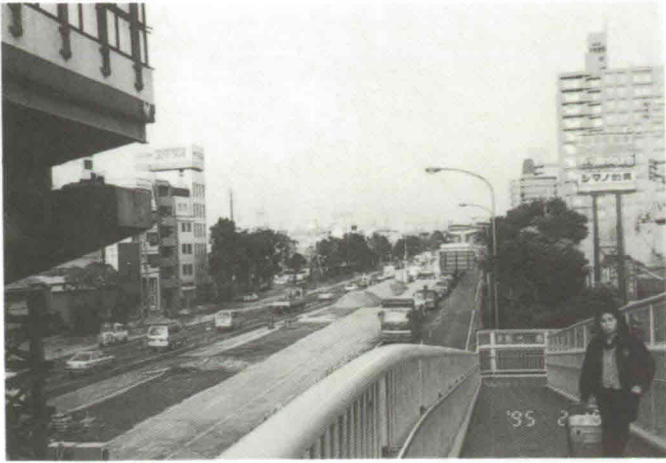
Photograph 1 National Highway Route 43 (Near Fukae)

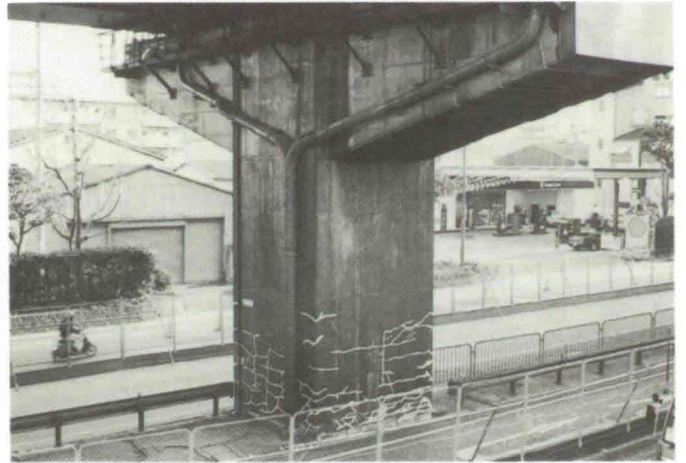
Photograph 2 Concrete viaduct pier repaired by resin injection

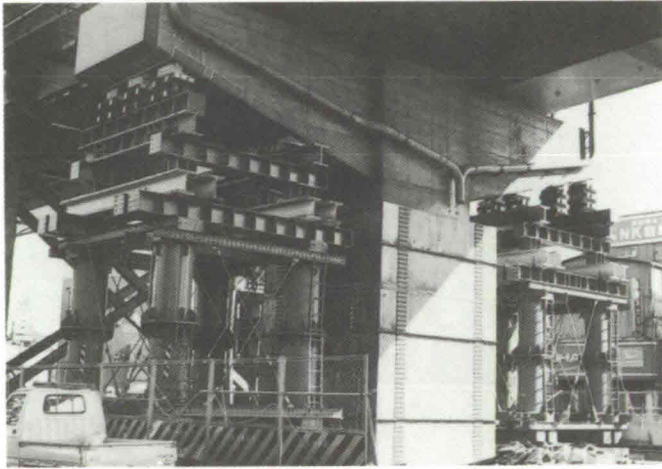
Photograph 3 Concrete viaduct pier under repair

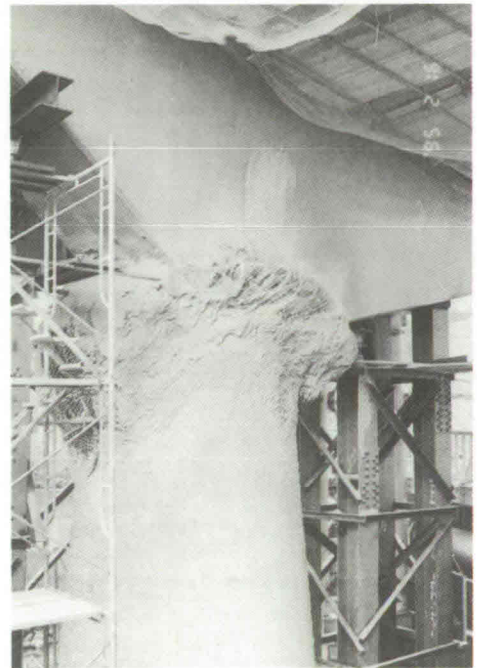
Photograph 4 Mortar spraying on concrete viaduct pier

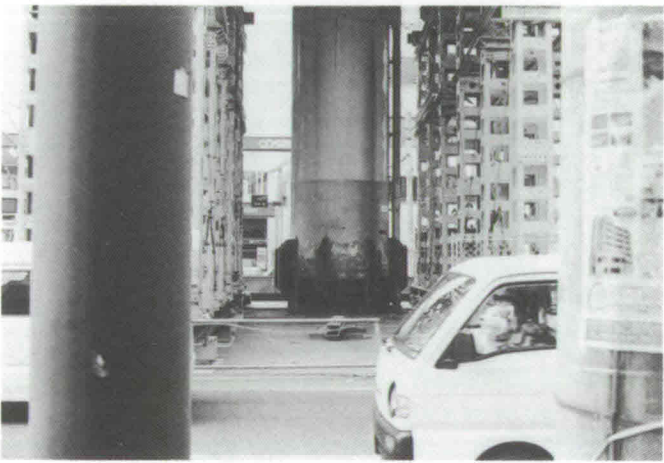
Photograph 7 Steel viaduct pier under repair

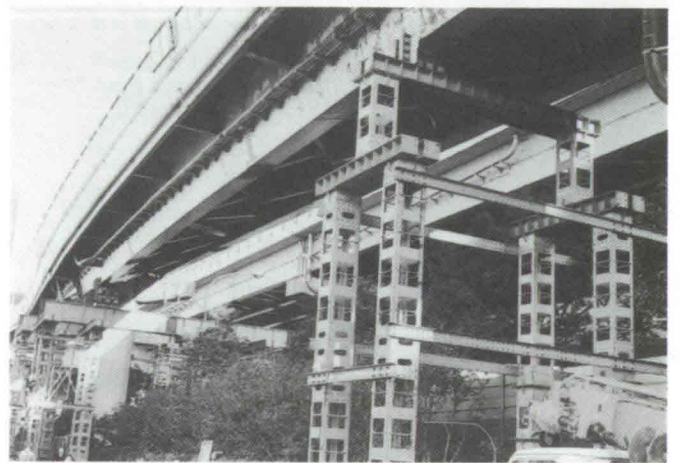
Photograph 8 Prevention of superstructure fall-off (1)

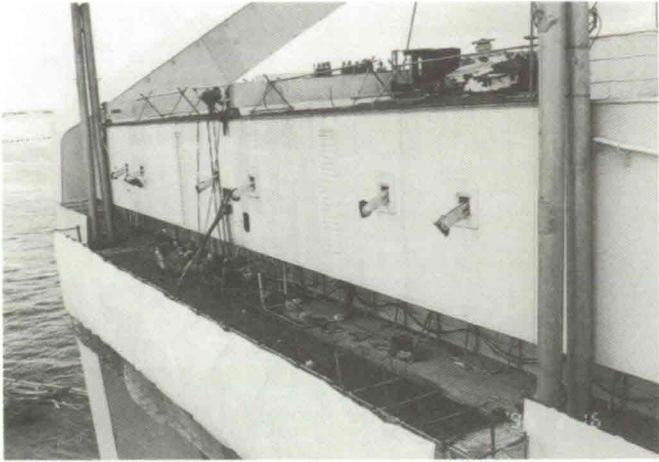
Photograph 11 Repair work on side span of Nishinomiya Port Bridge

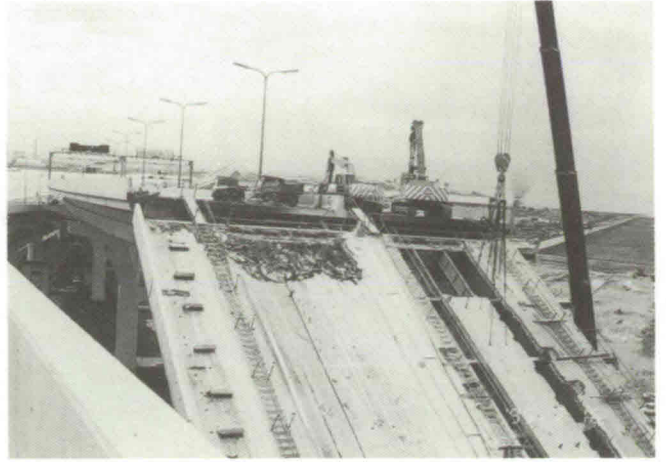
Photograph 12 Removal of floor slabs on side span of Nishinomiya Port Bridge

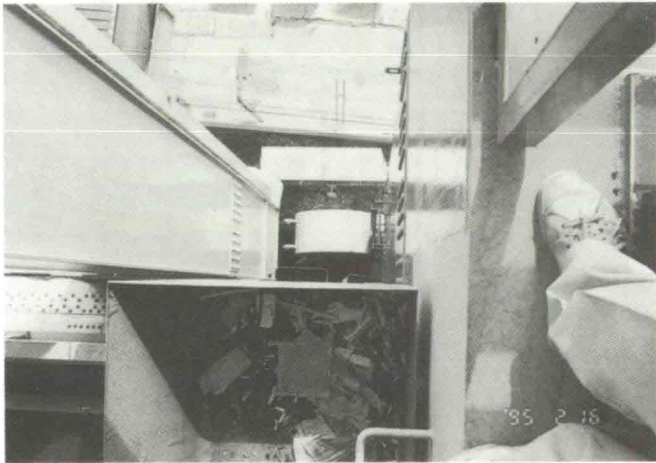
Photograph 13 Damage to a bearing on Higashi-Kobe Bridge

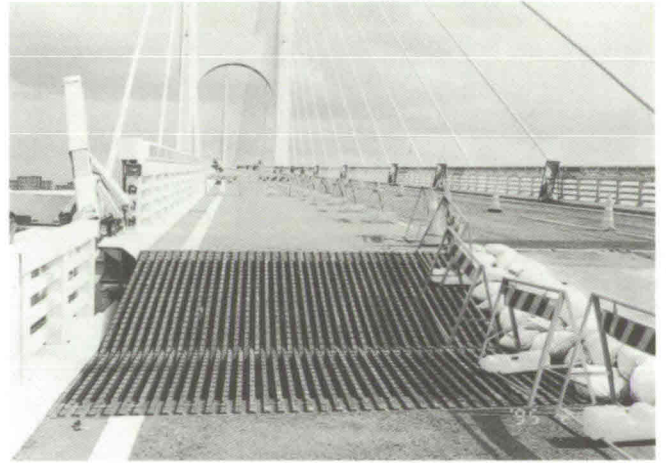
Photograph 14 Drop on the road surface on Higashi-Kobe Bridge

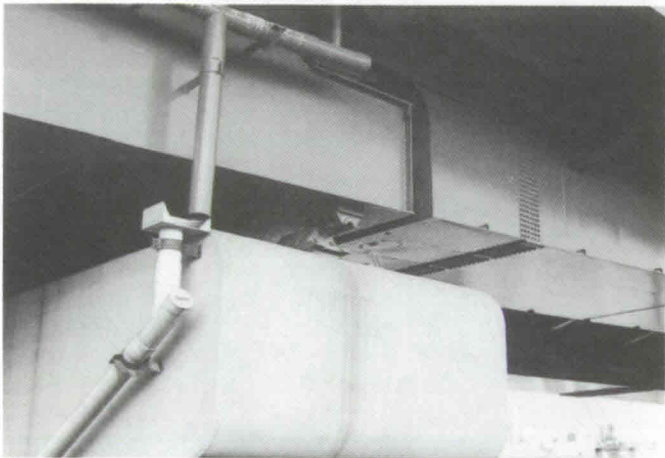
Photograph 19 Damage to a bearing on Second Maya Bridge

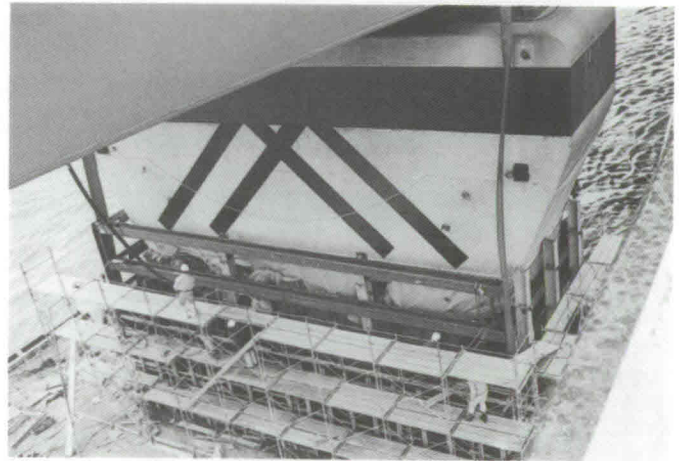
Photograph 20 Pier under repair on Second Maya Bridge

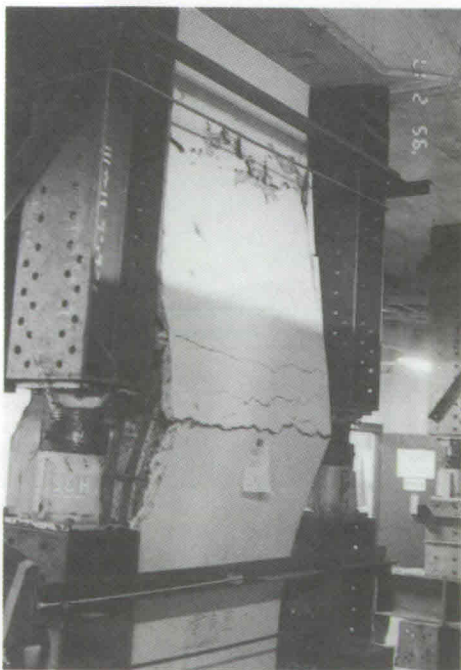
Photograph 21 Middle columns at Kamisawa Station, Kobe Municipal Subway

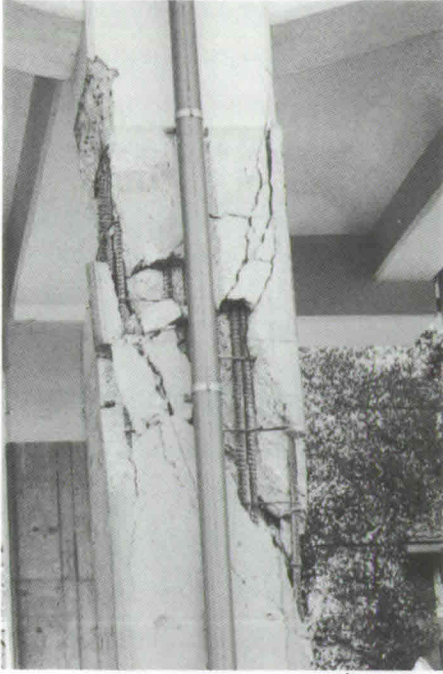
Photograph 1 The column has undergone shear failure along a plane whose orientation is indicated by the arrow.

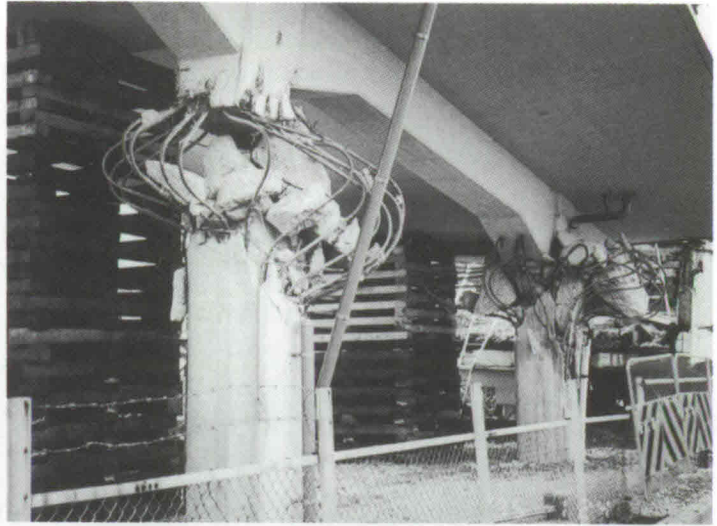
Photograph 2 The column has collapsed as a result of the progress of the condition shown in Photograph 1

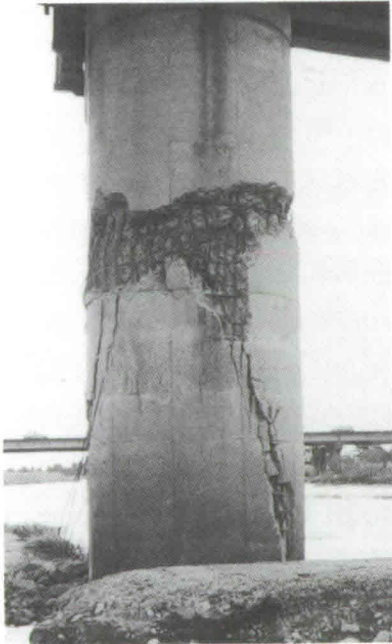
Photograph 3 The pier has undergone shear failure along planes whose orientation is indicated by the arrows.

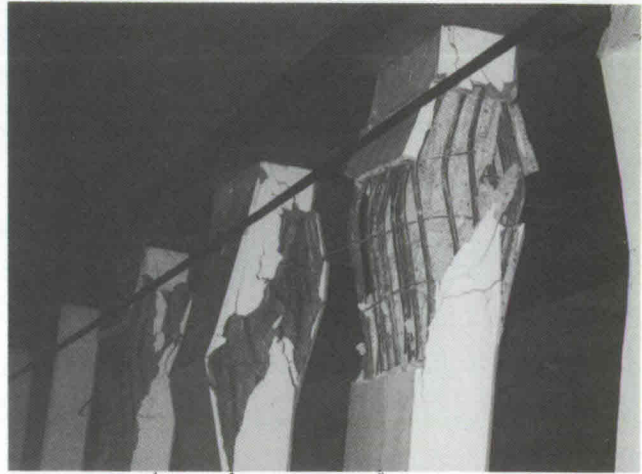
Photograph 4 These columns have undergone shear failure along planes whose orientation is indicated by the arrows.

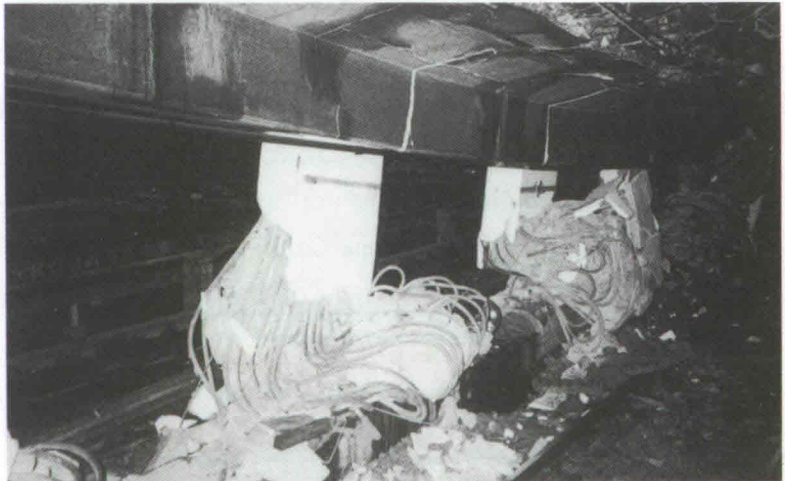
Photograph 5 The columns have collapsed as a result of the progress of the condition shown in Photograph 4

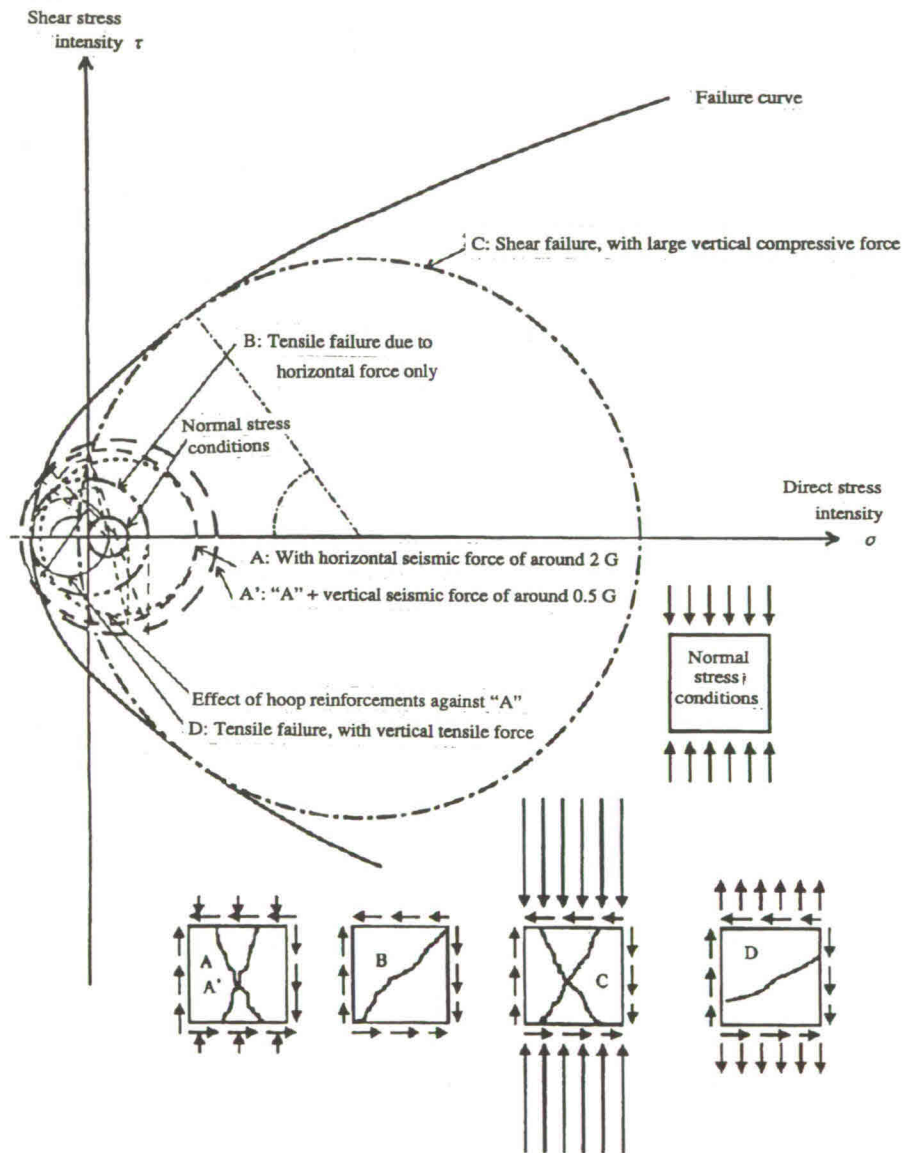
Figure 1 Mechanism of Shear Failure of Concrete (Conceptual Drawing)
