Preliminary Report on
**THE GREAT
HANSHIN
EARTHQUAKE**

January 17, 1995

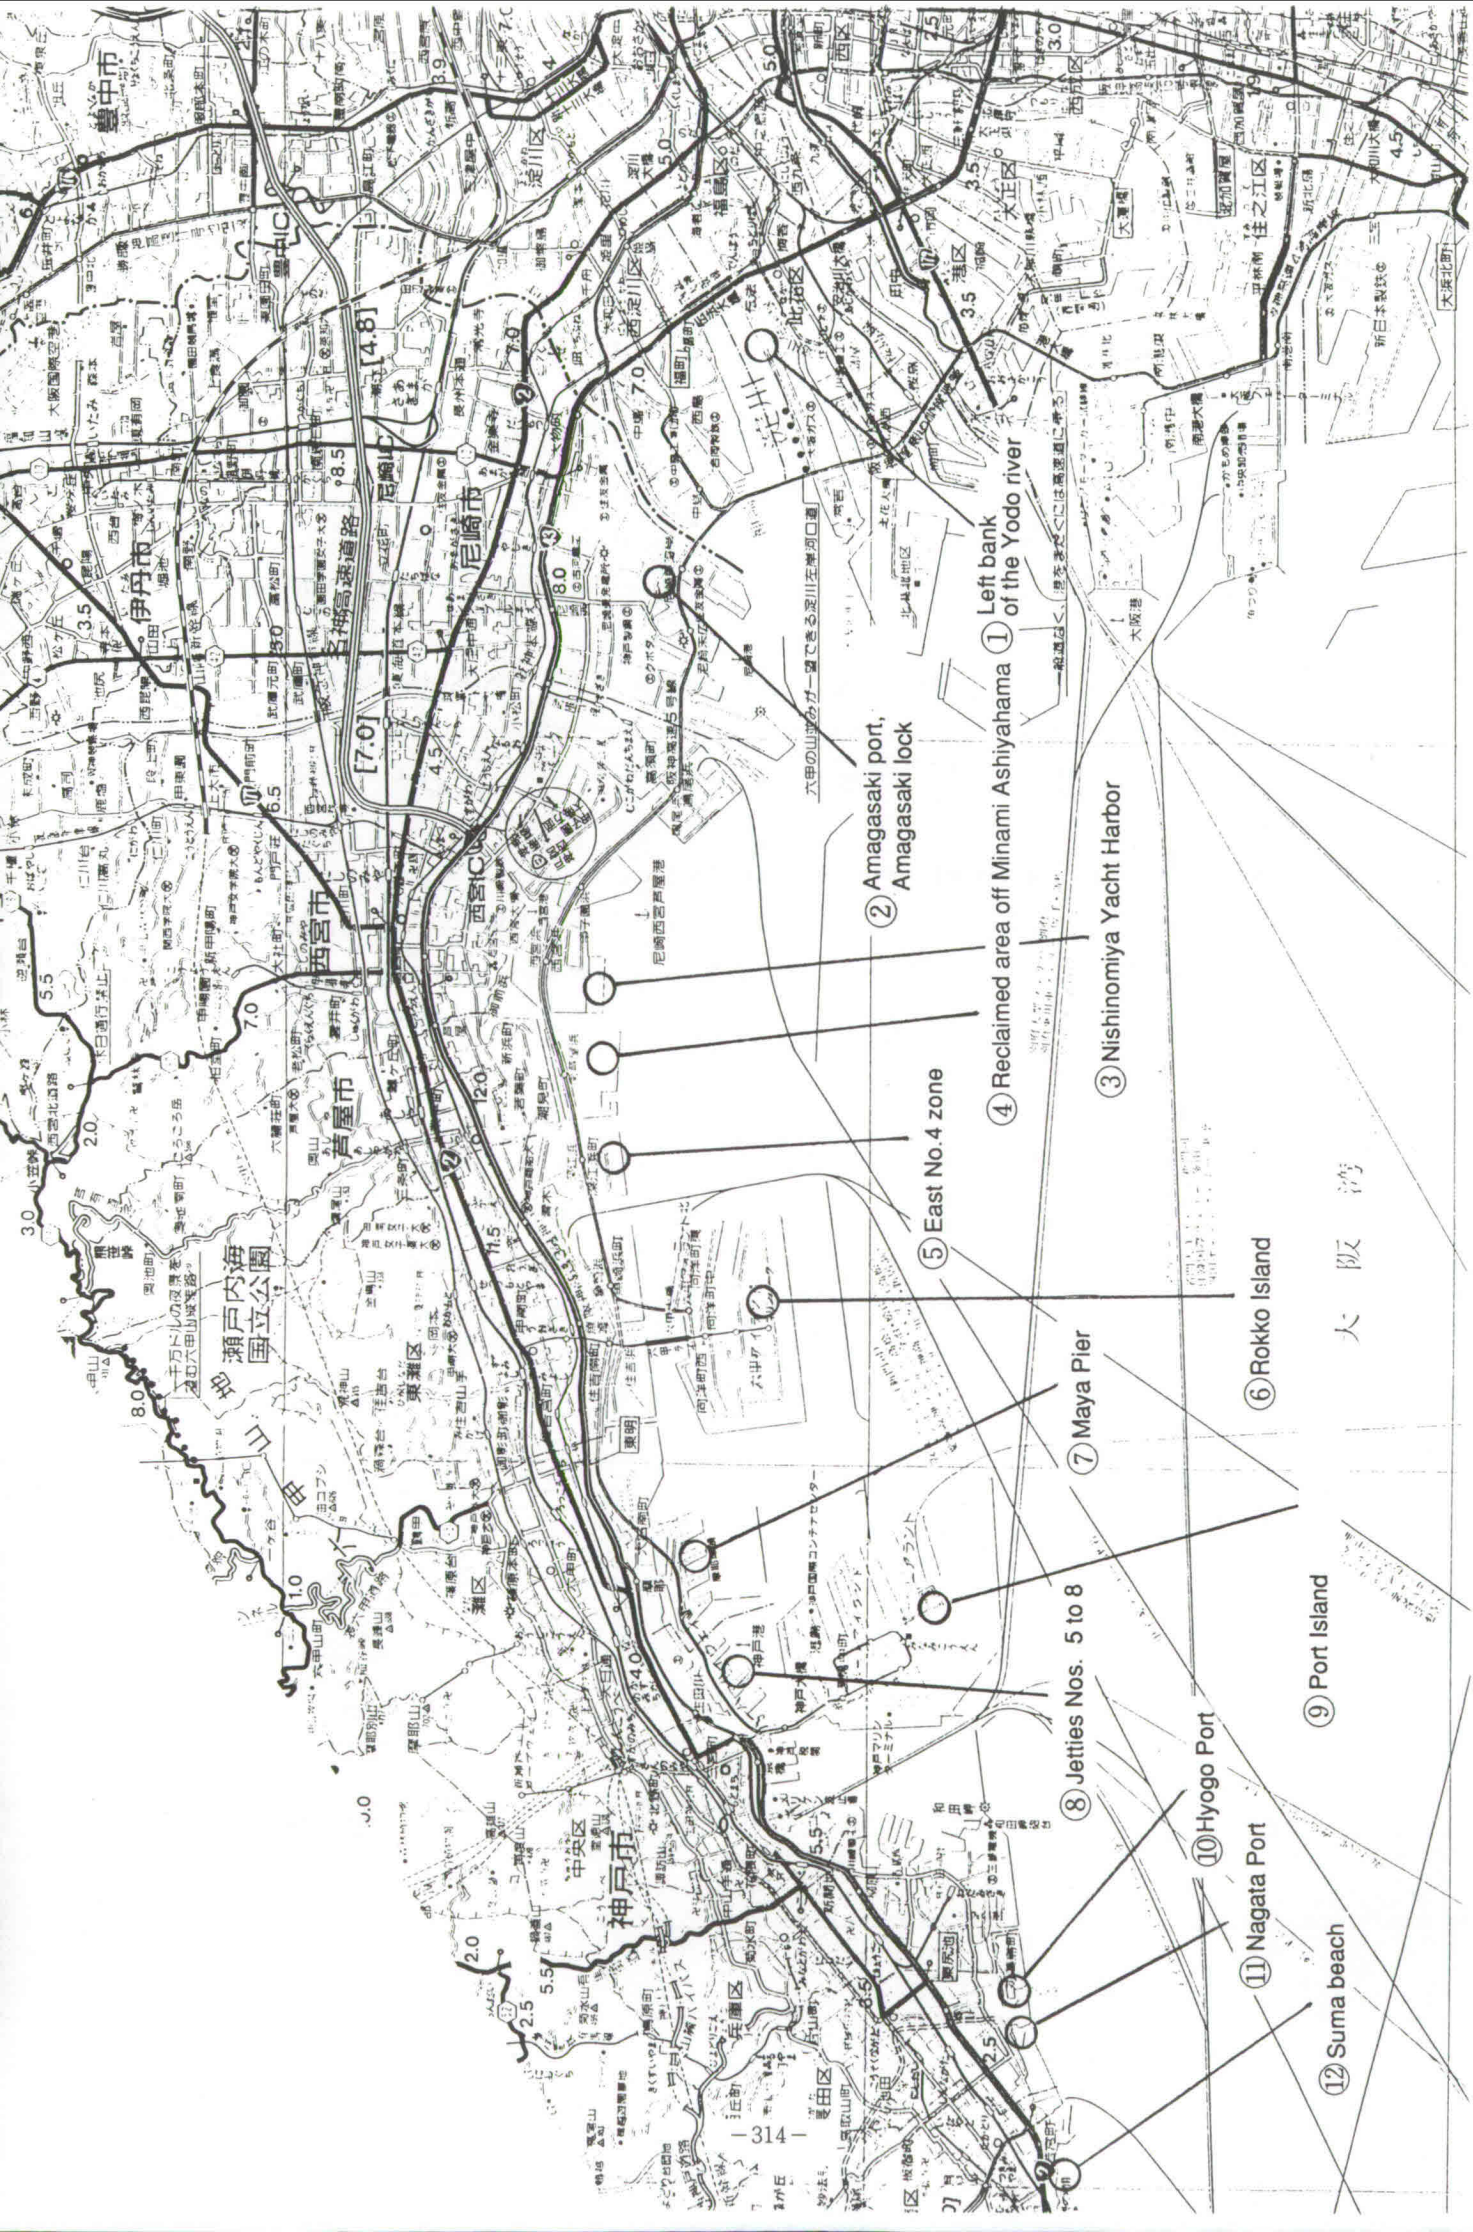
Fig. 1 Facilities covered by the investigation

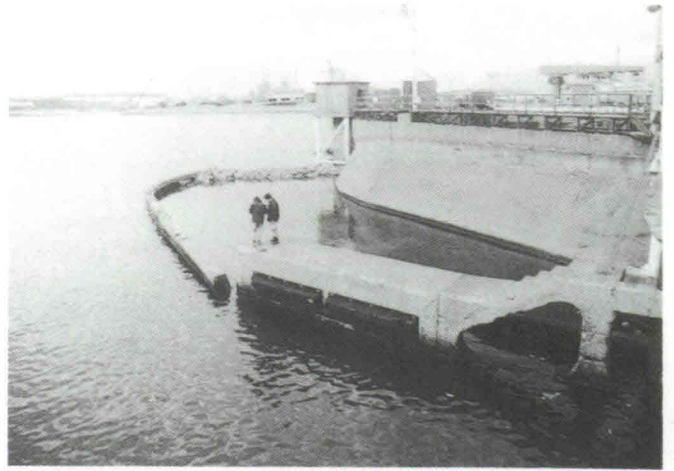
Photo 2 Damage to the Amagasaki Lock

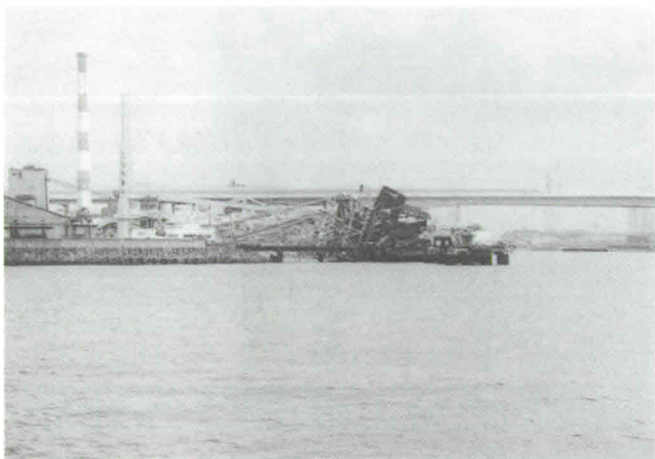
Photo 3 Overturned lifting crane at the Amagasaki Port

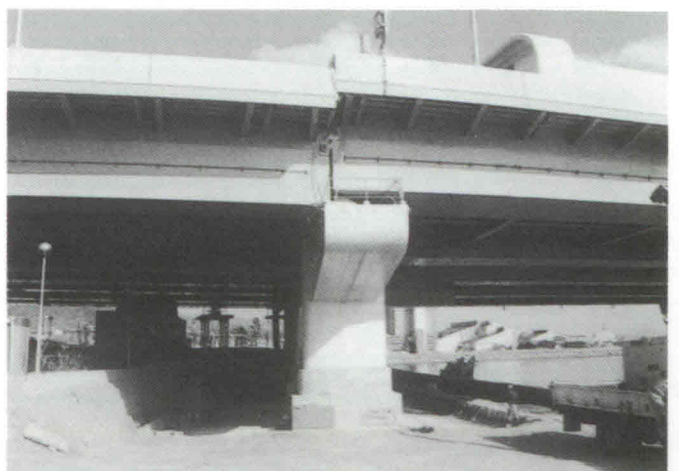
Photo 6 Lateral movement of the foundation of the Hanshin Expressway Wangan Route

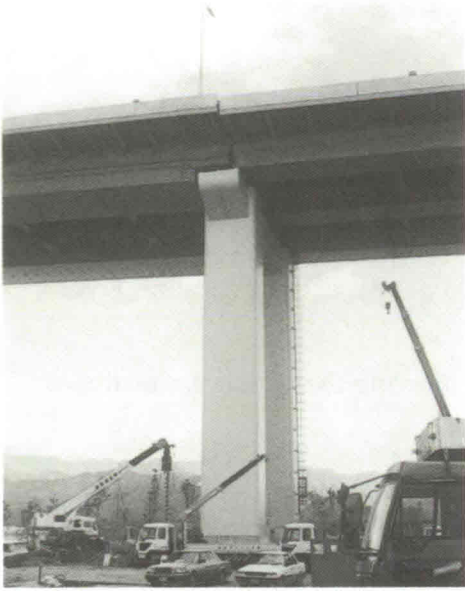
Photo 7 Lateral movement of the foundation of the Hanshin Expressway Wangan Route

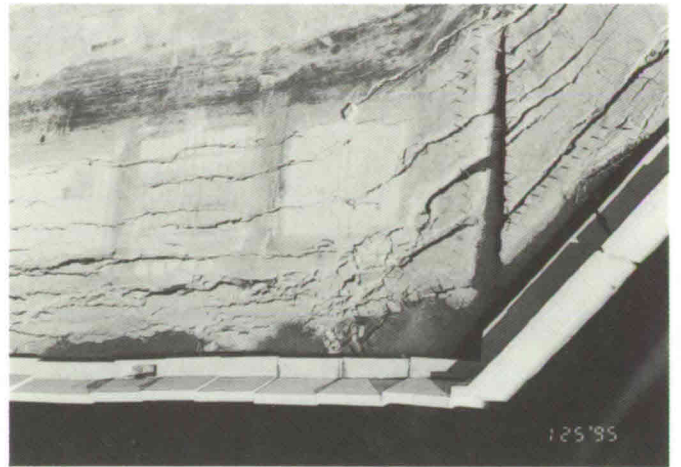
Photo 8 Damage to coastal dikes at the second reclamation zone on Port Island

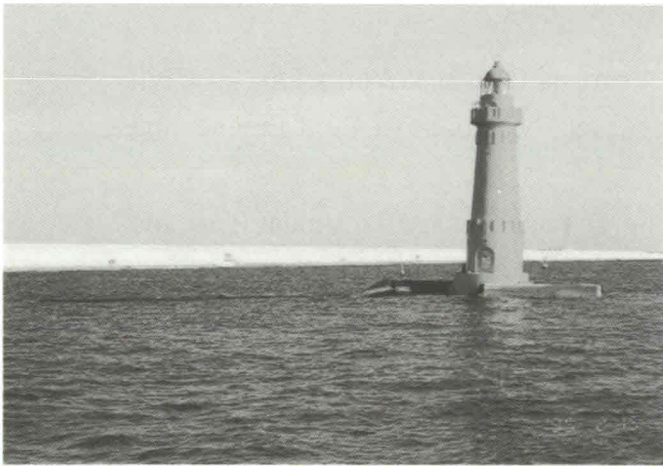
Photo 9 Subsidence of the Port Island Breakwater

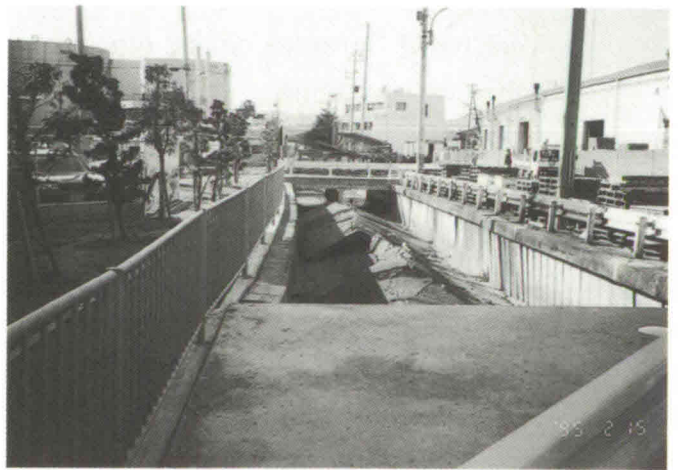
Photo 12 Damage to the concrete riverbed near Nagata Port

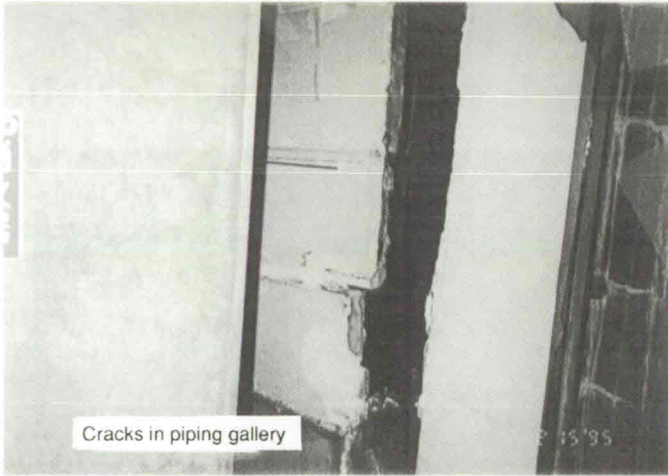
Cracks in piping gallery

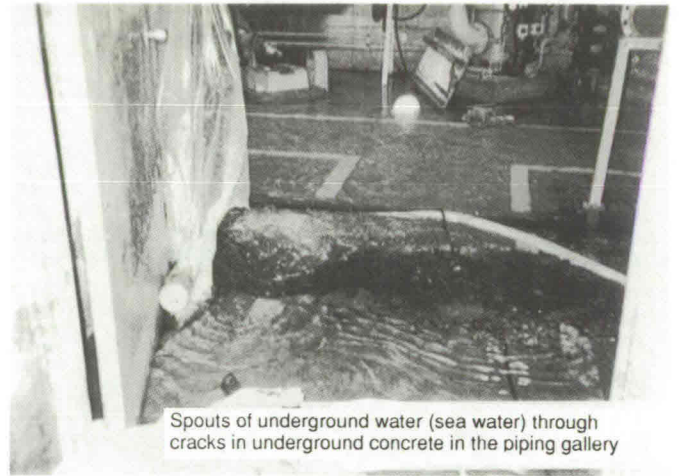
Spouts of underground water (sea water) through cracks in underground concrete in the piping gallery

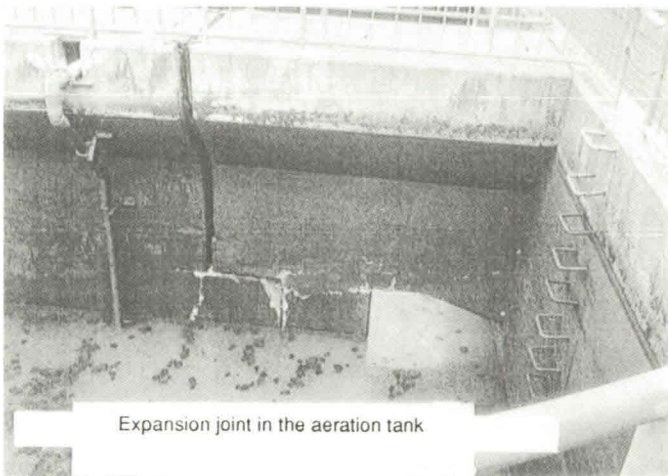
Expansion joint in the aeration tank

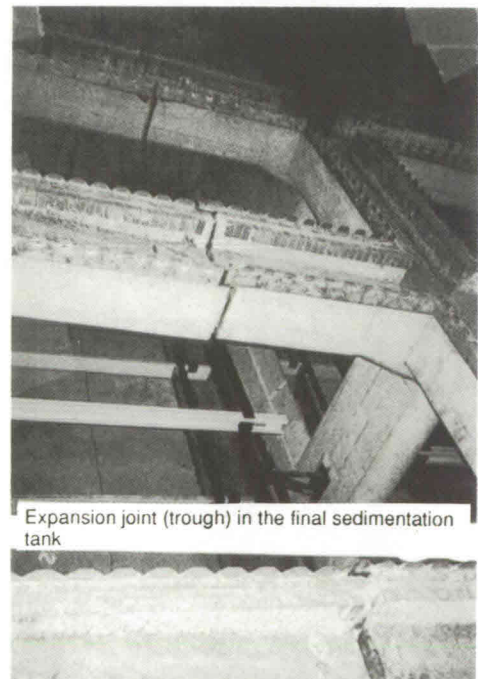
Expansion joint (trough) in the final sedimentation tank

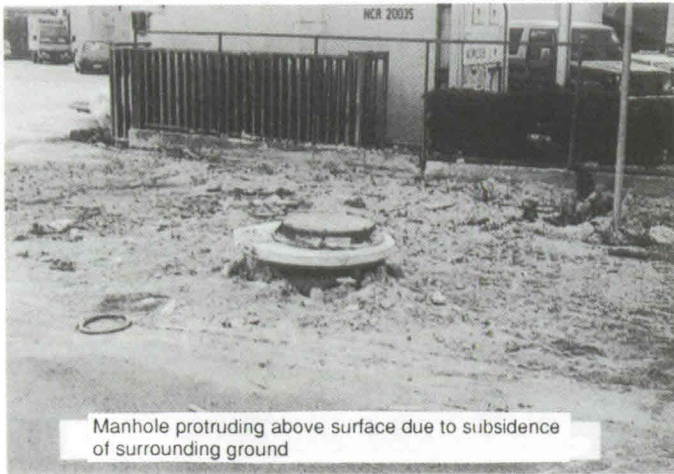
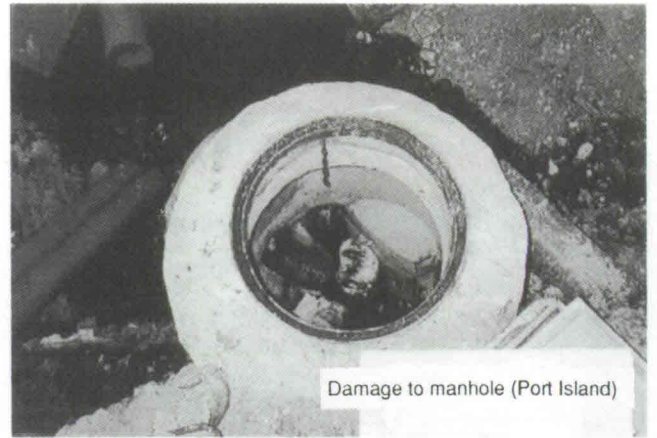
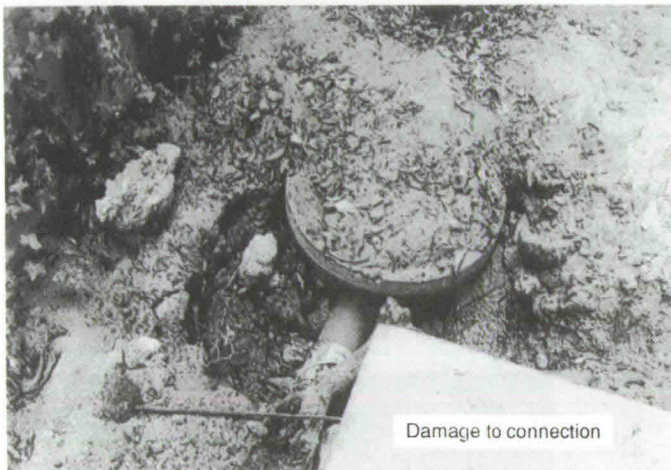
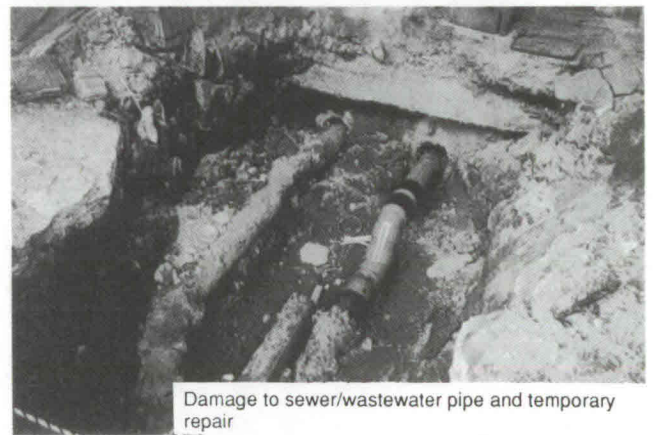
Photo 2: Damage to Manholes and Connecting Sewers

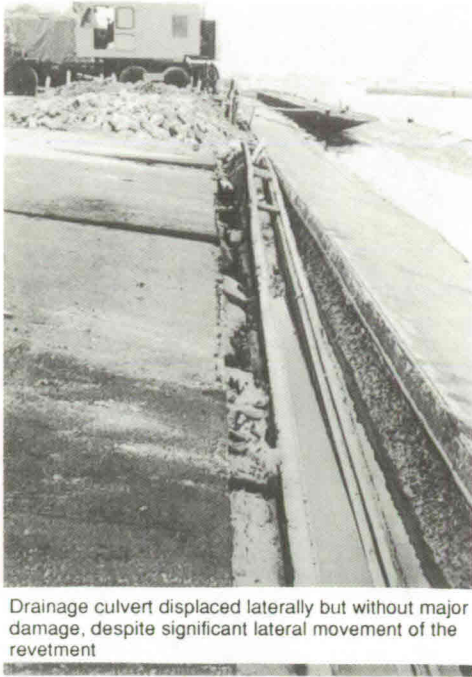
Drainage culvert displaced laterally but without major damage, despite significant lateral movement of the revetment

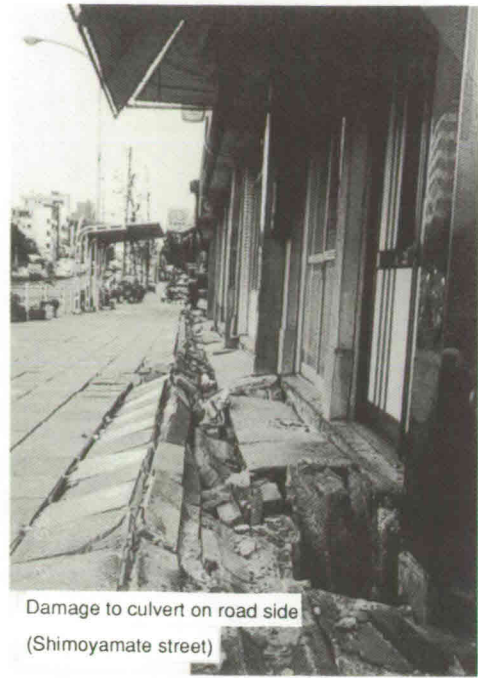
Damage to culvert on road side
(Shimoyamate street)

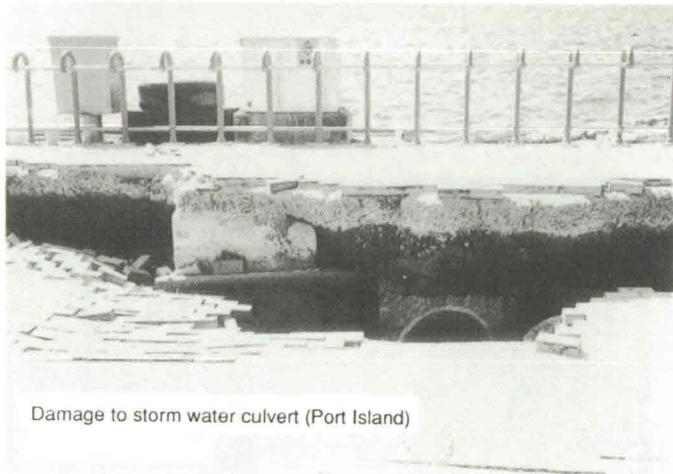
Damage to storm water culvert (Port Island)

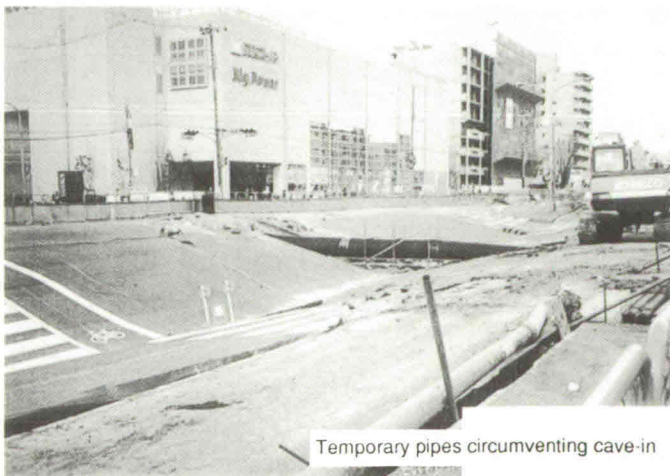
Temporary pipes circumventing cave-in

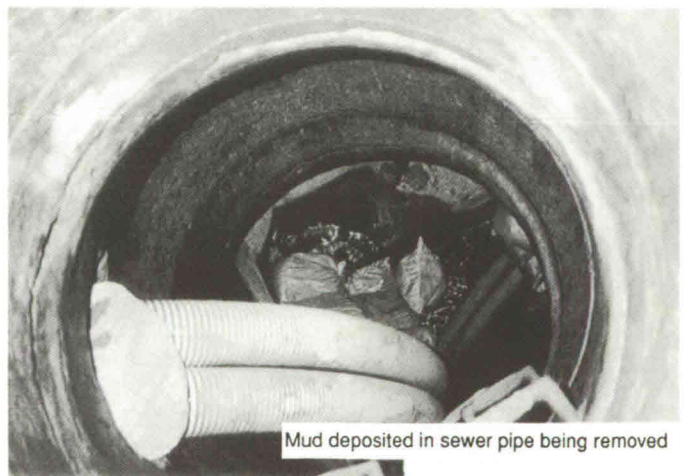
Mud deposited in sewer pipe being removed

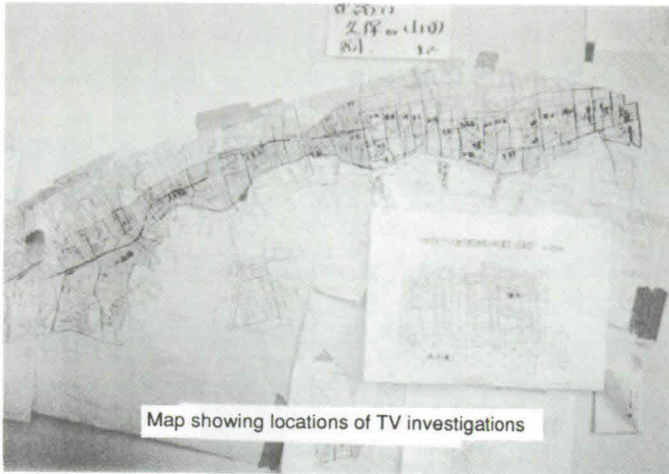
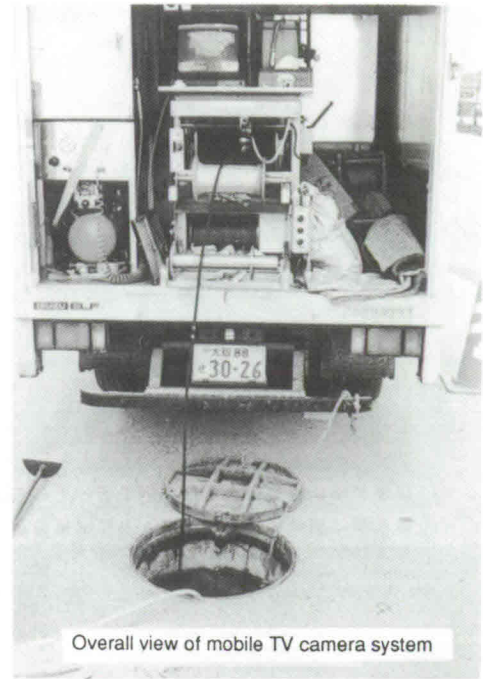
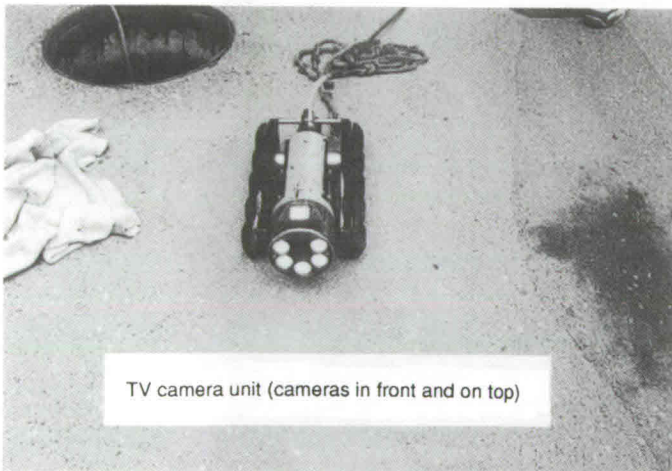
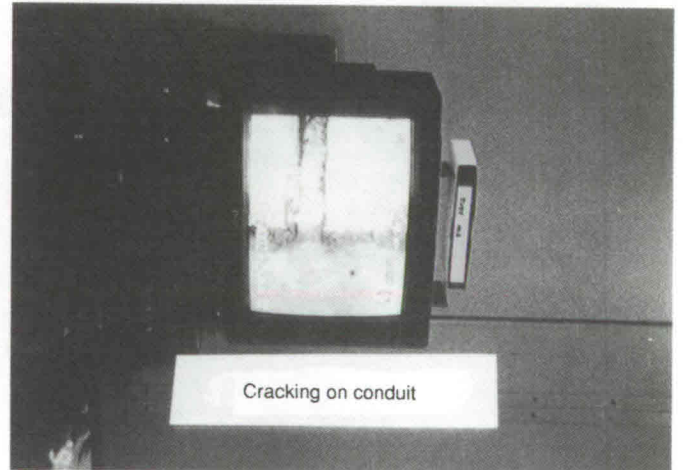
Photo 5: TV Camera Investigation of Sewer Piping

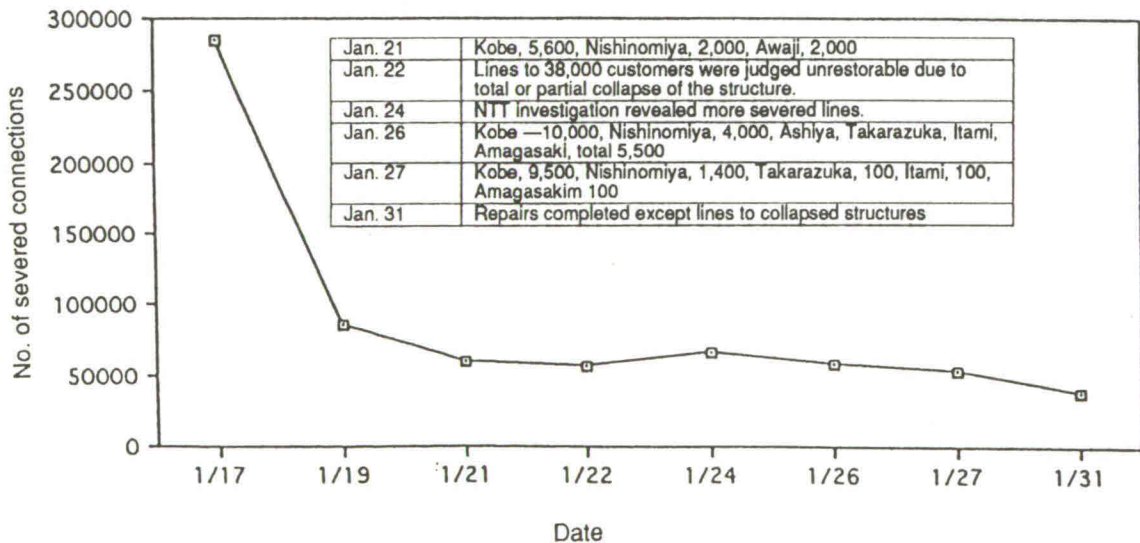
Fig. 2.1 Recovery of severed connections

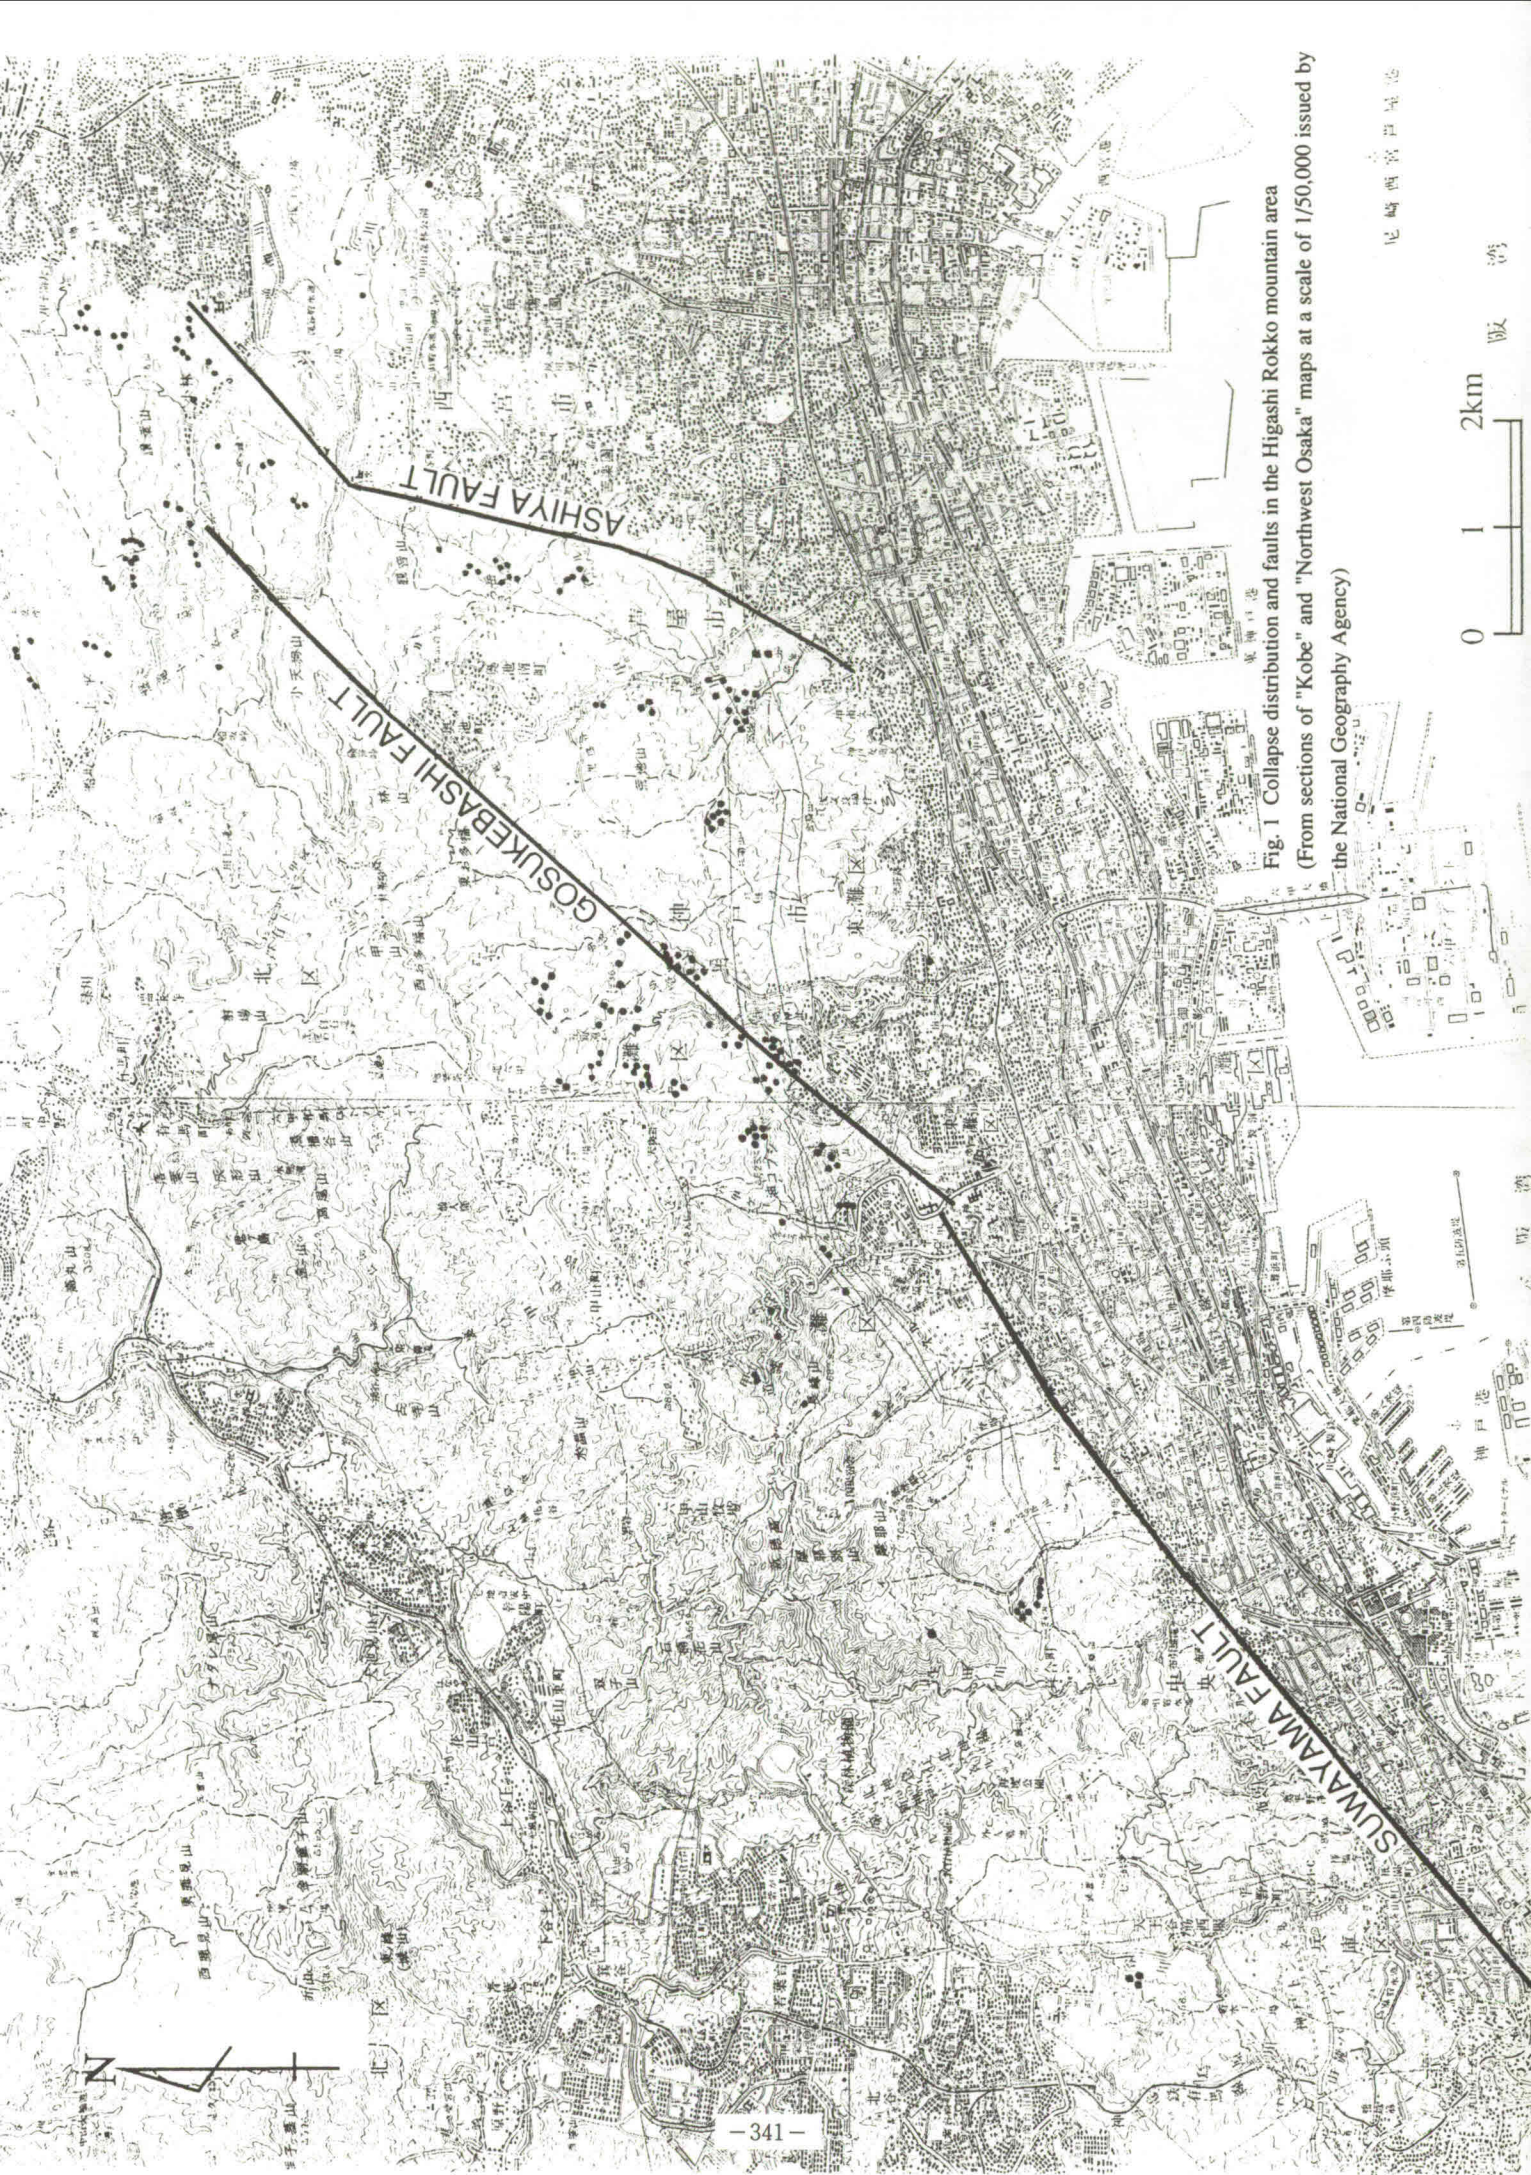
Fig. 1 Collapse distribution and faults in the Higashi Rokko mountain area
 (From sections of "Kobe" and "Northwest Osaka" maps at a scale of 1/50,000 issued by
 the National Geography Agency)

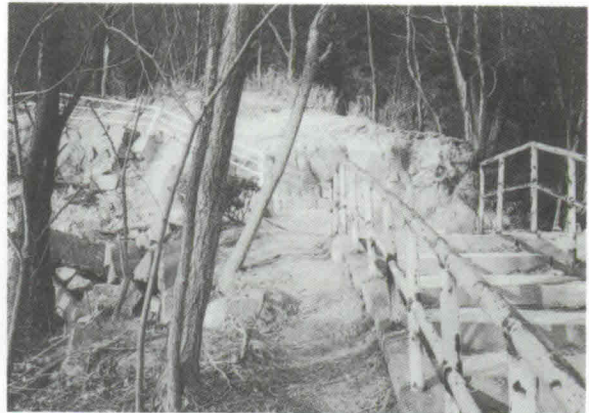
Photo 2 Damaged slope in the Tsuru-
kabuto area, Nada Ward

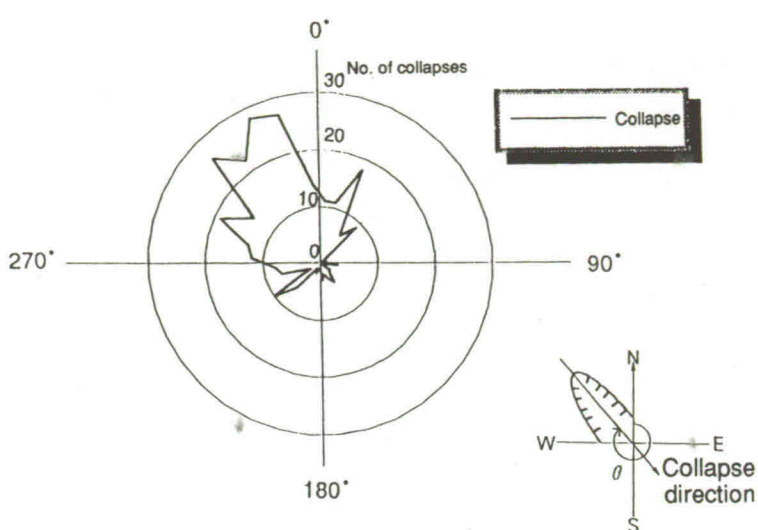
Fig. 2 Directions of collapse

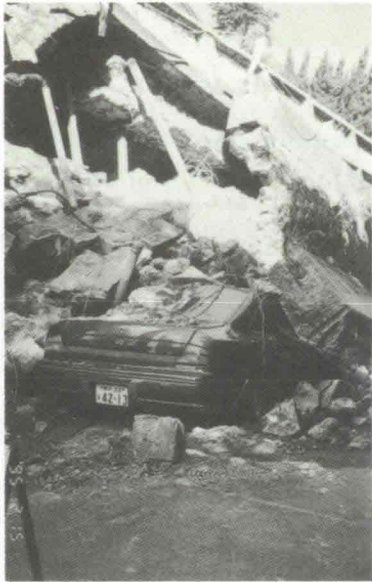
Photo 3 Collapse of stone retaining wall

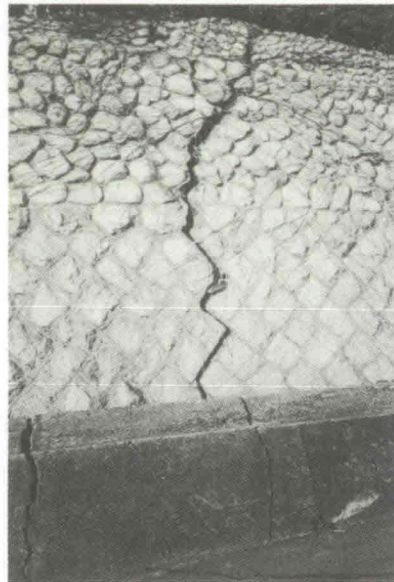
Photo 4 Vertical crack in stone retaining wall

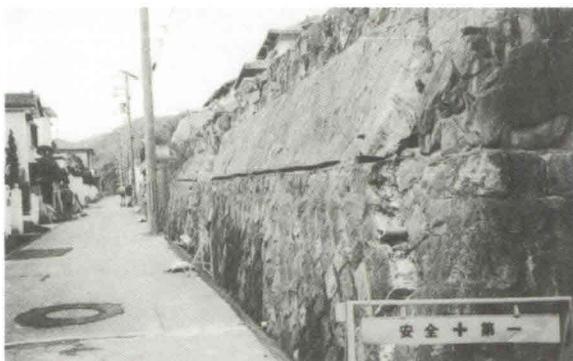
Photo 5 Bulging of two-stage retaining wall

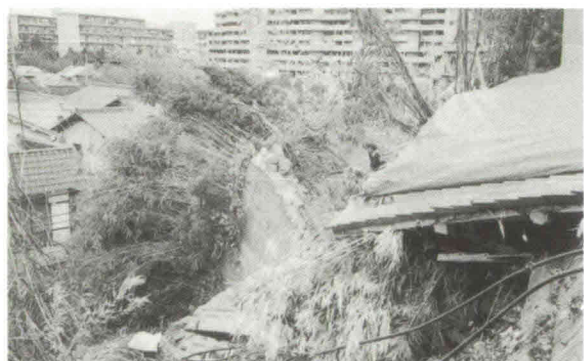
Photo 6 Overturned concrete retaining wall
