## Monitoring Pilot Study of Temporary Permeable Structures for Mangrove Restoration

Water

# Monitoring Pilot Study of Temporary Permeable Structures for Mangrove Restoration

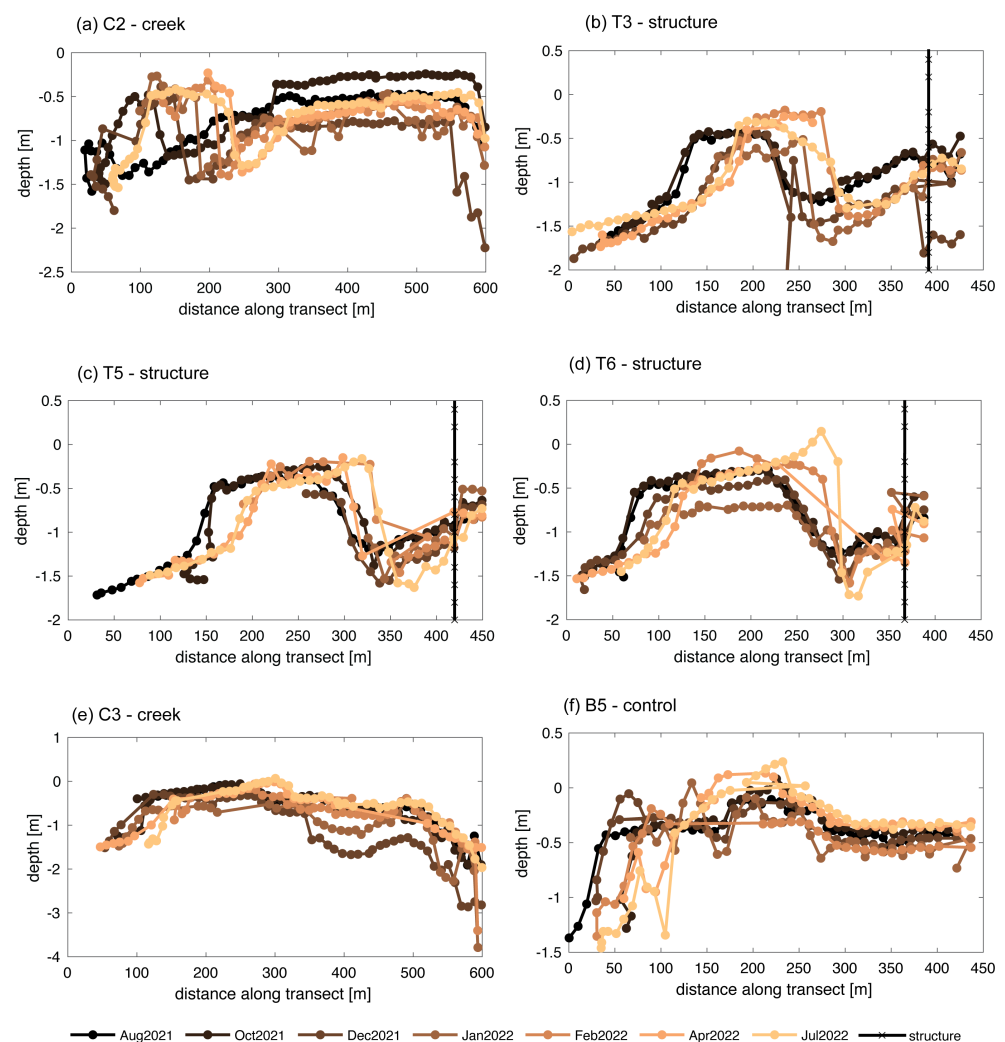
Cross-shore bathymetric profiles show that the chenier was highest in the control transect (Figure 5f), with an initial elevation of  $-0.1$  m with respect to mean sea level, and grew in height over time until reaching a maximum crest elevation of  $0.23$  m. Bed levels increased behind the chenier up to  $\sim 0.1$  m. Despite these accretive effects, the bed level remained at  $-0.3$  m with respect to MSL at the most landward bathymetry measurements, which is below the bed level required for mangrove establishment. Satellite imagery also reveals that both the coastline and the mangrove edge continued to retreat over time (Figure 6). Behind the structures, the bed level response varied, as illustrated in the plots of different structure transects (Figure 5b–d). It is important to note that maintaining exact alignment when walking transects across different measurement periods was challenging (see Figure 4c). Therefore, the bathymetric data offers a broader overview of the site's dynamics, while the monitoring pole data delivers more precise information on vertical bed level changes at specific locations.

**Figure 5.** Bathymetric profiles across several transects, representing the water depth relative to mean sea level (MSL) in meters. (a) C2, (b) T3, (c) T5, (d) T6, (e) C3, (f) B5. The most seaward points are shown on the left, and the most landward at the right. Transects T3, T5 and T6 are located across structures, while B5 is situated without a structure. T3 partly collapsed during a storm in January 2022, whereas T5 and T6 remained intact. C2 and C3 are located along creeks. Different lines represent bathymetry data collected at various times between December 2021 and July 2022, illustrating the migration of a chenier across the transects over time.

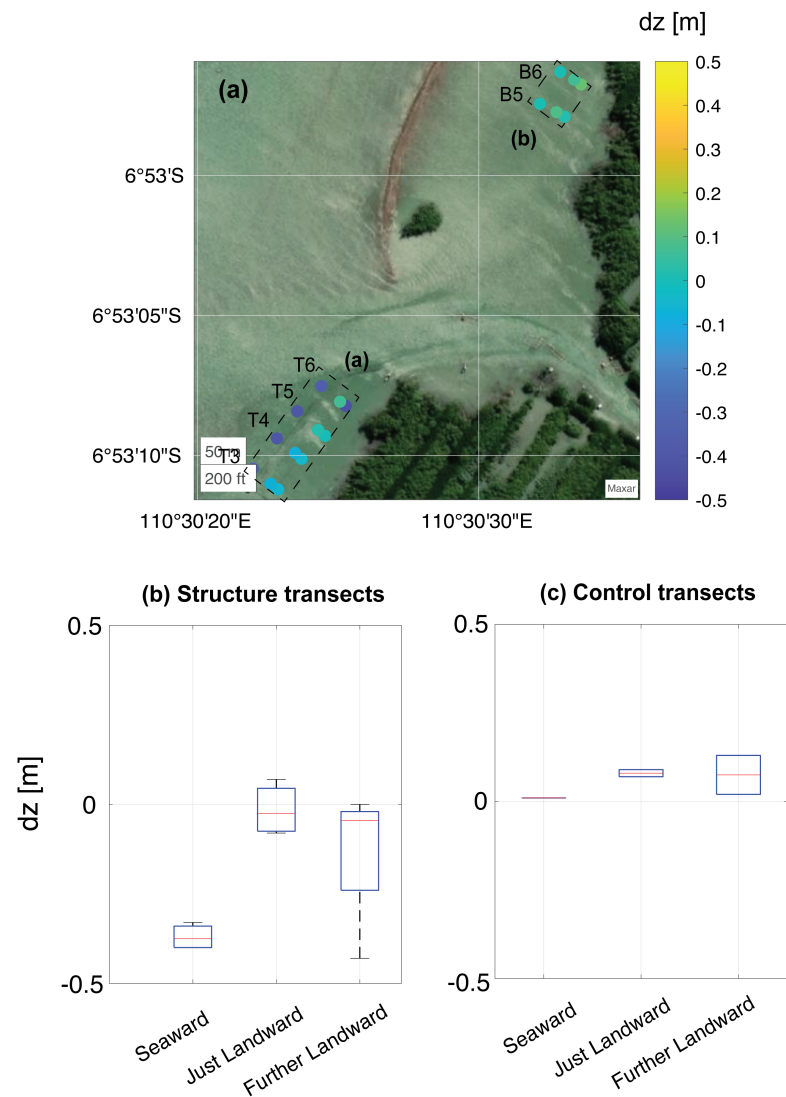
The comparison of average bed level changes at monitoring poles between December 2021 and December 2022, from structure and control transects is shown in Figure 7. At the control transects (no structures), monitoring poles showed consistent sediment accretion. Mean bed level changes between both control transects reached accretion values of 0.01 m on the most seaward pole, 0.08 m landward, and 0.13 m further landward. At the structure transects, on average, considerable erosion is measured seaward from the structures (mean change =  $-0.38$  m), with slight erosion just landward of the structure (mean change =  $-0.03$  m), and larger erosion further landward (mean change =  $-0.05$  m). Standard deviations at these points were relatively high, particularly further landward (standard deviation = 0.2 m), indicating substantial spatial variability in sediment dynamics within the structured area, as also shown in Figure 7b.

Erosion seaward of the structures likely resulted from a combination of processes, including creek development along the structures, sediment stirring and scouring caused by wave reflection [26], as well as landward sediment influx due to wave height reductions across the structures [27]. Wave reflection and transmission likely varied for different structures, considering variations in designs [26] and differing levels of damage during the northwest monsoon (Figure 3), with T3 and T4 heavily damaged by mid-January, while T5 and T6 remained intact. Despite differences in structure stability, and possibly in performance, during storms, the relatively uniform erosion observed along all sections suggests that creek development may have played a significant role in driving erosion on the seaward side of structures. Landward of the structures, responses varied: T3 and T4 experienced erosion, T5 remained stable, and T6—adjacent to a creek—showed initial accretion near the structure (0.07 m) but substantial erosion ( $-0.43$  m) farther landward (Figure 7).

**Figure 7.** (a) Map depicting bed level changes (denoted as  $dz$ , in meters) between December 2021 and December 2022 for both structure and control transects. (b) Boxplot illustrating bed level changes at structure transects for monitoring poles located 10 m seaward, 10 m (just) landward, and 20 m (further) landward from the structure. (c) Boxplot for control transects, showing bed level changes at poles placed at equivalent distances from the shore.

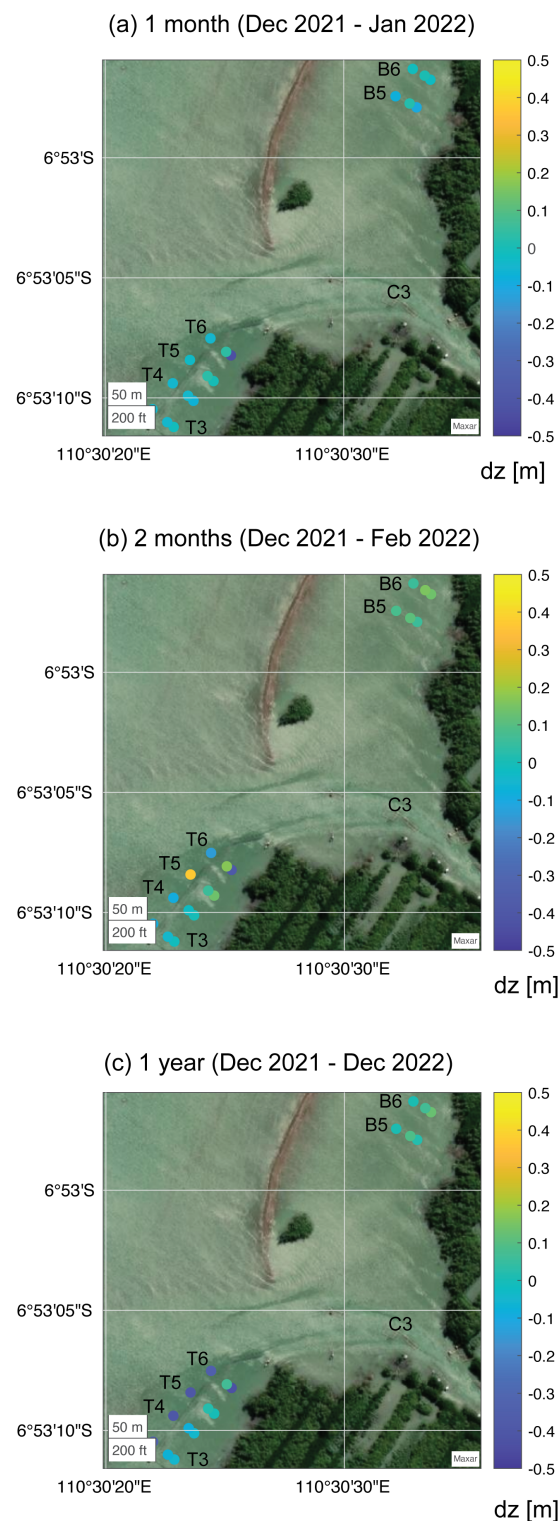
Seaward erosion occurred mainly within the first two months (Figure 8a,b), continuing into subsequent months as the area deepened significantly by June (Figure 8c) before stabilizing between June and December (see Figure 9). Behind T3 and T4, mild erosion persisted throughout the year. At T5, the bed level raised by 0.1 m between January and February 2022, perhaps due to sedimentation during storms within this period (see consecutive storms in January in Figure 3) but this sediment had eroded again by June. At T6, significant erosion occurred at the most landward point during the first month (Figure 8a), while bed level changes elsewhere were minor. The severe erosion observed at the seaward pole of T6 appears influenced by creek development, supported by the deepening of creek C3 in December 2021 (Figure 5e).

**Figure 8.** Bed level changes measured at monitoring poles across structure transects (T3–T6) and control locations (B5–B6). (a) Changes observed between 9 December 2021, and 11 January 2022, highlighting erosion and localized accretion patterns. (b) Bed level changes between 9 December 2021, and 9 February 2022, showing continued accretion near structures and minimal changes at control sites. (c) Bed level changes over the longer term, from 9 December 2021, to 10 December 2022, illustrating overall erosion in front of the structures and variable accretion and erosion behind them.
