## Microstructural investigation into the damage mechanism of short pitch rail corrugation

Zhang, Pan; Li, Shaoguang; Ren, Fang; Hajizad, Omid; Dollevoet, Rolf; Li, Zili

Engineering Failure Analysis

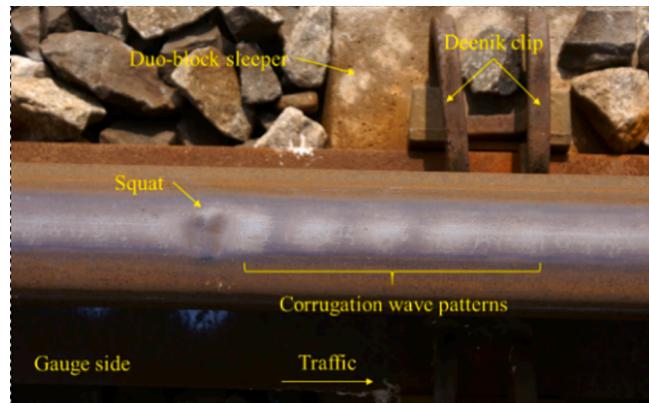
The rail corrugation was visually identified with shiny crests and dark valleys, as shown in Fig. 1. It followed a mature squat and disappeared after five distinguishable wave patterns in the traffic direction, suggesting that the corrugation was likely induced by large wheel-rail dynamic loads excited by the squat. This phenomenon was commonly observed in the Dutch railway network, and statistical data indicated that 41 % of rail squats induced corrugation wave patterns after them [23]. The corrugation wavelength was about 36 mm, falling in the typical short pitch range of 20–80 mm. RailProf was used to measure the vertical-longitudinal corrugation geometry

**Fig. 1.** Rail corrugation investigated in this study from the Dutch railway network. The corrugation was induced by a rail squat on a straight track with duo-block sleepers and Deenik fastening clips.

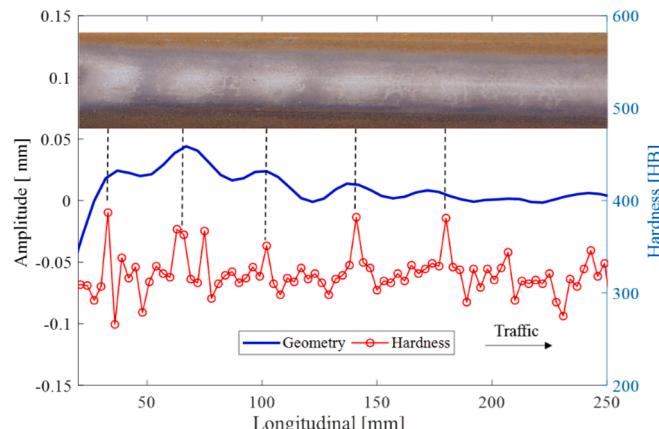
**Fig. 4** shows the measured corrugation geometry and surface hardness variation in the centre of the running band along the traffic direction. The corrugation peaks correspond to the shiny areas of the rail surface, while the troughs align with the darker regions. The corrugation has a wavelength of about 36 mm, corresponding to a corrugation frequency of about 1080 Hz with a train speed of 140 km/h. This wavelength falls within the range of 20–40 mm, a typical wavelength range of dynamic contact forces in the Dutch railway system [23]. The maximum peak-trough amplitude is about 18  $\mu\text{m}$  at the first wave, which decreases rapidly in the traffic direction. After about 180 mm away from the squat, corrugation wave patterns become almost invisible.

The rail surface hardness also shows periodic fluctuations and is in phase with the corrugation geometry, consistent with the findings reported in [11,16,19]. The corrugation peaks generally correspond to prominent hardness peaks, reaching up to 382 HB, as indicated by the dashed lines in **Fig. 4**. The hardness difference between corrugation peaks and troughs suggests varying mechanical properties of rail materials along the corrugation, which resulted from different contact stress and work hardening at these locations induced by dynamic loads. Furthermore, the average surface hardness is around 320 HB, which is 1.23 times the nominal value of 260 HB for R260Mn grade steel. This increase in hardness indicates significant work hardening caused by plastic deformation in rail surface materials due to cyclic wheel-rail contacts. Similar to the corrugation geometry, after about 180 mm, the fluctuation of the surface hardness becomes less pronounced and more irregular, indicating a transition to a non-corrugated zone.

**Fig. 4.** The corrugation geometry and surface hardness in the centre of the running band.

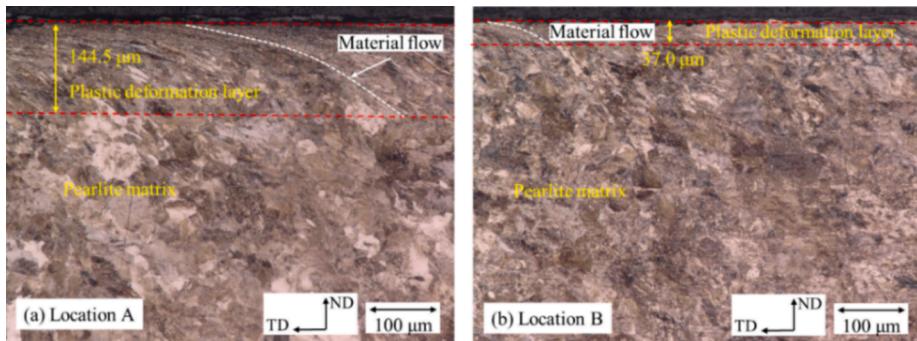
Fig. 5 shows the LOM images of the rail microstructure at two locations: one at the corrugation peak of specimen S5 (Location A, Fig. 5a) and the other at the corrugation trough of specimen S6 (Location B, Fig. 5b). In Fig. 5a, a clear material plastic flow toward the traffic direction is observed from the running surface to a depth up to approximately 144.5  $\mu\text{m}$ , indicating severe plastic deformation at the corrugation peak. Within this severe plastic deformation layer (PDL), the pearlite lamellae were realigned following the predominating shear stress directions during train passages [25,26]. The orientation of these deformed pearlites relative to the traffic direction gradually increases from about 10° near the surface to about 35° at a depth of 144.5  $\mu\text{m}$ . Beneath this PDL, the microstructure of the bulk materials is less influenced by the dynamic loads. Fig. 5b shows that the PDL at the corrugation trough is much thinner than the peak, which is only about 37.0  $\mu\text{m}$ . This result agrees with the microstructural observations of corrugated rail samples in [16,21].

Fig. 5. OM images of the rail microstructure at (a) Location A, the corrugation peak of specimen S5; (b) Location B, the corrugation trough of specimen S6. ND indicates the normal direction and TD traffic direction.

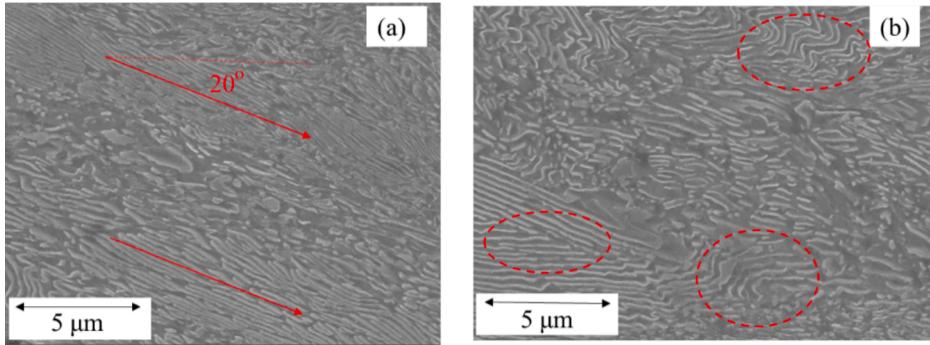
Microstructural differences between the PDL and the original pearlite matrix are further examined using SEM at higher magnification, as shown in Fig. 6. Both regions show a typical lamellar structure composed of dark ferrite and white cementite bands. In the PDL (Fig. 6a), the lamellae are oriented at approximately 20° due to contact stresses, as indicated by the red arrows. In contrast, the lamellae within the pearlitic matrix are randomly oriented, highlighted by red dashed ovals in Fig. 6b. Additionally, the lamellar spacing in the PDL is observed to be smaller than that in the pearlite matrix. The spacing between cementite lamellae is a critical factor that influences the rail hardness and wear resistance. A smaller spacing, as observed in the PDL, suggests increased wear resistance compared to the original pearlitic structure of the rail material [27,28].

Fig. 6. SEM micrographs in (a) the severe plastic deformation layer; and (b) the original pearlite matrix.

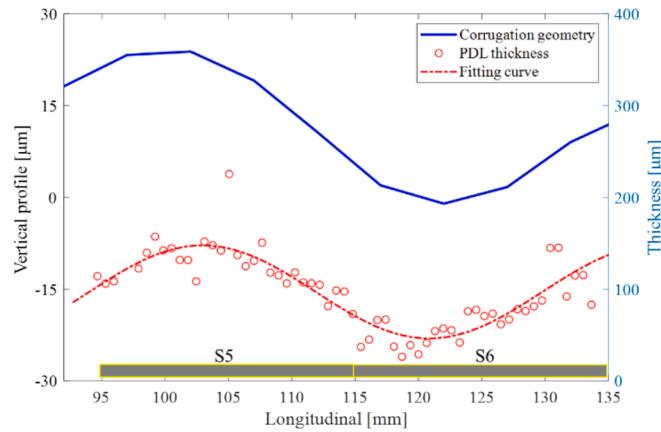
Fig. 7 shows the measurement of the PDL thickness in specimens S5 and S6 by OM, which covers a complete corrugation wave pattern. It can be seen that the PDL thickness fluctuates around 96  $\mu\text{m}$  in the traffic direction, and gradually decreases from about 150  $\mu\text{m}$  at the peak to 40  $\mu\text{m}$  at the trough. The fitting curve reveals that this fluctuation follows an approximately sinusoidal pattern, aligning with the corrugation geometry in both wavelength and phase. However, it is noted that the peak-to-trough variation in PDL thickness is about 100  $\mu\text{m}$ , significantly larger than the peak-to-trough amplitude (i.e., 14  $\mu\text{m}$  shown in Fig. 4) of the corrugation geometry. The reason will be discussed in Section 4.

Fig. 7. The thickness of the plastic deformation layer at specimens S5 and S6 in the corrugation zone.

peaks. This explains the results in [Fig. 7](#) why the peak-to-trough variation in PDL thickness (i.e., 100  $\mu\text{m}$ ) is significantly larger than the peak-to-trough amplitude of the corrugation geometry (i.e., 14  $\mu\text{m}$ ). This phase is called 'corrugation growth damage', dominated by both differential wear and differential plastic deformation accumulation.

The findings in [Fig. 7](#) and [Fig. 10](#) provide insights into determining the appropriate grinding depth. It can be seen that the depth of the corrugation-affected zone is over 0.1 mm, considerably deeper than the measured corrugation amplitude. Therefore, the rail grinding depth is suggested to account for the differential PDL thickness (see [Fig. 7](#)) to prevent corrugation reoccurrence due to subsurface material inhomogeneity.

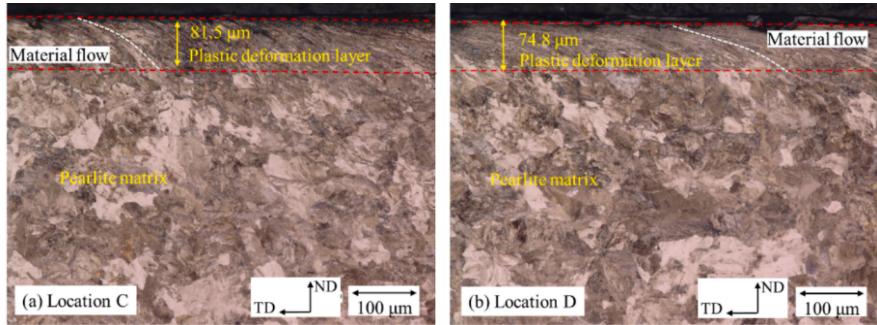
Fig. 8 presents LOM images of the rail microstructure at two locations in the non-corrugation zone: Location C in specimen S10 at 202 mm and Location D in specimen S11 at 233 mm. Similar to the observations in Fig. 5, both locations show two distinct layers: a PDL and an underlying pearlite matrix. However, unlike the significant PDL thickness differences in the corrugation zone, the PDL thickness at these two locations is relatively comparable, around 81.5  $\mu\text{m}$  at Location C and 74.8  $\mu\text{m}$  at Location D.

Fig. 8. OM images of the rail microstructure at (a) Location C in specimen S10 at 202 mm; and (b) Location D in specimen S11 at 233 mm. ND indicates the normal direction and TD traffic direction.

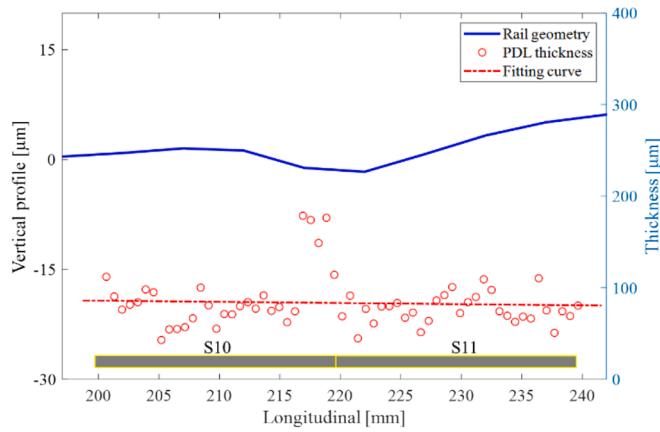
Fig. 9 further shows the PDL thickness in specimens S10 and S11 using OM along with the corresponding rail geometry. In this non-corrugation zone, the average PDL thickness is approximately 78  $\mu\text{m}$ , which is thinner than that observed in the corrugation zone. Besides, the PDL thickness in this region shows only slight and random fluctuations, unlike the strong variation consistent with corrugation geometry in Fig. 7. The fitted trend line follows a nearly linear pattern, indicating uniform plastic deformation in the non-corrugation zone. Notably, a pronounced peak is observed at around 218 mm, corresponding to a thick mixed layer of WEL and BEL, which will be shown in Section 3.4.

Fig. 9. The thickness of the plastic deformation layer at specimens S10 and S11 in the non-corrugation zone.

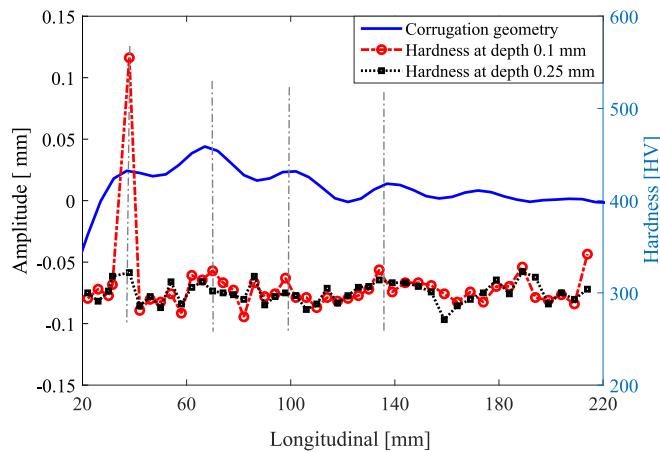
Fig. 10 shows the micro-hardness distribution at depths of 0.1 mm and 0.25 mm along the traffic direction, against the corresponding corrugation geometry. It can be seen that the hardness values at both depths fluctuate around 300 HV, but they follow

different patterns. At a depth of 0.1 mm, hardness peaks generally align with the corrugation peaks, as indicated by the vertical grey dashed lines. In contrast, the hardness at 0.25 mm depth shows relatively random variation without a clear correlation with the corrugation geometry. This suggests that the corrugation-affected zone, where differential plastic deformation and material hardening occur, reaches at least 0.1 mm deep but less than 0.25 mm. This finding aligns with the LOM observations in Fig. 7, where the PDL thickness at the corrugation peak is between 0.1 mm and 0.15 mm. Additionally, when compared to the variation trend of the surface hardness in Fig. 4, the subsurface hardness fluctuation at 0.1 mm depth is generally in phase but less pronounced, suggesting an attenuating influence of corrugation with increasing depth. Furthermore, a notable hardness peak is observed at around 39 mm, reaching up to 550 HV. This peak is caused by the presence of a thick mixture of WEL and BEL at this position, which will be presented in more detail in Section 3.4.

Fig. 10. Micro-hardness distribution in the traffic direction together with the corrugation geometry.

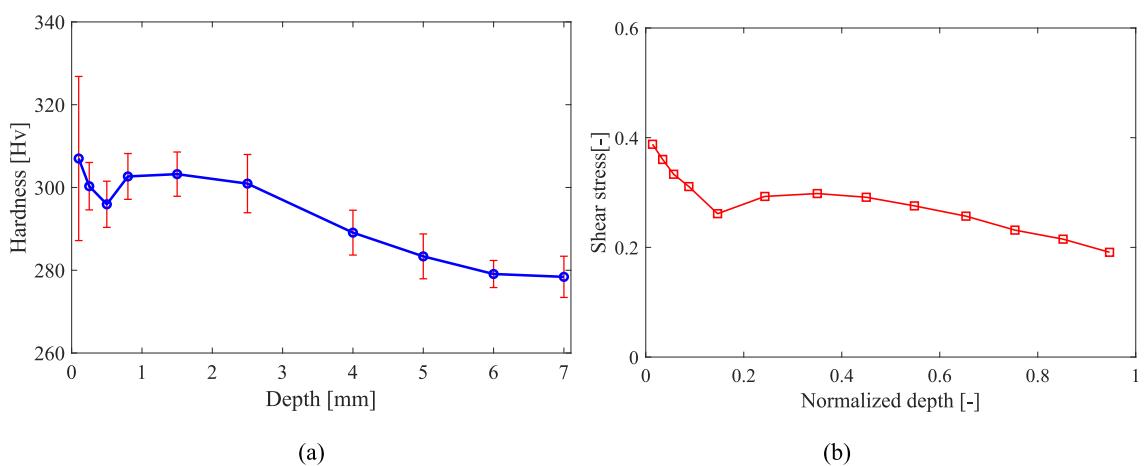
Fig. 11. Micro hardness distribution in comparison with shear stress distribution along the rail depth. (a) Micro hardness distribution from measurement; (b) simulated shear stress distribution from [29]. The shear stress is normalized by normal pressure, and the depth is normalized by the semi-axis of the wheel-rail contact area.

[Fig. 11](#) shows the hardness distribution at different depths of the rail specimens: 0.1 mm, 0.25 mm, 0.5 mm, 1.0 mm, 2.0 mm, 3.0 mm, and 7.0 mm. Each data point and corresponding red bar represent the average hardness and standard deviation between 20 mm and 220 mm along the depth. At the depth of 0.1 mm, the hardness is approximately 307 HV. From 0.1 mm to 0.5 mm, the hardness drops to a local minimum of about 296 HV, then rises to 301–303 HV between 1.0 mm and 2.5 mm. Beyond 2.5 mm, the hardness gradually decreases, reaching about 279 HV at a depth of 6.0 mm. Below 6 mm, the hardness remains almost constant at 278 HV, close to the nominal hardness value of R260MN pearlitic steel.

These hardness variations with depth are caused by the wheel-rail contact and the resulting subsurface stress distribution. It is found that the hardness pattern shown in [Fig. 11a](#) closely aligns with the maximum shear stress distributions of the rail subsurface under the contact patch in [Fig. 11b](#) [25,29], confirming that shear stress plays a significant role in the work hardening and plastic deformation of rail materials. The highest hardness at 0.1 mm depth is due to the proximity to the wheel-rail interface, where it experiences the largest shear stress from traction forces. This surface layer also shows the largest deviation in hardness, likely due to dynamic loading from corrugation and the presence of WEL and BEL at certain locations. Deeper into the rail, a typical ‘kink’ is observed in the shear stress distribution [29], corresponding to a hardness trough at around 0.5 mm depth and a peak between 1 mm and 2.5 mm. Beyond 2.5 mm, as the shear stress decreases, the hardness gradually declines until it reaches the hardness of bulk materials. Similar results of pearlitic rails in UK railway lines have been reported in [30].

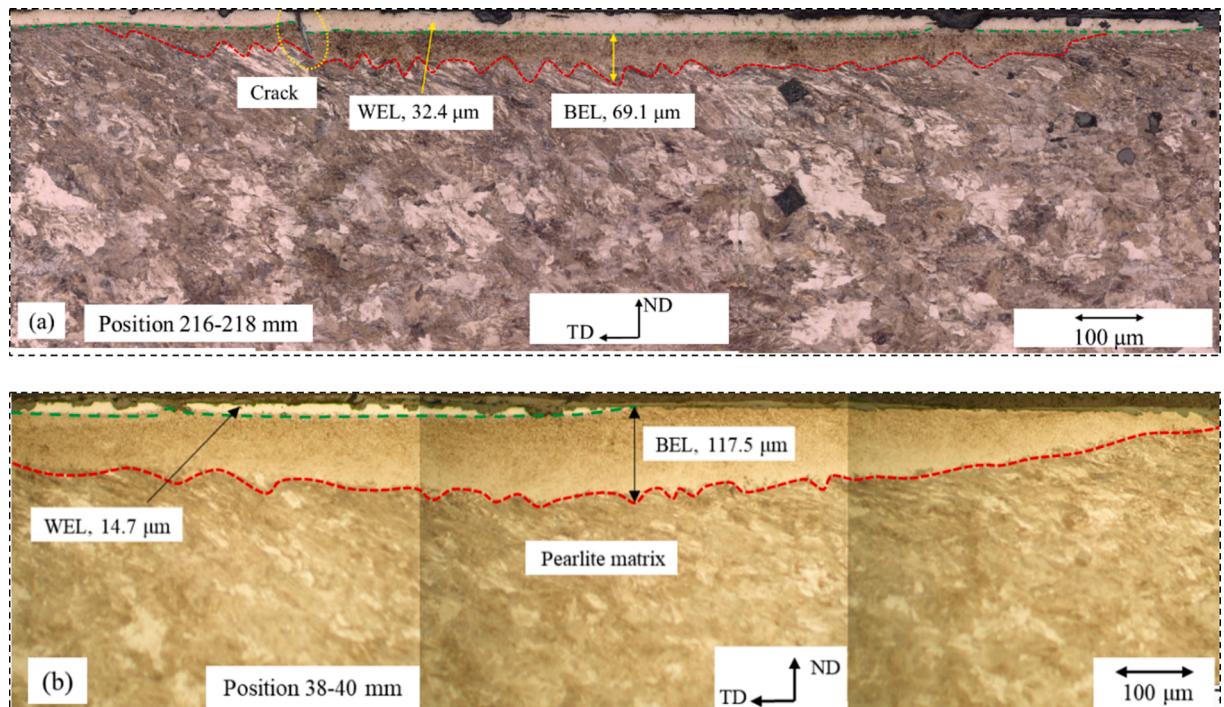
In [Figs. 9](#) and [10](#), notable hardness peaks are observed around 218 mm and 39 mm, respectively. These anomalies are caused by the presence of a mixture of WEL and BEL, as depicted in [Fig. 12](#). WEL and BEL, which appear white and brown under OM after etching, are significantly harder and more brittle than the bulk matrix [24,31]. The WEL in [Fig. 12a](#) has a thickness of approximately 32.4  $\mu\text{m}$ , while the BEL is 69.1  $\mu\text{m}$  thick. A 70  $\mu\text{m}$ -long crack is present within both layers, with an orientation of about 80°, and it had not propagated into the underlying pearlite structure. [Fig. 12b](#) shows the WEL is thinner at 14.7  $\mu\text{m}$ , with a thicker BEL of 117.5  $\mu\text{m}$ , and no micro-cracks are observed.

It is found that WEL and BEL can either coexist, as shown in [Fig. 12](#), or occur independently. When they coexist, BEL typically forms between the upper WEL and lower pearlite matrix, suggesting that BEL may represent a transitional state from the pearlite structure to the WEL. [Fig. 12](#) also shows that the boundaries between WEL and BEL are relatively smooth, while the boundaries between BEL and the pearlite matrix are more irregular. Similar phenomena are observed in Australian pearlitic rails [33]. The size of these irregularities is comparable to the pearlite grain or colony sizes, indicating that the formation of BEL may be related to the changes of these pearlitic structures due to mechanical or thermal-mechanical loading. Besides, previous studies have primarily reported the occurrence of WEL at corrugation peaks [16,21]. However, through continuous OM observations, we found that WEL and BEL can form not only at the peaks but also at troughs and along the slopes of corrugation. This phenomenon could be explored further in future studies.

**Fig. 12.** A mixture of WEL and BEL at (a) 216–218 mm; (b) 38–40 mm. ND indicates the normal direction and TD traffic direction.

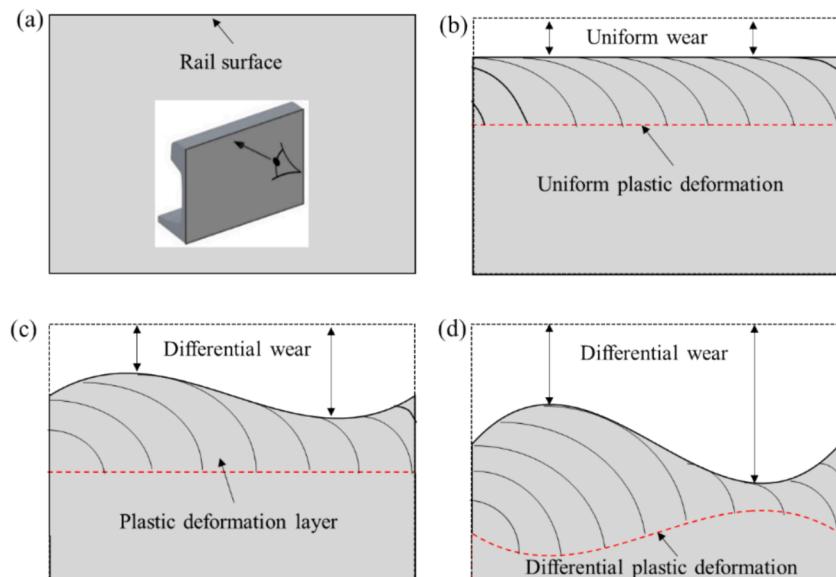
Based on the microstructural analysis in this work and the numerical simulations in [10,19], the corrugation damage mechanism is identified as four phases, as depicted by a schematic drawing in [Fig. 13](#). At the beginning (Phase I), the rail is new without damage, as shown in [Fig. 13a](#). After certain load cycles before corrugation initiates, the rail surface is worn uniformly and a homogeneous PDL forms, as shown in [Fig. 13b](#). The formation of PDL could possibly be caused by the contact surface asperities that leads to local stress concentration and a much higher pressure than smooth-surface contact [36]. This phase (II) is referred to as ‘pre-corrugation damage’, supported by the microstructural observations of the non-corrugation zone in [Figs. 8](#) and [9](#). Afterwards, an initial excitation starts to take notable effects in the vehicle-rail system, causing longitudinal dynamic force, visible accumulation of differential wear, and corrugation initiation [10], as shown in [Fig. 13c](#). Differential wear means that rail wear is more at corrugation troughs than peaks, which results in a thinner PDL at the troughs. This is consistent with the observations in [Fig. 7](#), where the PDL thickness follows an approximately sinusoidal pattern, in phase with the corrugation geometry. This phase (III) is referred to as ‘corrugation initiation damage’, primarily driven by differential wear.

With increasing accumulation of differential wear, corrugation continuously grows with larger amplitude, as shown in [Fig. 13d](#). During this phase (IV), corrugation itself becomes an increasingly significant excitation to the vehicle-track system that causes larger vertical dynamic force, additional to the initial excitation [10]. Based on the numerical simulations in [19] with severe corrugation, the corrugation peaks experience higher residual stress and plastic strains compared to troughs, causing greater plastic deformation at

**Fig. 13.** The schematic drawing of the corrugation damage mechanism. (a) Phase I, new rail without damage; (b) Phase II, pre-corrugation damage with uniform wear and plastic deformation; (c) Phase III, corrugation initiation damage primarily driven by differential wear; (d) Phase IV, corrugation growth damage dominated by both differential wear and differential plastic deformation.
