# Assessing Salt-Induced Degradation in Historic Timber-Masonry Buildings Using Micro-Drilling: A Dutch Soda Factory Case Study

The timber elements of the monumental Sodafactory building in Schiedam, the Netherlands, were investigated to assess the extent of salt-induced degradation. The damage was primarily caused by defibration, a chemical process caused by salt crystallization within the wood structure, which separates the wood cells, induces mechanical rupture, and ultimately results in a complete loss of strength. While the damage is visually detectable, it is difficult to quantify reliably. To address this, micro-drilling measurements were performed in radial and tangential direction on eight wooden beams, which appeared to be severely defibrated. Micro-drilling proved effective for quantitative measurements of decay, supported by a TU-Delft developed algorithm to scientifically determine decay from micro-drilling signals. Results showed that, beneath the layer of defibrated wood, the beams generally remained structurally sound. Only two of the eight beams were found to be severely decayed, with less than 50% of their original cross-section remaining intact. Microscopic anal

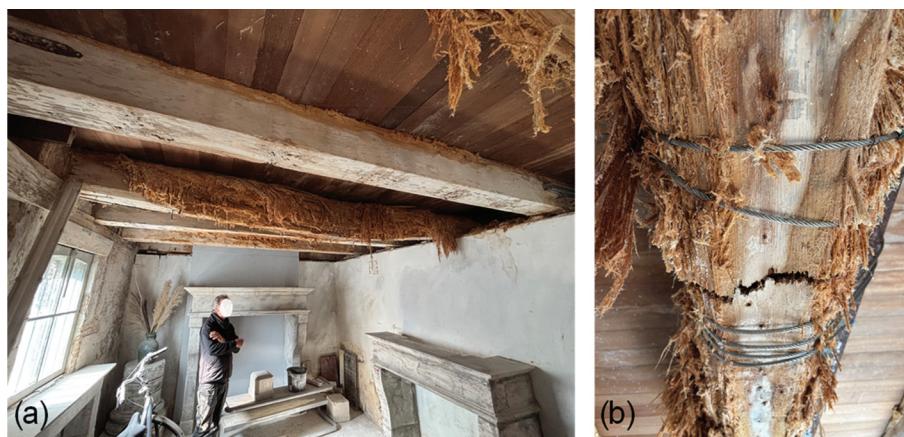
The second floor of the Lijfland building was used to store soda in containers, allowing it to dry and crystallize. It is highly likely that this process was the primary cause of degradation observed in the wooden elements. Water, rendered alkaline by the presence of sodium carbonate, could come into contact with the wooden beams, leading to chemical damage and accelerated deterioration of the wood. This theory helps to pinpoint a specific salt source in the building, useful for identifying the cause of the damage. Based on this assumption, selected primary and secondary beams on the ground, first, and second floors of the Lijfland building were investigated (see Chapter 2: Materials), with the choice

**Figure 3.** Effect of crystallization in timber beams (a) leading to the rupture of a secondary timber beam (b) on the ground floor.

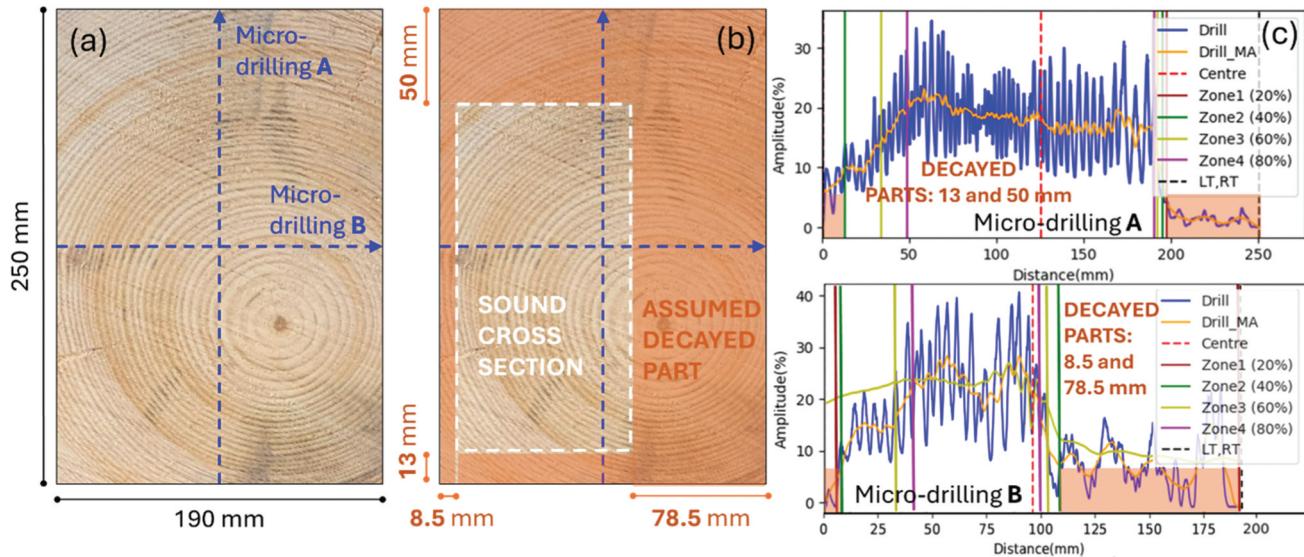
The decayed regions were primarily concentrated in the top portion of the beams, corresponding to the upper part of the radial micro-drilling measurement (right side of signal A). This is likely due to the top of the beam being in contact with the floor's transversal purlins, where moisture could accumulate more than in other areas. The limited ventilation at this interface would further promote moisture retention, facilitating the transport of salts and accelerating crystallization within the beam. The micro-drilling assessment in the tangential direction generally indicated lower decay compared to the radial direction, limited to approximately 3 cm. An exception was observed in beam SF-S03-2, where a decay depth of 78.5 mm was measured on the right side. This is shown in [Figure 9b](#), which also illustrates a precautionary steel beam placed adjacent to the test beams. Notably, the high radial decay can likely be attributed to the beam's position directly above the soda tanks, where damage was more extensive. Finally, the micro-drilling analysis of primary beam SF-P06, which showed very limited signs of deterioration ([Figure 9c](#)), confirmed the absence of relevant decay within the beam. Micro-drilling demonstrates its effectiveness in measuring wood decay in the Sodafabriek. Especially in the case of extensive decay, when a portion of the beam is largely covered by defibrated wood, it would be difficult to accurately estimate the depth of damage without quantitative techniques such as micro-drilling.

**Figure 8.** Decay assessment with micro-drilling: (a) cross section of the beam (example with secondary beam SF-S03-2) and relative micro-drilling measurements A and B. (b) Assumed decay part of the cross section based on decayed parts measured radially with micro-drilling A (c) and with tangentially with micro-drilling B (d). The areas in orange represent the assumed decayed parts of the spruce beam, based on micro-drilling measurements.

- (3) Results showed that while the outer layers of the beams exhibited extensive decay, the inner timber cores often remained structurally intact. In two beams, however, more than 50% of the cross-section was severely degraded. The defibration damage was often more severe on the upper side of the beams, at the interface with the transversal purlins of the floor, likely due to poor ventilation and the accumulation of residual moisture in this area.

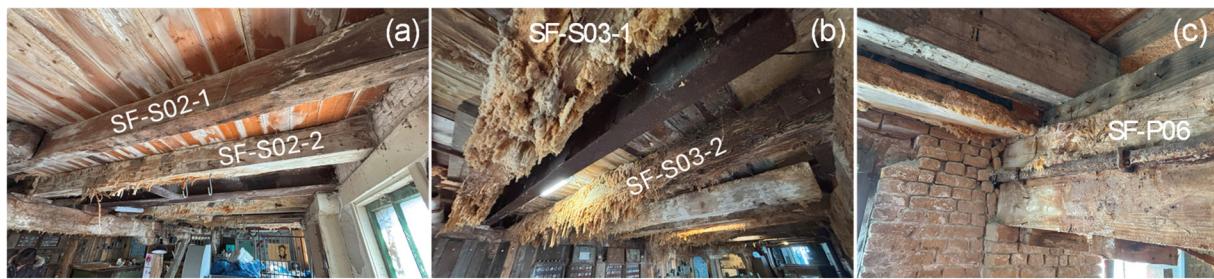
**Figure 9.** (a) beams assessed at the 2nd floor of Lijfland building, in the first span showing limited signs of defibration. (b) beams located on the 2nd floor in the mid bay, showing extensive signs of defibration. (c) detail of the connection between masonry wall and primary beam SF-P06.

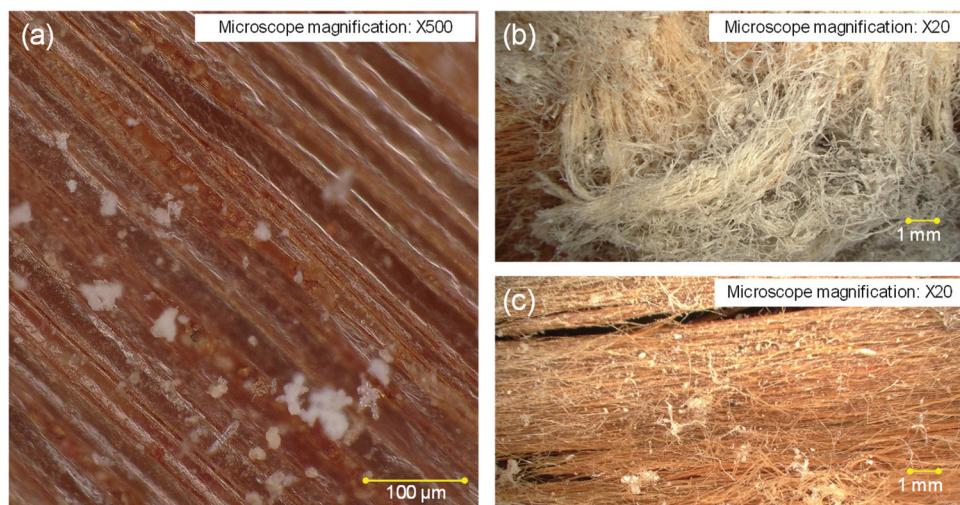
Figure 10a shows a wood sample extracted from a sound portion of the outer surface of the analysed beam. The fibers appear compact, with crystalline deposits visible along the cell walls, suggesting localized salt accumulation. Figure 10b shows the surface of a defibrated sample, where extensive fiber separation and defibration indicate advanced mechanical rupture of the wood cell structure (Johnstone et al. 2007; Kirker, Zelinka, and Passarini 2016). The corrosive actions of the salt degraded the middle lamella causing wood cells to separate (Ortiz et al. 2014), ultimately leading to long fibers well separated from each other as visible in Figure 11b.

Finally, Figure 10c illustrates a sample taken directly beneath the defibrated wood layer, after the removal of the decayed fuzzy part, in a zone where the beam

**Figure 10.** Microscopic views of wood samples from beam SF-S03-1: (a) sound sample taken from the beam's outer layer. At 500 $\times$  magnification, the fibers appear compact, with crystalline deposits along the cell walls, indicating localized salt accumulation. (b) Defibrated samples. At 20 $\times$  magnification, the surface exhibits extensive fiber separation and defibration. (c) Sample taken below the defibrated part of the beam. At 20 $\times$  magnification, the fibers appear intact, presenting residuals of defibrated wood tissue and scattered crystalline deposits.

appeared visually intact. Here, the fibers are better preserved than in Figure 10b, although slight defibration and scattered crystalline deposits remain, representing a boundary part where the defibration started.

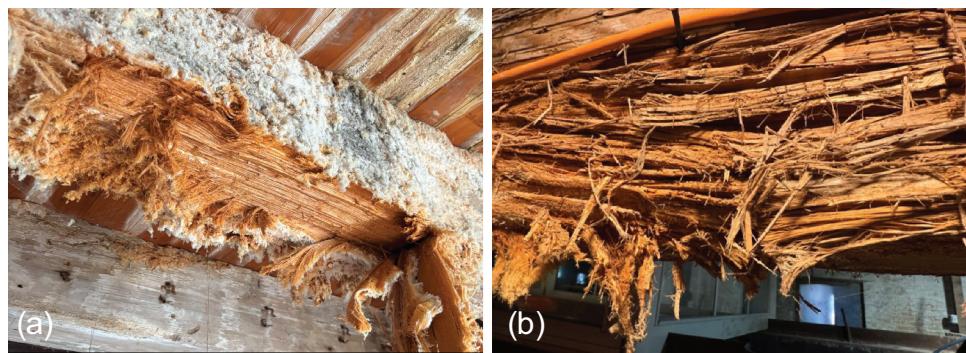
**Figure 11.** Salt-induced damage leading to: (a) defibrated outer surface of the timber beam, while beneath the fuzzy, decayed layer, the wood structure appears intact; (b) long wood fibers, well separated from each other, between the white salt deposits on the beam.

These observations align with the micro-drilling results, confirming that defibration and decay are mainly concentrated in the beam's outer layers. Beneath the degraded surface, the wood is less decayed and retains a uniform structure (Figure 11a), suggesting that much of its load-bearing capacity is preserved. Nevertheless, the significant presence of salt on the wood surface indicates a continuing risk: if exposed to high moisture levels, these salts could possibly reactivate, promoting ongoing decay.

- (5) Preventive interventions are recommended, including improving roof isolation to avoid water ingress, and removing surface salts on timber beams to limit further defibration damage.
