Confirming Debonding of Non-Metallic Inclusions as an Important Factor in Damage Initiation in Bearing Steel

Nikolic, Ksenija; De Wispelaere, Jelle; Ravi, Gopalakrishnan; Hertelé, Stijn; Depover, Tom; Verbeken, Kim; Petrov, Roumen H.

In this work, we investigated a failed tapered roller bearing that operated in a wind turbine. The bearing was removed from the gearbox following the formation of an axial crack. All specimens were extracted from the inner ring. The specimens are made of AISI 52100 martensitic steel and have a chemical composition as shown in Table 1. The resulting microstructure consists of tempered martensite, spheroidal carbides homogeneously distributed in the martensitic matrix, and transition carbides [42]. Transition carbides are precipitates formed during tempering treatment from supersaturated martensite; they include η and ϵ carbides [46]. To examine the presence of non-metallic inclusions (NMIs) and any associated damage in the bearing, 4 samples were cut from the zone of interest along circumferential and axial planes in the loaded zone (Figure 1). Samples were prepared for metallographic observation using a Struers (Struers, Ballerup, Denmark) type 50A15

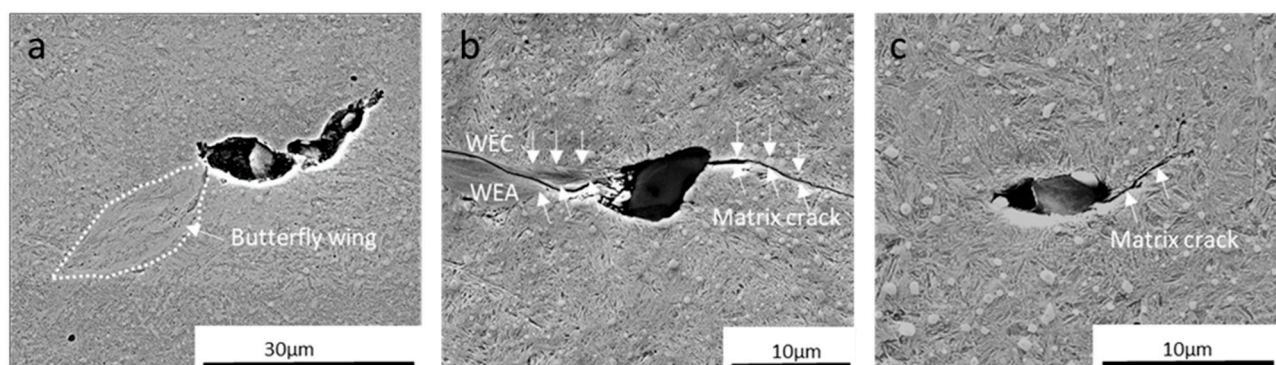
This work distinguishes between inclusions forming “butterfly wings”, white etching cracks/white etching areas, and matrix cracks. In the investigation, WECs were observed with a WEA, and no WEA was present without a WEC. The EDS spectra and point analysis of WEA can be found in Appendix A, Figures A1 and A2. “Butterfly wings” are small features measured in tens of micrometers—these are wings-shaped white etching zones with a typical 45-degree orientation to the raceway surface. White etching cracks are recognized as cracks with shallower angles that typically exhibit a longer appearance than BWs, with an accompanying white etching area. Matrix cracks refer to cracks starting from inclusions in the bulk material without the formation of a WEA. These three different types of damage are shown in Figure 3. Some inclusions showed two types of damage: a matrix crack observed on the left side and a butterfly wing on the right (Figure 3b). Therefore, one inclusion may fall into two categories. The damage orientation is measured as the angle between the matrix crack/WEA/WEC and the orientation of the image.

Figure 3. SEM-SE images of different types of damage observed in this study. (a) Appearance of butterfly wings. (b) White etching crack and white etching area. Arrows in the upper part point to the WEC, and arrows in the lower part indicate the WEA and (c) matrix crack.

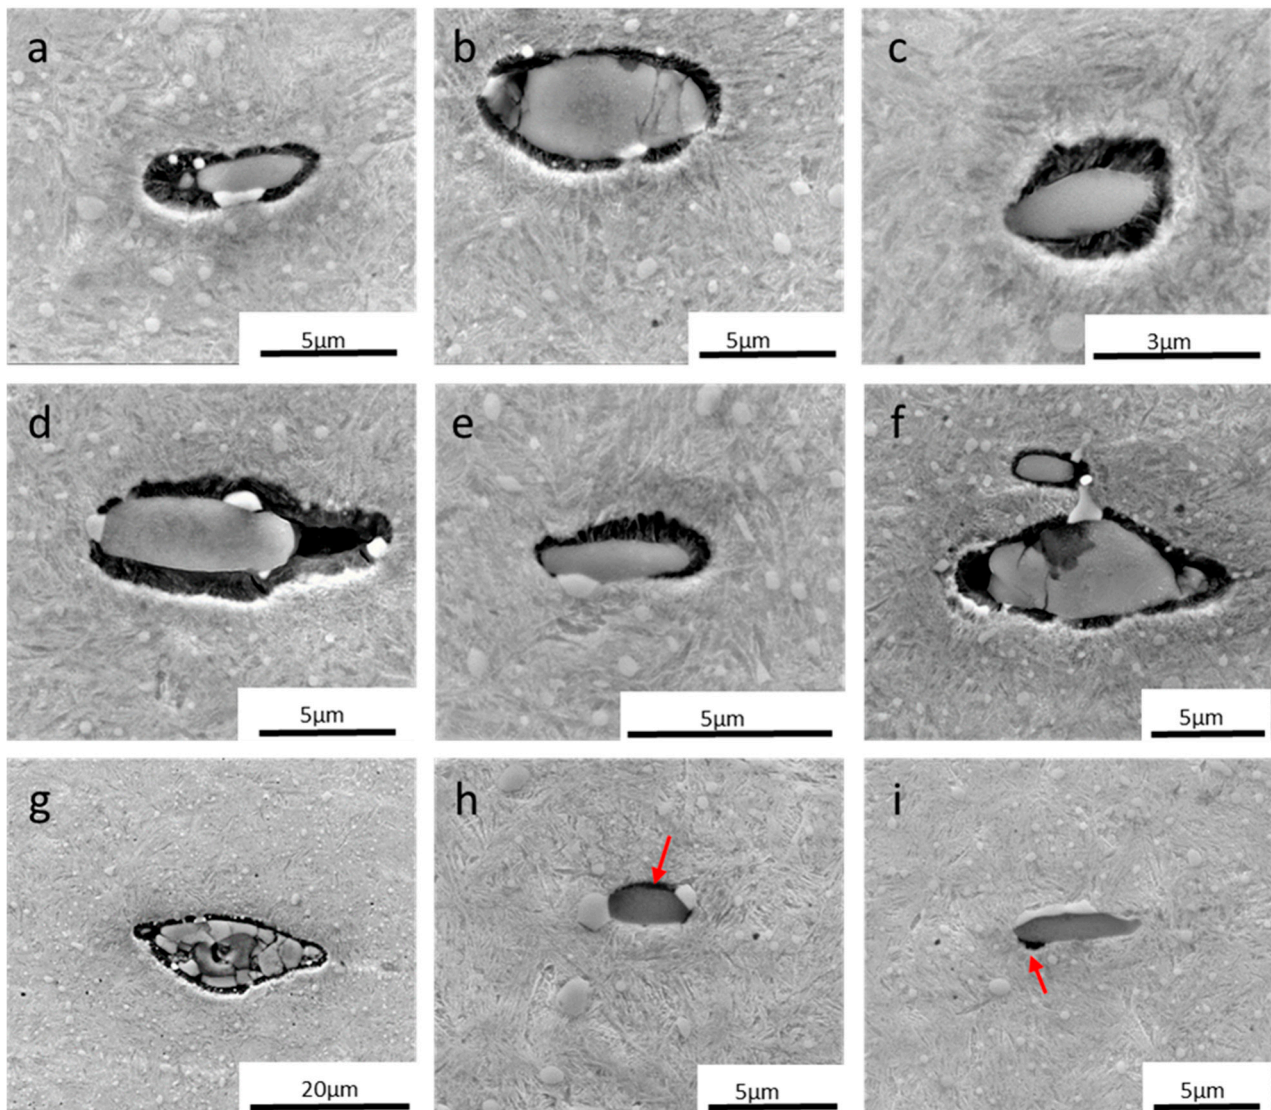
To understand the role of non-metallic inclusions in damage formation, we first investigated the non-metallic inclusions in the non-loaded zone. For that purpose, 70 inclusions were characterized at distances greater than 3 mm below the raceway surface. According to [23], this distance is sufficiently far below the loaded zone and, thus, will allow assessment of the attachment of inclusions to the bulk material in the initial state prior to the rolling. Microstructural alterations associated with WECs, BWs, and matrix cracks were not observed in this zone. Figure 4 illustrates nine inclusions in the non-loaded zone, showing that seven of them are marginally bonded to the martensitic matrix (a–g). Figure 4h,i depict inclusions that are intensely bonded to the bulk material, although there were slight indications of debonding (indicated in red). Figure 4 shows fragmented inclusions; this is rather unexpected due to the insignificant stress state. Fragmentation of inclusions can be associated with the ring rolling process. To verify that inclusion debonding is not caused by acid damage resulting from the etching process, the sample was repolished and

Figure 4. SEM-SE overview of the inclusions in the non-loaded zone. (a–f) Most of the inclusions shown (6 out of 9) are debonded from the bulk material. (g–i). Examples of bonded inclusions notwithstanding slight detachments indicated by red arrows.

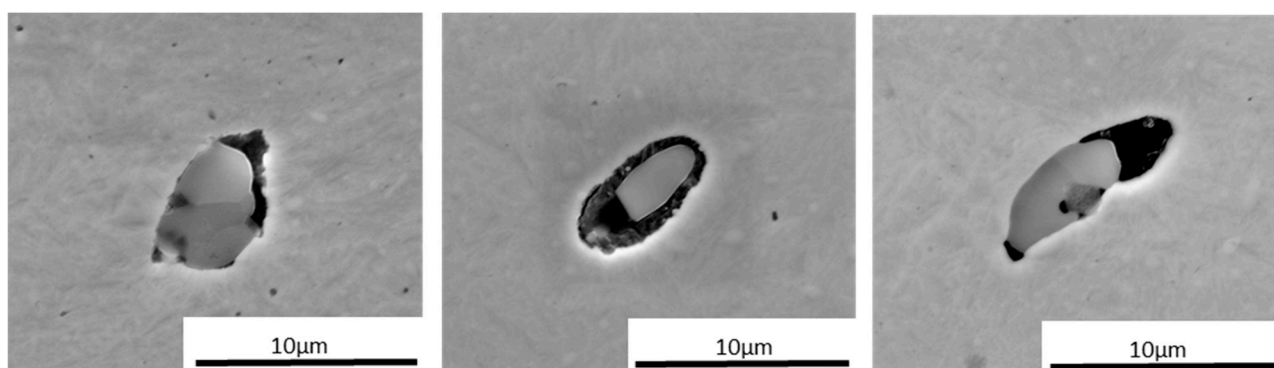
re-examined using SEM, as shown in Figure 5. It can be seen that debonding is still present within the material and was not altered due to the etching process. The average size of the inclusion, average length, aspect ratio, and the number density of the inclusions in the non-loaded zone are presented in Table 2. Most of the inclusions (77%) were MnS, and 88% of all inclusions were detached from the steel matrix. Given the fact that inclusions were already debonded prior to service, the question arises as to whether the initial stage of bonding plays a significant role in damage initiation and development, and consequently influences the bearing lifetime.

Figure 5. The SEM–BSE images of non-etched inclusions in the non-loaded zone confirm debonding in the absence of rolling contact fatigue.

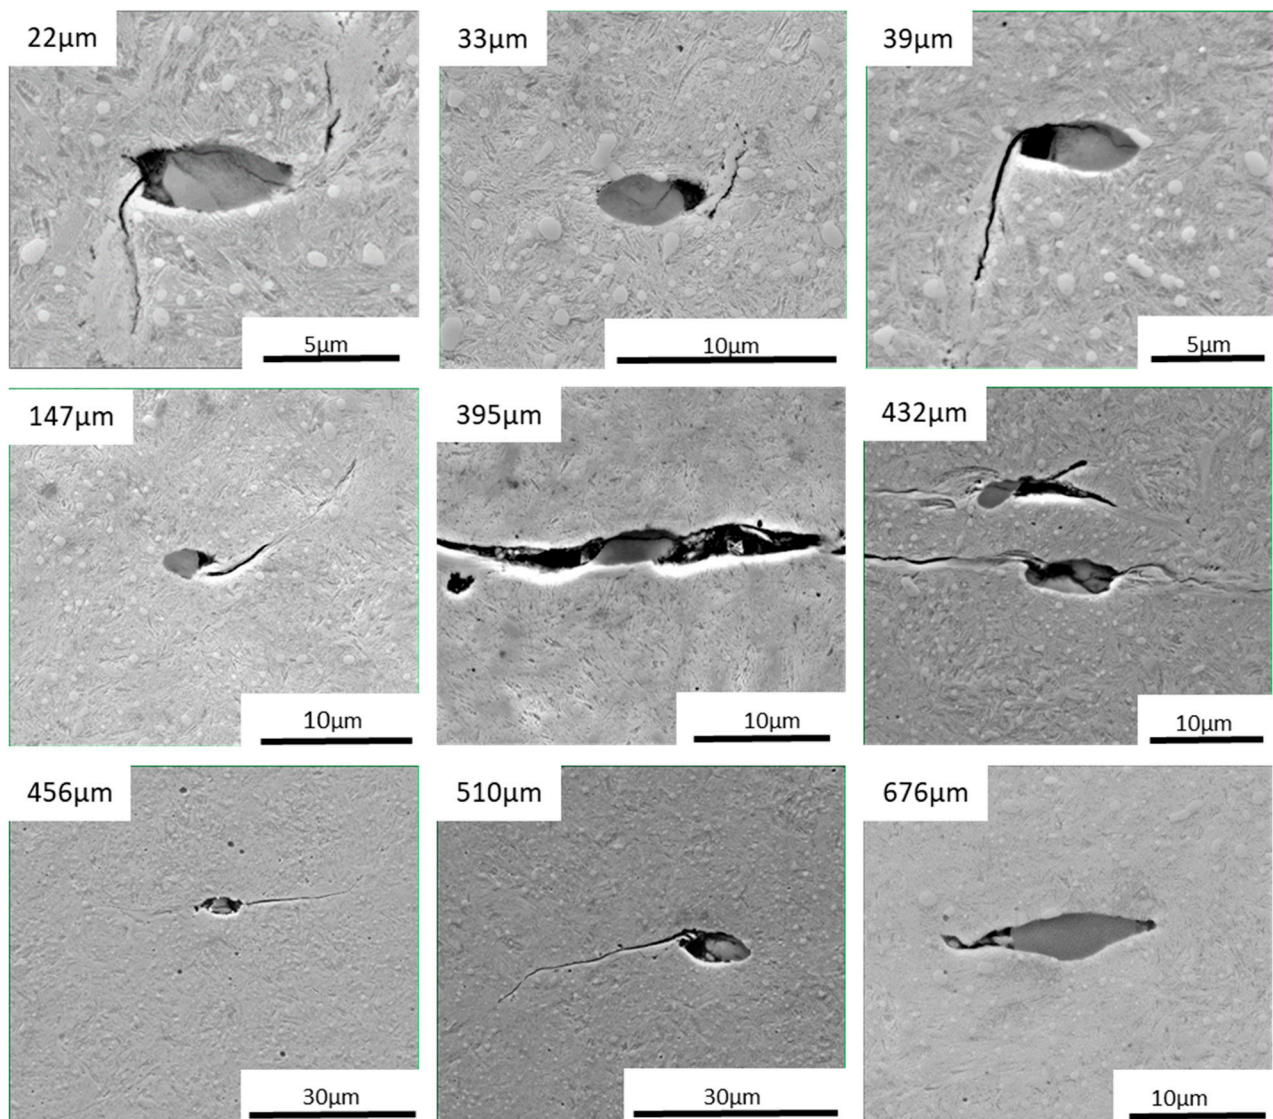
The examination of the loaded zone revealed micro-damaged zones present as butterfly wings, matrix cracks, and white etching cracks. None of the BWs reached the raceway surface; they do not grow, and they do not create networks. Furthermore, WECs were found with a length of a few hundred microns, and no larger networks spanning millimeters in size were detected within the material, although connections between WECs were observed. Figure 6 shows inclusions and the damaged zones around them; the upper-left corner insertion indicates the distance from the raceway surface. It was found that damage is mainly present on the side of the inclusion detached from the bulk material. In addition, 72% of MCs and 73% of WECs started from the debonded side. The distance from the raceway surface varied from 22 to 676 μm , suggesting that debonding plays a role in the majority of the loaded zone rather than at the region of maximum shear stress, the latter of which was determined in [21,24]. Internal inclusion cracking is reported to be one of the forms of damage initiation [21,23,29]. In this study, a possible link between inclusion cracking and stress can be established since inclusion cracking peaked at 500 μm below the raceway surface. Under this distance, fewer cracked inclusions were observed. The inclusions with an equivalent diameter of 2–7 μm , determined as an average of major and minor inclusion axes, showed a larger tendency to crack. However, not all inclusions that developed BW/WEC/matrix cracks showed internal cracking.

Considering debonding as an important factor, all inclusions in the loaded zone were analyzed, and it was found that most of the inclusions (85%) in the loaded zone were detached from the steel matrix. The investigation of the inclusions in the non-loaded zone suggests that the load is not responsible for the debonding. This is most likely due to the different thermal expansion coefficients and/or strain incompatibilities being enhanced during the deformation processing. Moreover, the different thermal expansion coefficients of inclusions with the bulk material can result in the development of tensile and compressive residual stresses parallel to the normal inclusion–matrix interface. In addition, strain incompatibilities during the formation processing of the steel can result in the formation of cavities at the inclusion interface [42]. Given such a high number, it is suggested that size, shape, and chemical composition do not influence debonding of the inclusions.

Figure 6. SEM-SE images of damage around inclusions in the loaded zone. The top-left number represents the distance from the raceway surface. The damage started on the side of the inclusion that was debonded from the bulk material. This is applicable for the wide range of distances (from 22 to 676 μm) from the raceway surface, suggesting that debonding plays a role in the entire loaded zone.

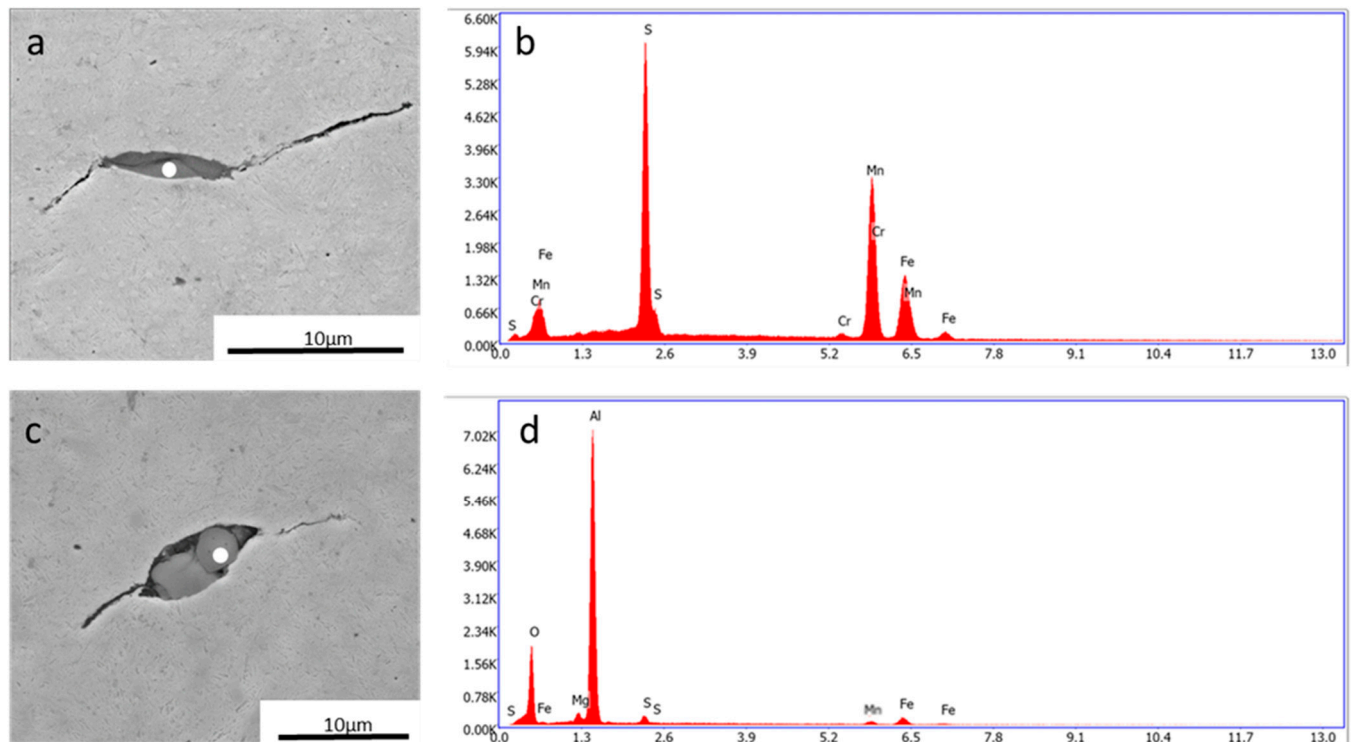
The chemical composition of the studied inclusions was analyzed with energy-dispersive spectroscopy. Only two types of inclusions were present in the studied bearing: pure MnS (77% of the studied database) and MnS with the addition of alumina (aluminum oxide). TiN and pure alumina were not detected in the material. Figure 7a,c show the

non-metallic inclusions captured by SEM, with white dots representing the locations of the EDS analysis. The corresponding EDS spectra of (a) and (c) are represented in (b) and (d), respectively. The different chemical composition of inclusions can also be observed in SEM figures; MnS is light grey without a different contrast, while two ‘particles’ (MnS + Al₂O₃) have different contrast, visible in (c). The percentage of the inclusions that caused a WEA is similar for both types: 34% for pure MnS and 37% for the MnS + Al₂O₃ type. Thus, our observations do not indicate a markable influence of the chemical composition of the inclusion on damage initiation.

Figure 7. Types of inclusions present in this study. (a) SEM–SE figure of MnS inclusion; the white dot is where the spectra were taken. (b) EDS spectrum of the dot in (a). (c) MnS + Al₂O₃ inclusion type; this is also visible in the SEM figure, where contrast is present within different non-metallic compounds. (d) EDS spectrum of the white dot presented in (c).

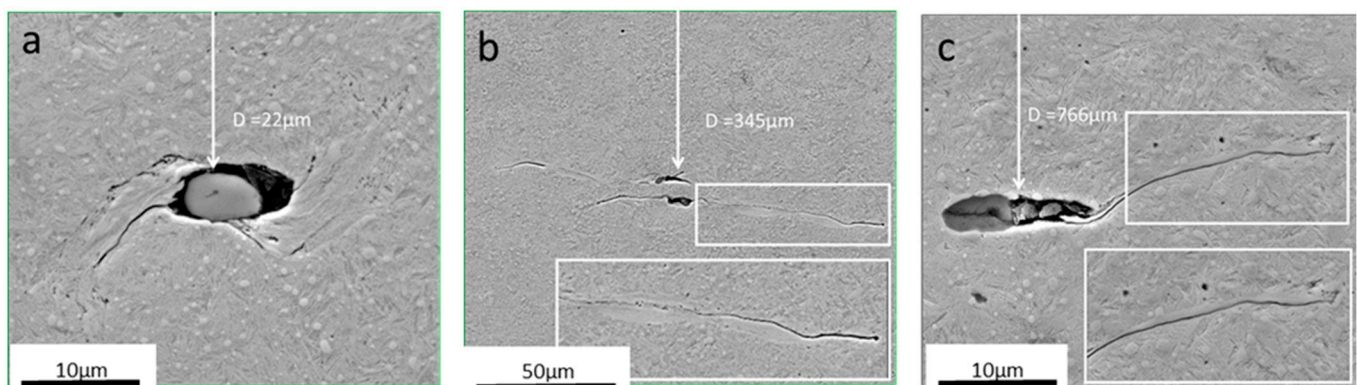
To illustrate potential damage orientations, examples of microstructural alteration are shown in Figure 10. A typical butterfly wing pattern of 45 degrees is depicted in Figure 10a, where both sides of the non-metallic inclusions developed BWs. The distance of this inclusion was very close to the raceway surface (22 μm); however, no connection of the crack to the surface was observed. Further away from the surface (345 μm), microstructural alterations propagate at shallower angles (cf. Figure 10b). Here, cracks also developed from both sides of the inclusions; cracks are longer than BWs, and the altered zone is broader in this zone. On the contrary, at distances greater than 500 μm , cracks were typically evolving from only one side of the inclusions, and a very thin WEA was observed around them (Figure 10c). These findings were consistent throughout this investigation and supported the hypothesis that WECs are an extension of BWs.

Figure 10. Development of damage at the depth of the sample. (a) Orientation of butterfly wing, (b) Orientation of white etching cracks, (c) orientation of matrix crack.

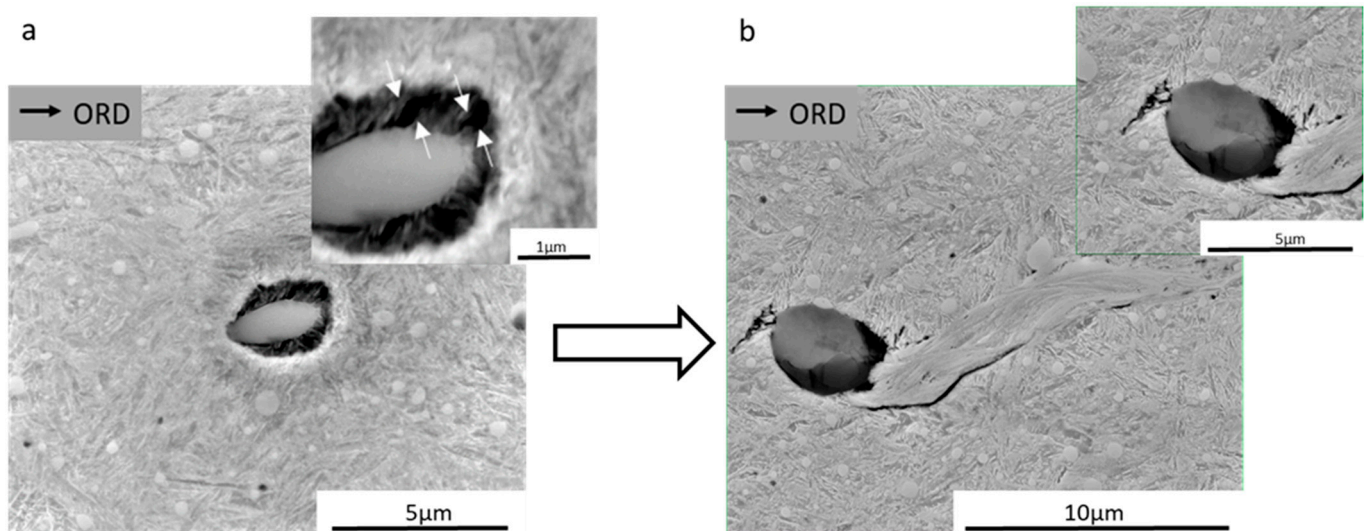
The microstructural observation that proves the proposed formation mechanism of the crack initiation in the bulk material is shown in Figure 13. The debonded inclusion is located in the loaded zone (up to 1 mm from the raceway surface). As the rolling cycles occur, local stress concentration develops around the debonded area, as shown in Figure 13a. Over successive rolling cycles, the stress levels increase, resulting in the formation of voids (regions with white arrows in Figure 13). These voids serve as regions of local high-stress concentration, which eventually develop microcracks into bulk material as means of stress relief. Figure 13b shows an inclusion with a fully developed butterfly wing on the right-hand side, while the left side only has a small indication of the crack in the bulk material.

Figure 13. Proposed damage development. ORD represents the over-rolling direction. (a) Non-metallic inclusion in the non-loaded zone. (b) Once the non-metallic inclusion located in the loaded zone experiences rolling cycles, damage first initiates in the debonded zone and initiates a crack in the bulk material as a way of stress relief.

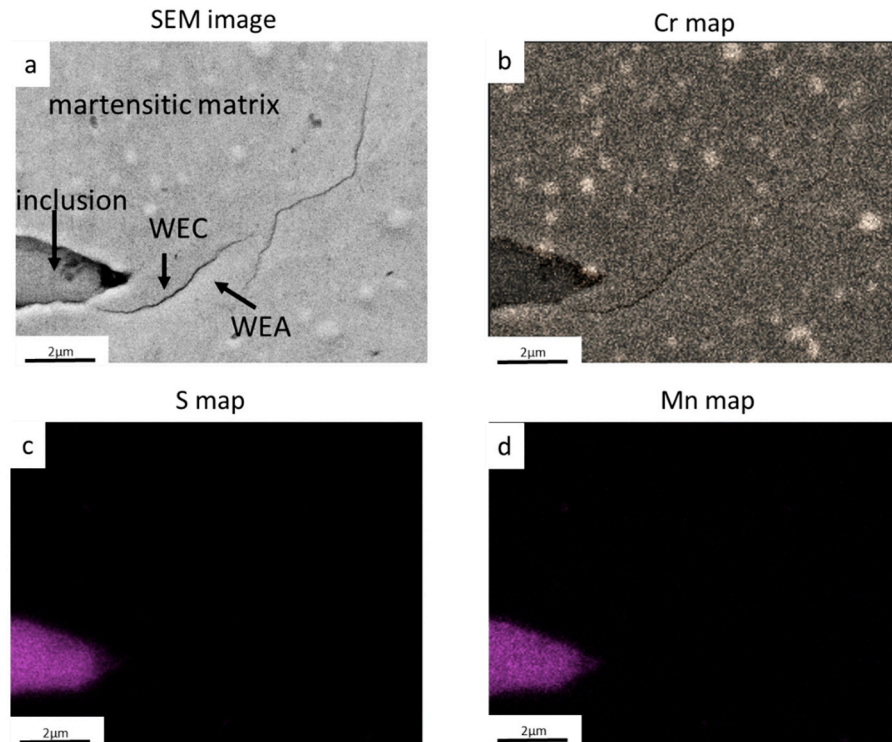
Figures A1 and A2 represent the energy EDS analysis over the white etching area. Figure A1a shows the SEM–SE image over the area of interest. Depletion of chromium carbides in the white etching area is visible from the chromium map in Figure A1b. Sulfide and manganese compositions of the non-metallic inclusion are shown in Figure A1c,d,

Figure A1. EDS spectrum on white etching area and inclusion. (a) SEM–SE image on the area of interest. (b) Chromium map. (c) Sulfur map. (d) Manganese map.

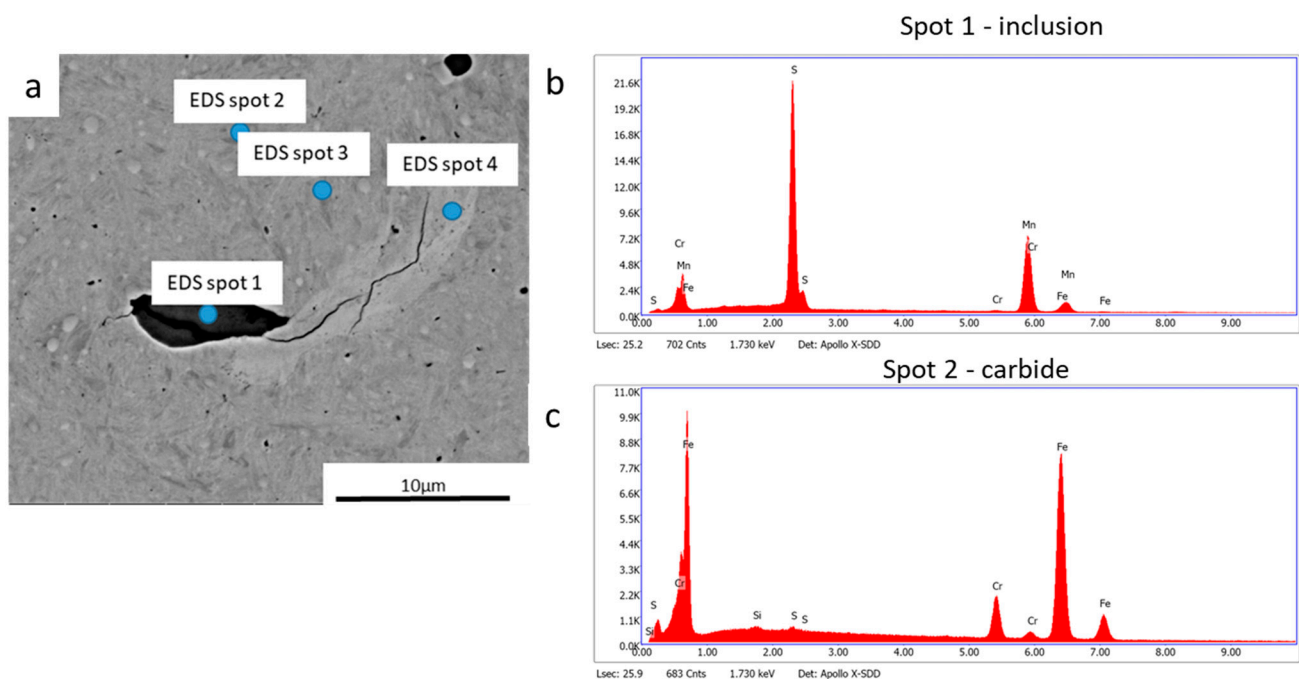
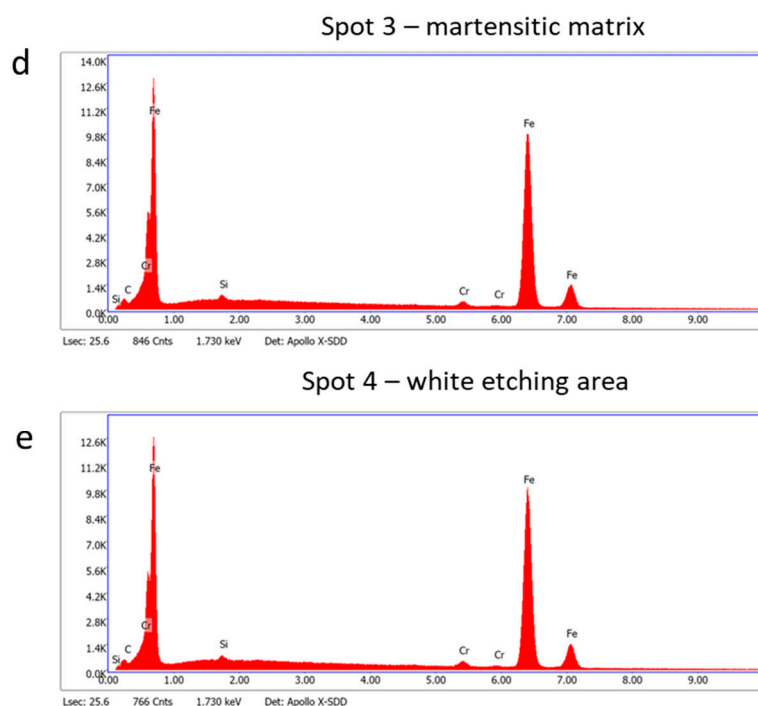
respectively. The spot EDS analysis shows the same area as in Figure A1. The altered zone (white etching area) is more visible in the backscattered image in Figure A2a. The spectra from the inclusion, carbide, martensitic matrix, and white etching area are represented in Figure A2b–e, respectively.

Figure A2. EDS spot analysis. (a) SEM–BSE area of interest; blue dots represent the location where the spectra analysis was taken. (b) Inclusion. (c) Chromium-rich carbide. (d) Martensitic matrix. (e) White etching area.
