# Creep Failure of Reformer Tubes in a Petrochemical Plant

**Abstract:** This paper investigates a failure in HP-Mod radiant tubes in a petrochemical plant. Tubes fail after 90,000 h of working at 950 °C. Observed failure is in the form of excessive bulging and longitudinal cracking in reformer tubes. Cracks are also largely branched. The microstructure of service-exposed tubes was evaluated using optical and scanning electron microscopes (SEM). Energy-dispersive X-ray spectroscopy (EDS) was used to analyze and characterize different phases in the microstructure. The results of this study showed that carbides are coarsened at both the inner and the outer surface due to the long exposure to a carburizing environment. Metallography examinations also revealed that there are many creep voids that are nucleated on carbide phases and scattered in between dendrites. Cracks appeared to form as a result of creep void coalescence. Failure is therefore attributed to creep due to a long exposure to a high temperature.

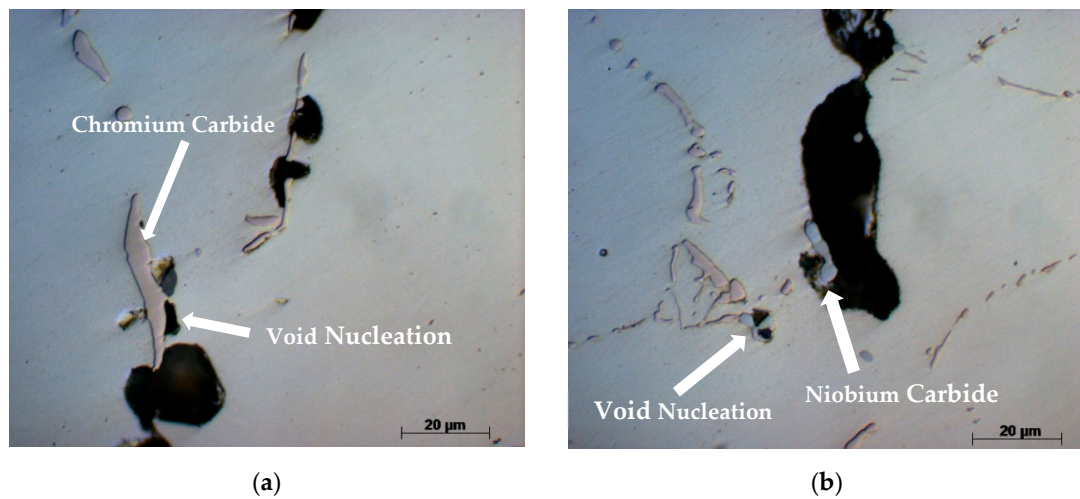
**Figure 5.** Void nucleation on (a) chromium carbide and (b) niobium carbide particles.

- Creep voids were nucleated on both chromium and niobium carbides. Cracks were formed due to the growth and coalescence of voids.
- The root cause analysis of the concerned failure showed that tubes failed due to creep failure.
