## Root cause analysis of surface cracks in heavy steel plates during the hot rolling process

# Root Cause Analysis of Surface Cracks in Heavy Steel Plates during the Hot Rolling Process

**Abstract:** This paper investigates the root cause of the formation of surface cracks on hot-rolled C–Mn constructional steel heavy plates. Cracks are rather evenly distributed over the surface in the form of colonies of cracks. Samples were cut from the heavy plate. The microstructure of samples in the as-cast and hot-rolled states were studied using optical and electron microscopes as well as energy dispersive X-ray spectroscopy (EDS). Results show that cracks are heavily oxidized. De-carburized areas are also seen alongside cracks. The crack tip is in the form of a deer-horn, indicating that crack branching has taken place during deformation. The crack initiation sites are V-shaped grooves on the surface of as-cast slabs. Correlations between microstructures, processing parameters, and crack formation are discussed.

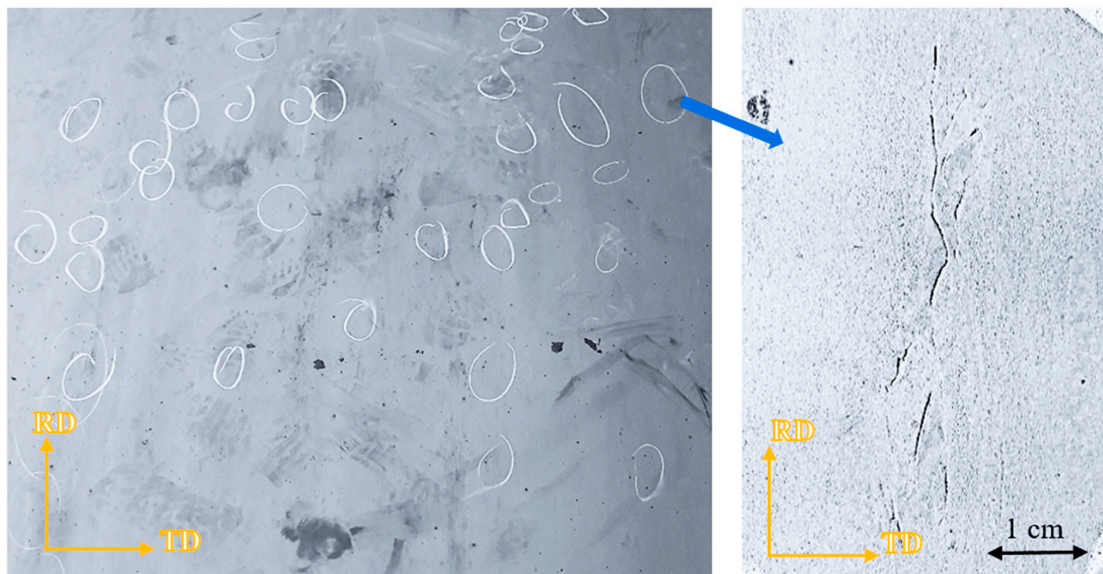
Surface cracks in this case are related to heavy plates of 30 cm thickness with average chemical composition 0.16 C–1.20 Mn–0.022 P–0.02 S–0.257 Si–0.045 Al–Fe (Bal.) (wt. %). Original slabs were made by continuous casting. Slabs were pre-heated at approximately 1250 °C up to 4 h, and were hot rolled to the final thickness of the heavy plate (30 cm) after approximately 16 passes in a reverse mill. Figure 2 shows the visual appearance of surface cracks on the heavy plate. Cracks are scattered all over the surface. There is no indication that cracks are more frequent at the side or the centre of plates. Spots, shown in Figure 2, are colonies of accumulated smaller cracks. The size of these crack colonies range from 5 to 30 cm. Cracks are all oriented along rolling direction. The depth of observed surface flaws in some cases are so high that plates are inevitably returned to the casting unit. In some cases, surface cracks can be eliminated by surface grinding. This causes major trouble in the rolling company, in the sense that these cracks need to be removed by grinding of the surface, which necessitates spending a lot of time as well as performing double inspection (one before grinding and the other one after grinding). This work aims at investigating the root cause of the problem.

**Figure 2.** Visual appearance of surface cracks on the surface of heavy plates.

To solve this problem, one needs to minimize the formation of surface V-grooves, given that these surface irregularities are spots, where cracks can nucleate. Presence of the oxide phase inside the crack is possibly to do with an improper pre-heating atmosphere. In case the oxygen/gas ratio in the pre-heating stage is not optimized, free excess oxygen can enter into surface notches and this results in the formation of an iron oxide phase inside cracks. The oxide phase is in nature a brittle phase which cannot accommodate plastic deformation. Besides, oxidization inside cracks is associated with de-carburization of the alloy in the vicinity of the cracks. In the worst case condition, this will result in a fully ferritic microstructure adjacent to the crack. This means that the area close to the crack is comparatively softer and undergoes a higher degree of deformation, which in turn has

implications for crack propagation. One way to tackle this problem is therefore trying to minimize oxidation during reheating. During reheating of the slab before rolling, oxygen present in the reheating furnace diffuses through the crack opening and reacts with the carbon of the steel, resulting in partial decarburization around the crack. Decreasing the oxygen/gas ratio in reheating furnaces could have a key positive impact.

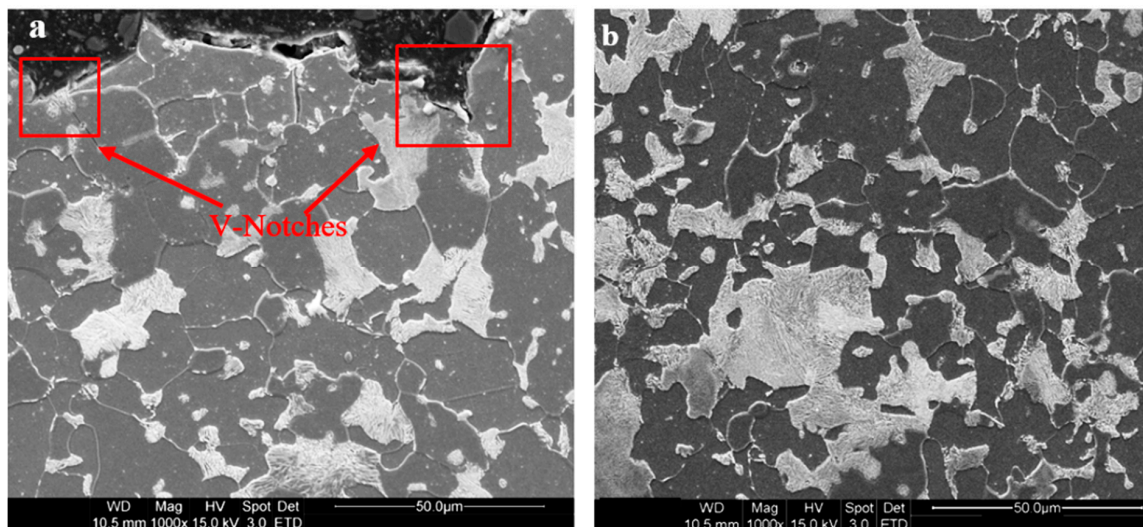
Figure 3 shows a SEM image of the typical ferritic–pearlitic microstructure of heavy plates in the bulk and surface of slabs (before hot rolling). There were not many inclusions found in the microstructure, inferring that the quality of the alloy in terms of secondary oxide/sulphide particles was overall very good. Typical features at the surface of the slab were surface V-notches, as marked in Figure 3a. These V-notches have depth in the order of a few tens of micro meters and are filled with surface oxide scales/phases. V-shaped grooves are possibly formed because of oscillation during the casting stage. Oscillation marks are a normal surface feature in continuously cast slabs. They periodically form at the meniscus because of mold oscillation. Yet, in case of improper control, the depth of these oscillation marks can increase to levels that they act as crack initiation sites [17,18].

**Figure 3.** Typical ferritic–pearlitic microstructure from (a) the surface and (b) the bulk of slabs.

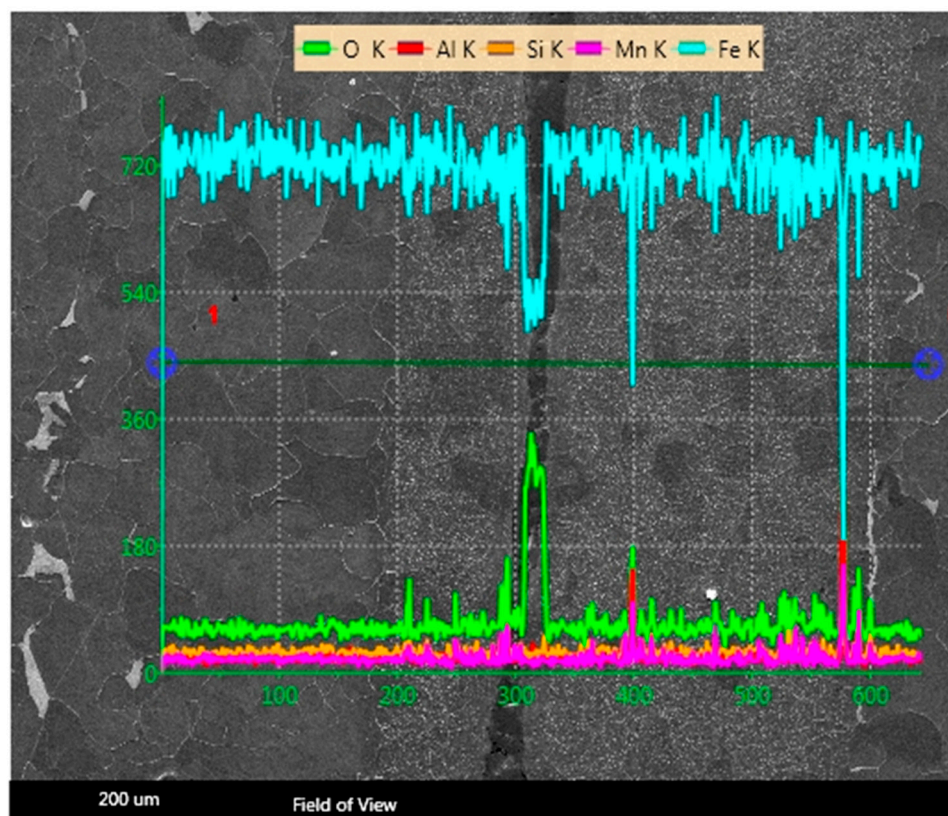
Figure 4 represents an elemental line scan on top of a crack. As can be seen in this figure, the concentration of oxygen at the crack is significantly higher than that in the vicinity of cracks, inferring that the crack is filled with an iron oxide phase.

**Figure 4.** Elemental line scan on top of a crack at the surface of the heavy plate.

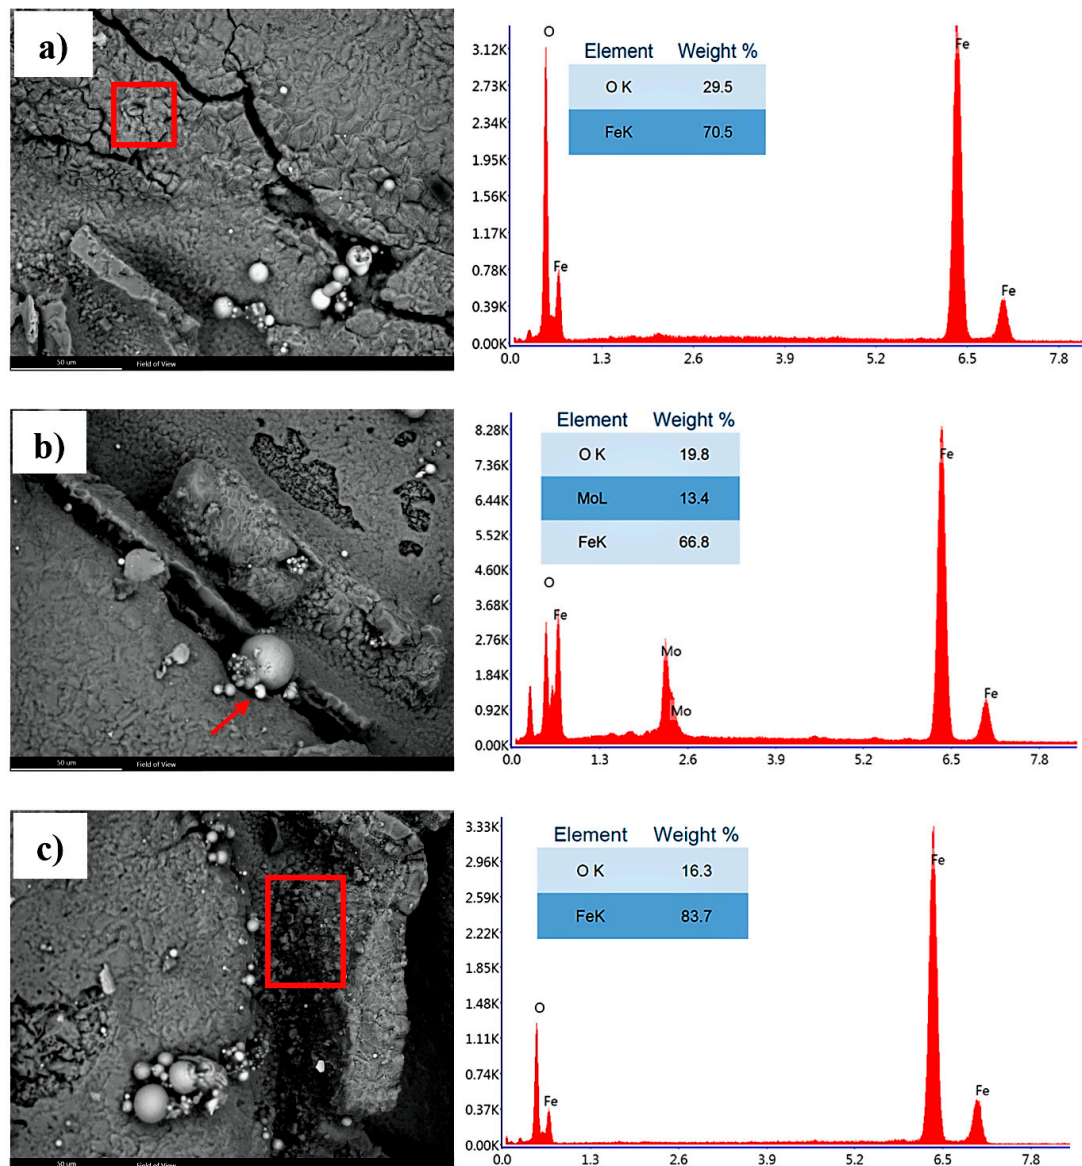
Figure 5 shows SEM images of a crack at the surface. It appears that the crack is formed due to the breakage of the oxide layer on the surface. Some rounded particles are also observed inside cracks and in areas in the vicinity of the cracks with their sizes ranging from a few microns up to 30 microns. Three different features were analyzed using EDS, i.e., the surface, as shown in Figure 5a, rounded

white particles, as shown in Figure 5b, and small particles inside cracks, as shown in Figure 5c. Results of EDS analyses indicate that rounded particles are either iron oxide particles or molybdenum-rich particles. Small molybdenum-rich particles are only in small percentages of rounded particles inside cracks. Most particles inside cracks are iron oxide particles. Given that the starting material is not expected to contain any molybdenum, and as molybdenum is not added to the melt, the only option left for the origin of these molybdenum-rich particles must be residues from the processing.

**Figure 5.** SEM images and energy dispersive X-ray spectroscopy (EDS) analysis of cracks on the surface of a hot-rolled heavy plate. The highlighted spot is analyzed by EDS. (a) Surface area surrounding crack, (b) rounded white particles, and (c) small particles inside cracks.

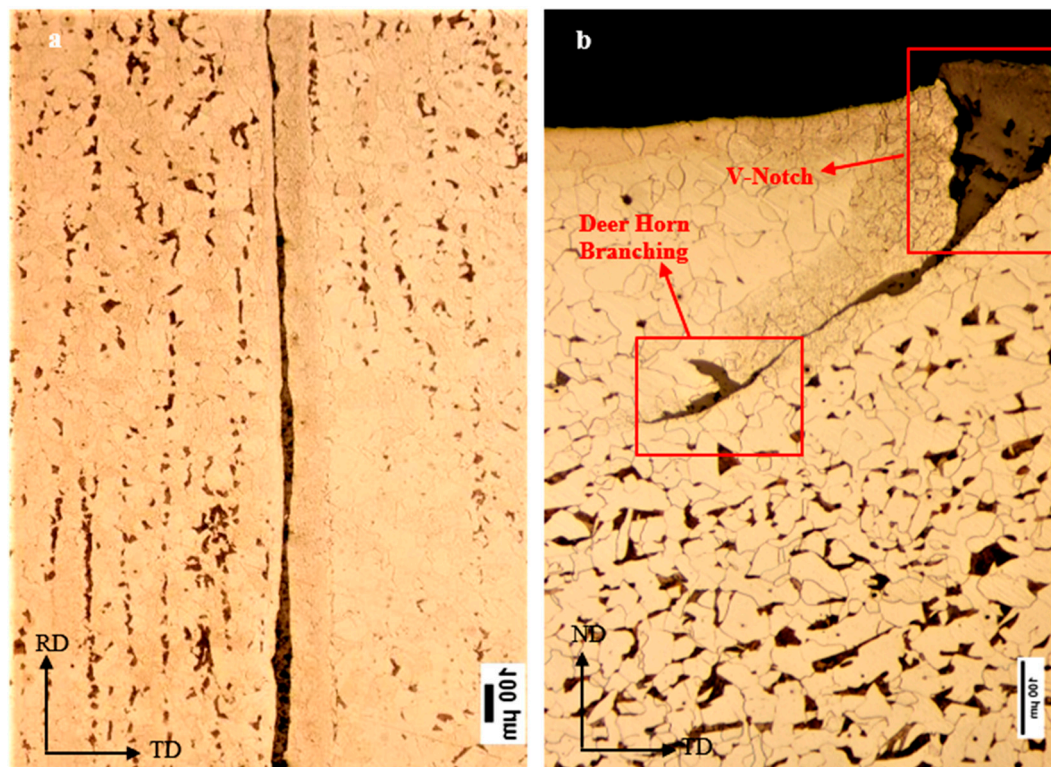
Figure 6 reveals optical microscope images of the microstructure around the crack. There are several features worth mentioning. First of all, the crack is completely filled with an iron oxide phase. The presence of this oxidizing environment inside the crack results in de-carburization in the vicinity of cracks, in such a way that there is a band of fully de-carburized ferritic microstructure alongside the crack. The microstructure of the steel away from the crack is ferritic–pearlitic as commonly observed in plain carbon steel plates. Other than this de-carburized layer, there is no other

microstructural abnormality, like excessive grain coarsening or deformed/elongated grains in either side of the surface crack.

**Figure 6.** Optical microscope images of cracks (a) from the top and (b) perpendicular to the crack.

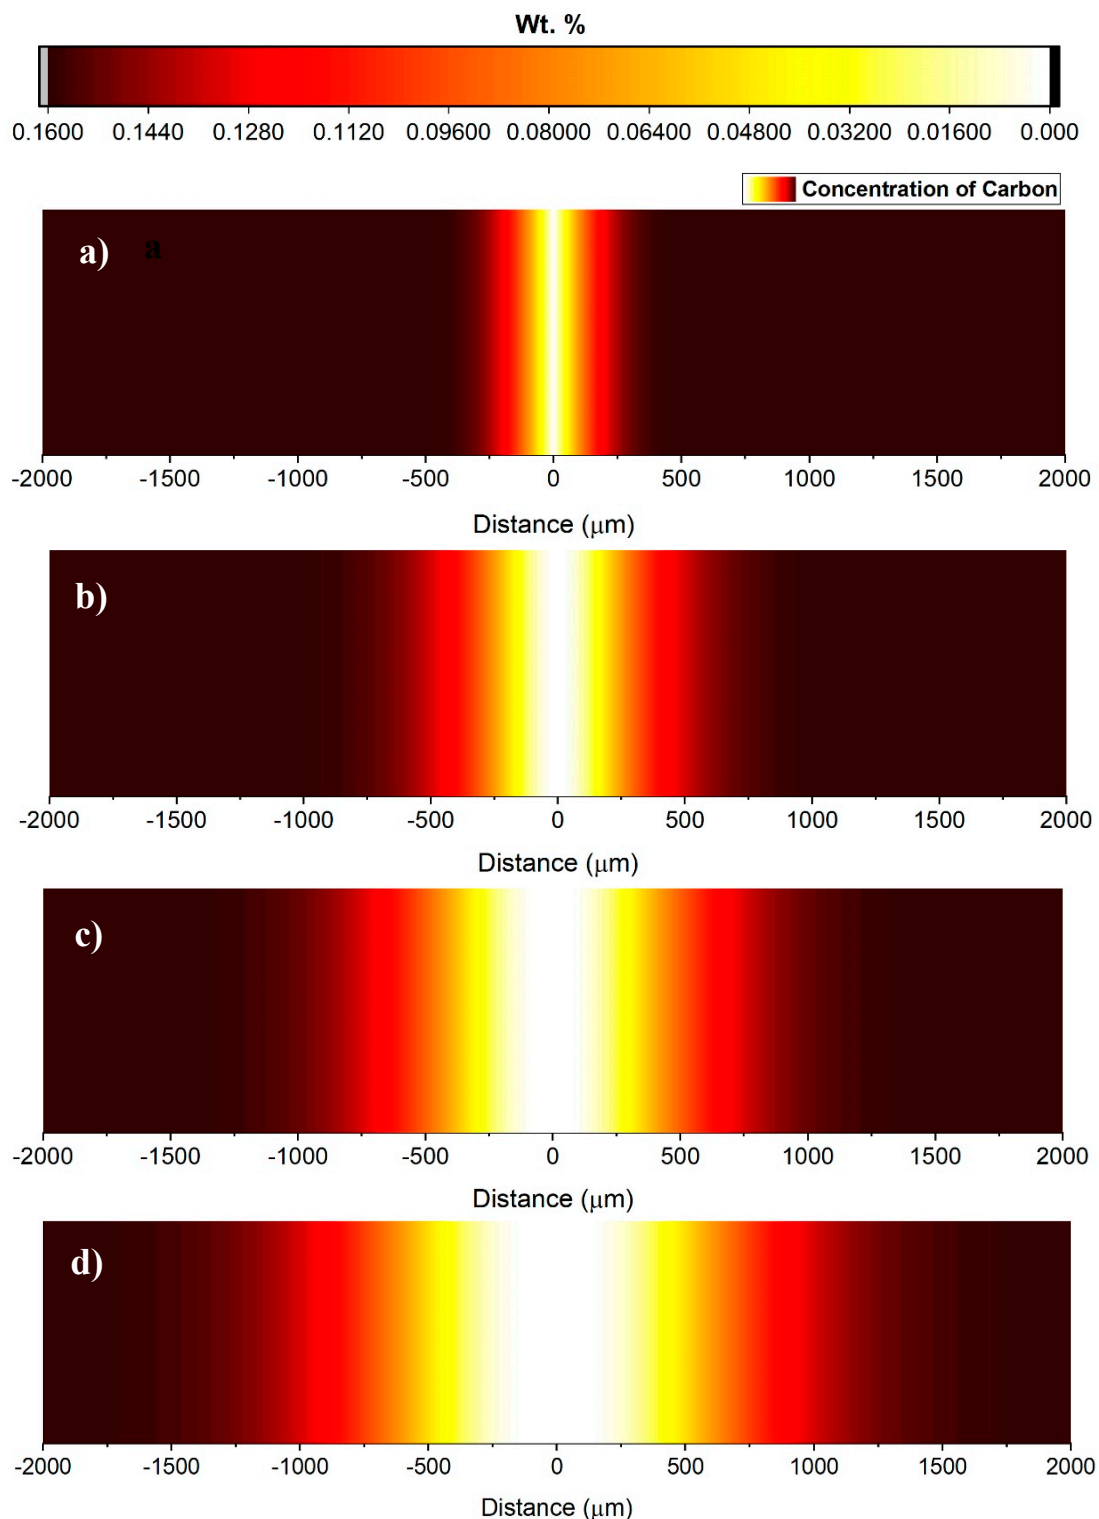
where  $D_0 = 2.3 \times 10^{-5} \text{ m}^2/\text{s}$ ,  $Q = 148 \text{ kJ/mol}$ , and  $R = 8.314 \text{ J/mol}\cdot\text{K}$  [20]. An average value of  $1100^\circ\text{C}$  was assumed for the rolling temperature. Figure 7 shows the contour of carbon diffusion across the crack. Results show that after 16 passes carbon is heavily depleted in approximately  $300\text{--}400 \text{ }\mu\text{m}$  distance from the crack. It is also seen that with increasing pass numbers, the depletion layer gets wider. According to Fe-C diagram, pearlite is not expected to form in carbon content less than  $0.008 \text{ wt. \%}$ . Results of this calculation is very well in accordance with the experimental results.

**Figure 7.** Contour of carbon diffusion in and around areas of a crack (a) after 1 pass of hot rolling, (b) after 5 passes, (c) after 10 passes, and (d) after 16 passes.

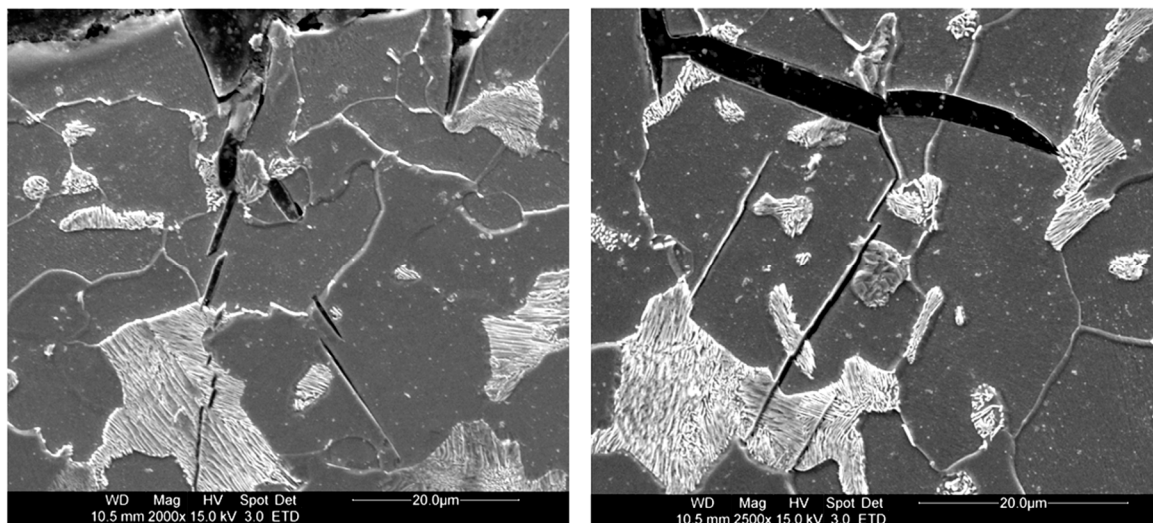
Figure 8 shows other examples of deer-horn crack end branching. It appears that surface cracks are initiated at the tip of V-grooves and are propagated during differential loading. The crack propagation

path is initially straight in the sense it does not seem that crack is following the grain boundary path. The last stages of rolling are associated with crack branching. The cracks must have developed in the initial rolling stages and branched during the subsequent rolling passes. There are many influencing factors that might result in surface cracking on hot-rolled steel heavy plates [10]. Defects of the surface are due to different reasons, but generally they are confined into two main categories: (1) primary defects existed on continuous casting process slabs which propagate or are inherited from defects generated by rolling processes and are originated from upstream rolling processes defects and (2) also these defects can occur because of incorrect rolling technologies and foreign bodies were unevenly rolled in the interface of the strip rolled [6]. In this case the origin of cracks is certainly V-notches. Any mitigation strategy needs to address this problem by trying to eliminate these V-grooves at the surface. Surface notch V-grooves have a very sharp end which obviously is a place where stress intensity goes up and this in turn results in the crack initiation and propagation.

Figure 8. Examples of crack ends branching.

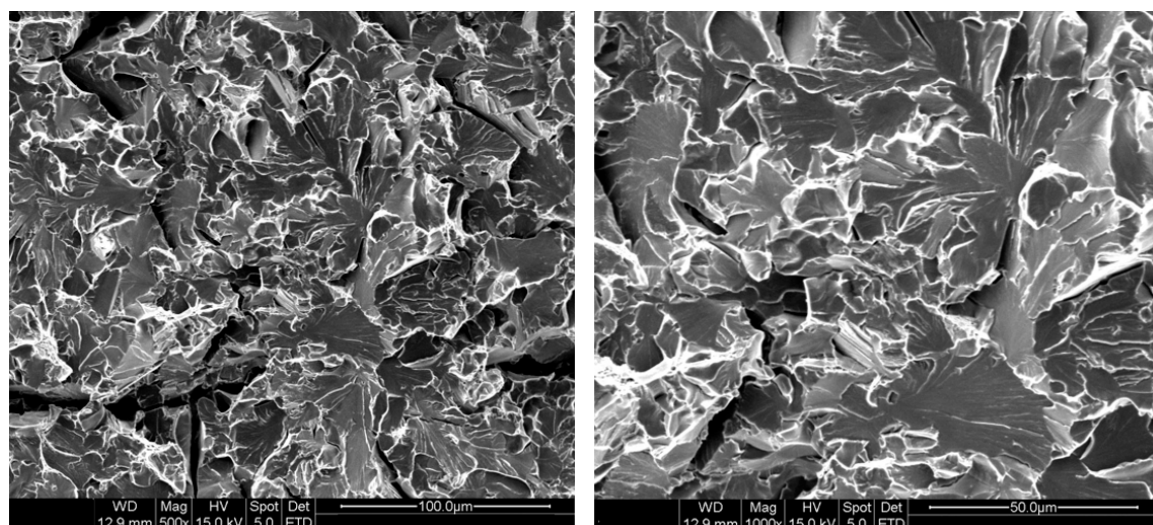
Figure 9 shows the fracture surface of the sample, taken from the surface of heavy plates, containing cracks. The fracture is typically transgranular in nature. As well, one can see de-cohesions and discontinuities at the fracture surface, which are due to the presence of surface cracks in the sample.

Figure 9. Examples of the fracture surface of the sample, containing surface cracks.

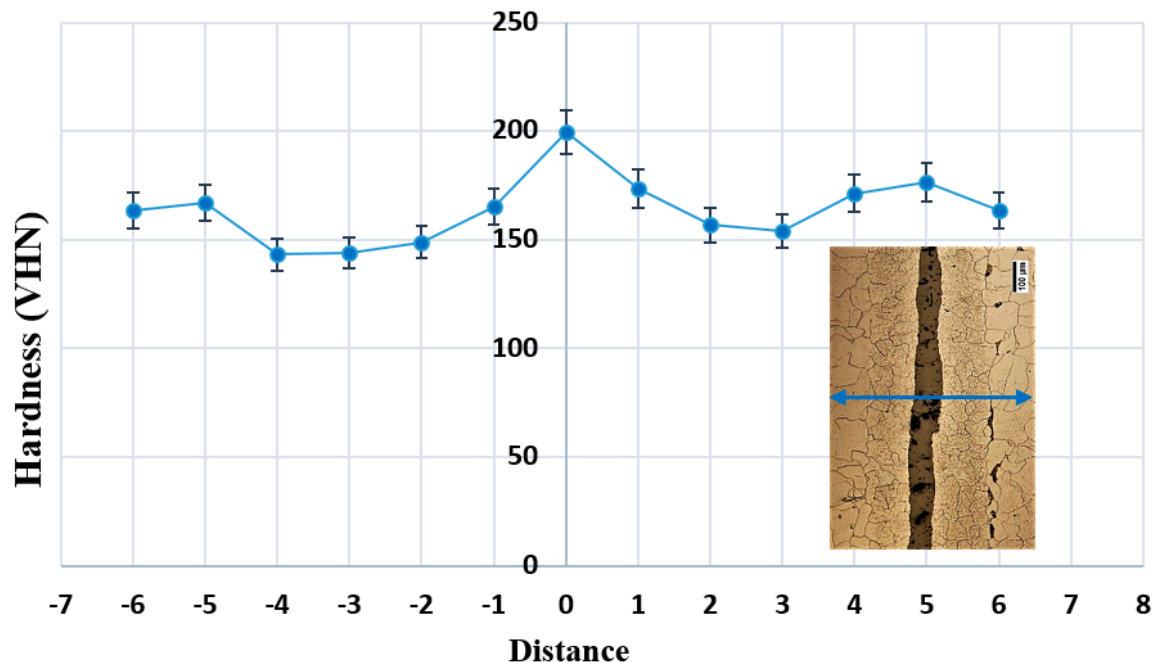
Figure 10 shows a typical hardness profilometry across the crack. As can be seen in this figure, the hardness at the center of the crack, where the oxide layer is present, has significantly increased. This is not surprising, since the layer inside the crack is heavily oxidized. Areas in close proximity to the oxide layer are clearly the weakest spots, which obviously has to do with the fact that the microstructure at the vicinity of the cracks is ferritic.

**Figure 10.** Hardness profilometry across the crack (distance between spots is 100 microns) (VHN: Vickers Hardness Number).
