## Unravelling corrosion degradation of aged aircraft components protected by chromate-based coatings

2024

Engineering Failure Analysis

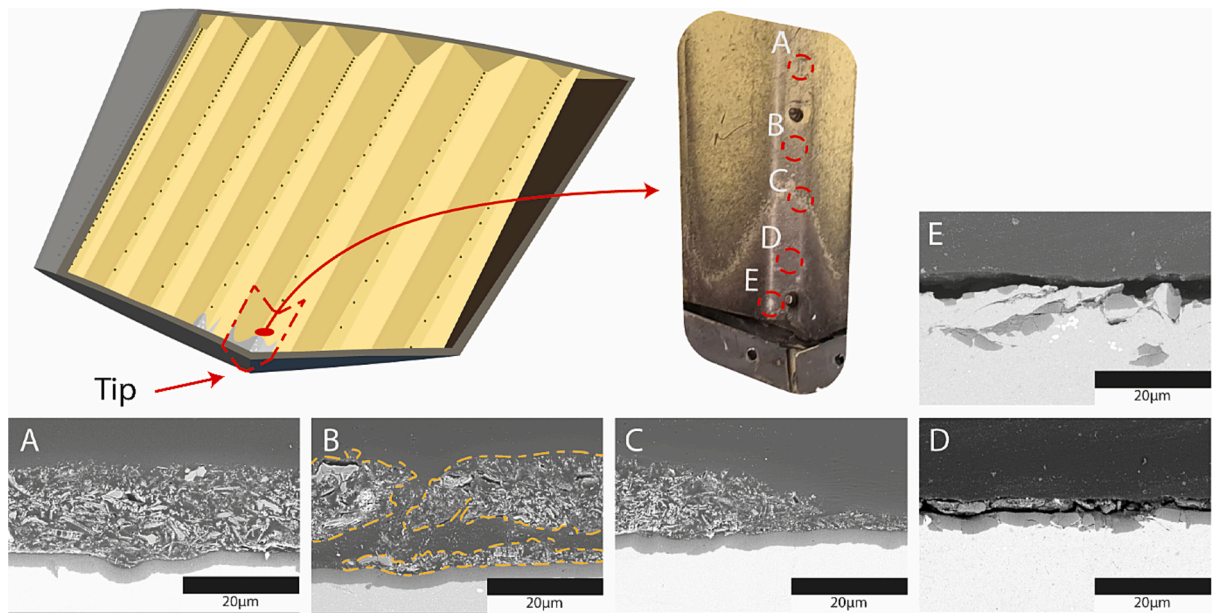
In this section, the eroded areas at the tip of the aluminium structural aircraft parts are investigated. Through visual examination, cross sections were scrutinized using SEM, ranging from the intact parts of the coating to severely damaged regions. This is depicted in Fig. 3. Interestingly, these findings indicate that despite the damage extending down to the bare metal “area E”, no apparent signs of corrosion are evident.

**Fig. 3.** SEM cross-sectional images illustrating distinct degradation stages observed in eroded areas at the tip: (a) intact coating; (b) adhesive and cohesive failure; (c) coating partly eroded; (d) only anodized layer intact; (e) local erosion down to bare metal.

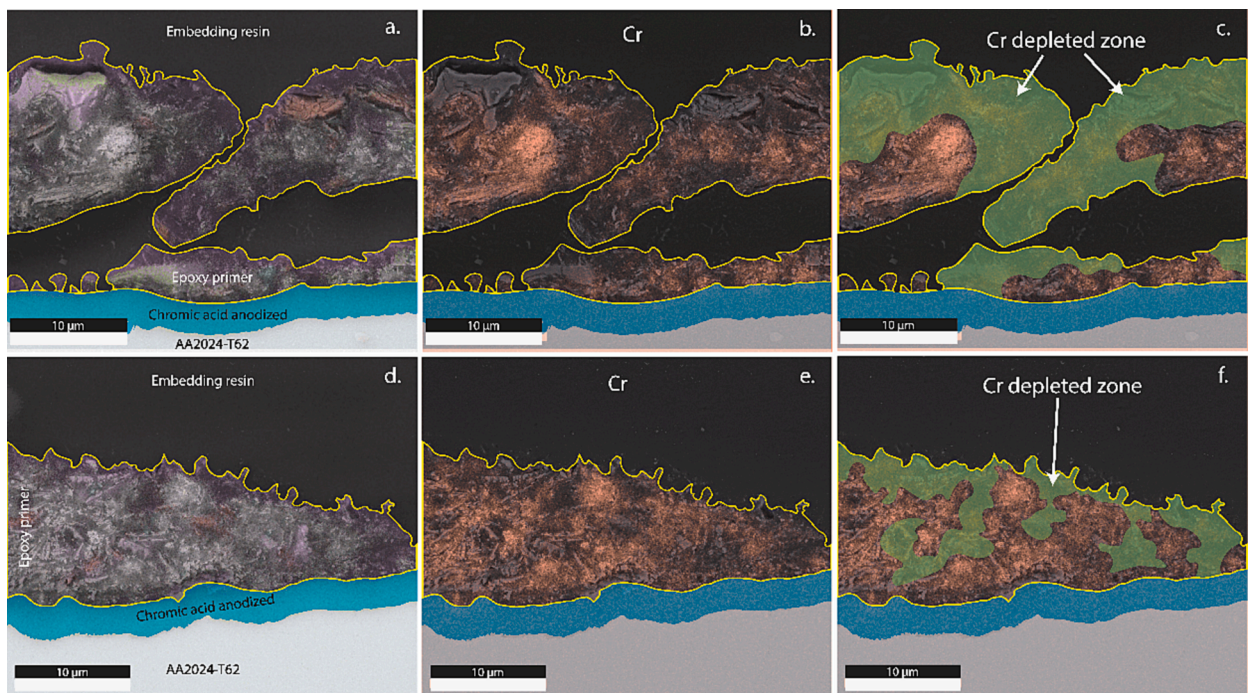
In order to elucidate the reasons behind this lack of corrosion, EDX images were acquired and analysed, specifically in areas (B) and (C) as shown in Fig. 3. The resulting EDX images are presented in Fig. 4. Analysis of these images revealed a notable presence of chromium remaining within the coating. However, some chromium is leached out as observed in Fig. 4c and 4f. This finding, including the findings of the intact coating, implies relatively dry conditions during service, despite periodic humid cycling and extended rainy periods during its service life under conditions where humidity levels exceed 90 % for over a week. These conditions might have induced minor moisture ingress into the coating, which triggered the leaching of chromate around the damaged area at the tip.

**Fig. 4.** SEM-EDX images revealing the coating conditions in eroded areas: (a) exhibiting adhesive and cohesive failure, accompanied by its corresponding image (b) illustrating chromium distribution; (c) revealing the chromium-depleted zone; (d) showcasing the coating erosion interface, along with its corresponding image (e) highlighting chromium distribution and in (f) the chromium-depleted zone.

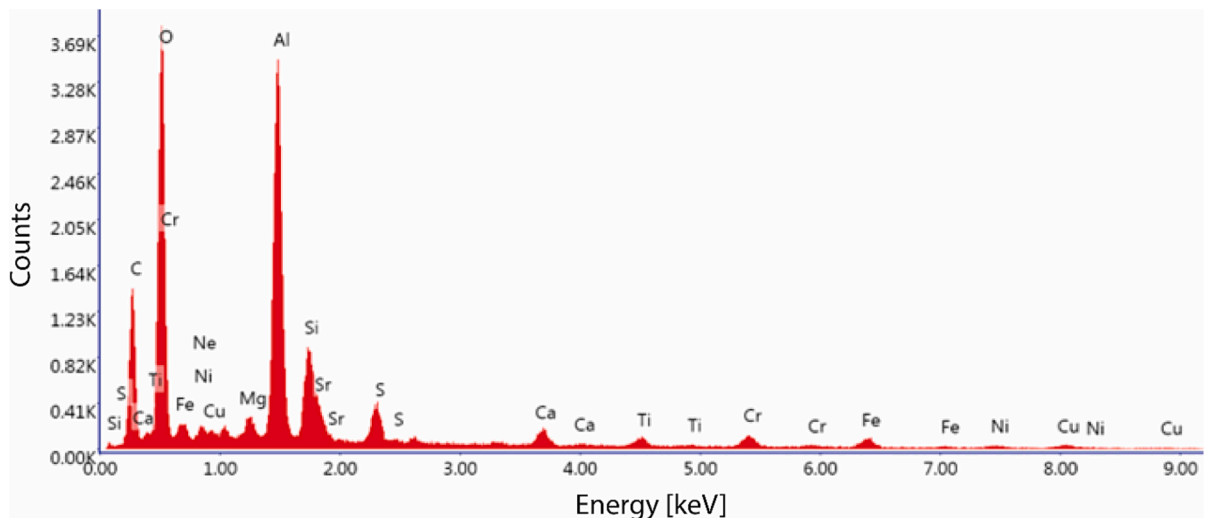
Continuing the investigation, the grey deposited dust atop the eroded areas was also investigated. The EDX analysis of the grey deposited dust clearly unveiled its predominant composition, arising from identifiable coating particles marked by the presence of C, Si, and Sr. Furthermore, traces of sealant, characterized by S and Ca, were identified, along with traces of stainless steel, distinguished by the presence of Fe, Ni, and Cr. These elements were discerned within the deposited dust, alongside aluminium oxide originating

Fig. 6. EDX analysis of grey deposited dust discovered in the eroded areas of the aircraft component.

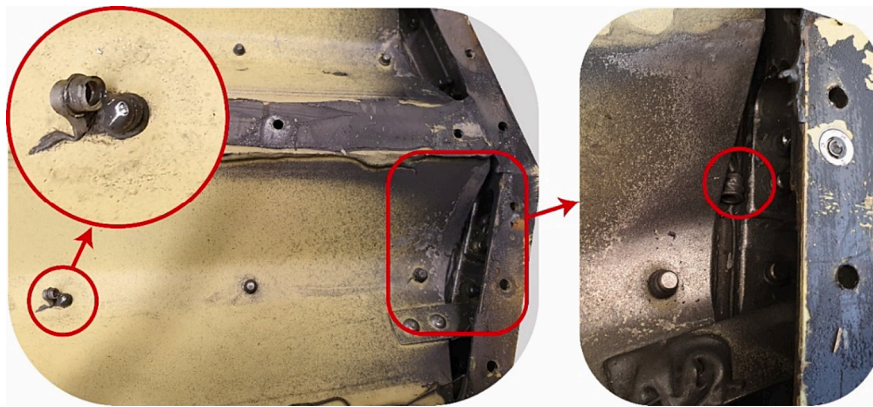
Furthermore, a notable observation was made of physical pieces of rivets within the aircraft parts. This finding lends further support to the presence of stainless steel particles and strongly suggests that the damage observed in the eroded areas is the result of the rivets eroding the surface at the tip of the aluminium structure over the course of its service life.

These rivet particles found inside the part may have entered during the manufacturing process. When incorrectly installed rivets require replacement, the head of the rivet is removed and the remaining part is pushed through the outer skin using a punch. In this way, the remains of the rivet may drop inside the part and adhere to the structure, due to the presence of wet sealant. This is shown in Fig. 7. Over time, during operational service these particles may detach, become mobile and potentially cause erosion of the coating at the tip.

Fig. 7. Pieces of stainless steel blind rivets, found at the tip of the aircraft part investigated.

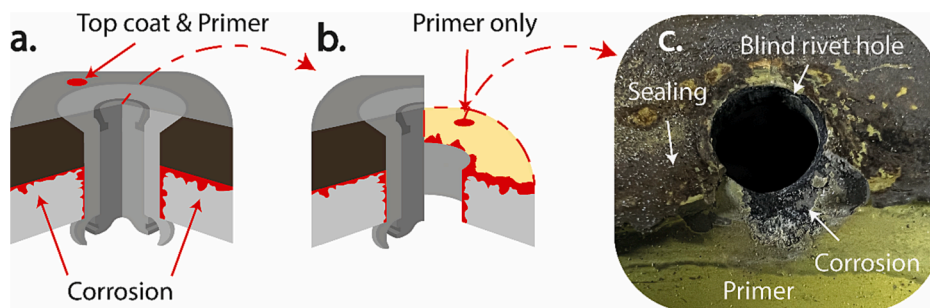
The forensic investigation revealed corrosion attack around stainless steel blind rivets used to attach the skin to the aluminium structure. It was found that the aluminium structure at the perimeter of these rivets exhibited exfoliation corrosion, which is shown in Fig. 8. It appears that this corrosion damage is partially induced by crevices surrounding the rivets, as well as by galvanic potential differences among the various materials involved. Cracks in the coating around the corroded rivets further support this hypothesis. This visual evidence is presented in Fig. 9, where the corroded rivets are clearly visible with a black oxide film on top of the coating, which is commonly referred to as “smoking rivets” in the aviation industry [48,49].

Fig. 8. Corrosion evident near the stainless steel blind rivet, utilized for connecting the CFRP skin to the aluminium structure, featuring (a) a cross-sectional view of a blind rivet; (b) the specified field of view for image (c); (c) highlighting the corrosion attack in and around the rivet hole.

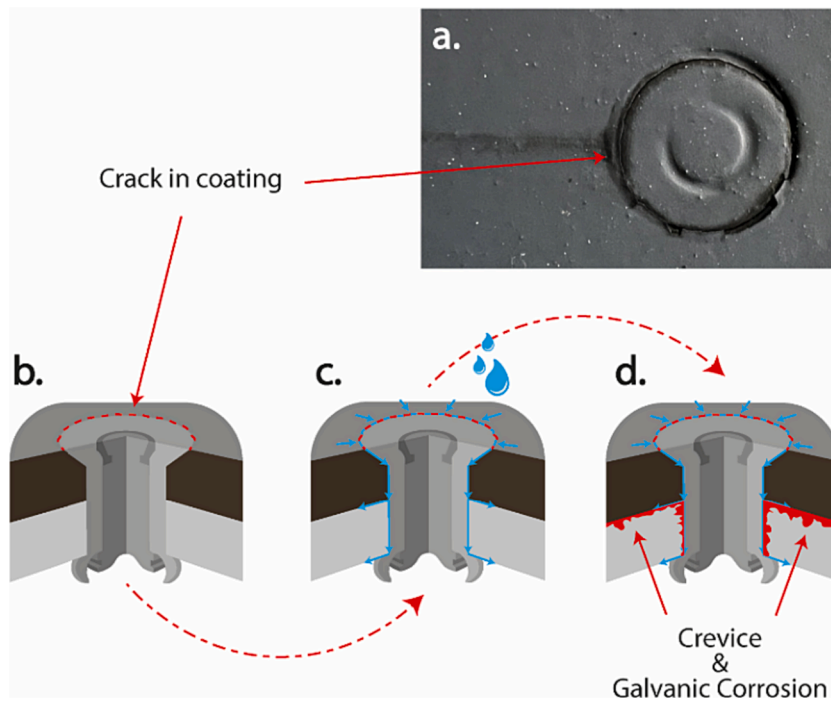
It can be hypothesized that moisture enters the component through the cracks surrounding the rivets, acting as an electrolyte. This moisture penetrates along the rivet interface, deeper between the CFRP skin and the aluminium structure. As a result, this creates conditions for galvanic as well as crevice corrosion to occur. Additionally, when moisture comes into contact with the coating and diffuses into it, this causes the leaching of chromate, which slows down the corrosion process. The next section will describe the specific mechanisms involved, as there are similarities between the corrosion mechanisms observed around steel fasteners at the leading edge.

**Fig. 9.** Visualization of cracks encircling stainless steel blind rivets and a corrosion tail (a) depicting the hypothesized sequence; (b) initiation of a crack in the coating surrounding the rivet; (c) infiltration of moisture through the crack, penetrating around the rivet into the part; (d) resulting in corrosion of the aluminium structure.

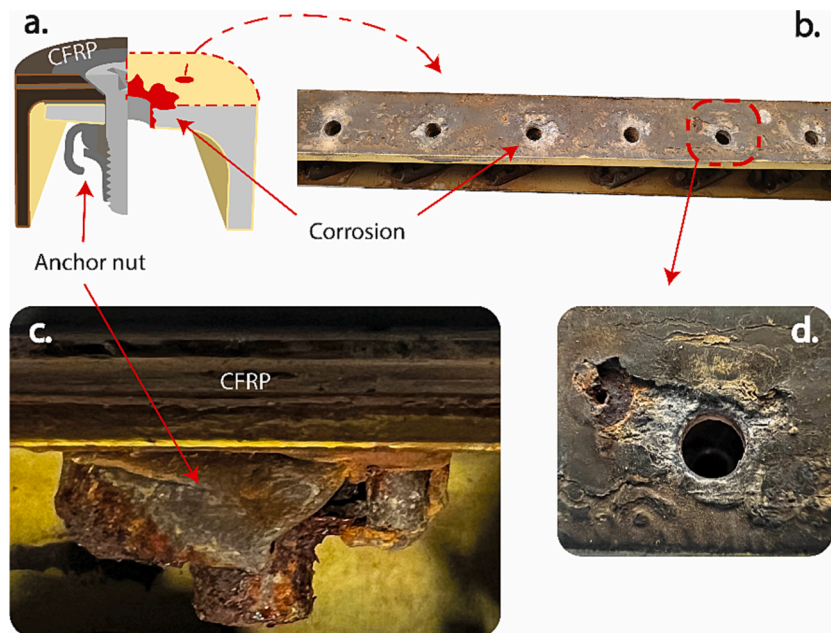
In one particular case, on part #5903, severe corrosion was observed around steel screws holding the leading edge in place. The corrosion was predominantly found on the aluminium spar and primarily exhibited exfoliation, as shown in Fig. 10. Additionally, a crack was identified in the coating surrounding the corroded fasteners, providing an entry point for moisture to penetrate into the component. Even the steel anchor nuts exhibited significant corrosion. This is an uncommon occurrence considering the connection of steel fasteners with the aluminium structure. The steel typically benefits from the protective nature of aluminium in the case of electrical contact. This aspect will be further discussed in this section.

The corrosion around steel fasteners at the leading edge showed similarities to the corrosion observed around the stainless steel blind rivets. What sets this case apart is the absence of a dedicated drain hole in the area, allowing moisture to accumulate and exacerbate the corrosion process.

**Fig. 10.** Corrosion observed at the aluminium leading edge spar of #5903, with (a) illustrating the design detail; (b) highlighting corrosion of the aluminium spar; (c) depicting corrosion on the anchor nut; and (d) offering a close-up view of corrosion around a fastener hole.

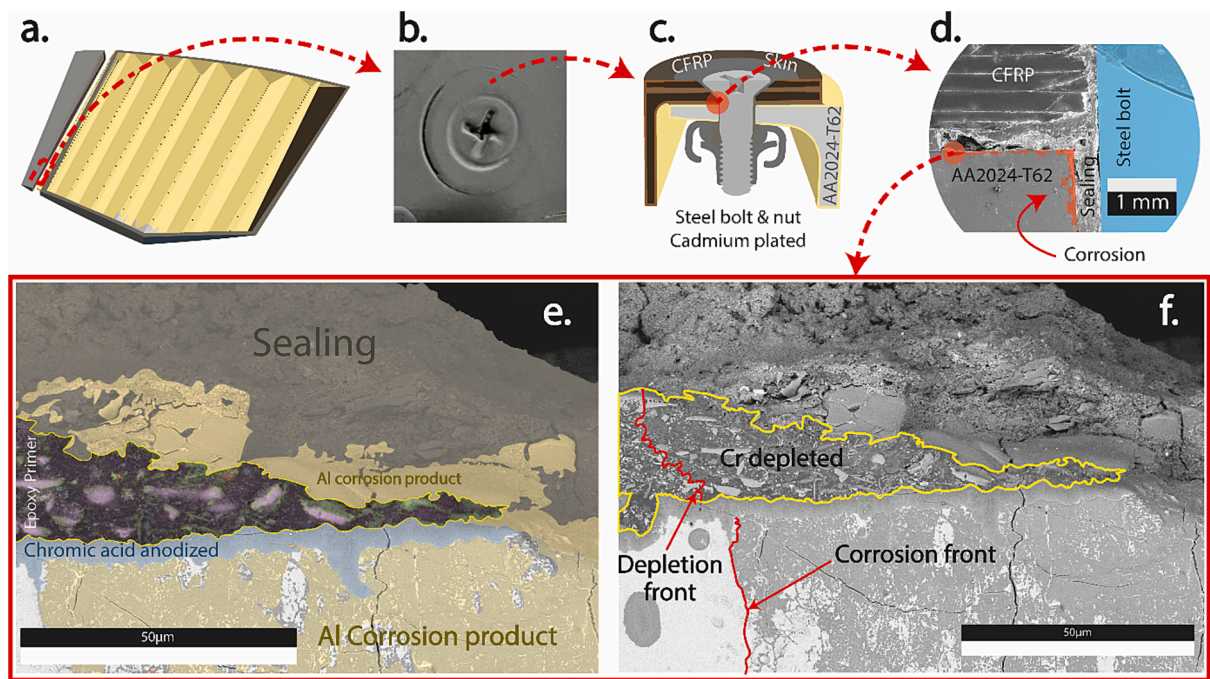
Fig. 11f shows the presence of a Cr depletion front inside the coating: at the left-hand side, chromate is present in the coating, whereas at the right-hand side the chromate is almost entirely depleted. Additionally, this Cr depletion front appears to be present in the aluminium spar, with a clear distinction between the pristine material at the left-hand side and the corroded area at the right-hand side. This is a strong indication that moisture ingress had taken place while chromate slowly dissolved when it came into contact with moisture. The same also applies to the corrosion itself, with the presence of electrolyte as an essential condition.

**Fig. 11.** SEM image of a cross-section of corrosion on the aluminium spar, where (a) presents the area of interest; (b) top view with a fastener installed; (c) graphical cross-section of an installed fastener; (d) low-magnification SEM image of a cross-section of an installed fastener; (e) high-resolution SEM image including a graphical clarification of the substances observed; (f) SEM image including a clarification of the Cr-depletion zone and corrosion front.

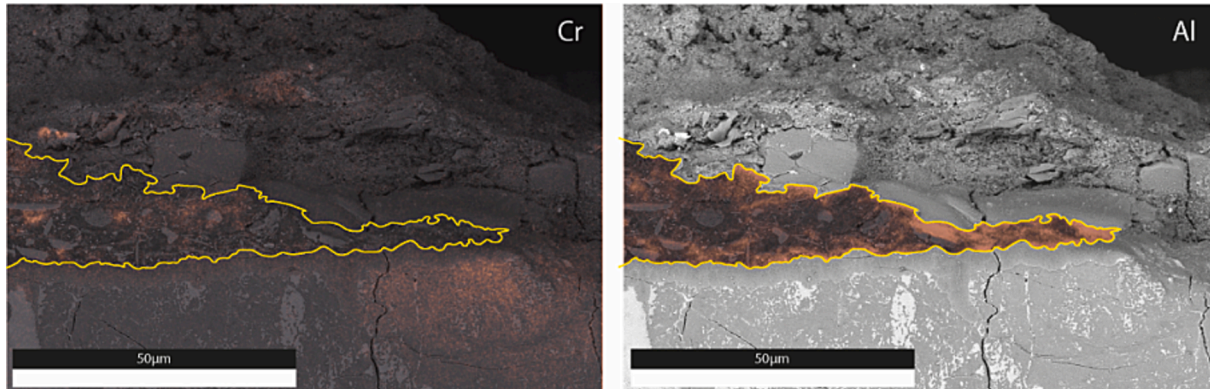
Additional EDX images reveal the distribution of chromium and aluminium, as seen in Fig. 12. Notably, chromium is mainly present in the corroded aluminium of the spar, indicating its functionality to protect the aluminium and to prevent further corrosion. Additionally, aluminium is observed inside the coating itself. This is remarkable since in principle this type of coating does not contain any aluminium particles.

**Fig. 12.** EDX images showing Cr and Al distribution of the corroded aluminium spar.

Based on the analysis of Fig. 12, it is confirmed that a substantial amount of chromium is found in the aluminium corrosion product inside the spar. The presence of rust on the anchor nut, as seen in Fig. 9, further supports the hypothesis of passivation of the aluminium spar, since the iron oxidation rate is limited if a less noble material like aluminium in an active state is in direct electrical contact with the bolt. However, the inhibition power of hexavalent chromium was insufficient to fully suppress corrosion of the spar.
