# Geotechnical Hazards | Geological Considerations in Dams Failure

Teodora Barbuntoiu

A Thesis in the Field of GeoEngineering  
For the Degree of Bachelor of Applied Earth Science

Delft University of Technology

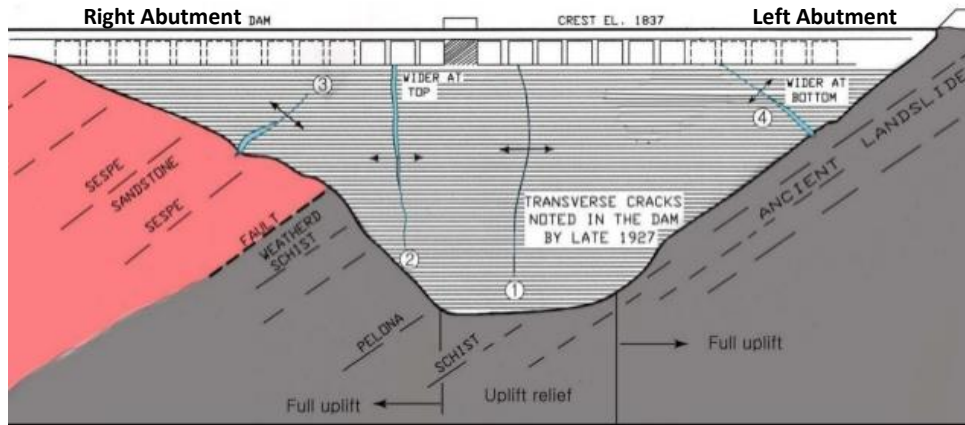
Figure 6: Cross section of St. Francis dam looking downstream (Hartley, 2016)

For the local geology, the cross-section in Figure 6 gives the stratigraphy at the site location. The upper right abutment consists of the Vasquez formation, later renamed Sespe. The reddish conglomerate sandstone is soft and plastic in unsaturated conditions, and susceptible to slacking when submerged (Rogers, 2013), reaching a strength of only 3.5 MPa (Stapledon, 1976). However, in dry state, the material is much firmer but exhibits fractures filled clay or gypsum gauge (ICOLD, 1974).

The lower section of the right abutment consists of moderate strength Pelona formation which consists of quartz, mica and feldspar minerals. The layer continues under the dam structure and forms also the left steep bank (see Figure 6). The metamorphic rock is sheared and thus its

strength is considerably reduced. The lamination is parallel to the steep slope of abutment (ICOLD, 1974). Figure 7 shows the surface at the dam site after the water eroded the weathered rocks after the failure event. It can be clearly distinguished between the reddish conglomerate on the left side, and the grey schist on the right, as well as a sharp interface between the two formations.

Part of regional geology are the paleolandslides displayed also in the cross-section in Figure 6. The ancient landslides take place in the Pelona Schist Formation. Proof of their existence are the exposed topographic benches developed in the Sierra Pelona Ridge surrounding the reservoir which are relicts of large landslide grabens. These sudden movement of masses would have blocked the San Francisquito Creek at various locations which promoted the development of a less steep valley where trees can grow and fluvial sediments can be deposited on the creek's floor (Rogers, 2013). In the geologic map from Figure 5, we can observe this Quaternary alluvium material that is heavily deposited in the creek (the yellow layer). The ancient landslide can be clearly observed from Figure 8, where the curved sliding surface can be depicted, as well as the graben formed in the heavily foliated Pelona Schist.

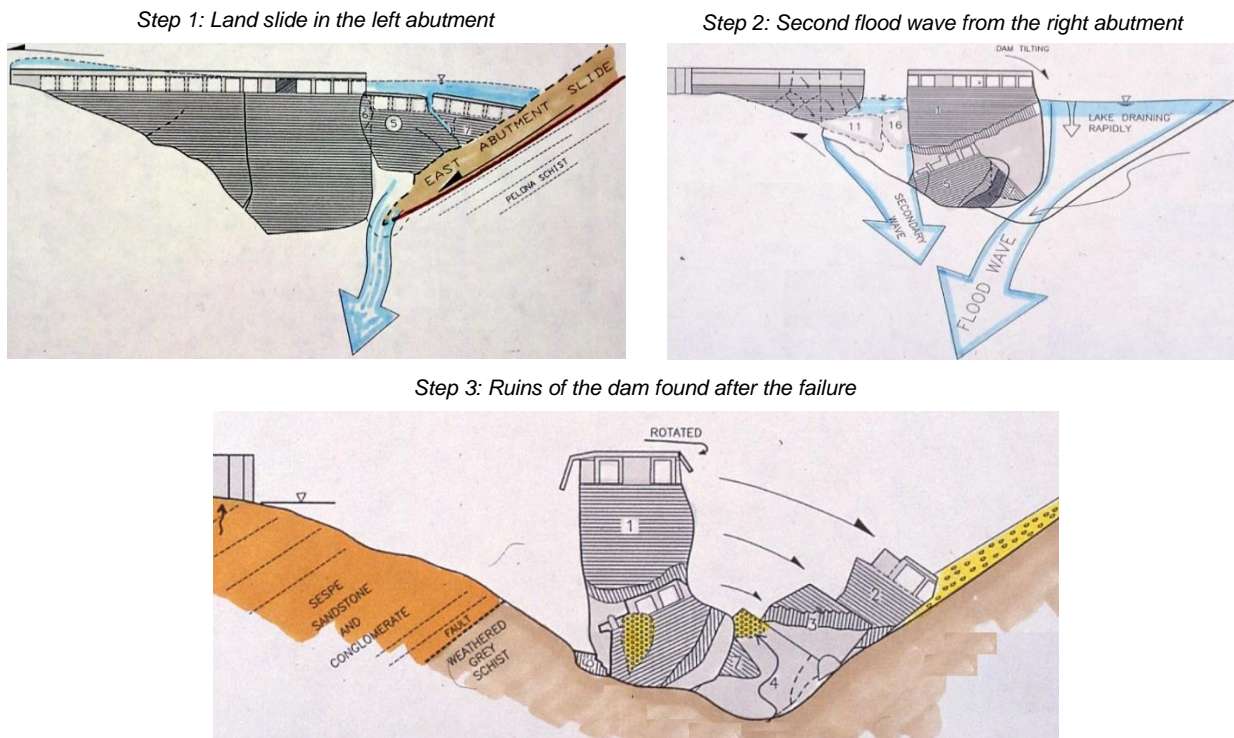
Figure 9: Sketch with the sequence of events which led to the rupture of Saint Francis Dam (Rogers, 2013)

All in all, the chain of events that led to St. Francis Dam failure can be depicted from Figure 9 which illustrates the interpretation given by Rogers. The incident started with a small landslide of 30 cm before the event which created uplift at the bottom of the east abutment slope and allowed high velocity water to create an orifice. The schist got easily eroded by the concentrated orifice flow and a massive landslide happened in the left abutment (step 1). The middle part of the foundation was the only part of the structure anchored in the subsurface, however, since the left side of the dam had been flushed downstream, the middle block started to tilt and the water entered through another shrinkage crack on the western side of the dam (step 2). Thus, a secondary wave broke through the cement structure at the base of the right abutment and the weakened structure, crumbled and disintegrated as it was not anchored to the bed neither. In the end, only the middle block is left in place, slightly tilted clockwise (step 3).

Founding the construction on paleo-landslide slope without any reinforcements caused a lot of problems which have great consequences on the project. The main body of the dam (the one that remains standing) had uplift relief valves, while the abutments did not exhibit any and thus allowed the water to infiltrate and create an overpressure. Additionally, until 1945, most engineers assumed that concrete was sufficiently impermeable (and dry) to resist complete saturation, and that dams founded on low permeability strata would not be subject to hydraulic uplift (Rogers, 2013).

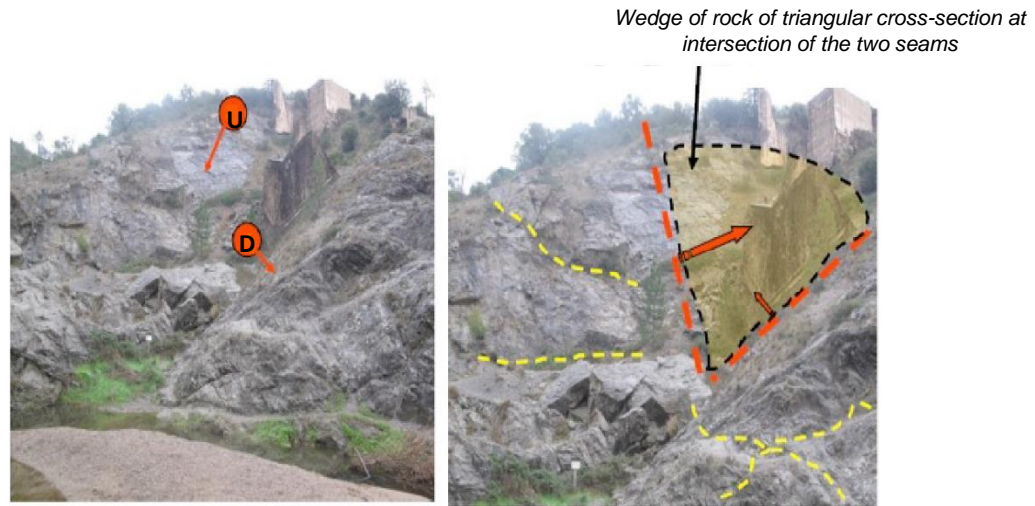
Figure 14: Dihedral shape gash in the left abutment appeared after the collapse (Goodman, 2013)

The downstream surface of the dihedral coincided with the face of a fault which belongs to the most recent type of east-west faults, with an irregular thickness of clayey breccia gouge up to 80 cm (Goodman, 2013). Please refer to the left picture of Figure 14 for the downstream wall (D arrow), pointing to the seam that is breaking out to the surface at an angle of approximately 45 degrees. The fault has a strike which can be traced across to the opposite bank, parallel to the foundation of the dam, as its thickness remains less than 1 m (Duffaut, 2013a). The fault had no morphological feature visible from the ground surface before the dam failure. Moreover, no gouge was found in the site investigation boreholes. It could be that borehole quality was not as high as nowadays. The rock shows fractures (see figure 14, right picture), it is easily breakable and mechanically unable to resist sliding due to the presence of sericite.

The upstream wall of the dihedral is a structure which shows a great number of potential shear surfaces (foliation structure) dipping from upstream to downstream, almost parallel to the layering of the schist, and tangent of the arch (ICOLD, 1974). The rock is coated with fine mylonite and shows fractures which form blocks of big size (see arrow D in Figure 14) and it is clear that the rock had undergone a lot of pressure (Goodman, 2013), please refer to Figure 14, right picture.

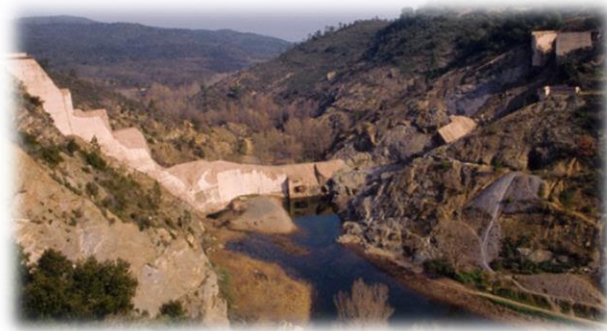
Figure 15: Malpasset Dam site after the failure (Goodman, 2013)

After the collapse, the left abutment had been shifted 2 m horizontally with little vertical movement. The base of the dam and the right bank rotated almost 80 cm without the structure breaking up (ICOLD, 1974). As a consequence of this, a large crevasse opened between the concrete and the rock (Duffaut, 2013a), depicted at the base of the right abutment. The post disaster picture of the dam (Figure 15) exhibits only the base and the part of the right side of the dam as a standing staircase.

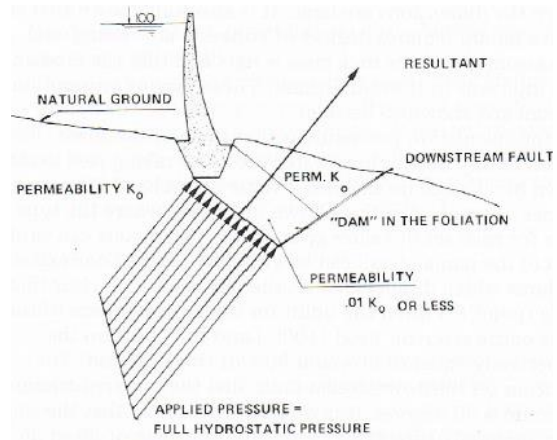
Figure 16: Failure of the Malpasset Dam (Goodman, 2013)

As a more detailed clarification on how was this possible, the structure was unable to adapt to the increased deformability, so both the concrete buttress and the arch dam shell would fail in this order. The Commission also explains that the force which ruptured the root of the lateral wing wall plus the resistance of the abutment itself is far greater than the total arch thrust, making the arch move relative to the rock (Jaeger, 1979). Because the shear planes found in the upstream surface were almost parallel to the tangent to the arch, the dam forces, instead of spreading out in the foundation, remained concentrated generating high compressive strength (ICOLD, 1974). The concrete shell of the dam is a rigid body and could not be deformed as such, thus the required thrust was meant to be transmitted to the rock in the abutment, which soon became overloaded. Thus, the first phase of the rupture was actually the redistribution of the forces in the dam shell which could have lasted days, and then later a more instantaneous collapse of the dam took place (Jaeger, 1979).

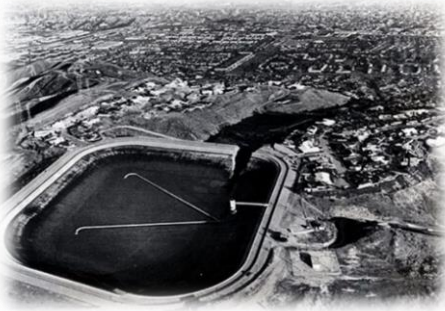
Figure 17: Aerial view on the Baldwin Hills Reservoir when it collapsed (MacDougall, n.d.)

Consequences of the disaster were minimal compared with what would have occurred if no warning had been provided, despite this, the damage consisted of five lives lost, \$12 million property, and loss of the reservoir itself (Hamilton & Meehan, 1971). The investigation that followed the disaster was conducted by the State Engineering Board of Inquiry and a consulting board (ICOLD, 1974). The crack can also be visualized in Figure 18, which coincides with one of the faults, as will be later explained, and Figure 17 shows the crack on the northern abutment as the water was rushing downhill

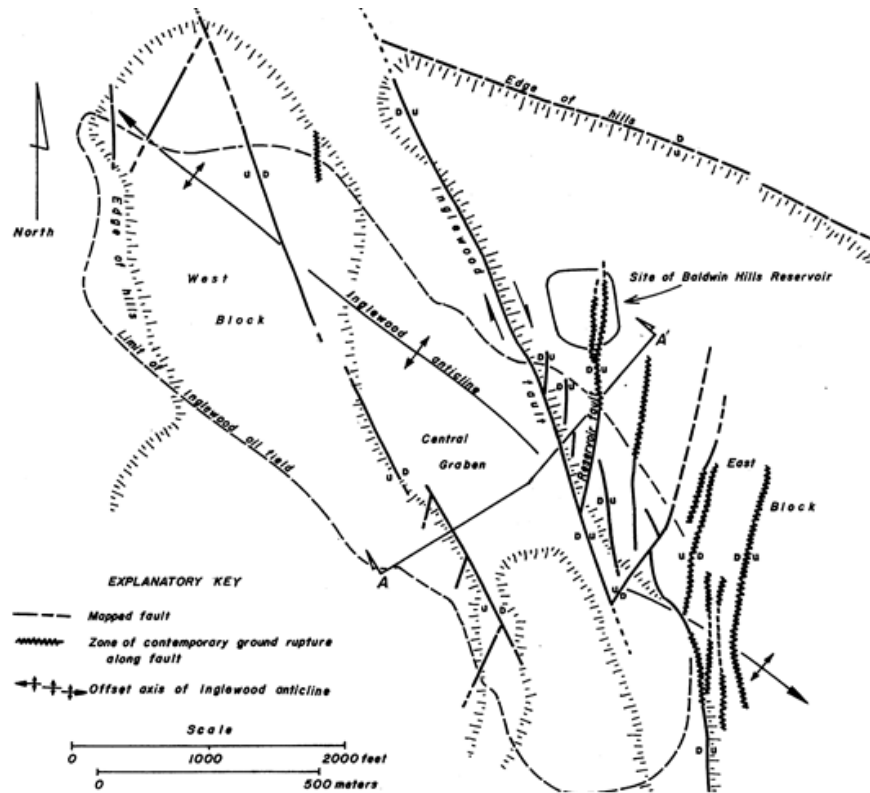
Figure 21: Map of Baldwin Hills and the main geological structures (Hamilton & Meehan, 1971)

Fault number I was discovered during construction and named the Reservoir Fault, please refer to Figure 21 for the visualization of the location of the faults. Reddish-brown clayish gauge of 0.3 to 10 cm thickness, fresh slickensides (which implied that the fault was active) and cementation of silts and fine sands were found along the fault (ICOLD, 1974). Horizontal displacement could not be recorded, however since completion, a vertical displacement of about 20 cm for fault I and 8 cm for fault II (Hamilton & Meehan, 1971) was established, classifying the faults as normal or extensional faults.

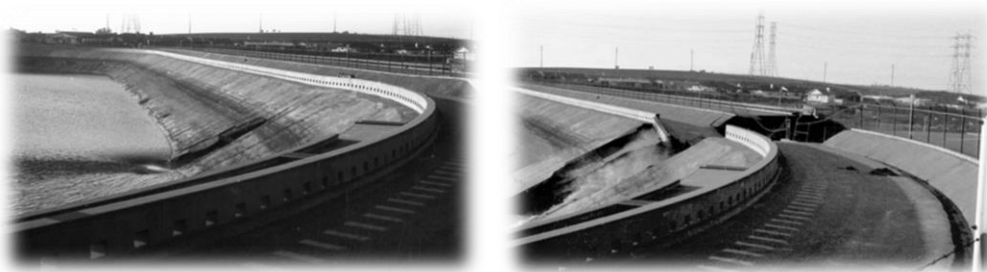
Figure 23: Initial crack formed in the embankment (on the left) and the development of the crack until collapse (on the right) (DHS and FEMA, 2002)

This differential settlement could trigger a fault movement; however, it is unclear why the fault activation happened exactly on the day of the failure. Therefore, there was probably a gradual culmination of effects that built up over the years. Most probably, one or more cavities, formed during the operational years of the reservoir, broke through the foundation and led to the failure (Scott, 1987).

Moreover, another theory speculates that there is a remarkable coincidence between the crack growth rate below the reservoir and the sequence of injection episodes relating to the oil field nearby (Hamilton & Meehan, 1971). These changes in volume and in strength of soil with fluid-filled voids are shown to be fundamentally related to change in stress within the solid skeleton. An increase in the effective stresses accompanying fluid withdrawal and a decrease in fluid pressure due to hydrocarbon extraction clearly lead to subsidence. Thus, the fault gets activated through the response of stressed ground to artificially induced fluid pressure in the ground (Hamilton & Meehan, 1971).

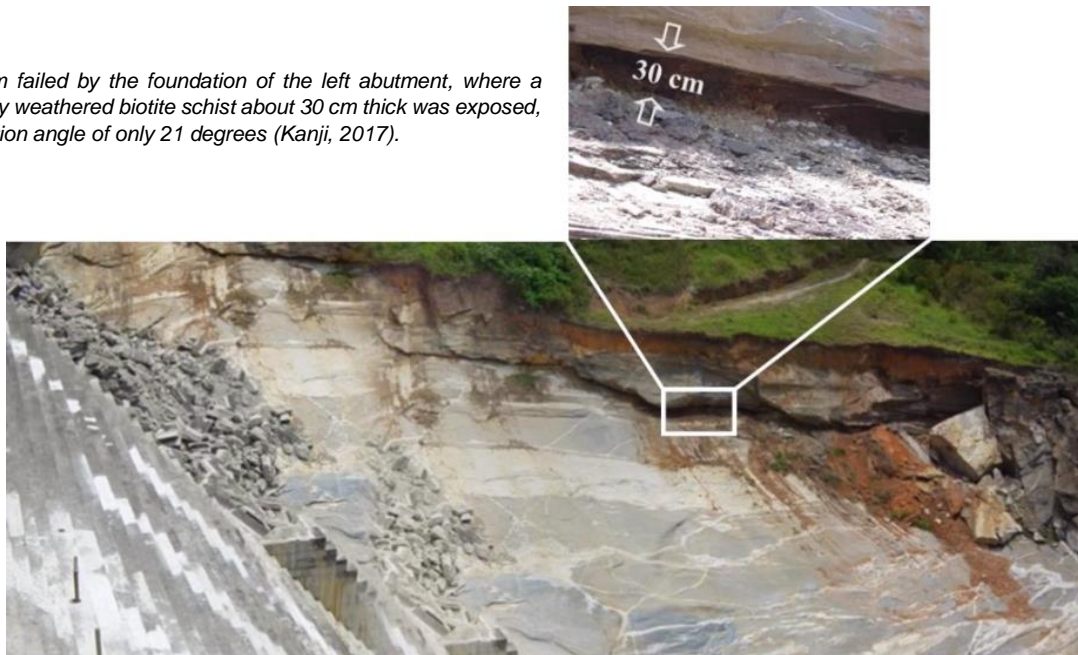
*Figure 24: Camará Dam foundation affected by geological aspects (Kanji, 2017)*

The geology at the site consists of a base rock of gneissic migmatites with foliation dipping 30 degrees toward the right abutment (USBR & USACE, 2015). The abutment is stable during construction, but unstable under the uplift pressure due to reservoir filling up. From core sample, geologists could have recognized the weak layers which coincides with the failure plane (please see Figure 24), and on top of this, the weak plane was also exposed during construction, but was wrongly considered to be very shallow (it was excavated and filled with concrete) (Kanji, 2017).

*Camará Dam failed by the foundation of the left abutment, where a layer of totally weathered biotite schist about 30 cm thick was exposed, having a friction angle of only 21 degrees (Kanji, 2017).*

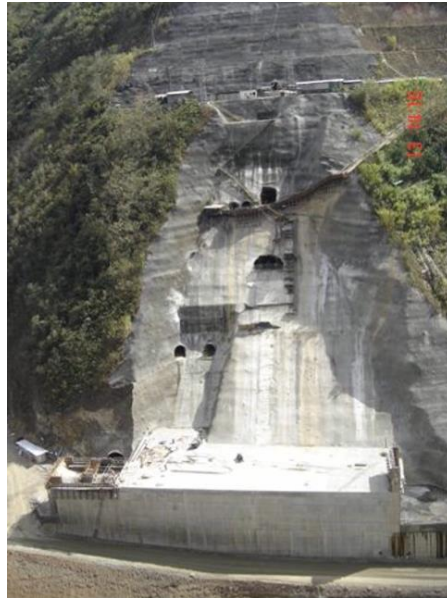
Figure 25: Shear key completed for Pirris Dam (Kanji,2017)

Pirris Dam in Costa Rica is a concrete gravity dam finished in 2011 (RCC Dams, n.d.) founded on highly cemented mudstone, of strength greater than 100 MPa. The rock is highly jointed and exhibits possible weak planes which could endanger the stability of the structure (Kanji, 2017). At one site visit, the team acknowledged joints 12 cm wide infilled with plastic clay parallel to stratification, with little friction angle. They have modeled the discontinuities using finite element analysis and established a Factor of Safety less than 1 in many areas (Kanji, 2017). The same as in Camará Dam case, the structure is stable during construction, but potential hazardous when the reservoir is full. The team found a solution to build a shear key in the abutment (please refer to Figure 26) and since then, the dam has been under regular operations.
