# Investigation on Manufacturing Defects

in CFRP T-stiffened co-cured Single Aisle flap skin panels

A.S. Wulfers, B.Sc.

Faculty of Aerospace Engineering · Delft University of Technology

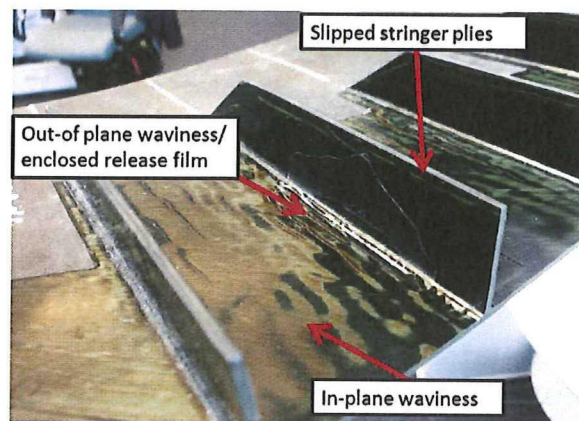
**Figure 4.3:** Overview of defects visible with visual inspection

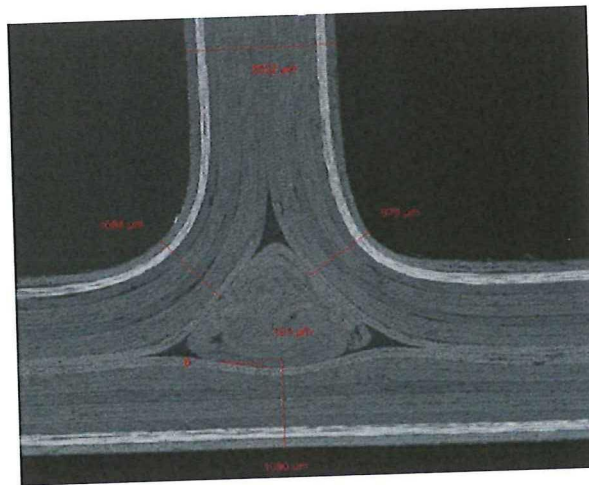
Another solution would be to change the shape or rigidity of the filler material to make it fit better in the triangular region. That way, no resin rich areas will be present at the three corners around the filler. Also, by having an exact match in shape of the filler material, the filler material will be kept in place better. Currently, the filler material is bundled together by twisting UD-preprep fibres stands with the length of the whole panel with a screwdriver. This creates a round shape which becomes oval as soon as pressure is applied. When an external force is applied to the stringer, it will be less likely to shift due to the counteracting force exerted by the newly shaped filler. This is because of the larger contact surface between the filler and the stringer compared to the oval shaped filler. The larger surface can be created by having a filler of the right shape or made of a material that is able to be pressed easily into the intersection, obtaining the shape of the junction. Having the right shape or a less ridged material, the filler will also remove the fibre waviness in the skin plies underneath the filler. This is caused by a too large filler that applies a too high local pressure to the layers of the skin underneath when the autoclave pressure is applied. This effect can be seen in figure 4.6.

**Figure 4.6:** Effect of a too large filler

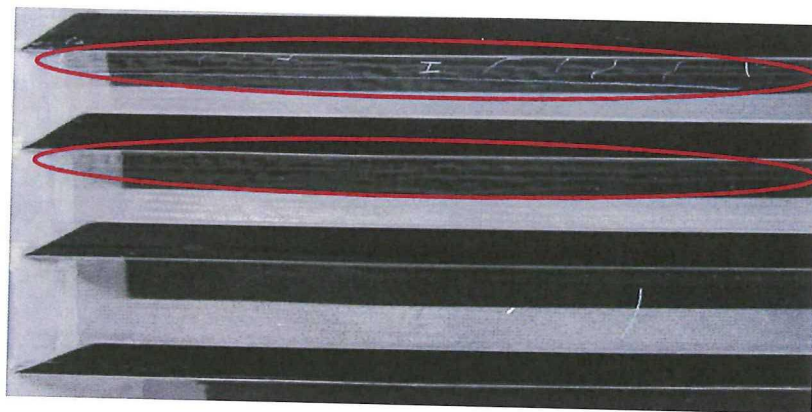
The in-plane waviness can occur in every location of the flap in both the skin and stringers. Usually, the waviness is not completely random and has a specific origin of for instance the corner section between the skin and stringer. The waviness can also be present over the entire length of for instance the skin between two stringers. This indicates that it can be a local phenomenon or that it is caused by for instance the entire autoclave core. A zoomed out example of in-plane waviness over a larger section of the flap can be seen in figure 4.12.

**Figure 4.12:** In-plane waviness over a larger section

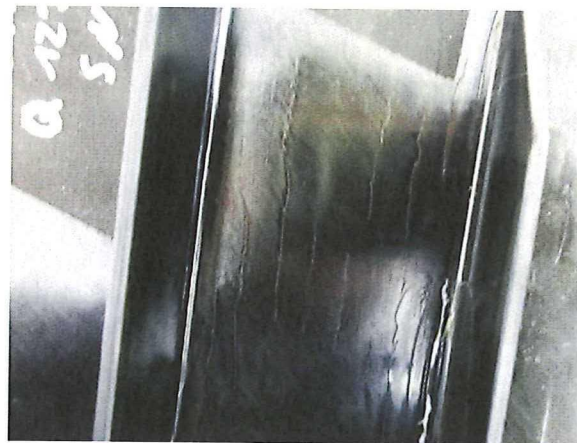
In the figure, a cross sectional picture was taken from the skin of a scrapped part. The waviness is present in multiple layers across the thickness. The top and bottom layers in the panel show no sign of waviness at all, which means that it can be invisible from the outside. That is why it is important to examine the inner quality when determining the quality of the total part. It is also possible that the out-of plane undulations are present in the outer layer. In that case, they can be clearly seen by visual inspection. An example of the out-of-plane undulations that are also present in the top layer can be seen in figure 4.15.

**Figure 4.15:** Out-of-plane waviness (undulations) on the outer surface

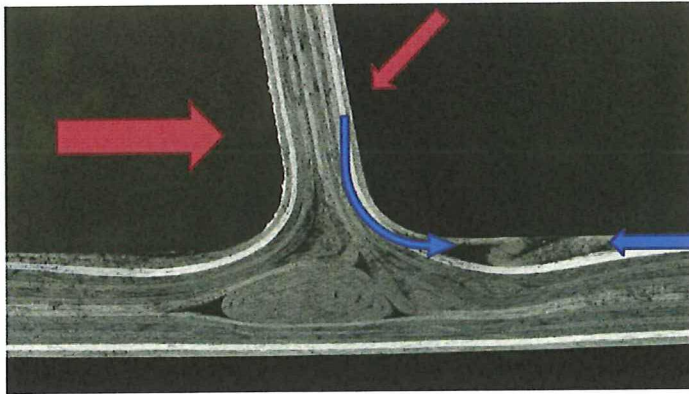
In the corner section of the stringer and skin it sometimes occurs that the release film is enclosed by the laminate. This can be seen on the bottom right side of the skin in figure 4.15. This kind of undulation is a special kind of waviness where the carbon fibre layer folds over itself, and could thereby entrap the foil in the surface layers. From now on this defect shall be referred to as wrinkles. When looking at the cross sectional image of such a wrinkle, the fold can be clearly seen in the top layer only (figure 4.16).

Figure 4.16: Wrinkle in the corner section

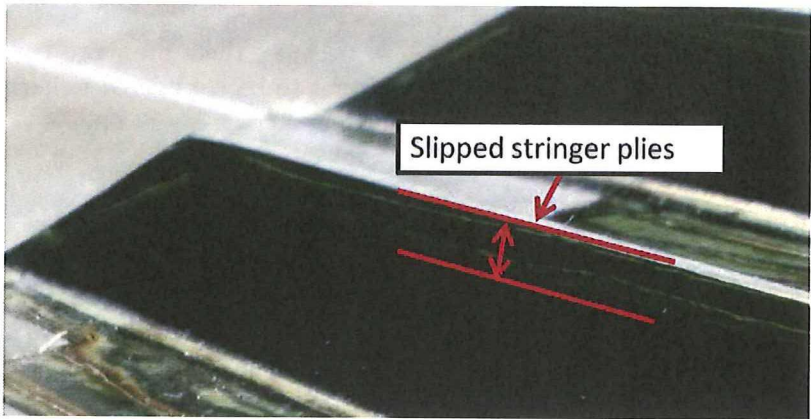
The carbon fibre material to form the wrinkles described earlier needs to come from somewhere, since it is not flexible enough to elongate by this amount. Because only the outer fibre has moved down, it also means that the slipped layer is shorter on the top of this stringer. This can be seen in figure 4.17.

Figure 4.17: Slipped stringer plies

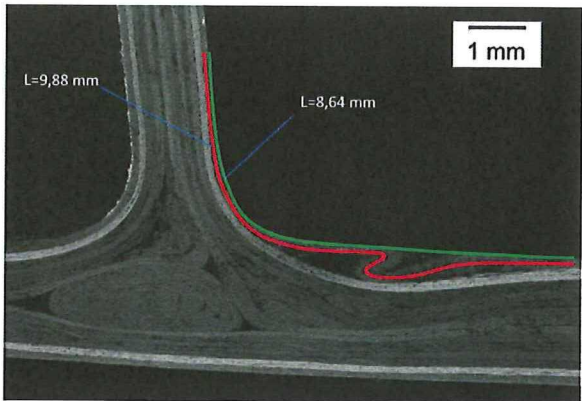
Since it concerns only one or several layers, this defect is referred to as a slipped stringer ply. A slipped stringer ply does however not always have to fold over to form a wrinkle. When looking at figure 4.18, the total slippage of the outer layer can be determined by subtracting the normal layer length in the corner section (depicted in green in the figure 4.18 below) and the length of the layer with the wrinkle present (depicted in red).

Figure 4.18: Wrinkle in the corner section

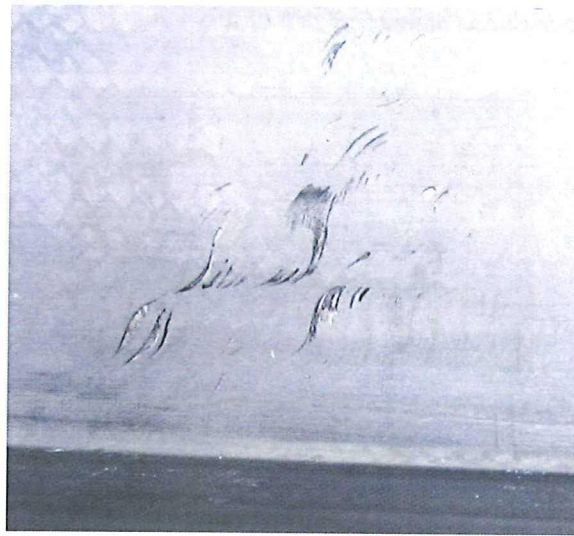
A cause of the dry spots could be that air is enclosed between the mould and the laminate. If the evacuation of that air is not done properly when the autoclave pressure is applied, the air remains entrapped in the laminate causing these dry spots. Improper evacuation of air can be caused by sealing the panel too much on the sides and top with air impermeable foils or tape, a too low autoclave pressure or temperature or an improperly designed tool or mould that does

**Figure 4.21:** Dry spots on the surface

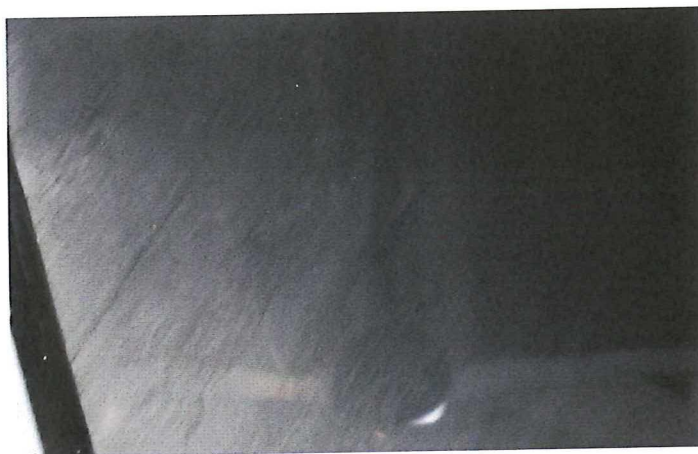
The small in-plane waviness can be seen in every panel that is manufactured and also occur in the actual flaps. The small in-plane waves that are present in the test panel can be seen in figure 6.3.

**Figure 6.3:** In-plane waviness that is present in the prepreg material

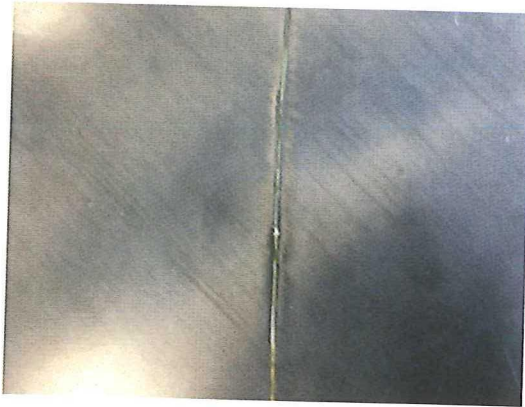
**Figure 6.4:** Filler indentations on the back of the skin of the panel along the filler location

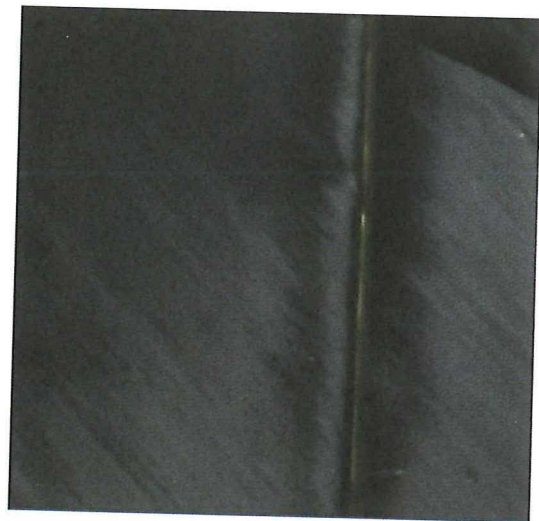
**Figure 6.5:** Local in- and out-of-plane waviness, originating from the filler indentation

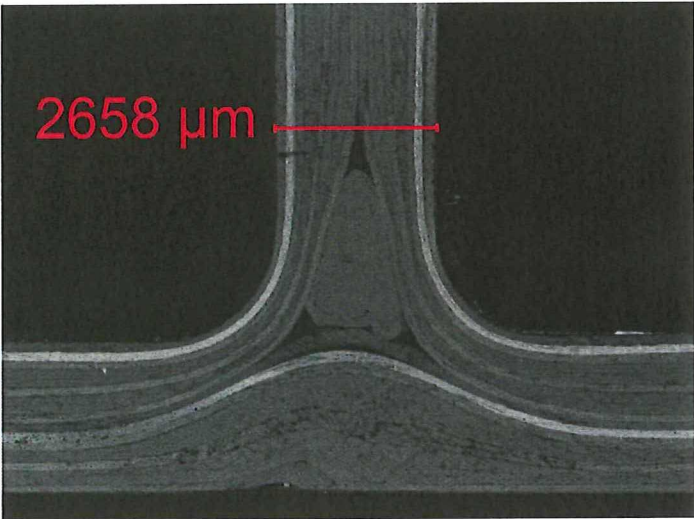
Figure 6.7: Vertical filler movement

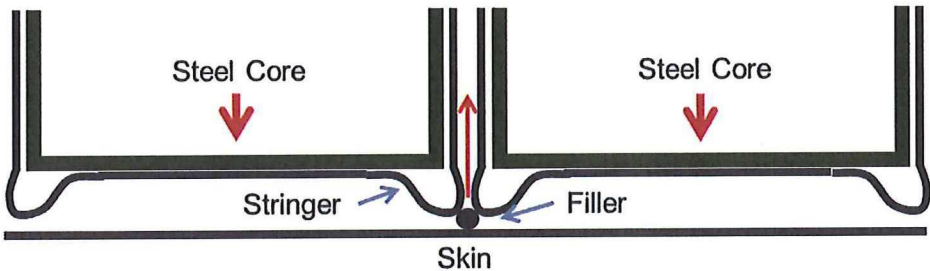
The movement of the filler material is also observed in cross section 0 at stringer 1. This movement can be explained by the error that occurred in the preforming stage of the manufacturing with the help of the following figure 6.8.

Figure 6.8: Vertical filler movement due to wrong preforming

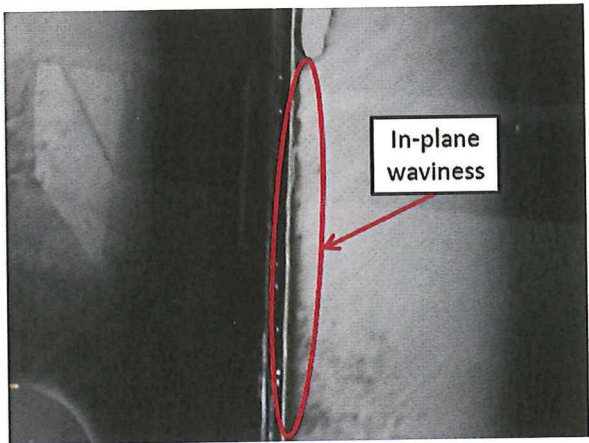
Again the small in-plane waviness is present in the whole part. There is however also in-plane waviness present in the web of the stringers near the corner sections. This is shown in figure 6.22.

Figure 6.22: In-plane waviness in the web of the stringers near the corner sections

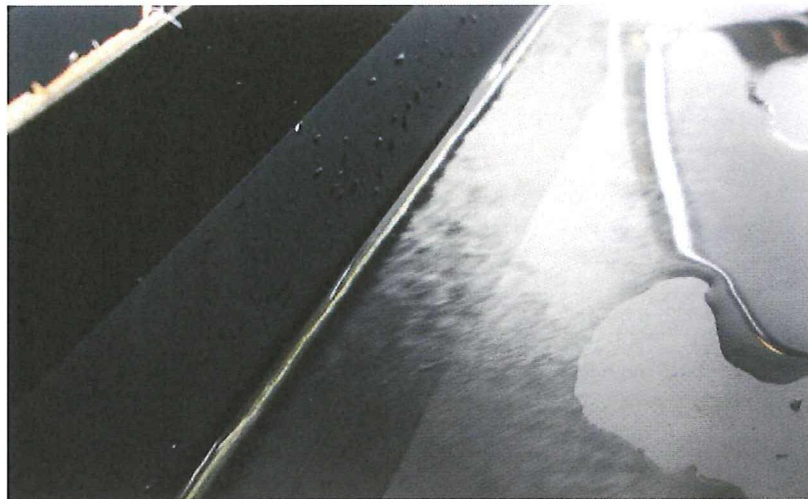
**Figure 6.35:** In-plane waviness in the web of the stringer originating from the corner sections

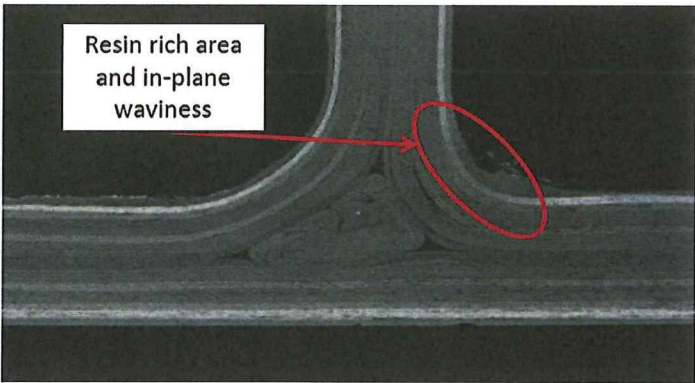
Figure 6.38: Horizontal filler movement in stringer 3 with an offset of almost 1mm

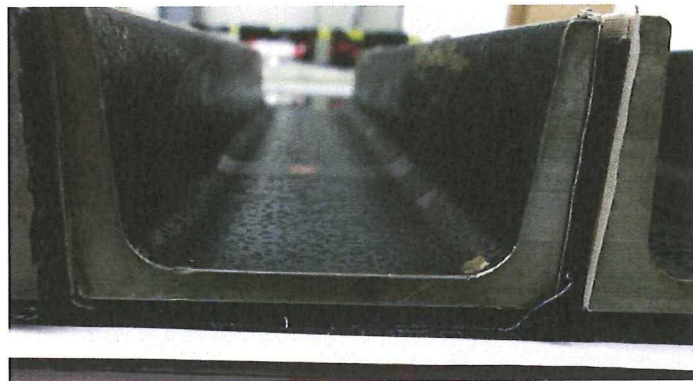
**Figure 6.42:** Higher placed cores with a gap between core and laminate

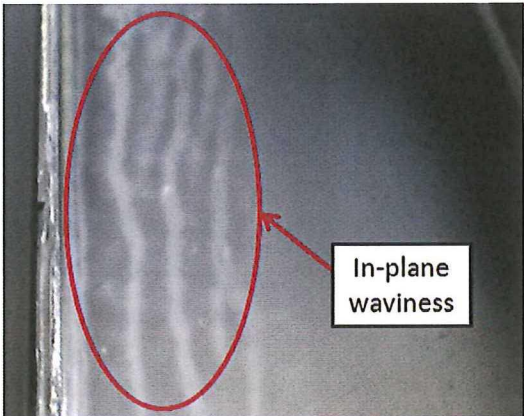
**Figure 6.49:** Out-of-plane undulations near the corner sections of core 3

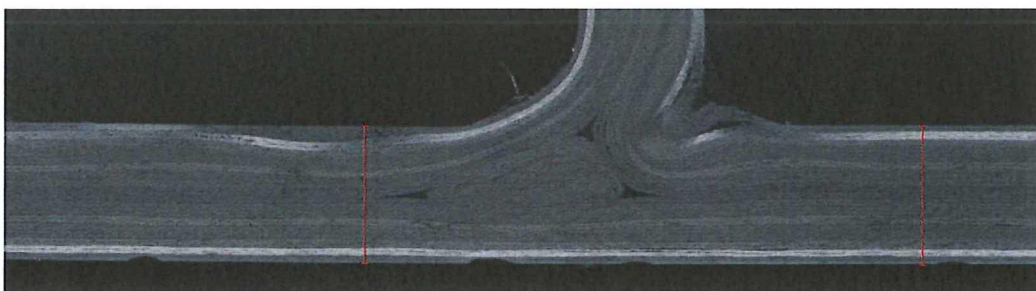
In stringer 1, the misalignment is observed with a large resin rich area on the side where the stringer moved to. Also, the resin rich area on the right side of the stringer corner is more severe than in test panel 4 due to a larger shifting of the stringer. This leads to the fact that the outer layer of the stringer formed a wrinkle in the corner section. The outer layer of the stringer is saturated with resin, because there is a cavity present on the right side of the stringer corner. The outer layer expands in thickness because of the extra space. This can be seen in figure 6.50.

**Figure 6.50:** Expanding outer layer as well as in- and out-of-plane undulations and wrinkle in the right corner section in stringer 1

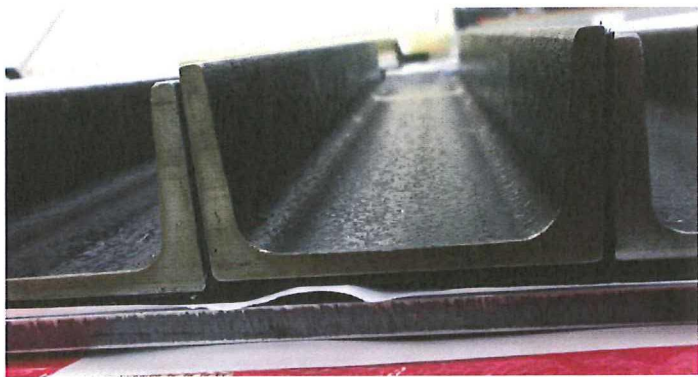
Figure 6.62: Hanging core on the other side of the core with almost no height difference

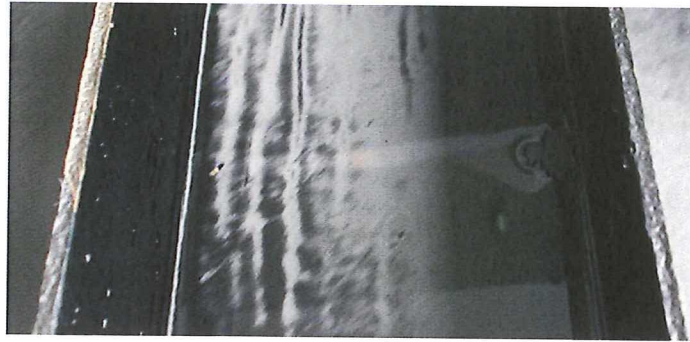
There is in- and out-of-plane waviness present in the web between stringer 2 and 3 where the hanging core 3 was introduced. This can be observed in both the outer skin on the outer mould line of the ground plate and the skin between the stringers on the inner mould line of the steel cores. A detailed view of the in-and out-of-plane waviness in the skin can be seen in figure 6.65 and the out-of-plane waviness in the outer skin can be seen in figure 6.66.

**Figure 6.65:** In-and out-of-plane waviness on the web of the stringer on the inner mould line

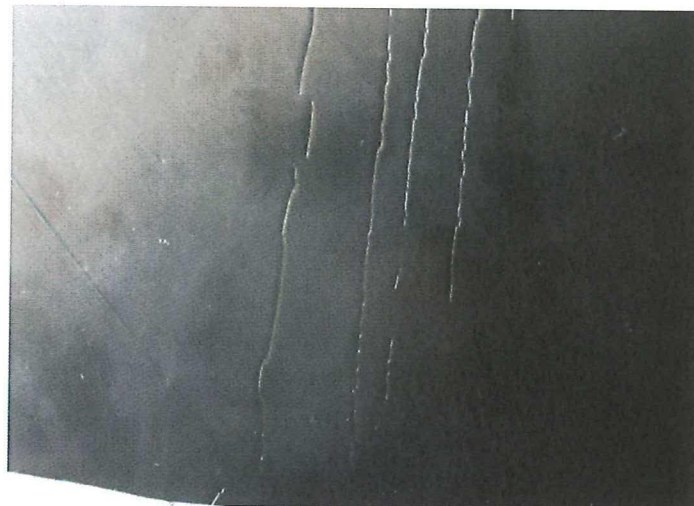
**Figure 6.66:** Out-of-plane waviness on the outer skin on the outer mould line

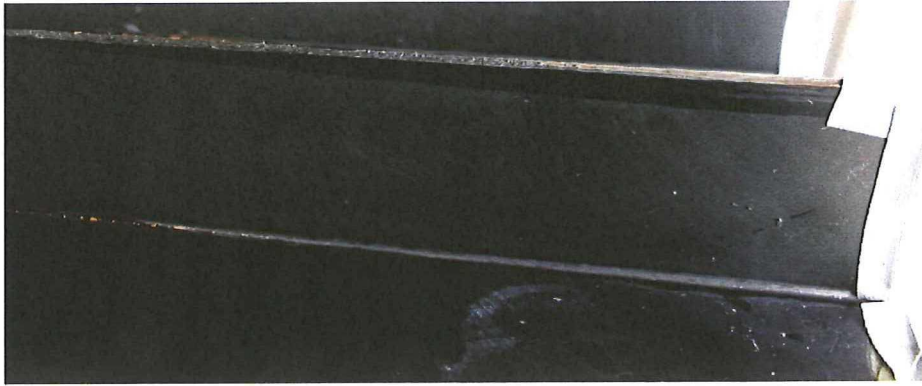
direction. The slippage of the plies can also be seen clearly at the top of the stringers on the side where the core was hanging. Here, the maximum slippage distance is 6 mm. The slipped stringer plies are shown in figure 6.67.

**Figure 6.67:** Slipped stringer plies on the stringer with the hanging core

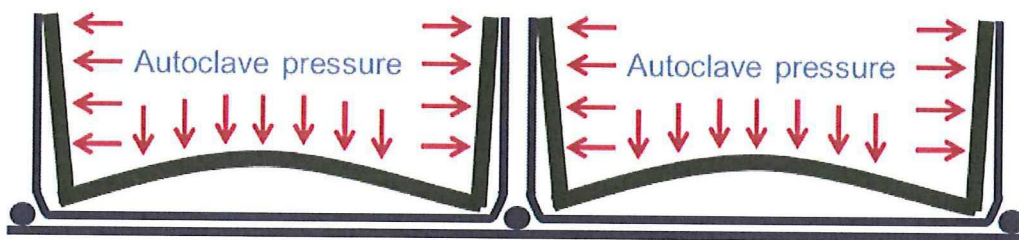
**Figure 6.74:** W-effect where the steel cores deform elastically due to the autoclave pressure

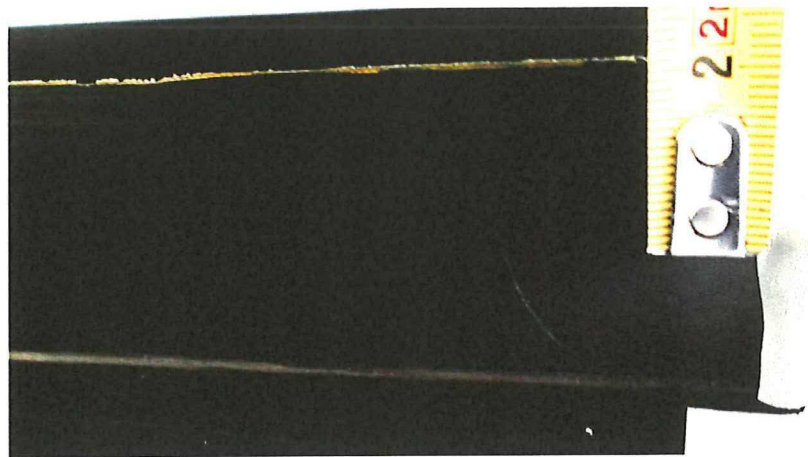
**Figure 6.79:** Slipped stringer plies in stringer 3 with a distance of 20 m

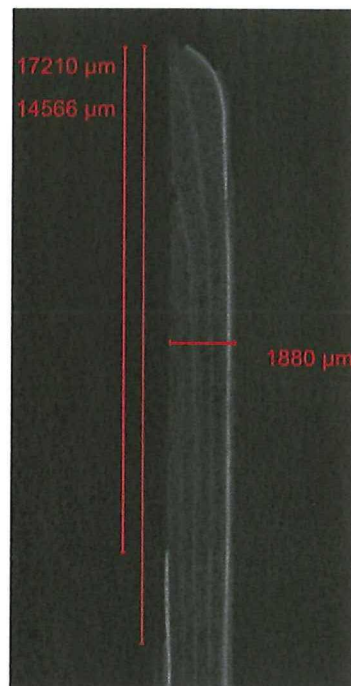
**Figure 6.84:** Slipped stringer plies in stringer 3 over a distance of 17,2 mm

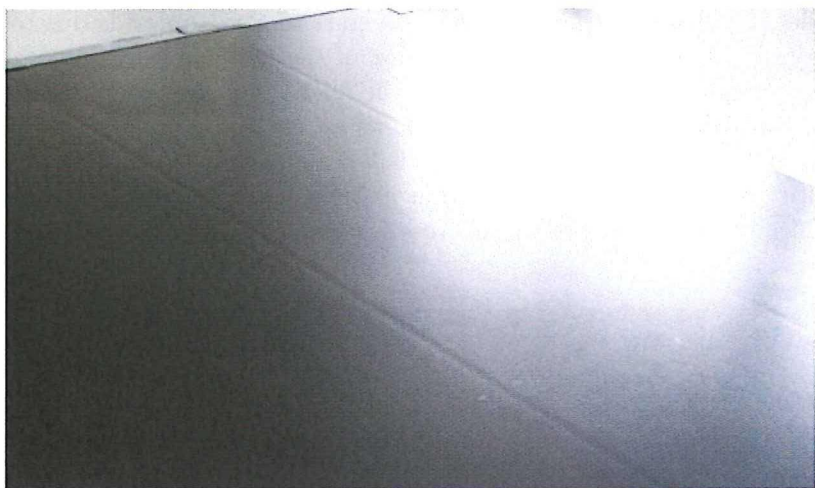
**Figure 6.92:** Indentation at the location of the filler on the back of panel on the outer mould line

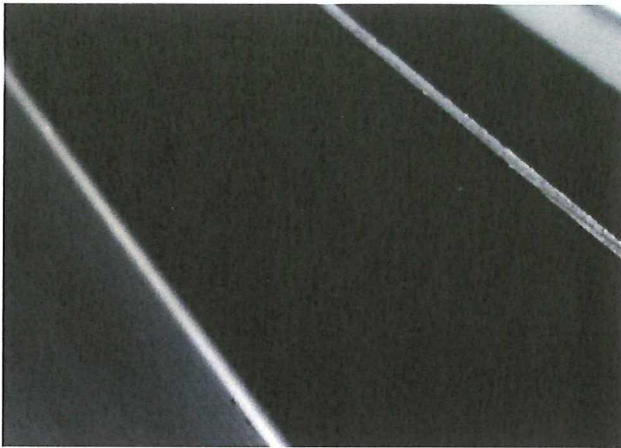
**Figure 6.93:** In-plane waviness in stringer 1

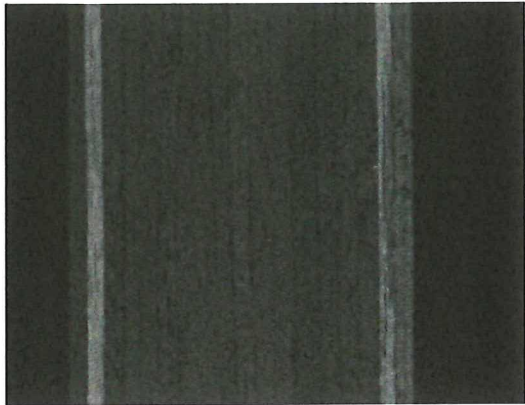
Figure 6.96: In-plane waviness in stringer 1 seen from the cross section

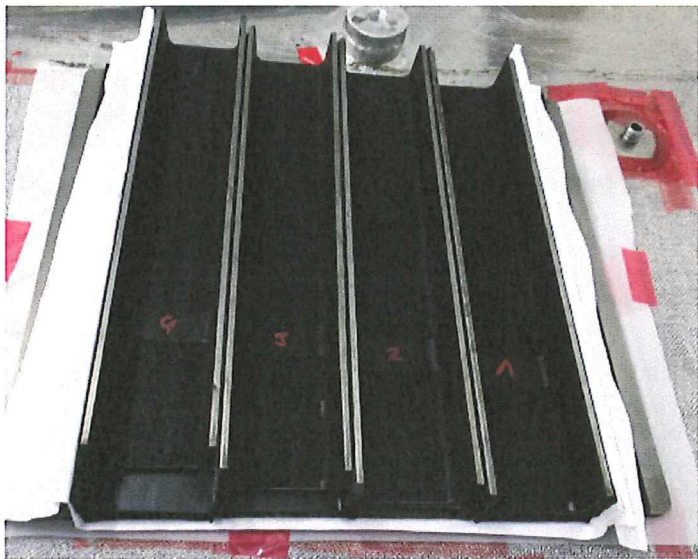
Figure 6.106: Shifting of the cores in the test part

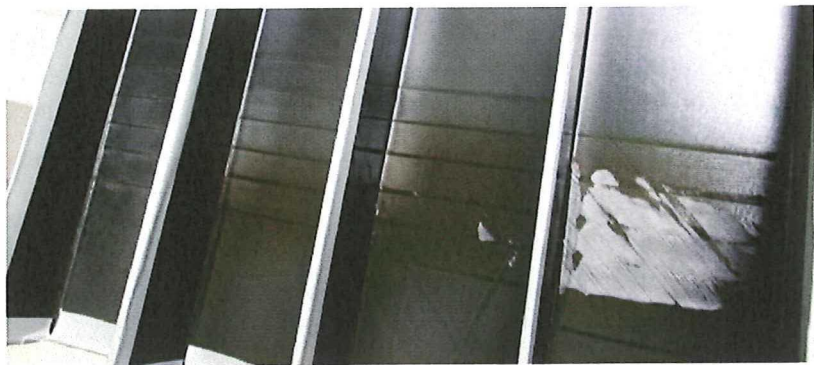
Figure 6.113: Increasing severity of brown areas for an increasing shifting distance

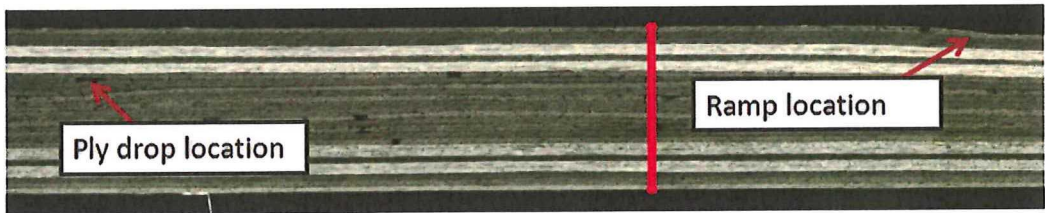
Figure 6.114: Mismatch of ply step location and tooling ramp location in core 4

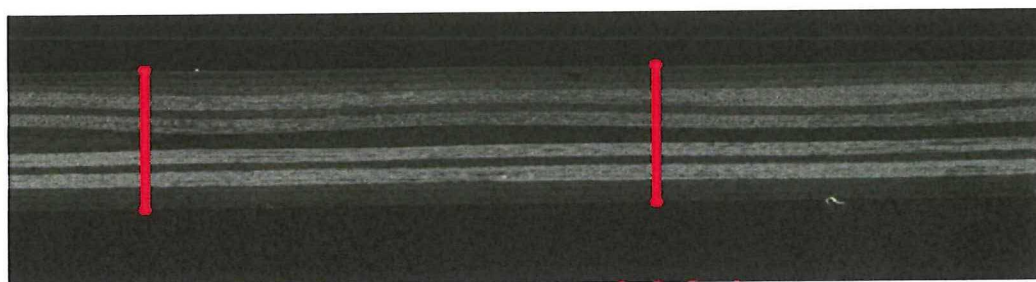
**Figure 6.119:** Out-of-plane undulations caused by the expansion of the layers in x-direction

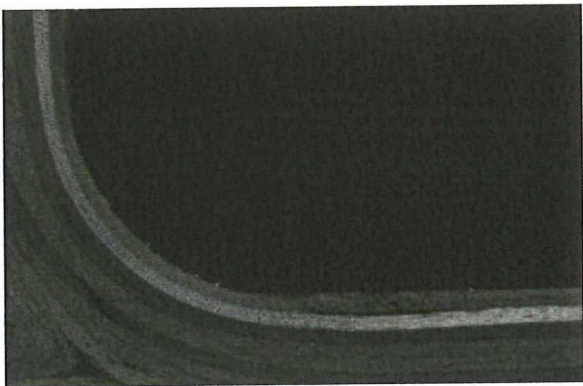
Figure 6.146: Cross sectional image of in-plane waviness in the corner section of stringer 1

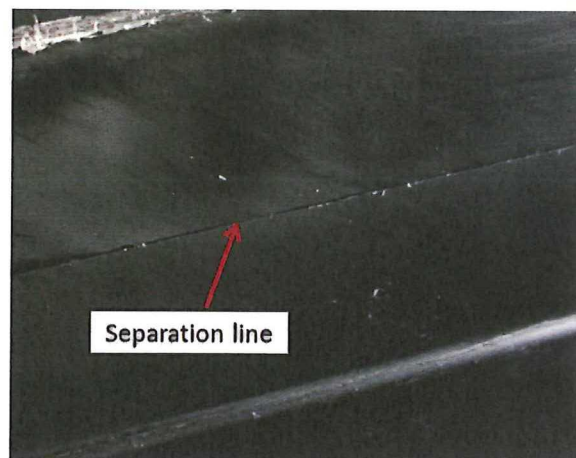
**Figure 6.159:** In-plane waviness in stringer 3

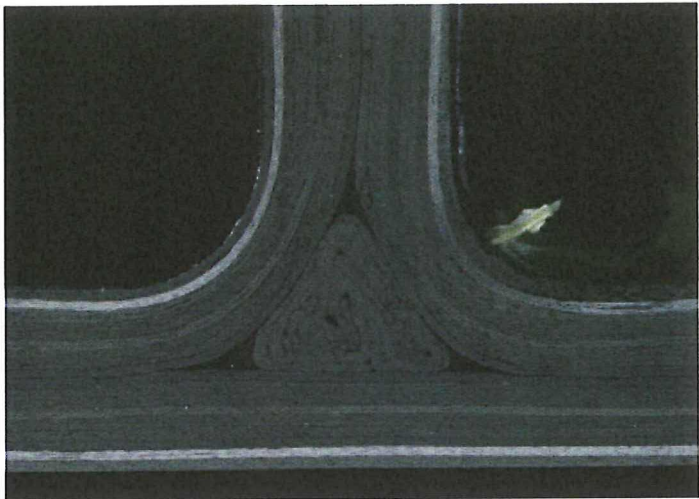
**Figure 6.160:** Resin rich areas in the corner sections as well as enclosed release film on the right side of the corner section in stringer 3

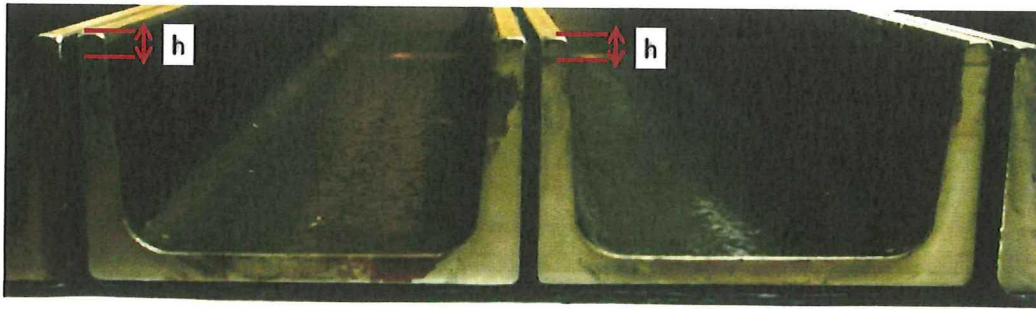
**Figure 6.164:** Lower stringers than the cores, with stringer 1 on the left

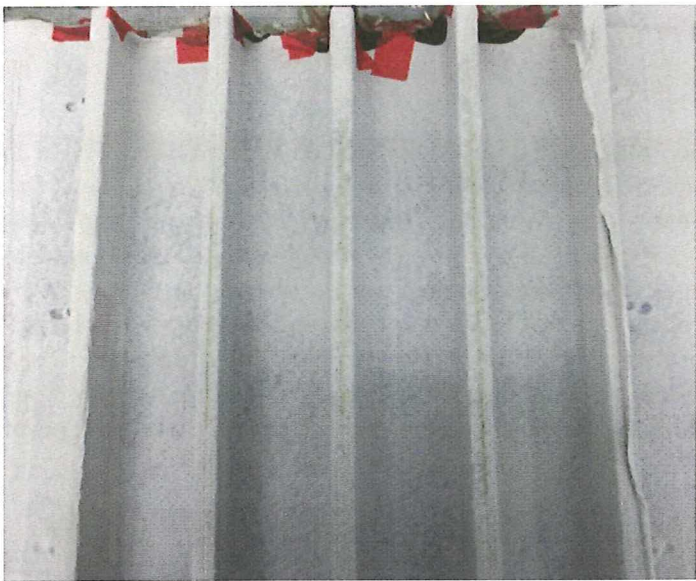
**Figure 6.167:** Brown stains in the airweave on top of the stringers after curing

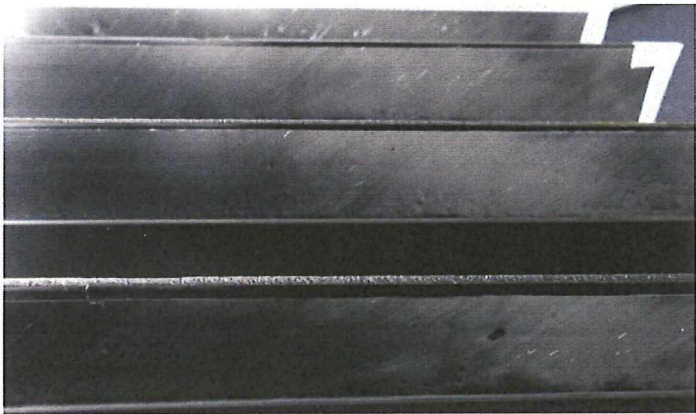
**Figure 6.168:** Slipped stringer plies in the stringers, with stringer 3 in the front

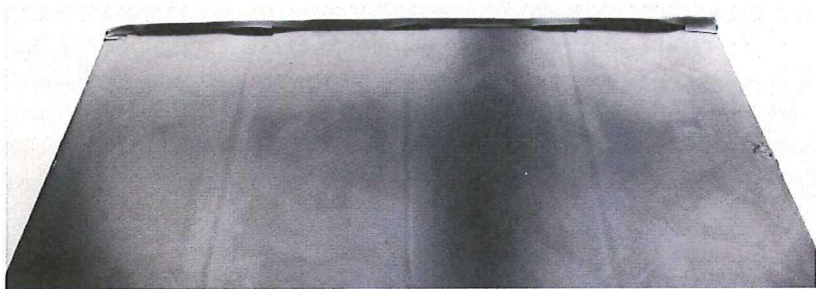
**Figure 6.169:** Filler indentations on the back on the outer mould line with core 1 on the left

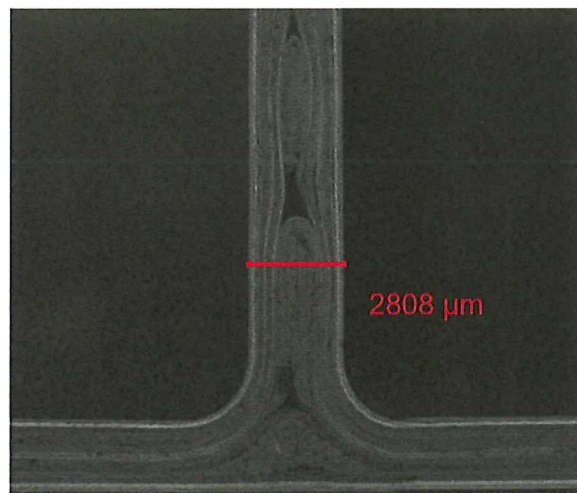
**Figure 6.170:** Vertical filler movement in stringer 3

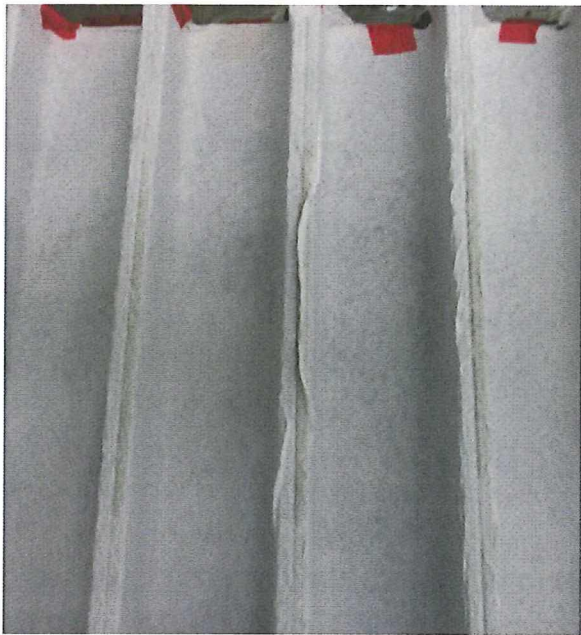
**Figure 6.177:** Brown stains in the airweave on top of the stringers after curing

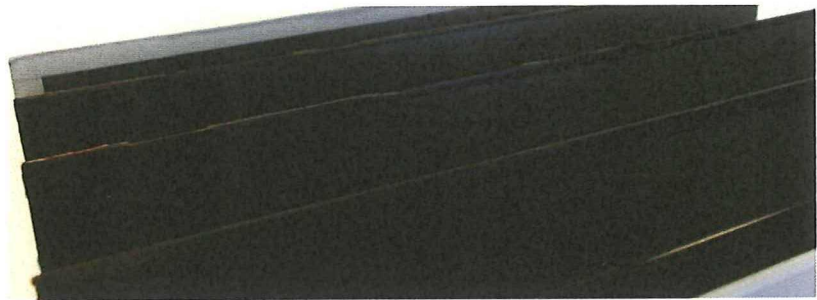
**Figure 6.178:** Slipped stringer plies with stringer 3 in the front

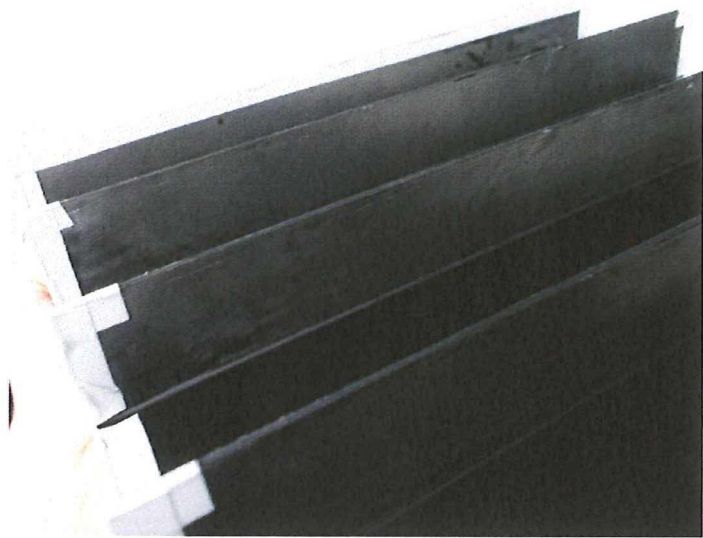
Figure 6.191: In-plane undulations in the stringers
