Experimental Investigation Into the Condition of Insulated Rail Joints by Impact Excitation

M. Oregui¹ · M. Molodova¹ · A. Núñez¹ · R. Dollevoet¹ · Z. Li¹

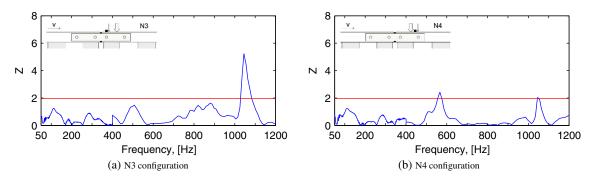
Fig. 13 Z test at the IRJ with broken fastening with ($_$) Z_{lim}, and ($_$) Z at the IRJ with broken fastening

For the N4 configuration, the FRF-based statistical method also identifies 566 Hz as a possible frequency related to the IRJ with broken fastening. This type of damage affects the interaction between the sleeper and the rail, which is one of the dominant phenomena defining the dynamic response of the track in the medium frequency range [17, 21, 30, 31].

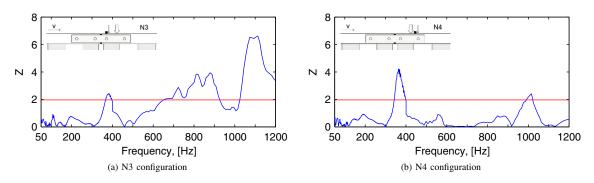
The responses of the IRJ with a damaged insulation layer and the IRJ baseline were compared via the FRF-based statistical method. The Z statistics for the N3 and N4 configurations are shown in Fig. 16(a) and (b), respectively. For the two configurations, the Z statistic crosses the statistical limit Z_{lim} at approximately 380 and 1040 Hz. The crossing at approximately 380 Hz may be related to a loosened support as the presence of white stones in the track suggests. Bellow 500 Hz, the ballast, sleeper and their interaction

For the N3 configuration, the Z statistic is also larger than the statistical limit Z_{lim} approximately between 670 and 920 Hz. In this frequency range, the receptance function has significantly higher values than the baseline receptance function. This means that the rail vibrates with larger amplitudes at these frequencies for the same input force. Thus, one should expect larger wheel-rail vibrations immediately after the gap when a wheel rolls over a IRJ with a damaged insulation layer than over a good IRJ.

Fig. 16 Z test at the IRJ with broken fastening with (-) Z_{lim} , and (-) Z at the IRJ with a damaged insulation layer

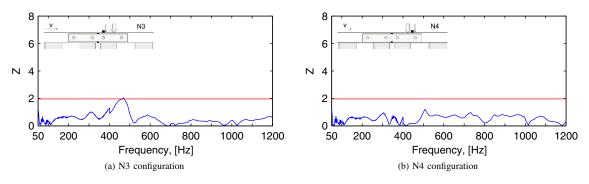
420-600 Hz: Between 420 and 600 Hz, the frequency of 566 Hz is identified for the IRJ with broken fastening and the frequency of 470 Hz is identified for the IRJ with plastic deformation (see Figs. 13 and 18, respectively). The IRJ with damaged insulation layer shows a characteristic frequency at lower frequency (i.e. 380 Hz) most probably because the structural differences (i.e. different plates) have significantly changed the characteristic frequencies of the IRJ. Regarding the IRJ baseline, the average receptance function shows two shallow depths at 470 and 566 Hz for the N3 configuration (see Fig. 9). The receptance value of these depths differ statistically for the damaged IRJs and the IRJ baseline; the difference could be caused by the changes in the rail, joint and support.

Fig. 18 Z test at the IRJ with broken fastening with (_) Z_{lim}, and (_) Z at the IRJ with plasticity

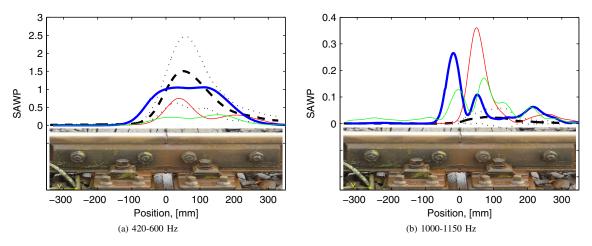
The largest difference between the damaged IRJs and the IRJ baseline is found in the frequency band of 1000-1150 Hz (Fig. 19(b)). Whereas the ABA measurements at the IRJ baseline has SAWP values lower than 0.05, the three damaged IRJ show local maxima larger than 0.15. In the frequency range of 420-600 Hz (Fig. 19(a)), the maximum SAWP value decreases with increasing visual damage. This is, the largest SAWP value is obtained for the IRJ baseline, whereas the smallest SAWP value is obtained for the IRJ with the damaged insulation layer. By comparing the maximum SAWP values and considering the degree of visual damage, the IRJs can be divided into two groups (see Table 1). In the first group, the IRJ baseline and the IRJ with plasticity show a maximum SAWP value larger than 0.9. In

Fig. 19 SAWP of the ABA signals along the IRJs: (- - -) the average SAWP of IRJ baseline, (--) one standard deviation with respect to the average SAWP, (-) the IRJ with the broken fastening, (-) the IRJ with the damaged insulation layer and (-) the IRJ with plasticity

the second group, the IRJ with a broken fastening and the IRJ with a damaged insulation layer displayed a maximum SAWP value lower than 0.8.
