**SSC-272**

**IN-SERVICE PERFORMANCE  
OF STUCTURAL DETAILS**

"Structural Details Failure Survey"

IN-SERVICE PERFORMANCE OF STRUCTURAL DETAILS

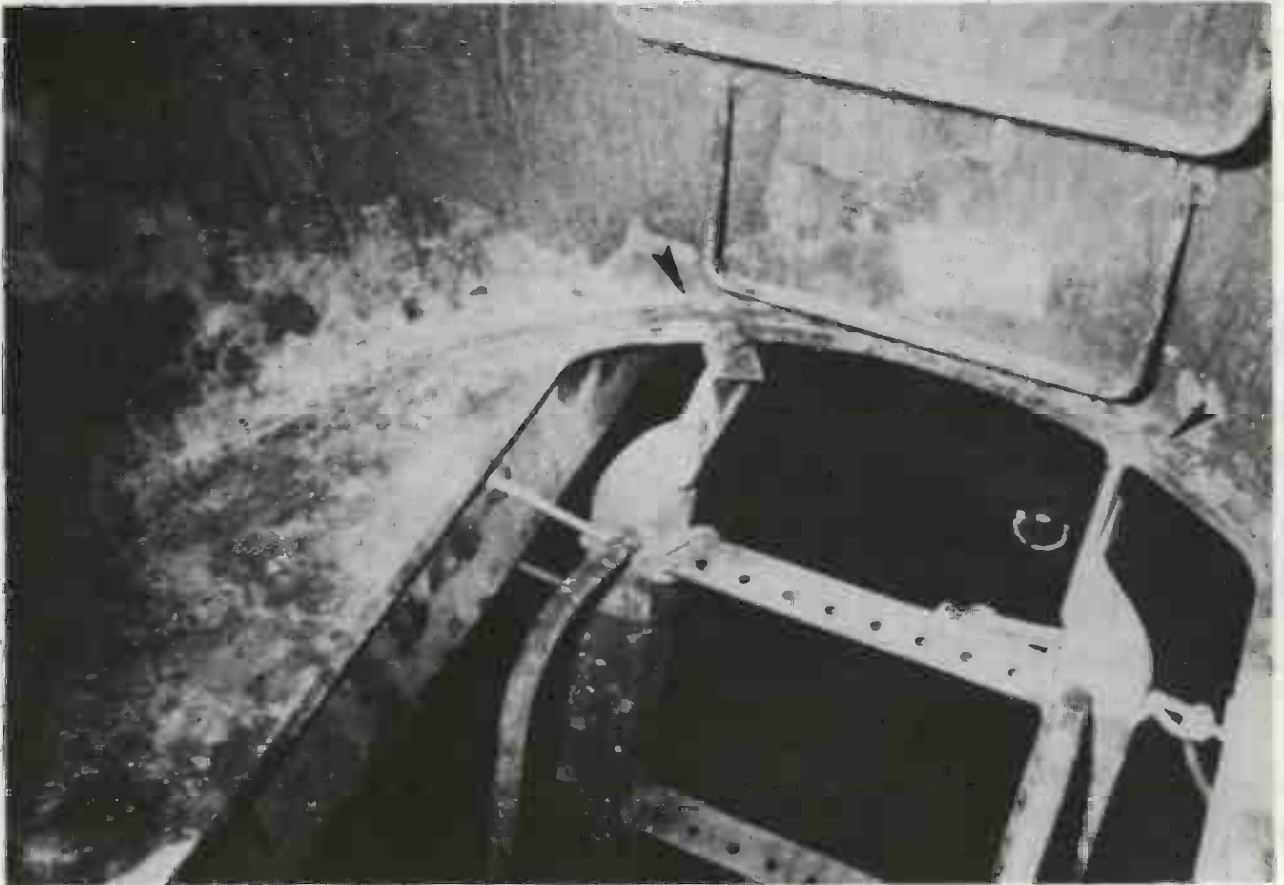
FIGURE 2

FAILED CARGO TANK LADDER CLIPS

The flat bar clips are welded to the underside of the deck and to the ladder frame. A square piece of cardboard has been inserted in the crack in the left-hand clip.

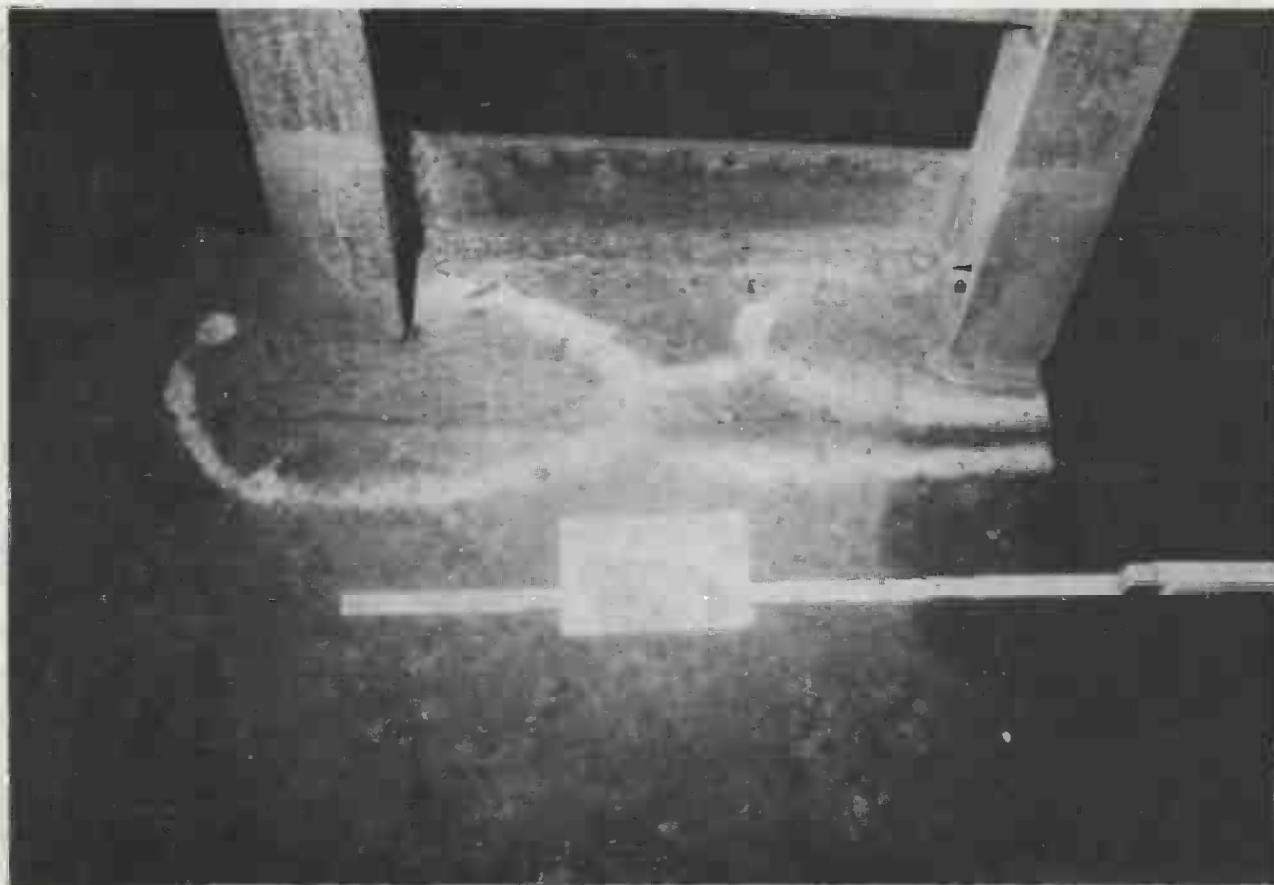
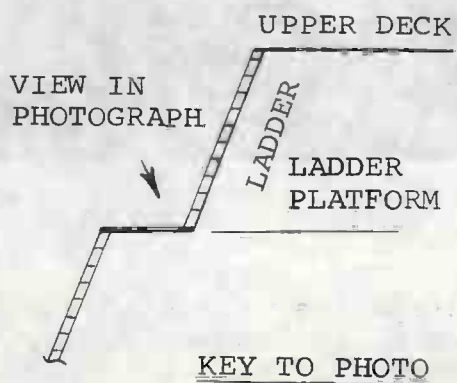
FIGURE 3

CRACKS IN LANDING PLATFORM  
FOR CARGO TANK LADDER

The cracks are encircled by white paint in order to aid location by repair men. The platform was still intact enough to hold the ladder.

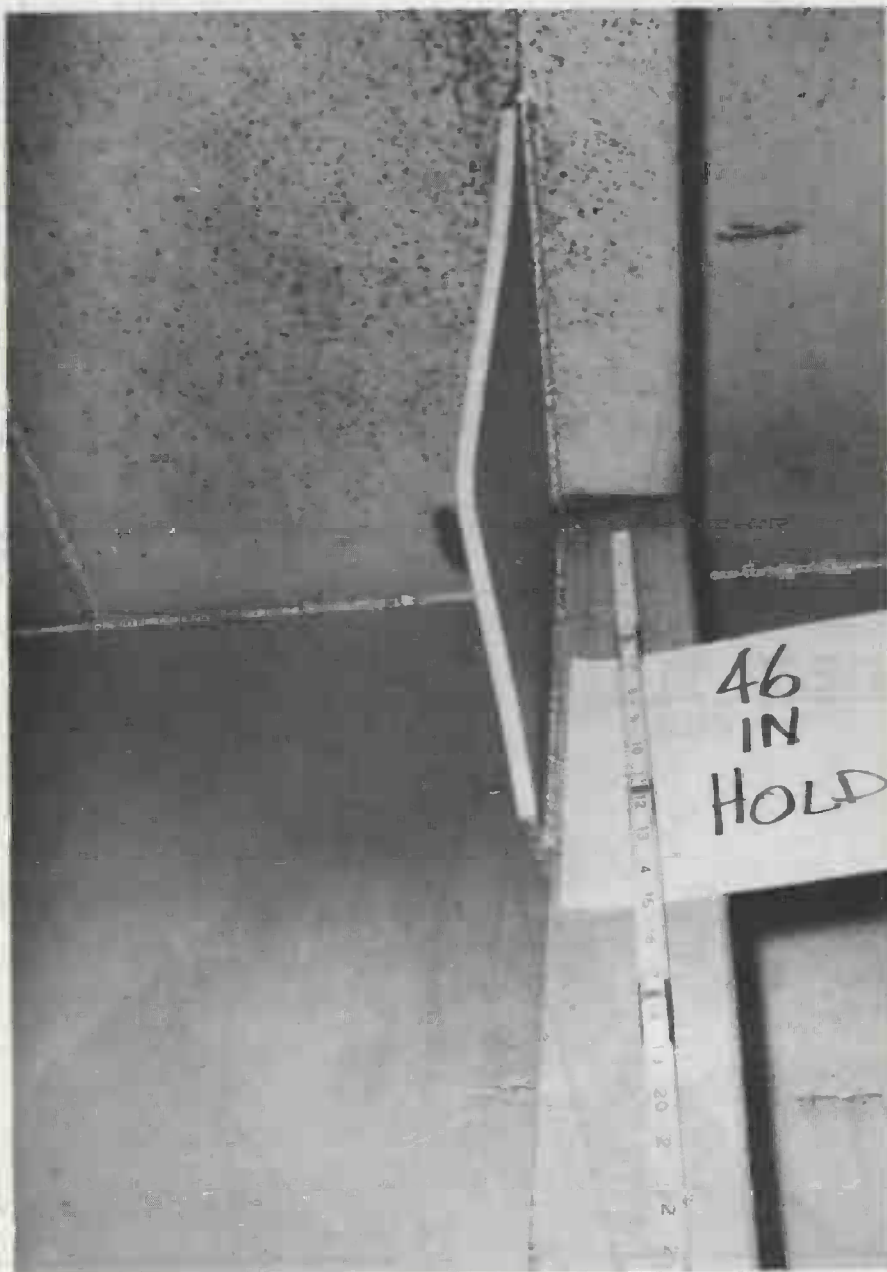
FIGURE 6

FAILED FLAT PLATE CORNER  
BRACKET ON A CONTAINERSHIP

The buckled bracket is similar to detail 1-C-1.

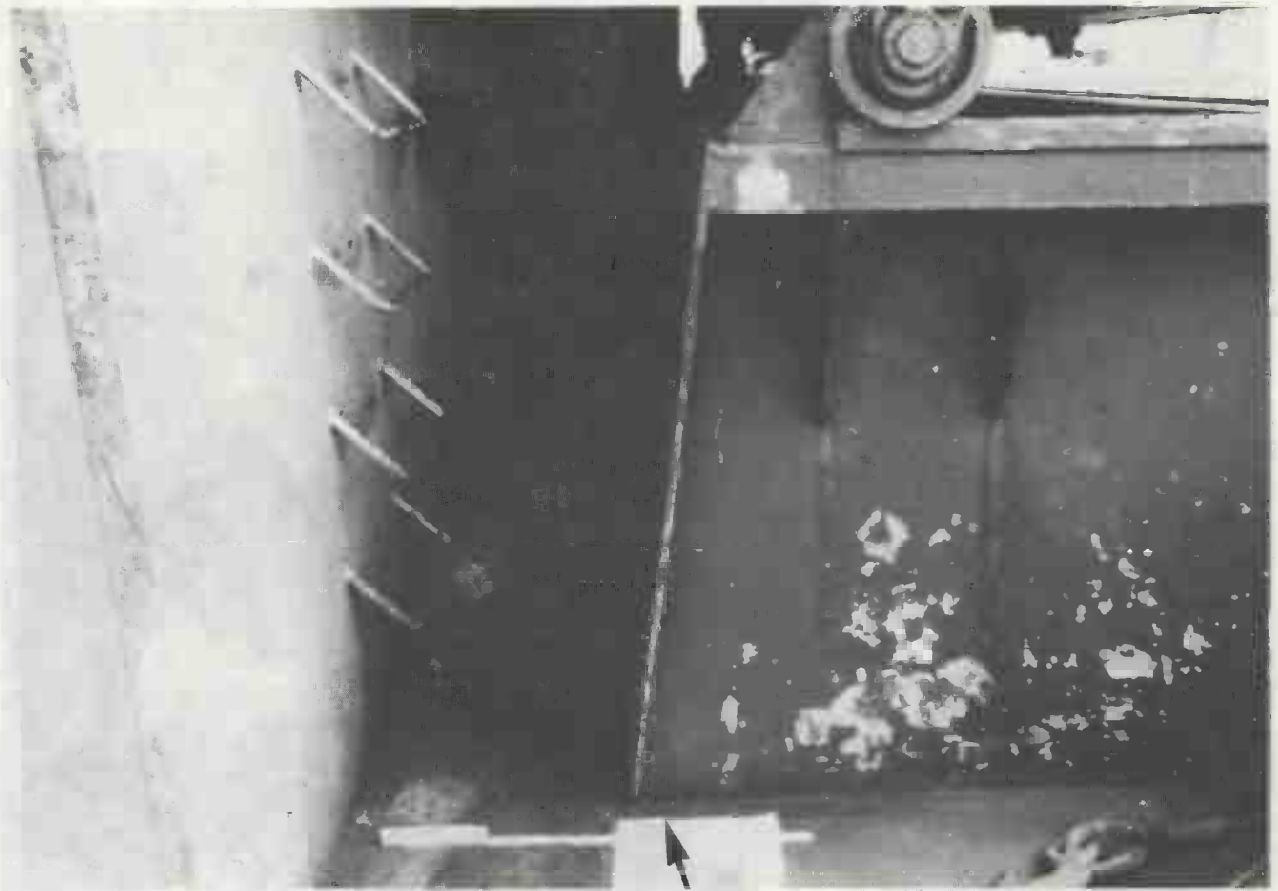
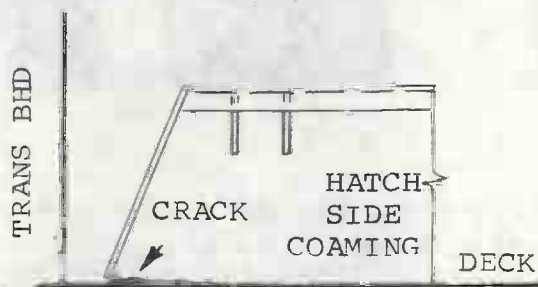
FIGURE 7

FAILED END BEAM BRACKET  
ON A COMBINATION CARRIER

This photograph shows the end of a hatch side coaming (detail 1-J-3) on weather deck. The ruler is oriented fore and aft and parallels the crack in the heat affected zone of the weld to the deck.

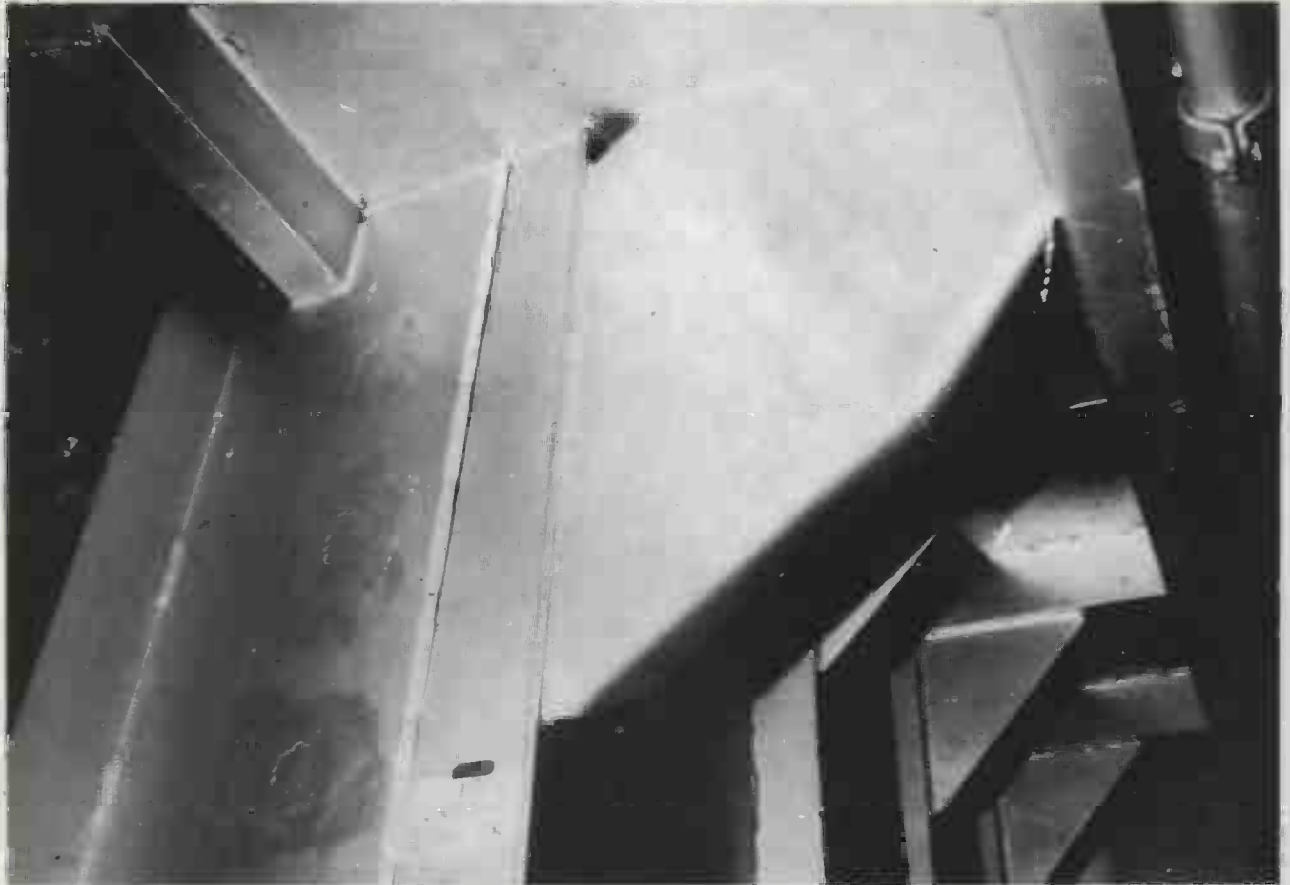
FIGURE 8

FAILED FLANGED PLATE END BRACKET ON A TANKER

The photographer is standing on upper deck and looking up toward forecastle deck. The bracket (similar to detail 1-K-3) is cantilevered in the transverse direction from the chain locker bulkhead and attaches to a deck longitudinal girder on the outboard end. Loading apparently came from on forecastle deck and continued through the deck girder and into the bracket.

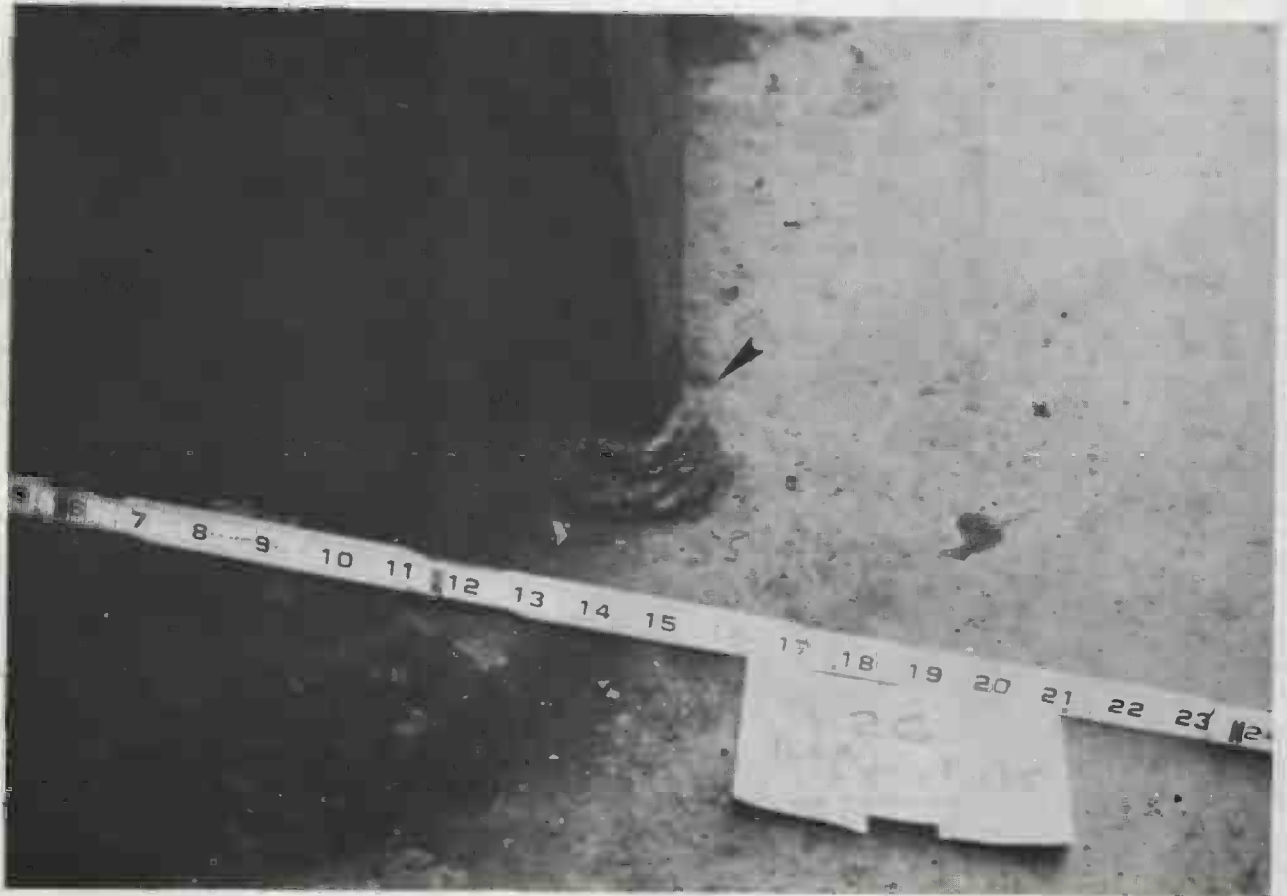
FIGURE 11

FAILED TRIPPING BRACKET AT A HATCH  
END ON A CONTAINERSHIP

This flanged plate tripping bracket supports a transverse hatch coaming on main deck. The picture is of the bracket toe at main deck where layers of welds have been added in an attempt to distribute the load in the deck plate over a larger area. A short crack exists in the bracket immediately above the weld layers.

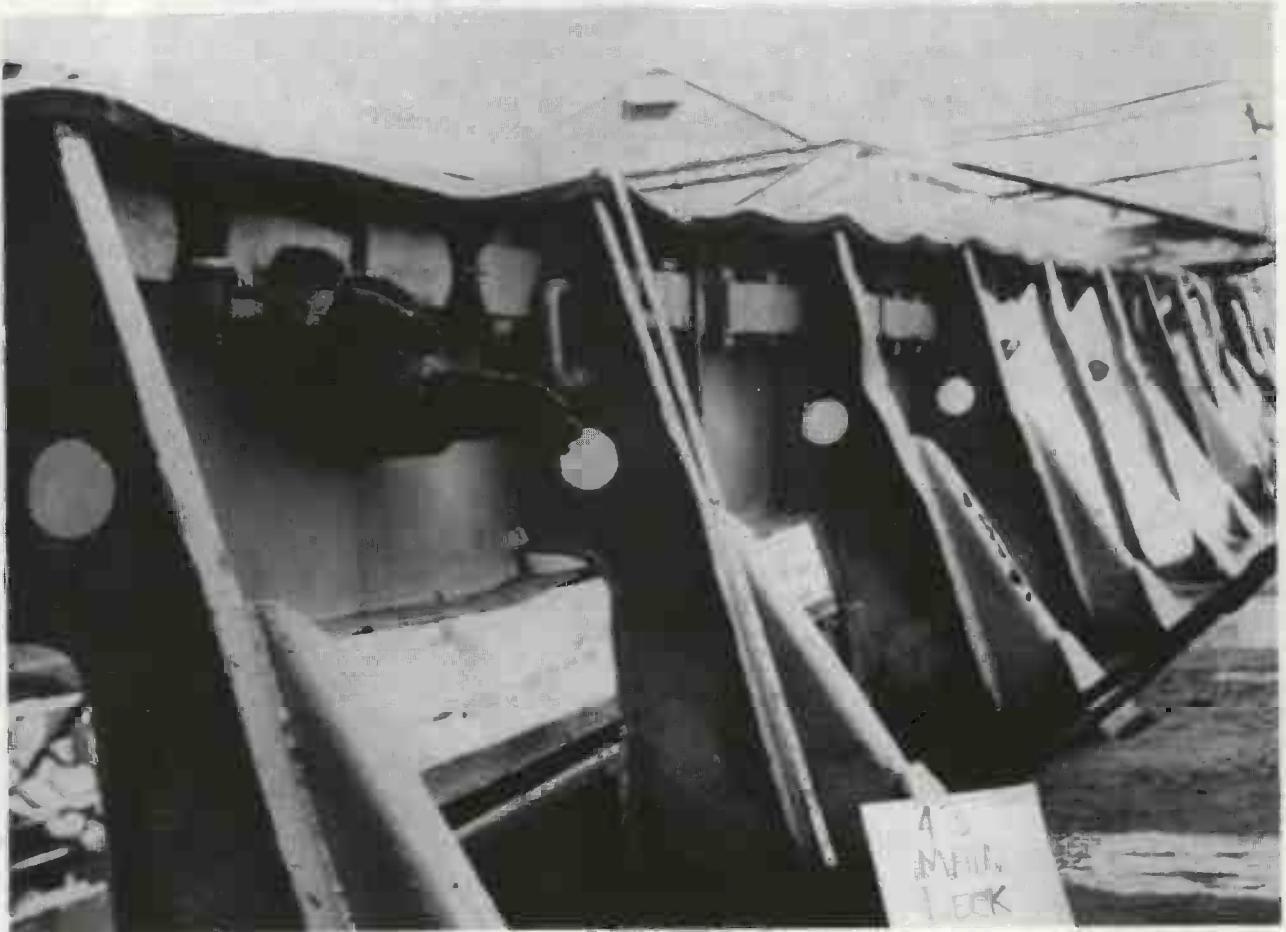
FIGURE 12

FAILED TRIPPING BRACKETS SUPPORTING  
THE BULWARK AT THE SHELL ON A GENERAL CARGO SHIP

The photograph is on starboard side looking outboard and aft. In addition to the obvious battered coaming and flanges, cracks exist in diverse places in the brackets at the connections.

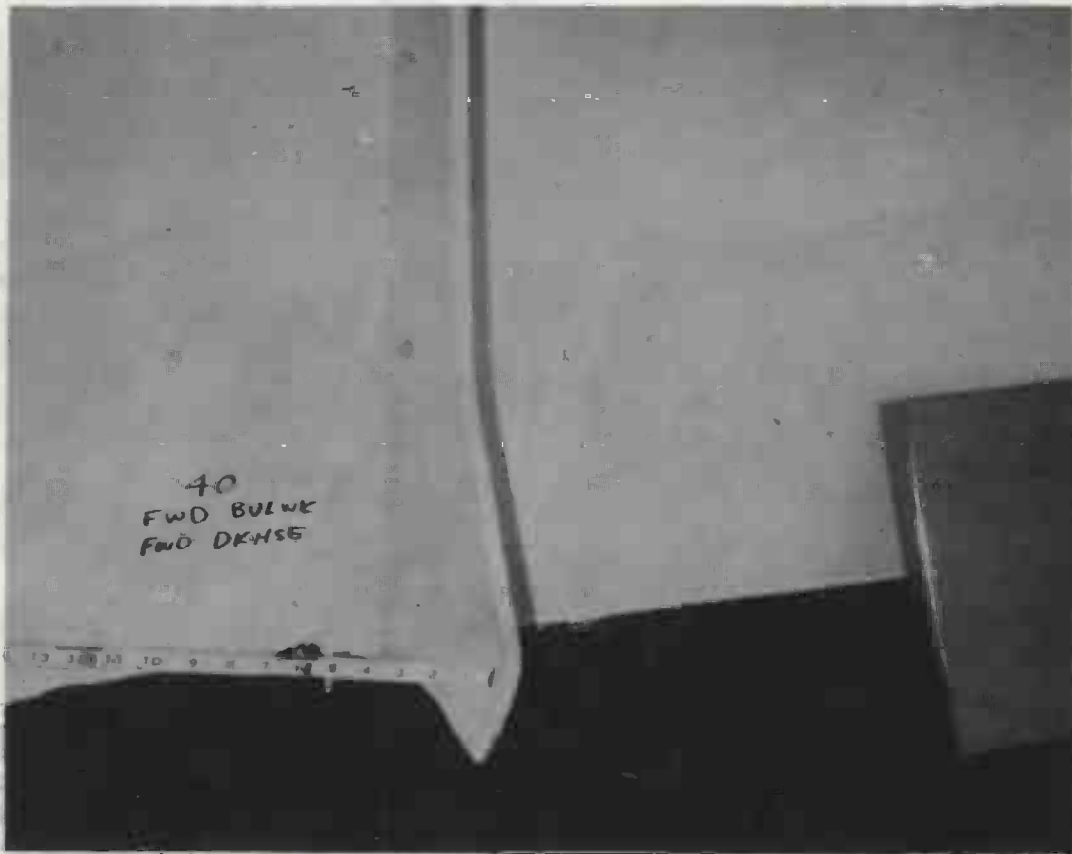
FIGURE 13

FAILED TRIPPING BRACKET SUPPORTING  
A DECK-HOUSE BULWARK ON A TANKER

The bulwark is on the forward side of a deck-house. The buckle in the bracket is due to an impact load on the bulwark. A crack also exists at the corner weld clearance cutout where the bottom of the bracket connects to the bulwark and to the deck.

In summary, design of tripping brackets on transverse hatch ends should be carefully considered especially on ships where three tiers of containers on the cargo hatches are expected; tripping brackets need not be on both sides of an in-plane loaded web; and landings of tripping brackets should be on relative strong stiffeners or on deck locations directly above backup structure. Ship operators can expect structural failures when the ship is "driven" through stormy seas.

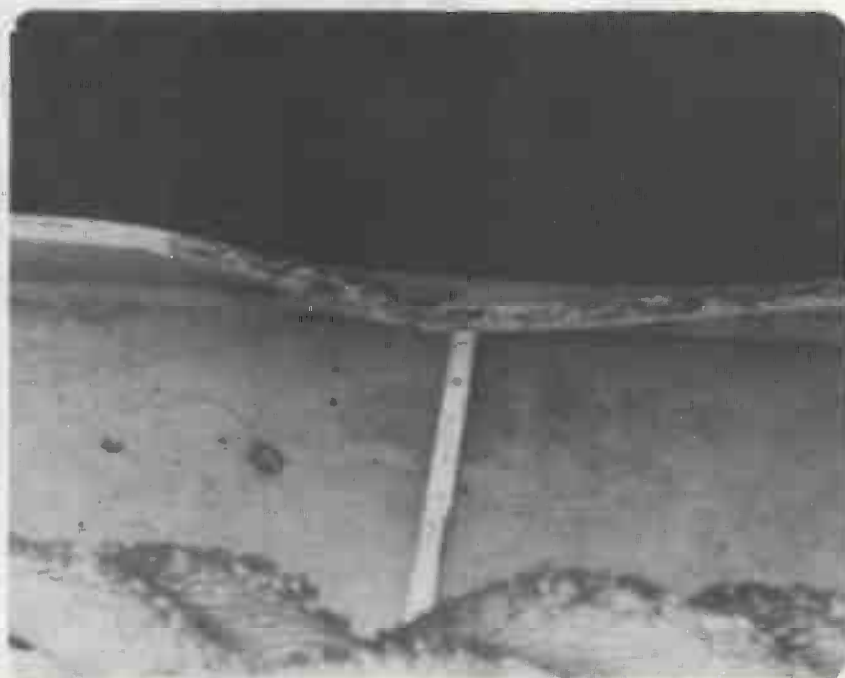
FAILED GUNWALE CONNECTION  
ON A MISCELLANEOUS VESSEL

Photographer is standing on main deck looking down at the gunwale. These out-of-plane displacements occurred in several places along the length of the gunwale on both sides of the vessel. Cracks were not observed in the detail which is similar to 5-B-8. The upper part of the picture shows part of a rope above the ruler.

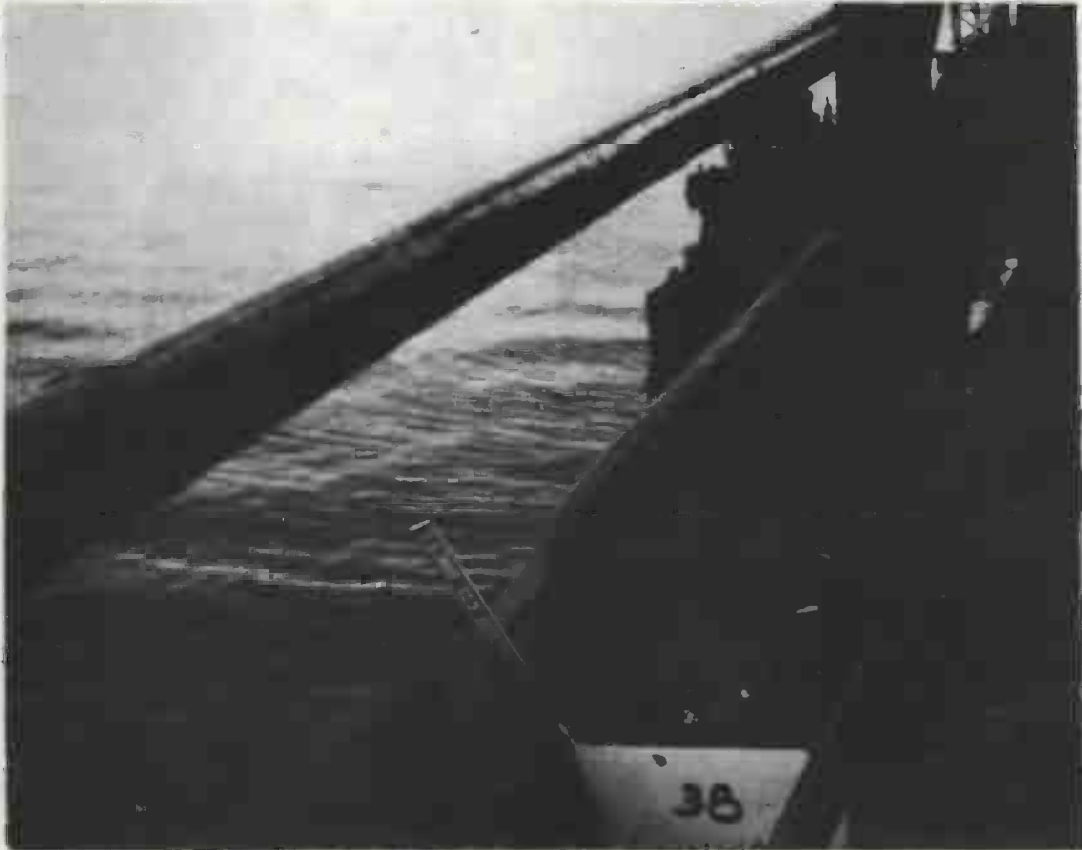
FIGURE 19

FAILED GUNWALE CONNECTION ON A TANKER

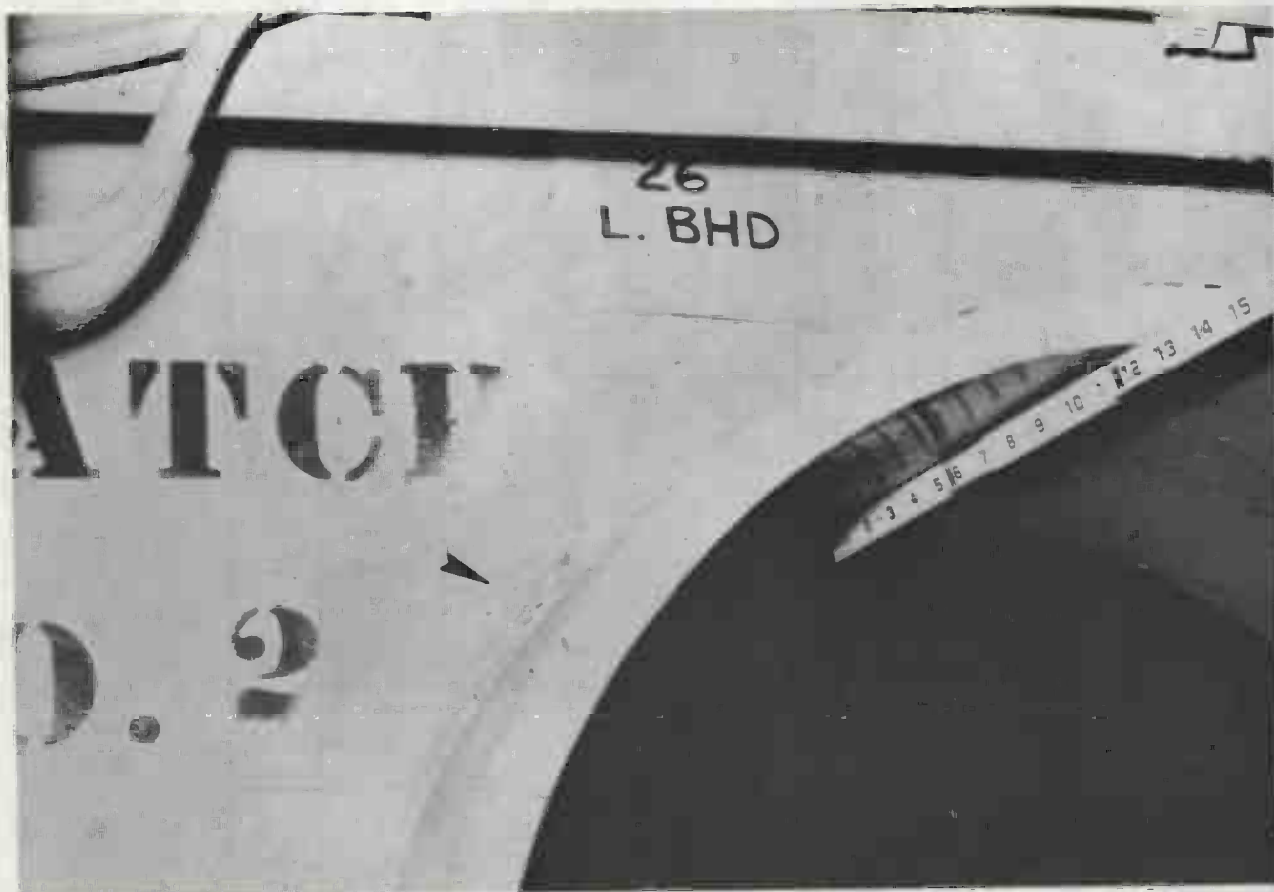
DEFECT AT AN ACCESS OPENING  
IN A CONTAINERSHIP

The access opening similar to detail 7-A-6, is near the forward end of the cargo space and in the longitudinal bulkhead of the box girder. The defect is a four inch crack in the weld of the coaming to the bulkhead plating. This detail has a history of repairs - see text.

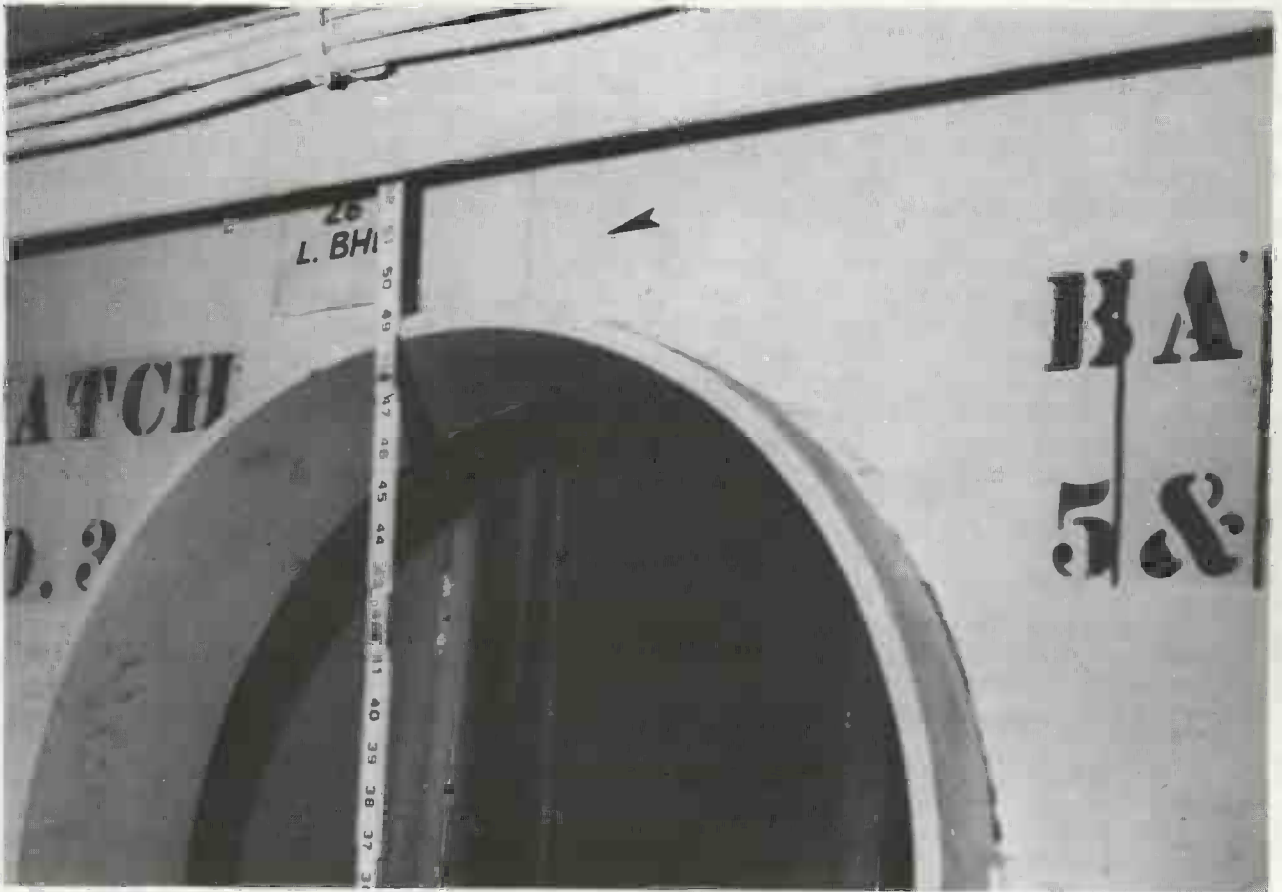
FIGURE 22

HISTORICAL DEFECT AT AN ACCESS  
OPENING IN A CONTAINERSHIP

The access opening is in the same box girder as the opening in Figure 21. Similar to detail 7-A-6, this opening has intermittent welds connecting the face plate to the longitudinal bulkhead of the box girder. The face plate is smaller than the one in Figure 21. The vertical weld centered above the opening repaired a crack that had developed in the bulkhead plating.

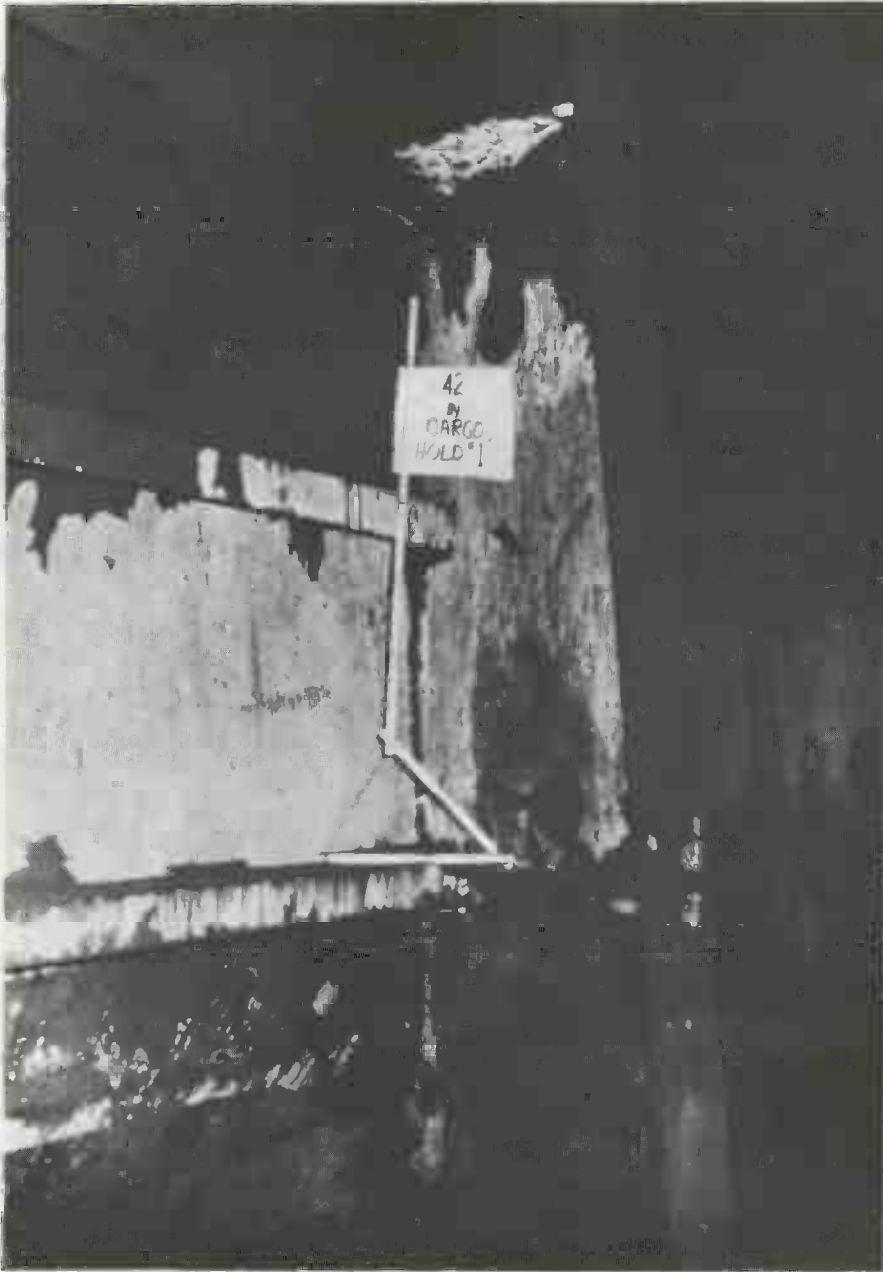
FAILED LIGHTENING HOLE IN A WEB  
FRAME OF A BULK CARRIER

In addition to the diagonal crack originating at the top and bottom of the center lightening hole, the panel of plating in the side shell web frame is buckled. The buckle is not apparent in the picture.

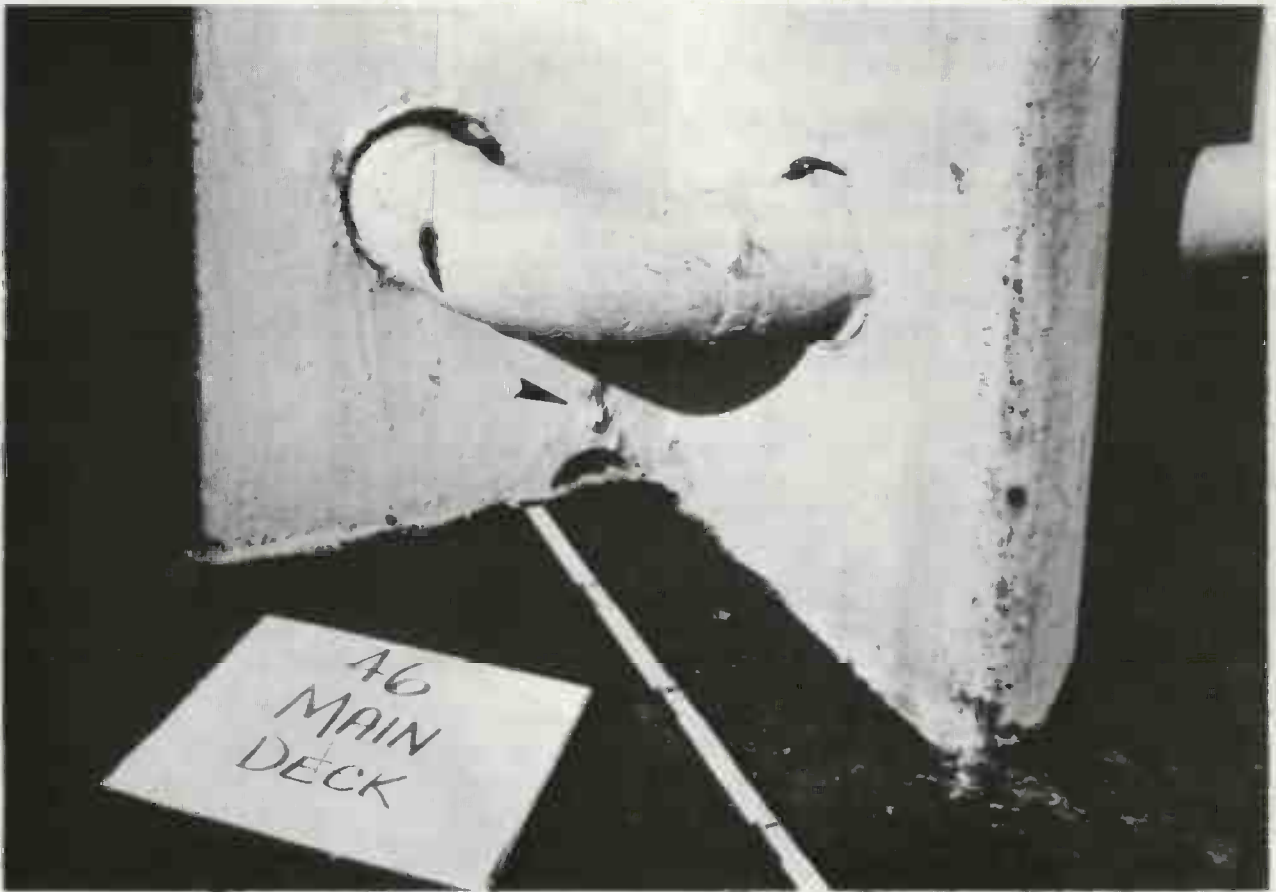
FAILED WELD CLEARANCE CUT ON A CONTAINERSHIP

The crack has been rewelded above the clearance cut at the end of the folding rule. The cut is in a bracketed end of a hatch side coaming on main deck.

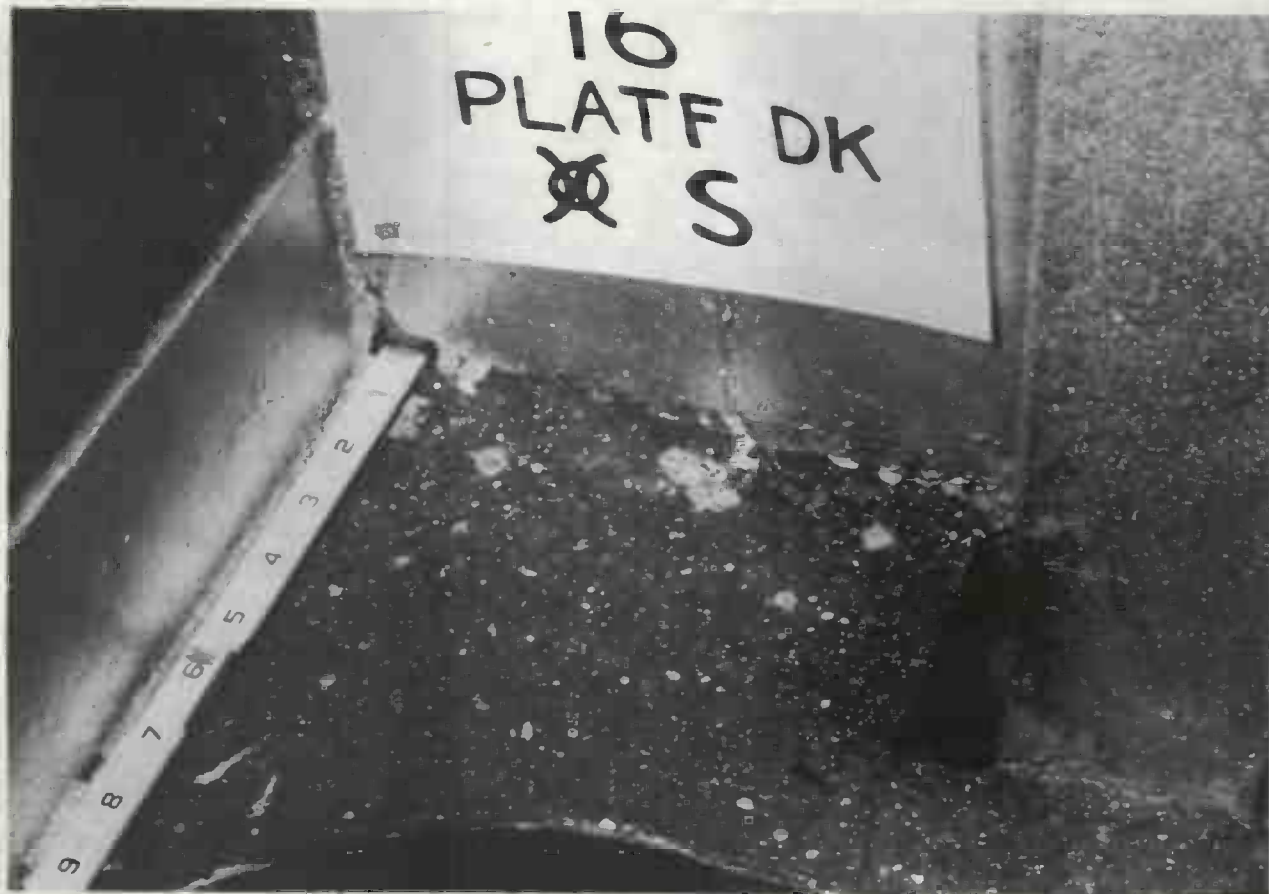
FAILED CLEARANCE CUT AT AN ACCESS  
OPENING ON A COMBINATION CARRIER

The view is looking down at the side of an access opening in a platform deck aft but forward of the machinery space. The crack is between the clearance cutout, detail 8-B-2, and the larger access opening.

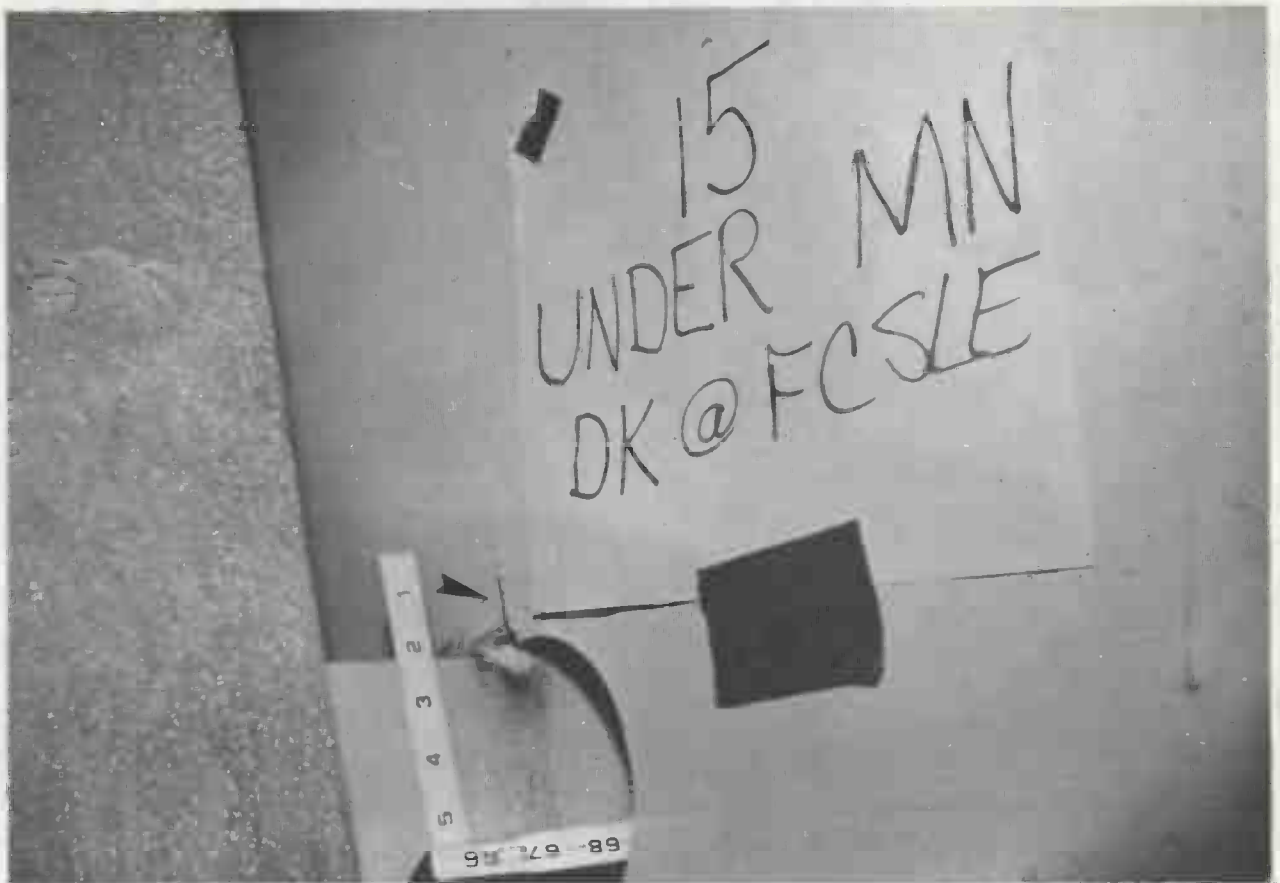
FAILURE MODE FOR GROUP "D" CLEARANCE  
CUTOUTS ON A COMBINATION CARRIER

The view is of a detail 8-D-6 cutout around a shell longitudinal piercing a transverse web frame. The cracks at these cutouts are invariably in the plating at the through stiffener heel.

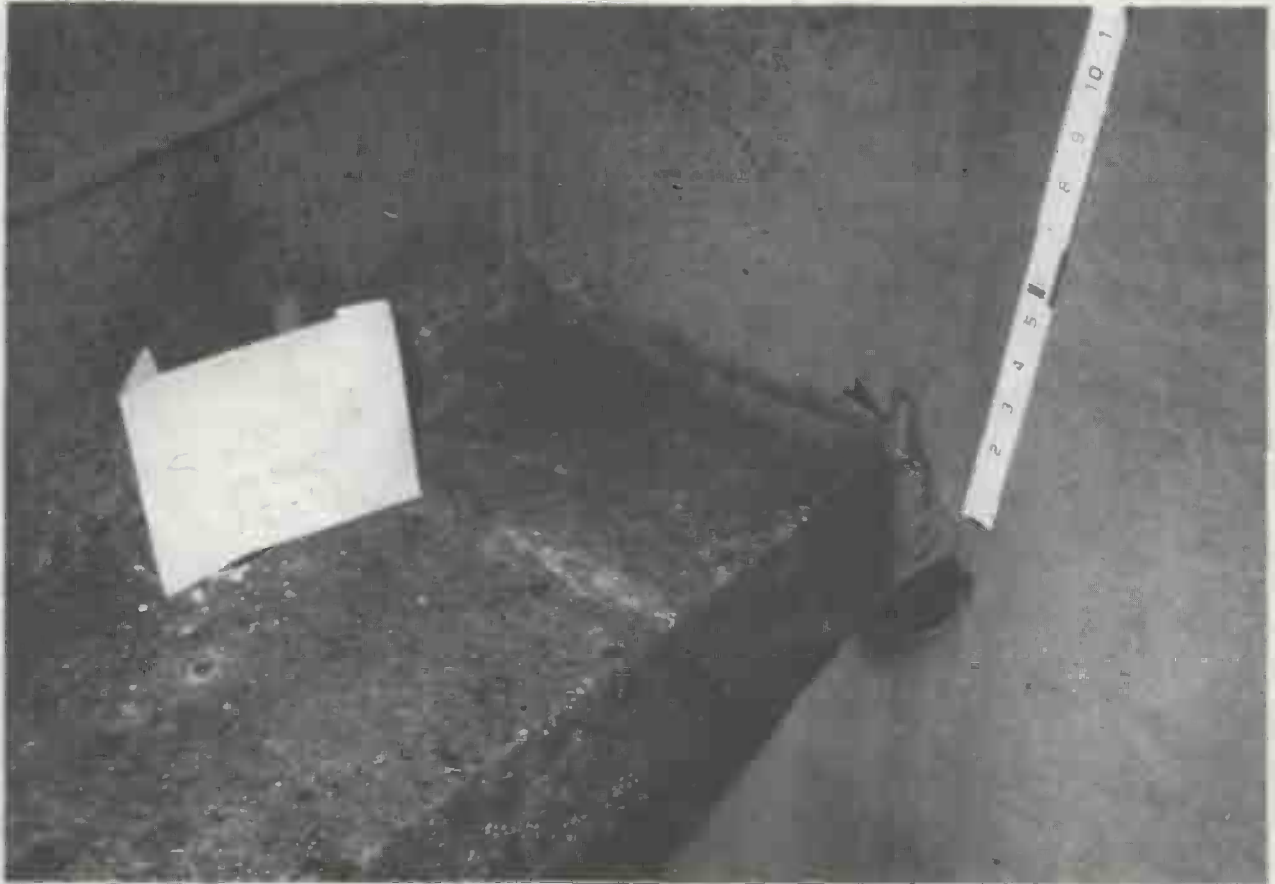
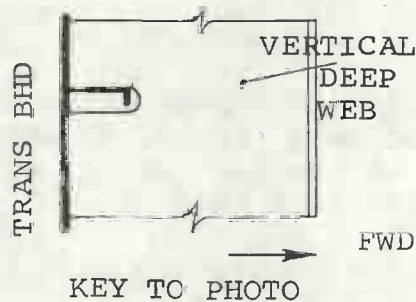
FAILURE MODE FOR GROUP "D" CLEARANCE  
CUTOUTS ON A TANKER

The view is of a detail 8-D-6 cutout around a horizontal stiffener piercing a vertical web on the transverse oil tight bulkhead. The expected failure mode is a crack in the plating at the stiffener heel.

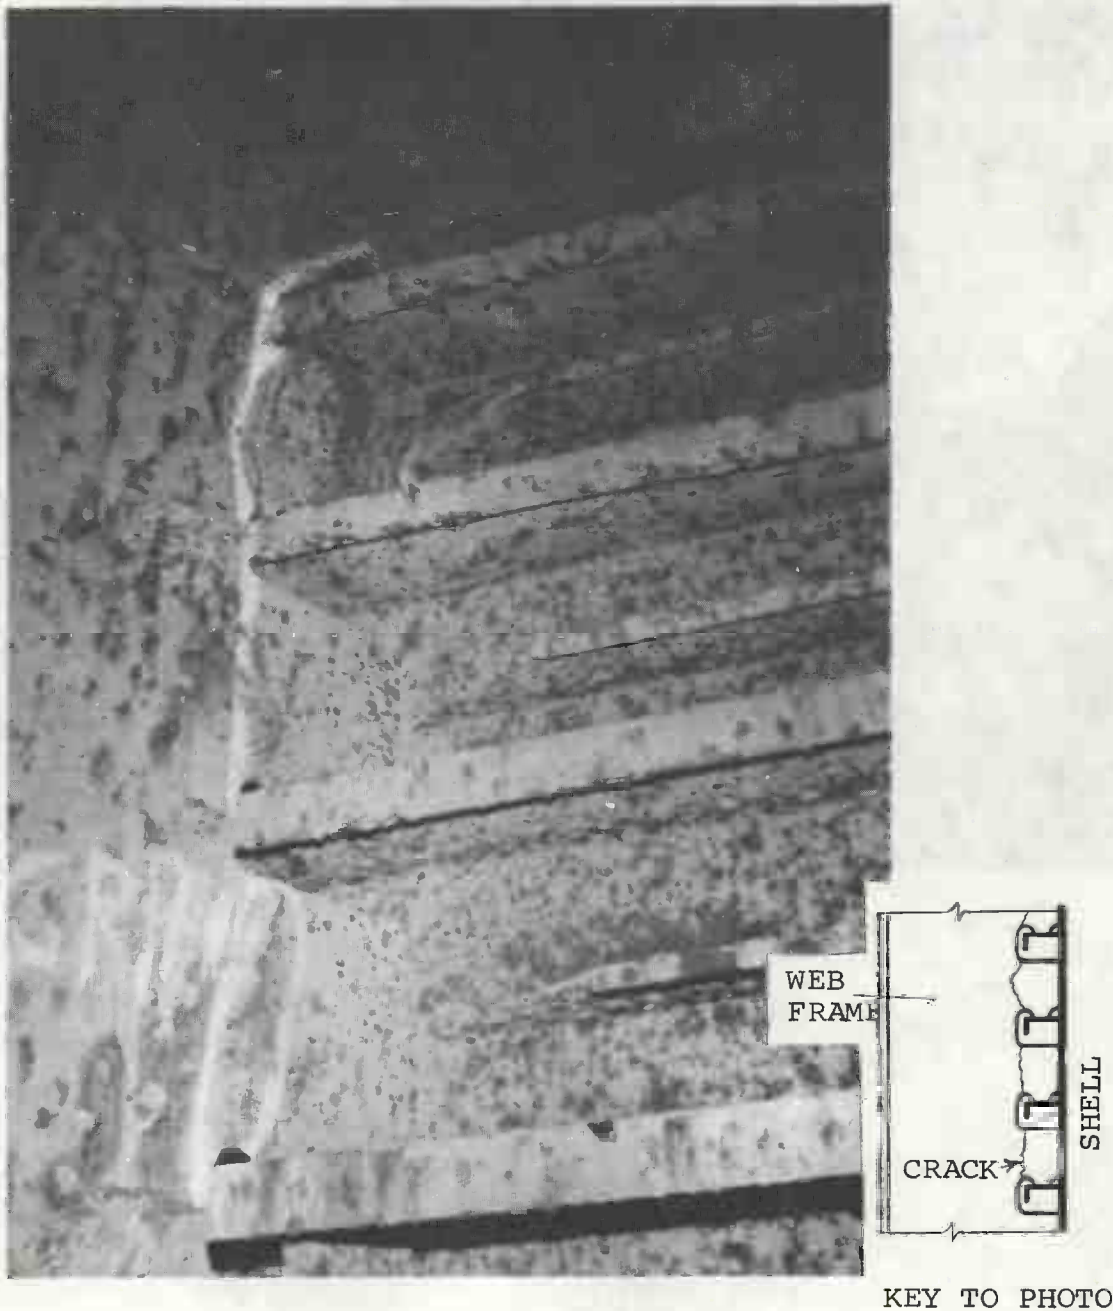
FAILED GROUP "E" CLEARANCE  
CUTOUTS ON A BULK CARRIER

The view is of detail 8-E-2 cutouts in a side shell web frame which allows passage of the through shell longitudinals in the forward deep tank. Cracks that continue from cutout to cutout parallel the paint marks.

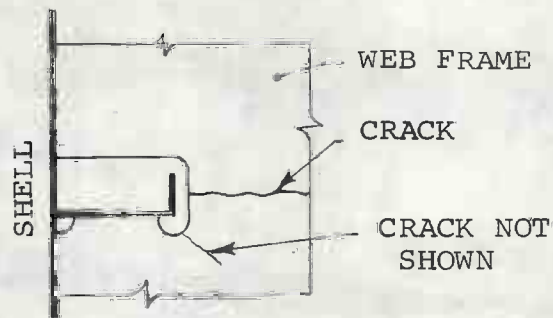
FIGURE 36

UNUSUAL CRACK AT A GROUP "E"  
CLEARANCE CUTOUT ON A BULK CARRIER

The fourteen inch crack is in a side shell web at a detail 8-E-2 cutout in the same forward deep tank as in Figure 34. Note the deterioration due to corrosion.

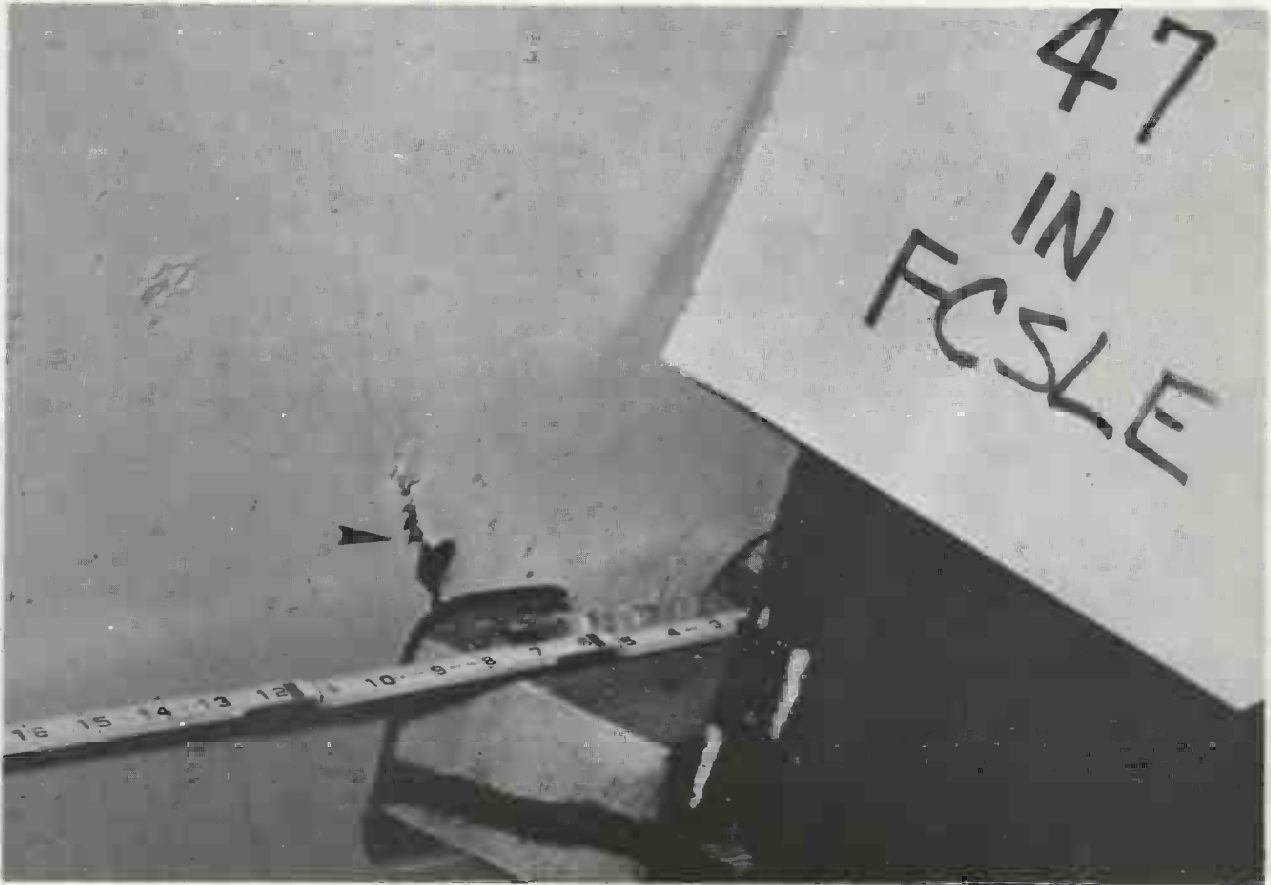
FAILED GROUP "E" CLEARANCE  
CUTOUT ON A TANKER

The cutout is in a shell web frame between upper and forecastle decks. Flaked paint indicates the crack in the web plating at the through angle heel.
