**SSC-272**

**IN-SERVICE PERFORMANCE  
OF STUCTURAL DETAILS**

"Structural Details Failure Survey"

IN-SERVICE PERFORMANCE OF STRUCTURAL DETAILS

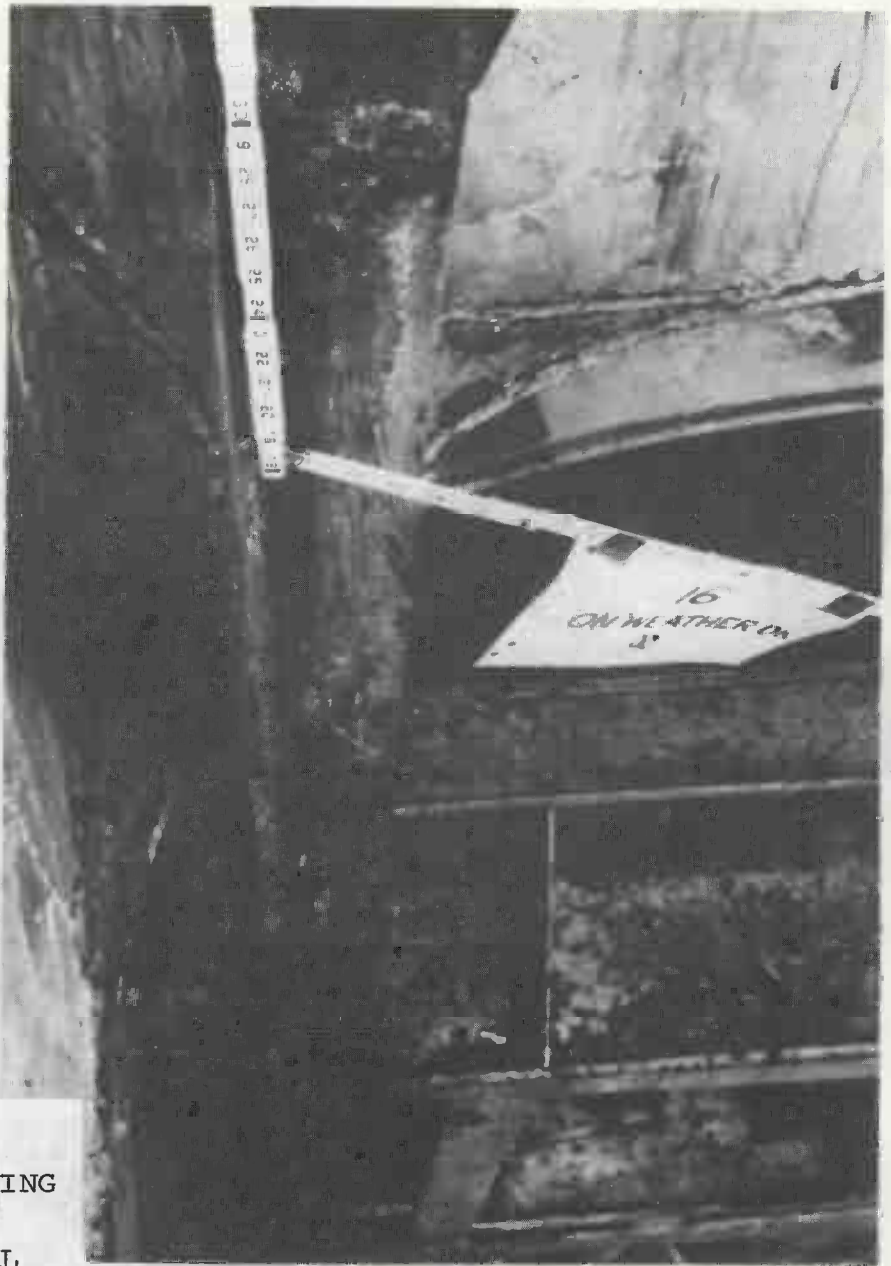
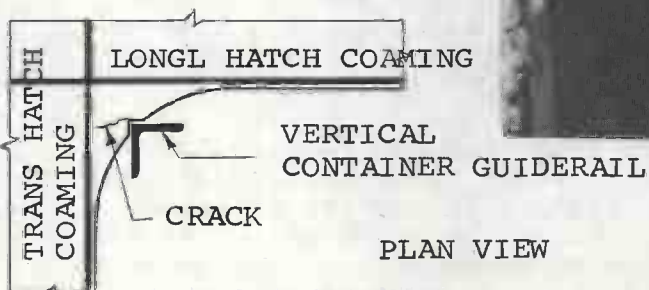
FIGURE 40

FAILED HATCH CORNER ON A COMBINATION CARRIER

This view is looking down at a radius hatch corner similar to detail 9-C-2. A notch has been cut in the deck plating to accommodate the vertical container cell guide. A ten inch crack in the plating originated at the notch.

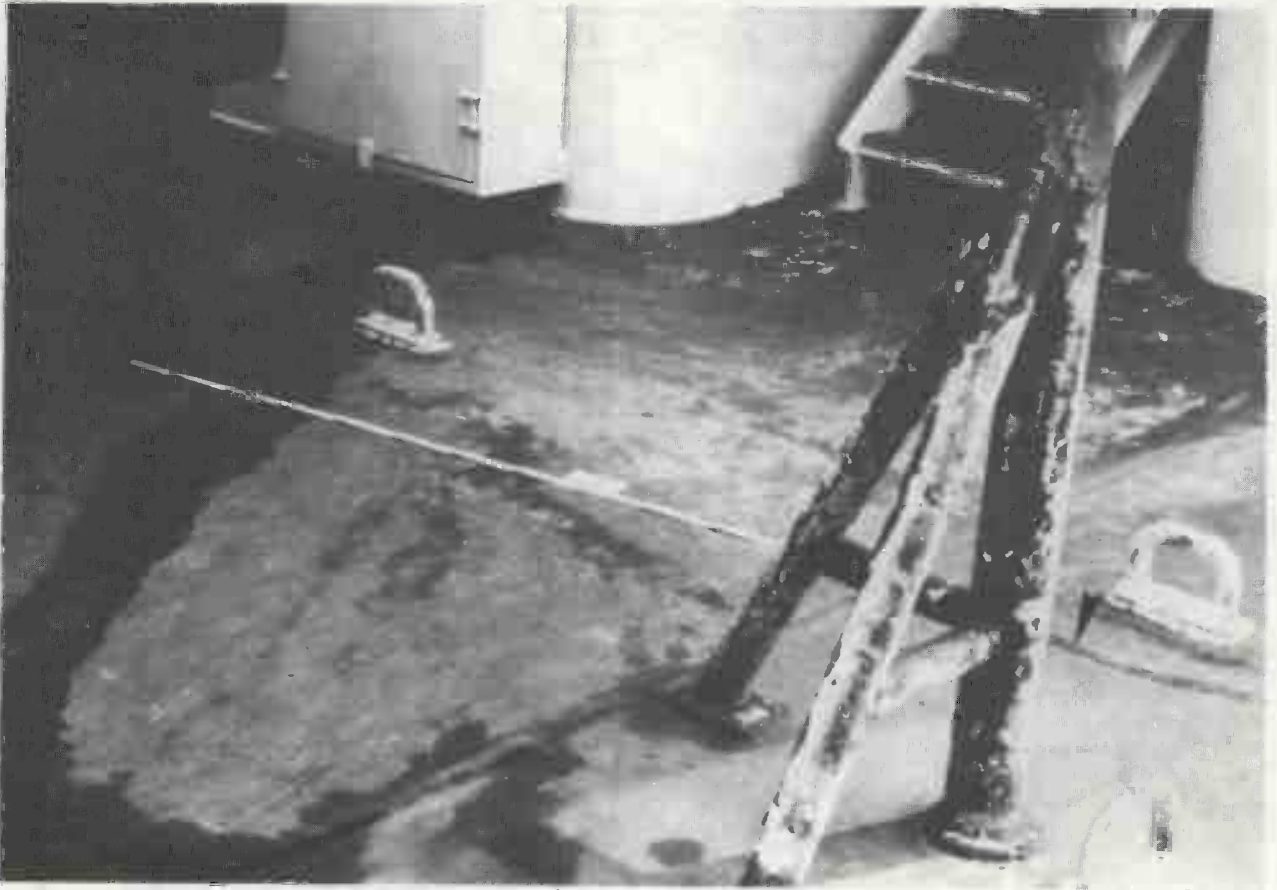
HISTORICAL CRACK AT A HATCH  
CORNER ON A CONTAINERSHIP

This view is on the starboard side of the ship and looking down on the main deck plating outboard of the forward corner of No. 1 main cargo hatch. The folding ruler is on the renewed deck plating and in the approximate location where the crack existed outboard of the hatch corner. Note the rewelded portion of the crack at the outboard end of the ruler.

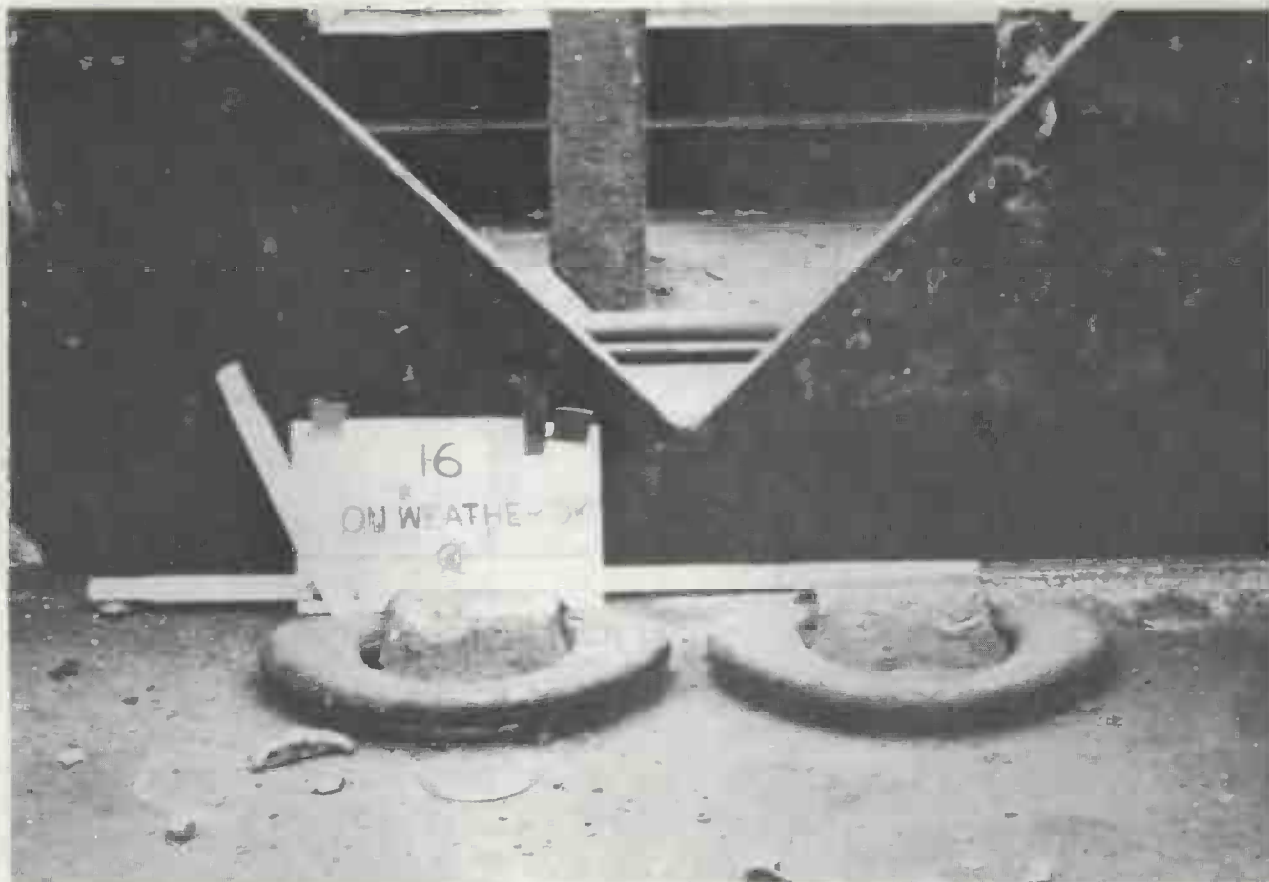
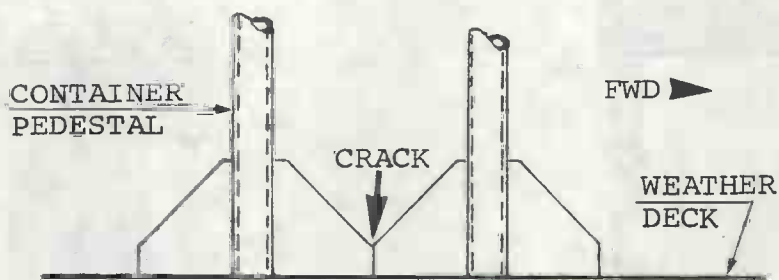
FIGURE 44

FAILED STANCHION END BRACKET  
CONNECTION ON A COMBINATION CARRIER

View on weather deck looking outboard at the intersection of two container stand brackets, similar to detail 10-B-9. The crack originated at the vee notch and continued through the weld to the deck plating.

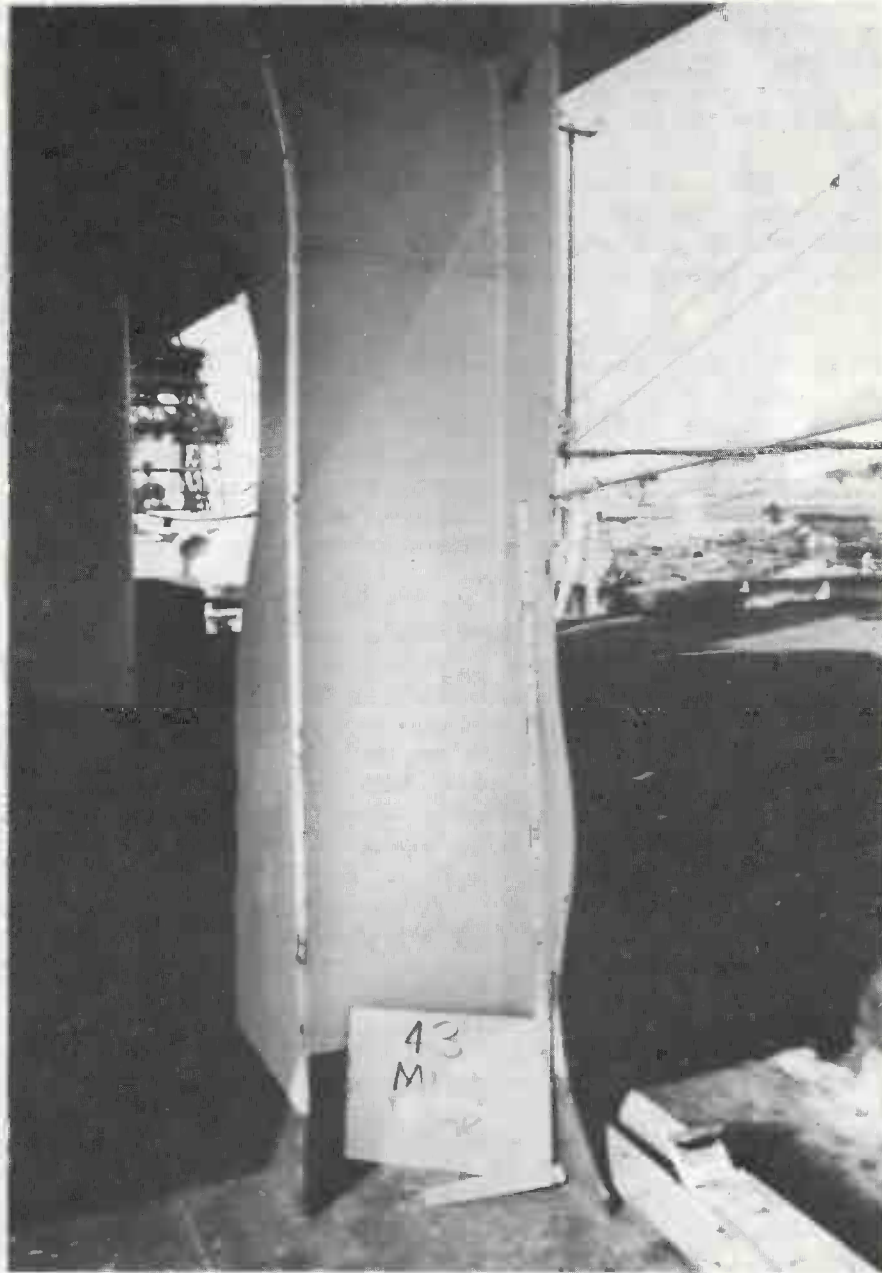
DISTORTED STANCHION ON A GENERAL CARGO SHIP

The stanchion supports equipment on a miscellaneous deck-house. Distortions in the flanges appear to be due to direct impact loading. Note the crack in the right hand flange near the top of the stanchion.

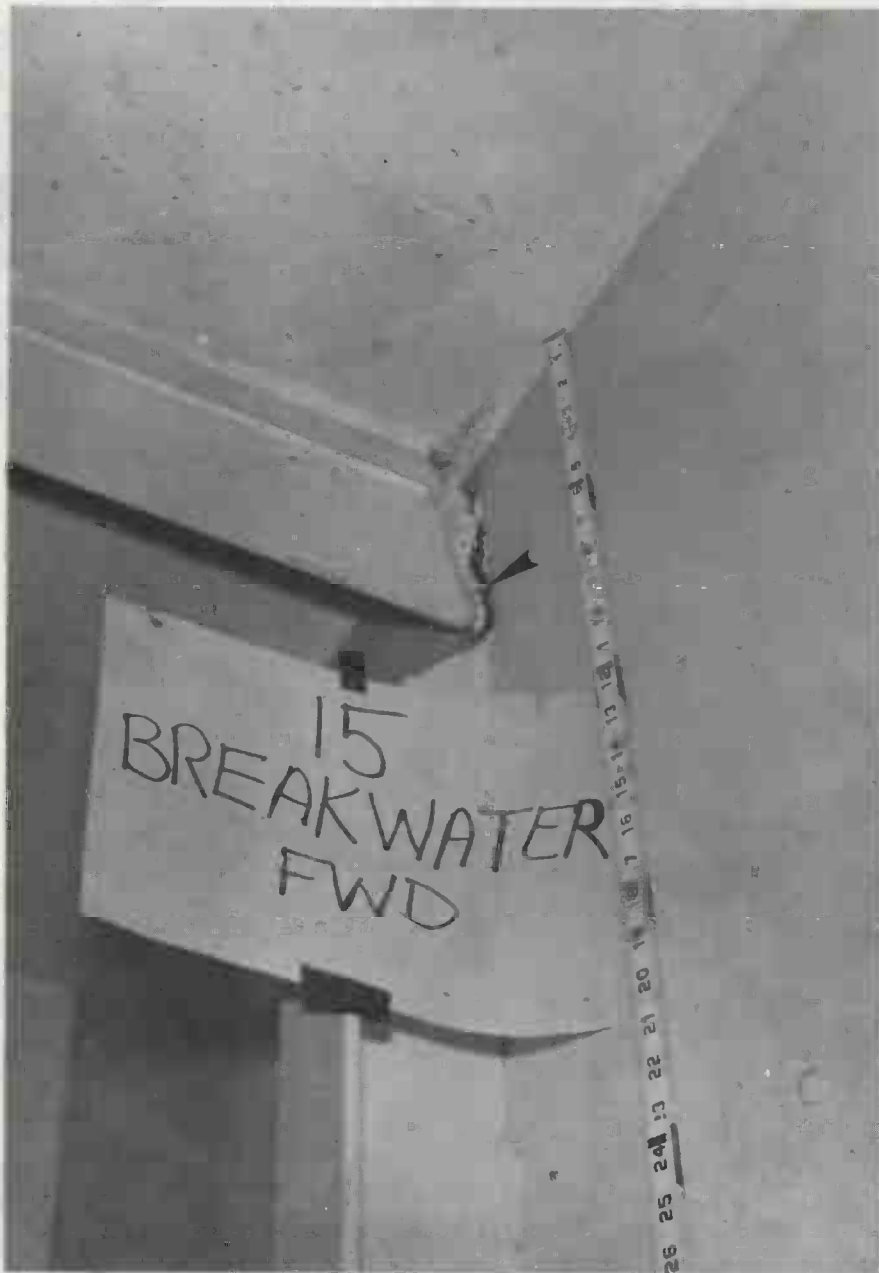
FAILED STIFFENER END ON A COMBINATION CARRIER

The view is looking forward with the deck above as forecastle deck. The crack in the horizontal stiffener's web completely detached the stiffener from the longitudinal bulkhead plating. Note that the stiffener's flange is sniped as in detail 11-A-7.

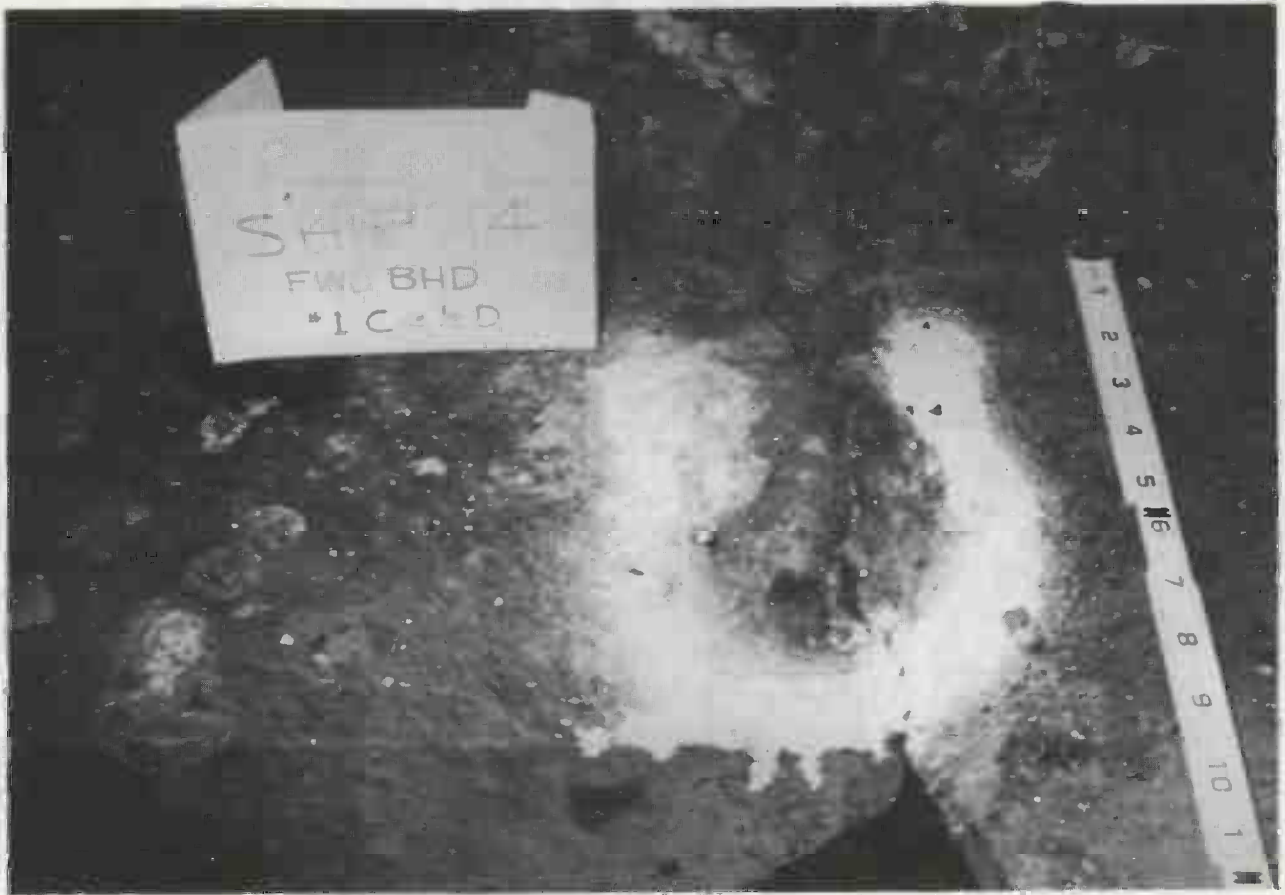
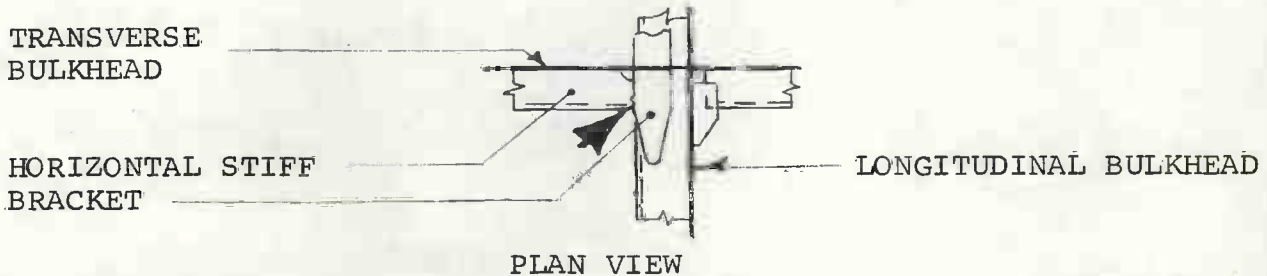
FIGURE 49

FAILED STIFFENER END ON A TANKER

Photograph shows a crack in a transverse bulkhead horizontal stiffener web at the connection to a bracket plate on the longitudinal bulkhead - tanker. See key plan below and Figure 47 detail 1100. Crack is encircled with white paint. The stiffener end is similar to detail 11-D-5.

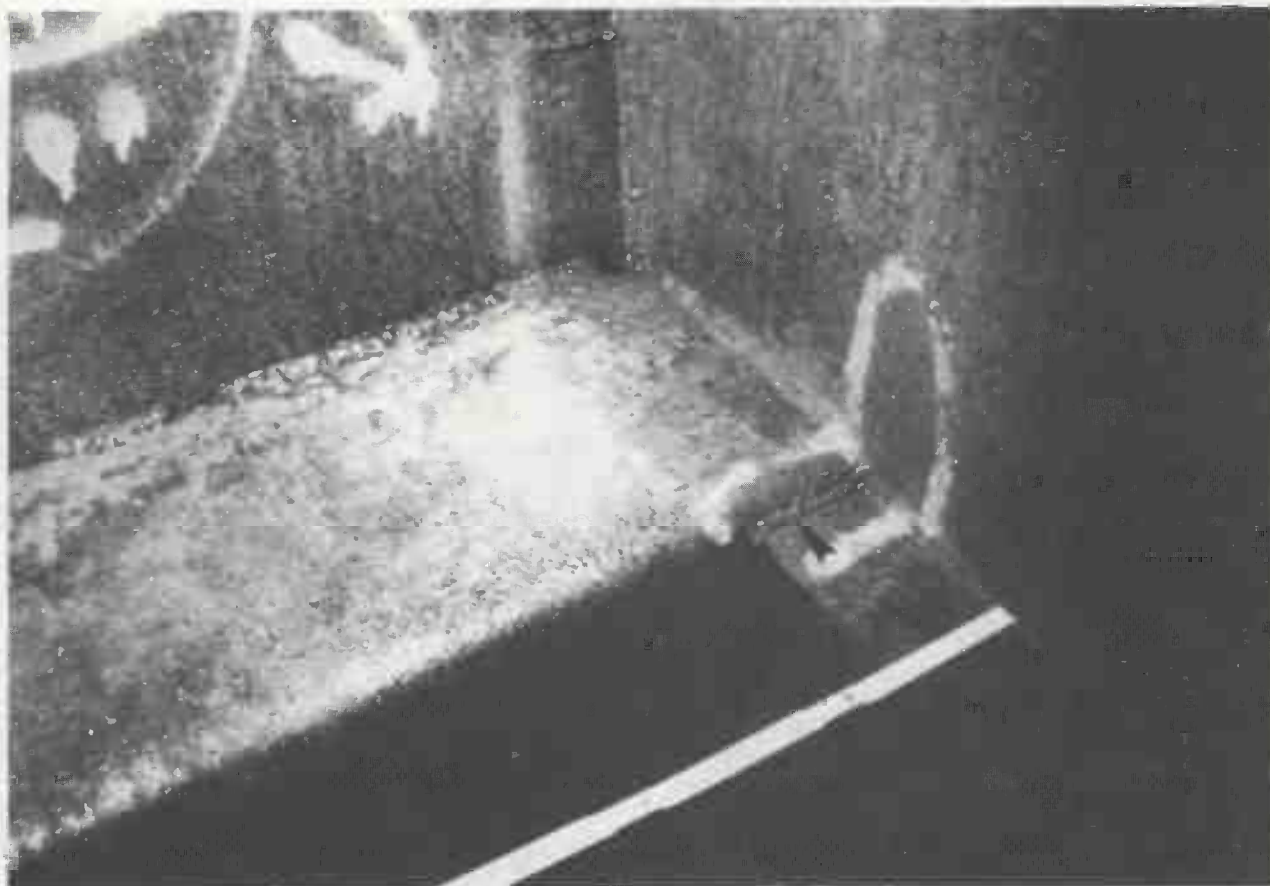
PANEL STIFFENER FAILURE ON  
WEB FRAME OF A TANKER

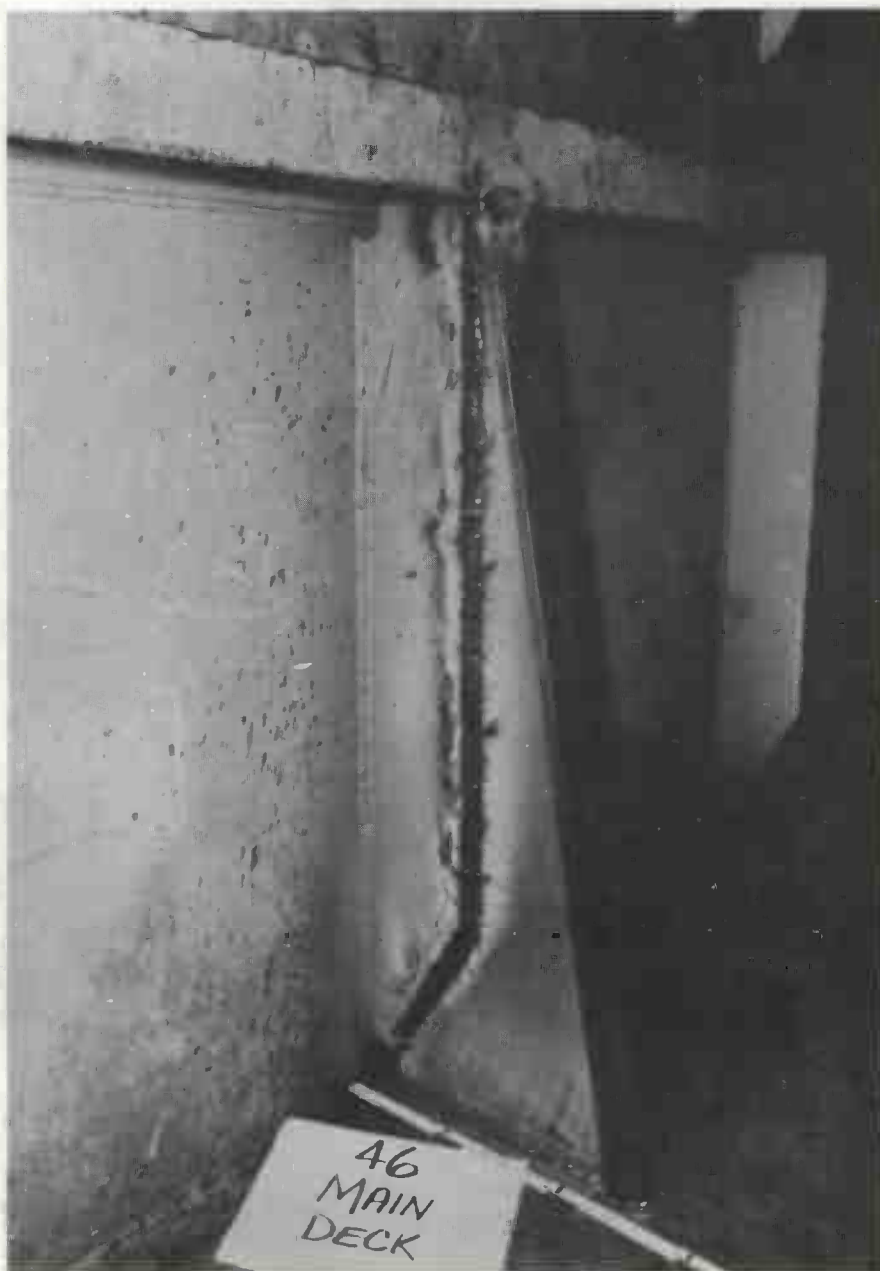
REINFORCED PANEL STIFFENER  
ON A CONTAINERSHIP

The vertical sniped flat bar panel stiffeners are on a transverse hatch side coaming. Reinforcement of the panel stiffeners to alleviate cracks at the ends was by an addition of a flanged plate which makes the detail into a tripping bracket. Visible in the upper right corner of the picture is a horizontal crack in the hatch cover side immediately below two attached container tie down fittings.
