ELASTOCOAST PILOTS IN THE NETHERLANDS
STORM SEASON 2007/2008

ELASTOGRAN GMBH

15 September 2008

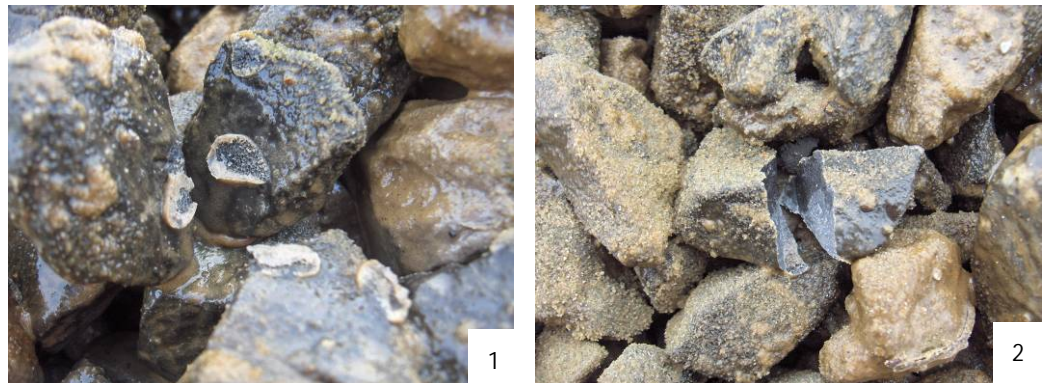
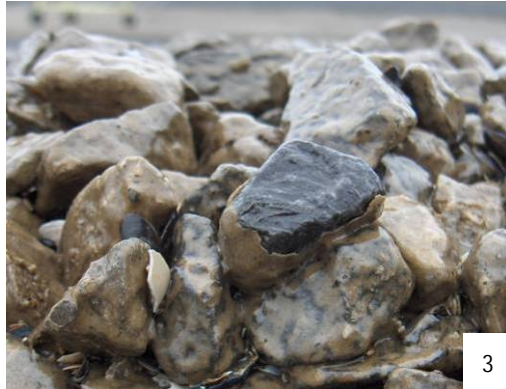
- 1) failure of polyurethane contact point (Zuidbout)
- 2) fracture of rock (Zuidbout)
- 3) stripping of Elastocoast coating from rock (Petten)

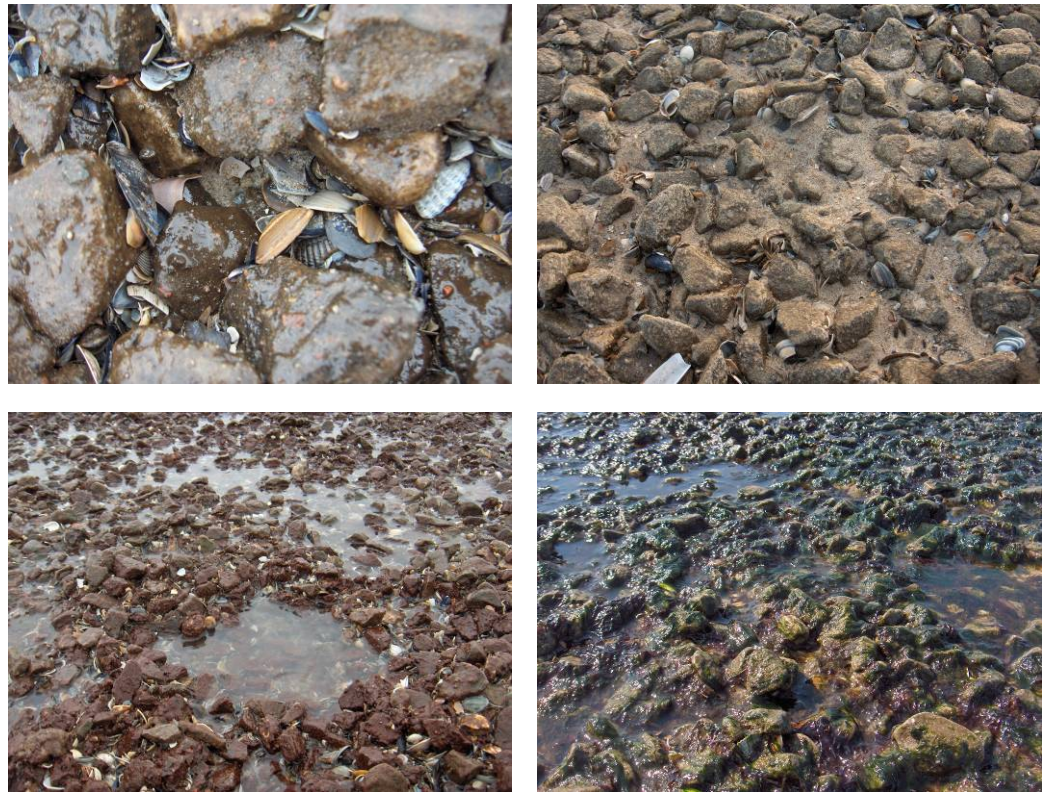
Formation of puddles on clogged Elastocoast (bottom).

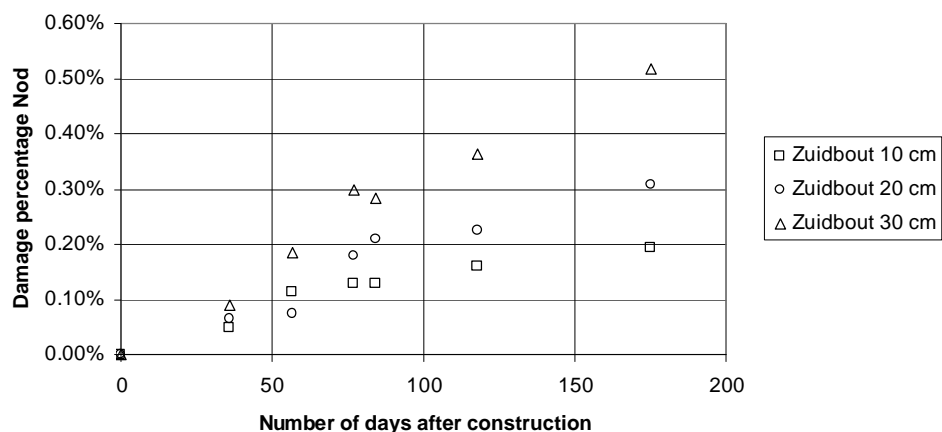
Figure 4.10
Damage development at the Zuidbout.

Although the length of the record is limited, the data does not support progressive growth of damage. Also the visual observations show no indication of additional damage at locations with missing stones. Therefore the scenario of progressive damage development is considered unlikely. However, both of the two other scenarios produce a reasonable fit. Based on the data, a definitive choice for one of the other two damage models can not be made. The visual observations point towards the burn-in scenario.

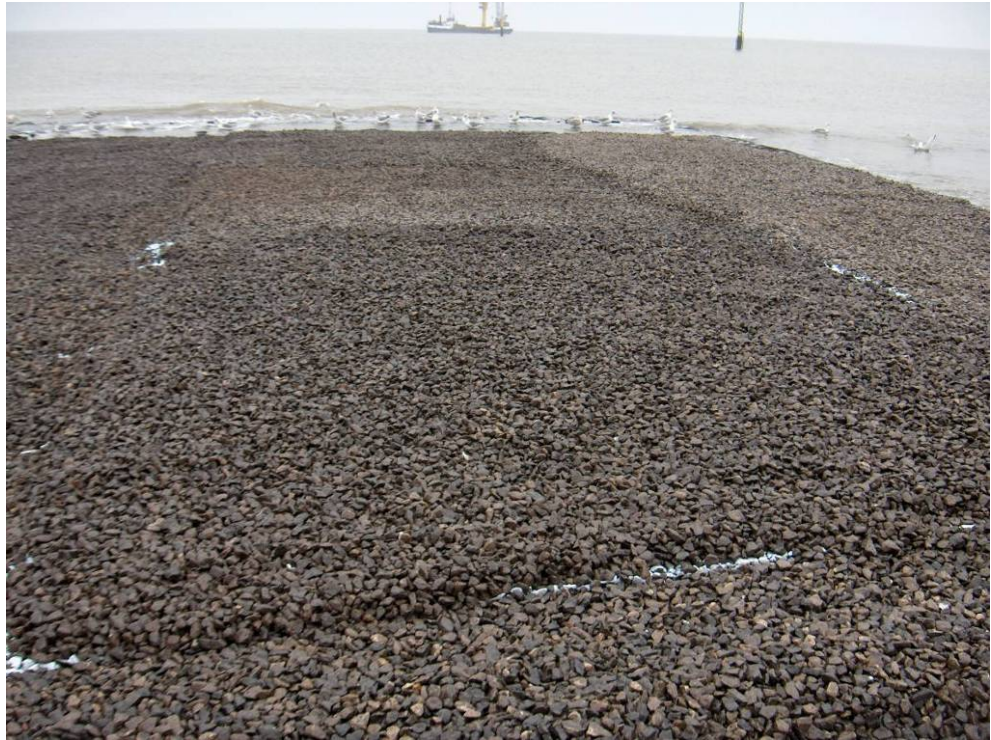
Problem area B: extra 10 cm on top of bad area where stones were too hot.
