Wear Induced Failure of Automotive Disc Brakes—A Case Study

Abstract: This paper investigated a failure in a ventilated disc brake in an automobile. The failed brake disc had been in service for approximately 10 years. The observed failure was in the form of radial cracks that appeared to have initiated at the outer edge of the disc brake. The cracks were rather straight with no branching. Optical microscope, scanning electron microscope (SEM), and energy dispersive X-ray spectroscopy (EDS) were used to study the microstructure of the failed disc. Vickers microhardness test was also used to evaluate the hardness of the samples. Results showed that the root cause of crack formation, in this case, was related to the excessive wear in the brake disc. Different wear mechanisms, namely abrasive and adhesive wear, were recognized in the failed specimen. Moreover, the worn surface in some areas was covered with fine oxide particles. These particles appeared to have a significant contribution toward abrasion. To further understand the wear mechanisms, pin-on-disc experiments were also conducted on the samples. Results of the pin-on-disc experiments were compared and correlated to the resu

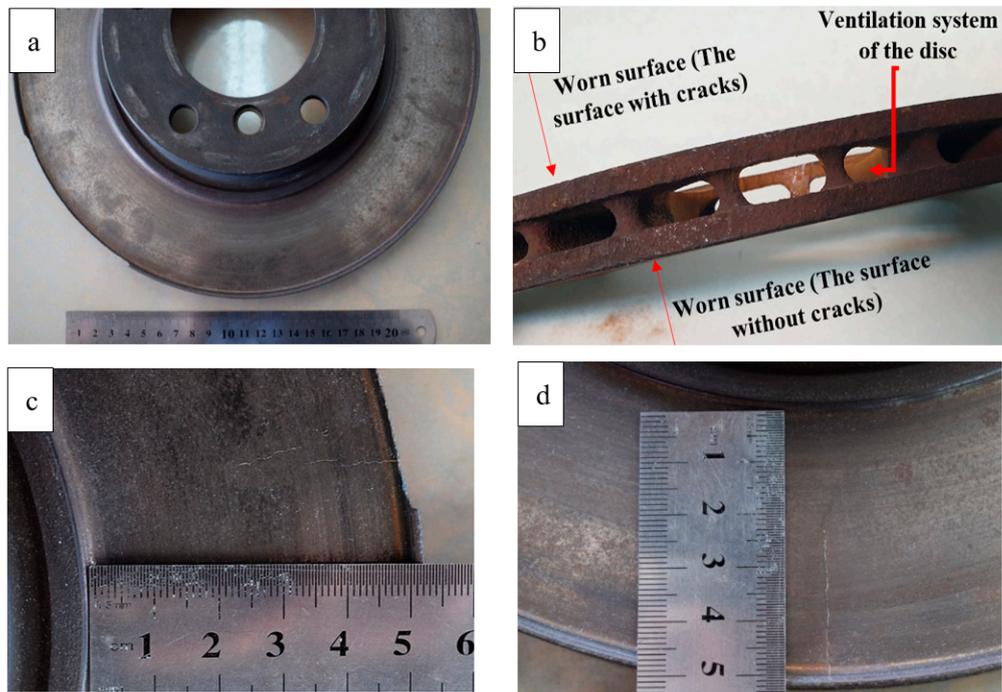
The failure, in this case, was related to the gray cast iron (Fe-3.3% C, 2.1%Si, 2.2% Mn, 0.2%P and 0.1%S, given by the supplier) disc brake in an automobile (see Figure 1a,b). The failed disc had been in service for approximately 10 years. The mileage when the failure was reported was 100,000 km (10 years of service). The disc had been in operation in temperature variations between $-10\text{ }^{\circ}\text{C}$ (in winter) to $35\text{ }^{\circ}\text{C}$ in summer in a rather dry atmosphere. The disc was a ventilated one and it was cast with two sides being in contact with the break-pad simultaneously. However, micro-cracks were formed only on one side. The observed failure was in the form of radial cracks, which appeared to be initiated at the outer edge of the brake disc. There were two rather large cracks, with one being approximately 30 mm and the other one being around 40 mm (see Figure 1c,d). The former crack was in fact two separated cracks, propagated in one direction, while the latter one was a straight continuous crack. There was no indication of the crack branching on the surface.

Figure 1. (a,b) Optical images of the disc and (c,d) images of the cracks at the surface of the brake disc.

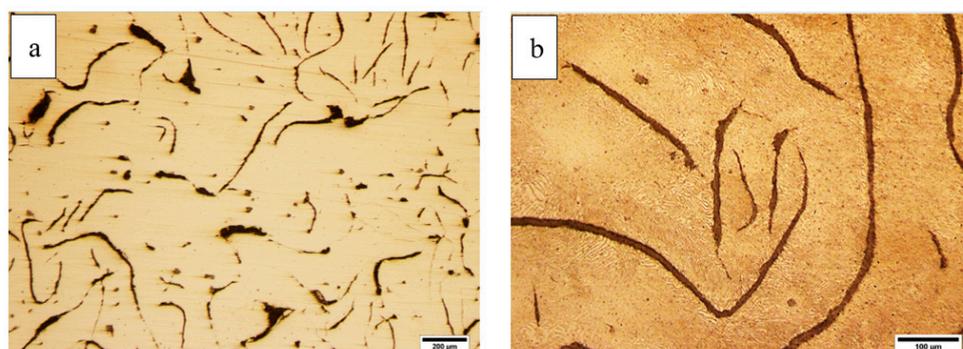
Figure 2 shows optical microscope images of the disc before and after etching. As shown, graphite flakes were distributed in a pearlite matrix. Graphite flakes are excellent thermal conductors, making gray irons good thermal conductors as well. This also has to do with the fact that graphite flakes form an interconnected network, forming an easy path for heat transfer. Moreover, graphite flakes are known to absorb sounds created by the brake pad-brake disc contacts [20]. Figure 3 shows the SEM images of cracks on the surface of the disc from the top view and from the cross-section. The former image shows that crack openings on the surface in some areas were as large as 200 μm . It appeared that these large openings on the surface were formed due to the spallation of rather large chips from the surface. The remainder of these chip-like features were still visible inside the crack. Further away at the right side of the crack, there was a spot (roughly 200 μm \times 100 μm), which was seemingly the area from which a surface chip spallation had taken place. Figures 3b and 4 are images of the cross-section of the crack. There was no branching or any major deviation from the straight line. Figure 5 shows the laser profilometry of the surface topography in the vicinity of the crack. There were deep ups and downs parallel to each other [21]. Sharp edges on the surface were indications of surface cutting and abrasive wear on the surface.

Figure 2. Optical microscope images of the microstructure in (a) as-polished and (b) etched conditions.

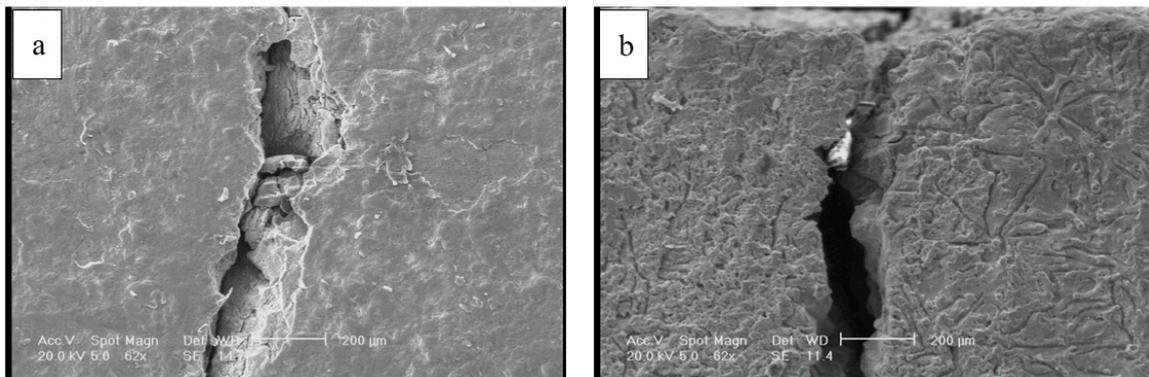
Figure 3. Scanning electron microscope (SEM) images of the crack, in (a) top view and (b) cross-section.

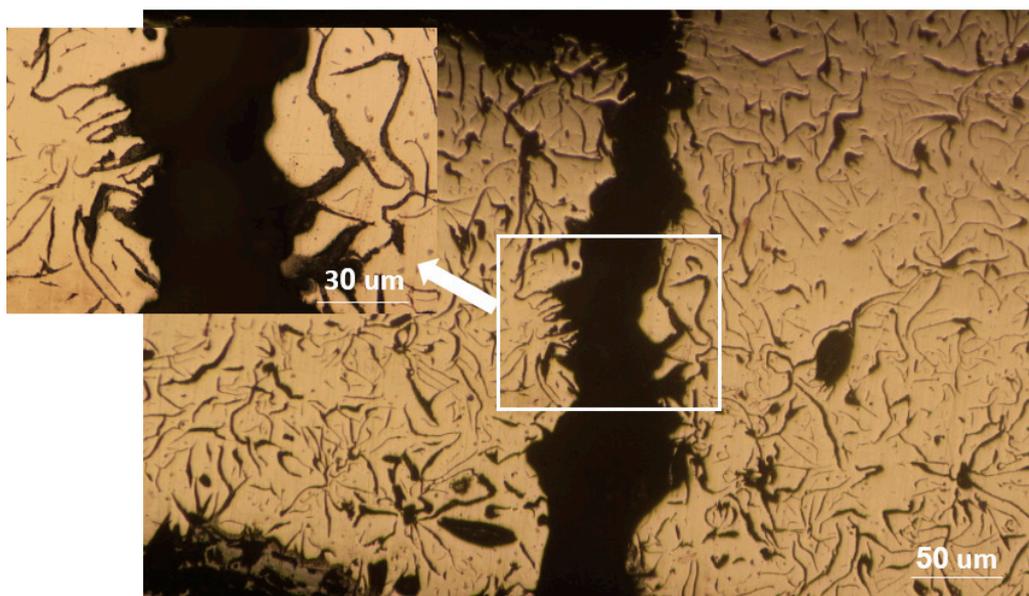
Figure 4. Optical microscope image of the cross-section of the crack.

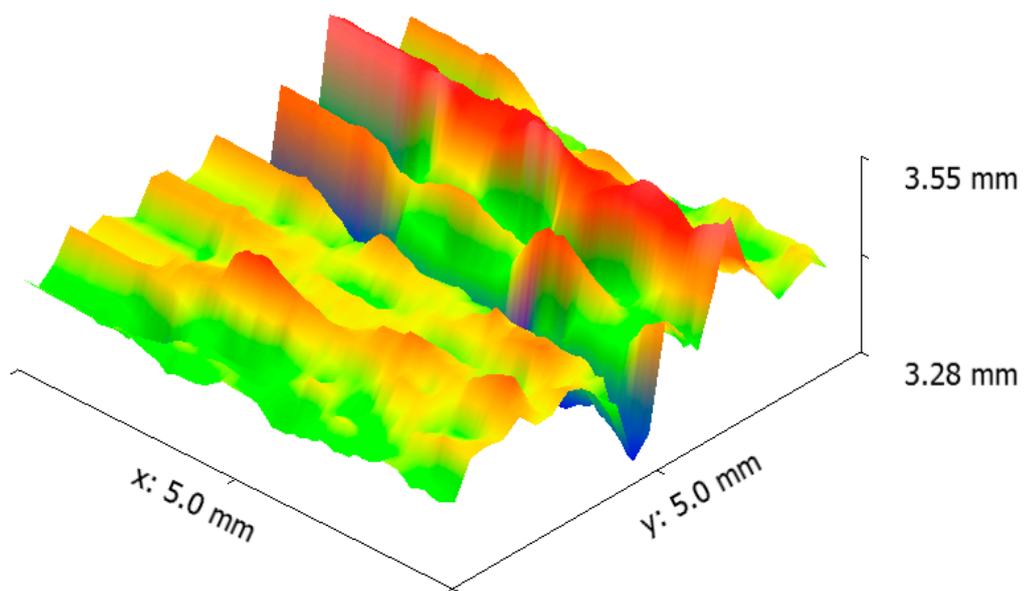
Figure 5. Laser profilometry of the disc brake surface in the vicinity of the crack.

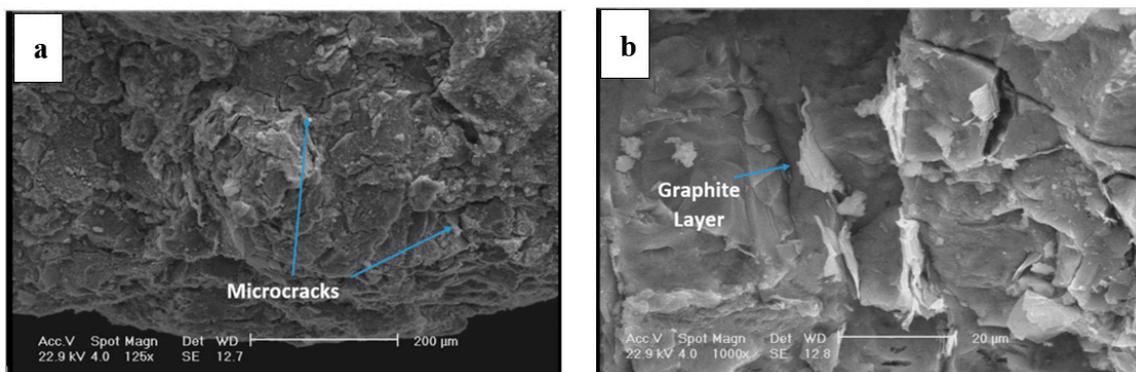
Figure 6 shows the fracture surface of the disc. Fracture is overall brittle with a layered structure (see Figure 6a). The fracture surface was covered with a network of fine microcracks. The interface of matrix-graphite, in which matrix is referred to pearlite, is a suitable place for crack initiation, given that the adhesion of graphite to the iron-based structure is rather weak. An example is depicted in Figure 6b. It appears that the fracture had mostly initiated from the graphite/matrix interface. Figure 7 shows that the fracture surface in some areas is covered with fine agglomerated particles. EDS results show that these particles were mostly Fe- and Si-containing oxide particles. These particles were formed during the wear of the surface and detachment of the particles. This is while the high temperature of the disc during the contact of the pad and the disc resulted in the diffusion of the oxygen atoms into the lattice and the oxidation of the particles. Fine oxide particles have relatively higher hardness compared to the matrix. These particles can cause severe abrasion in case they are entrapped between two moving components, which in this case for the brake pad and the disc. The formation of fine oxide particles between the brake pad and the disc had to do with localized temperature increase due to the excessive friction at local contact points between the pad and the disc.

Figure 6. (a,b) SEM images of the fracture surface in the brake disc.

- Graphite-matrix interface detachment was observed on the fracture surface of the disc. Graphite detachment creates surface roughness and surface irregularities, which in turn increase the coefficient of friction.

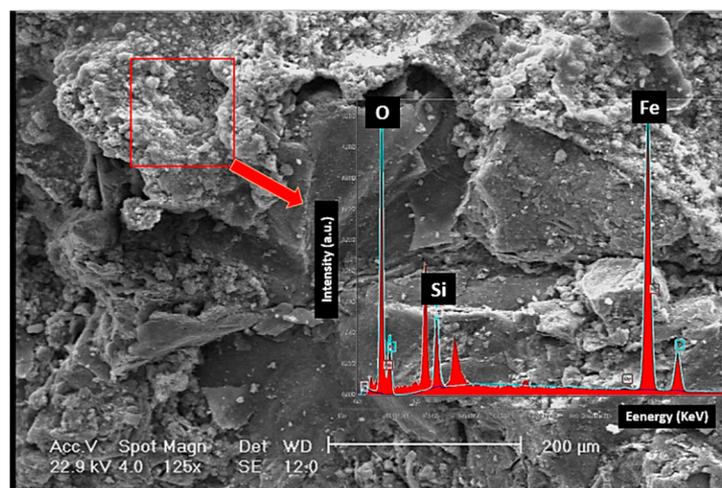
Figure 7. SEM/EDS analyses of the oxide particles.

- Inside cracks in some areas were filled with chip-like and fine spherical particles. These external particles inside cracks are characterized to be oxide particles in nature.

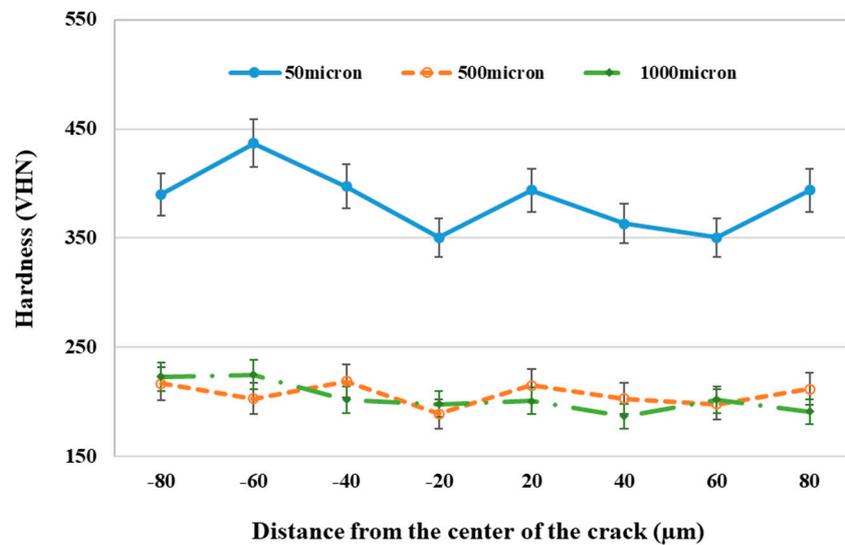
Results of microhardness profilometry across the crack at different depths from the surface are shown in Figure 8. Disc brakes experience large surface compression stresses due to exerted loads from the brake pad. This results in plastic deformation and work hardening at layers close to the surface. In this case, this resulted in an increase in the hardness from about 200 VHN at deep layers inside the brake disc to 400 VHN in layers close to the surface. This increase in the hardness confirmed the argument that the surface was heavily deformed and work-hardened during service. Prasad [4] also reported the occurrence of work hardening in gray cast iron discs during a wear test. The depth of the

work-hardened layer was dependent on the loading conditions, the sliding distance (service time), and the temperature increase at local contact points.

Figure 8. Hardness profilometry across the crack at different depths from the surface.
