AIAA SCITECH 2022 Forum

# Re engineering history: Flight of the Phoenix, what can we learn from a movie crash?

Michiel J. Schuurman<sup>\*</sup>, Roeland De Breuker<sup>†</sup> and Christos Kassapoglou<sup>‡</sup>

*Delft University of Technology, Faculty of Aerospace Engineering, Delft, 2629HS, The Netherlands*

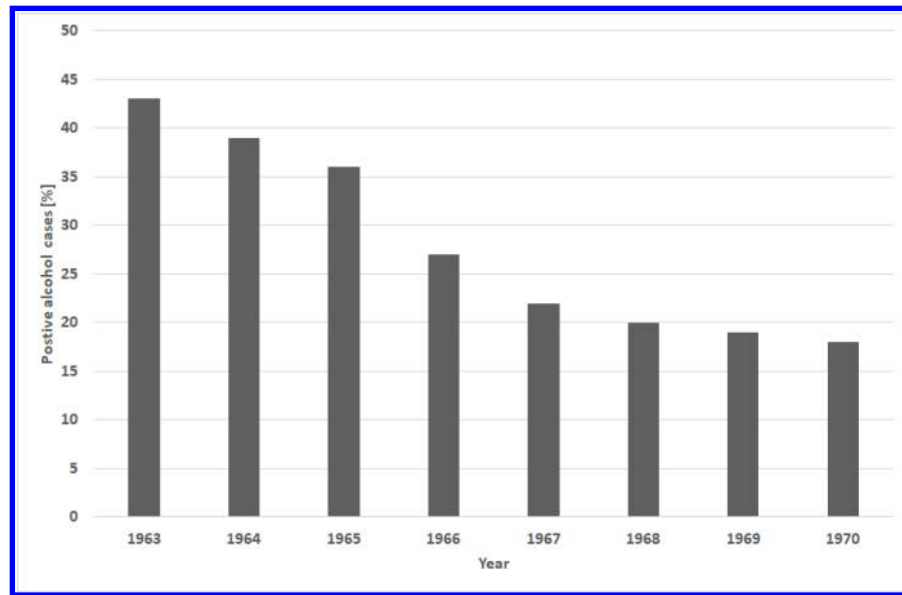
**Fig. 6 General Aviation positive alcohol cases [%] [27]**

Reviewing the general aviation accidents from 1963-1970 it is evident that alcohol was present in many accidents, see Figure 6. In a 1963 study a total of 35.4% pilots involved in general aviation accidents had measurable level of alcohol in their blood at the time of their crash [30]. This study however did not account for contamination of the blood and putrefaction. Subsequent studies which accounted for contamination revealed lower values [31][32][33]. Especially in case of extensive (abdominal) trauma, which is very likely in aviation disasters (e.g. rupture of the viscera), interpretation of blood alcohol values in autopsy specimens from the pilot and crew is highly contentious [34]. In recent studies the main conclusion is that care must be taken to reach a valid conclusion related to blood alcohol levels.
