**A global safety deficiency
False glide slope capture affecting aircraft**

Schuurman, Michiel

Journal of Aviation Management

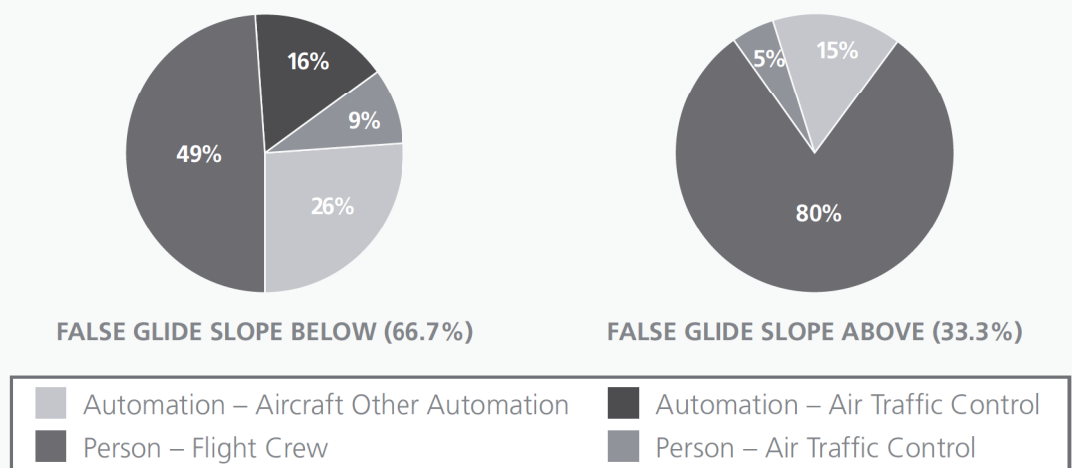
Figure 1 - ASRS Database Overview Problem Description Above and Below Glide Slope

For statistical purposes, ASRS attributed a problem to each event. The ASRS assessment of these events is not definitive, but the database suggests that human factors and navigation facility equipment played a major part. For the investigation, DSB analysed these ASRS events in more detail, and found that a distinction could be made between glide slope events from "Above" and "Below" the 3-degree glide slope (See Figure 1). The analysis shows a difference in assessment of the contributing factors. In cases of "Above" 3-degree glide slope events, the database suggests the problem is mostly related to the flight crew. But does this reflect what is really going on? What do we know about the ILS glide slope antenna?

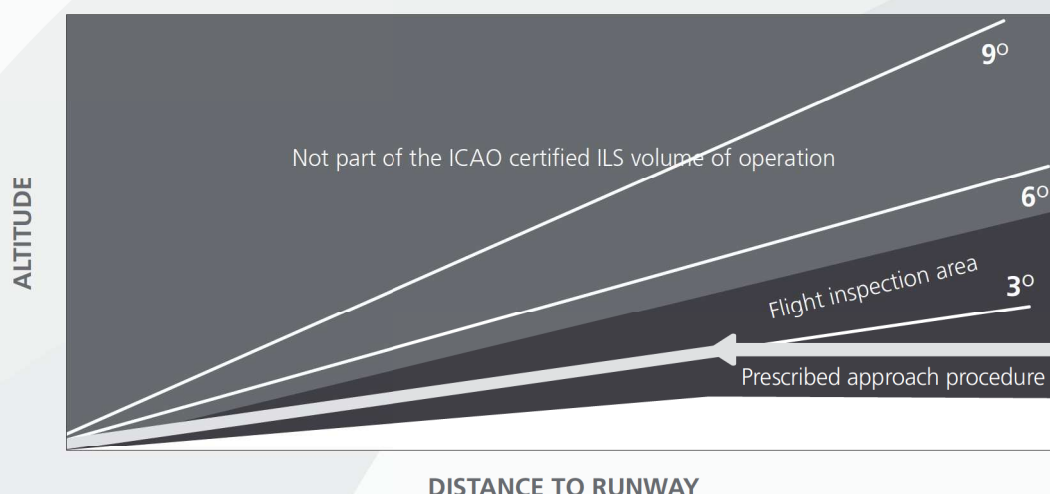
Figure 3 - ILS Glide Slope Certified Volume of Operation

The measurements to determine the glide slope field as performed in DSB investigation were not part of a normal flight inspection, which is performed on the 3-degree glide path. Above an angle of 5.25 degrees, the glide slope field characteristic is not required by ICAO regulations to be inspected (See Figure 3). This means that when flying above the 5.25-degree glide path, the aircraft is flying beyond the reliability threshold, which is certified and periodically checked by flight inspection. The pitch-up upset events were all flying in the area above the 5.25-degree glide path.

Despite SMS methodologies and previous investigations, the reported pitch-up upset incidents occurred in airspace, which is not part of the ICAO certified ILS volume of operation. None of the parties identified this latent safety deficiency.
