**Rolling contact fatigue
Spalling versus transverse fracture of rails**

Rolling contact fatigue: Spalling versus transverse fracture of rails

Michaël Steenbergen

Delft University of Technology, Faculty of Civil Engineering and Geosciences, Railway Engineering Group, Stevinweg 1, 2628 CN Delft, The Netherlands

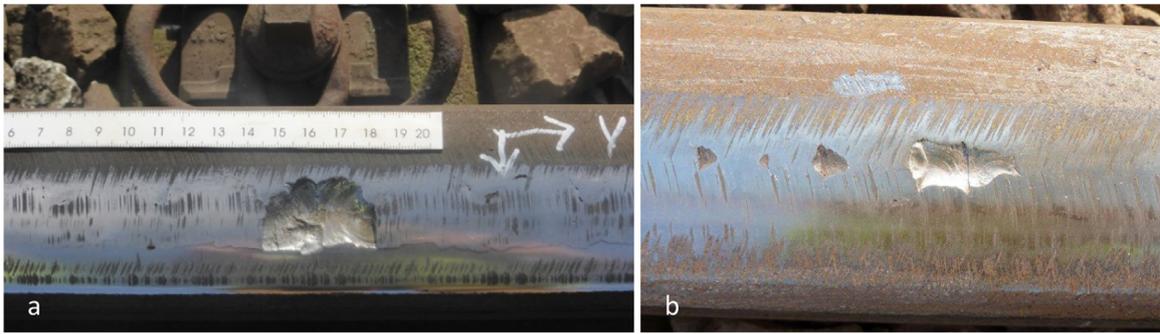
Fig. 1. Spalling defects on grade R370crHT (type MHH) according to classification [3].

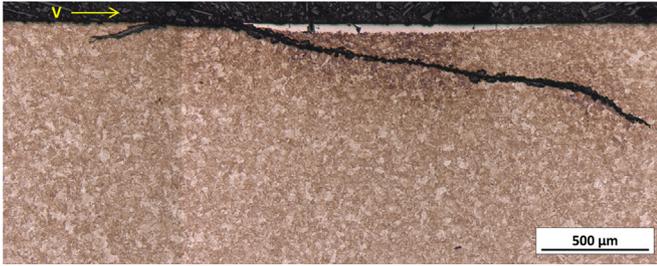
'stud' defect with a thermal origination route in the absence of plasticity is shown in Fig. 2.

Fig. 2. Longitudinal cross-section over a 'stud' defect on grade R350HT according to classification [3].

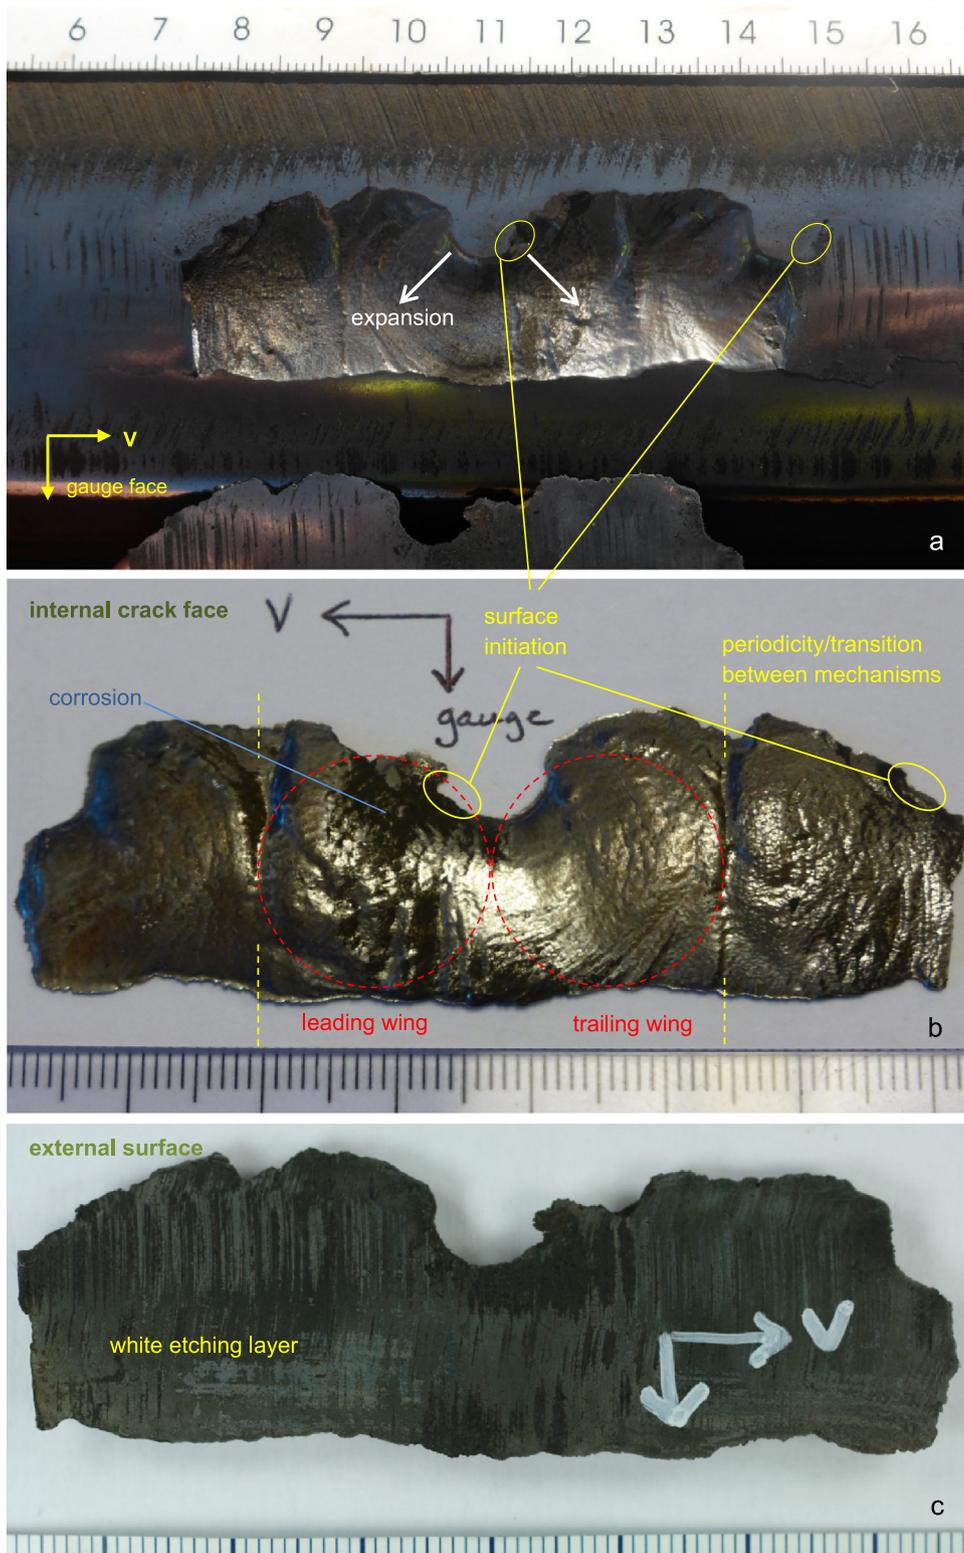
Fig. 3 shows an example of a fully developed individual spalling defect, which, like the defect in Fig. 1a, makes part of a longer, repetitive series of identical defects on heat-treated premium rail in the upper leg of a 2240 m radius curve.

At first view, the geometry of the surface-breaking cracks is striking: the defect shows the 'wedge' shape which is characteristic for squat defects. The crack fronts (Fig. 3a and b) in the subsurface clearly 'expand' from this wedge-shaped surface crack to the other side of the rail. This process would, in the case of squats, give rise to local surface settlement and the development of two 'wings' or 'lobes' in the running band (see for example Fig. 1 in Ref. [7]). However, in this case the wedge opens toward the *field* face of the rail, whereas in the case of squats this opening is systematically toward the *gauge* face [1,7]. Fig. 4 shows another example of a similar spalling defect where this same difference is visible in the crack pattern.

A second observation from Fig. 3 concerns the exact position of the initiation of the defect. Fig. 5 shows in more detail multiple positions of crack initiation: they coincide, both in position and in alignment, with particular grinding grooves. As is particularly clear from Fig. 3c, which shows the surface of the spalled part after

polishing with an etching agent (3 percent Nital), after this initiation surface-breaking cracks start to circumscribe the *deepest* area on the rail surface resulting after grinding; a demarcated zone where both individual grinding marks and corrosion are visible due to a lack of contact history under passing wheels. Since this area is the deepest, this means that more material has been removed as compared to the surrounding area, which may suggest the presence of a different (and more harmful) residual stress profile. Fig. 3b shows the internal crack face of the spalled part, where corrosion has started from the position of initiation (the 'oldest' part of the fracture surface), disappearing with increasing distance. A clear distinction is visible between leading and trailing 'wing' of the defect for each individual mechanism, where the term 'mechanism' denotes an individual defect that has fully developed and grown together with its neighbour, forming a defect chain.

Fig. 3. Spalling defect on grade R370CrHT (MHH): top view of the rail with periodic crack pattern; internal crack face and external top view of spalling part (comprising in total 2 'mechanisms').

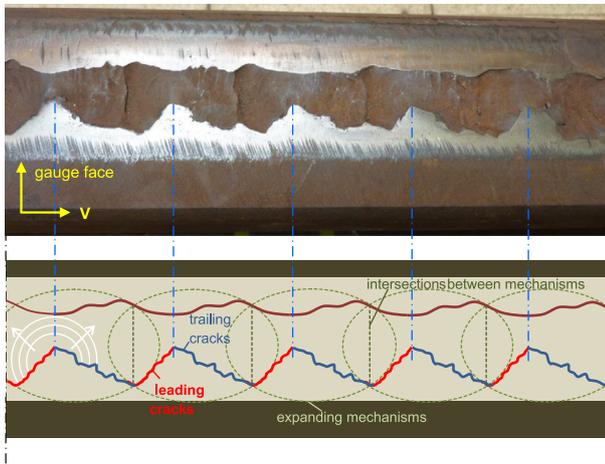
Fig. 4. Fully developed periodic spalling defect (see Ref. [4], Fig. 8b) with serial failure mechanism and schematization.

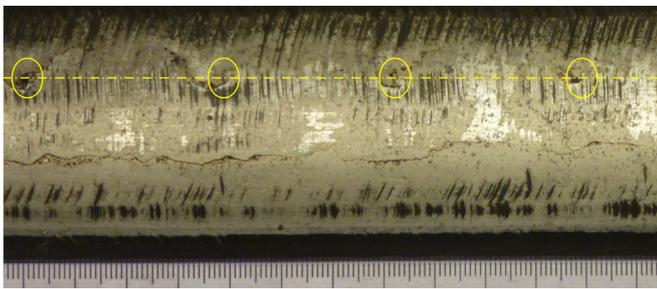
Fig. 5. Surface crack initiation positions of the defects in Figs. 1a and 3.

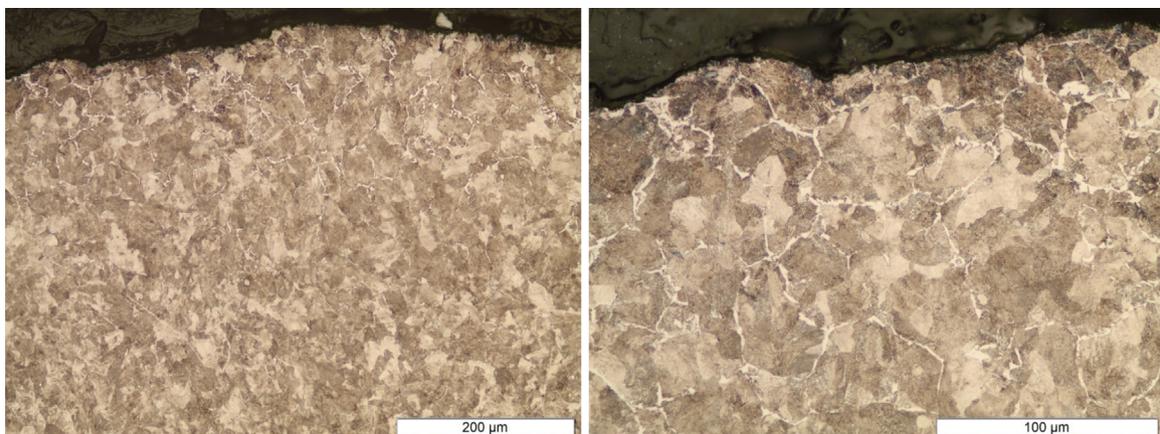
Fig. 6. Example of decarburisation (pro-eutectoid or free ferrite, visible as a white phase along the grain boundaries) in the surface layer of rail grade R350HT.

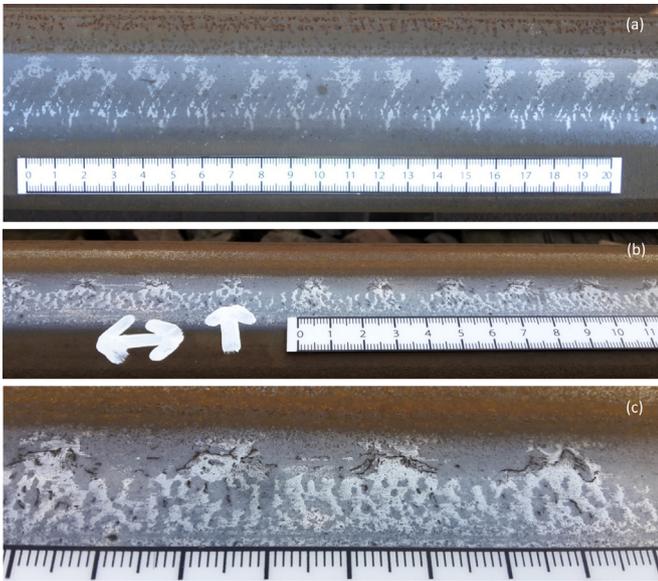
Fig. 7. Non-uniform WEL at the rail surface (R260Mn on straight track) (a,b,c); associated to surface cracking (b,c (close-up)) (photos b-c: courtesy Gijs Brefeld).

observable non-uniform WEL on a rail, one of which is associated to surface cracking. The WEL has formed under a loading history with bi-directional train operation at high traction/adhesion levels with significant microslip/creepage. It is also noted that the mentioned factors that cause a deviation from the general situation may interact. This occurs in the case of generation of a non-uniform WEL as a result of locally increased micro-slip in the presence of significant contact roughness. Such a case is exemplified in Fig. 8.

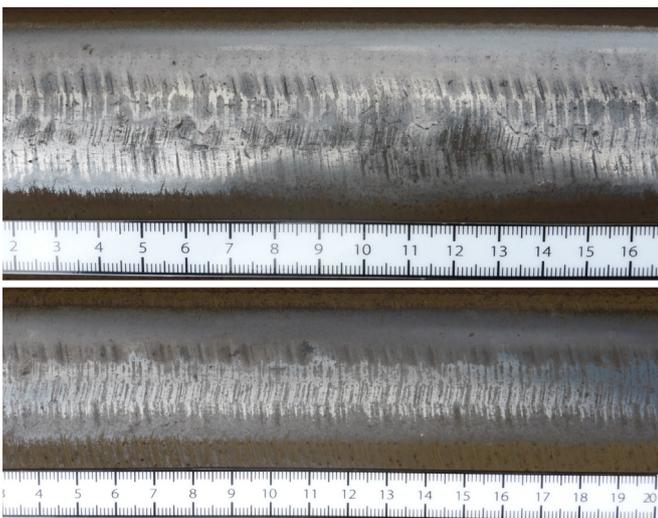
Fig. 8. Non-uniform WEL in the running band of the rail (R260Mn on straight track) associated to macro-roughness of the surface and consecutive train operation.

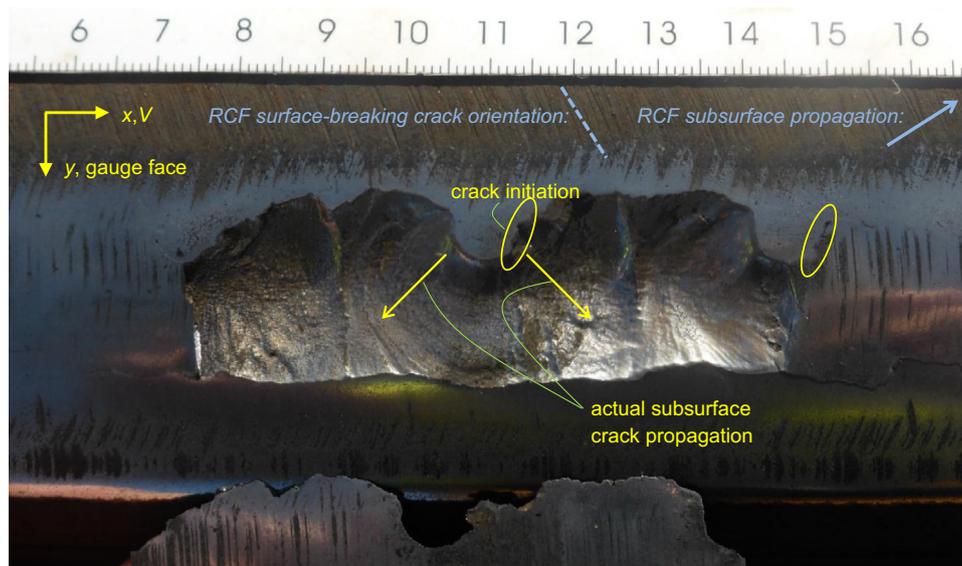
The above can be illustrated for the defect shown in Fig. 3 and discussed in Section 2. The result is depicted in Fig. 11, showing the orientation of a surface-breaking crack under regular RCF for this case, the direction (quarter-space) of subsurface crack propagation

Fig. 11. Spalling defect on R370crHT (MHH) in the upper leg of a 2240 m radius curve (see Fig. 2).

leading to a TD defect in accordance with the scheme of Fig. 10, and on the other hand the actual surface-breaking crack initiation line and both internal actual propagation directions. Because the surface-breaking crack orientations do not match, *both* subsurface crack planes are situated in the spalling domain. The defect is therefore not a conventional case of RCF/squat formation and will not (or is not able to) lead to a transverse rail defect. This is, as has been mentioned in the introduction, an important conclusion in view of the essential difference in operational safety risk, and therefore the required monitoring and maintenance actions.

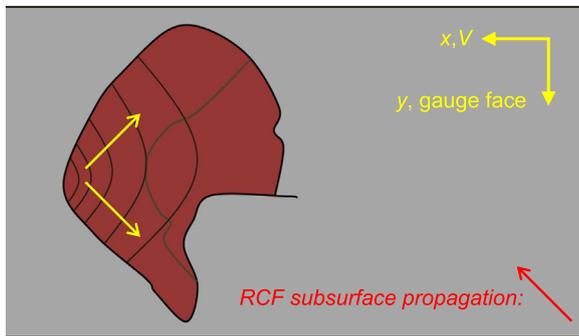
Fig. 12. Spalling defect in Ref. [6] and interpretation according to the model in Fig. 10.

The model can, in the same way, also be applied to results reported in the literature. Fig. 1 in ref. [6] shows a spalling defect ('stud'). From the figure the location of surface-breaking crack initiation remains unclear (though most likely at the left in the centre of the running band) and it is questionable whether it is unique (multiple grinding marks are visible). However, the subsurface propagation directions (quadrants) are very clear from the fatigue marks and reproduced in Fig. 12, which also shows the RCF subsurface propagation quadrant according to the scheme (upper

part) in Fig. 10. It is clear that the defect has developed entirely in the spalling domain, is therefore not a classical squat defect and represents a negligible risk with respect to rail fracture.

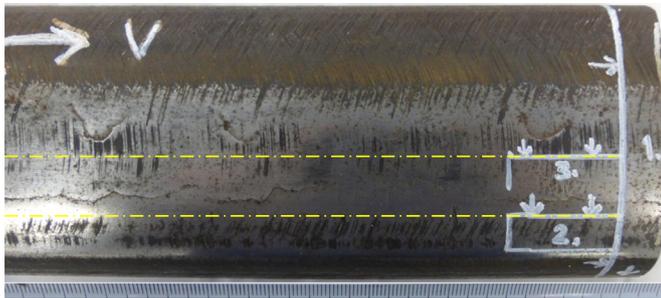
Fig. 13. Examined cross-sections (1–3) along the surface of the defect zone.

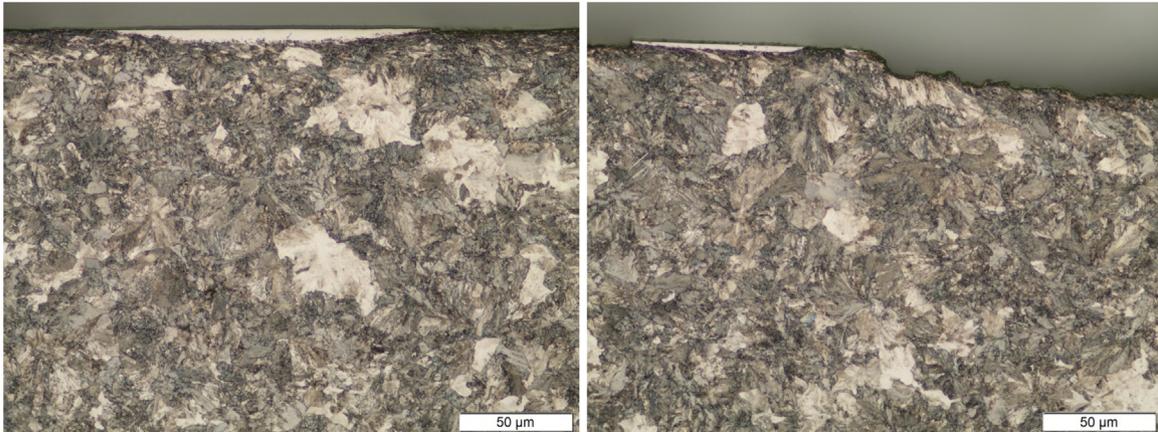
Fig. 15. White etching material embedded in the surface, within the running band (gauge side right); transverse cross-section (1).

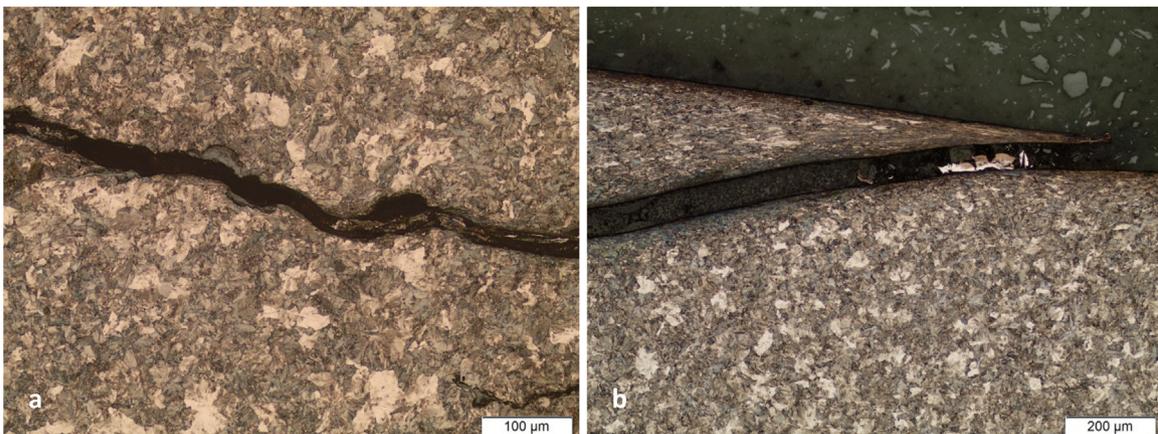
Fig. 16. Sub-surface cracking in the transverse cross-section (1): no crack face deformation (a) and flattening of the gauge-side tip of the material portion spalling off (b) (gauge side right).

clearly been flattened by cyclic normal stresses (Fig. 16b).

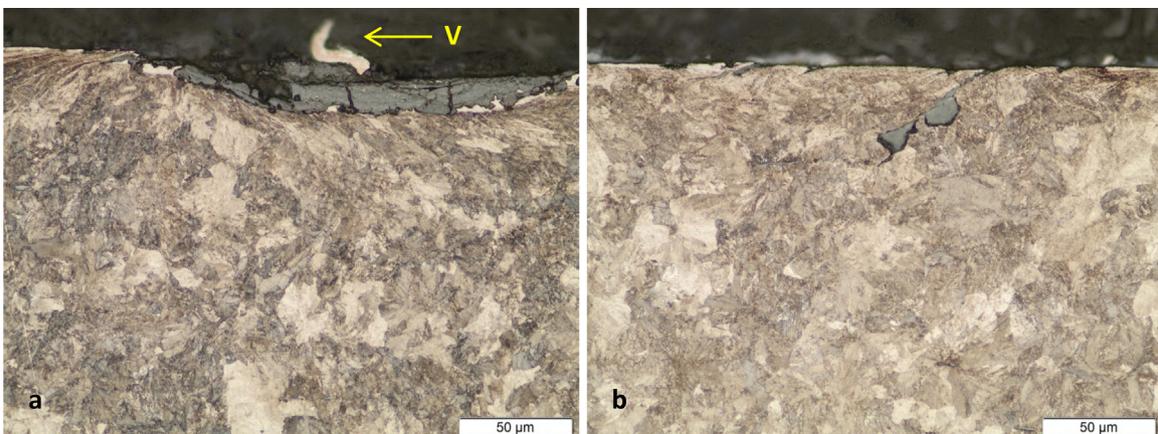
The longitudinal cross-section (3) along the surface, in the centre of running band and within the spalling zone, shows remainders of grinding grooves (filled with corrosion) along with local deformation, as well as multiple crack initiations at the surface, examples of which are shown in Fig. 17. The surface deformation from the wheel-rail contact history is directed against the running direction, as can be expected in the high rail of a curve. The subsurface crack in the longitudinal cross-section shows a consistent and strong deformation of both crack faces,

Fig. 17. Longitudinal cross-section (3): remainders of grinding grooves (a) and multiple surface crack initiation (b).

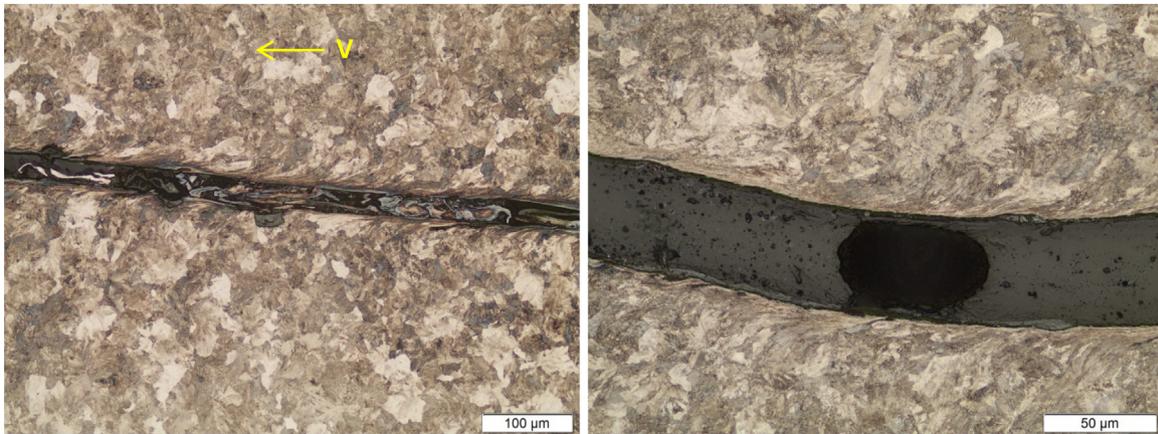
indicating a transfer of longitudinal shear stresses ('rubbing') in line with the tangential stress history by passing (and notably driven) wheels (Fig. 18) (see also ref. [7], Fig. 7).

Fig. 18. 'Rubbing' of subsurface crack faces in the longitudinal cross-section (3) indicate significant transfer of longitudinal shear stresses.

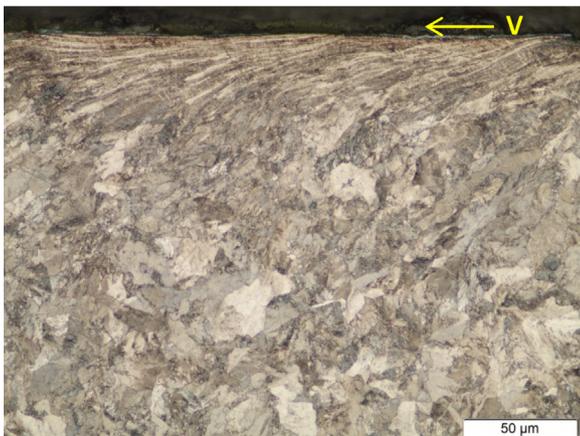
Longitudinal Section (2), taken in the gauge corner and outside the spalling zone shows a similar image. There are remainders of grinding grooves, and the subsurface deformation from the wheel-rail contact history is strong, with also at this transverse position a clear directivity against the running direction (Fig. 19).

Fig. 19. Subsurface deformation directivity against the running direction; longitudinal cross-section (2).
