## Grinding – good or bad for reduction of rolling contact fatigue– observations from in-service rails with white etching layer

Tim Vernailen<sup>a,b</sup>, Pan Zhang<sup>a,\*</sup>

Rail grinding has been widely applied in railway networks worldwide to remove or prevent rolling contact fatigue (RCF) cracks. However, some concerns have arisen regarding grinding, that it may introduce initial damage to the rail and largely shorten the RCF life. This work aims to better understand the effect of grinding on the long-term degradation of in-service rails, particularly concerning White Etching Layer (WEL) and RCF cracks. Seven rail samples were selected and taken from the Belgian and Swedish railway networks, with different grinding histories, accumulated loads, and steel grades. The mechanical and microstructural properties of these samples were examined through the hardness test and optical microscopy. WEL and microcracks were observed in both ground and non-ground rails, suggesting that rail grinding does not create additional defects nor negatively impact the rail surface after long-term service. Macrocracks were observed only in rail samples that had undergone zero or a single grin

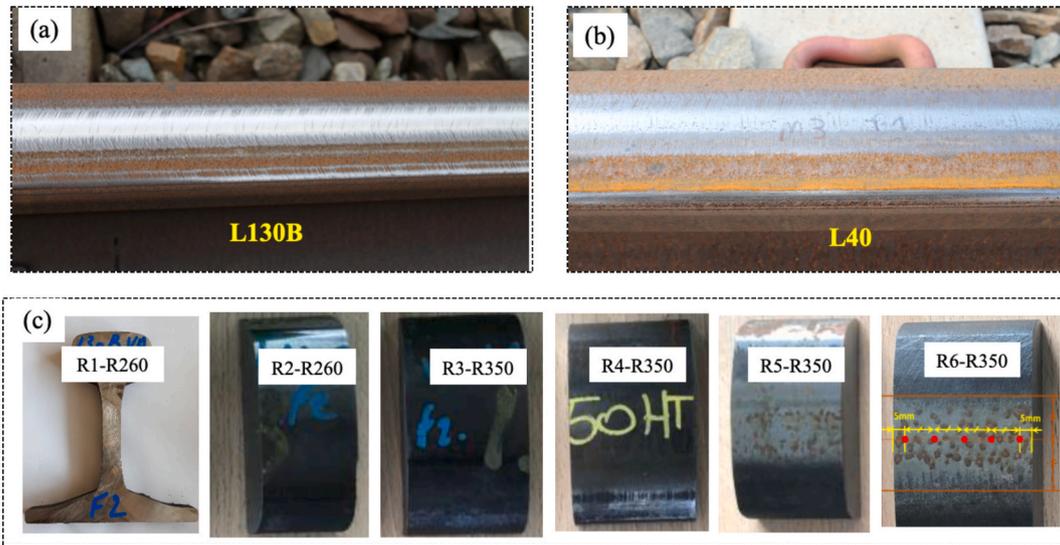
Fig. 1. Six rail samples taken from two straight lines in Belgium. (a) Track segment on Line 130B after one grinding cycle; (b) track segment on Line 40 after one grinding cycle; (c) six rail samples R1 to R6 in the laboratory. The five red points on R6 indicate the surface hardness measurement locations.

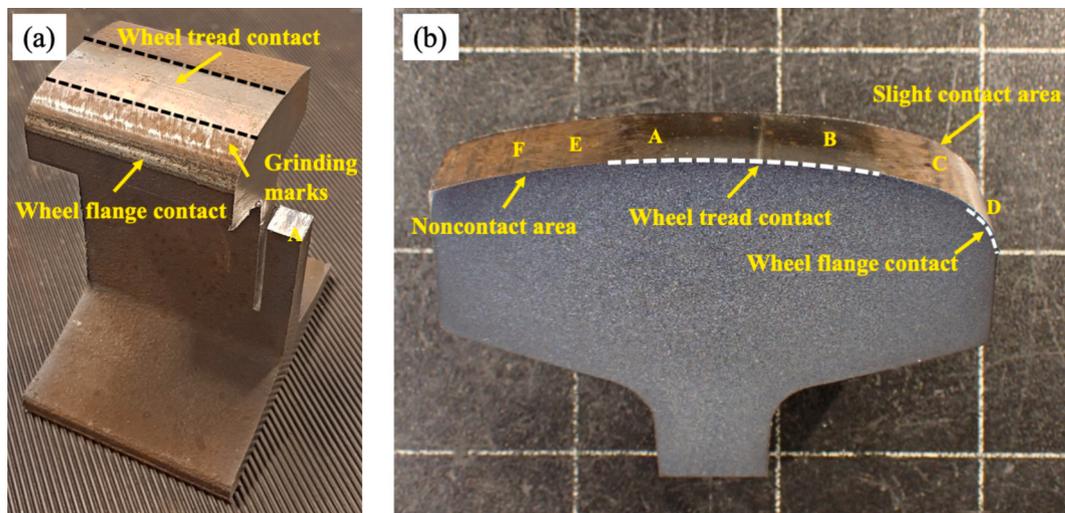
One rail sample was collected from Line 414 of the Swedish railway network with a traffic speed of 180 km/h, as shown in Fig. 2a. The rail, made of R260 with a 50 E3 profile, was installed in a curve with a radius of 1000 m in 1974 and has been subjected to an annual traffic load of 13 MGT. In Sweden, standard preventive rail grinding typically involves 4–5 passes, removing 0.3–0.5 mm of material from the rail head. However, in 2020, an extended grinding operation was carried out on Line 414 to reprofile the rail and fully remove head checks. This procedure involved 30–35 grinding passes, resulting in a total material removal of approximately 5–6 mm. This rail sample from the high rail was removed from service in 2021, around one year after the grinding. Taking into account both artificial wear from grinding and natural wear from service, the total vertical wear of the sampled rail reached approximately 11 mm.

Fig. 2. The rail samples collected from the Swedish railway network. (a) The rail sample; (b) the prepared cross-section for microstructural analysis.

Fig. 2b. Based on observations and surface features, the rail head was divided into four distinct zones: 1) the wheel tread-rail head contact zone (Positions A, B), 2) the wheel flange-rail gauge contact zone (Position D), (3) a slight contact region on the rail shoulder (Position C) with residual grinding marks (see Fig. 2a), and (4) a non-contact area (Positions E, F). The examination was conducted using OM and scanning electron microscopy (SEM) at these zones across the rail head. Microhardness tests were performed using Vickers indentation from the rail surface to a depth of 10 mm. The prepared rail sample was used to

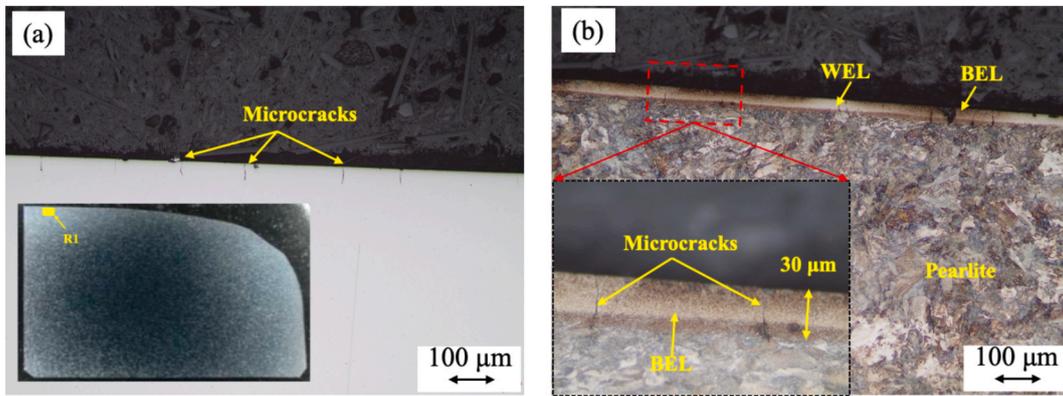
Fig. 3. The transverse cross-sections of Sample R1, R260 rail on Line 130B after one grinding cycle, (a) before etching, (b) after etching.

located approximately in the centre of the running band within the wheel–rail contact zone. The unetched image in Fig. 3a reveals that the rail running surface contains many fine, predominantly vertical cracks. After etching, a distinct layer comprising a mixture of WEL/BEL is observed in the proximity of the rail surface; it has a thickness of about 30 μm, as shown in Fig. 3b. Several microcracks are found to originate within this layer, and some are seen to penetrate through it and reach the boundary between the BEL and pearlitic microstructure, see the close-up in Fig. 3b. These could be attributed to the brittle nature of the WEL, which makes it prone to cracking under cyclic contact loading. These microcracks are similar to the observations in [25], which show multiple cracks propagating at an angle of ~ 90° to the surface within the WEL region.

The hardness values on the rail surface range from 307 to 389 HV, significantly exceeding the nominal hardness of R260 pearlitic steel, which is approximately 275 HV [38]. This increase is mainly caused by

the work hardening and plastic deformation resulting from repetitive wheel–rail contact as well as rail grinding. They are lower than the typical hardness range reported for WEL/BEL, and likely represent a combined response of the near-surface material, including the rail pearlitic matrix and any thin WEL/BEL present. No pronounced plastic deformation is observed in the subsurface, which may be related to the observation location on a straight track where lateral wheel–rail interaction is limited.

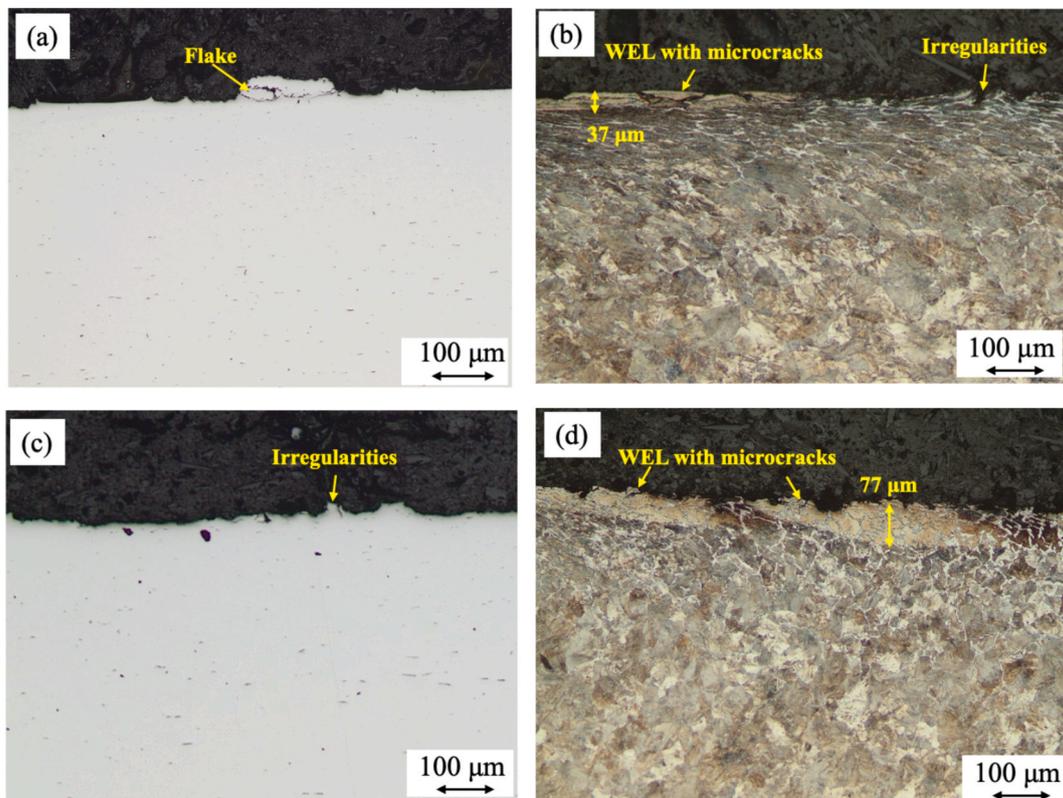
Fig. 4 shows OM images of the R260 rail microstructure at Sample R2, which had not undergone any grinding. The unetched image (Fig. 4a and 4c) reveals an irregular rail head surface characterized by small flaking and surface microcracks. After etching, a WEL layer is observed in the rail materials in Fig. 4b and 4d, with a thickness ranging from 5 to

Fig. 4. The OM images of Sample R2, R260 rail on Line 130B without grinding, (a) Longitudinal cross-section before and (b) after etching; (c) transverse cross-section before and (d) after etching.

77  $\mu\text{m}$ . Additionally, severe plastic deformation is observed in the near-surface region of Fig. 4b with depths of approximately 200–300  $\mu\text{m}$ . Given the substantially higher accumulated tonnage ( $\sim 31$  MGT) and the absence of grinding, the WEL is more likely associated with severe plastic deformation-induced microstructural transformation (mechanical WEL) rather than a thermal WEL [22,39]. The rail surface hardness of R2 ranges from 343 to 394 HV, comparable to and slightly higher than those of Sample R1.

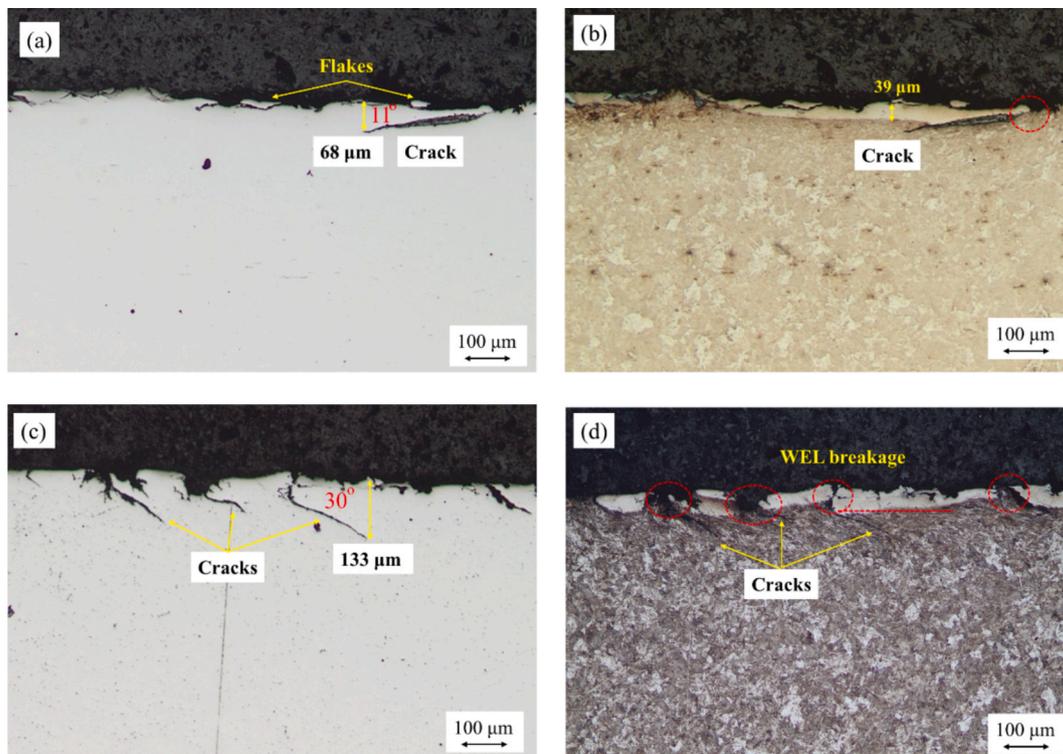
Fig. 5 shows OM images of the R350 rail microstructure at Sample R3, which had not been subjected to grinding. The unetched images (Fig. 5a and 5c) reveal a highly irregular rail surface with many flakes. Notably, both microcracks and macrocracks are present in this sample. For instance, the crack shown in Fig. 5a extends to a depth of 68  $\mu\text{m}$  and a length of 280  $\mu\text{m}$ , oriented at an angle of  $11^\circ$  relative to the rail surface in the longitudinal cross-section. In Fig. 5c, four cracks are visible, with depths reaching up to 133  $\mu\text{m}$  and an orientation angle of approximately  $30^\circ$  in the transverse cross-section.

Fig. 5. The OMs of Sample R3, R350 rail on Line 130B without grinding. (a) Longitudinal cross-section before etching; (b) longitudinal cross-section after etching; (c) transverse cross-section before etching; (d) transverse cross-section after etching.

Post-etching images (Fig. 5b and 5d) show the presence of a WEL near the rail surface, with thicknesses ranging from 5 to 45  $\mu\text{m}$ . Unlike Samples R1 and R2, where microcracks are confined to the brittle WEL/BEL layer, Sample R3 has macrocracks that propagate deeply into the underlying pearlitic microstructure. Besides, these cracks are observed to initiate at discontinuities in the WEL, either at layer breakages or at the interface between the WEL and the pearlitic material, as highlighted by the red dashed ovals. The surface hardness ranges from 528 to 988 HV, indicating significant surface hardening and confirming the presence of the WEL.

In comparison to Sample R2 (R260 rail), the R350 rail appears to exhibit lower resistance to RCF under the examined conditions ( $\sim 31$  MGT), as evidenced by the presence of deeper and more severe cracks. Similar observations have been reported in [29,32].

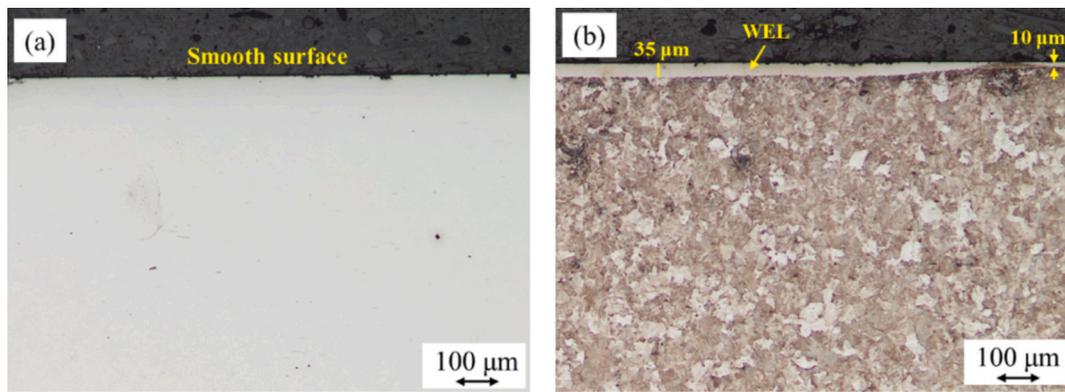
Fig. 6 shows OM images of the R350 rail microstructure at the centre of the running band of Sample R4, where one grinding cycle had been performed. The unetched image in Fig. 6a shows a relatively smooth surface with few microcracks. After etching (Fig. 6b), the WEL layer becomes visible, with a thickness ranging from 5 to 35  $\mu\text{m}$ . The underlying pearlitic grains show slight plastic deformation, and no macrocracks are observed. The surface hardness is between 449 and 697 HV, much smaller than that of R3.

In comparison to Sample R3 (unground R350), Sample R4, after one year of service following a grinding cycle ( $\sim 4$  MGT), has significantly fewer microcracks, the absence of macrocracks, a smoother surface, and lower surface hardness. These observations suggest that rail grinding has a beneficial effect on the resistance of R350 rails to RCF by removing the pre-existing plastic deformation layer and initial cracks.

Fig. 6. The longitudinal cross-sections of Sample R4, R350 rail on Line 130B after one grinding cycle, (a) before etching, (b) after etching.

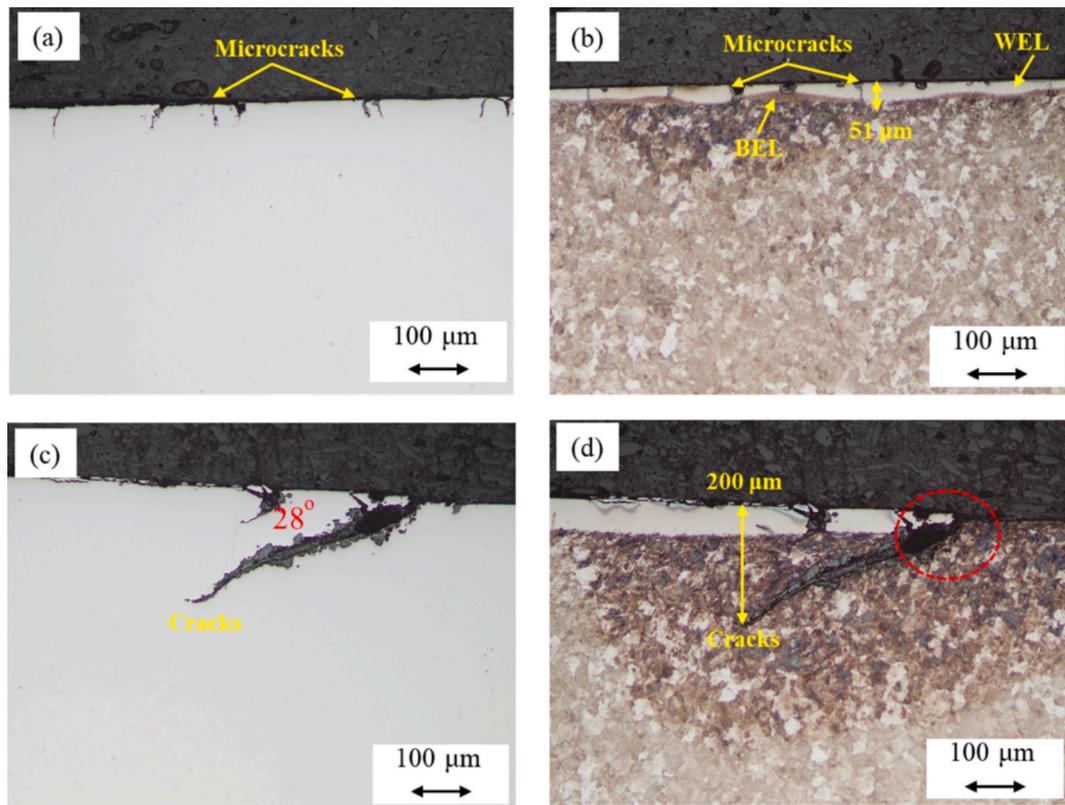
Fig. 7. The OMs of Sample R5, R350 rail on Line L40 with one grinding. (a) Longitudinal cross-section before etching; (b) longitudinal cross-section after etching; (c) transverse cross-section before etching; (d) transverse cross-section after etching.

R5, taken from the other track, Line 40, after one grinding cycle. The unetched images (Fig. 7a and 7c) show numerous microcracks as well as some macrocracks on the running surface. In particular, Fig. 7c shows a prominent crack reaching a depth of approximately 200  $\mu\text{m}$ , with an orientation angle of  $28^\circ$  relative to the surface, similar to the angle observed in Sample R3. The grey material observed inside the crack is likely oxide debris formed during repeated crack opening and closing under rolling contact [6], which allows oxygen and moisture to ingress, particularly in an open-track environment.

After etching (Fig. 7b and 7d), a mixture of WEL/BEL is observed, with a thickness ranging from 20 to 80  $\mu\text{m}$ . The microcracks are seen to initiate within this layer and propagate into the underlying pearlitic structure. The macrocracks are predominantly located at the transition between the WEL and the pearlite. Surface hardness ranges from 470 to 948 HV, which is similar to the values recorded for Sample R3.

Despite differences in railway lines and total accumulated loads (around 61 MGT for R5 and 31 MGT for R3), both the ground Sample R5 and the unground Sample R3 exhibit macroscopic cracks with comparable orientations and similar ranges of surface hardness. A closer analysis reveals that both samples experienced a similar post-grinding load: approximately 29 MGT for R5 and 31 MGT for R3 (without grinding), suggesting that accumulated tonnage after grinding is a more relevant parameter than total service tonnage when assessing RCF development.

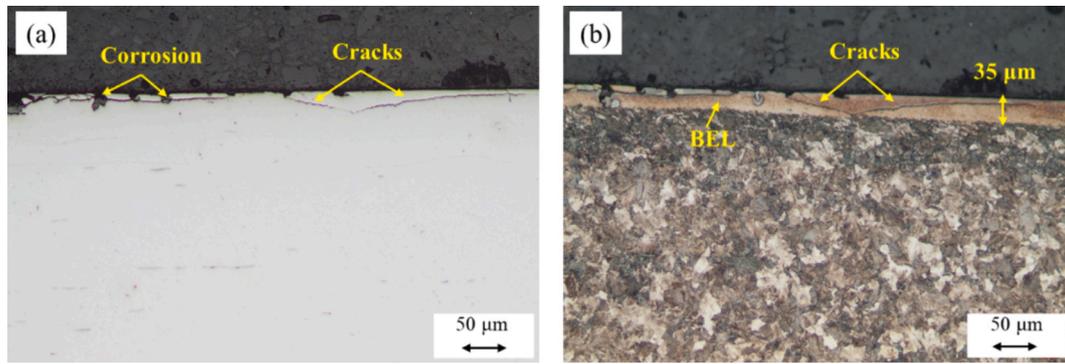
Fig. 8 shows OM images of the R350 rail microstructure at Sample R6, which had undergone two grinding cycles. The unetched image (Fig. 8a) shows the presence of corrosion products near the surface, along with minor surface flakes and microcracks. After etching (Fig. 8b),

Fig. 8. The OMs of Sample R6, R350 rail on Line 40 with two grinding cycles. (a) Longitudinal cross-sections before etching; (b) longitudinal cross-sections after etching.

a BEL is observed in the rail material, with a thickness ranging from 10 to 40 µm. Relatively long cracks are seen to initiate within this layer, either parallel to the surface or propagate with a shallow angle and stop at the interface of the underlying pearlitic microstructure. The surface hardness values range from 564 to 734 HV.

Compared to Sample R5, Sample R6 has no macrocracks penetrating into the pearlite, but some microcracks confined within the BEL layer. The lower surface hardness may result from a combination of reduced accumulated plastic deformation and the absence of a hard WEL, with the near-surface region being dominated by BEL. These observations indicate that the second grinding cycle performed on R6 had a beneficial effect in removing pre-existing damage layers and enhancing resistance to RCF cracks. Additionally, the surface hardness of R6 is comparable to and slightly higher than that of Sample R4, which may be attributed to their relatively low post-grinding loads, approximately 9 MGT for R6 and 4 MGT for R4, significantly less than the loads for Samples R3 and R5. This further supports the hypothesis that post-grinding load is more relevant in determining surface condition and RCF development.

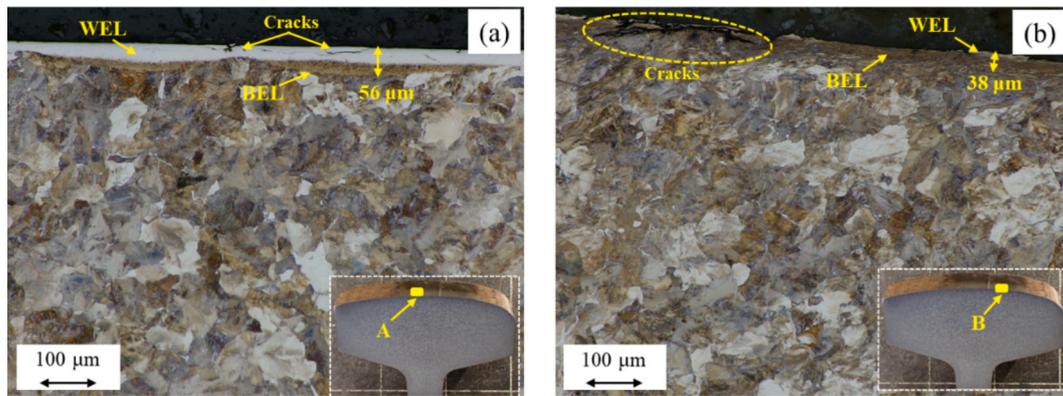
Fig. 9 shows the OM images of the R260 rail microstructure in the wheel tread-rail head contact zone at two positions, A and B (see Fig. 2). It can be seen that a continuous WEL/ BEL layer was present at Position A with a thickness of about 20–60 µm, while at Position B the WEL is discontinuous and appears as small patches together with an underlying BEL. Cracks and voids oriented nearly parallel to the rail surface are also visible, although they do not appear to propagate into the underlying pearlitic structure. The micro-hardness at both locations was about 280–290 HV near the rail surface, and reduced to 235–245 HV at a depth of 10 mm. Within the WEL, localised hardness values reach as high as 830 HV. It is observed that position B contains a thicker BEL and a much

Fig. 9. The OM images of the Swedish rail sample in wheel tread-rail head contact zone. (a) Position A; (b) Position B.

thinner WEL compared to position A. Moreover, the cracks at position B are longer and penetrate more deeply, suggesting a larger local wheel-rail contact stress. It is also noted that the boundary between the BEL and the underlying plastic deformation layer cannot be clearly distinguished due to their similar contrast in the current optical micrographs; further analysis using higher magnification or SEM would be required to observe this boundary more clearly.

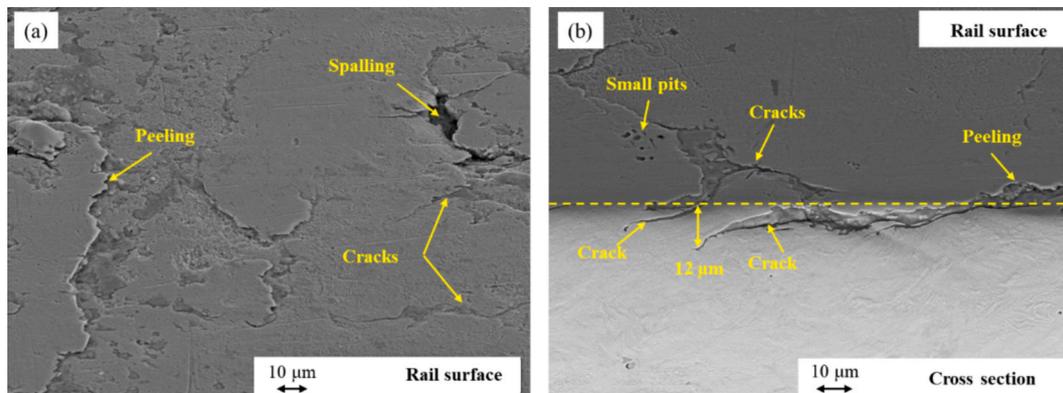
Fig. 10 presents the SEM images of this rail sample at position B for a more detailed examination. It can be seen from Fig. 10a that the rail surface shows signs of degradation after around 11 MGT of service, including peeling, spalling and small cracks. These cracks have a depth of dozens of micrometres, are nearly parallel to the surface, and stay within the surface WEL/BEL, as shown in Fig. 10b. Notably, no head checks or other defects were observed in this region of the sample, as shown in Fig. 2.

Fig. 10. The SEM images of the Swedish rail sample at position B. (a) on the rail surface; (b) a combination of the rail surface and cross section.

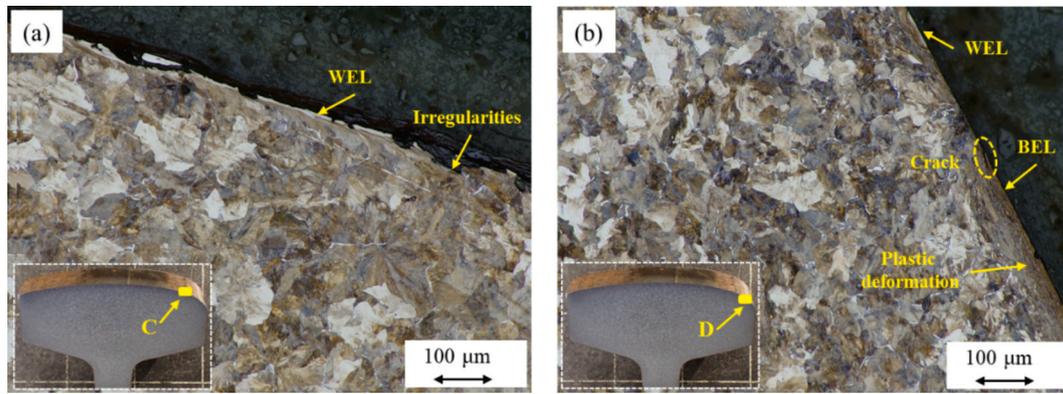
Fig. 11 shows OM images of the R260 rail microstructure at two locations: the slight contact region on the rail shoulder (Position C) and the wheel flange-rail gauge contact zone (Position D). As shown in Fig. 11a, the rail surface at Position C contains a thin and discontinuous WEL, with a thickness ranging from 5 to 15  $\mu\text{m}$ . This region also exhibits signs of slight plastic deformation and an irregular surface profile, probably resulting from the grinding. In contrast, the microstructure at Position D (Fig. 11b) reveals a much smoother surface, which should be caused by more intense and consistent wheel-rail sliding contact. This area shows pronounced plastic deformation, a relatively thick BEL, and only limited WEL presence, similar to the characteristics observed in Fig. 9b. A small surface crack is observed in this region, approximately 43  $\mu\text{m}$  in length. The micro-hardness at both locations was about 285 HV near the rail surface.

**Fig. 11.** The OM images of the Swedish rail sample in the wheel flange-rail gauge zone. (a) A slight contact region on the rail shoulder, Position C; (b) the wheel flange-rail gauge contact zone, Position D.

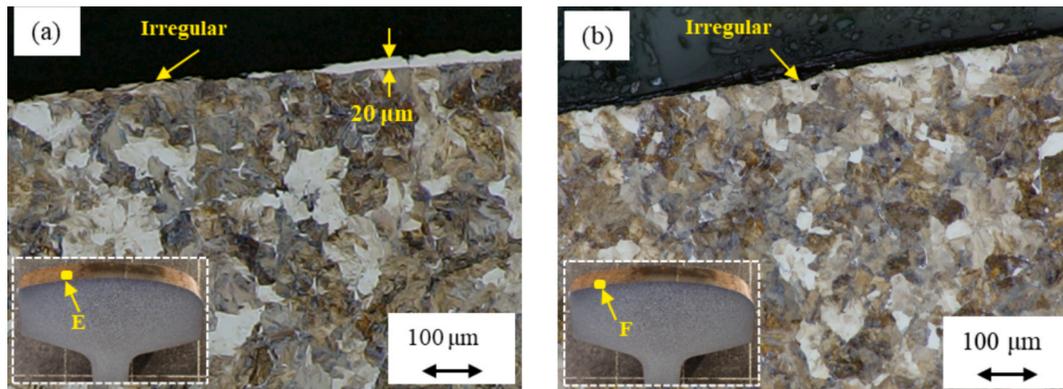
Fig. 12 shows the OM images of the R260 rail microstructure in the non-contact zone at two positions, E and F. A discontinuous WEL is observed near the rail surface, with a maximum thickness of approximately 20  $\mu\text{m}$ . In some areas, the WEL is absent, as shown in Fig. 12b. The rail surface has some irregularities, similar to those in Fig. 11a, probably introduced by the grinding. Microhardness measurements near the surface at both positions range from 280 to 290 HV, about 15% higher than the hardness measured at a depth of 10 mm, indicating that grinding has induced a certain degree of plastic deformation and surface hardening.

Compared to the contact zones shown in Fig. 9, the WEL in the non-contact zone (Fig. 12) is thinner, less continuous, and associated with fewer microcracks and with a more irregular surface. The overall hardness values are comparable in both cases. Additionally, the microstructural characteristics observed in the slight-contact region (Fig. 11a) closely resemble those in Fig. 12a, confirming minimal contact in that area.

**Fig. 12.** The OM images of the Swedish rail sample in the non-contact zone. (a) Position E; (b) Position F.
