# Microbiologically Influenced Corrosion of a Pipeline in a Petrochemical Plant

**Abstract:** This paper investigates a severe microbiologically influenced failure in the elbows of a buried amine pipeline in a petrochemical plant. Pipelines can experience different corrosion mechanisms, including microbiologically influenced corrosion (MIC). MIC, a form of biodeterioration initiated by microorganisms, can have a devastating impact on the reliability and lifetime of buried installations. This paper provides a systematic investigation of a severe MIC-related failure in a buried amine pipeline and includes a detailed microstructural analysis, corrosion products/biofilm analyses, and monitoring of the presence of causative microorganisms. Conclusions were drawn based on experimental data, obtained from visual observations, optical/electron microscopy, and Energy-dispersive X-ray spectroscopy (EDS)/X-Ray Diffraction (XRD) analyses. Additionally, monitoring the presence of causative microorganisms, especially sulfate-reducing bacteria which play the main role in corrosion, was performed. The results confirmed that the failure, in this case, is attributable to sulfate-reducing bacteria (

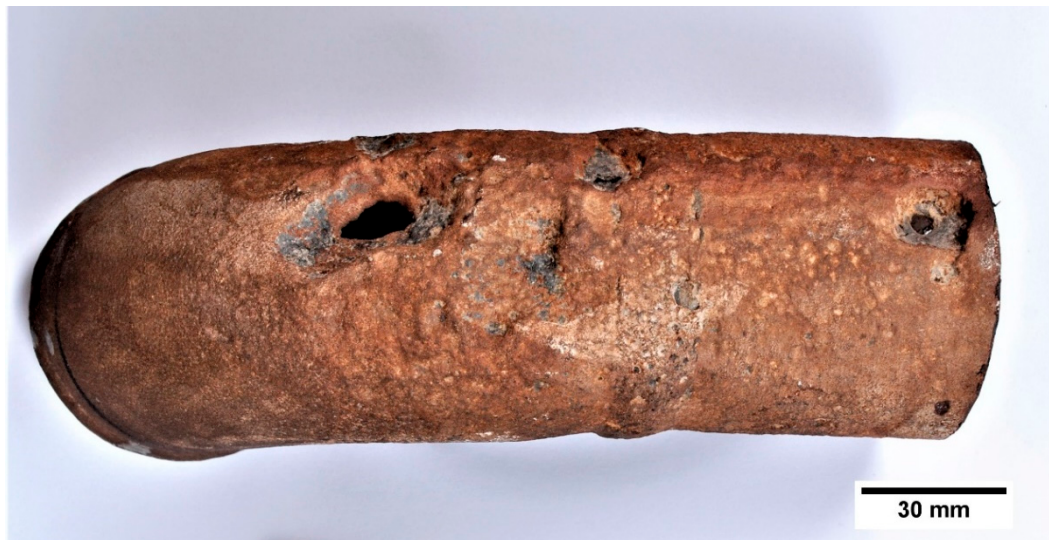
Figure 2 shows a typical failed elbow, taken out of the service. Both the inner and outer surfaces were covered with red/yellow–brown and, in some spots, black rust layers. The elbows were heavily damaged at the outer surface. Large pits and perforations were seen on the surface. Pits on the exterior of the failed elbows were at different stages, with some at the early stages, while a few have turned into big holes during service. While the outside part of the elbows had undergone severe localized corrosion, the inside part hardly showed any pitting, see Figure 3, indicating that the pitting had started from the outer surface. There were hardly any signs of surface irregularities (e.g., erosion or surface deformation) other than severe surface pitting.

**Figure 2.** An example of the failed elbows.

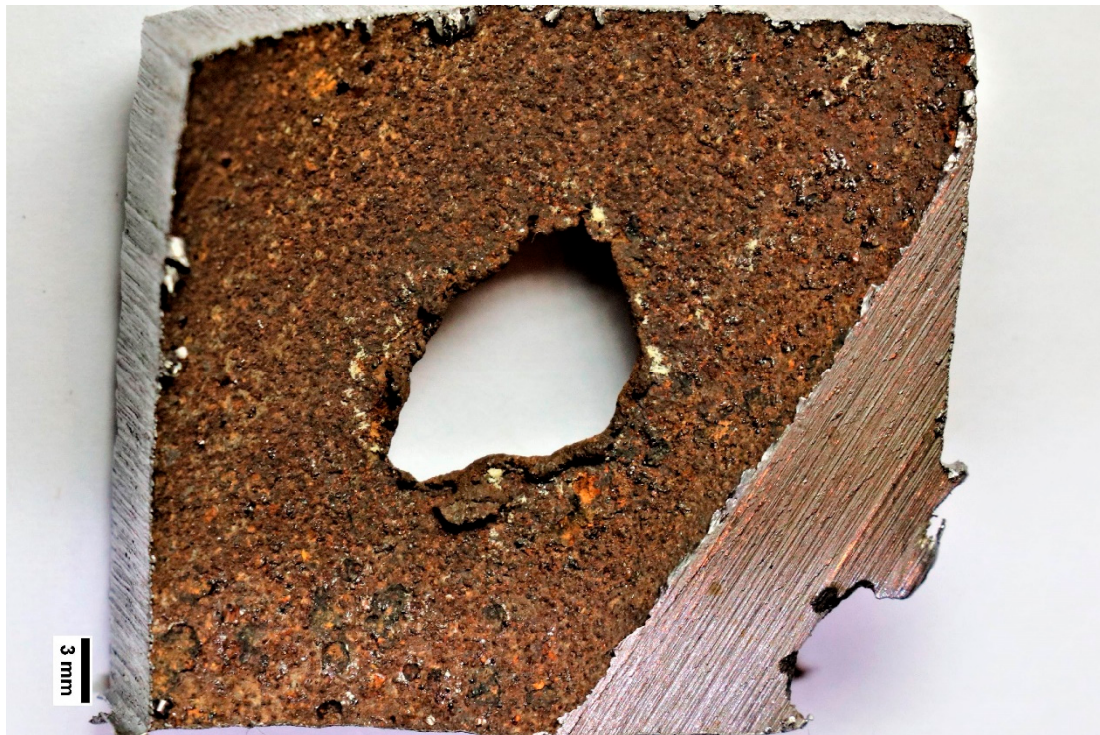
**Figure 3.** An inner surface of the failed elbows.

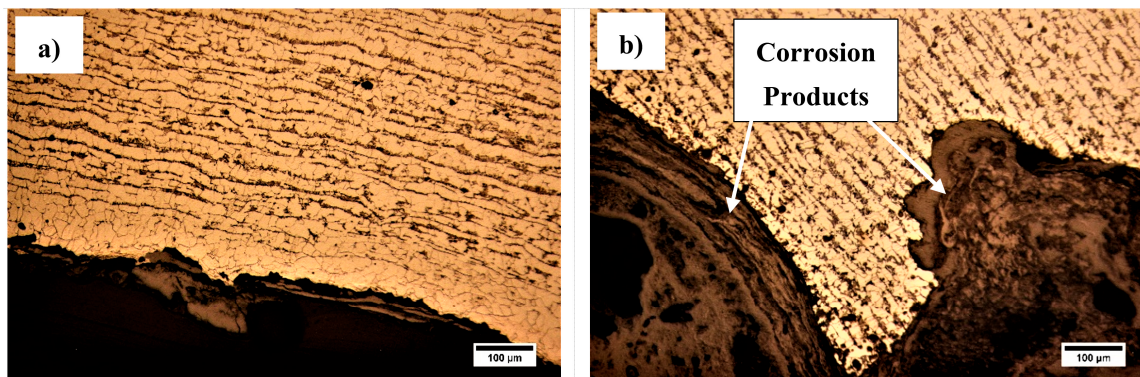
Figure 4a shows the microstructure of the failed elbow at the inner surface. The observed elongated ferritic–pearlitic microstructure is an indication that the alloy was in the as-rolled state. As mentioned before, there was no indication of pitting at the inner surface. Figure 4b shows the microstructure of a cross-section at the outer surface. Severe perforation and deep pits were observed at the outer surface. Furthermore, pits were covered with corrosion products, while in some cases, corrosion products had a layered structure.

**Figure 4.** The optical microscopy (OM) microstructures of the (a) inner surface and (b) the outer surface.

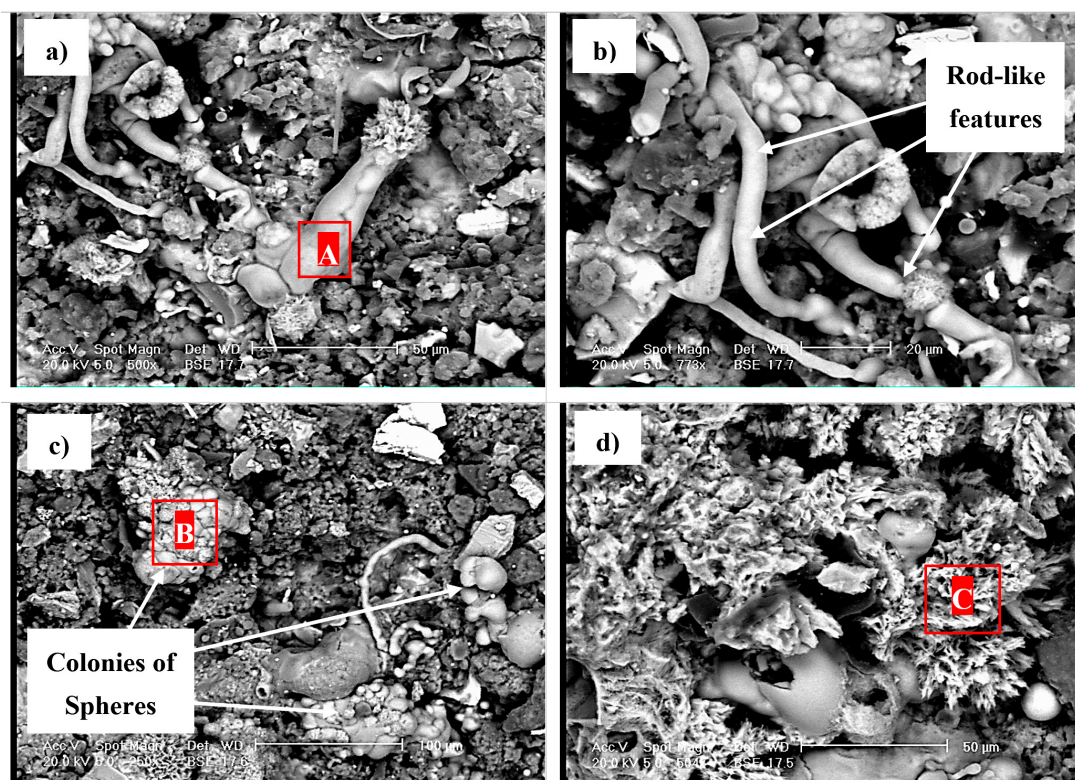
Figure 5 shows the typical features found inside pits at the outer surface. This figure clearly shows that the surface was covered with a biofilm. Biofilms, consisting of complex communities/colonies of microorganisms and EPS, can dissolve oxygen and create gradients of pH, resulting in localized forms of corrosion, such as crevice corrosion and pitting [10]. Three noticeable features were seen in the biofilm:

- (i) Rod-shaped products, with approximate length of 50  $\mu\text{m}$ ;
- (ii) Colonies of spheres, with their size ranging from 10 to 100  $\mu\text{m}$ ;
- (iii) Flower-like surface features, all shown in Figure 5.

Rod-like features were, statistically, more frequently seen than the other two morphologies. The distributions of all the mentioned morphologies were rather homogeneous, i.e., all features were seen in each and every pit.

**Figure 5.** Scanning Electron Microscope (SEM) photomicrographs showing biofilms (or surface deposit) and features inside biofilms, i.e., (a) and (b) rod-like features, (c) colonies of spheres, and (d) flower-like features.

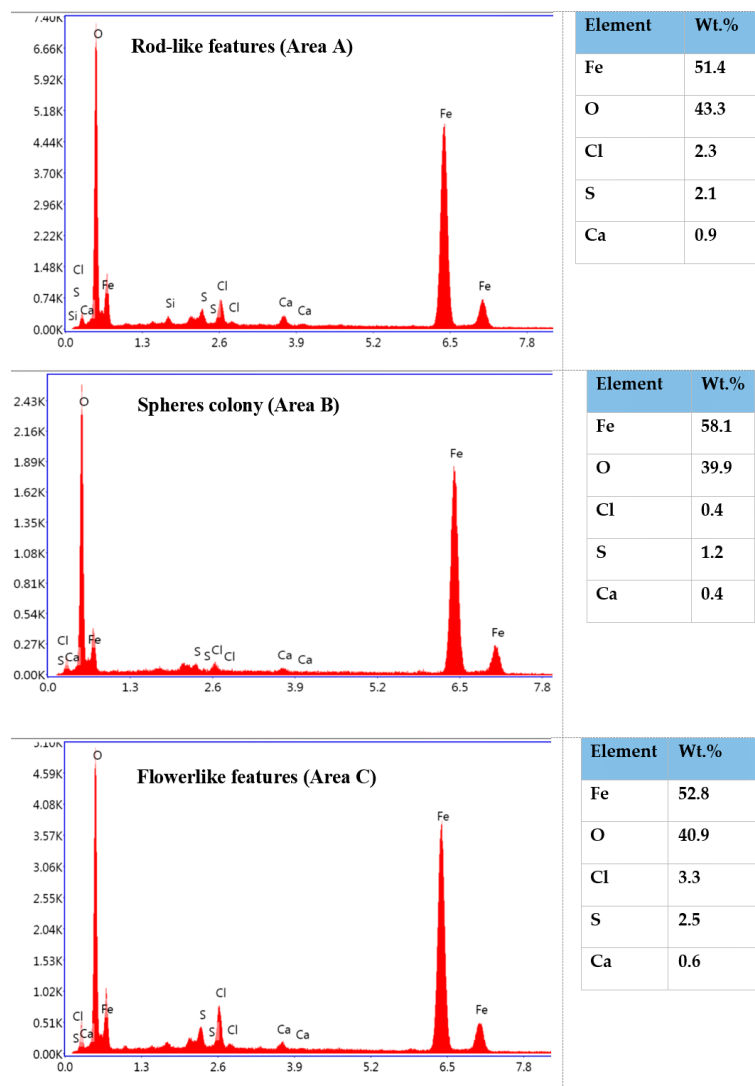
Figure 6 shows the results of EDS analyses of rod-like, spherical, and flowerlike corrosion products. In terms of the chemistry, there was no meaningful difference between these features, inferring that the difference between these features is only morphological. The presence of sulfur in all the EDS spectra is an indication that the observed features are SRB, which is an anaerobic bacterium. SRB is known to be the primary factor of MIC. Organic compounds attracted to the surface of steel make it an ideal environment for the colonization of microorganisms [2]. Amongst different microorganisms, SRB is known to have excellent adaptability to extreme conditions. Biochemical energy for the growth of SRB is obtained by reducing sulfate ( $\text{SO}_4^{2-}$ ) to sulfide ( $\text{S}^{2-}$ ) in the presence of natural organic compounds. At the same time, with the absorption of atomic hydrogen (H) on the surface of iron, it will gradually disappear [16]. Overall, the major detrimental metabolic activities of SRB are mostly related to its ability to:

**Figure 6.** Energy dispersive X-ray spectroscopy (EDS) analyses of areas shown in Figure 5, related to rod-like, spherical, and flower-like features ( $x$ -axis: Energy (KeV),  $y$ -axis: a.u.).

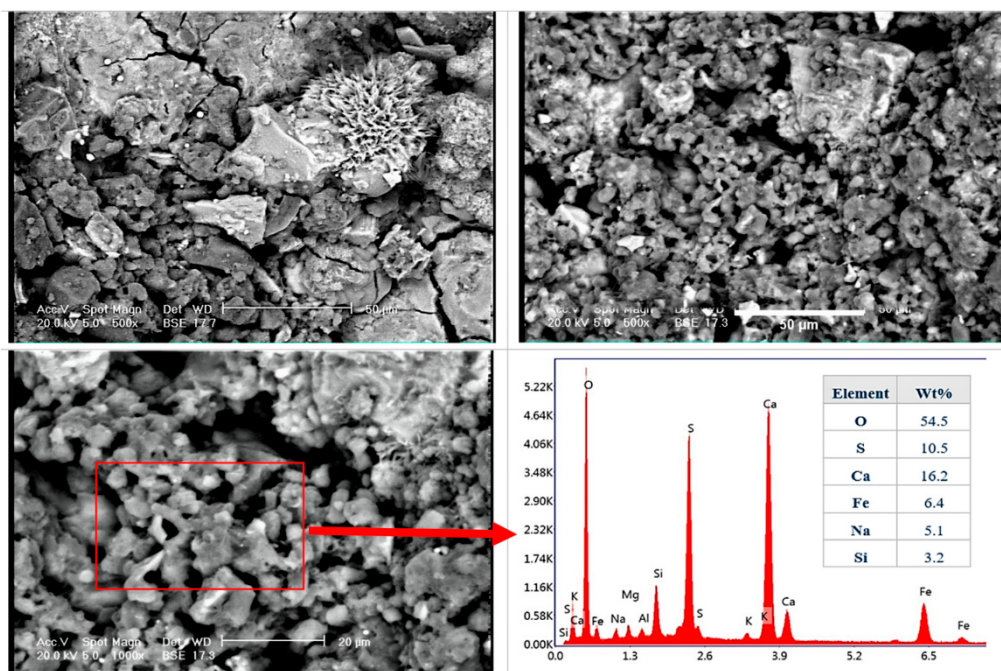
Figure 7 represents a closer look at the biofilm in the outer surface in which microorganisms are distributed. Biofilm is a self-produced firmly-attached EPS surface layer. In fact, the stability of microorganisms is dependent on the biofilm, given that the biofilm provides structural support for microorganisms and, to a great extent, protects them from environmental, physical, and chemical stresses. Biofilms could host a variety of different microorganisms including fungi, bacteria, eukaryotes, and archaea, with each having a different metabolic ability [2]. The SRB, in particular, has a vigorous metabolism, producing a certain amount of EPS (in fact, often there are also other microorganisms present that are mainly responsible for EPS production), which rapidly adhere to the surface of the metal and build a biofilm [14,18]. The biofilm, in this case, has a porous nature, making the ion/nutrition exchange much easier. EPS are composed of charged polymers and can significantly contribute to the accumulation of different chemical species inside EPS. In the case where organic acids are produced by microbial species, mineral dissolution rates are expected to increase [19,20]. The results of EDS analysis show that elements oxygen, sulfur, calcium, chloride, and iron were present in the biofilm. Figure 8 shows typical XRD patterns of corrosion products, taken from the surface of the pipe. The results confirmed the formation of a significant amount of oxide-hydroxide (FeOOH), iron oxide, and iron sulfide. The latter is a typical corrosion product when SRB is the controlling microorganism.

Figure 7. Examples of SEM images of biofilms together with EDS analysis.

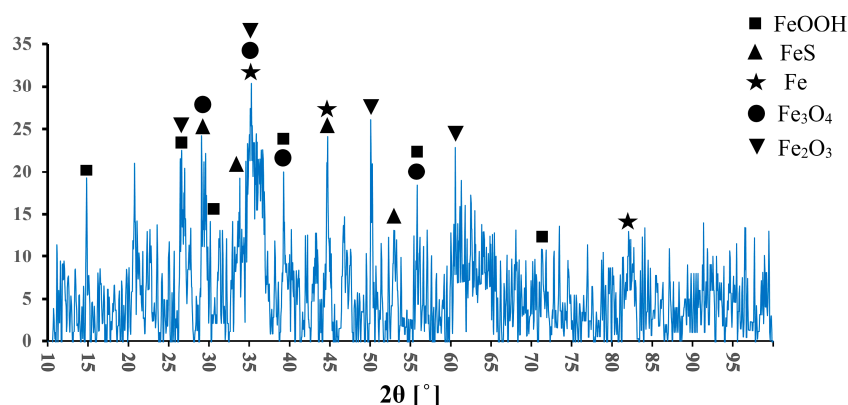
Figure 8. An X-ray diffraction analysis of the surface of the pipe.

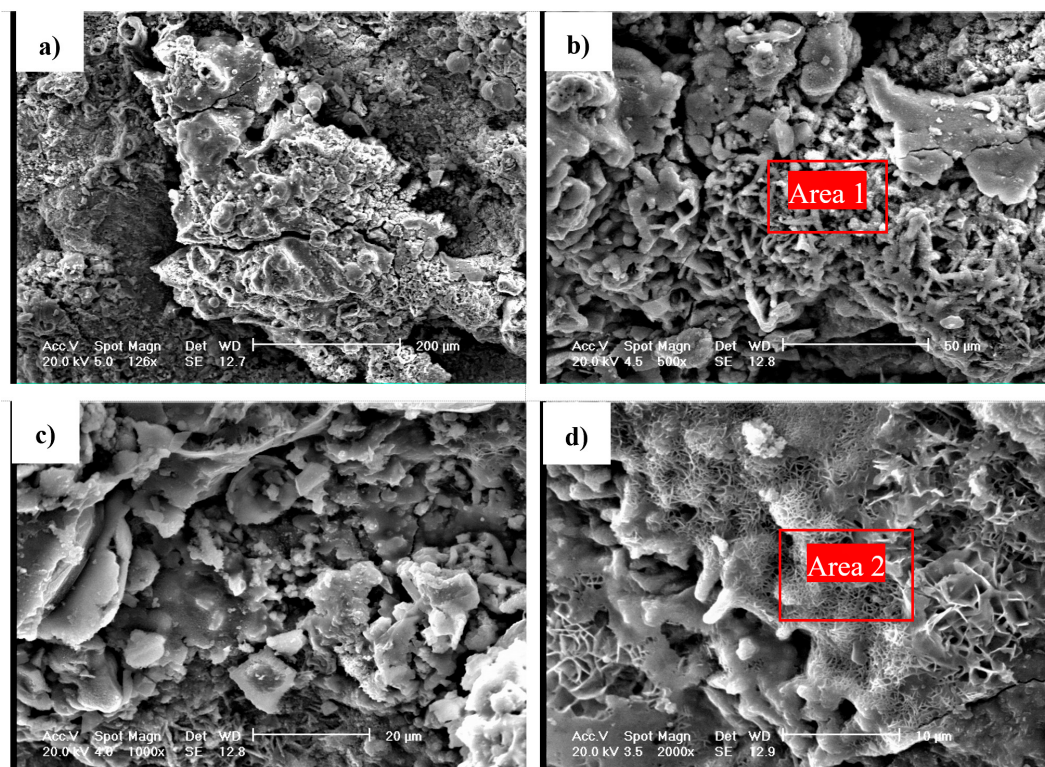
Figure 9 shows SEM images of corrosion products at the inner surface. As mentioned earlier, there was hardly any sign of localized corrosion. The inner surface in some areas was covered with a porous scale-like layer intermingled with some globular  $\alpha$ -FeOOH particles, see Figure 9a,b. Other observed morphologies of corrosion products were plate-like micaceous crystalline features, see Figure 9c, and honeycomb-like structures, see Figure 9d, with both being typical morphologies of  $\gamma$ -FeOOH. Therefore, overall, the inner surface was covered with different iron oxide-hydroxides and possibly other oxide products. Figure 10 shows the EDS analysis of the areas shown in Figure 9. There was no sign of sulfur and chloride, unlike what was seen at the outer surface. It appears that the failure has started from the outer pipe surface, and corrosion products at the inner surface were caused by the liquid inside the pipeline.

**Figure 9.** Different morphologies of the corrosion products at the inner surface: (a) and (b) scale-like layer intermingled with some globular  $\alpha$ -FeOOH particles, (c) plate-like micaceous crystalline features, and (d) honeycomb-like structures.

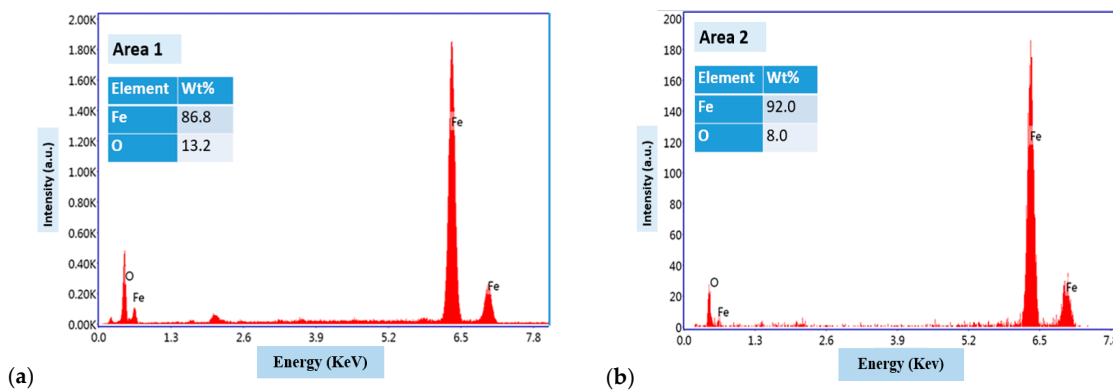
**Figure 10.** EDS analyses of (a) area 1 and (b) area 2, shown in Figure 9.

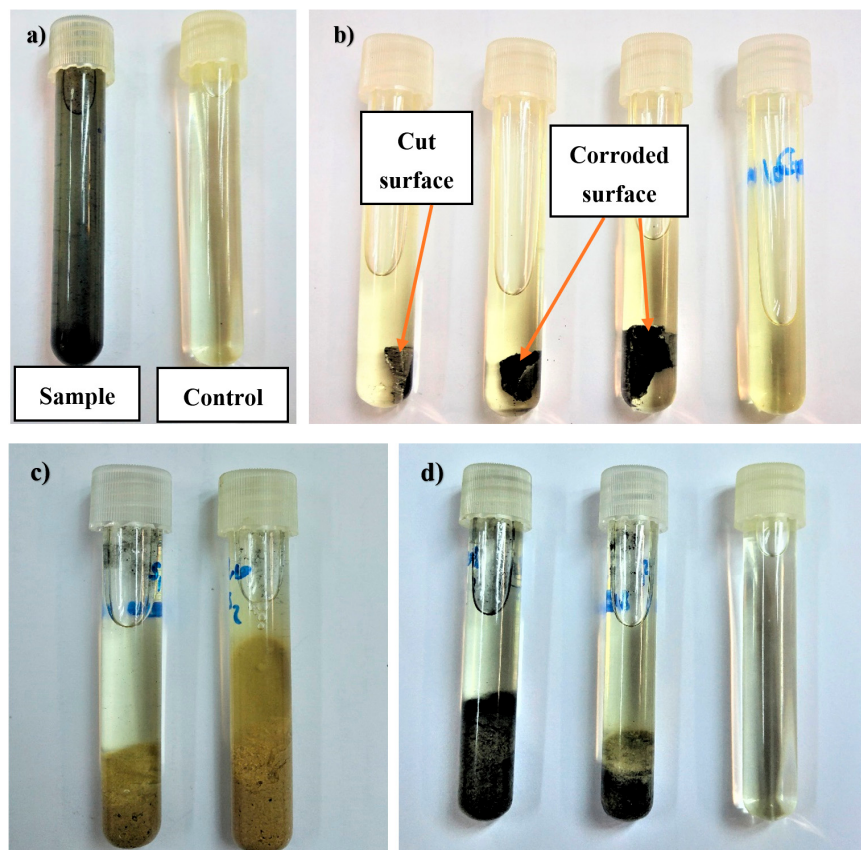
Surface scratches from the corroded elbows and samples of soil from the corrosion area were inoculated in SRB-specific media and incubated in anaerobic conditions for 20 days. As shown in Figure 11, the black precipitation is created due to SRB growth and  $H_2S$  and FeS production in the media. It is noticeable that the SRB-induced black precipitation was only created on the corroded surface of the failed elbow, and there was no sign of black precipitation on the cut surface, see Figure 11b. The formation of SRB cells was confirmed by SEM images, see Figure 12, and EDS spectra, see Figure 13. SRB is resistant to environmental stresses such as pH and temperature variations, chloride concentration, and high values of pressure. They form biofilms and create massive corrosion products by deteriorative mechanisms [21,22].

**Figure 11.** SRB growth monitoring in specific media after 20 days. Control: The specific medium without inoculation. (a) Surface scratch from corrosion tube, (b) the corrosion tube cuts (c) the soil samples of corrosion area after five days, and (d) after 20 days.

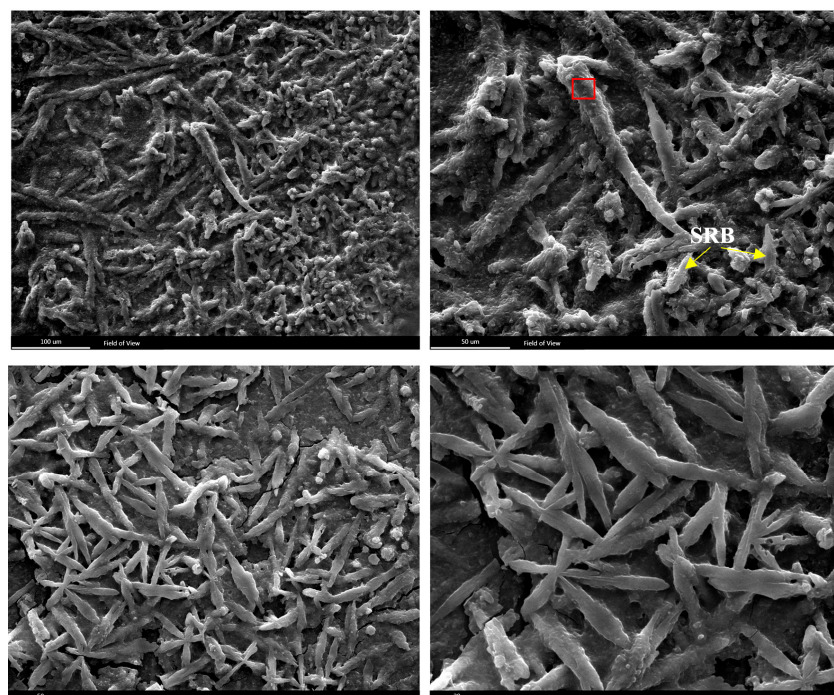
**Figure 12.** SEM images of SRB growth in specific media inoculated by the surface scratches of the corroded sample (all pictures are from similar features with different magnifications).

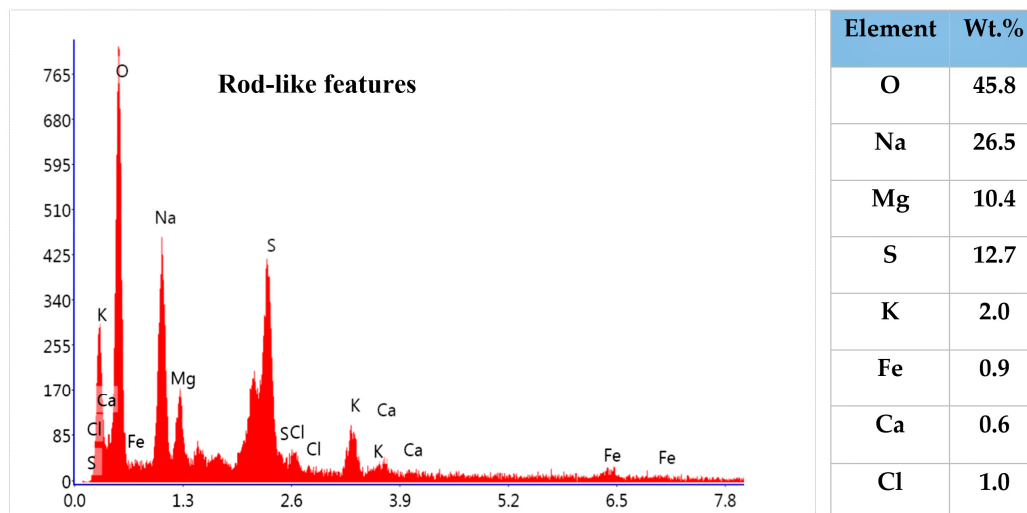
**Figure 13.** An EDS analysis of area shown in Figure 12 ( $x$ -axis: Energy (KeV),  $y$ -axis: a.u.).

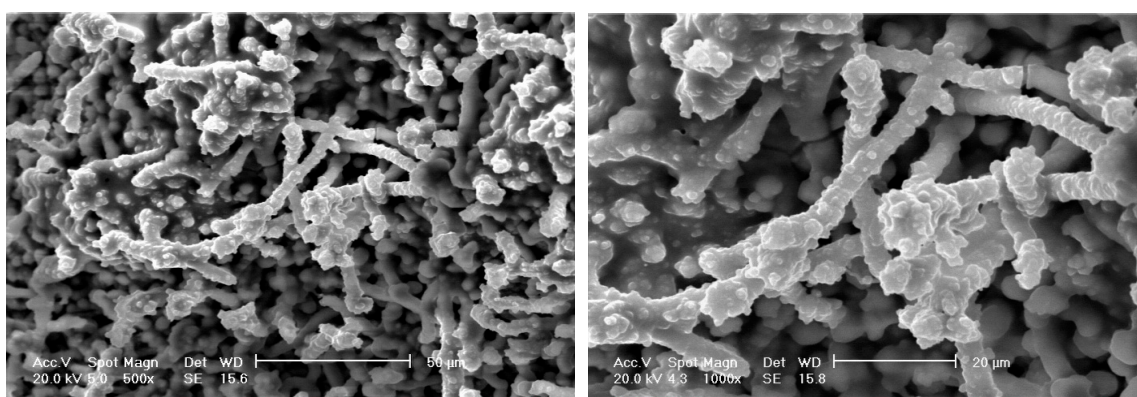
The corroded tube was also cultivated in the media. The results revealed that due to reactivation and reproduction of SRB, the amount of corrosion products increased. The corrosive effects of SRB are shown in Figure 14. The redox potentials of as-received soil before inoculation in an SRB-specific medium and that after inoculation were 19 and  $-315$  mV, respectively. The decrease in the redox potential can be attributed to the enhanced activity of SRB, which is in accordance with the presented results of Figures 11–13 [23,24].

**Figure 14.** Corrosion products development after reactivation of SRB due to inoculation of the corroded tube cuts in the SRB-specific media (Images are from similar features with different magnifications).
