A case study for scientific research prior to conservation of marine metal artefacts

Journal of Archaeological Science: Reports

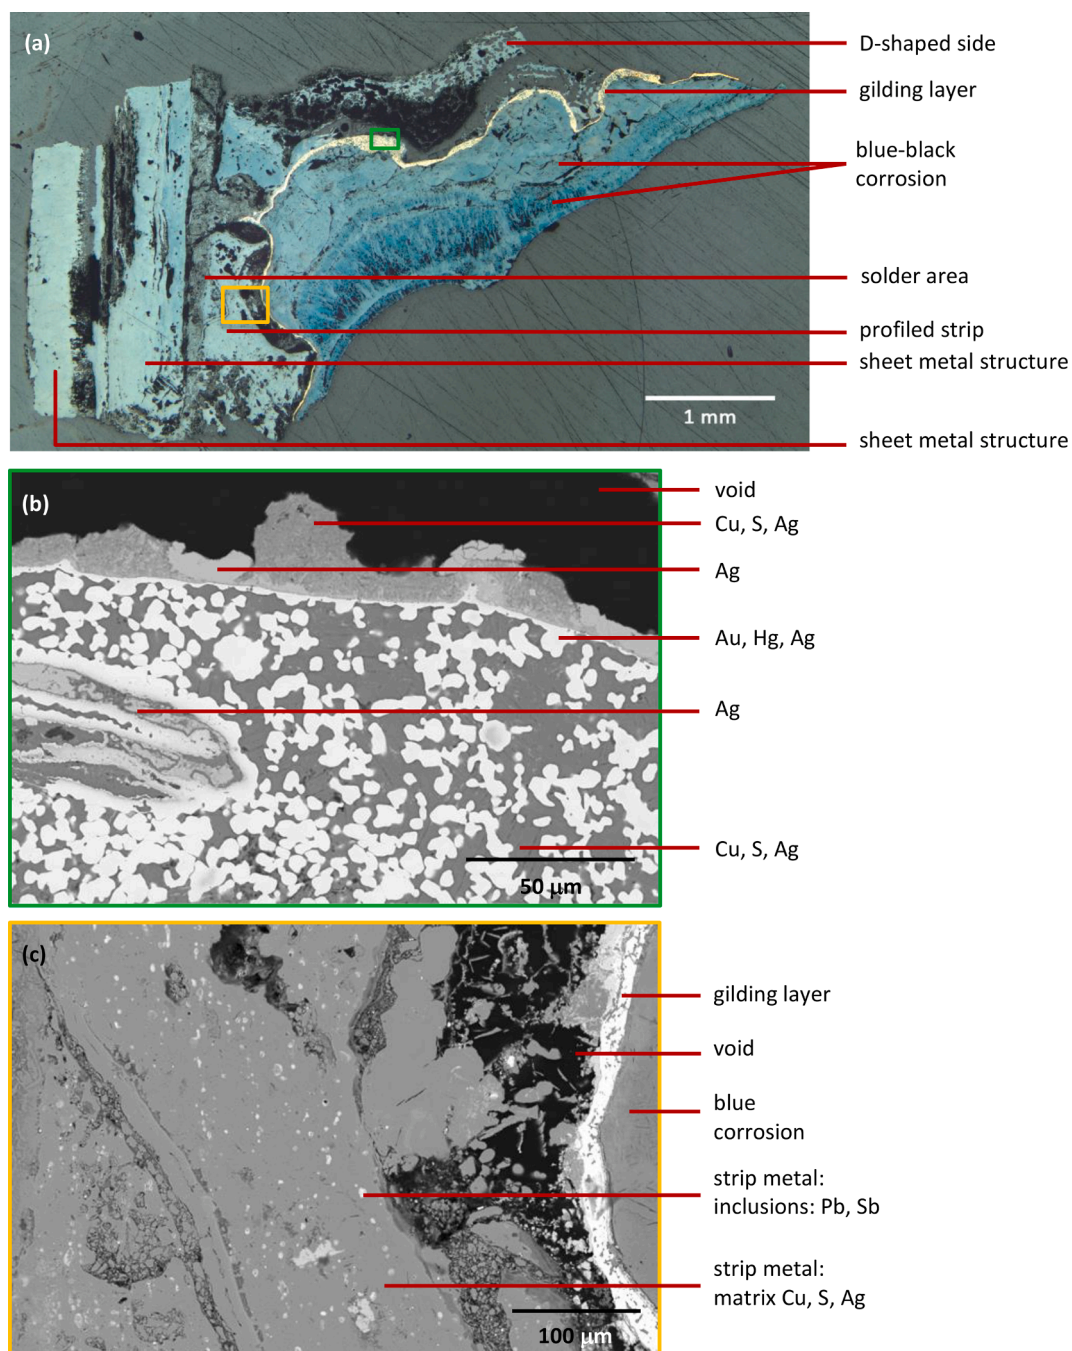
Fig. 5. Embedded cross-section (see Fig. 2). (a) Optical micrograph showing multiple constructional parts of the oval box. In green, the area shown in (b) is indicated, in yellow the area shown in (c); (b) backscatter electron image showing the entire cross-section of the gilding layer, revealing gold (Au) particles (white) with traces of mercury (Hg) and silver (Ag) dispersed in a copper (Cu)- and sulphur (S)-rich layer (grey). Silver-rich areas are present both inside the gilding layer and between the D-shaped side and the gilding layer (light grey); (c) backscatter electron image showing a corroded brass (Cu, Zn) matrix with inclusions containing lead (Pb) and antimony (Sb).

A fragment was found detached from the box and its origin could be reconstructed with high certainty, see Fig. 2. An embedded cross-section of this fragment was studied by OM and SEM-EDS. A clear gilding layer with a thickness varying between 10 and 100 μm is found in between a dark-coloured matrix and a blue-green layer (Fig. 5a).

SEM-EDS analyses (see SOI 4 for more details) of the gilding area (Fig. 5b) show the layer is composed of gold-rich areas (white), containing traces of mercury and silver, dispersed in a matrix of copper and sulphur (grey). The presence of mercury and the globular morphology is consistent with the process of amalgam gilding on copper (Anheuser, 1999, 24, 34). A relatively thick layer with undeformed gold-rich areas (Fig. 5b) is the result of the application of a large amount of amalgam paste that is not subsequently burnished, while a thinner, more compact layer is a typical result after burnishing (Fig. 5c). The copper-based matrix in which the gold-rich areas are dispersed is most likely an infill that has formed during corrosion of the brass box during its presence in the marine environment. The microstructure and composition (Fig. 5c) of the dark-coloured vertically oriented parts as analysed with SEM-EDS (see SOI 4 for more details) lead to the conclusion that these parts are corroded brass components, which belong to the interior sheet metal structure and profiled decoration strip. The blue layer could be identified with SEM-EDS as a layer consisting of copper, sulphur and traces of iron, consistent with the XRD results on the exterior of the box: chalcopyrite (CuFeS_2) and covellite (CuS). The presence of trace amounts of silver in nearly all phases present in the entire cross-section indicates that silver is present in the alloy materials in the form of traces in the copper matrix and/or inclusions.
