### A case study of St. Christopher in Maria Church, Nisse

Gatto, Valentina; Anisimov, Andrei G.; Lettinga, Wouter; Tao, Nan; Lantman, Merel; Crijns, Bernice; Groves, Roger M.

# Application of shearography and the percussion method for the structural inspection of wall paintings: a case study of St. Christopher in the Mariakerk, Nisse

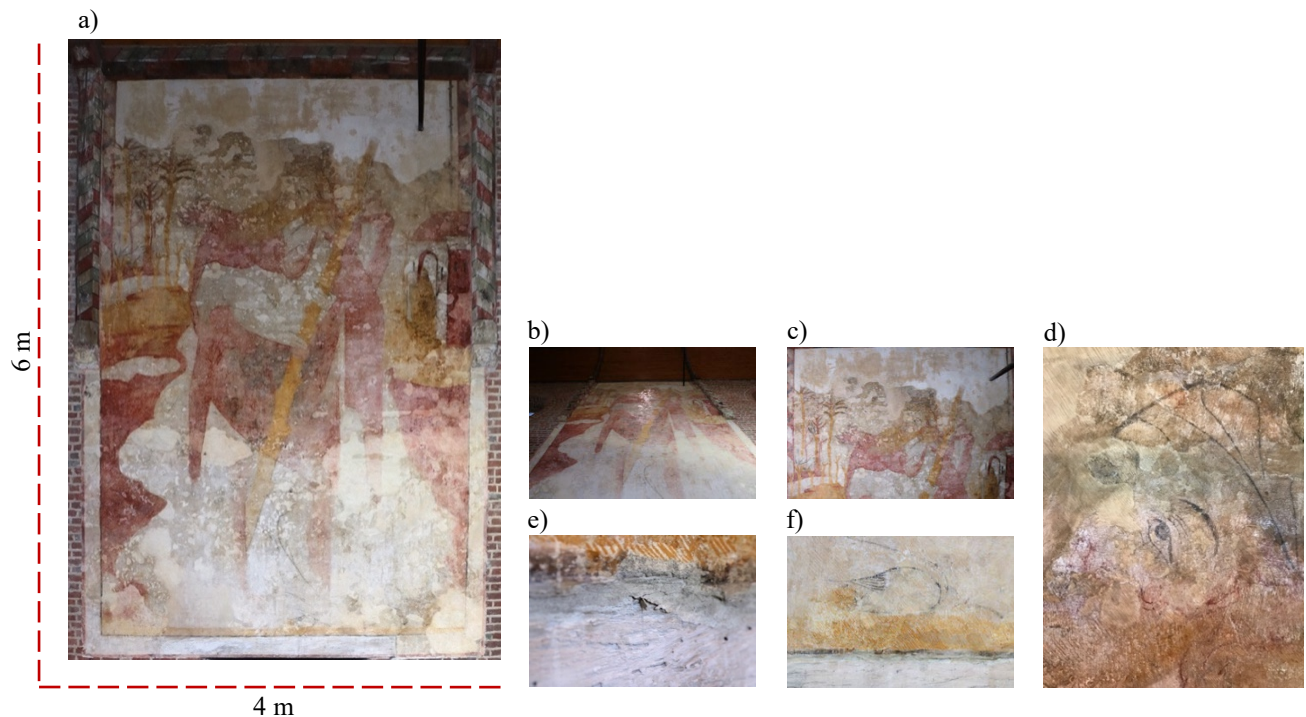
Figure 1. Wall painting depicting St. Christopher (a\*), with close-up details and degradation phenomena: (b) widespread surface gloss, (c) large areas of loss and retouching, (d) extensive retouching and visible surface gloss, (e\*) visible delamination, (f\*) fading of painted system and extensive retouching. \*Photo credit: Jorien Duivenvoorden

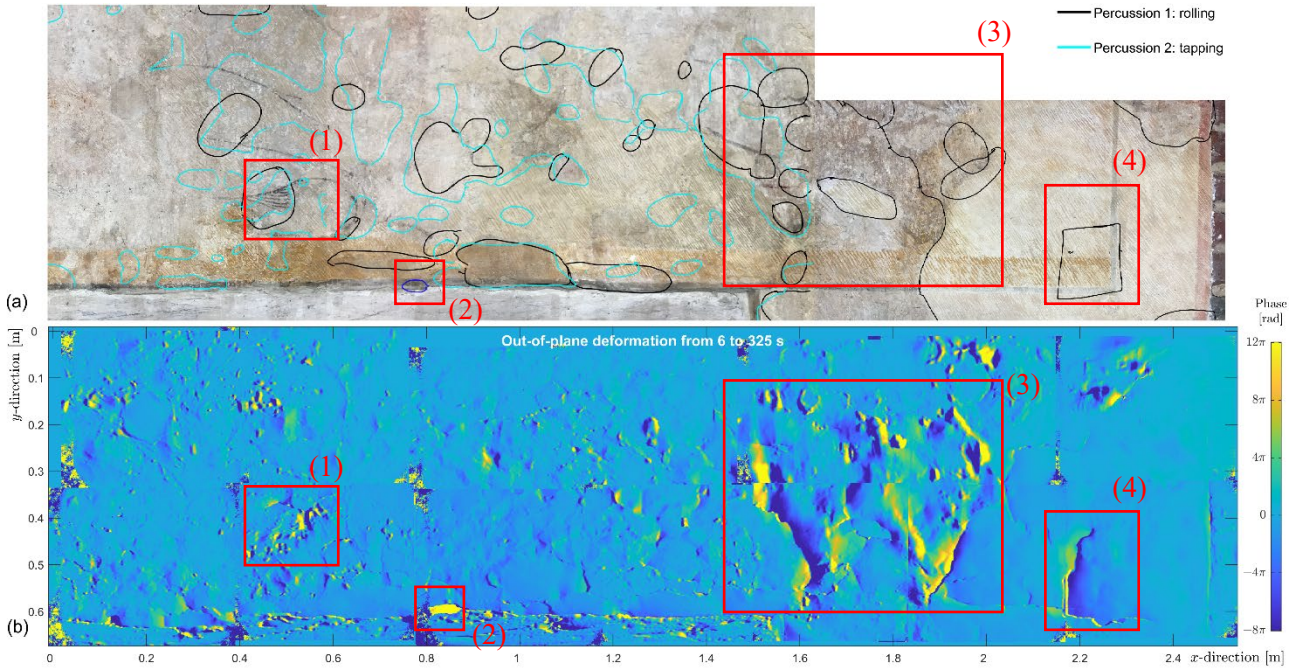
The percussion tests were executed in a collective approach, in order to reduce biases and subjective inclinations (Figure 2). After the tapping or the rolling of an area had occurred, the generated acoustic reactions were discussed and subsequently mapped (Figure 4 (a)). It can be easily observed that the implementation of the two percussion methods, despite involving the same mechanism of interpretation and collection of data, gave somewhat different results (Figure 4 (a)). It can be stated that the percussion method involving the tapping of a nail resulted in identifying more areas with delaminations than the percussion methods involving the rolling of the acoustically isolated plastic ball. In overall, some similarities in the results obtained were observed, especially in areas surrounding the wooden lintel, part of the door underlying the wall painting of St. Christopher (left and right side on the lower part of the wall painting in Figure 4 (a)).

Figure 4. Comparison of the inspection results obtained with (a) two percussion methods (shown as contour plots) and (b) the total phase difference obtained with shearography corresponding to the out-of-plane surface strain component. Four areas of particular interests have been identified in red, to facilitate argumentation.

The resultant phase map reveals multiple structural defects that relax after the thermal excitation to a stable state causing mechanical out-of-plane surface strain. The colour code in Figure 4 (b) is directly proportional to the strain magnitude.

Four main areas of interest have been identified and plotted in red in Figure 4 (b). As it can be observed by comparing area 1 in Figure 4 (b) and the correspondent area in Figure 4 (a), the presence of large areas of structural delamination was only identified by the percussion methods; shearography only detected a slight surface displacement, indicative of the presence of some structural defects. Area 2 has been mapped during all testing executed; it must be noted that the area in question was showing visible surface delamination and, therefore, could be easily identified with the naked eye (Figure 2 (e)). Similarly, strong correspondence in the detection of large areas of structural defects can be observed in area 3 in Figure 4 (b); the latter depicts a strong strain displacement which was also perceived as a vulnerable area during both percussion tests. Ultimately, it was deemed of interest to examine area 4 in Figure 4 (b). The latter is indicating an area where delamination might be occurring, which was only detected during the percussion testing that involved the rolling of an acoustically isolated plastic ball.

In conclusion, a partial correspondence between results obtained with the percussion methods and shearography was established. It can be argued that, areas perceived as vulnerable and indicative of the presence of delamination (such as area 1 in Figure 4 (a)) could not be detected by shearography because of two reasons:

1. The acoustic response documented during percussion testing was generated by the presence of materials of different composition and density.
2. The delamination might be relatively deep and might not affect the surface strain, therefore it would not be detected by shearography.
