Train Hunting Related Fast Degradation of a Railway Crossing—Condition Monitoring and Numerical Verification

Abstract: This paper presents the investigation of the root causes of the fast degradation of a railway crossing. The dynamic performance of the crossing was assessed using the sensor-based crossing instrumentation, and the measurement results were verified using the multi-body system (MBS) vehicle-crossing model. Together with the field inspections, the measurement and simulation results indicate that the fast crossing degradation was caused by the high wheel-rail impact forces related to the hunting motion of the passing trains. Additionally, it was shown that the train hunting was activated by the track geometry misalignment in front of the crossing. The obtained results have not only explained the extreme values in the measured responses, but also shown that crossing degradation is not always caused by the problems in the crossing itself, but can also be caused by problems in the adjacent track structures. The findings of this study were implemented in the condition monitoring system for railway crossings, using which timely and correctly aimed maintenance actions can b

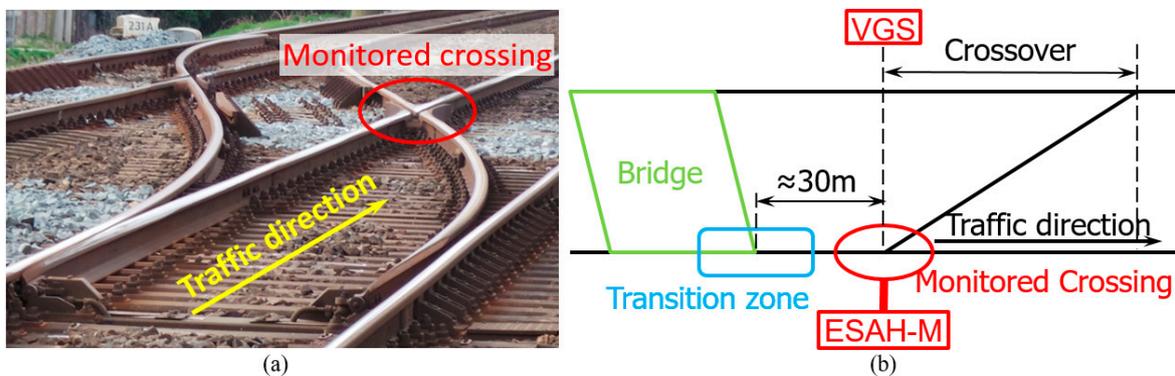
The monitored crossing was a cast manganese crossing with an angle of 1:9. As part of a crossover, trains mainly pass the crossing in the facing through route (Figure 2) with a velocity of around 140 km/h. The on-site view of the crossing is shown in Figure 10a. According to the maintenance record, this crossing was suffering from fast degradation with the service life of only around three years (18 years on average [2]). At the beginning of the condition monitoring, the damaged crossing was completely renovated.

Figure 10. Overview of the monitored crossing. (a) On-site view. (b) Sketch view.

Figure 10b gives a sketch view of the crossing, including the setup of the monitoring devices and the layout of the adjacent structures, especially the small bridge in front of the crossing. Considering that the bridge is located quite close to the monitored crossing, the performance of the crossing might be affected by the bridge, which will be discussed later.

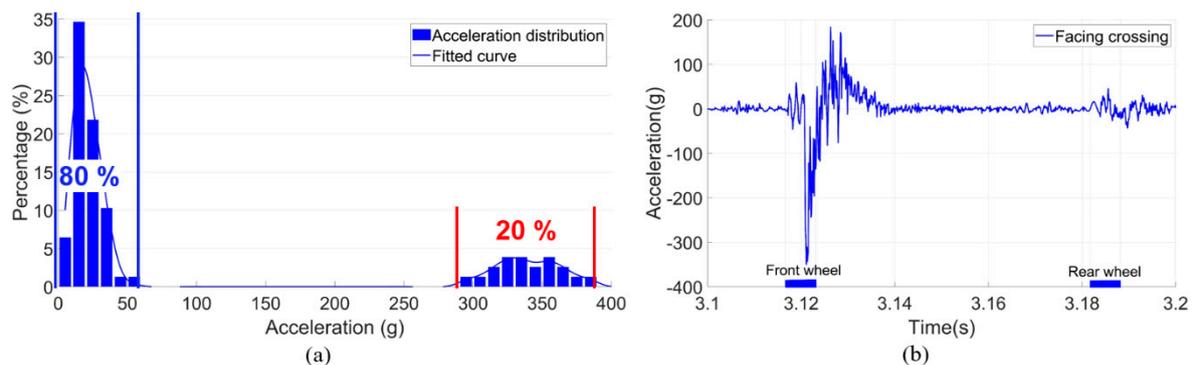
The sample size, in this case, was 78 passing wheels. It can be seen that the wheel impacts presented a bimodal distribution. Around 80% of the wheel impacts were below 50 g, while the remaining 20% of the wheel impacts were extremely high with a mean value of around 350 g. Such a polarized distribution of impacts indicates the highly unstable wheel-rail interaction in this crossing. It was demonstrated in a previous study [29] that for this type of railway crossing, the average level of the wheel impact is around 50 g, meaning that the 20% of high impacts of the monitored crossing are already more than seven times higher than the average impact level. It can be imagined that such high impacts will dramatically accelerate the degradation procedure of the crossing.

Figure 11. Vertical acceleration responses of the monitored crossings. (a) Distribution based on multiple train passages in one day. (b) Example of impacts due to one bogie.

An example of the impact acceleration response in the time-domain due to the first bogie of a VIRM train is shown in Figure 11b. It can be seen that for the two passing wheels from the same bogie, the impacts can be quite different. The impact due to the front wheel was up to 350 g, while the rear wheel activated vertical acceleration was only 20 g. It has to be noted that the high impacts were not always introduced by the front wheel, but appeared to have random occurrences. Such results further confirmed the instability of wheel-rail interaction at this crossing.

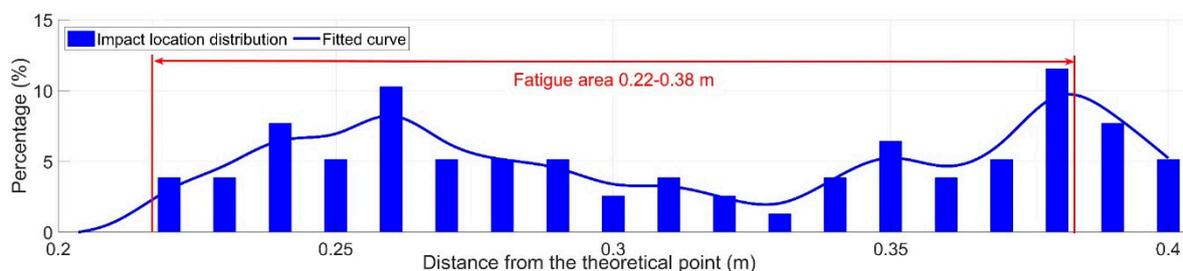
The measured fatigue area of the monitored crossing is presented in Figure 12. It can be seen that the wheel impacts were widely distributed at 0.22–0.38 m from the TP with the fatigue area size of 0.16 m. According to the previous study [28], the transition region (Figure 2) for this type of crossing is around 0.15–0.4 m. The fatigue area widely covered 64% of the transition region, which can be considered to be in line with the expectation of a new crossing profile. Such results further confirmed that the crossing rail was not worn or deformed.

Figure 12. Measured fatigue area of the monitored crossing.

It has to be noted that the fatigue area does not conform to the normal distribution (referring to the “Worn” stage demonstrated in Figure 5b). Combined with the results of the wheel impacts such a fatigue area further confirmed the instability of the wheel-rail contact in the monitored crossing.

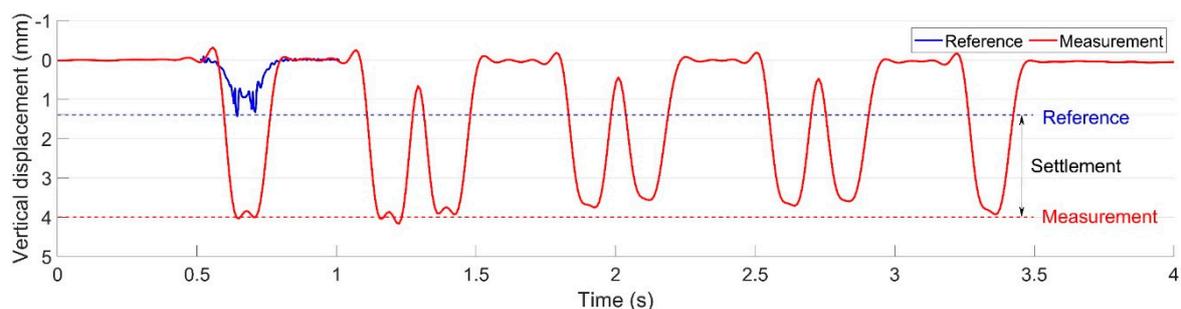
The measured vertical displacement of the crossing rail is presented in Figure 13. It can be seen that the vertical rail displacement was around 4 mm. The measured displacement result can be considered to have two main parts: the elastic deformation and the gap between the sleeper and ballast. Considering that the ballast settlement is the accumulated effect due to multiple wheel passages, the plastic deformation caused by each passing train can be neglected. Due to the high impacts in the crossing panel, the ballast is usually settled unevenly, which results in hanging sleepers. Using the validated MBS model, it was calculated that the rail displacement in the reference condition was 1.4 mm (Figure 13), which only consisted of the elastic deformation part. By comparing these two results, it could be calculated that the gap between the sleeper and ballast was 2.6 mm, which can be estimated as the settlement of ballast. It was observed that the rail displacement obtained from the MBS simulation was much higher than that in a normal track (less than 1 mm [27,31]), which indicates the vulnerability of the ballast in the railway crossings.

Figure 13. Ballast settlement in the monitored crossing.

In a previous study [27], it was found that track irregularities such as rail joints and turnout crossings can lead to the fast deterioration of the ballast, and the ballast settlement will in turn accelerate the degradation procedure of other related track components. In this study, the 2.6 mm ballast settlement was already higher than those in the previously monitored welded joints (≈ 1.5 mm) and movable crossings (≈ 2 mm), which revealed the seriously deteriorated ballast condition.

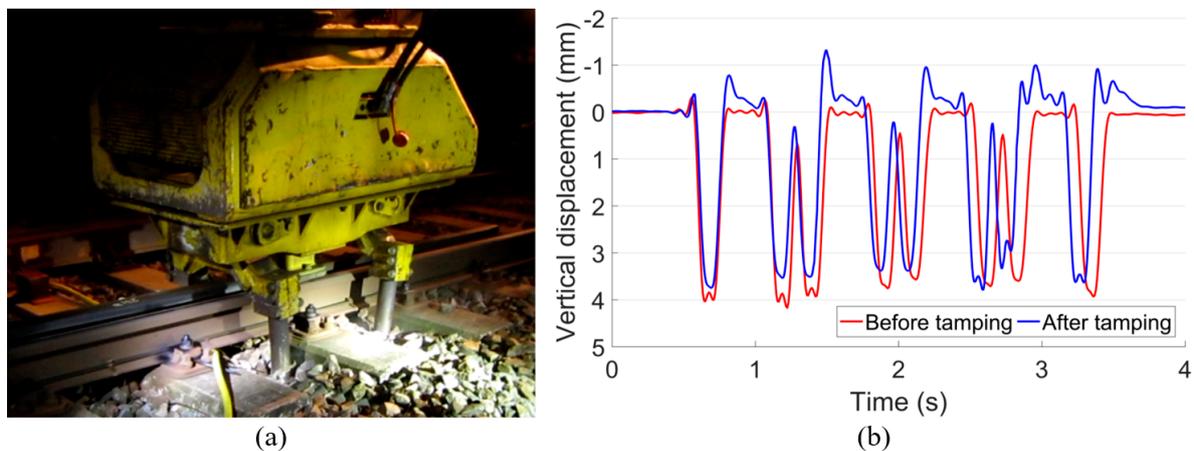
Therefore, ballast tamping actions were frequently performed in this location by the local contractor. However, due to the lack of maintenance facilities, the tamping actions were mainly performed using the squeezing machine (Figure 14a) without track geometry correction. It can be imagined that the settled ballast cannot be fully recovered with such tamping action. As shown in Figure 14b, after tamping, the rail displacement was not dramatically reduced.

Figure 14. (a) Squeezing machine used for ballast tamping in the monitored crossing. (b) Measured rail displacement before and after ballast tamping.

It can be concluded that such frequently implemented ballast tamping had no improvement in either the ballast condition or the dynamic performance of the monitored crossing. Without figuring out the root causes for the fast crossing degradation, such ineffective ballast tamping should be suspended.

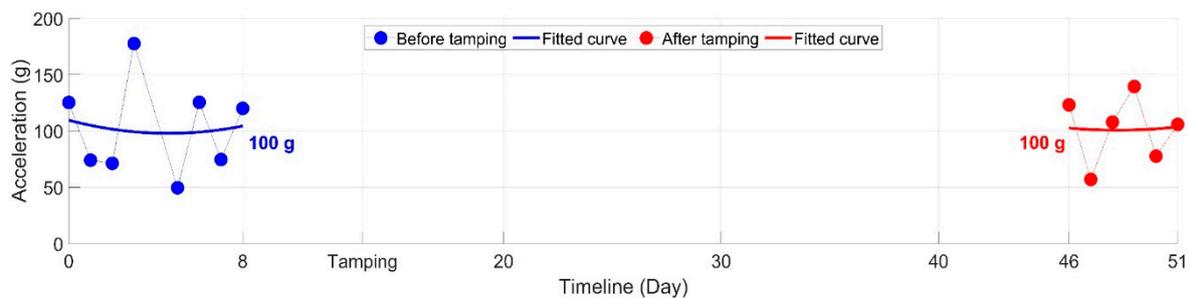
The development of the wheel-rail impacts before and after tamping are presented in Figure 15. In this figure, each point represents the mean value of the impact accelerations based on multiple wheel passages in one monitoring day. It was discussed in a previous study [28] that the fluctuation of the wheel impacts was highly affected by external disturbances such as the weather. Still, it can be seen that the regression values before and after tamping were both around 100 g.

Figure 15. Development of the wheel-rail impacts before and after ballast tamping.

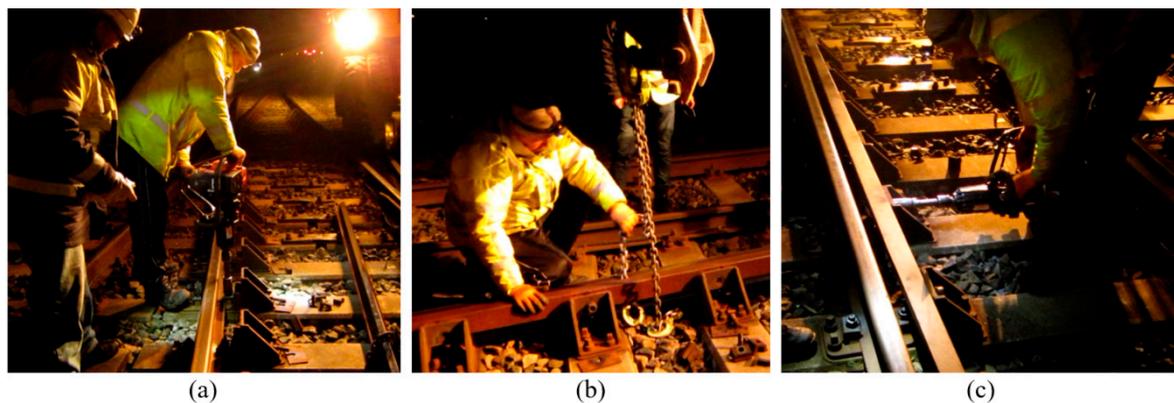
During the monitoring period, the fastening system was found to be degraded with some broken bolts. Such degradation affected the lateral stability of the track. Therefore, the fastening system, mainly the bolts in the guard rails and the clips, was renovated, as shown in Figure 16.

Figure 16. Fastening system renovation. (a) Remove the broken bolts. (b) Reposition the guard rail. (c) Install new bolts.

- Fastening system renovation helped improved the crossing performance by providing better lateral support in the track but was not targeted to the fundamental problem. Therefore, such damage repair action is useful, but not enough for an improvement in the crossing performance.

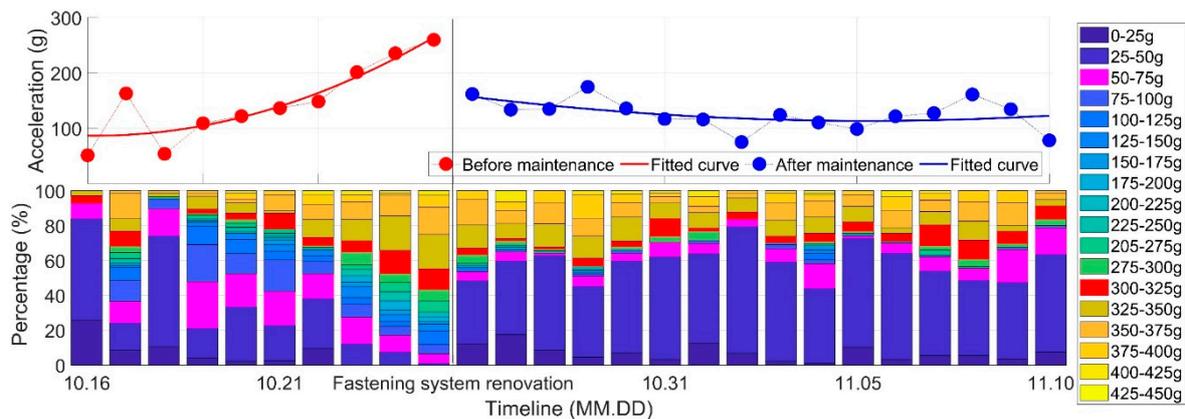
Figure 17. Effect of fastening system renovation on the dynamic performance of the crossing.

It can be seen from Figure 17 that before the renovation, the wheel-rail impact showed a clear increasing trend with the impact values widely distributed from 0 to 450 g. Such a degradation trend indicates that maintenance is urgently required due to the defects of the fastening system. After the renovation, the wheel-rail impacts were dramatically reduced in terms of the mean value and separated into two distribution modes, which is similar to those shown in Figure 11a. Such improvement is due to the enhancement in the track integrity. However, the wheel-rail impacts above 300 g were still a large proportion after maintenance, which means that the sources for such high wheel-rail impacts were not found.

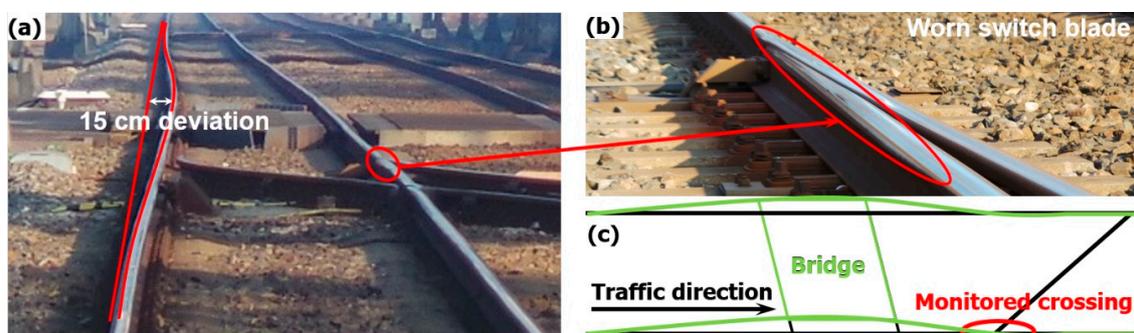
In the field inspection, it was found that the bridge was not well aligned in the track, but deviated around 15 cm, as shown in Figure 18a. Such deviation introduced a curve into the track, which was likely to be out of design since no elevation was set up in the outer rail. It can be imagined that the passing trains could not pass the track along the central line but tended to have wheel flange contact with the outer rail, which eventually leads to the severe wear in the switch blade (Figure 18b).

Figure 18. Track deviation in front of the crossing. (a) Inspected curve introduced by the bridge. (b) Worn switch rail. (c) Demonstration of the bridge deviation.

It has to be noted that although the curve in front of the crossing did not directly activate train hunting, the activated lateral shift of the passing wheels resulted in the wear in the switch blade (Figure 18b) and contributed to the track gauge deviation. Therefore, such a curve can be considered as the root cause of the fast degradation of the monitored crossing. To improve the performance of the crossing, this curve has to be first eliminated.

- The fast crossing degradation was directly caused by the extremely high wheel-rail impacts, and the root cause for such high impacts was the hunting of the passing trains that were activated by the track lateral misalignment in front of the crossing. When the lateral deviation of the passing wheel exceeds a certain extent (e.g., 2.3 mm), the wheel-rail contact situation will change and the wheel impacts will be dramatically increased. To improve the current situation, such track misalignment needs to be eliminated;

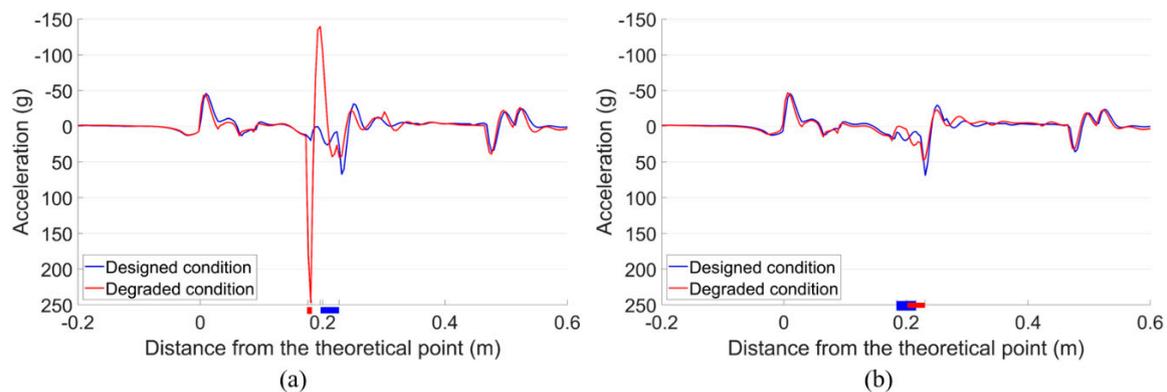
Figure 20. Vertical impact acceleration responses and transition regions. (a) Front wheel. (b) Rear wheel.

It can be seen from Figure 20a that with the lateral irregularity taken into account, the impact of the front wheel was dramatically increased to 247 g, which was 4 times higher than the reference value (around 62 g) in the designed condition. While for the rear wheel from the same bogie, the impact was 48 g, which was even lower than the reference value. Despite the slight difference in the absolute values, the simulation results were consistent with the measurement results (Figure 11). Meanwhile, the transition region of the front wheel was 0.176–0.182 m from the TP with a size of only 0.006 m. Compared with the reference level (0.196–0.217 m with a size of 0.031 m, [29]), it was much narrower and closer to the TP, indicating earlier wheel impact and much sharper wheel load transition in the crossing. For the rear wheel, although the transition region was located farther from the TP, the size was almost the same as the reference value.

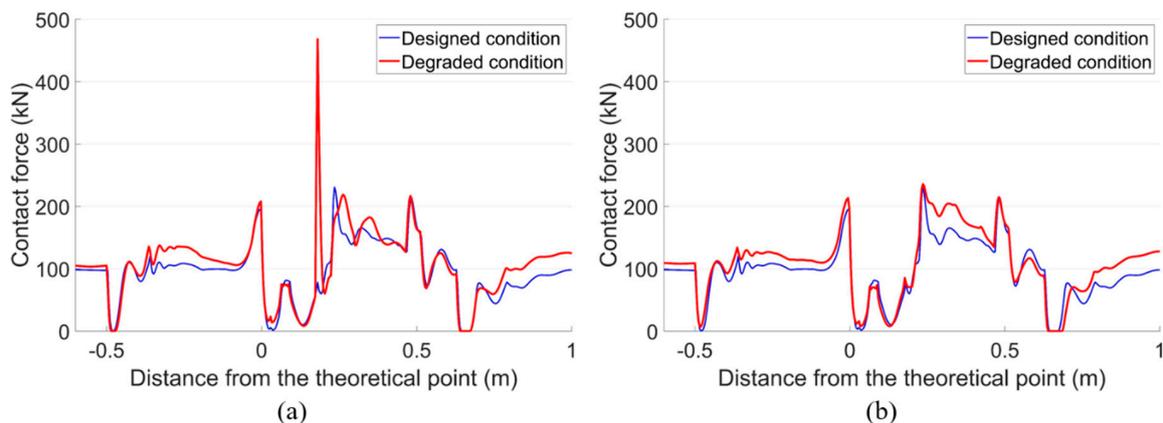
For the wheel-rail contact forces, the tendency was similar to the acceleration responses, as shown in Figure 21. With the degraded track condition, the maximum contact force of the front wheel in the degraded condition was 468 kN, which was twice as high as that in the designed condition (235 kN).

Figure 21. Vertical wheel-rail contact responses of the facing crossing. (a) Front wheel. (b) Rear wheel.

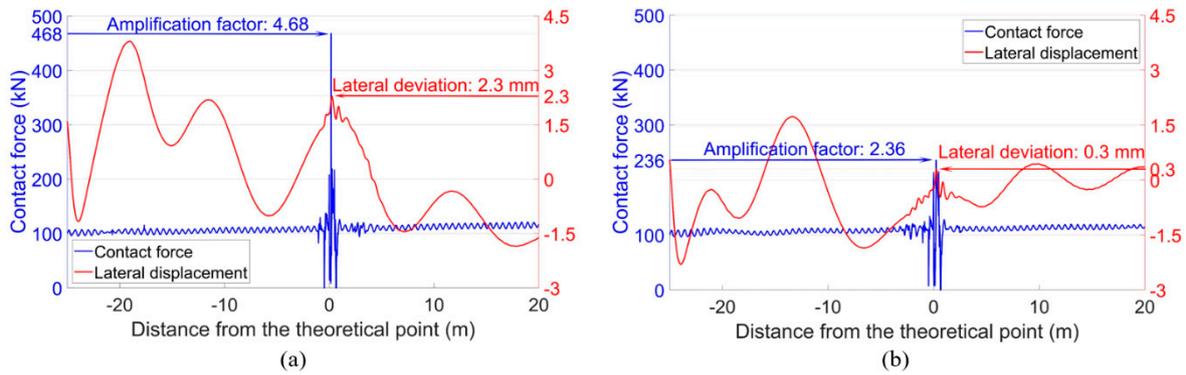
In the degraded condition with track lateral irregularities, the lateral displacements of the wheels were dramatically changed, as shown in Figure 23. It can be seen that both the front wheel and the rear wheel showed activated hunting oscillation before and after passing through the crossing, but the trajectories were quite different. For the front wheel, the lateral movement was more intense and ran toward the crossing nose rail near the TP. The maximum lateral displacement corresponding to the position with the highest contact force was 2.3 mm, which means that compared with that in the designed condition, the wheel flange was around 1.6 mm closer to the nose rail. Comparatively speaking, such displacement of the rear wheel was only 0.3 mm. Such results indicate that the wheel-rail impact was profoundly affected by the movement of the wheel. When the wheel approaches closer to the crossing nose, the wheel-rail impact is likely to be increased. It can be concluded that the train hunting activated by the lateral track misalignment in front of the crossing is the main cause of the extremely high wheel-rail impacts.

The train hunting effect also explains the unstable wheel-rail impacts. For the rear wheel, the lateral movement was affected not only by the track misalignment but also by the front wheel from the same bogie. As a result, these two wheels led to quite different wheel trajectories. It can be imagined that in the real-life situation, there are much more factors that may affect the hunting motion of each passing wheelset such as the initial position of the wheel when entering the misaligned track section, the mutual interaction between the adjacent wheelsets, the lateral resistance of the track, and even the weather condition [28], etc. The combined effect of all these factors ultimately resulted in the polarized distribution of the impact acceleration responses (Figure 11a).

Figure 23. Wheel-rail contact forces and wheel lateral displacements. (a) Front wheel. (b) Rear wheel.

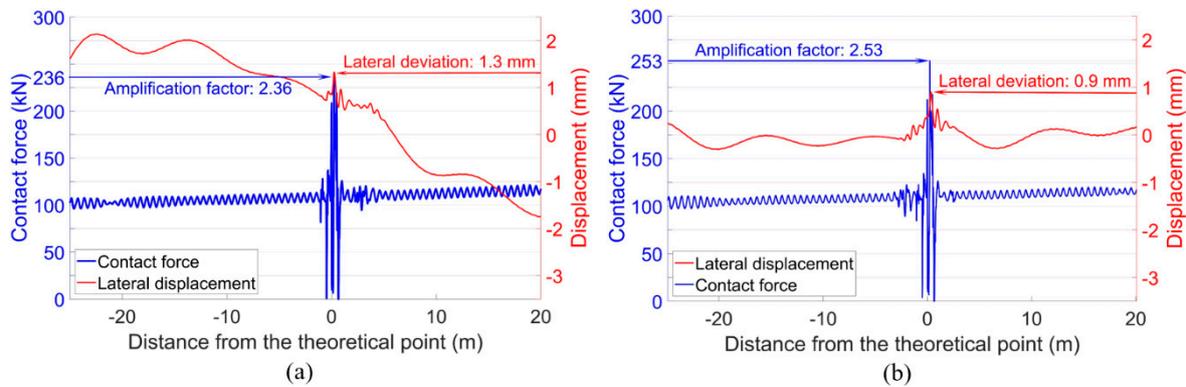
Considering the bridge-introduced lateral curve, the wheel-rail contact forces and the lateral wheel displacements were calculated, as presented in Figure 24. It can be seen that in the front wheel, the bridge-introduced curve mainly resulted in the lateral shift of the wheel trajectory due to the centripetal force. Such a shift was only 0.5 mm near the crossing nose when compared with the designed condition, and the effect on the wheel impact was limited. For the rear wheel, the combined effect of the curve and the motion of the front wheel resulted in the lateral deviation of 0.9 mm, which was quite close to that in the designed condition and had no significant influence on the wheel-rail impact.

Figure 24. Wheel-rail contact forces and lateral wheel displacements. (a) Front wheel. (b) Rear wheel.
