CHAPTER 27

STUDY OF EROSION ALONG HOMER SPIT AND VICINITY, KACHEMAK BAY, ALASKA

By Gail J. Gronewald 1/ and Walter W. Duncan 2/

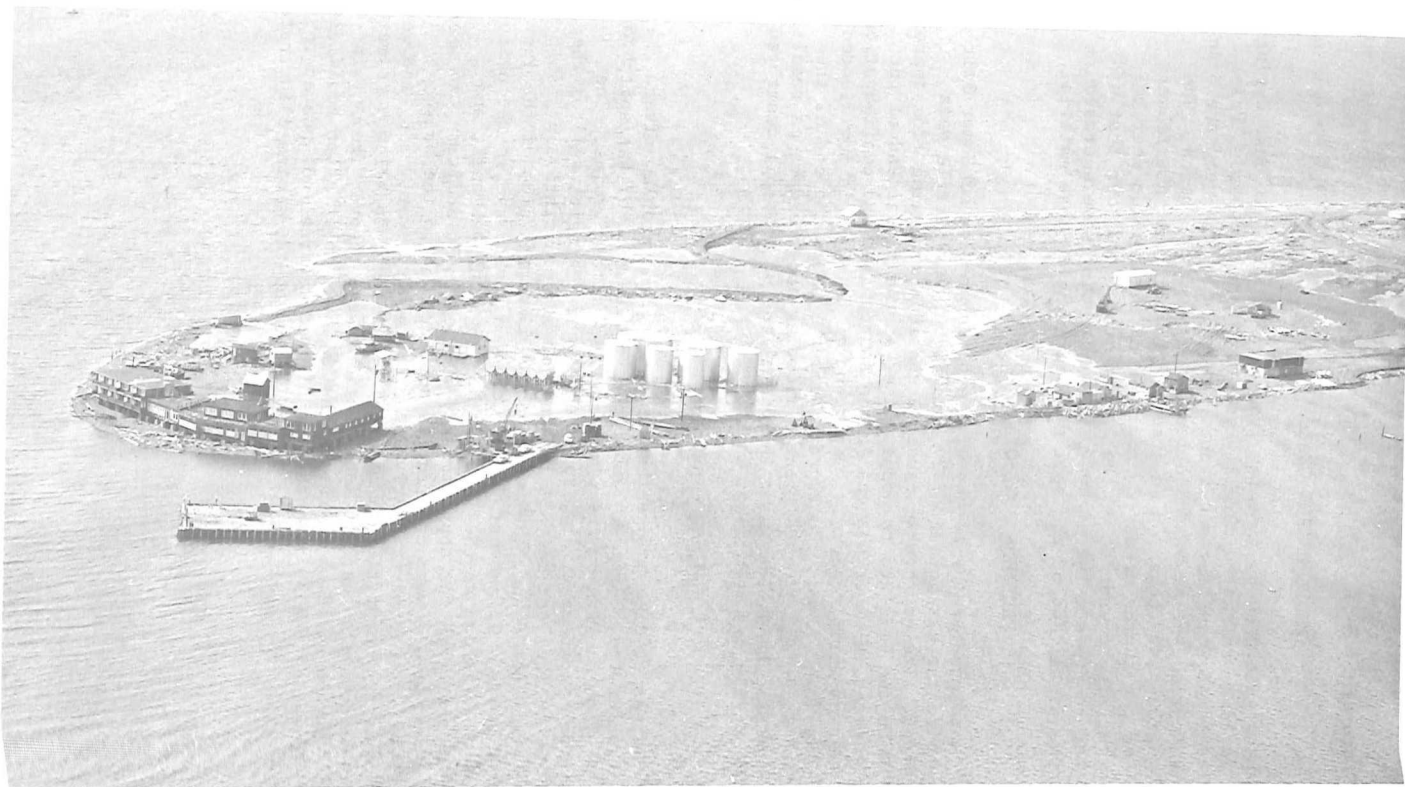
Photo No. 1. This photo of the outer end of Homer Spit was taken in April 1964 about one month after the 27 March 1964 earthquake. Occasionally the high tide is 2 to 3 feet higher than that shown in the photograph. Emergency repair had just been completed to the deep draft dock and the Lands End Hotel raised on cribbing.

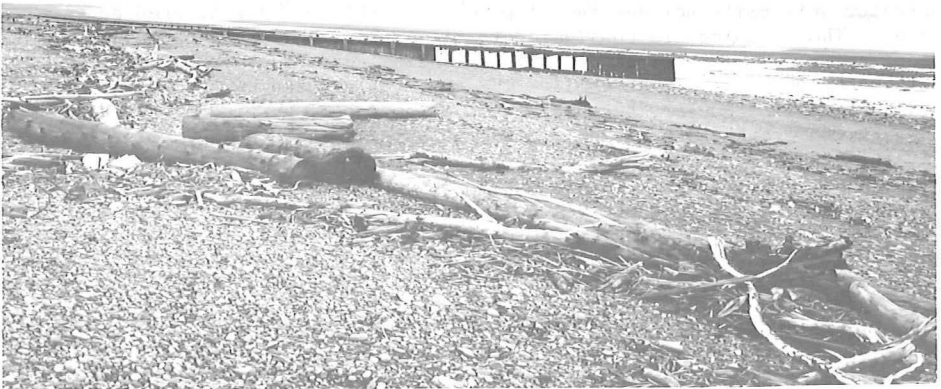
Photo No. 2 - June 1965. Shows the timber groins as opened up by cutting with a chain saw.

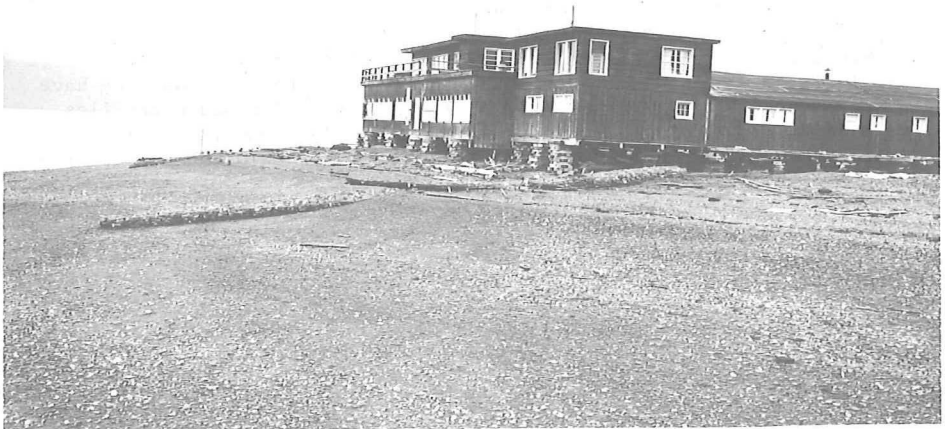
Photo No. 3 - June 1965. Shows the Lands End Hotel and gabions placed for erosion protection.

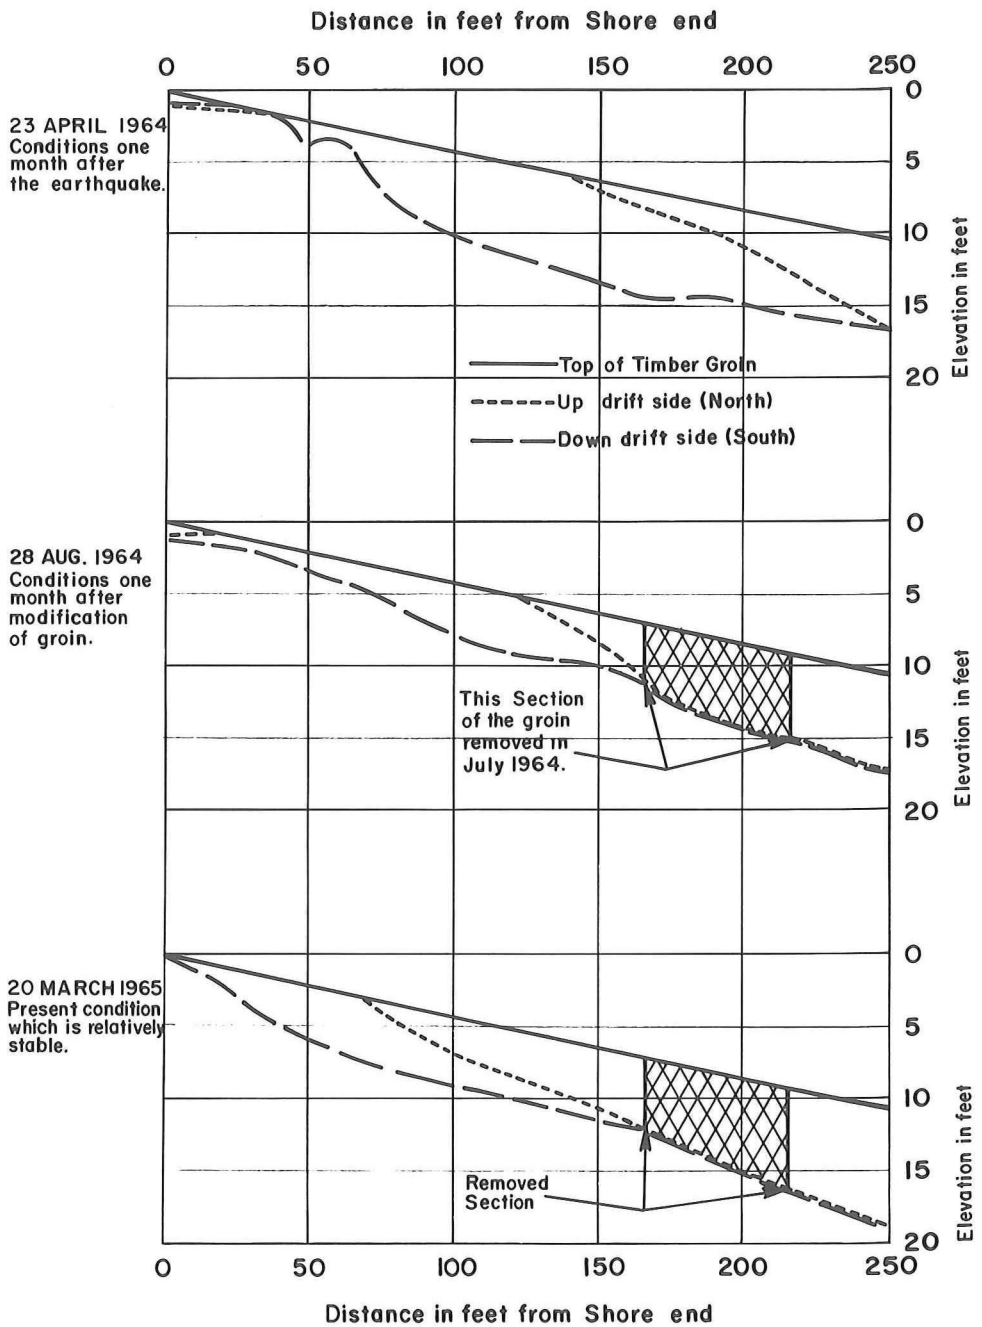
FIGURE 2

the changes in the fill configuration both before and after the modification was made. Figure 2 shows the changes that occurred on the third groin. It is interesting to note the profile of the groin on the weather side after modification more closely coincides with the natural beach slope of the spit than did the fill before modification. While the modification was accompanied by a recession of the fill at the proximal end of the groin, there was a general increase in fill along the lee side as well as a greater uniformity between the slope of the fill on the weathered and lee side. The examples are considered to illustrate the result of an overly long groin. The principle disadvantage being that of promoting of erosion along the lee side of the groin. The area between the new groins at first began to fill; however, because of a combination of hurried construction, design, and severe storms the 6th groin failed. The one cause of failure is believed to have been the bulkhead and groin were too high causing an undermining of the wall. Groin Number 5 and the bulkhead wall between it and groin Number 4 seem to be functioning satisfactorily, although some erosion is beginning to occur at the updrift junction of the groin and the bulkhead wall. This is being closely watched to determine if modifications may be desirable. In addition to erosion in the area of the groins, subsidence has caused the beach, in general along the spit, to recede. The recession is related to the higher stand of the sea upon the beach and, as such, the beach is adjusting to the new water level. Figure 3 ^{3/} illustrates the processes of changes occurring in the beach configuration. Material secured from the beach face has, and is still, being carried onto the spit where it has formed a new frontal berm. In areas, as shown by Photographs 4 and 5, the berm has migrated onto and temporarily blocked the highway necessitating removal of the material from nearly one-half mile of highway by the State Highway Department. In order to prevent flooding of the Land's End Hotel it was jacked up about 8 feet and placed on cribbing. Photograph Number 3 shows the hotel on cribbing and the gabions which have been placed around and under it to prevent further undermining. At the present time the gabions, which are wire mesh rock-filled baskets, seem to be doing an effective job.

THIRD GROIN FROM THE BASE OF THE SPIT

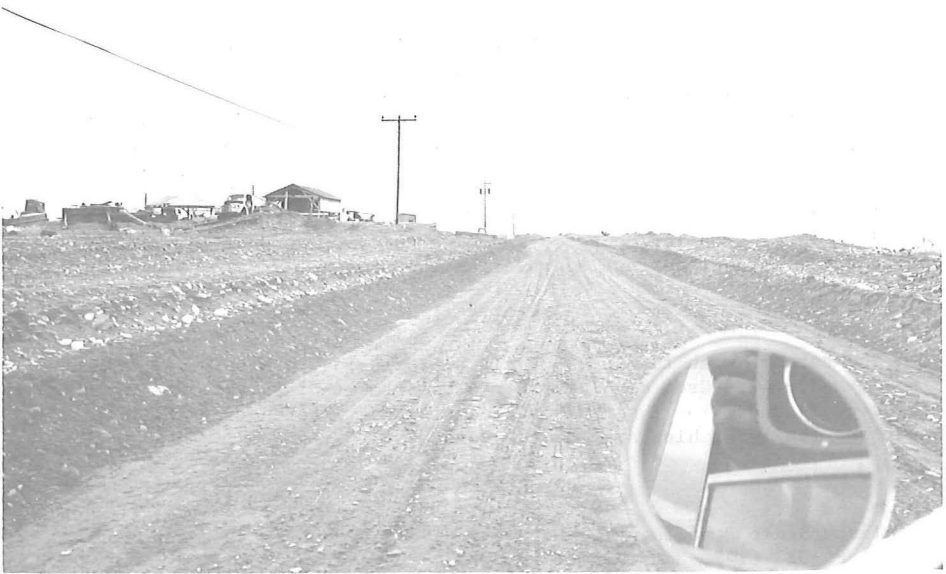
Photo No. 4 - June 1965. Shows the highway on Spit where combinations of high tides and waves have deposited material in a new berm. The Highway Department removes the material by either plowing to the side or banking it to another location.

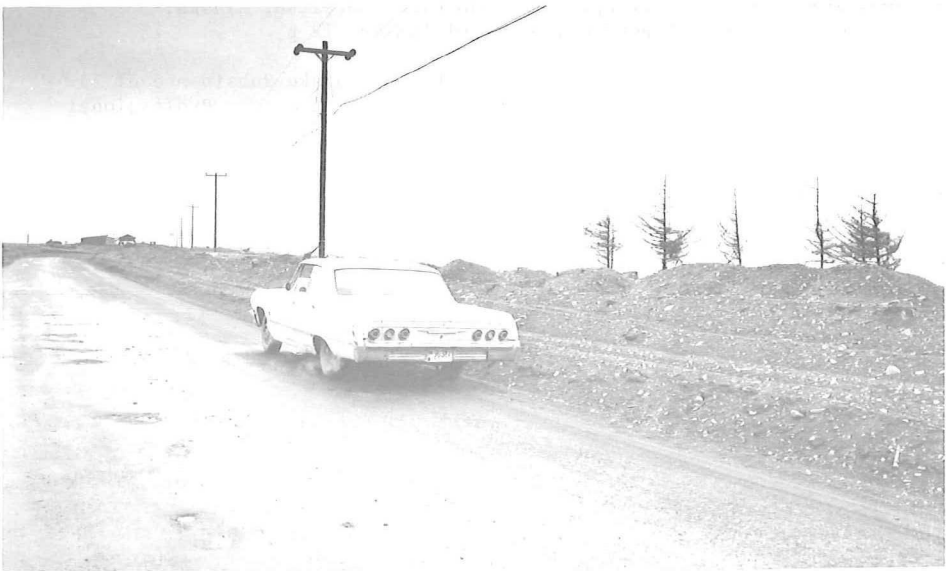
Photo No. 5 - This was taken in June 1965 and shows the new berm being built up 500 feet down drift from the groin area. The spruce trees in the picture have been killed by the salt water.
