Rolling Contact Fatigue in relation to rail grinding

Abstract Spalling defects of a periodic nature are sometimes observed on heat-treated pearlitic steel rails. Defect properties suggest that there may be a relationship between maintenance grinding on a regular basis and the initiation of rolling contact fatigue (RCF). In this work, the effects of maintenance grinding are investigated experimentally for both standard and heat-treated pearlitic rails. Results show essentially different behaviour for both steels. On standard grades, friction-induced martensite (FIM) generated during grinding delaminates when in service. However, grinding induces severe top-layer deformation which coincides with that induced by train operation, thus yielding ‘pre-fatigue’ of the rail. On heat-treated grades, portions of FIM accumulated at groove edges during grinding are pressed into the deeper pearlitic matrix in combination with severe plastic deformation under tangential wheel-rail contact stresses. That process results in severe and extensive crack initiation. According to quantitative test results reported in the literature, this initial condition yields a reduction of the normal RCF life by ro

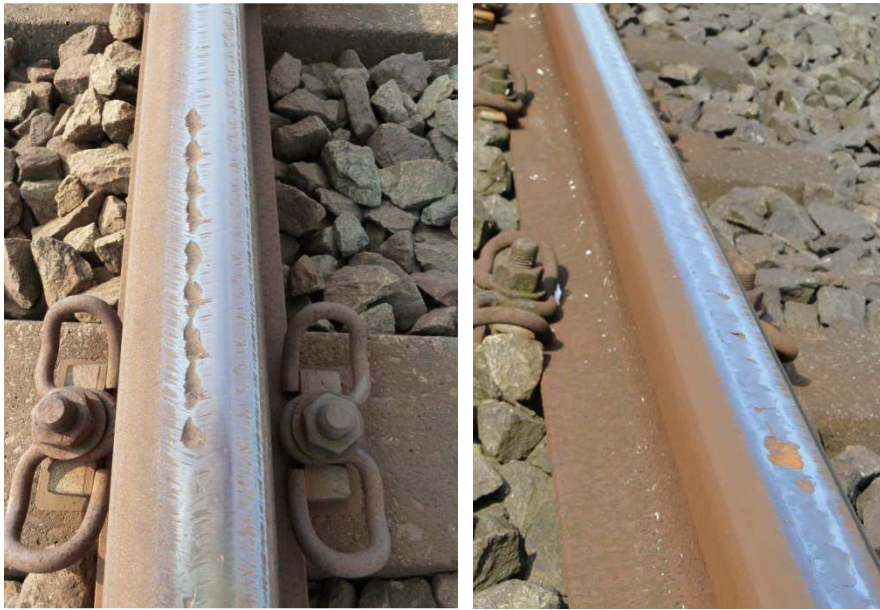
by the fact that the cracks associated with the defects propagate systematically in the subsurface and do not develop deep into the railhead, leading to transverse defects. Examples are shown in Fig. 1.

Fig. 1 Periodic spalling defects on heat-treated rail grade R370crHT/MHH

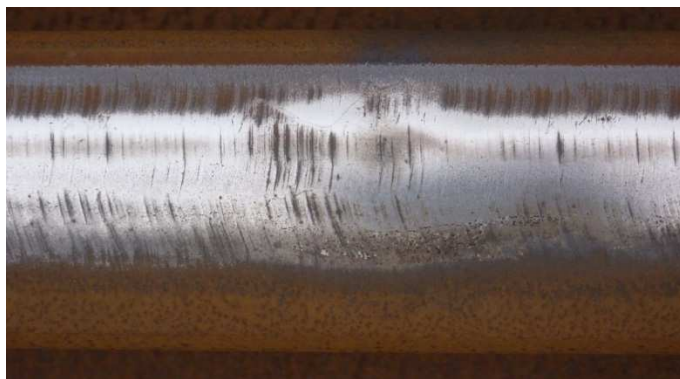
Fig. 2 A squat ground to an insufficient depth

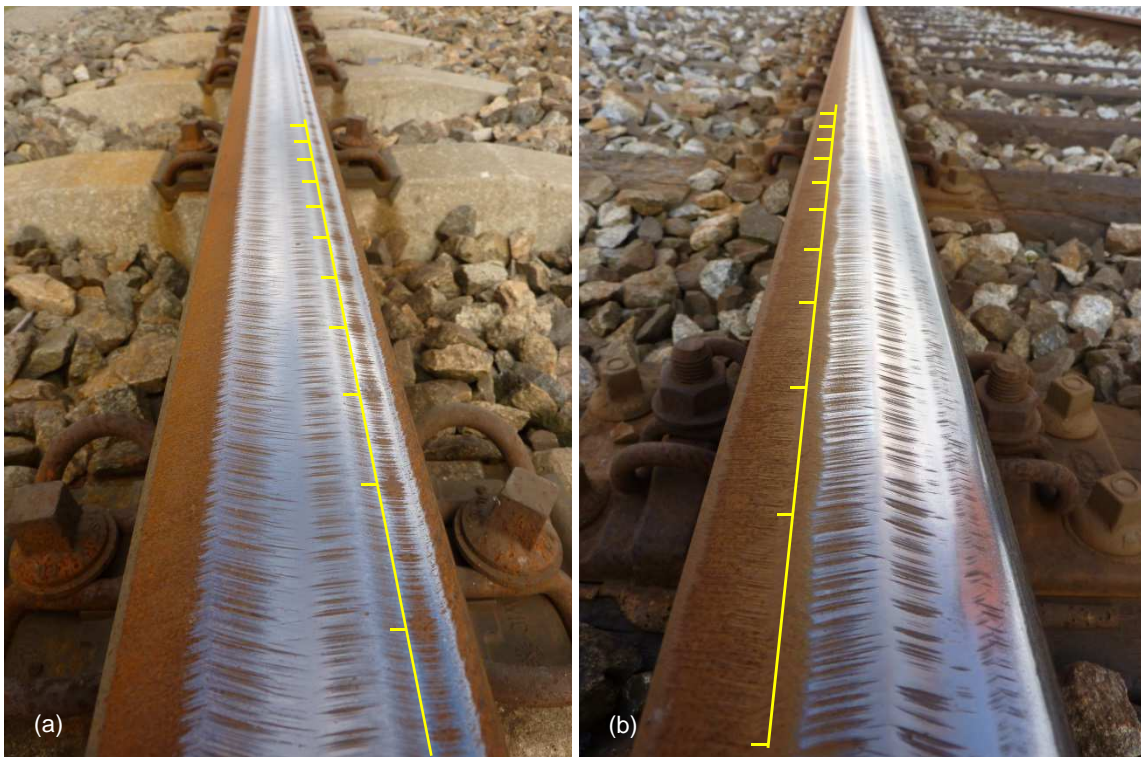
Fig. 3 shows images of rails after cyclic (rotational) grinding with a grinding train and a relatively short period of short train loading afterwards. In both cases the grinding facets have worn out; in the case at the left a repetitive groove pattern is visible, whereas in the case at the right a clear short-pitch, wavy pattern in the running band has developed. The periodicity typically ranges from 34 to 38 mm.

Fig. 3 Rail after grinding and a relatively small born tonnage: longitudinal grinding facets have disappeared – transverse grooves are still present; (a) periodicity and (b) waviness of the running band.

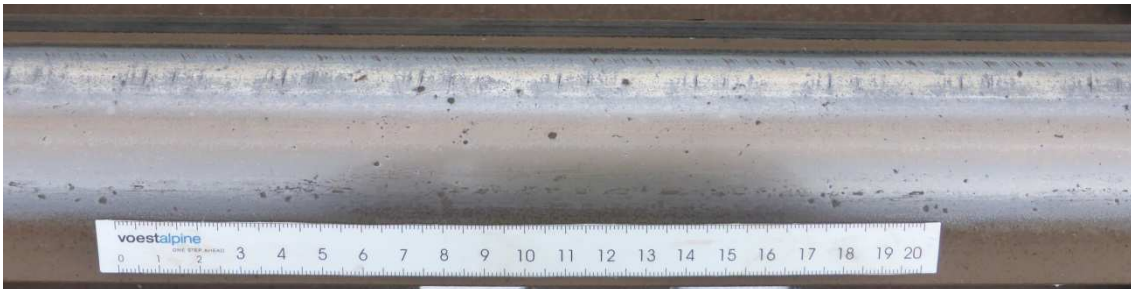
Fig. 4 Periodicity (about 34 mm) in both WEL and grinding marks at the gauge corner of a R260Mn rail (upper leg of a curve)

Fig. 4 shows a situation in the high leg of a curve with contact concentrating on the gauge corner, where a non-uniform white etching layer (WEL) pattern has developed at the surface with a periodicity (34 mm) coinciding with that of the grinding pattern. Fig. 5 shows examples of standard rails (grade R260Mn) where a non-uniform WEL pattern is visible at the surface, in this case with a 36 mm periodicity and WEL-zones in the form of ‘eggs’ embedded in the running band. Fig. 6 shows the longitudinal surface hardness pattern of such a rail, along with some microstructural features: the hardness clearly fluctuates periodically with extreme values at the centre of the egg-shaped WEL zones and minima, with the original hardness, in between. Fig. 7 shows again a well-developed periodic (36.5 mm) WEL formation in the running band, in this case already associated with short-pitch corrugation, though only with an amplitude in the order of 10 μm . Fig. 8 shows the periodicity in the spalling defect (with individual defects resembling squats), as discussed in the introduction (Fig. 1), with again the typical distance of 35 mm. Finally, Fig. 9 shows a developing long spalling defect where the relationship to the grinding effects is particularly evident: cracks have initiated along the periodic zone with the deepest grinding marks and grown together; surface etching clearly shows that the grinding marks are bordered by white etching material. Also in the case of unbranched squats cases occur where the same periodicity can be observed; an example is given in ref. [11] (Fig. 17 from this work; periodicity 34 mm); Fig. 9 shows another example from the high leg of a 1500 m radius curve.

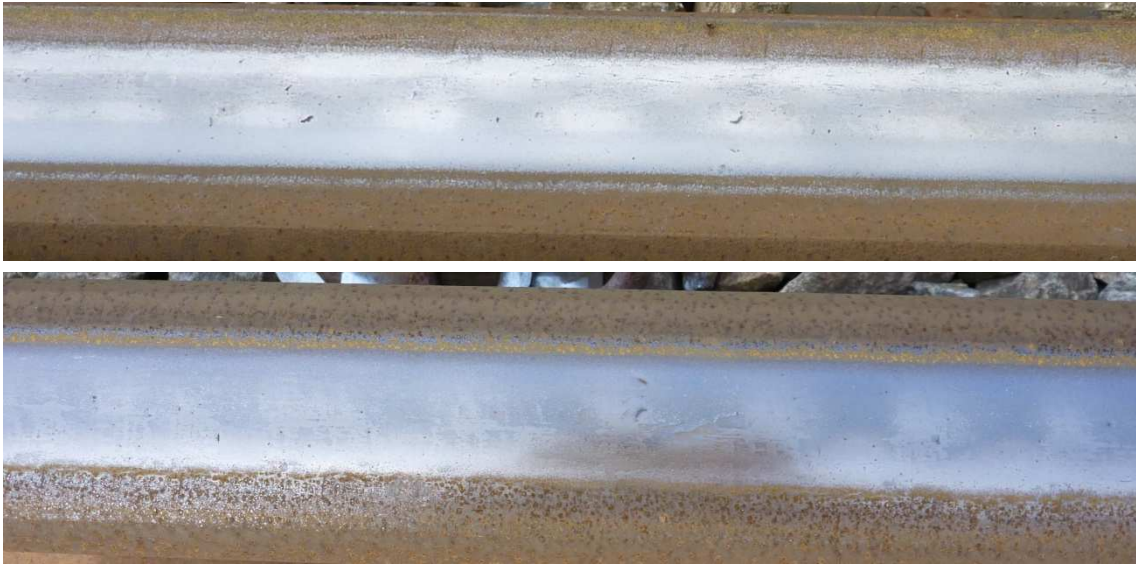
Fig. 5 Periodicity (35-36 mm; half the rail width of 70 mm) in WEL ('egg'-shaped) in the running band of R260Mn rail

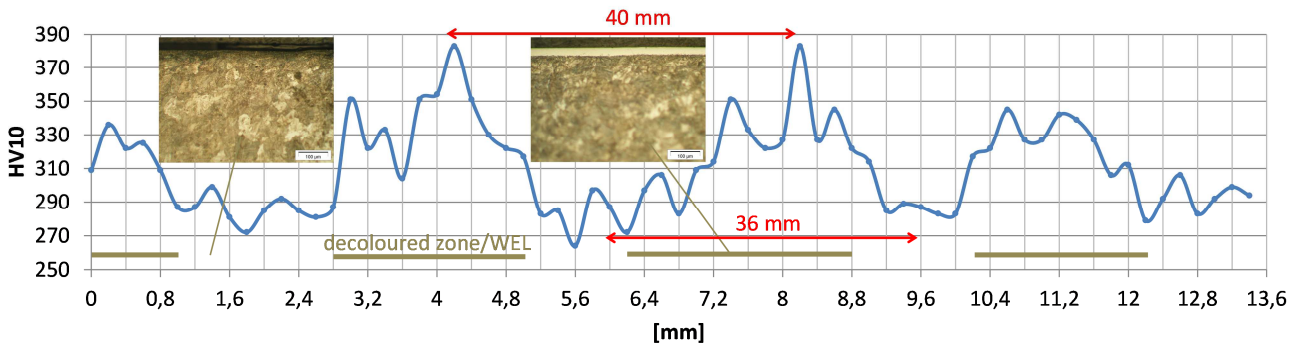
Fig. 6 Longitudinal hardness profile along a R260Mn grade rail with periodicity in material properties/WEL (thickness roughly 30 μ m) due to contact stress periodicity

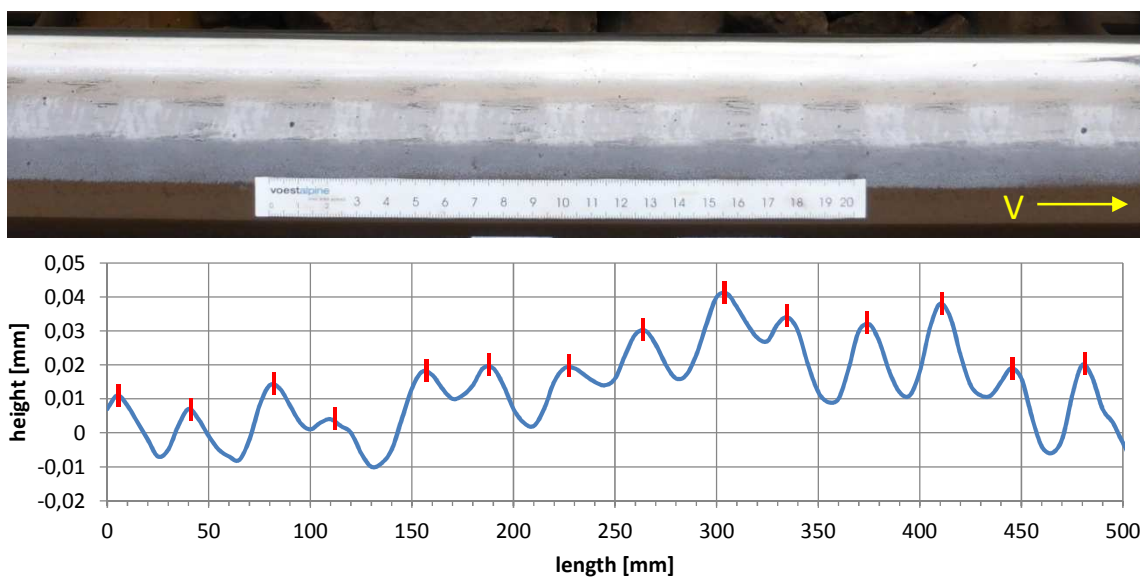
Fig. 7 Periodicity (36,5 mm average) in both WEL (top) and the height of associated short-pitch corrugation (bottom) in the running band of R260Mn rail

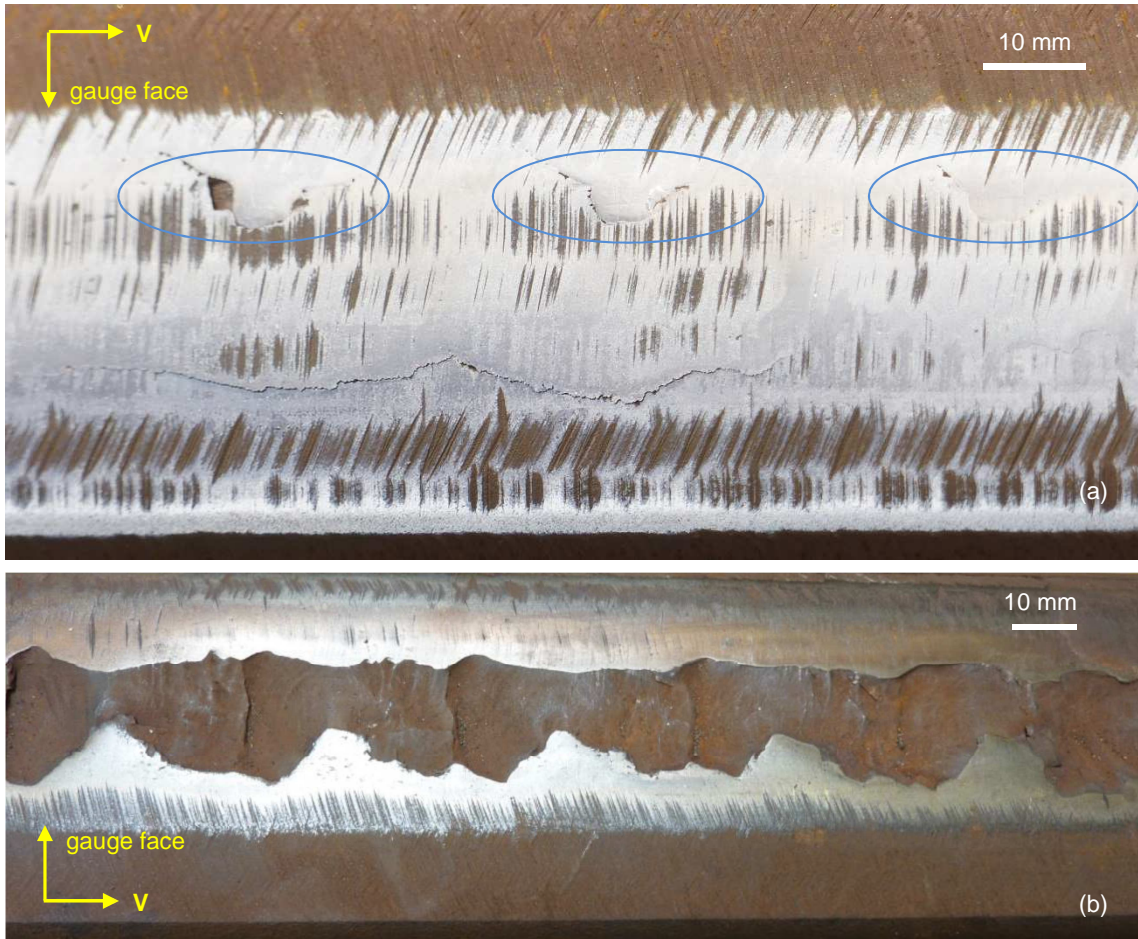
Fig. 8 Periodic (about 35 mm) spalling defects (as in Fig. 1), before (a) and after (b) spalling off, in the running band of two R370crHT/MHH rails

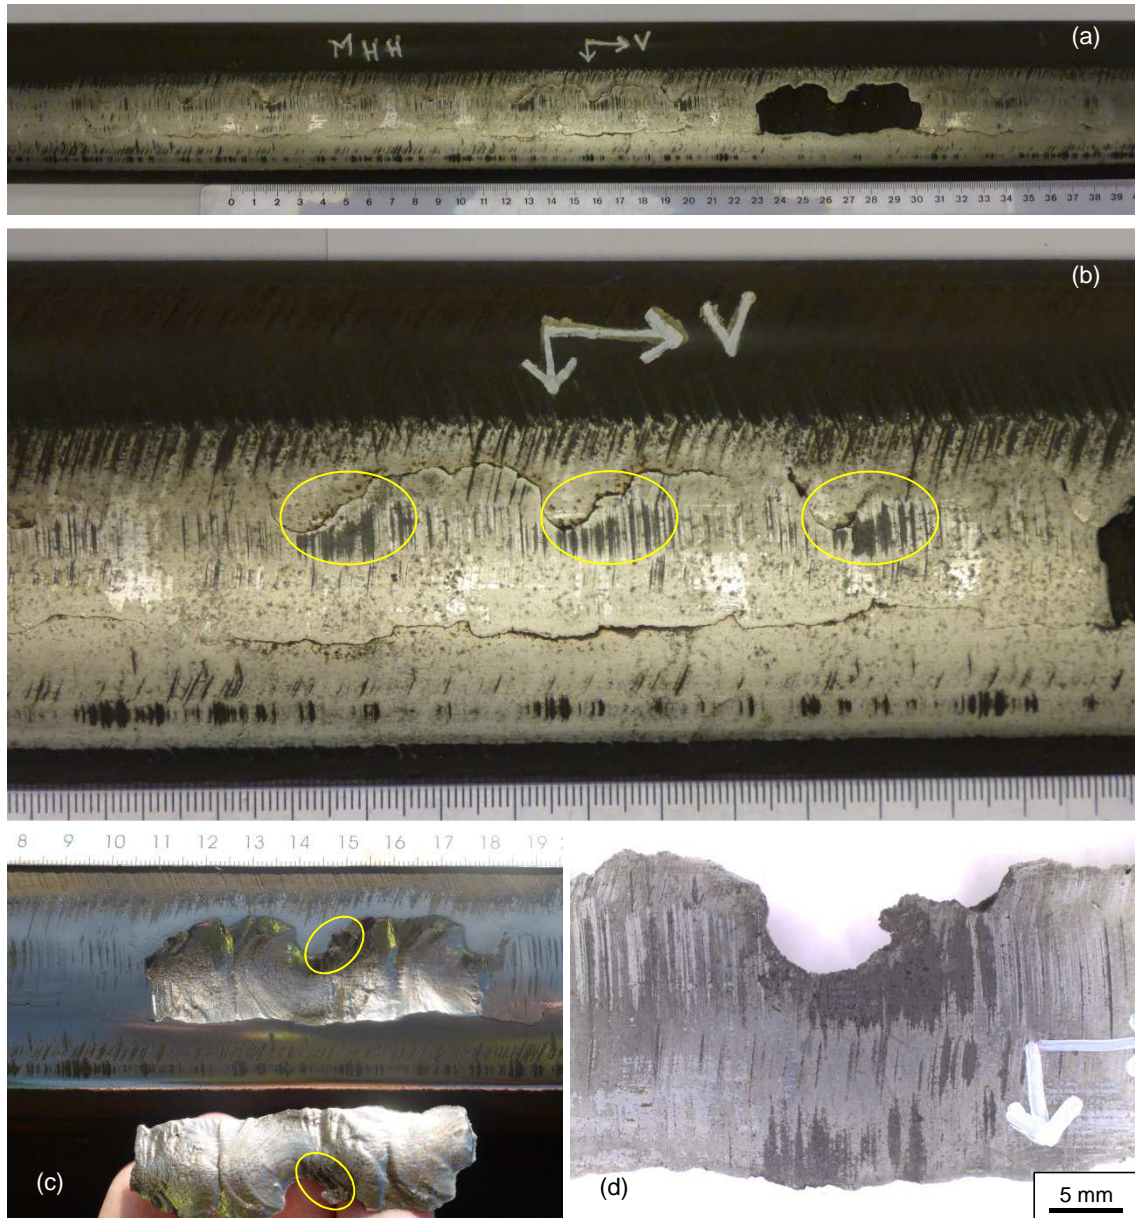
Fig. 9 Periodic spalling defect on ground R370crHT/MHH rail (a): crack initiations along the periodic zones with deepest grinding marks (b, c) and FIM visible on the surface (etched with 5 percent Nital) of the spalled part along the grinding marks (d).

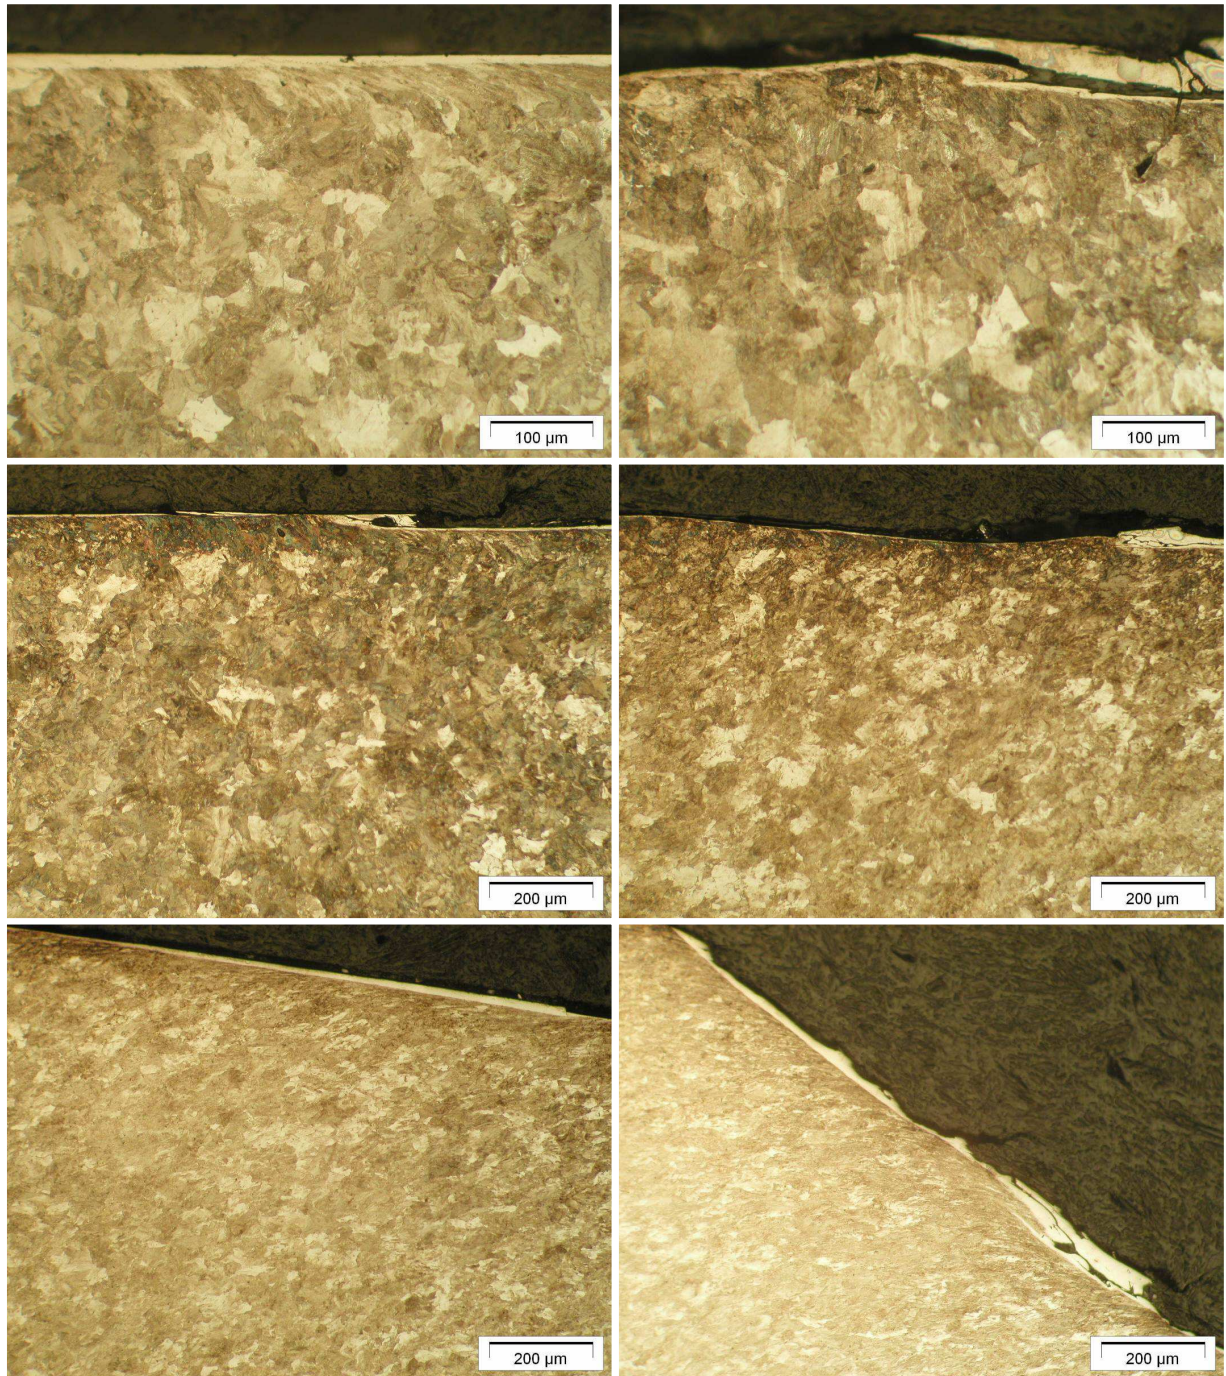
Fig. 13 shows different surface positions of a transverse cross-section of standard carbon rail (R260Mn) immediately after grinding. Observations of this cross-section show clearly the transitions between grinding facets, further the presence of a phase-transformed white etching FIM layer, deposits of which typically accumulate at the borders of the grinding facets, and finally a plastic deformation of the top layer which is strongly facet-dependent, and therefore non-uniform over the railhead. This deformation is however directed towards the inside of the rail on the part of the profile bordering the gauge corner. Longitudinal cross-sections (Fig. 14) show grinding grooves,

Fig. 13 Surface (transverse cross-section) of standard pearlitic rail (R260Mn) *immediately* after grinding: FIM and strongly facet-dependent plasticity. Images are taken from the field to the gauge side (at the right).

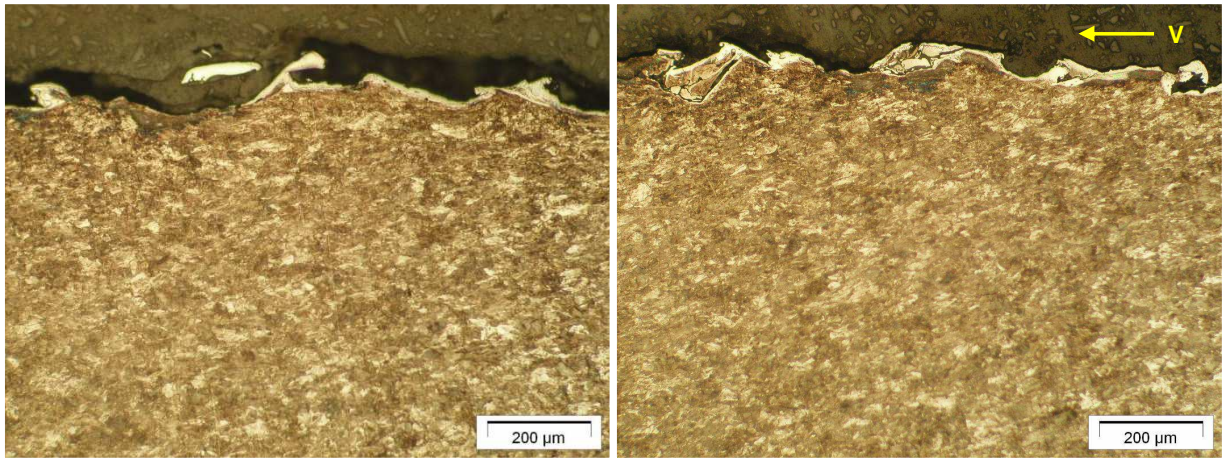
non-uniform loose portions of FIM, and the absence of severe longitudinal plastic deformation texture along the rail surface.

Fig. 14 Surface (longitudinal cross-section) of standard pearlitic rail (R260Mn) *immediately* after grinding: FIM and negligible plasticity. The train running direction is to the left.

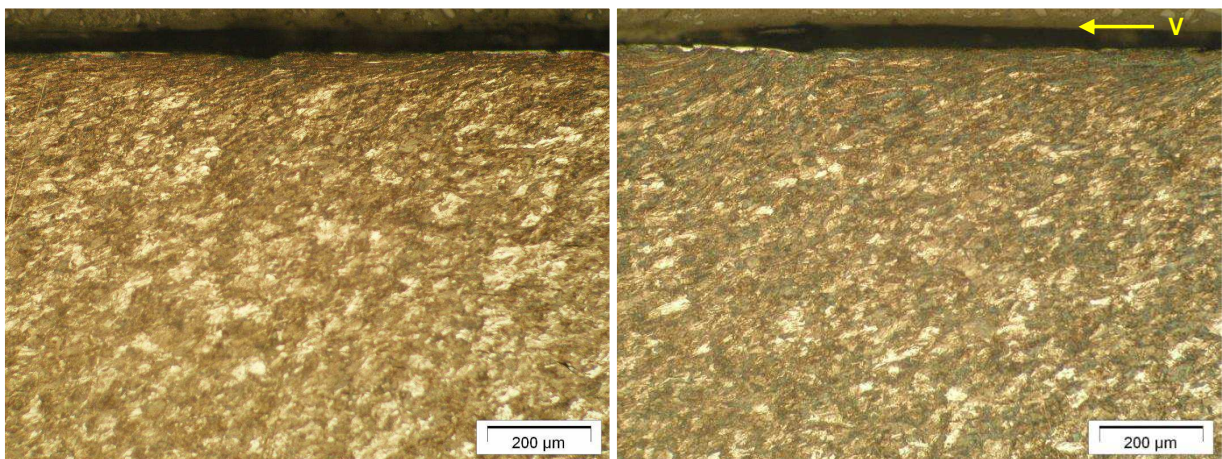
Fig. 15 shows the longitudinal rail surface after rail grinding and a few days of train operation consecutively: the FIM generated by grinding is largely removed; individual grooves have disappeared, and severe plastic strain of the pearlite matrix under the surface has appeared as a result of tangential forces by train operation. In transverse direction, also transitions between grinding facets have disappeared.

Fig. 15 Surface (longitudinal cross-section) of standard pearlitic rail (R260Mn) *after grinding and a few days of train operation consecutively*: FIM is largely removed; severe train-induced plastic strain has appeared.

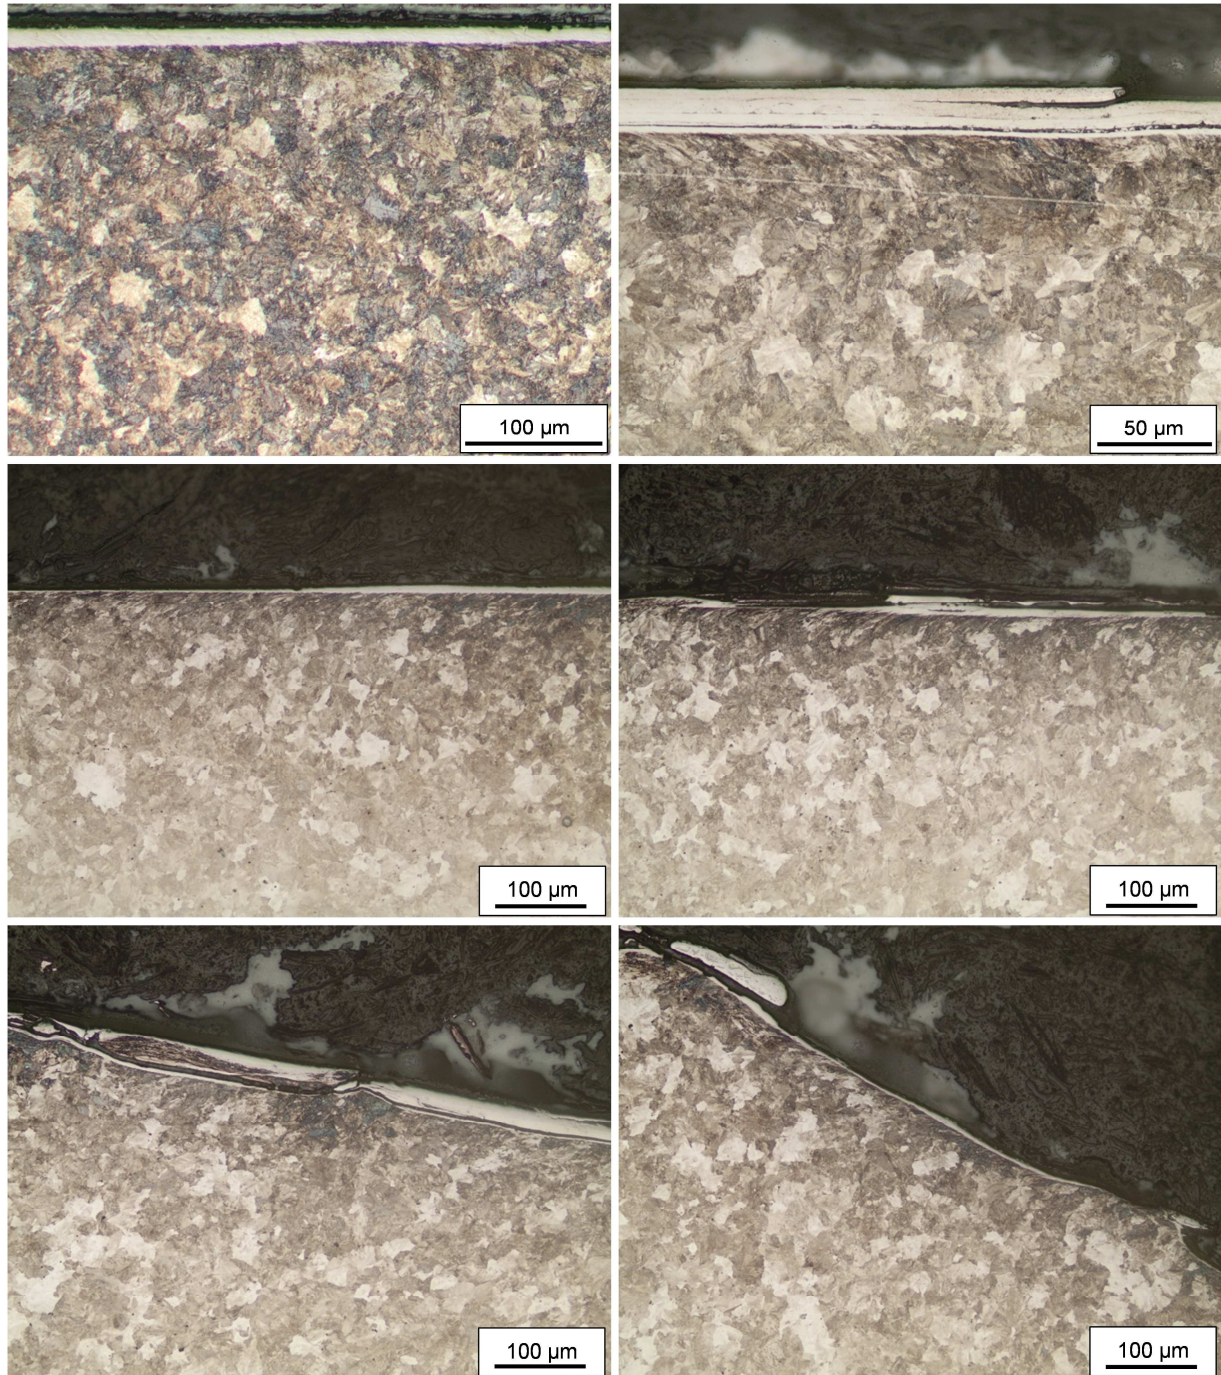
Results on heat-treated premium rails (R370crHT/MHH) are essentially different from that on standard rails. Fig. 16 shows different surface positions of the transverse cross-section immediately after grinding. Thick FIM layers are present at many positions; remarkable is their

stratification, which causes many of them to delaminate; FIM is present at the surface over the whole cross-section. Further, a strongly facet-dependent plastic deformation of the surface layer is present, directed toward the inside on the gauge half of the rail and the outside on the field half of the rail crown.

Fig. 16 Surface (transverse cross-section) of heat-treated pearlitic rail (MHH) *immediately* after grinding: FIM layers and strongly facet-dependent plasticity. Pictures are taken from the field to the gauge side (at the right).

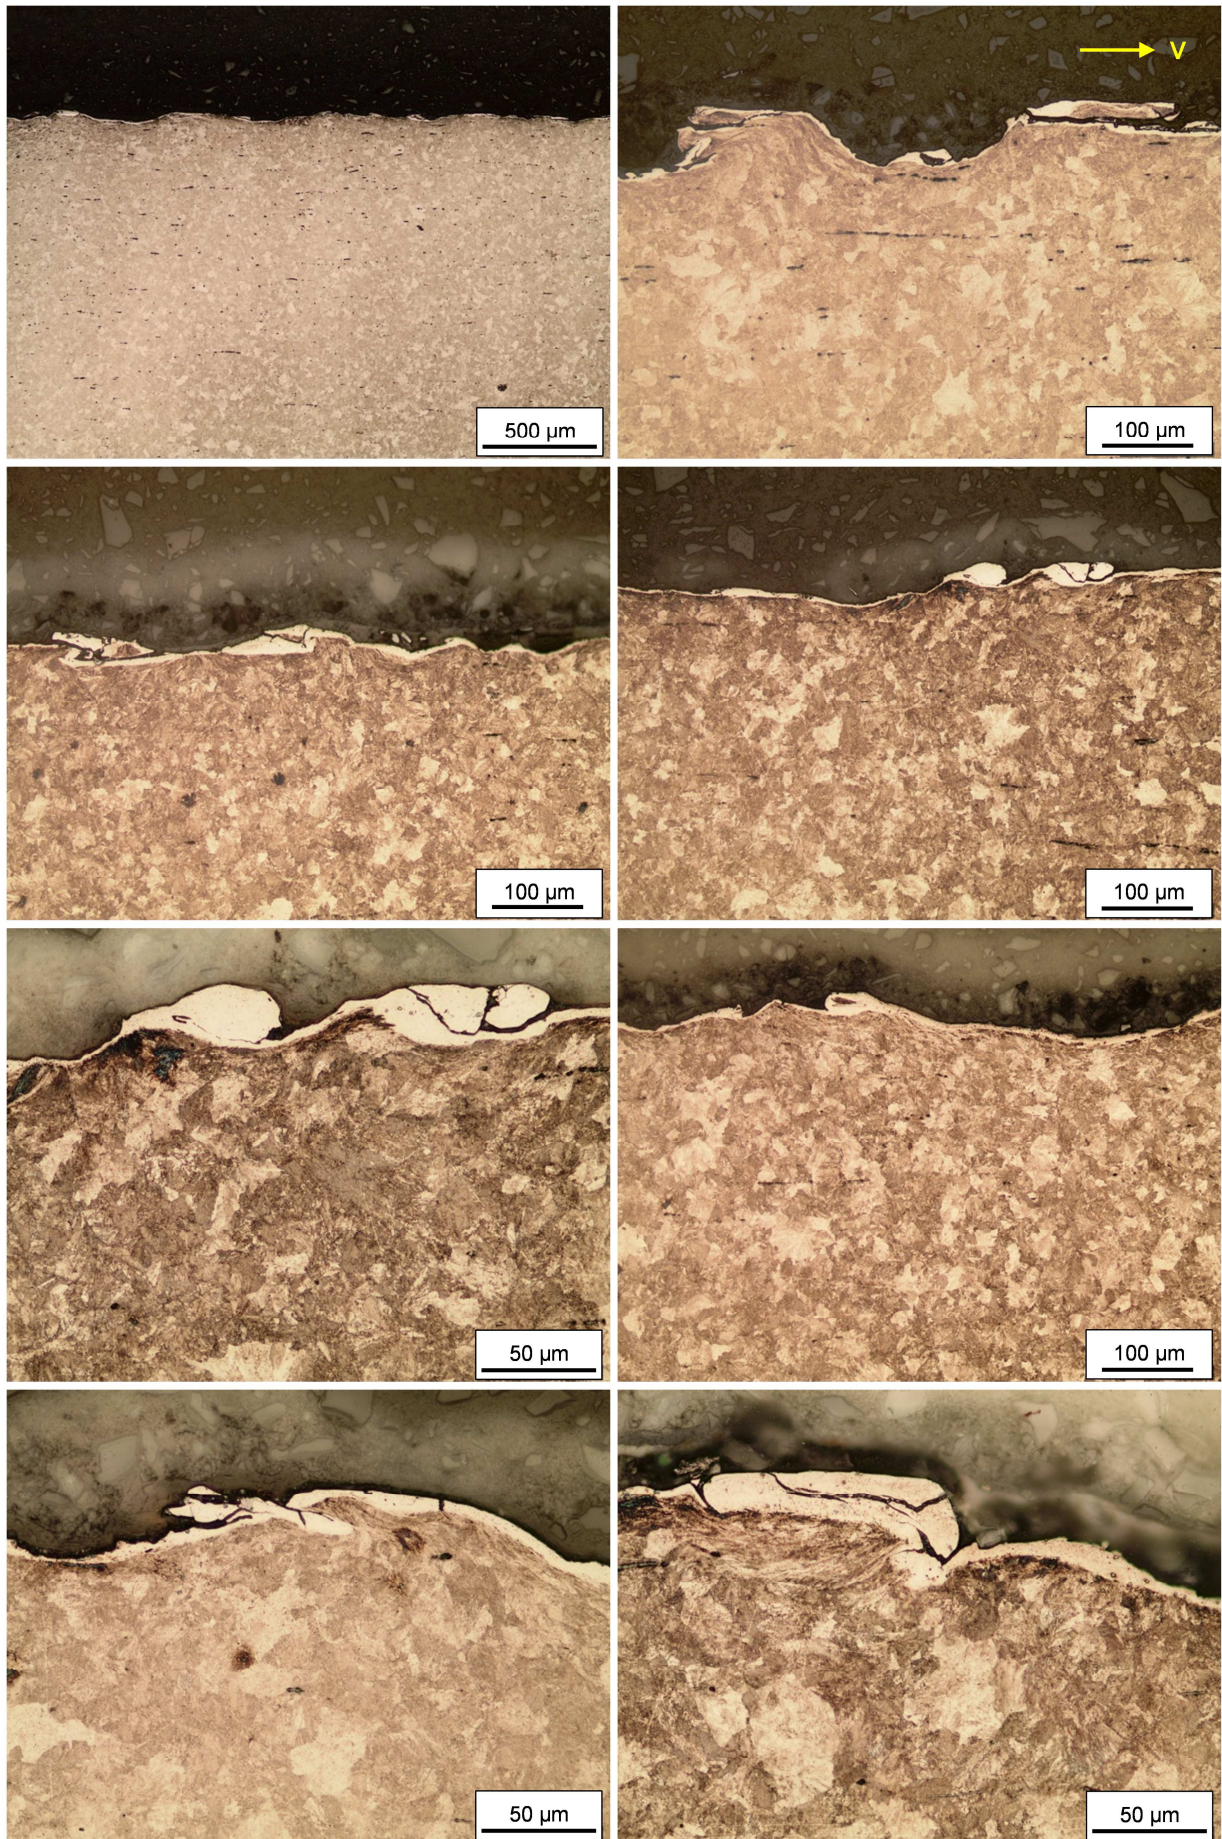
Fig. 17 Surface (longitudinal cross-section) of heat-treated pearlitic rail (MHH) *immediately* after grinding: FIM deposits and localised severe plastic strain.

Positions along the longitudinal cross-section (Fig. 17) show grinding grooves with severe localised plastic deformation and large portions of FIM, typically in the form of deposits at the edges of the grooves. Further, no uniform longitudinal plastic deformation texture of the top layer along the rail surface can be observed.

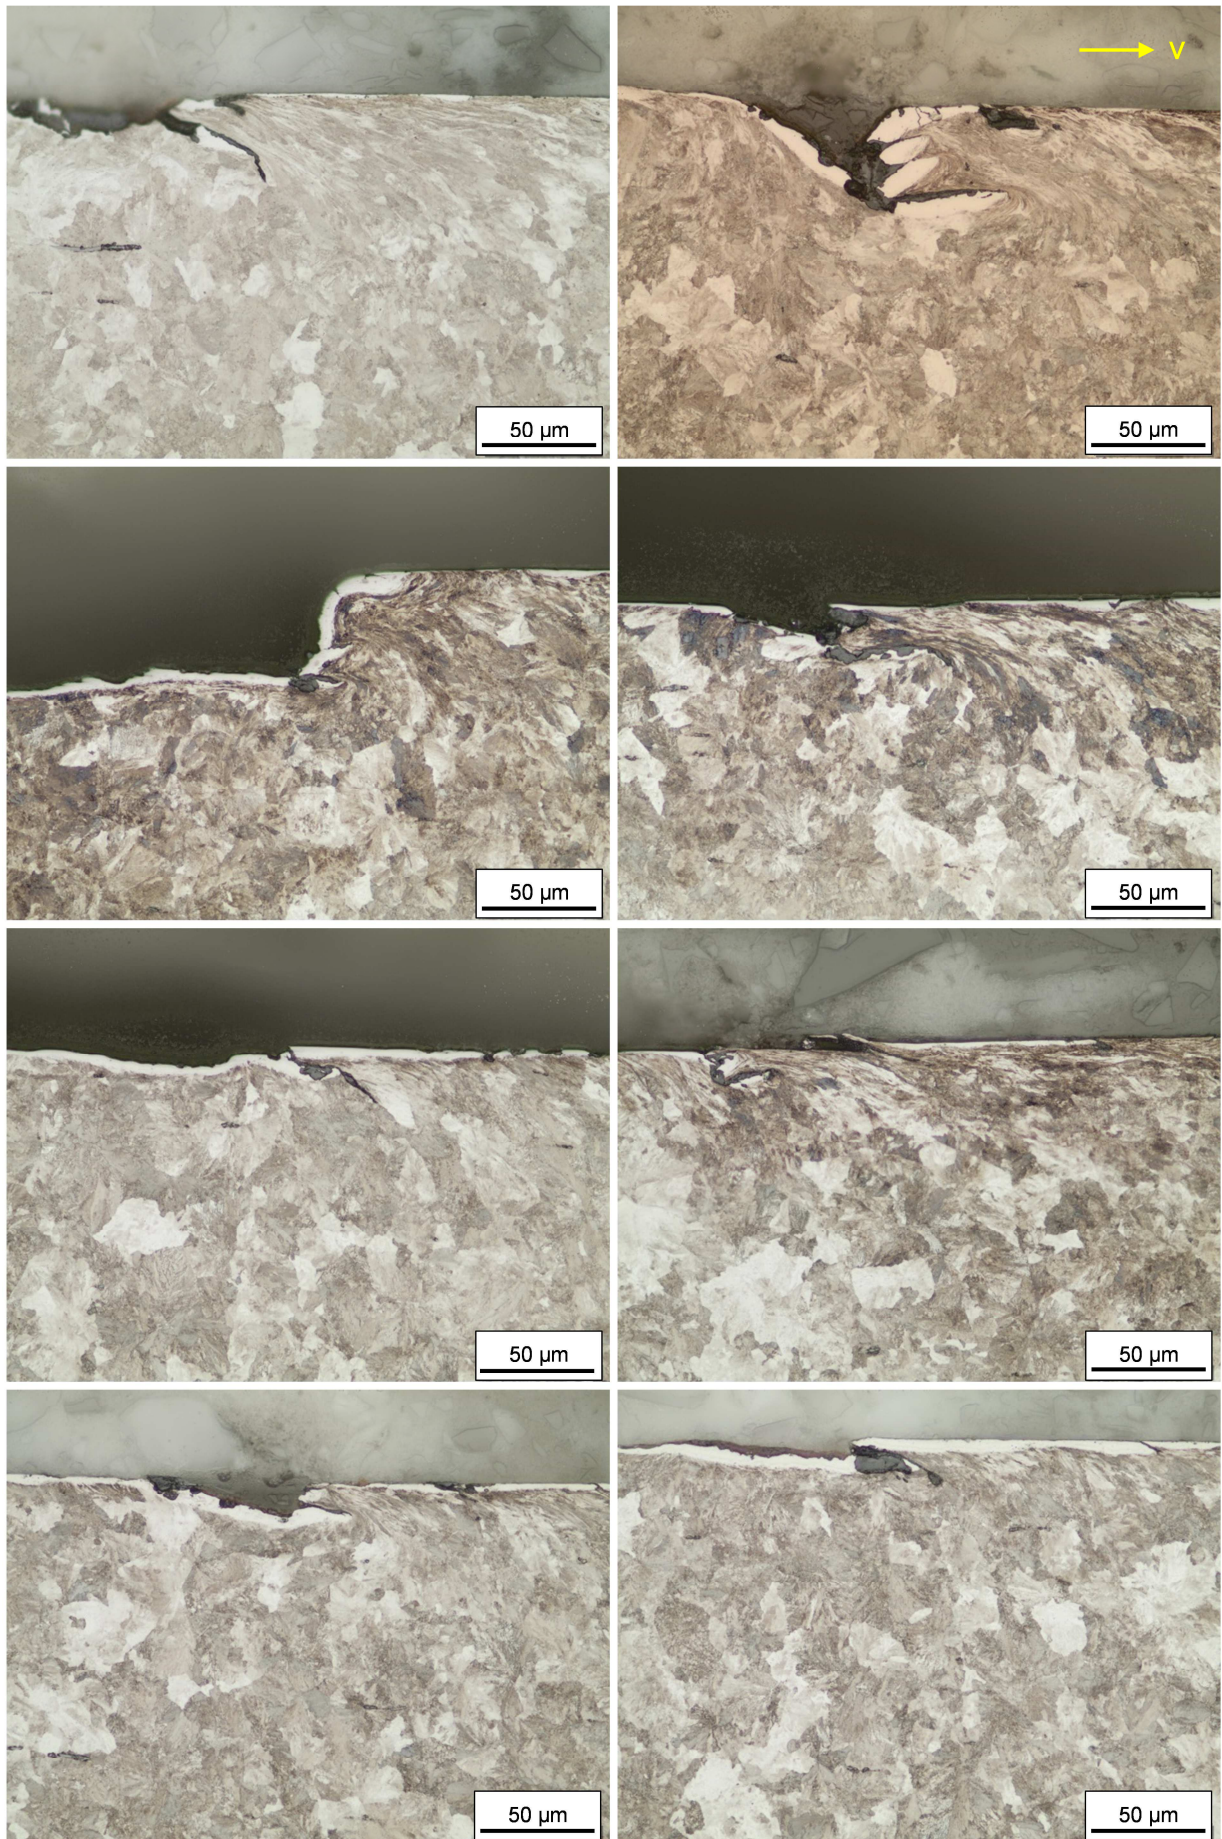
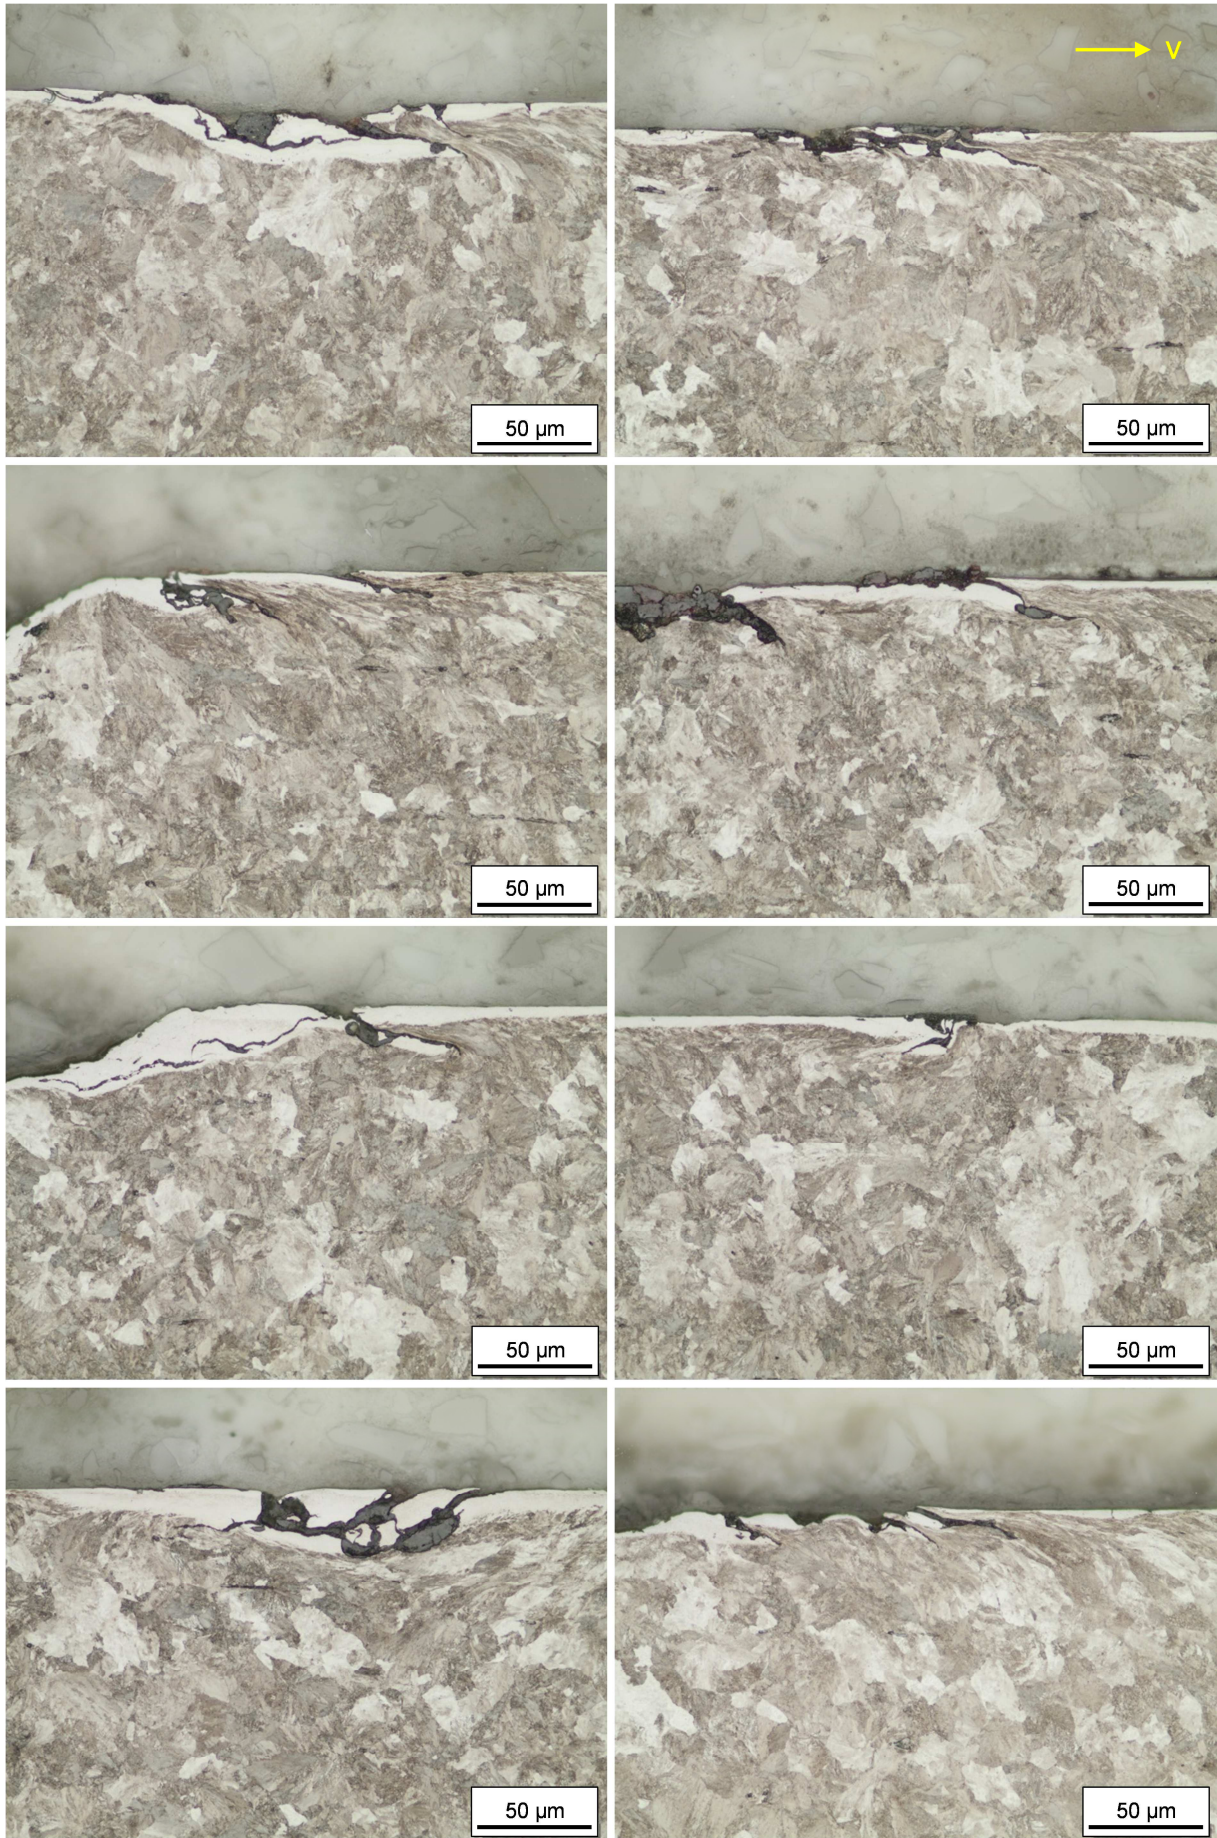
Fig. 18 shows the longitudinal rail surface after rail grinding and a few days of train operation consecutively: large amounts of FIM generated by grinding are largely removed by spalling wear; there is no uniform plastic deformation along the surface as a consequence of wheel-rail contact. However, at the same time individual portions of FIM are pressed into the surface, along with strong localised plastic strain under tangential stresses exerted in the wheel-rail contact patch. This phenomenon leads to local failure of the granular matrix and crack initiation: the surface is strewn with initiations up to depths of tens of micrometres, with subsurface crack paths propagating against the train running direction. Apparently, the work hardening capacity of the heat-treated material is not sufficient to accommodate the ‘imprint’ of the hard FIM portions in an elastic mode. The density of the crack initiations is correlated with the surface roughness (Fig. 11): each major FIM deposit at the edge of a major groove is a potential crack initiator. In the present case, crack initiations are – very roughly – interspaced at 1 mm. In the transverse direction (not shown), no significant developments can be observed with respect to the situation immediately after grinding; although many stratified FIM layers have delaminated and disappeared, the surface is still largely covered with a single FIM layer; transitions between grinding facets have not changed during the duration of the experiment. It is noted finally that the results of the microstructural analysis coincide with the conclusion from the non-destructive research discussed in section 2, where at the surface of R370crHT/MHH grinding grooves were found to be bordered by FIM (Fig. 9).

Fig. 18 Surface (longitudinal cross-section) of heat-treated pearlitic rail (MHH) *after grinding and a few days of train operation*: FIM and train-induced plastic strain cause severe crack initiation.

Fig. 18 (continued) Surface (longitudinal cross-section) of heat-treated pearlitic rail (MHH) after grinding and a few days of train operation: FIM and train-induced plastic strain cause severe crack initiation.

In order to avoid spalling damage, at least operational grinding specifications for rails need to be reconsidered such that the formation of white etching layers, accompanied by harmful residual stress fields, are avoided, with special attention for heat-treated grades.
