# On The Inspection of River Levee Safety in Japan by MLIT

**Abstract.** The ministry of land, infrastructures, transportation and tourism (MLIT) of the Japanese government maintains governmental managed river levee for the safety against flood whose total length is more than 10,000 km. The design standard of river levee had been traditionally done based on so called *shape based specification*, where levee is judged to be safe as long as a section satisfies the specified dimensions. In 2002, this policy had been changed and a new inspection guideline which is based on the modern soil mechanics principles had been introduced. The method mainly consists of the non-stationary seepage analysis followed by the circular slip line stability analysis. The exit gradient and uplift pressure are also checked based on specified safety factors. The way of the safety assessment is that, first a river is divided into so called *a continuous strip* (CS) which is judged to have similar configurations, geotechnical and hydraulic conditions. The typical length of a CS is half to several km long. Then a *representative cross section* (RCS) that is considered to represent all the CS section is select

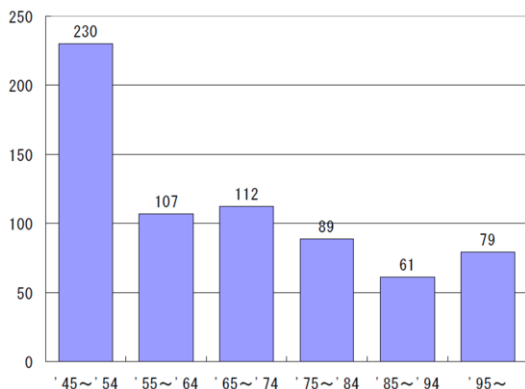
**Figure 1** Number of river levee failure between 1945 and 2002.

After the Second World War, between 1945 and 1960, many flood occurred due to the poor river levee conditions and other flood controlling facilities. Many efforts have been put to develop river levee during and after this period. Figure 1 presents the number of river levee failures after 1945. There were many failures before 1955, but the number has been reducing. About half of the failures are by overtopping of the flood.

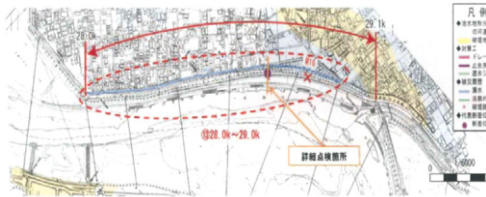
(b) A continuous strip

An example of such inspection result is presented in Figure 4 (a) and (b). Figure 4(a) is the representative section taken from the continuous strip shown in Figure 4(b). The length of the strip in this case is 1 km from station 28.0 to 29.0 km. The station indicates the distance from the river mouth. The results of the inspection is summarized in the table in Figure 4(a), which presents the cross section is safe for both front and back slopes stability of the embankment, but is NG (no good) for local exit seepage gradient for both horizontal and vertical directions at the place indicated by a red circle in Figure 4(a).

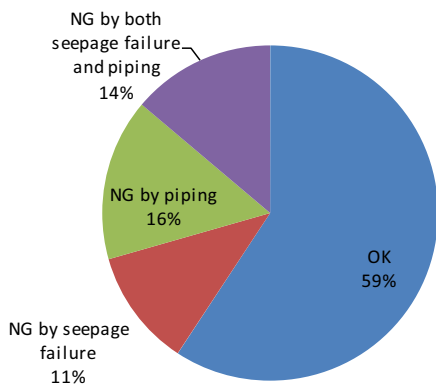
Figure 5 The result of the inspection (as of January 2011).

Figure 5 illustrates the result of whole inspection for 10050 km length of the major rivers at January 2011. Only 59% of the levee is judged to be safe for both seepage failure and piping. 14% is NG by the both phenome, 11% is NG by seepage failure and 16% by piping.

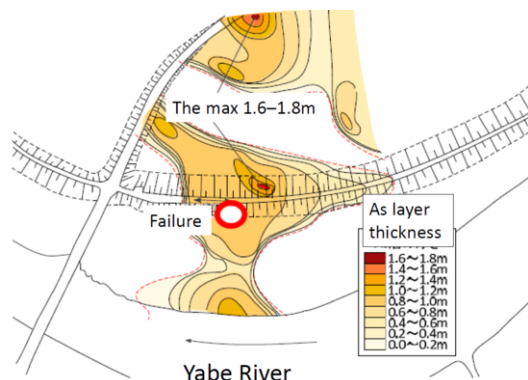
(b) Estimated As layer thickness at Yabe River station. 7.4km

The soil profile at the site drawn based on the investigation is illustrated in Figure 6(a). It was confirmed that a thin sand layer (As layer hereafter) with relatively high permeability distributed continuously under the clayey embankment. The thickness distribution of this sand layer is shown in Figure 6(b). As the layer is very thick at the place failure took place, and the layer extends to the downstream direction, but terminates in a short distance. It was also confirmed that As layer is outcropping in the river bed so that the water pressure induced by the flood might be propagated through this layer without much losing the pressure head.

Based on these findings, a presumed scenario for this failure event is as follows: First, induced by the rising of river water level, the pore water pressure in As layer rose which eventually broke through the top covering clay layer. The soil particles in As layer were washed out, and flushed out with the flushing water. As a result, cavities were developed in As layer under the embankment. As the cavities developed, soil in the embankment dropped into them, which resulted collapse and settlement of the embankment. Then, the collapsed part was overtopped by the river water, which eroded and expanded the failed portion of the levee.

This thin sand layer, As layer, had been overlooked in the soil investigation before the event. Because the distribution of this sand layer is very local, it is considered difficult to find
