# Failure Analysis of Two HP-Nb Heat-Resistant Tubes after 46,000 h Exposure to Reformer Service Conditions

**Abstract:** This study presents a failure analysis in two reformer tubes used for hydrogen production in a petrochemical industry. These tubes (Tube A and Tube B) were made by the centrifugal casting of HP-Nb alloy in such a way that one contained titanium as a micro-element, and the other was free from titanium in its chemical composition. Although the two tubes were subjected to similar creep conditions, Tube A failed after only 46,000 h of operation against the design life of 100,000 h. SEM images showed initiation and growth of creep pores next to chromium carbide particles, as well as the formation of microcracks in Cr<sub>23</sub>C<sub>6</sub> carbides. Pore initiation occurs as a result of grain boundary sliding and is strongly dependent on structural morphology. The tube containing titanium (Tube B) showed higher thermal stability and higher creep resistance than the tube without titanium (Tube A), which was due to the formation of finer and more discrete carbide particles. The final fracture of the tube without titanium (Tube A) occurred due to the coalescence of

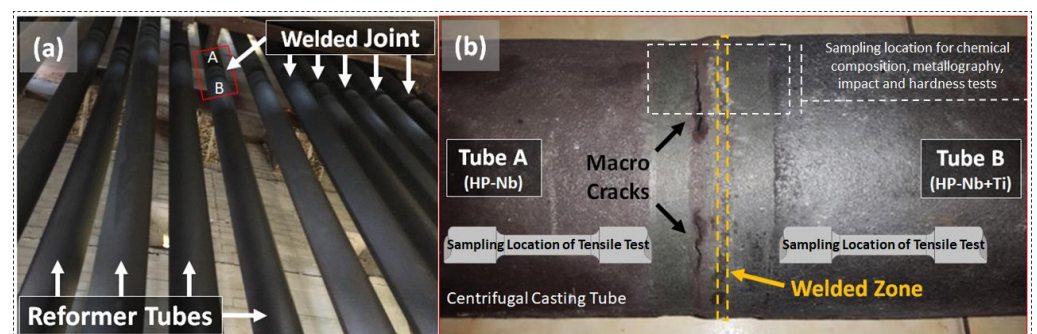
Figure 1a shows the location of these tube sections (Tube A and Tube B) in the reformer furnace. Although both tubes were under similar temperature and stress conditions, Tube A showed premature cracking and failure (Figure 1b). According to visual inspection, latitudinal cracks were observed at a distance of 6 mm from the welded joint in Tube A while no macroscopic cracks were observed in Tube B. The premature failure of the HP-Nb reformer tube without Ti (Tube A) after 46,000 h of service at the approximate temperature of 1000 °C as compared to Tube B (with 0.12% Ti) was studied. The observed damages included latitudinal cracks adjacent to the welding area, resulting in the need to replace the tubes after 46,000 h of service which is significantly lower than the expected life of the tubes.

**Figure 1.** (a) Centrifugal cast tubes in the reformer furnace and (b) latitudinal cracks formed perpendicular to the stress direction on Tube A.

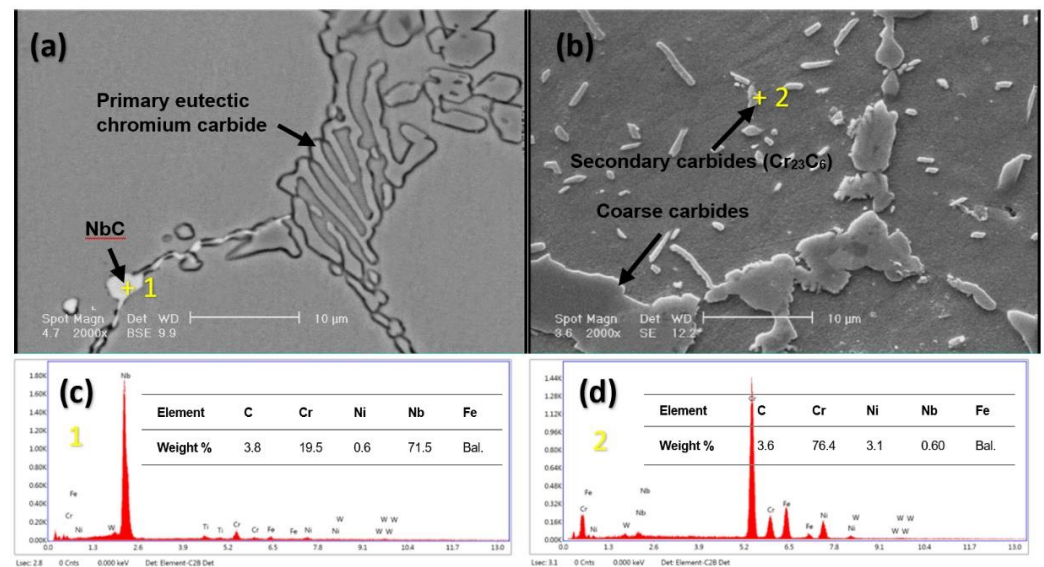
The failed tube (tube A) showed several microstructural features. As can be seen in Figure 2a, the as-casted microstructure before exposure to service conditions consists of a primary carbide network (mostly including chromium and niobium carbides) in the interdendritic grain boundaries. Due to the low solubility of niobium in the austenite matrix, the niobium carbides precipitated at the grain boundaries or cell boundaries. This resulted in higher activation energy for slip and formation of creep pores, which can be supplied through stress or temperature [20]. Exposure of the tubes to high temperatures results in the conversion of the primary eutectic carbides to coarse Cr<sub>32</sub>C<sub>6</sub> particles and the coalescence and precipitation of dispersed Cr<sub>23</sub>C<sub>6</sub> carbides in the matrix (Figure 2b).

**Figure 2.** SEM images of Tube A (a) as-cased, and (b) after exposure to reformer service conditions for 46,000 h, (c,d) point elemental analysis of present phases using EDS system.

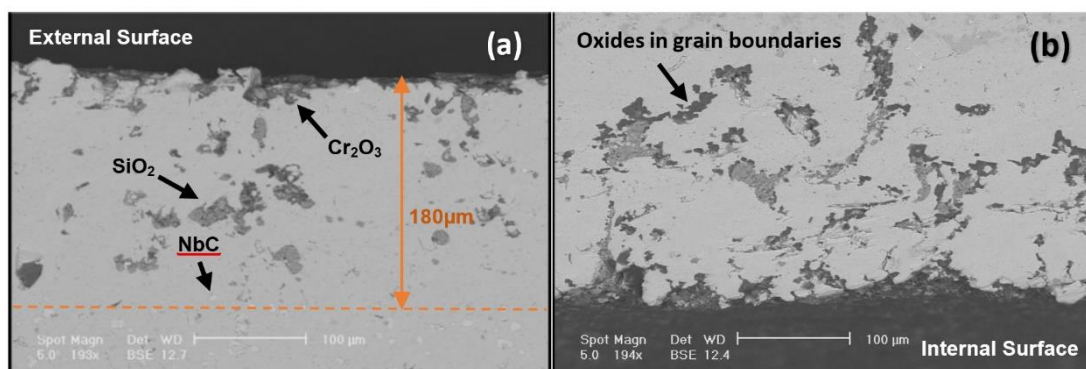
Near the outer shell of Tube A, a thin chromium-rich oxide layer and then a band of silicon oxides with an approximate thickness of 180 micrometres were observed (Figure 3a). In this region, despite the presence of niobium carbides as fine, dispersed particles (white precipitates), no chromium-rich precipitates were observed. The presence of the Cr<sub>2</sub>O<sub>3</sub> layer has resulted in the depletion of chromium from adjacent areas in this layer, creating a region with no chromium-rich precipitates. Similarly, on the internal surface of the tube, oxide particles were observed at the boundary of austenite grains with an approximate thickness of 200 micrometres after the oxide layer (Figure 3b). These precipitates resulted in extreme brittleness of the tube and can be the initiation point for creep cracks. Carburation of the internal surface can automatically decrease the alloy's ductility at high temperatures. During this process, the formation of grain boundaries as microcrack sources results in decreased ductility. Furthermore, a decrease in chromium content in the matrix can result in the loss of oxide films on the internal surface of the tube, thus resulting in decreased corrosion resistance [21]. Although carburation and oxidation processes are known as the failure processes for reformer tubes, no sources for creep pores or cracks were observed next to the external or internal surface of the failed Tube A. In other words, the main reason for failure in Tube A is not the carburation of the internal surface or oxidation of the external surface of the tube.

**Figure 3.** BSE micrograph of Tube A from (a) oxides and chrome-depleted zones near the external surface and (b) oxides and chrome-depleted zones near the internal surface of the tube.

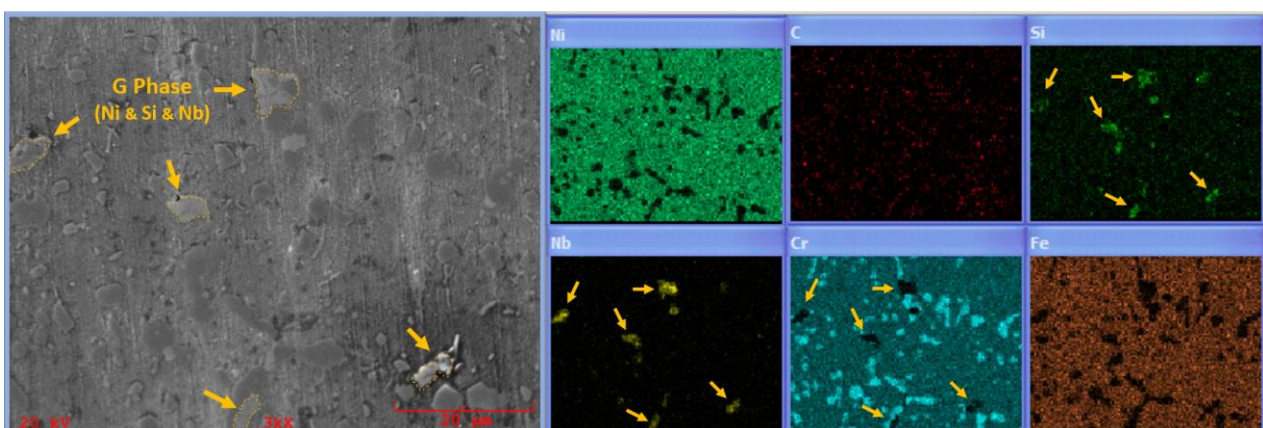
Our investigation showed that there is no evidence of the G phase in tubes containing titanium (Tube B). A low titanium concentration can result in the formation of niobium-titanium carbide complexes. Since titanium is insoluble in the G phase, it can increase the stability at higher temperatures and delay the transformation of (NbTi)C to the G phase. Therefore, the volume fraction of the G phase is lower in HP steel modified with Ti [22,24]. According to the X-Ray Mapping images presented in Figure 4, there are nickel, silicon, and niobium-rich areas identified in Tube A which is due to the presence of the G phase in tubes without titanium. These areas, indicated with arrows, have low chromium content, which, due to the lower strength and ductility of this phase compared to niobium carbides, are suitable areas for the initiation of creep pores. The volume expansion as a result of niobium carbide to G phase transformation can result in stress and therefore the formation of creep pores [12]. On the other hand, the transformation of niobium carbide into the G phase removes the hard phase (NbC) that can prevent the movement of dislocations and thus this phase transformation reduces the creep resistance [17].

**Figure 4.** X-Ray Mapping images of tube A showing the distribution of various elements in SEM images.

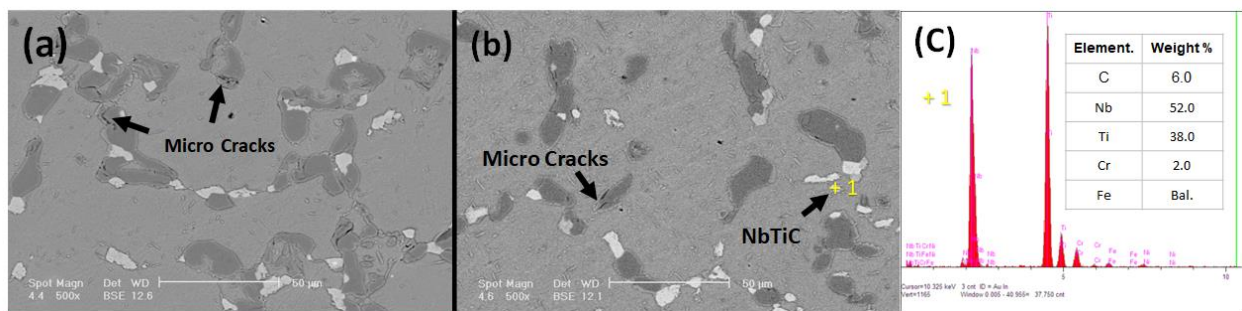
According to Figure 5, the coalescence of the carbide network in the titanium-free sample is higher compared to the sample containing titanium. Furthermore, the tube

containing titanium as an alloying element (Tube B) has a finer structure. Therefore, based on the effects of microstructural morphology on the initiation, growth, and coalescence of creep pores, it is expected for the Tube B to have higher ductility and creep resistance compared to the Tube A. This improvement in creep behaviour can be due to the presence of Ti carbonitrides and their effect on secondary carbide precipitates during ageing. The reason for the lack of failure in Tube B, despite tolerating similar service conditions to Tube A, is the positive effects of titanium on the creep behaviour of the alloy.

**Figure 5.** SEM images of tube microstructures after ageing: (a) Tube A without titanium and (b) Tube B containing 0.12 wt. % of titanium (c) point elemental analysis of NbTiC phase using EDS system.

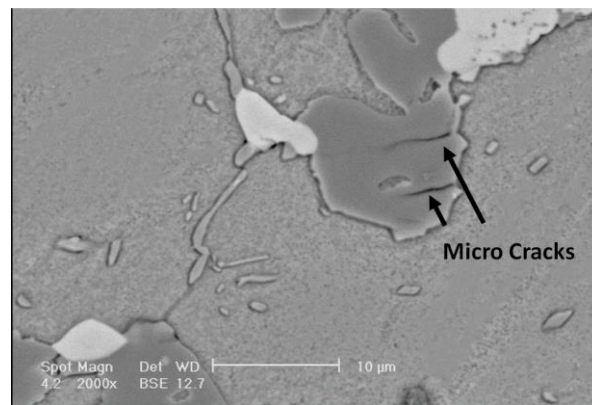
According to the data recorded during service conditions, the tubes have been exposed to 46 total unexpected furnace shutdowns. During unexpected shutdowns, the tubes are exposed to rapid cooling which undoubtedly results in thermal stress. During extreme service conditions, the thermo-mechanical strains can result in microstructural damages such as creep pores. The occurrence of these pores is not random but instead is related to some of the microstructural properties of the materials. As a result, almost all creep pores are formed next to carbide particles or in the carbide-austenite interfaces. The aged reformer tubes are more sensitive to thermal shocks due to their more brittle nature. As can be seen in Figure 6, the effect of thermal stress has resulted in the formation of microcracks on the chromium carbide particles.

According to the SEM images obtained from the microstructure of failed tube (Tube A) close to the main crack, the creep pores have initiated on grain boundaries perpendicular to the direction of the applied stress and their number and size has increased over time. The continuous initiation of creep pores in this case is dependent on the strain and is generally facilitated by the cracks formed on the Cr<sub>23</sub>C<sub>6</sub> carbide particles. As shown in Figure 7a,b, intergranular fracture occurred along the continuous carbides, and creep voids grew more on coarser carbides, especially in the triple grain boundary regions. According to spot analysis (Figure 7c) and the weight ratio of carbon and chromium, the stoichiometry of these carbides is mainly Cr<sub>23</sub>C<sub>6</sub>.

**Figure 6.** SEM images of microstructure of failed tube (Tube A). Micro cracks formed within chromium carbide particles are indicated with the arrows.

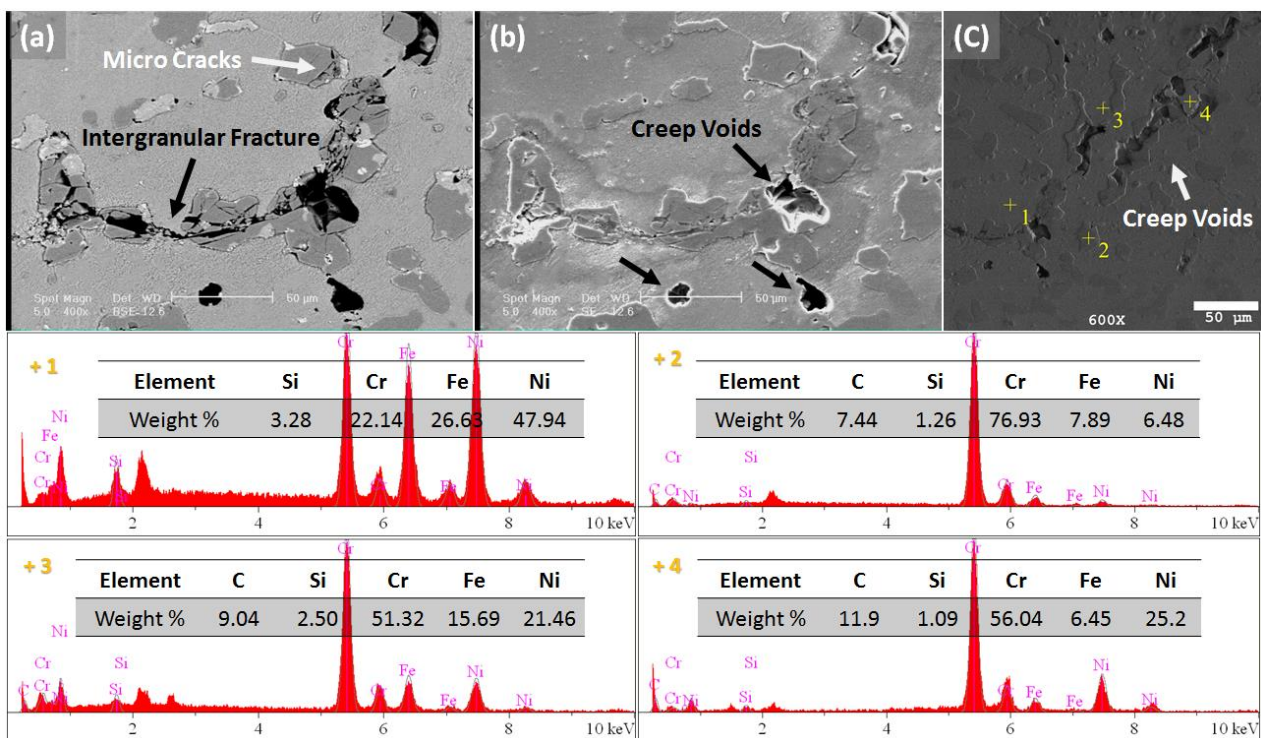
**Figure 7.** (a,b) SEM images of Microstructure degradation of Tube A, (c) point analysis of phases in the degraded area using SEM equipped with an EDS. The growth of creep voids and propagation of microcracks at grain boundaries and chromium carbides are shown.

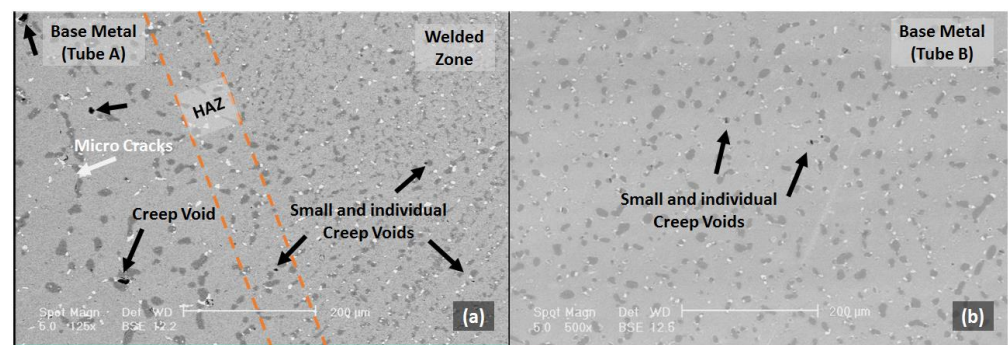
The SEM studies of the interface between the welded area and base metal in Tube A show no evidence of creep pores or microcracks in the welded zone. However, creep pores and microcracks are apparent at approximately 200 microns from the welded line in the base metal of Tube A (Figure 8a). This can be due to the presence of larger carbide particles in the base metal compared to the welded zone. As shown in Figure 8b, small and individual creep voids have nucleated in a base metal of the Tube B, but they have not been able to grow. This issue can be caused by the difference in microstructural morphology between Tube A and Tube B in terms of the distribution and size of chromium carbides.

**Figure 8.** SEM images of (a) the interface between welded zone and base metal in tube A, (b) base metal in tube B.

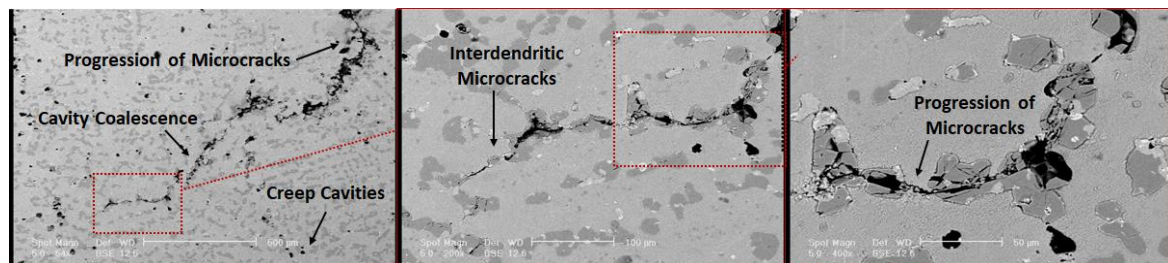
The decrease in the life cycle of reformer tubes is determined under the influence of creep damage which is indicated by progressive changes in the microstructure. The transfer of carbides, initiation of microcracks, and formation of creep pores often occur in the final stage of the creep damage and immediately before the failure. The growth of these creep pores mostly occurs perpendicular to the direction of the applied stress, and their growth rate is controlled by localized creep strain. The final fracture occurs due to pile-up of the pores, formation of grain boundary cracks, and an increase in the number and size of cracks. According to Figure 9, creep cavities are mostly observed in the triple or wedge-shaped areas and on chromium carbide particles. Coarsened chromium carbide particles merge under the influence of reformer temperature, and create suitable areas for initiation of creep pores. The pile-up of grain boundary cracks also occurs along the length of chromium carbide particles, indicating merged carbide particles as preferred crack initiation zones.

**Figure 9.** SEM images showing the pile-up of creep pores along the length of grain boundaries or inside grain boundary carbide particles and coalescence for the formation of cracks in the failed tube.

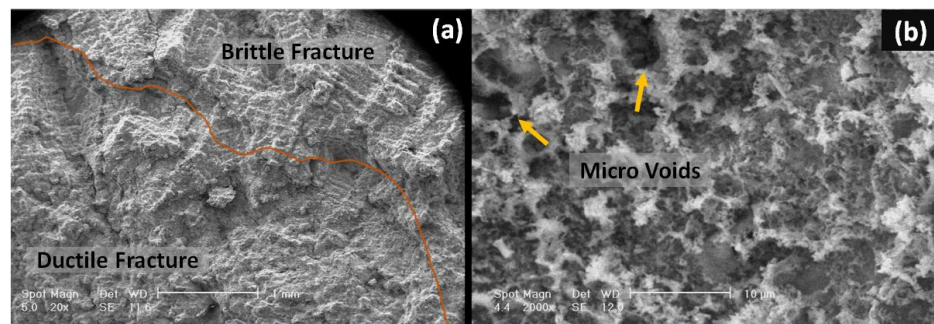
Based on the results of fractography studies, the fracture morphology of the failed tube (Tube A) is jagged, which indicates unsuitable mechanical properties. The furrow and ridges distributed on the fracture surface are seen in Figure 10a. The porosity has resulted in non-uniformity of distribution in tensile/compression stress. The imaginary line indicates the boundary between ductile and brittle fracture zones. As can be seen in Figure 10b, the fracture is ductile using the void coalescence mechanism in the areas with merged carbide particles (arrows). These microvoids are a suitable location for the coalescence of cracks due to the increase in local stress.

**Figure 10.** SEM images of fracture surface morphology of the failed tube, (a) final ductile and brittle fracture surfaces and (b) ductile fracture surface.

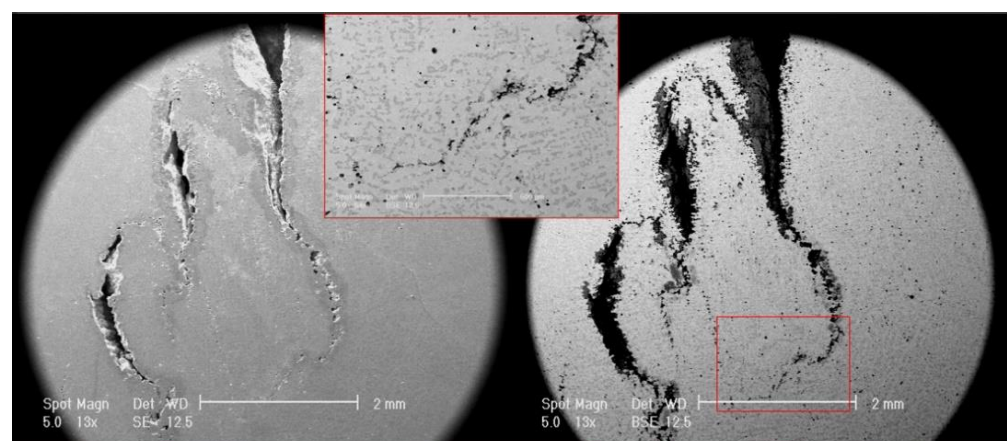
As a result of cyclic mechanical and thermal loadings caused by unexpected shut-downs, the thermal-mechanical fatigue process leads to microstructural damages such as carbide cracks and creep pores. According to Figure 12, the macrocracks are formed as a result of the coalescence of microcracks formed on the surface of chromium carbide particles as well as creep pores. The growth rate of these cracks is proportional to the applied strain and these cracks are grown perpendicular to the direction of applied stress. The creep behaviour of studied tubes in the current study is highly dependent on the difference in microstructural properties as a result of the addition of titanium to HP-Nb alloy.

**Figure 12.** SEM images of cracked regions; directional creep pores are seen along the length of main cracks. The singular creep pores have a uniform distribution in the matrix.
