**Post-flood field survey of the Ahr Valley (Germany)
Building damages and hydraulic aspects**

Technical Report

07.03.2022

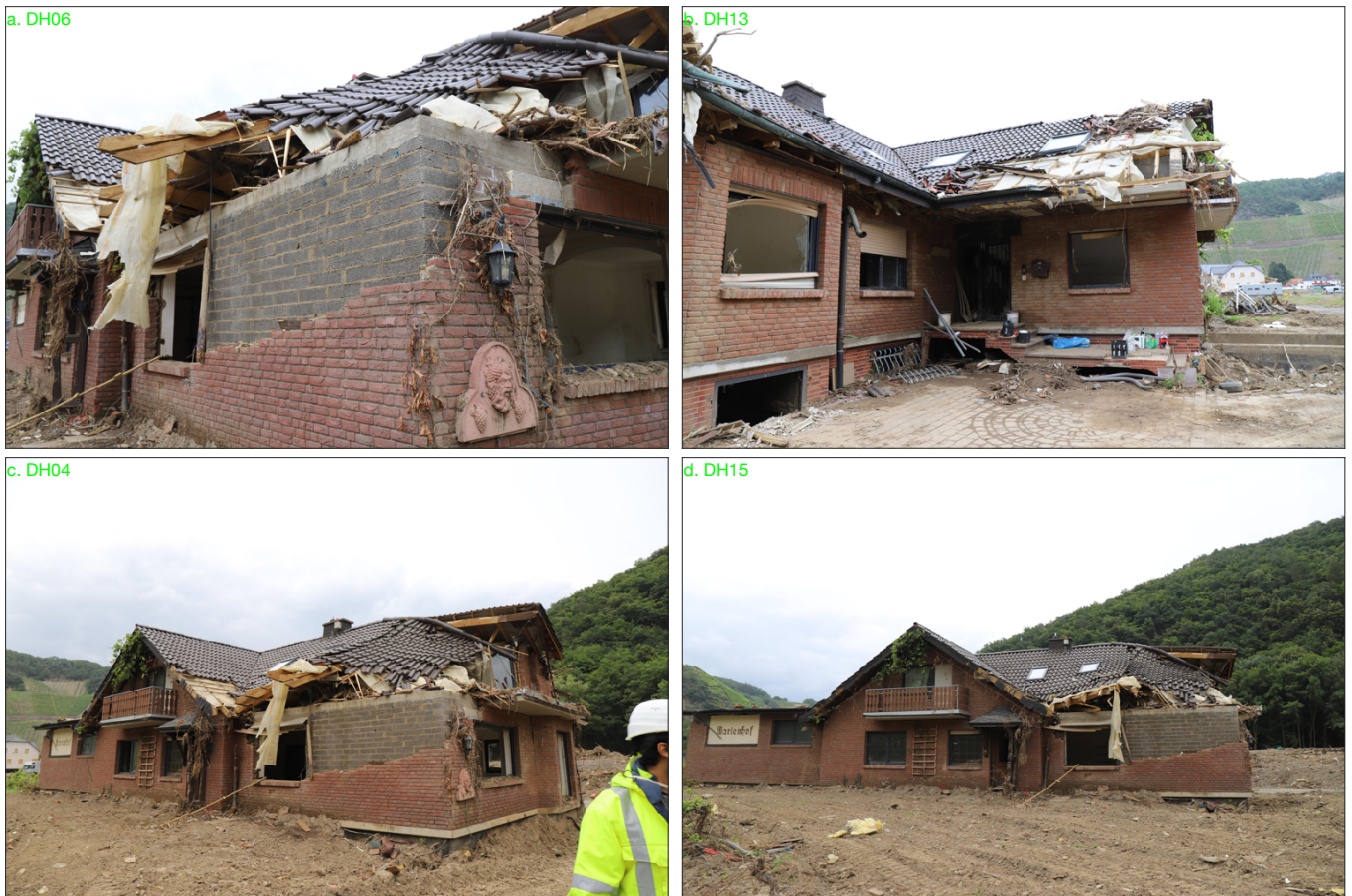
Figure 3.3. Case Study D_A

This structure, located upstream of a settlement east of Dernau and next to a bend in the river's path (see A in this section's map), was attacked by driftwood, which accumulated in its interior. The impact damaged and partially collapsed the timber roof structure of the building and the brick veneer of its façade. The structural masonry leaf, consisting of concrete blocks and confined by a concrete upper floor poured in-situ, seems to be unaffected.

Moreover, the flow of water caused scour around the foundation of the building at the front but did not reach a high depth.

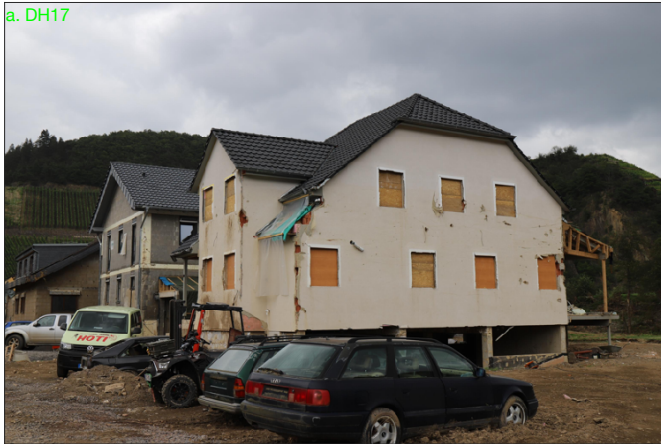
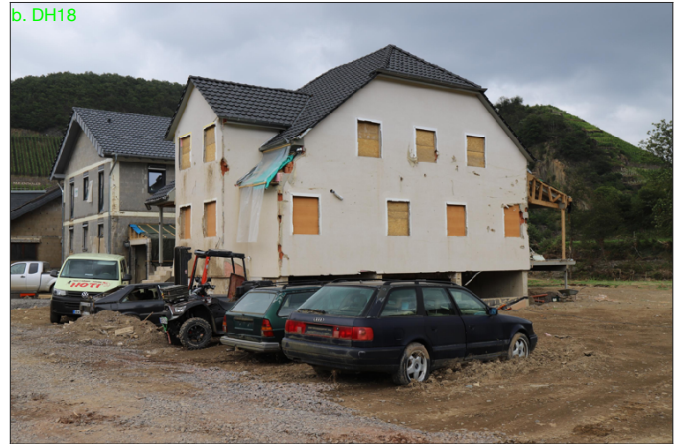
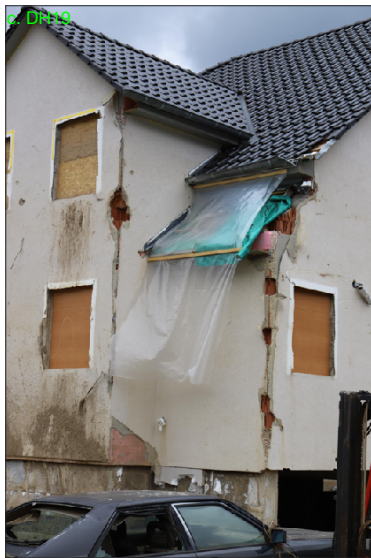
Figure 3.4. Case Study D_B

This three-storey building experienced high water levels that reached and damaged the windows on the top floor. The damage was likely caused by floating debris, as evidenced by the impacts left on three of the corners of the building oriented towards the flowing water.

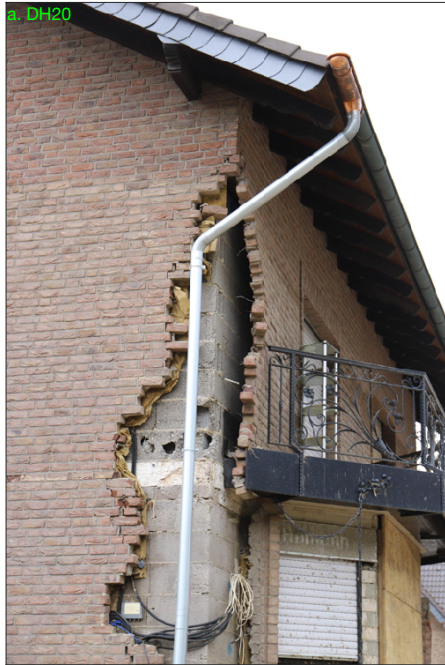
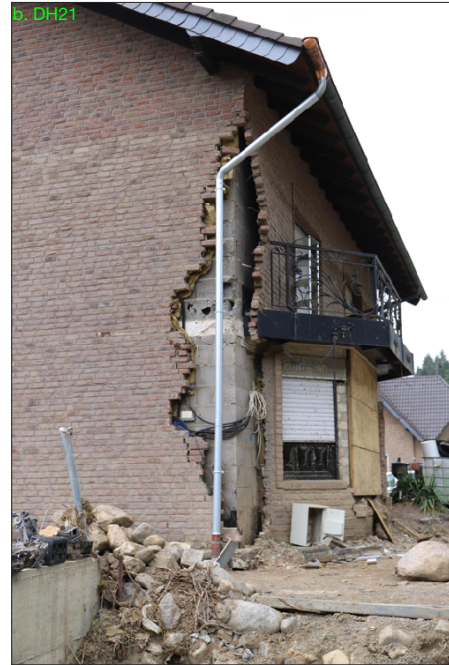
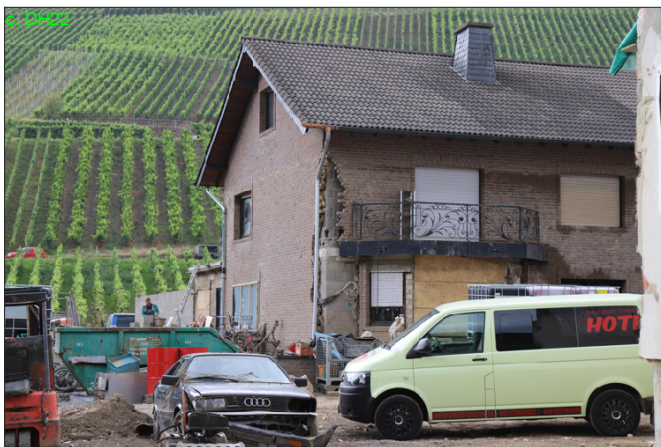
Figure 3.5. Case Study D_C

A two-storey water level affected this house sporting a cavity wall of inner concrete blocks and outer clay brick masonry. The corner of the building was damaged by high flow velocities or impacts of floating debris. The outer leaf collapsed in the corner, while the structural, hollow, concrete blocks were locally damaged.

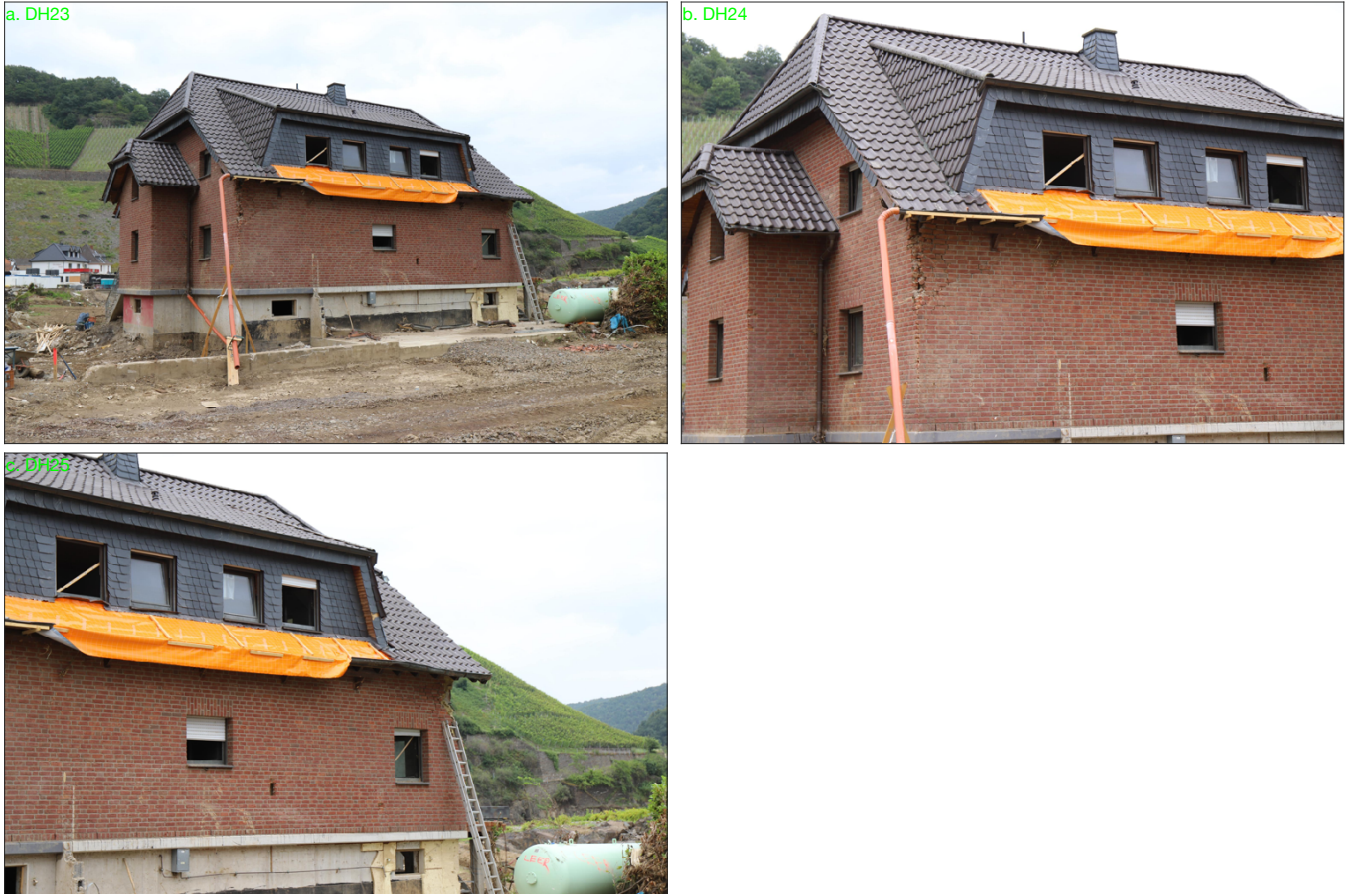
Figure 3.6. Case Study D_D

Similarly, this house also experienced damage to the outer leaf of the cavity walls and to the lower ends of the timber-structure roof. The outer leaf, which is only supported with (steel) ties to the inner, structural leaf, was pressed inwards by the water and potential debris at the corners of the structure.

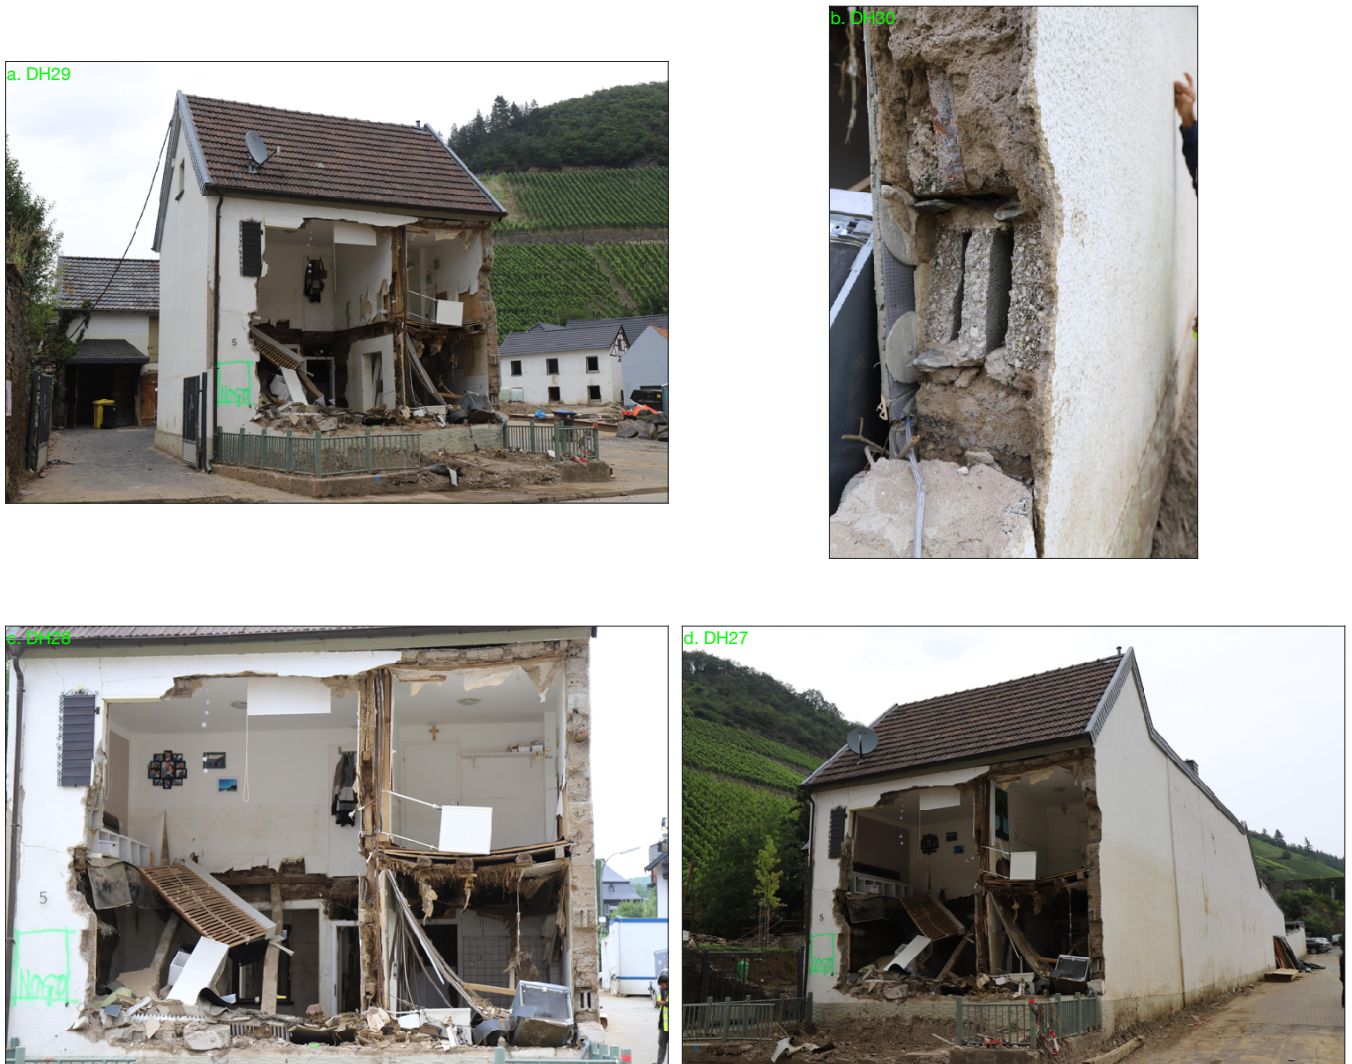
Figure 3.7. Case Study D_E

This house, with relatively old, hollow concrete blocks and timber floors, experienced the collapse of its front façade. Structurally, the house was poorly laid out since the timber joists, spanning only in one direction, were supported on the front façade which had many openings for windows. This is uncommon since it is structurally more favourable to support the floors (when they are one-way spanning) on the main transverse walls which sport fewer openings. The unusual configuration meant that when the weak front façade, with narrow piers, was affected by the pressure of water, possibly with a few of the piers being knocked out by impact of debris, the entire façade collapsed and with it, also the floors. Had the house being laid out 'correctly', the failed piers would probably not have failed altogether, and even if they had, the upper section of the façade would not have collapsed and neither would have the floors.

Newer structures are required to be designed with resiliency in mind, such that the aforementioned failure mechanism is not likely.

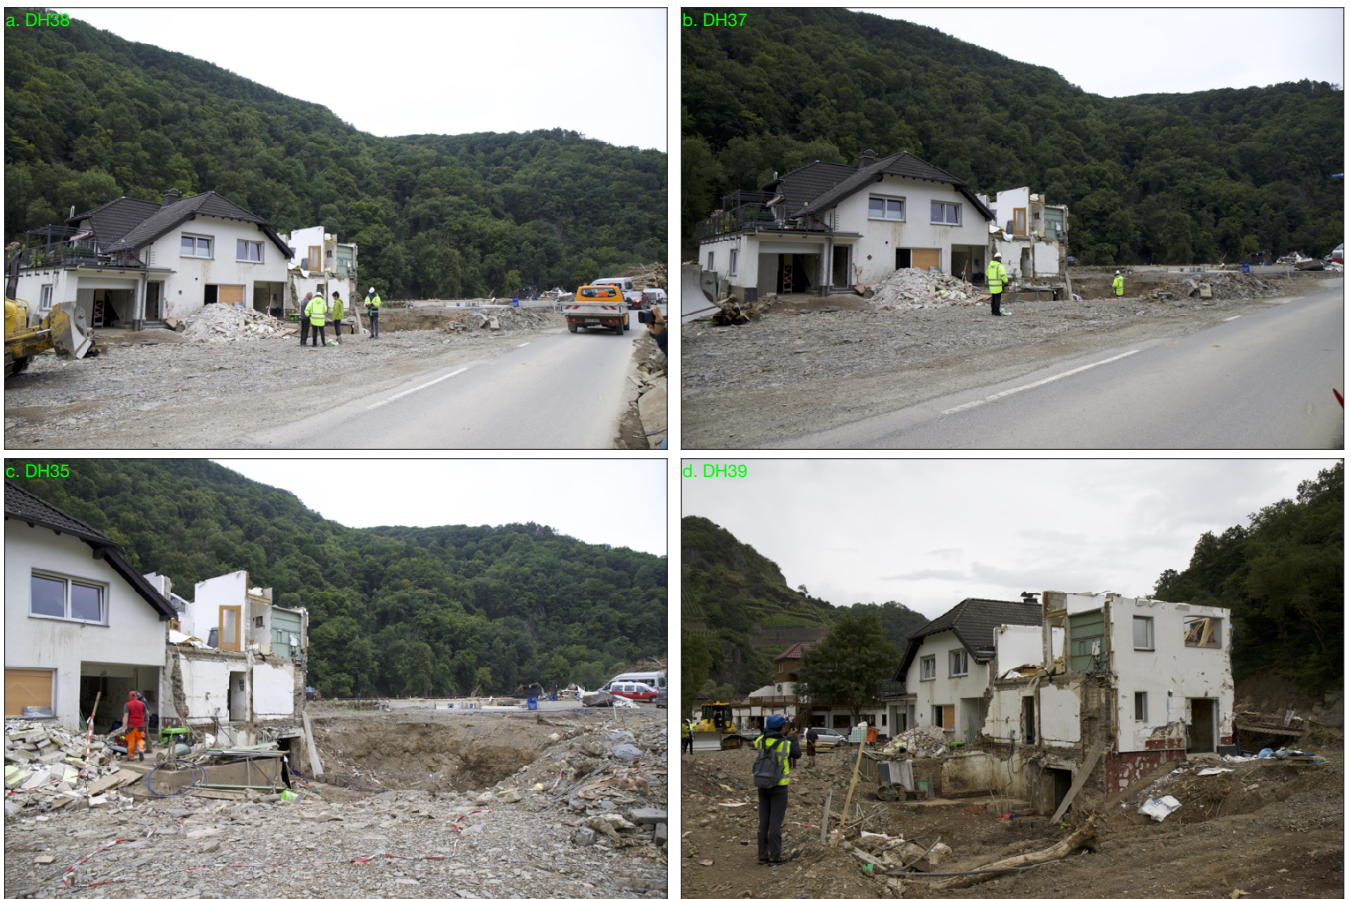
Figure 3.8. Case Study D_F

Considering the depth of the water and the damming of debris at the surface of the flow, which would place the point of application of the main turnover force much higher, this failure mechanism is not entirely inconceivable. In combination with a large buoyancy force, resulting from a rapid rise rate of the water, this part of the building could have been bent, sheared off, and ultimately turned-over by the water.

The larger part of the L, being parallel to the flow of the water, was much better prepared to withstand the flood actions.

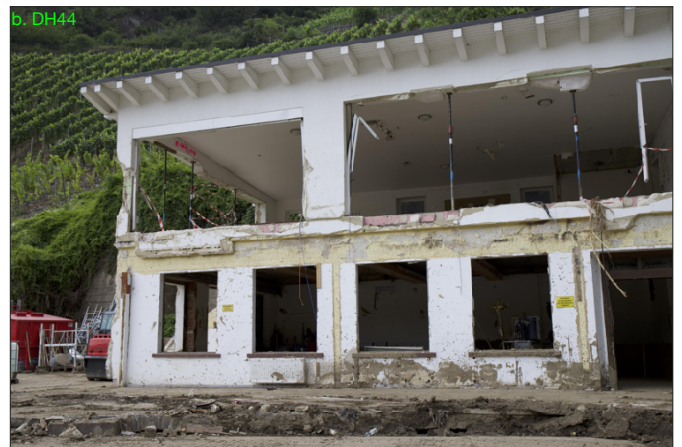
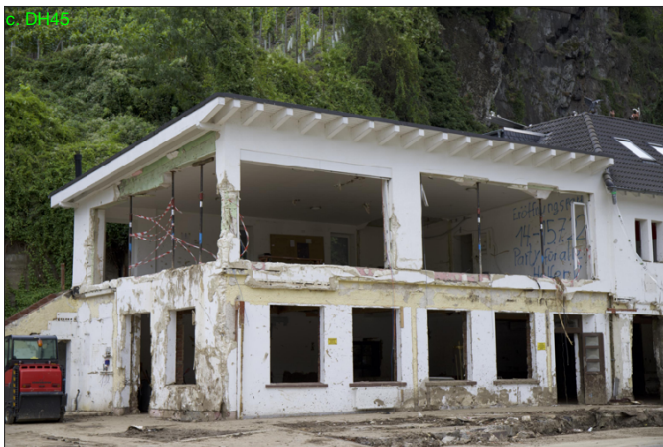
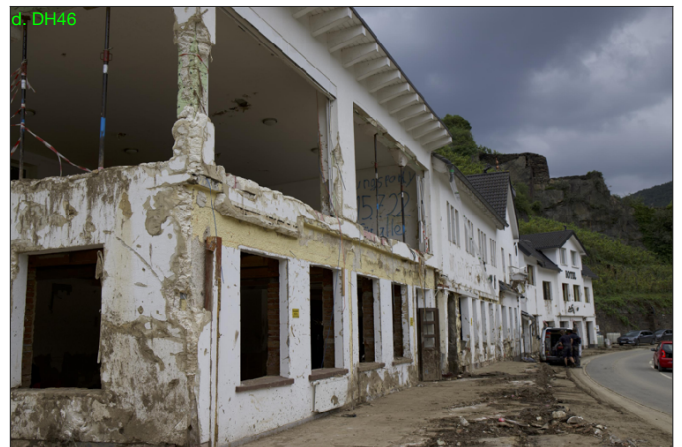
Figure 3.9. Case Study D_G

This structure looks to be impacted by debris. Its outer insulation appears damaged. In a few locations at the side of the building facing the flood wave, where large window openings were present and piers were consequently narrow, some piers were knocked out by the flood. Their locations match where the structure is propped up by steel pipes. Interestingly, only piers on the second level were affected. This may be due to two reasons: firstly, the higher location may have coincided with the depth of floating debris at the surface of the water (as supported by the watermarks); and secondly, the upper piers carried a lower vertical load which has a stabilising effect against lateral load and thus were more vulnerable than the piers on the first level which carry the entire first floor and upper storey of the building.

By the time this survey took place, the hotel had removed all the windows and renovation work had begun. It is suspected that many windows were affected by the flood.

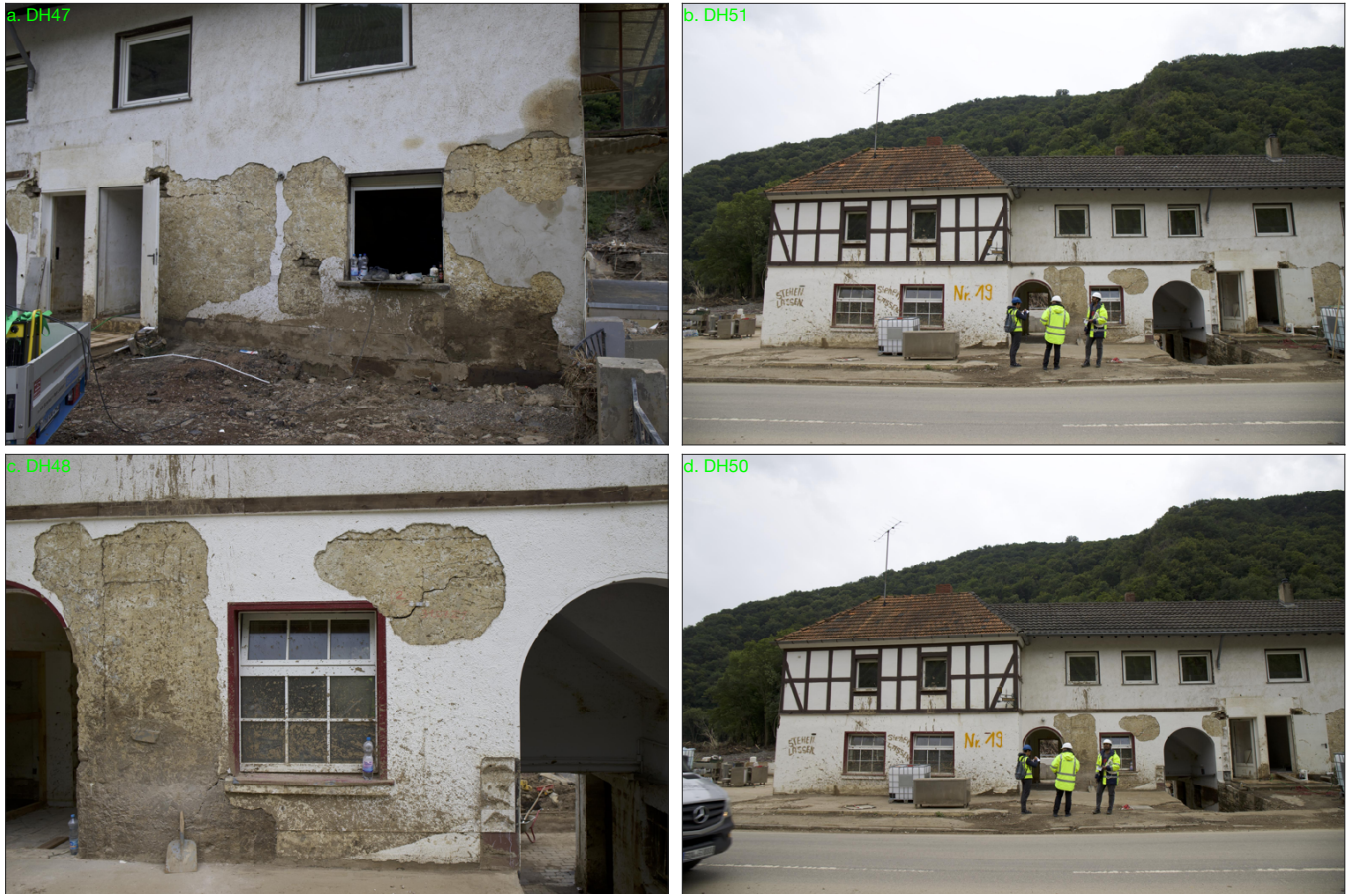
Figure 3.10. Case Study D_H

This long structure was relatively unaffected but displayed horizontal and diagonal cracks on the piers between windows. It is difficult to say whether the cracks were directly related to the flood actions or indirectly related through foundation effects. The direction of the cracks, if they are due to in-plane effects, is not entirely consistent with the orientation of the house in respect to the flood wave, nor is it consistent with the out-of-plane effect of water pushing inwards on the walls.

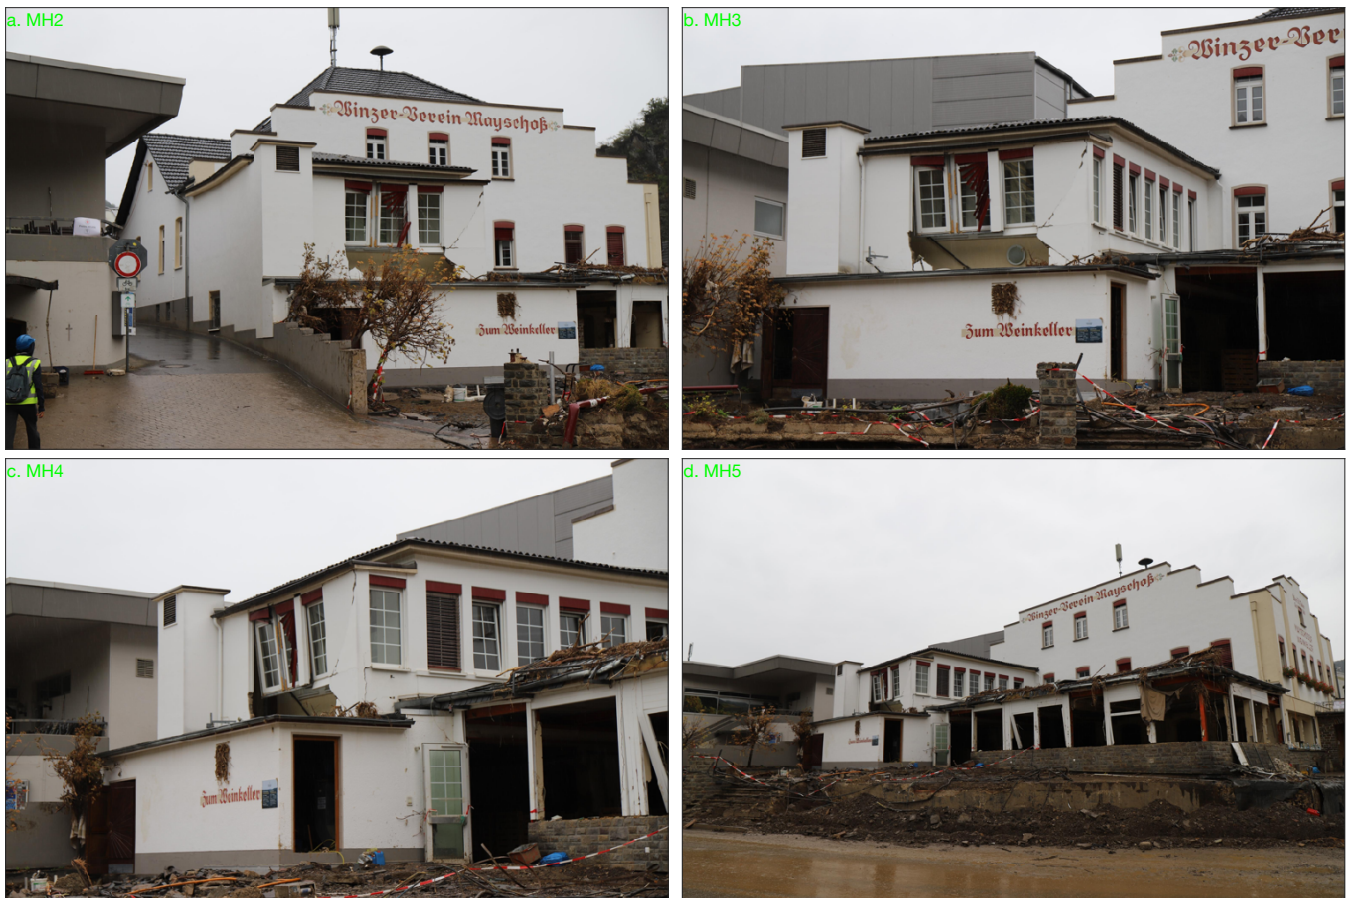
Figure 5.3. Case Study M_A

In Mayschoß, this structure displayed a peculiar failure mechanism in the first storey where the spandrel below a party of three windows was pushed inwards by the flood. This failure is similar to that of the stone masonry fence which encircled the terrain of the property and which was almost completely levelled by the flood actions. The spandrel was only supported at the sides since the small columns between the windows were not strong/stiff enough. Moreover, through the opening, one can observe the railing of a flight of stairs. This means that this spandrel was not supported at the level of the floors and was actually much taller. Such a tall wall was then toppled over by the hydrostatic or hydrodynamic actions of the flood, probably without the additional impacts of debris.

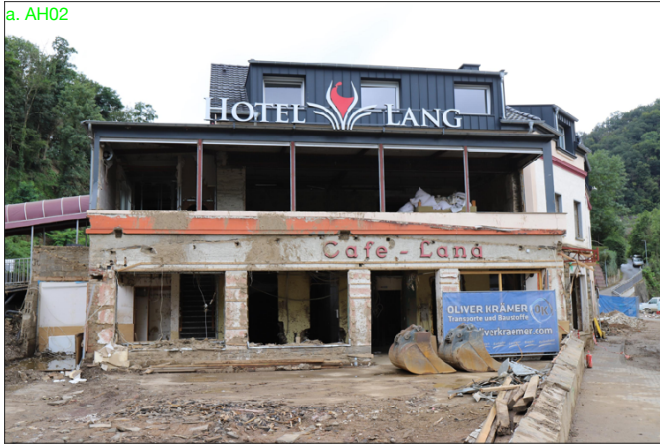
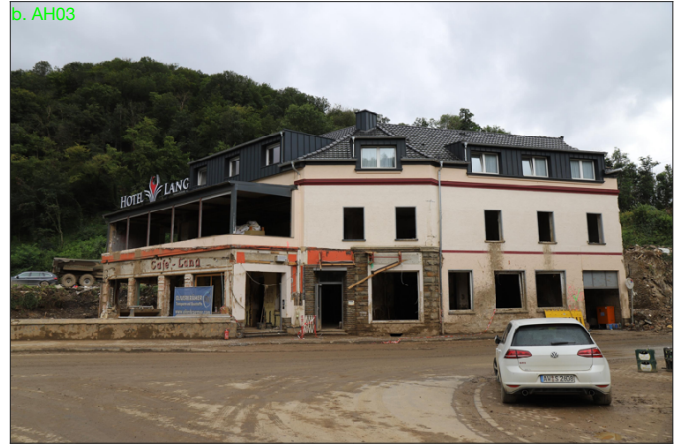
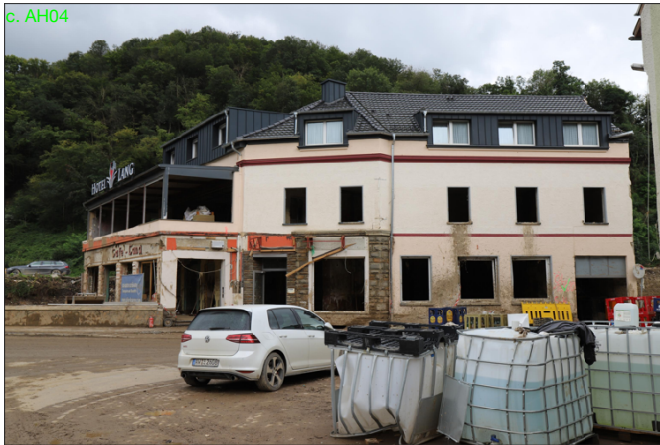
Figure 6.3. Case Study A_A

This structure used to have a roof covering its front terrace. The anchor points of the roof's joists can be observed on its façade. This roof was completely removed by the flood.

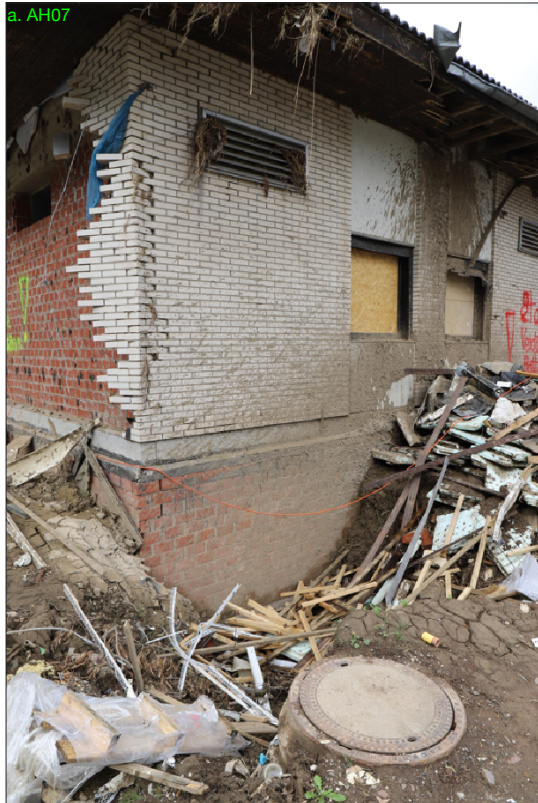
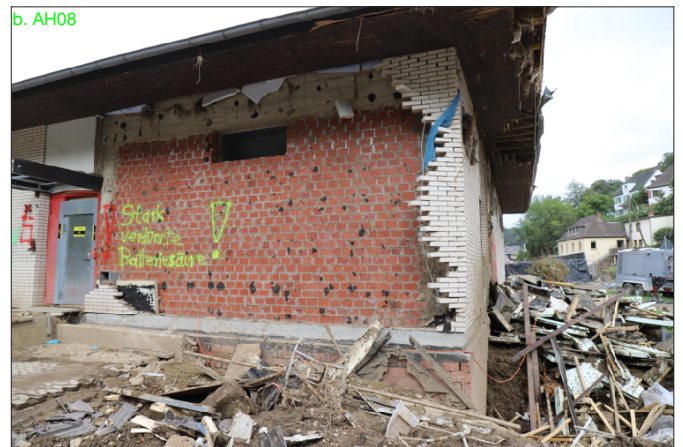
Figure 6.4. Case Study A_B

This building displays a large amount of scour together with the failure of the outer leaf of its cavity wall. The structural system appears to be confined masonry, with a double-wythe clay-brick masonry wall (all headers bond pattern) framed by reinforced concrete tie columns and tie beam. This is an unusually strong masonry system, often employed only in high-seismic areas which suggests that this structure had a special function either for industry or services.

The confined masonry seems unaffected by flood actions, while the outer leaf, from either calcium-silicate or light concrete bricks, only supported by cavity ties, was ripped out by the flood. It is also possible that part of the outer veneer was removed after the flood to prevent it from hazardously collapsing.

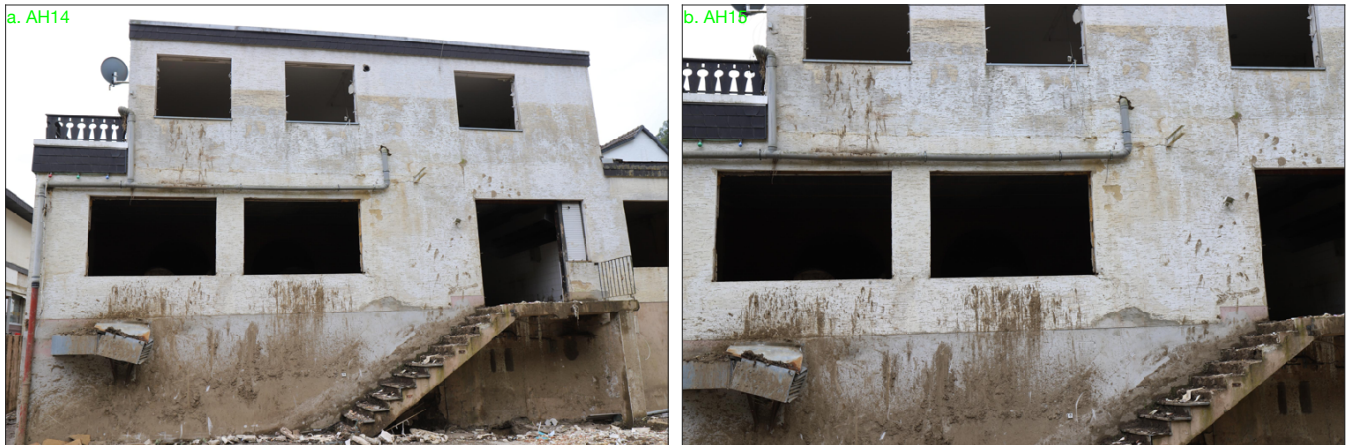
Figure 6.5. Case Study A_C

This structure was built next to the river (see map); subsequently, it experienced a high water level on its river-facing-façade. This level reached approximately the middle of the upper storey, which corresponds to a water level about 7 m. From the outside, the building appears structurally fine yet its façade is riddled with cracks (see magnified photo). Since the building was only observed from a distance, it is not clear whether the cracks appear only on the plaster of the outer insulation or if they also compromise the inner structural elements.

The cracks are very consistent with out-of-plane failure from loads acting inwards on the façade and further reveal the structural supports behind the façade.

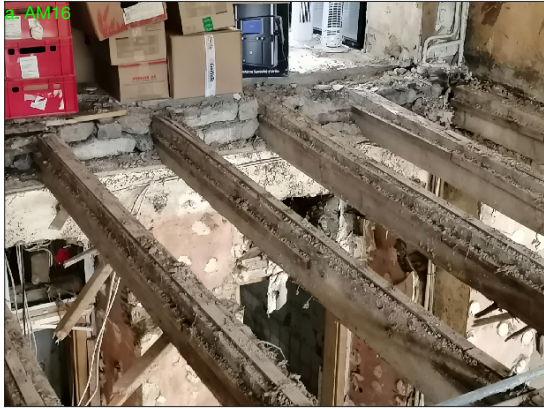
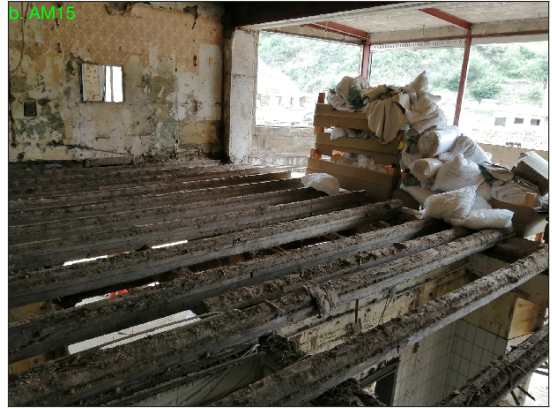
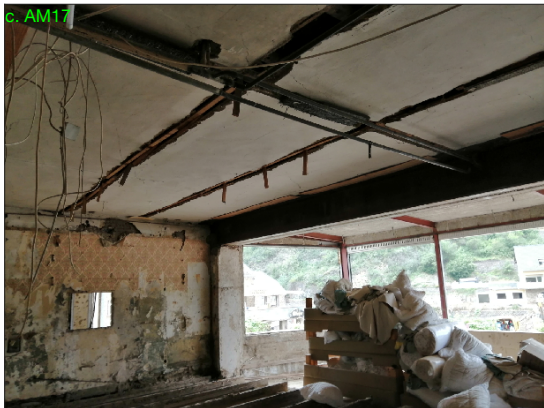
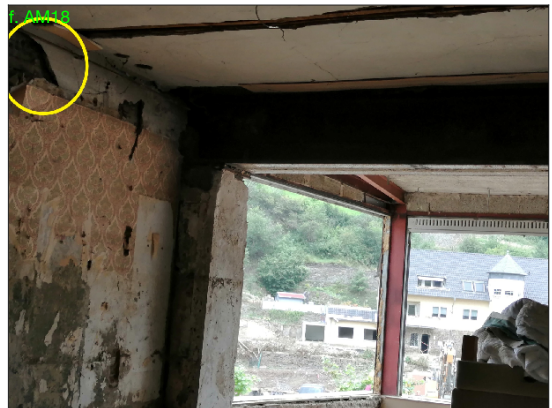
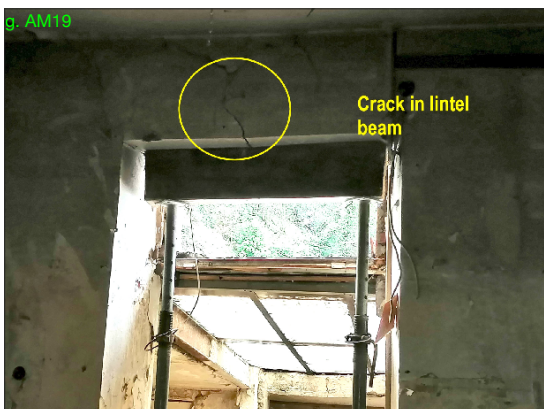
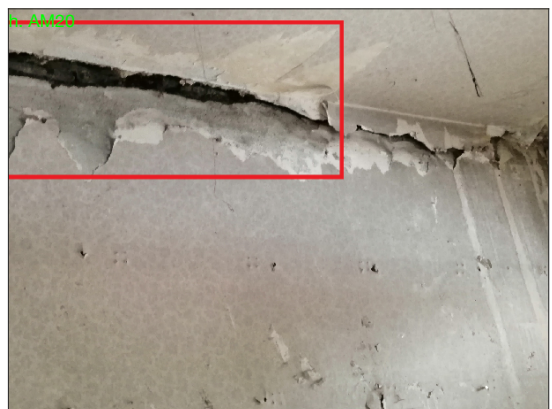
Figure 6.6. Case Study hotel Lang

The flow depth measured at the location was 6m, and a water depth of 1.8 m was identified at the first-floor slab level. The hotel was a framed structure, with columns (either RCC or composite) and beams (I section or composite section) spreading in the longitudinal direction. In the transverse direction, the timber joists spanned to support the wooden slabs (could be a one-way slab). The timber joists were positioned over the horizontal beams for support. Structurally, the hotel survived the flood. However, the internal components of the buildings were severely damaged; see figure. The façade of the building was utterly distorted during the flood. However, the supporting steel frames were unaffected.

Interestingly, although the flow depth did not reach the second-floor level, the timber flooring on the second floor was equally affected (Figure 6.6). A portion of the concrete spalled out in the transverse beam (It should be a composite section), and the crack was developed even at the second-floor level beams. The hydrostatic pressure was capable of dislodging the wall masonry wall from its position, even at the second-floor level. Overall, although the load-bearing columns and the beams were unaffected, the walls and the timber slabs were more affected. This kind of buildings required detailed structural member inspections followed by major retrofitting works for the non-structural member. Similar kinds of failures were observed in the nearby locations (see this section's map).

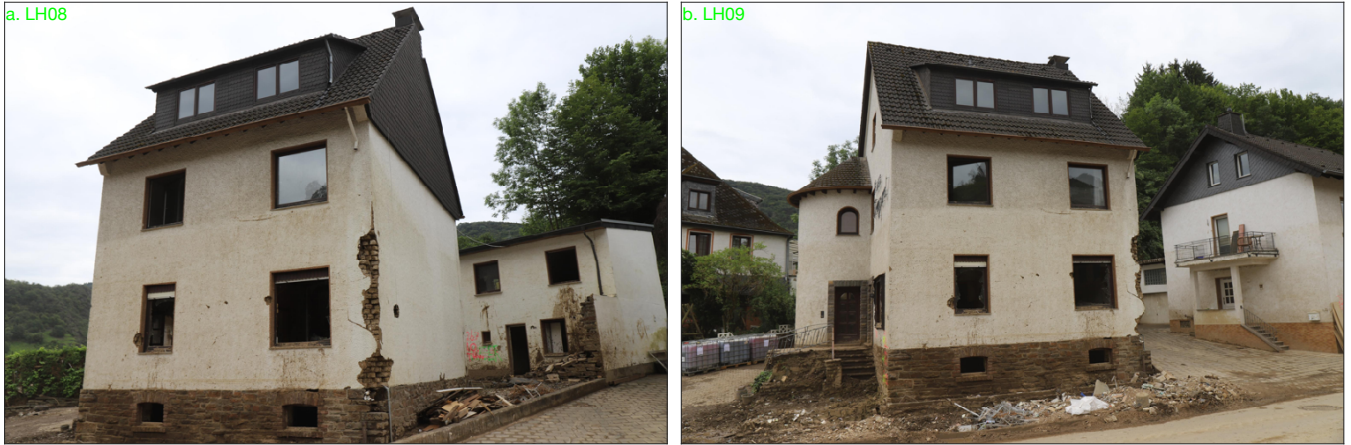
Figure 7.3. Case Study L_A

This older house, built from what appears to be old concrete bricks in a double-wythe configuration, seems to only have been affected at the corner which was facing the flood wave. This corner was possibly impacted by debris, yet the failure was only local and the rest of the structure appears to not have been affected.

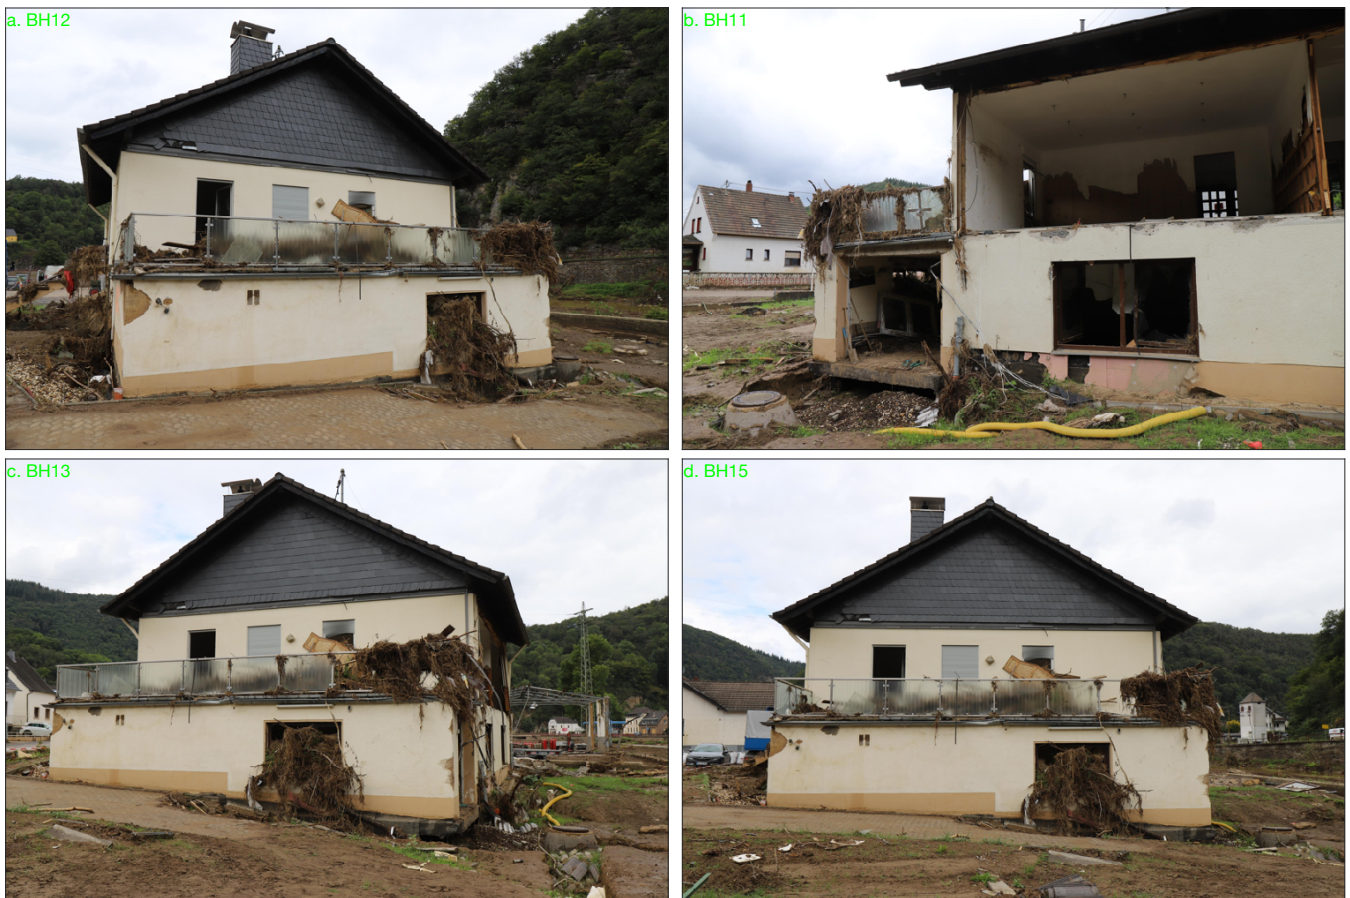
Figure 9.3. Case Study B_A

The building closest to the river and most upstream in the town of Brück was seriously affected by the flood. This building consisted of a concrete-block masonry ground floor and a timber-frame storey and roof. This building was one of the few that had not been cleaned at the time of the survey and showed the sheer amount of drift wood that tangled together and probably increased the hydrodynamic loading of the flood on the structure. One must note that only the debris which got stuck on the building remains to be observed and the rest continued to be carried by the flood.

From the outside, the masonry ground storey appears structurally unaffected. The side garage, which appears to be founded on a thin reinforced concrete slab under which severe erosion left large scour holes, also seems to be in relatively good condition. The upper timber-frame storey however, seems to have been ripped out by the flood actions. The upper beam appears split longitudinally, what suggests an outwards, out-of-plane failure mechanism of the timber façade. Yet, the rest of the timber structure seems to be supporting the roof and the structure should be able to be repaired.

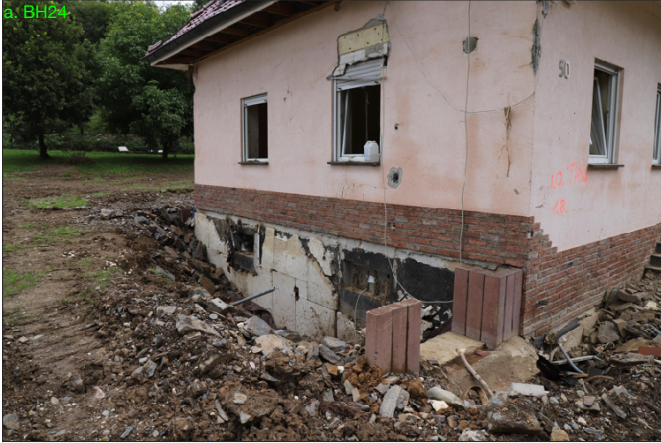
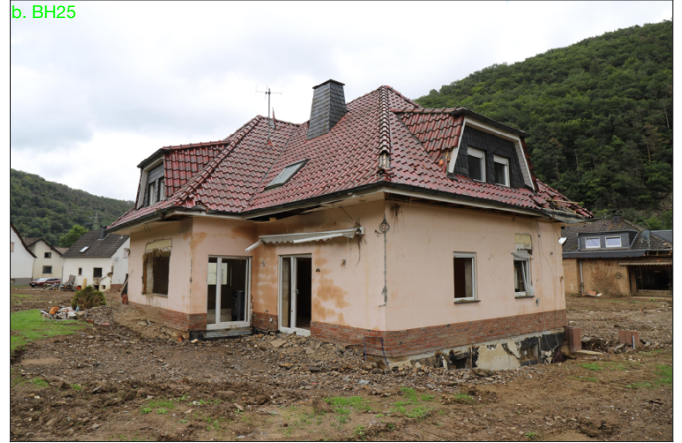
Figure 9.5. Case Study B_C

A large scour hole, about 1.5 m deep, formed next to this masonry structure. The basement of the structure prevented the scour from affecting its stability. The insulation material of both the basement and the upper structure was apparently damaged by debris collision. The tiling of the roof was also affected.

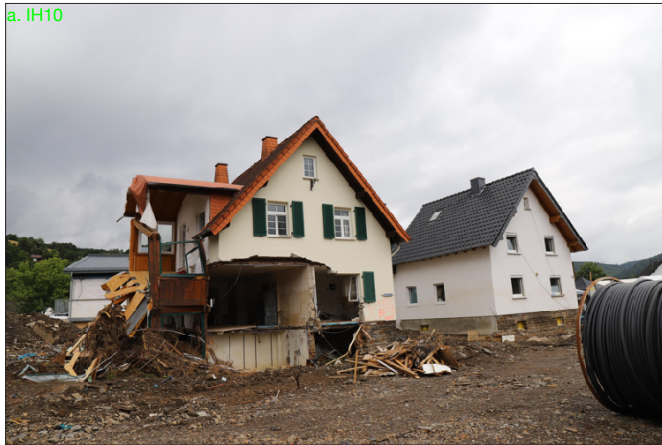
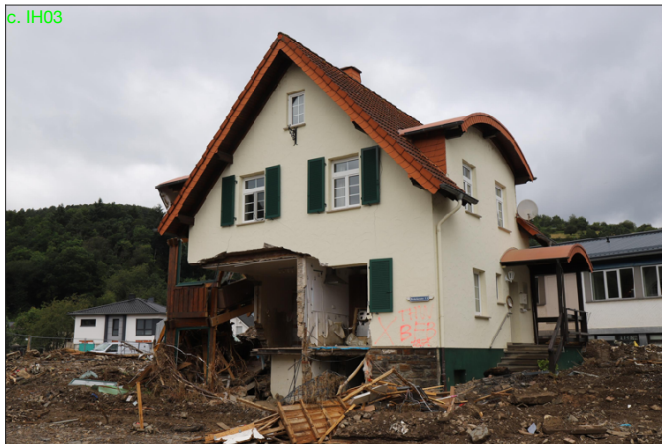
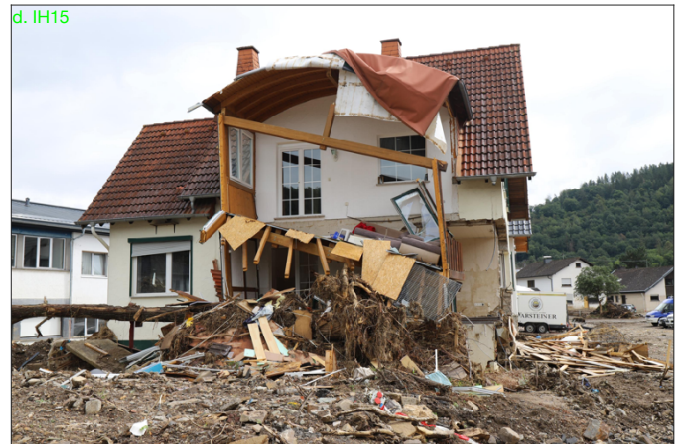
Figure 10.3. Case Study I_A

The building also sported an extension on the side as a separate, light structure constructed from timber members. This structure seems to have been undermined by erosion at its foundation. It is difficult to say whether the scour appeared before or after the collapse of the basement wall.

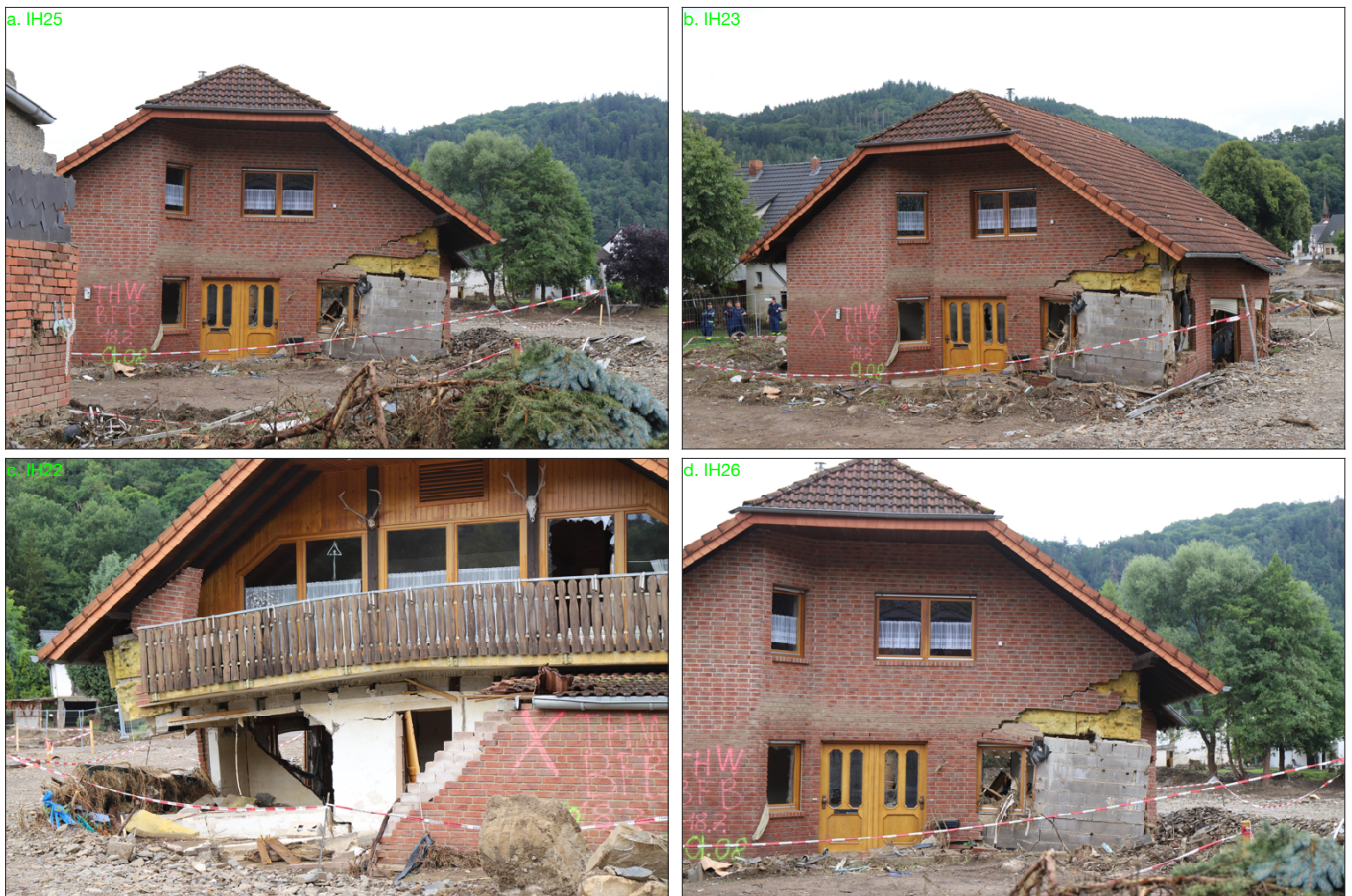
Figure 10.4. Case Study I_B

In sum, scour underneath the two corners of the building facing the flood seems to have led to the local failure of the shallow foundation and the masonry components supported directly on it.

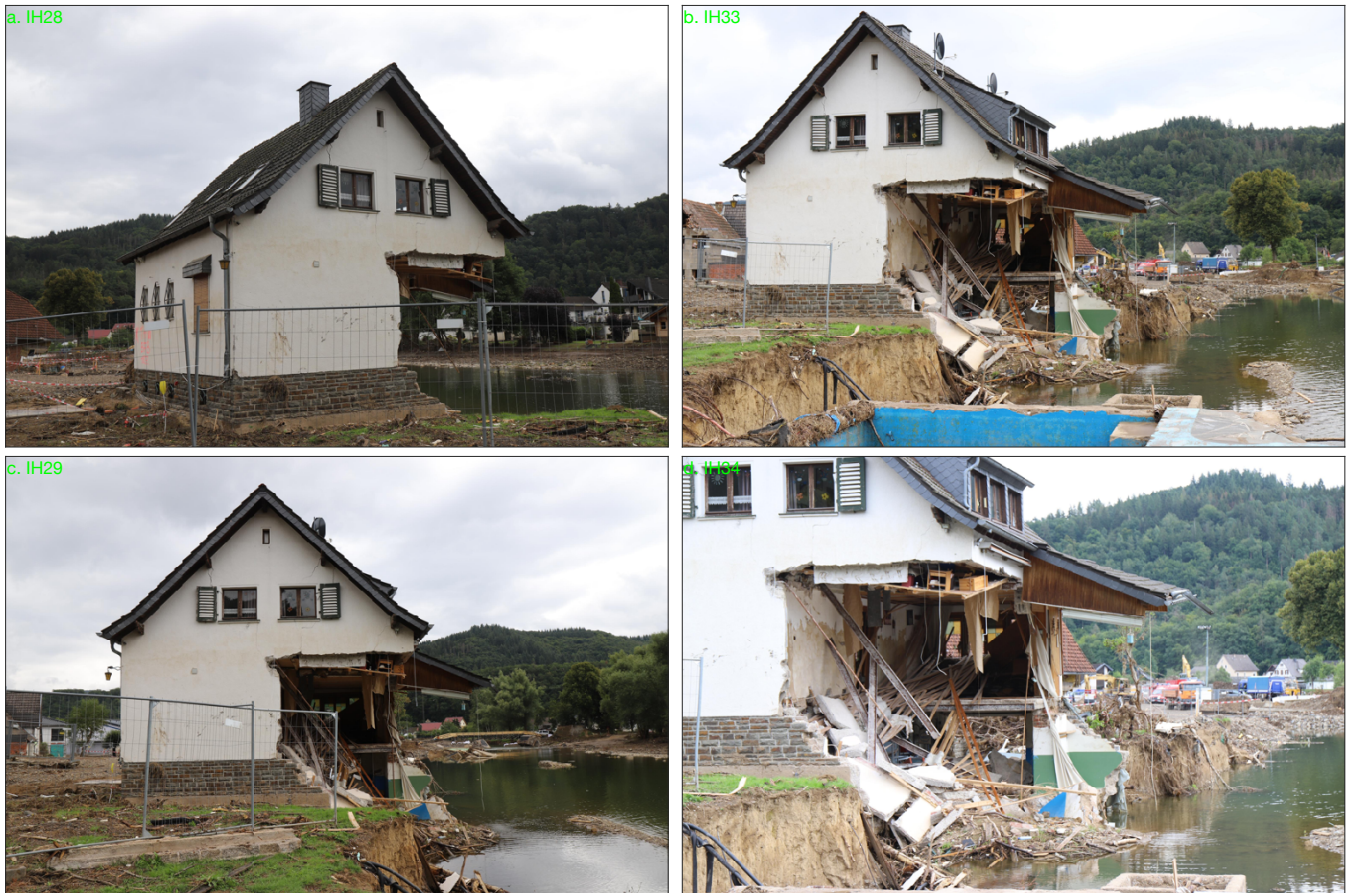
Figure 10.5. Case Study I_C

In sum, the flood, acting as an erosion-driving force, undermined the foundation of the building, even below the basement, which led to the subsequent collapse of a corner of the house. Had the stiffening concrete foundation beam been reinforced with steel rebar (what would have been a strange practice, especially for this older structure), it is likely that the house would have remained in one piece but instead tilted as a rigid body towards the undermined side.
