**Post-flood field survey of the Ahr Valley (Germany)
Building damages and hydraulic aspects**

Technical Report

07.03.2022

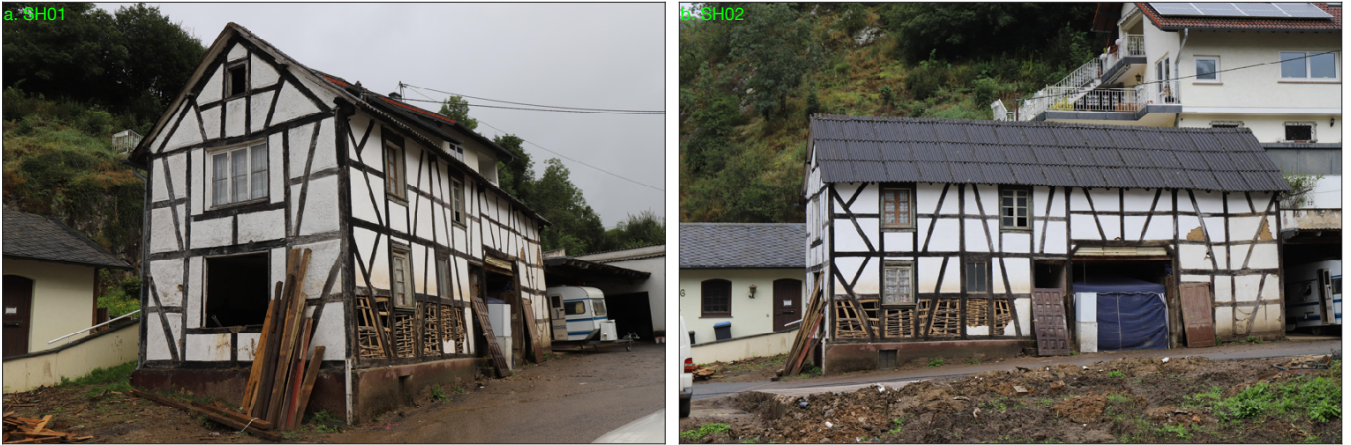
Figure 11.3. Case Study S_A

This old building with an exposed timber frame filled with plaster suffered some damage from the flood. In this case, it seems that the structural timber frame was unaffected, and only the plaster panels were damaged by the flood.

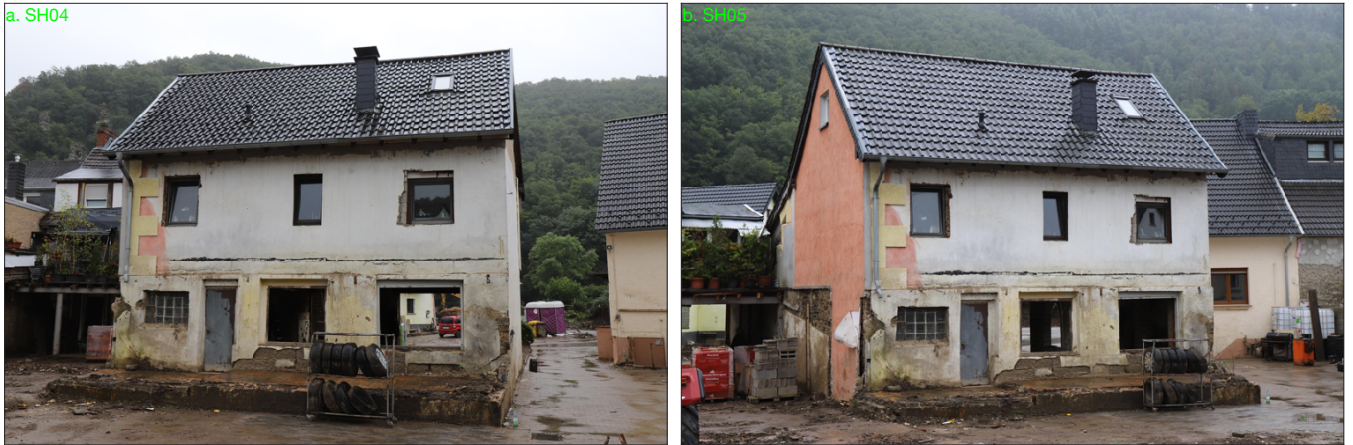
Figure 11.4. Case Study S_B

This structure seems to be built from large stone elements combined with stone bricks in the ground floor, and the upper storey seems to be of more recent clay-brick and stone-brick masonry. In this sense, the assorted construction technique did not seem significantly affected by the flood. The damage caused to the structure appears to have been limited to the removal of plaster from the masonry, small marks of collision from debris at the corners, and the damage to a veranda that may have been located at the front.

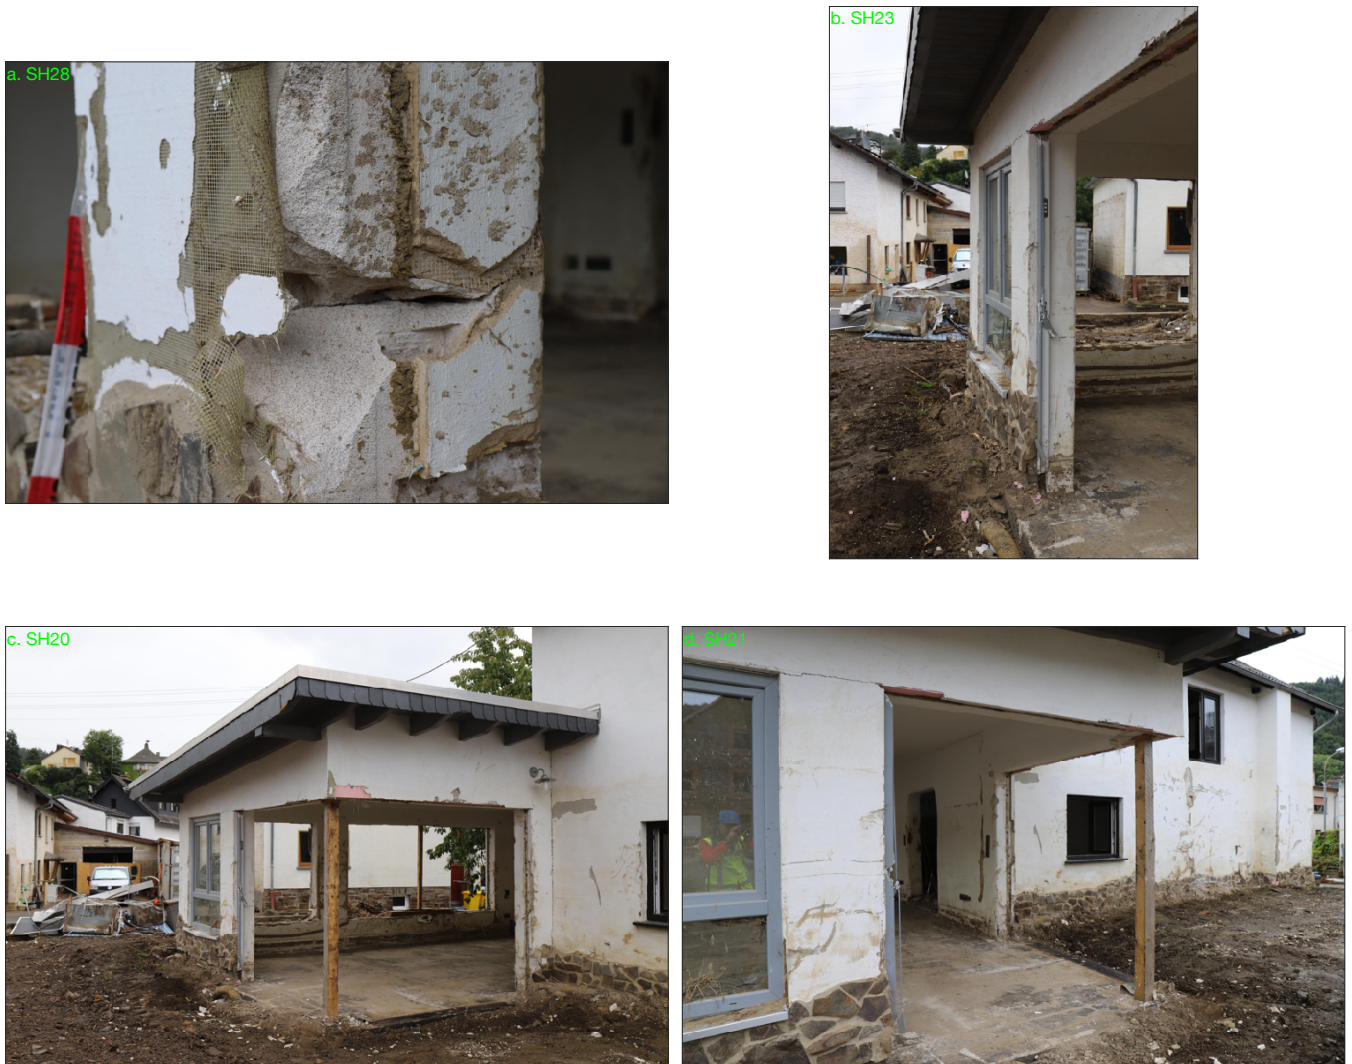
Figure 11.6. Case Study S_D

It is very likely that the damming effect of driftwood, focused the hydrodynamic pressure of the water flow onto the single piers which resulted in extremely large forces on these elements.

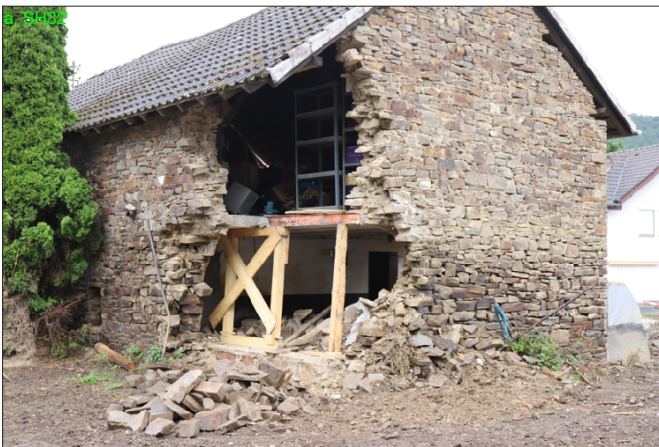
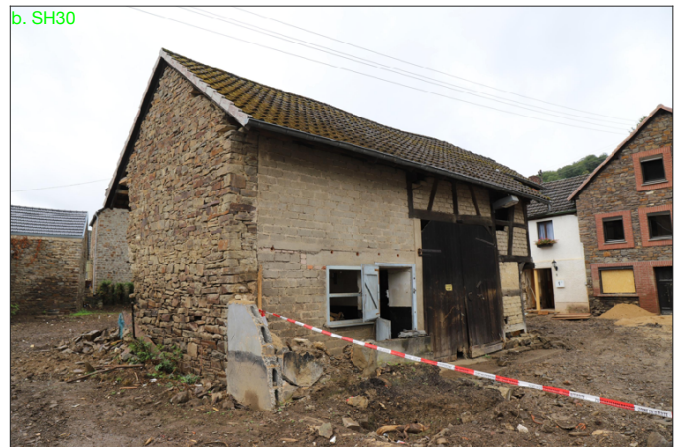
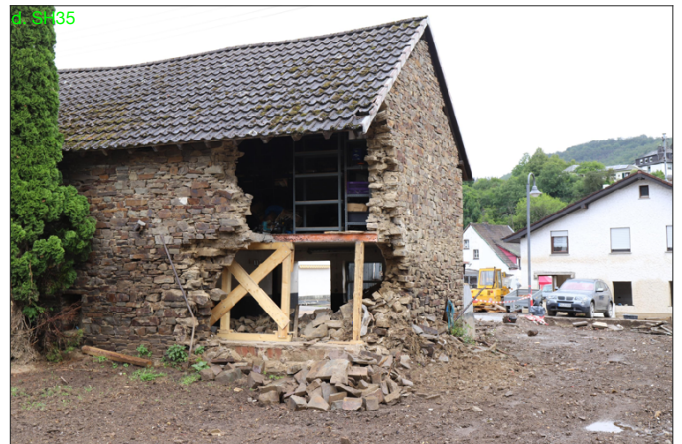
Figure 11.7. Case Study S_E

The corner of the building facing the presumed floor direction and made out between the two natural stone walls appears entirely collapsed. It is likely that the water flow carrying floating debris dislodged the stones from the wall until failure occurred.
