## Corrosion-fatigue damage identification in submerged mooring chain links using remote acoustic emission monitoring

Marine Structures

# Corrosion-fatigue damage identification in submerged mooring chain links using remote acoustic emission monitoring

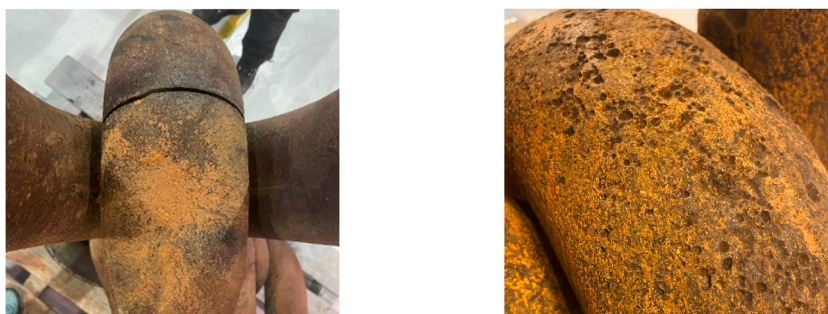
Fig. 1. Fatigue crack (left) and corrosion pits (right) in mooring chain links.

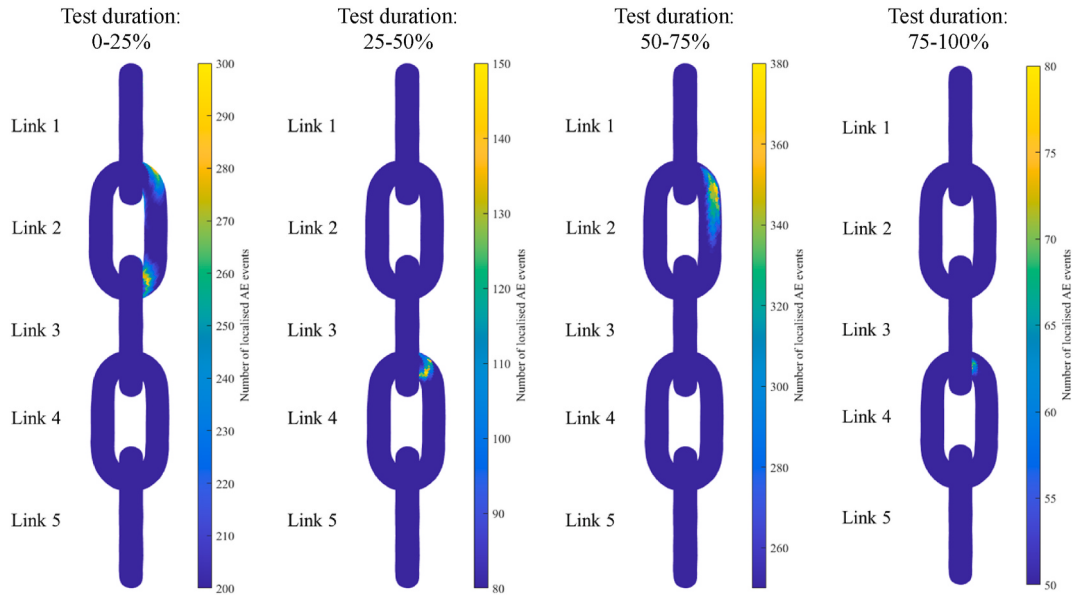
Fig. 8 shows the localisation map for four time periods of the test duration. Only from the AE source localisation maps, three damage zones can be identified. The damage zones are defined as the areas in the chain segment showing the highest number of localised AE events. These zones are located at the intersections of neighbouring links (i.e. Link 1–2, Link 2–3, and Link 3–4) and can generally be interpreted as the ‘crown areas’ (generally being the most susceptible to cracks, along with the welds). The first part of the test, 0–25 % of test duration, shows localised acoustic activity between Link 1–2 and Link 2–3. Both zones present a range of 250–300 localised AE events. In the second part of the test, 25–50 % of the test duration, the largest area of AE activity is located between Link 3–4, with 120–150 AE events. Between 50 and 75 % of the test duration, a relatively high number of AE events (in the order of 300–400) is localised around the crown area of Link 2, towards Link 1. The final part of the experiment, between 75 and 100 % of the test duration, shows acoustic activity in the upper crown of Link 4, with 50–80 AE events.

**Fig. 8.** Localisation map of AE sources for different periods of the test duration.

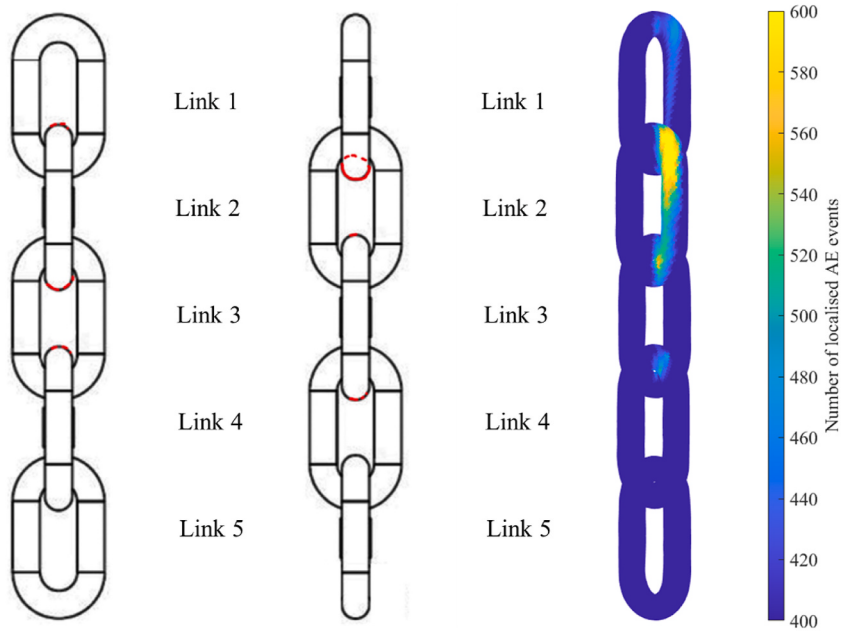
process. However, highly localised AE activity can manifest the presence of fatigue cracks. The most prominent localised area is observed in Link 1–2. This is characterised by a number of localised AE events of approximately 600, spread between the crown and the weld area of Link 2. The second-largest area of AE activity is situated in the crown area of Link 2, towards Link 3, with 550–600 localised AE events. These initial observations suggest that Link 1–3 was the most acoustically active part of the chain, confirming early indications from the parametric analysis of AE. A third zone of activity is noted in the crown of Link 4, toward Link 3, accounting for a total of localised AE events ranging between 450 and 500. A few limitations and improvement points can be identified in the AE source localisation map. First, the localised areas seem to be biased against the middle part of the chain link crown (where fatigue crack is expected to grow). This bias may arise from potential masking effects on the damage-induced ultrasound signals and the limited number of sensors in play in the localisation. Possible improvements involve increasing the number of sensors in the movable arrays and accounting for masking issues in the AE source localisation algorithm. Second, the difference in AE events numbers may be related to the extent and stage of damage, but it is also influenced by the sensitivity of the sensors and the monitoring duration in each specific position (of the movable array). Future work will incorporate the normalisation of the AE source localisation map to enhance a more accurate comparison of the monitoring results.

**Fig. 9.** Total localisation map of AE sources and a sketch showing the main fracture and the observed indications (red circle and red lines respectively) during the post-failure inspection.

When combined with the insights in Fig. 9, it can be inferred that the main AE source localised in Link 1–2 correlates with the main fracture (and linear indications) in the chain segment. The entity of the secondary AE sources (i.e. the number of localised AE events) localised in Link 2–3 and Link 3–4 correlate with the indications observed in the respective areas. All the locations where indications were found through MP testing have been detected and localised using the remote AE technique. Furthermore, there are no indications by the AE that have not been found using MP testing. It can be concluded that a good correlation between the post-failure observation and the AE localisation has been found.

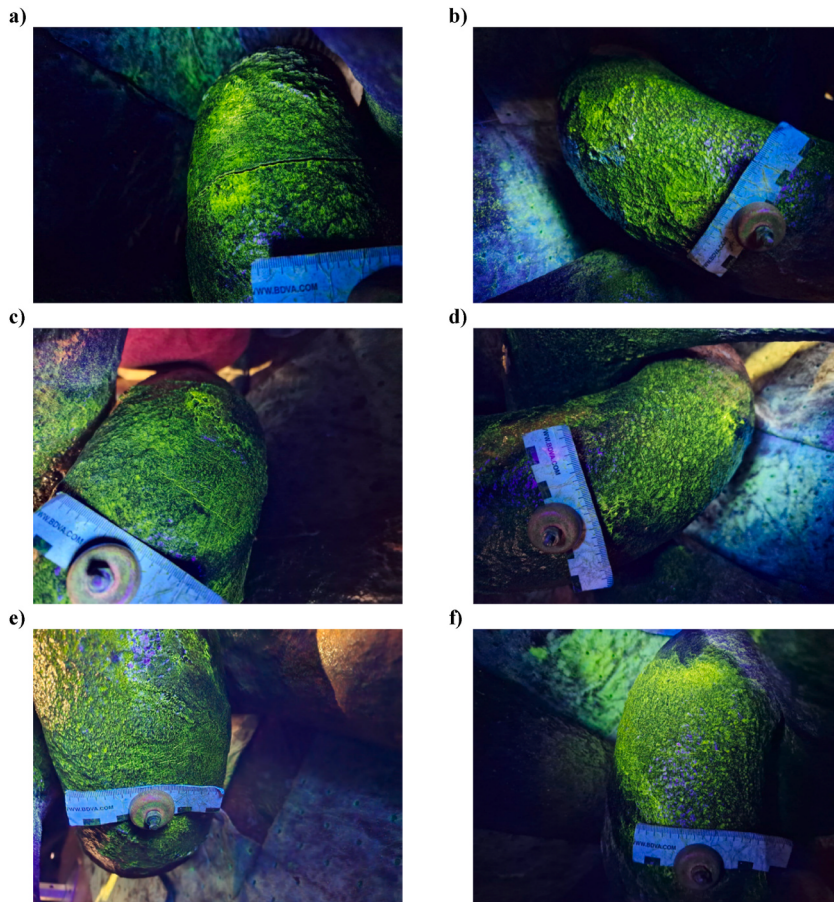
The condition of the chain segment was assessed at the end of the experiment through visual inspection and magnetic particle (MP) testing. All the links of the chain segment were tested. The positions in each link are labelled A, B, C, and D as shown in Fig. 10. The reported observations are located in the crown area of the chain links. The results of the post-failure inspection are shown in Fig. 11. The main fracture (Fig. 11a) was observed in Link 1 towards Link 2. The results of the post-failure inspection are summarised in Table 3.

Fig. 11. Results post-failure inspection. (a) Link 1, position D. (b) Link 2, position A. (c) Link 2, position D. (d) Link 3, position A. (e) Link 3, position D. (f) Link 4, position A.

| Link | Region | Observations | Shown in Figure |
|---|---|---|---|
| Link 1 | D | Fracture and linear indication measuring 12 mm. | Fig. 11a |
