Building Resilience: Analyzing Beira's Drainage Network and Flood Management

The impact of failure mechanisms on flooding in informal settlements

Job Knoop

to obtain the degree of Master of Science
at Delft University of Technology,
to be defended publicly on November 10, 2023 at 10 AM.

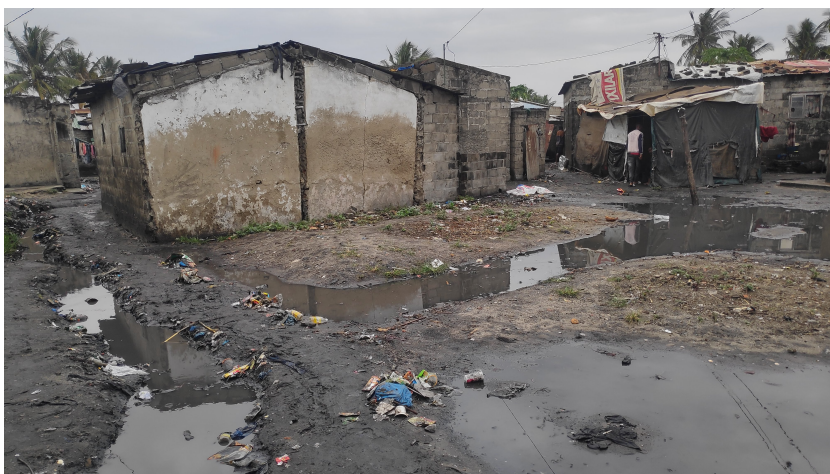
Figure 1.1: A flooded neighborhood in Munhava, Beira (picture by author)

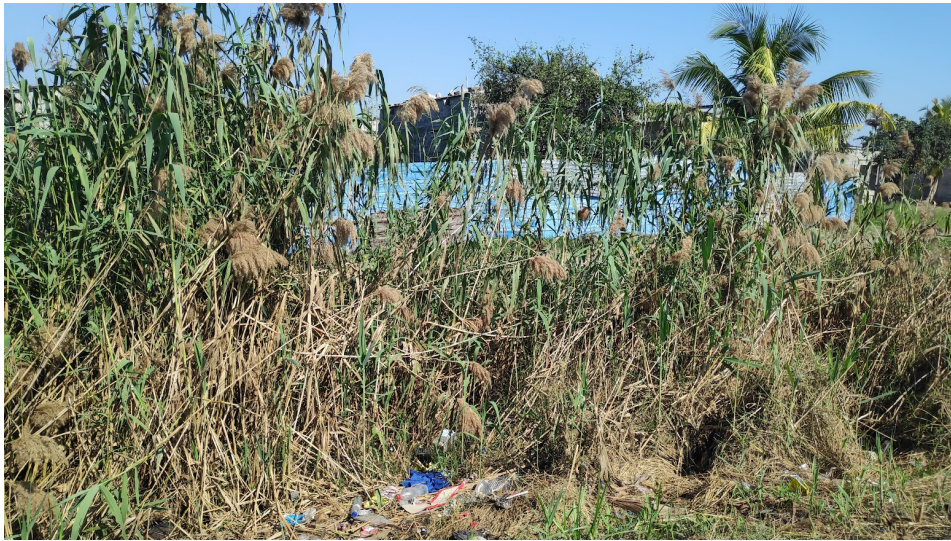
Commonly known as common reed or caniço in Portuguese, *Phragmites australis* (Figure 2.4a) is a perennial grass that is found in wetlands and other aquatic habitats around the world. It is known for its high Relative Growth Rate (RGR) - a measure for the growth of vegetation. The RGR of *Phragmites australis* is influenced by a variety of factors, including salinity, availability of nutrients and water depths (Cronk and Fennessy, 2016).

(a) *Phragmites australis* in Chota, Beira (picture by author)

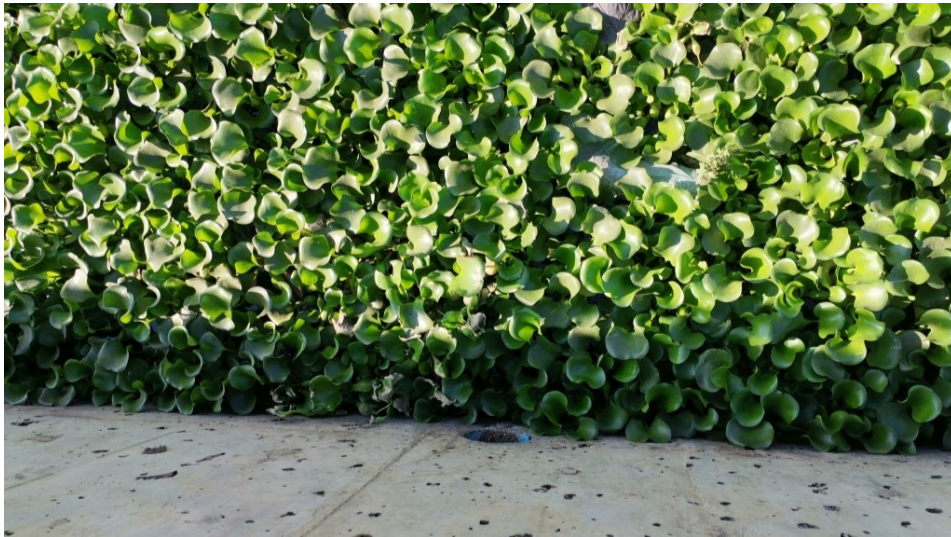
(b) *Pontederia crassipes* in a drainage canal in Munhava, Beira. Note that there is no flowering, as the picture was taken in June (picture by author)

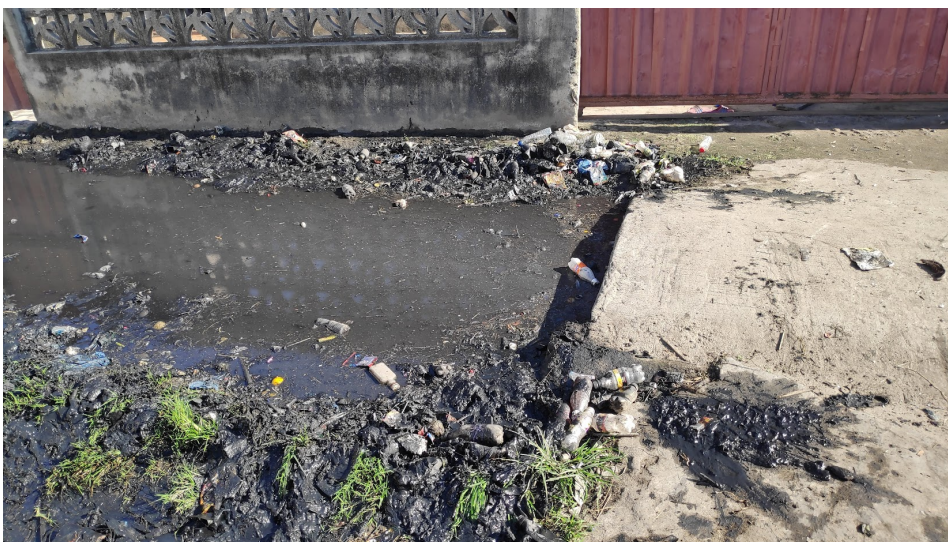
(a) A concrete bridge in a canal in Munhava-Matope, Beira (picture by author)

Human interference is typically observed in the form of complete houses constructed within the canals (Figure 2.5b), as well as bridges over the canals constructed using tires, concrete, or sand (Figure 2.5a). In informal settlements, it is generally difficult to displace, let alone prosecute individuals who have built illegally in the drainage canals due to the lack of alternative construction locations and the absence of a proper cadastral information system. Numerous examples exist of governments being unable to identify those responsible for illegal construction (Adigun, 2023).

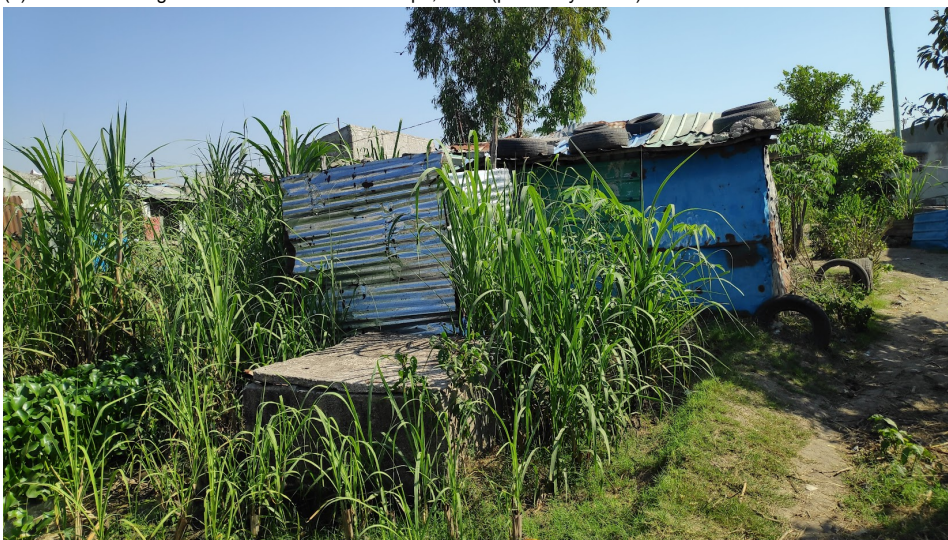
(b) An illegal house constructed in a vegetation-overgrown canal in Chota, Beira (picture by author)

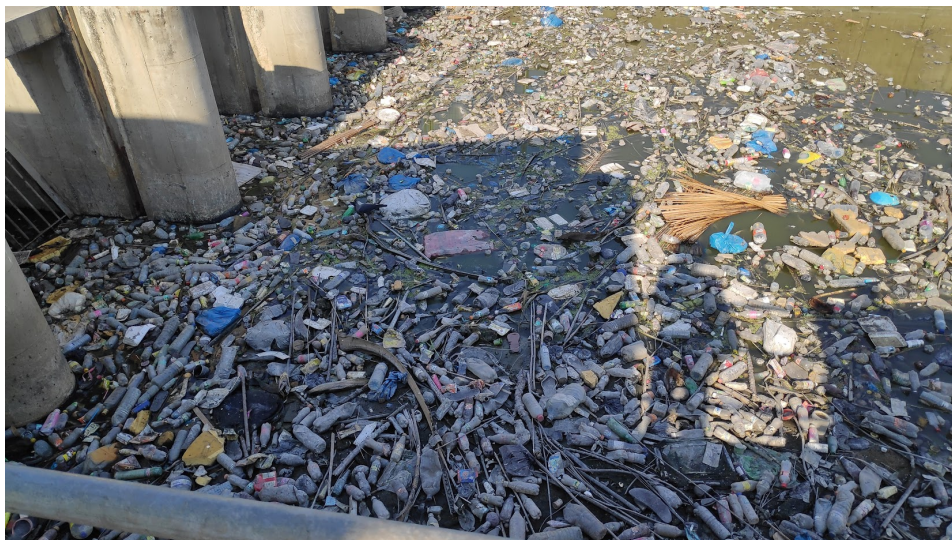
Figure 2.6: Waste accumulating at a bar screen in Beira (picture by author)

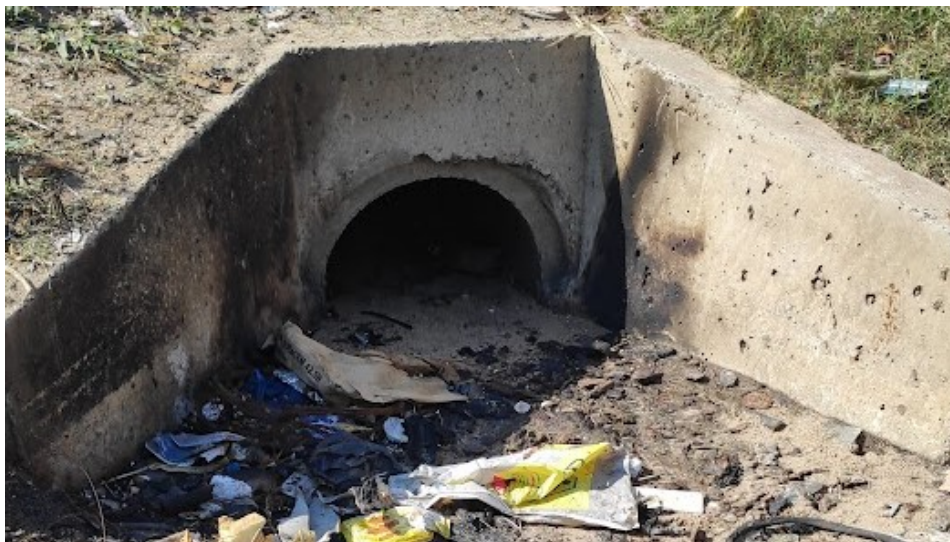
Figure 2.7: Accumulation of sediments in Palmeiras, Beira (picture by author)

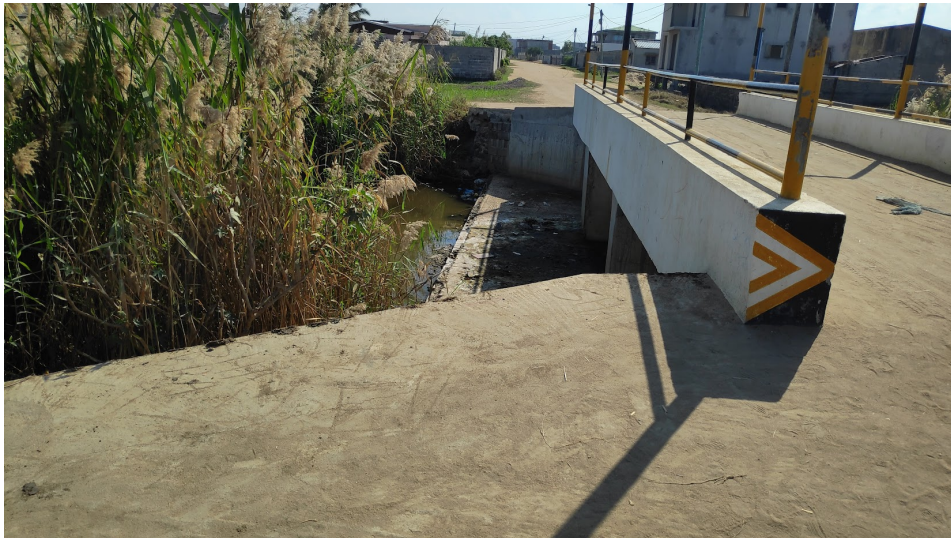
Figure 2.8: Bridge in the drainage system in Chota, Beira (picture by author)

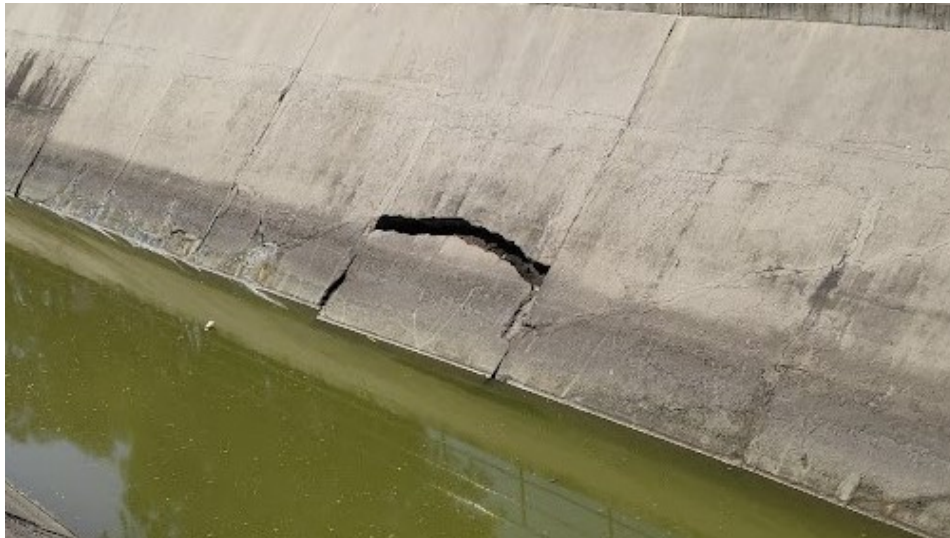
(a) A broken side wall in Munhava, Beira (picture by author)

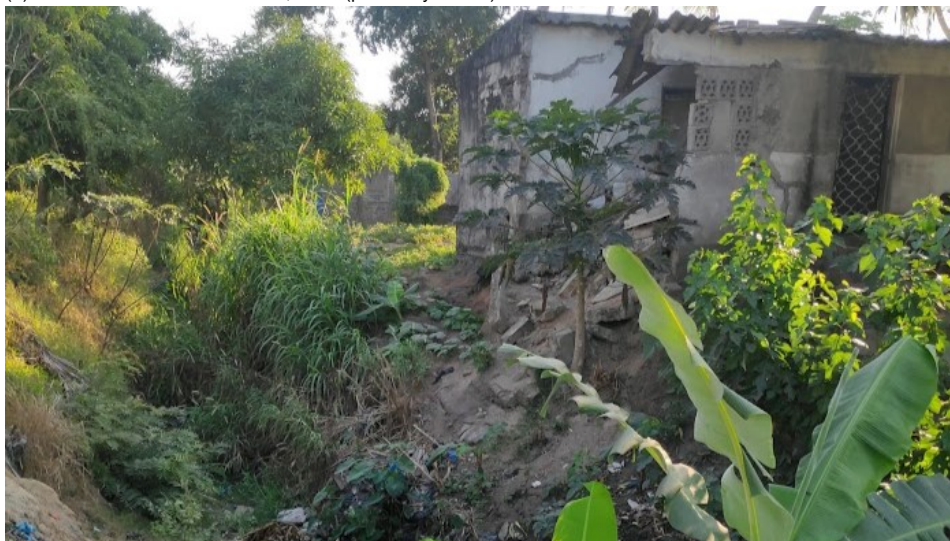
- **Erosion:** Erosion is generally caused by large precipitation events, resulting in high water velocities and mobilisation of soils. This erosion can change the course and dimensions of canals or cause damage to structures in the canals (Figure 2.9b).

(b) Erosion of a canal side wall, causing the collapse of a house next to a bridge in Manga, Beira (picture by author)
