## Quasi-static test on half-scale modern unreinforced masonry building with plan irregularity

Aşıkoğlu, Abide; Vasconcelos, Graça; Barontini, Alberto; Lourenço, Paulo B.

Bulletin of Earthquake Engineering

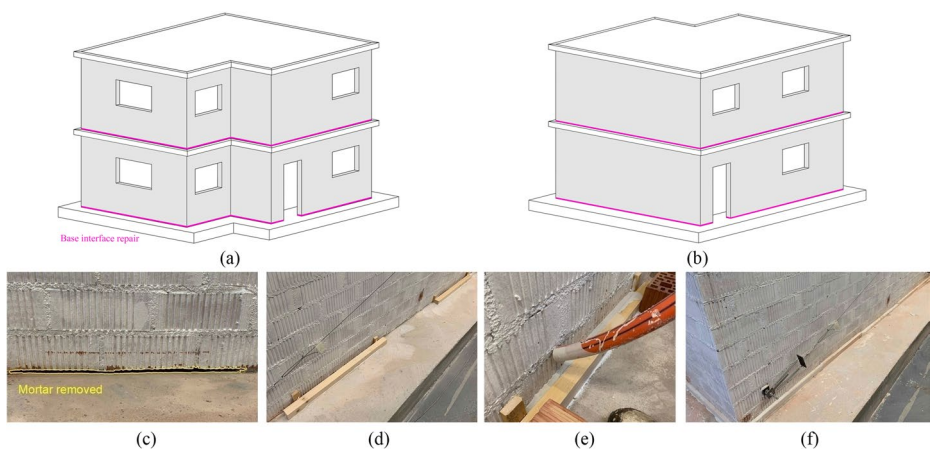
Following the completion of Test 1, minor damage was observed on the structural walls. However, the boundary interface of the walls was detached from the foundation, leading to detachment at the base. To ensure the specimen remains suitable for continued testing, lim-

ited modifications were carried out prior to Test 2. These modifications were guided by practical considerations and focused exclusively on restoring the original boundary conditions without altering the specimen's structural characteristics. Specifically, fluid mortar (Mape-Antique I) was used to re-establish the wall-foundation and wall-slab connections, ensuring continuity in load transfer and overall stability, see Table 4. The repair was carried out along the perimeter at the base interface of the walls on both floors, as shown in Fig. 9(a), and (b). The bed joint below the first course of bricks was carefully removed progressively, firstly on the first floor (Fig. 9(c) and (d)). A mould with a height of 70 mm was prepared to cast the new consolidation material. Before applying Mape-Antique I, the area was sprayed with water to prevent excessive absorption of water by the bricks and concrete. This cement-free hydraulic binder, with an 18 MPa compressive strength after 28 days, was selected for its superfluid consistency and a maximum aggregate size of 100  $\mu\text{m}$  to prevent the occurrence of voids (Fig. 9(e)). After repairing the first bed joint on the first floor, a 7-day curing period was considered before proceeding with the second floor (Fig. 9 (f)). No repairs were performed on the observed wall cracks, as introducing new materials and reinforcement could have influenced the structural behaviour.

**Fig. 9** Repair of the base interface along the perimeter (highlighted in pink) to restore the wall-foundation or slab connection after Test 1: (a) North-West façade, (b) South-East façade, (c) removal of the cement-based mortar, (d) preparation of the formwork, (e) filling in Mape-Antique I slurry, and (f) end of the application

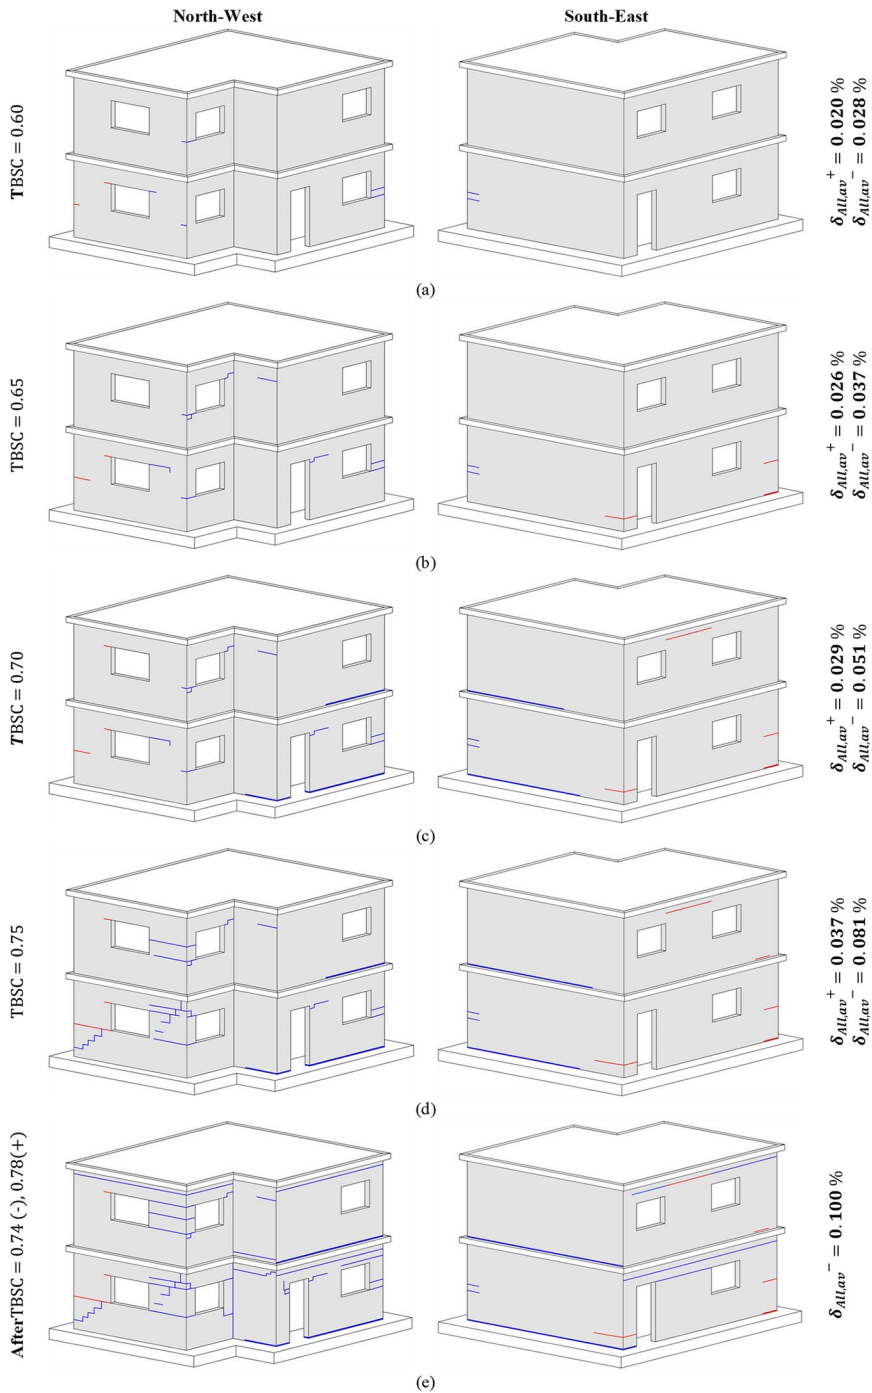
The damage analysis indicated no visible cracks until the applied lateral load reached 60% of the total weight of the structure (total BSC=0.60). The average drift ratio on the second floor ( $\delta_{All,ave}$ ) was measured at 0.020% (0.62 mm) in the positive direction and 0.028% (0.86 mm) in the negative direction (Fig. 14a). Crack initiation was identified at low drift values recorded on the first floor, with bed joint cracks appearing at the south-west corner at an inter-story drift ratio of 0.012% in the negative direction. see Fig. 15(c). Crack occurrence was primarily driven by the load applied in the negative direction. Signs

**Fig. 14** Evolution of damage throughout Test 1. The red colour refers to damage due to loading in the positive direction while the blue colour indicates cracks as a result of negative loading

of flexural tension cracks were detected on the North1 wall piers on the first floor. Initial cracks align with high-stress concentrations around window and door openings, as well as the corners (specifically, the southwest corner on the first floor and the northwest corner on the second floor). These cracks further expanded to perpendicular walls, highlighting the effectiveness of the flange, as shown in Fig. 17.

the structure. The second floor developed new cracks that were concentrated on the setback, such as a diagonal crack on the West1 and North2 walls (Fig. 14b).

As the final load step progressed to a maximum total drift of 0.049% (Total BSC=0.78) in the positive direction, the width of the existing cracks increased further, but there was no evidence of new occurrences. Additionally, the load application did not reach its target load in the negative direction, and the structure failed once the Total BSC reached 0.74, which was lower than in the previous cycle. This, indeed, shows that the maximum capacity of the structure was reached in the negative direction. Since the loading procedure was under force control, the experimental system could not maintain the force, and the displacement increased rapidly, resulting in the formation of new horizontal and diagonal cracks. The structural walls were severely detached from their boundary constraints on both floors, as demonstrated in Fig. 14 (e). Consequently, it was decided to stop the test.

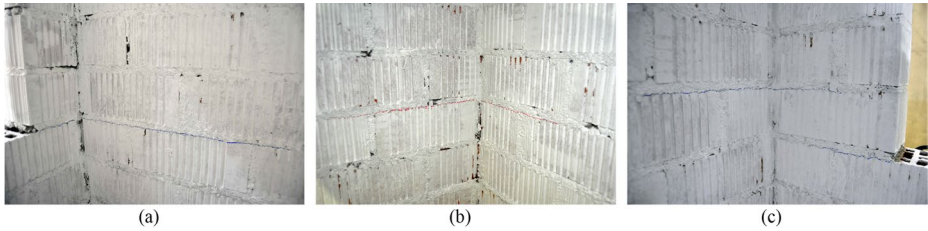
**Fig. 16** Horizontal cracks observed at the corners: (a) northwest corner, (b) northeast corner, (c) southwest corner

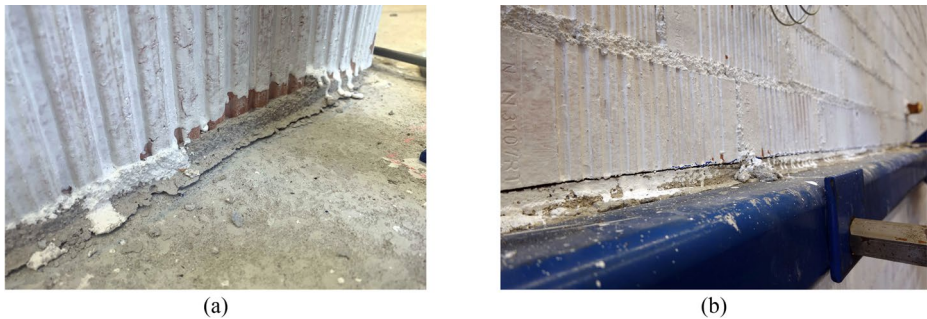
**Fig. 18** Uplift deformations observed at the boundary of the: (a) Southwest corner on the first floor, (b) South wall on the second floor

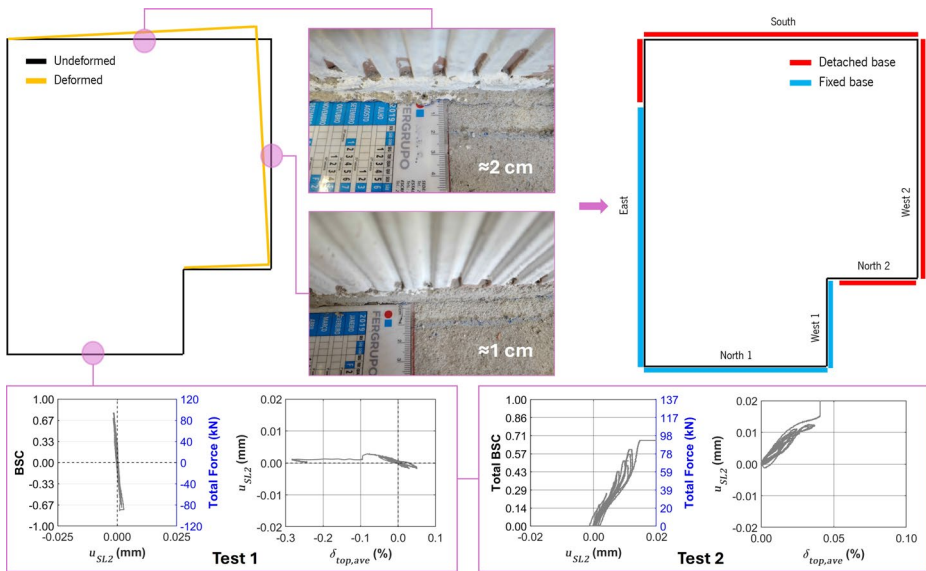
**Fig. 21** Visual representation and measurements of residual sliding displacement at the base of the structure after Test 1. Additionally, sliding displacements recorded during Test 2 are presented at their respective locations

SL2, which was significantly less than 0.01 mm, indicating no significant sliding below the North1 wall. A summary of inter-story drift ratios, total drift ratios, and their associated damage mechanisms is presented in Table 9 for each in-plane wall at various levels of Total BSC.

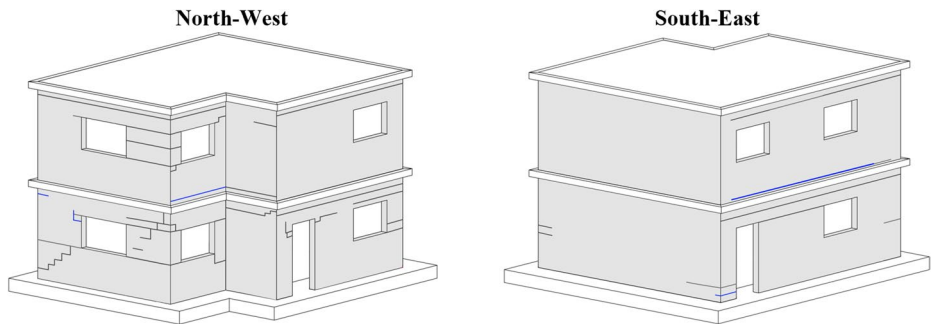
Figure 22 presents the progression of damage (indicated in blue) observed during Test 2, after boundary repair of the structure and more weight was added. Notably, no damage was recorded at the base of the structural walls, similar to uplift, highlighting the efficiency of the boundary interface repair conducted after Test 1. The observed damage, on the other hand, was predominantly linked to the activation of pre-existing cracks, which were observed to open and close during the test. Onset diagonal shear crack formed on the North1 wall, while horizontal cracks were observed at the base of West1 wall and the East wall on the second floor. It is stressed that the horizontal cracks transitioned directly above the first brick course rather than the repaired mortar layer, which suggests the efficiency of the repairing method. This implies that the repaired boundary interface contributed to the redistribution of the strains, thereby preventing damage along the boundary interfaces. This finding is consistent with the displacement measured on the South wall, which was relatively lower compared to other in-plane walls, as presented in Fig. 24. The maximum displacement recorded on the South wall was 1.0 mm, with less than 0.05 mm observed on the first and second floors, respectively.

**Fig. 22** Evolution of damage at the end of Test 2
