## Damage Diagnostics of a Composite Single-Stiffener Panel Under Fatigue Loading Utilizing SHM Data Fusion

# Damage Diagnostics of a Composite Single-Stiffener Panel Under Fatigue Loading Utilizing SHM Data Fusion

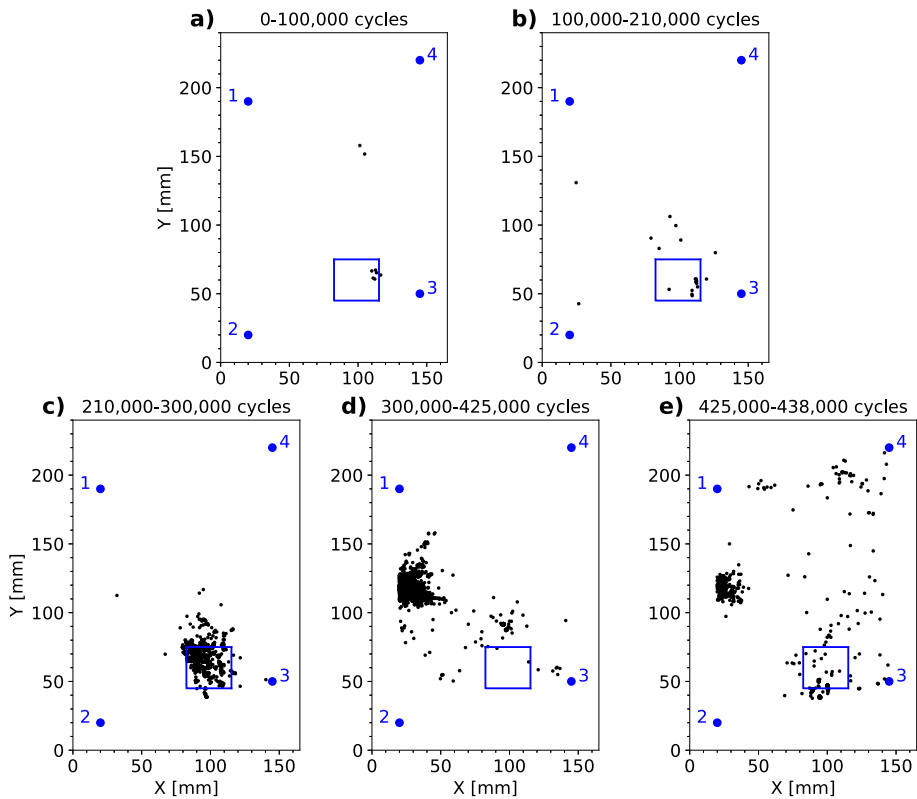
**Fig. 2.** Localized acoustic emission hits for specified cycle periods. The initial disbond location is indicated by a blue square and the AE sensors by blue circles.

all locations: the bottom region below a height of 90 mm shows a smaller absolute compressive strain reduction than the region above 90 mm. Evaluating the localized AE events for this cycle period (Fig. 2b), it is seen that some hits are localized around the disbond region. Figure 3 shows a further increase in cumulative energy, although it is a slightly steeper increase than in the previous cycle period. These results are an indication that, besides stiffness degradation, activity is present near the disbond resulting in disbond growth.

**210,000–300,000 Cycles.** Between 210,000 and 300,000 cycles, many AE events are localized, which are centered in the initial disbond area and above it (Fig. 2c). Furthermore, the cumulative energy curve (Fig. 3) has an increased slope and increases continuously throughout the considered period. The distributed strain measurements along the stiffener feet for 210,500 and 300,500 cycles are shown in Fig. 4a and b. Similar to the previous cycle period, the left stiffener foot experiences only minimal changes in strain values while the right stiffener foot shows larger differences: a small strain reduction is seen between 80 mm and 110 mm, while the region above 110 mm displays larger reductions in strain. Based on the results from both SHM techniques, it can be concluded that the disbond has grown during the considered cycle period. In addition, the direction of disbond growth can be derived from the results and it is believed to have grown upward along the length of the right stiffener. This is based on the concentration of AE events in the upper region and above the initial disbond area, as well as the minimal strain reduction on the right stiffener foot between

Nevertheless, it needs to be recognized that a large number of AE events is localized in the center height of the left skin. Moreover, the cumulative energy increases rapidly after 300,000 cycles. Evaluating the left stiffener foot, only a minimal compressive strain reduction is noted in the lower half, thereby providing little clarification on the cause of these AE events. Therefore, data from two additional SHM techniques was evaluated, namely the DIC system and LWDS. Neither provided indications of damage initiation and propagation. Given that a PZT of the LWDS is located at  $[x, y] = [25.0, 120.0]$  mm, it is therefore argued by the authors that these AE hits do not indicate a damage process but that these were instead caused by an external source. A further investigation is required to establish the actual cause; however, it is hypothesized to be either a faulty PZT or a mechanical process such as the cable of the PZT hitting the panel during fatigue loading.

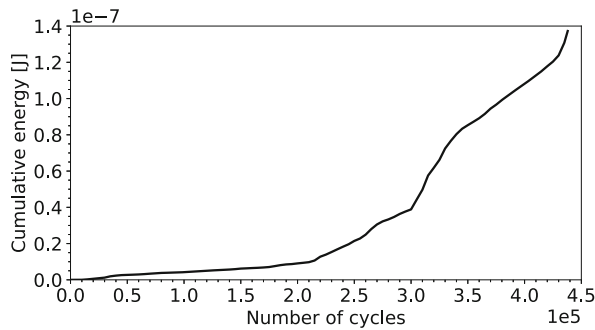
**Fig. 3.** AE cumulative energy versus number of cycles, with bins of 5000 cycles.

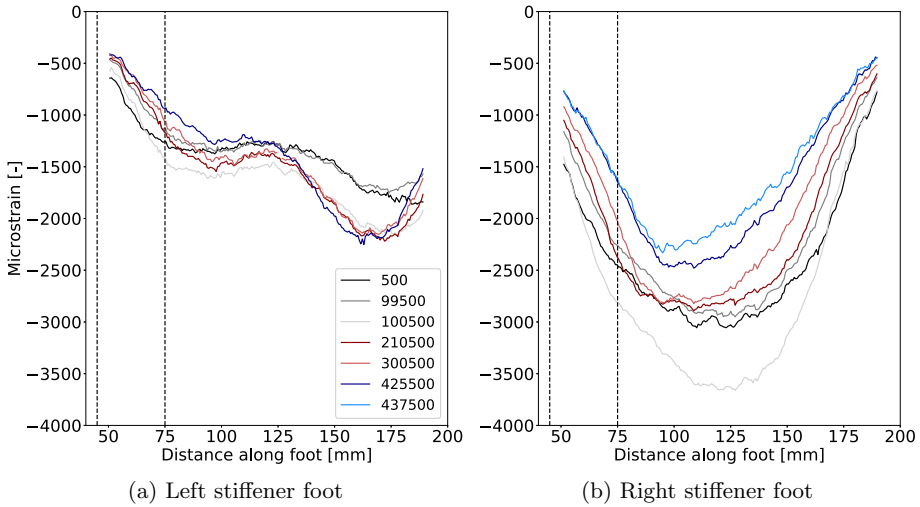
**0–100,000 Cycles.** The strain measurements on the stiffener feet at 500 and 99,500 cycles are displayed in Fig. 4a and b, while the localized AE events for a similar cycle period are shown in Fig. 2a. Both measurements do not show indications of damage growth during this cycle period. Moreover, the cumulative energy of the AE hits has only shown a minimal increase from 0 to 100,000 cycles. The latter, together with the identification of a minimal strain reduction along the lengths of both stiffener feet, can be an indication that only stiffness degradation took place under the fatigue loading rather than disbond growth.

**100,000–210,000 Cycles.** Figure 4a and b show comparisons between the strain measurements on the stiffener feet at 100,500 and 210,500 cycles. The compressive strain in both feet has increased at 100,500 with respect to 99,500 cycles due to the increased maximum load (–50 kN to –60 kN). Comparing the

strain measurements at 100,500 and 210,500 cycles, little change is detected on the left foot, while the right foot shows a larger reduction in compressive strain. However, this reduction in strain does not occur with a similar rate at

**Fig. 4.** Surface strain measurements along the stiffener feet. The disbond is located in the right stiffener foot and its initial location is indicated in both graphs using black dashed lines. Legend is similar for both figures.

**425,000–438,000 Cycles.** Evaluating results closer to final failure, it is seen that the strain distribution in the lower half of the right stiffener foot remains close to constant, while the region above 90 mm shows a further strain reduction. Simultaneously, the left stiffener shows a reduction in compressive strain between approximately 100 mm and 130 mm while the strain in the lower and upper regions remains close to constant. The latter might be caused by either a disbond growth upward along the right stiffener or by a disbond growth from the right stiffener foot to the left stiffener foot. This reasoning can be further substantiated when evaluating the localized AE events (Fig. 2e); events are localized both below and above the initial disbond region. Additionally, around a height of  $y = 60$  mm, multiple AE events are localized left of the disbond area. The growth of the disbond across the length of the stiffener as well as along its width is believed to have resulted in the final failure of the panel. The panel failed after 438,000 cycles during QS loading.
