## Experimental Study of Key Parameters in Turnout Crossing Degradation Process

X Liu<sup>1</sup>, V. L. Markine<sup>1</sup>, I.Y. Shevtsov<sup>2</sup>, R.P.B.J. Dollevoet<sup>1, 2</sup>

**KEY WORDS:** Railway turnout crossing; degradation process; field measurements; dynamic frequency response function; condition assessment

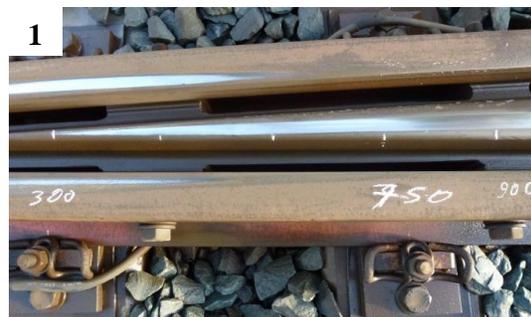
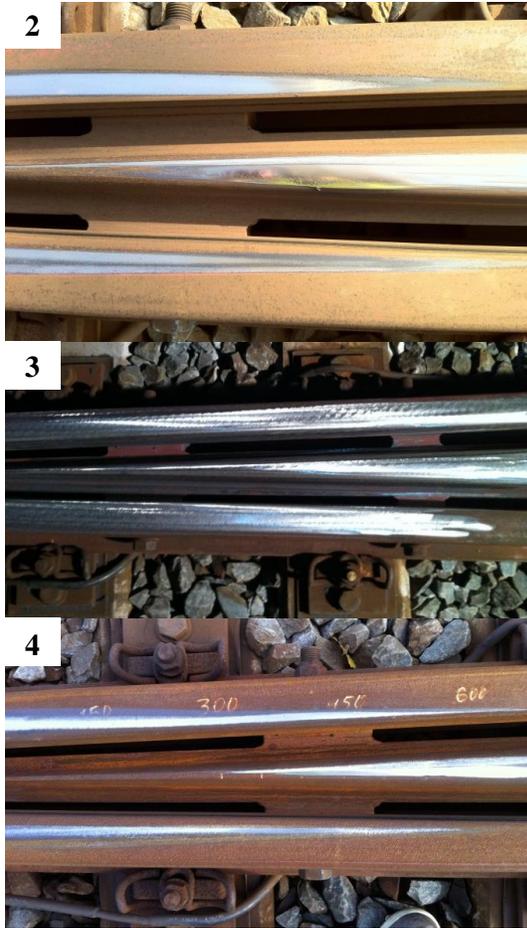
(1: Worn; 2: Damaged; 3: Welding and Grinding; 4: Maintained)  
Figure 1 Overview of the measured turnout crossing

In the “Worn” stage, the crossing nose had certain degree of wear, but no significant visible damage. Plastic deformation and cracks were clearly seen in the “Damaged” crossing. Through grinding and welding the damaged part was removed and the crossing was reshaped. After short operation period in “Maintained” stage, sharp angles were mostly polished by wheel/rail interaction, from the rail point of view, the crossing condition was good.
